# VOID DETECTION DEMONSTRATION PROJECT STATUS REPORT

Underground Mine Mapping Benchmarking Workshop  
Interstate Mining Compact Commission (IMCC) / Office of Surface Mining  
(OSM)

George H. Gardner, PE  
Senior Civil Engineer, Mine Waste and Geotechnical Engineering Division

Pittsburgh Technical Support Center

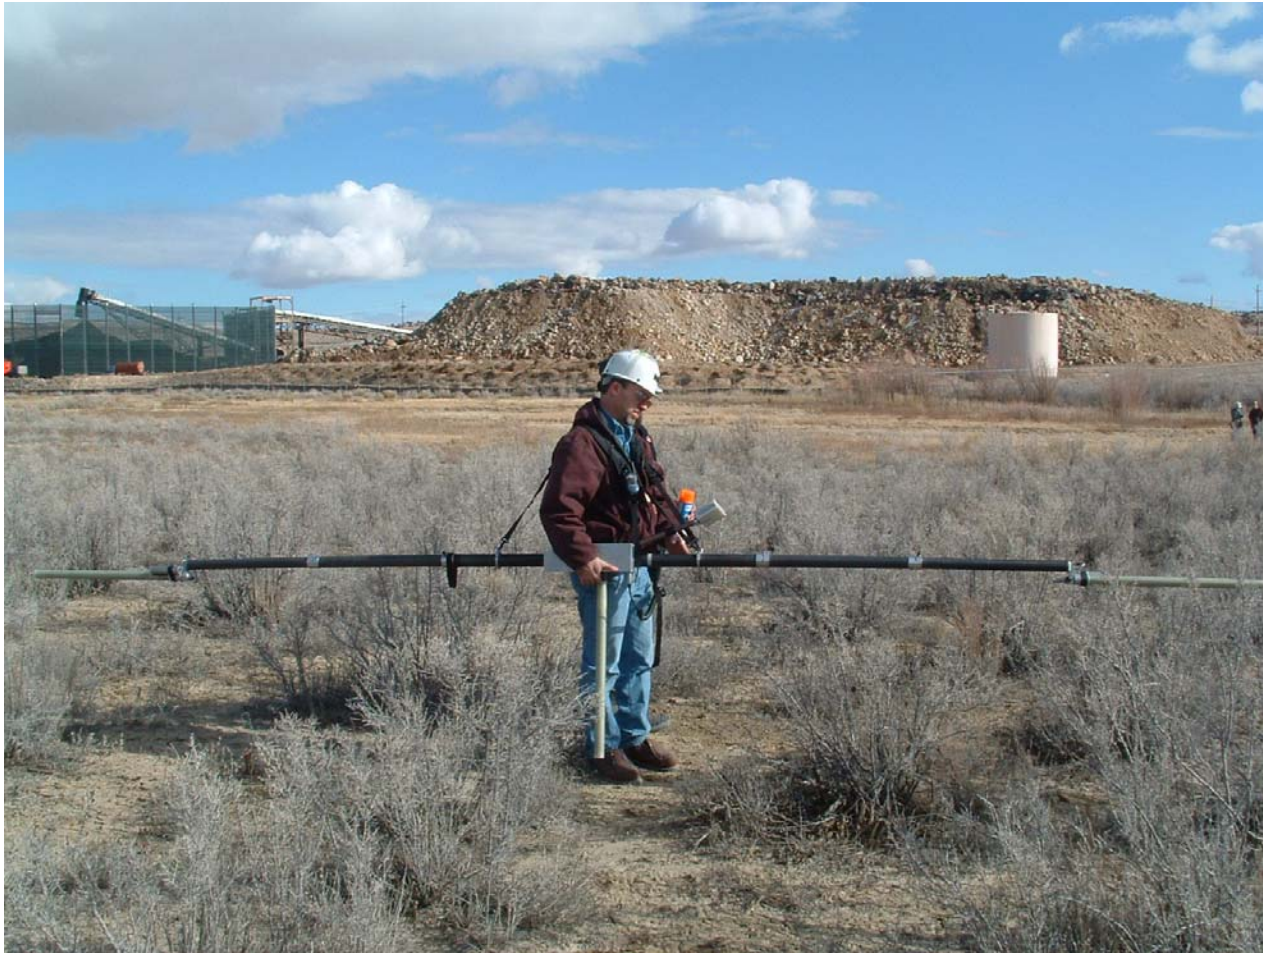
Gradiometer receiver at first survey area. Depth of cover over the entries is approximately 80 to 100 Feet.
