WOOD RIVER VALLEY AQUATIC HABITAT STUDY 2008 MONITORING REPORT

**USDA -- Natural Resources Conservation Service
1201 NE Lloyd Blvd, Suite 900
Portland, OR 97232**

December 2008

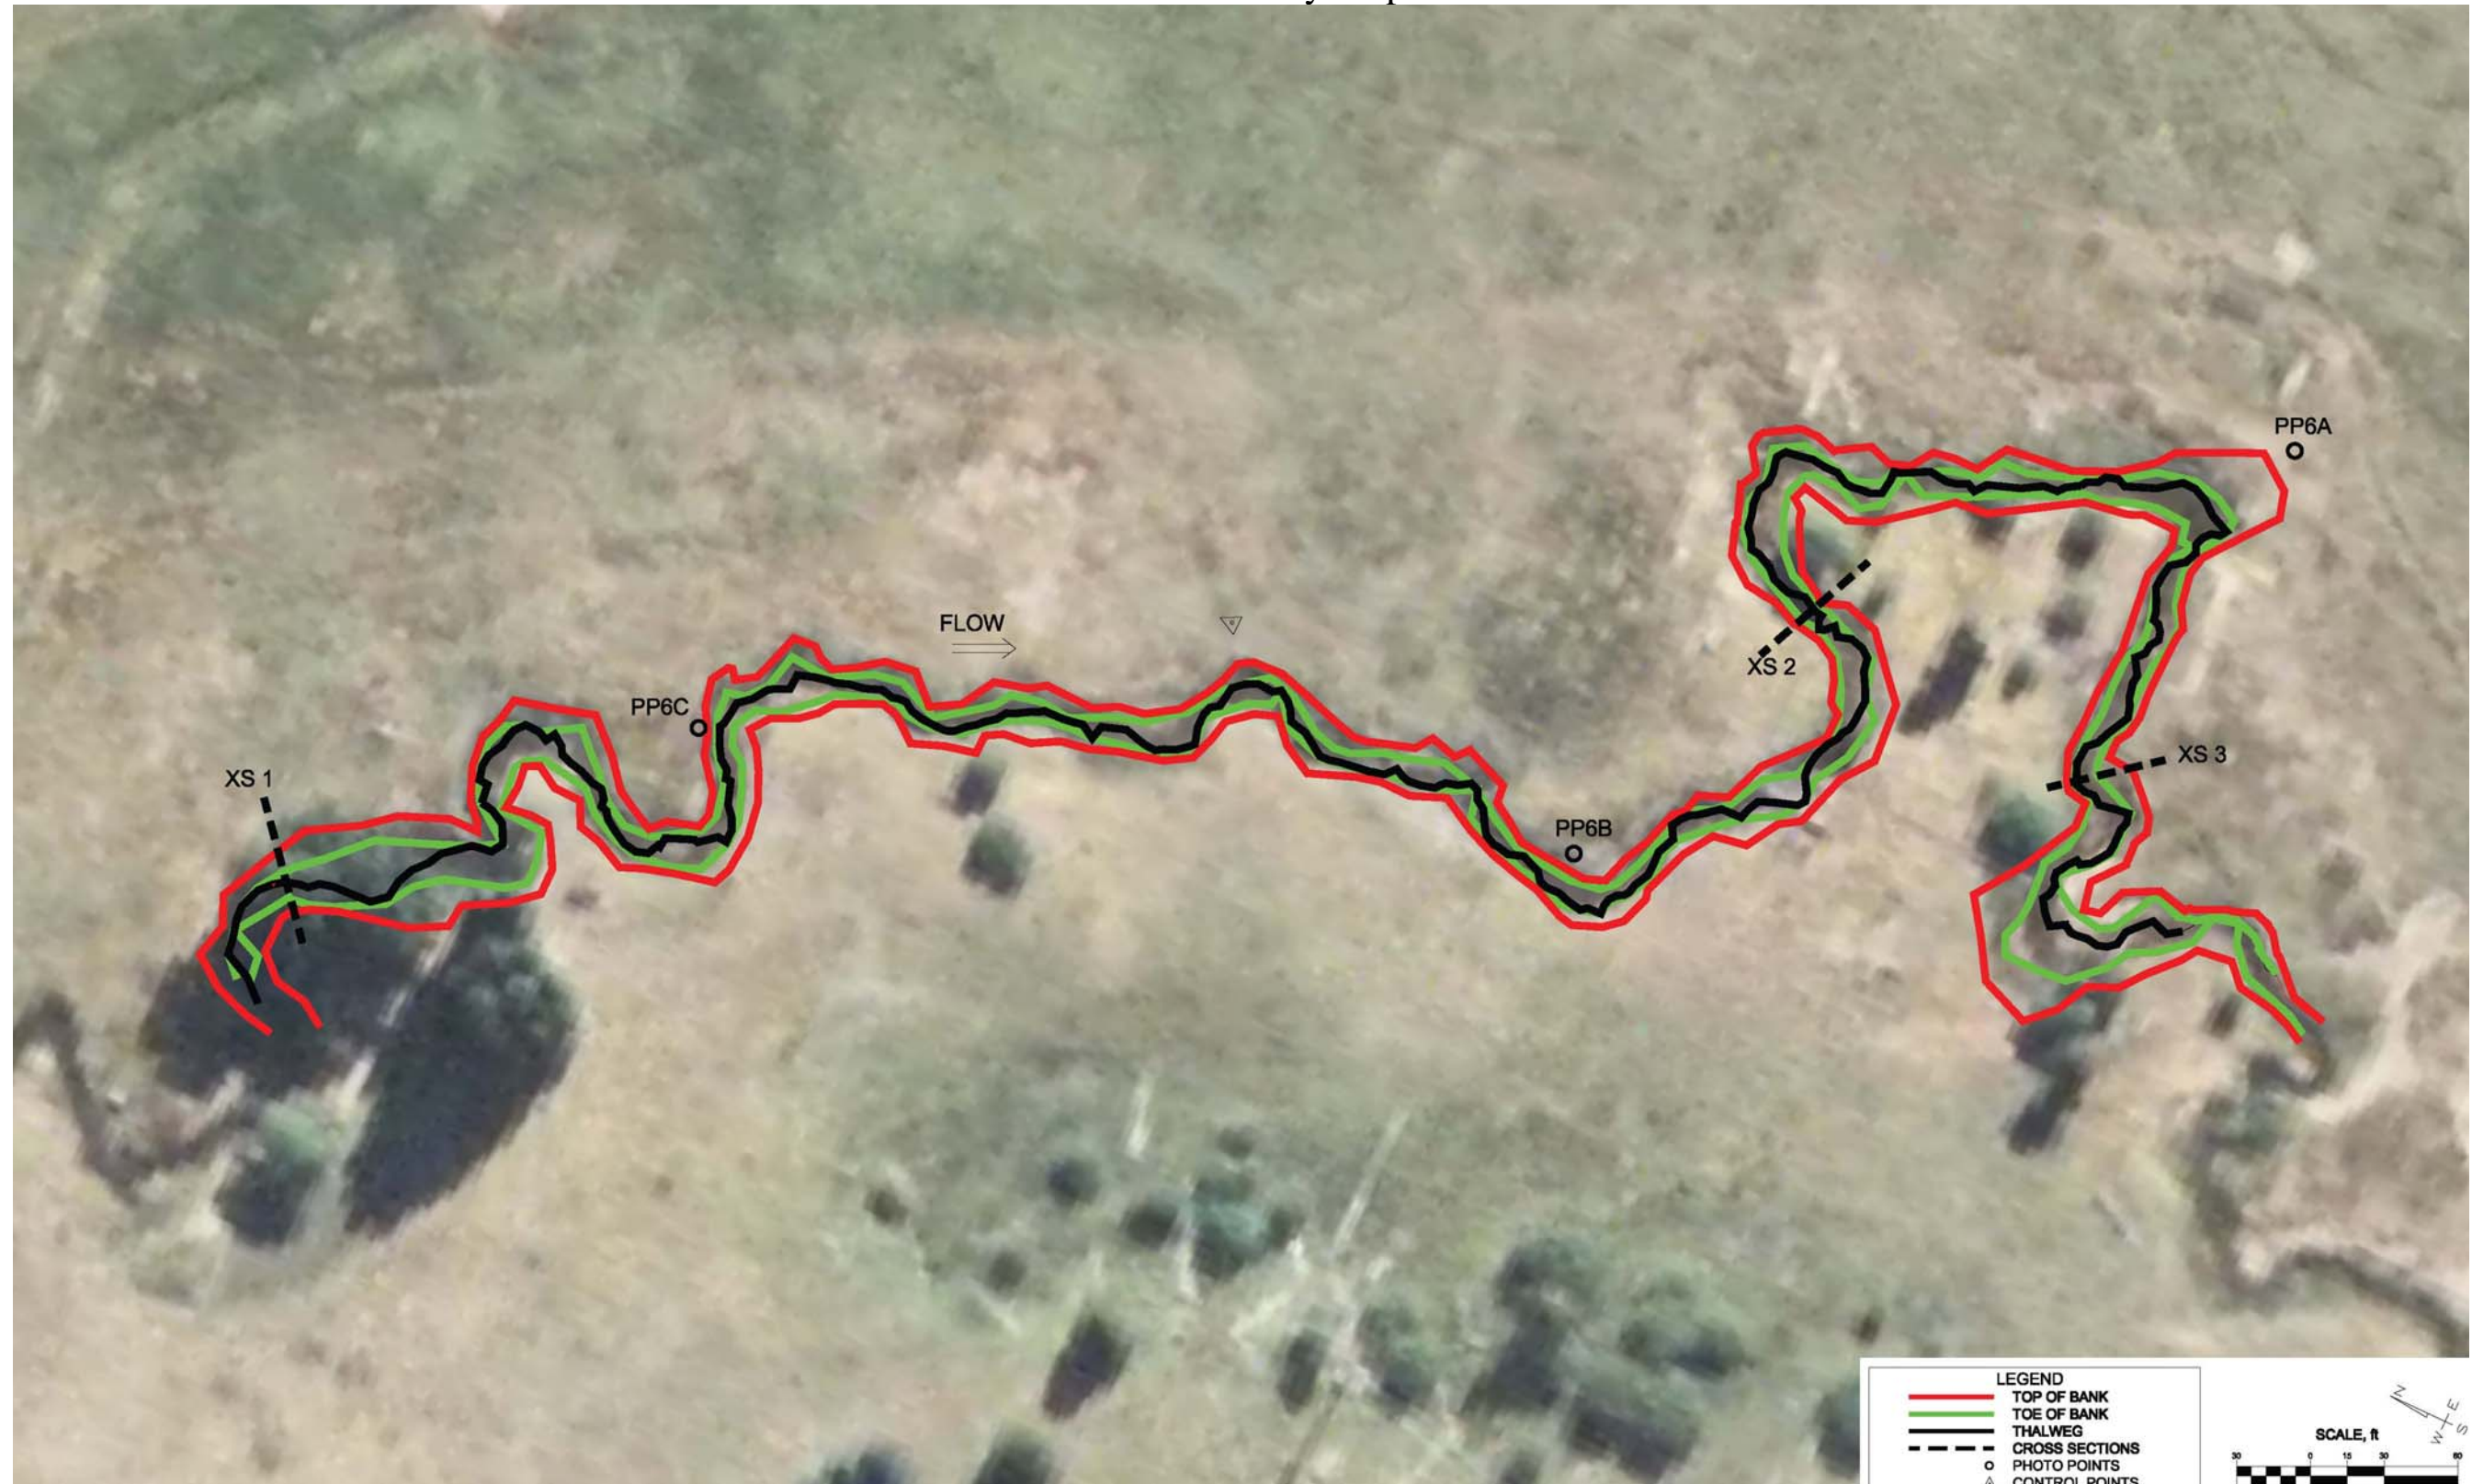
SEVENMILE CREEK
Reach 6 Survey Map

Planform 2008 survey maps of the three reaches along Sevenmile Creek are shown in Figures 3, 4, and 5 for Reaches 6, 5, and 2 respectively, presented in a downstream direction. The maps are overlain on a 2005 orthophoto and show top, toe, and thalweg point groups connected by line work, as well as cross section, control point, and photo point locations.

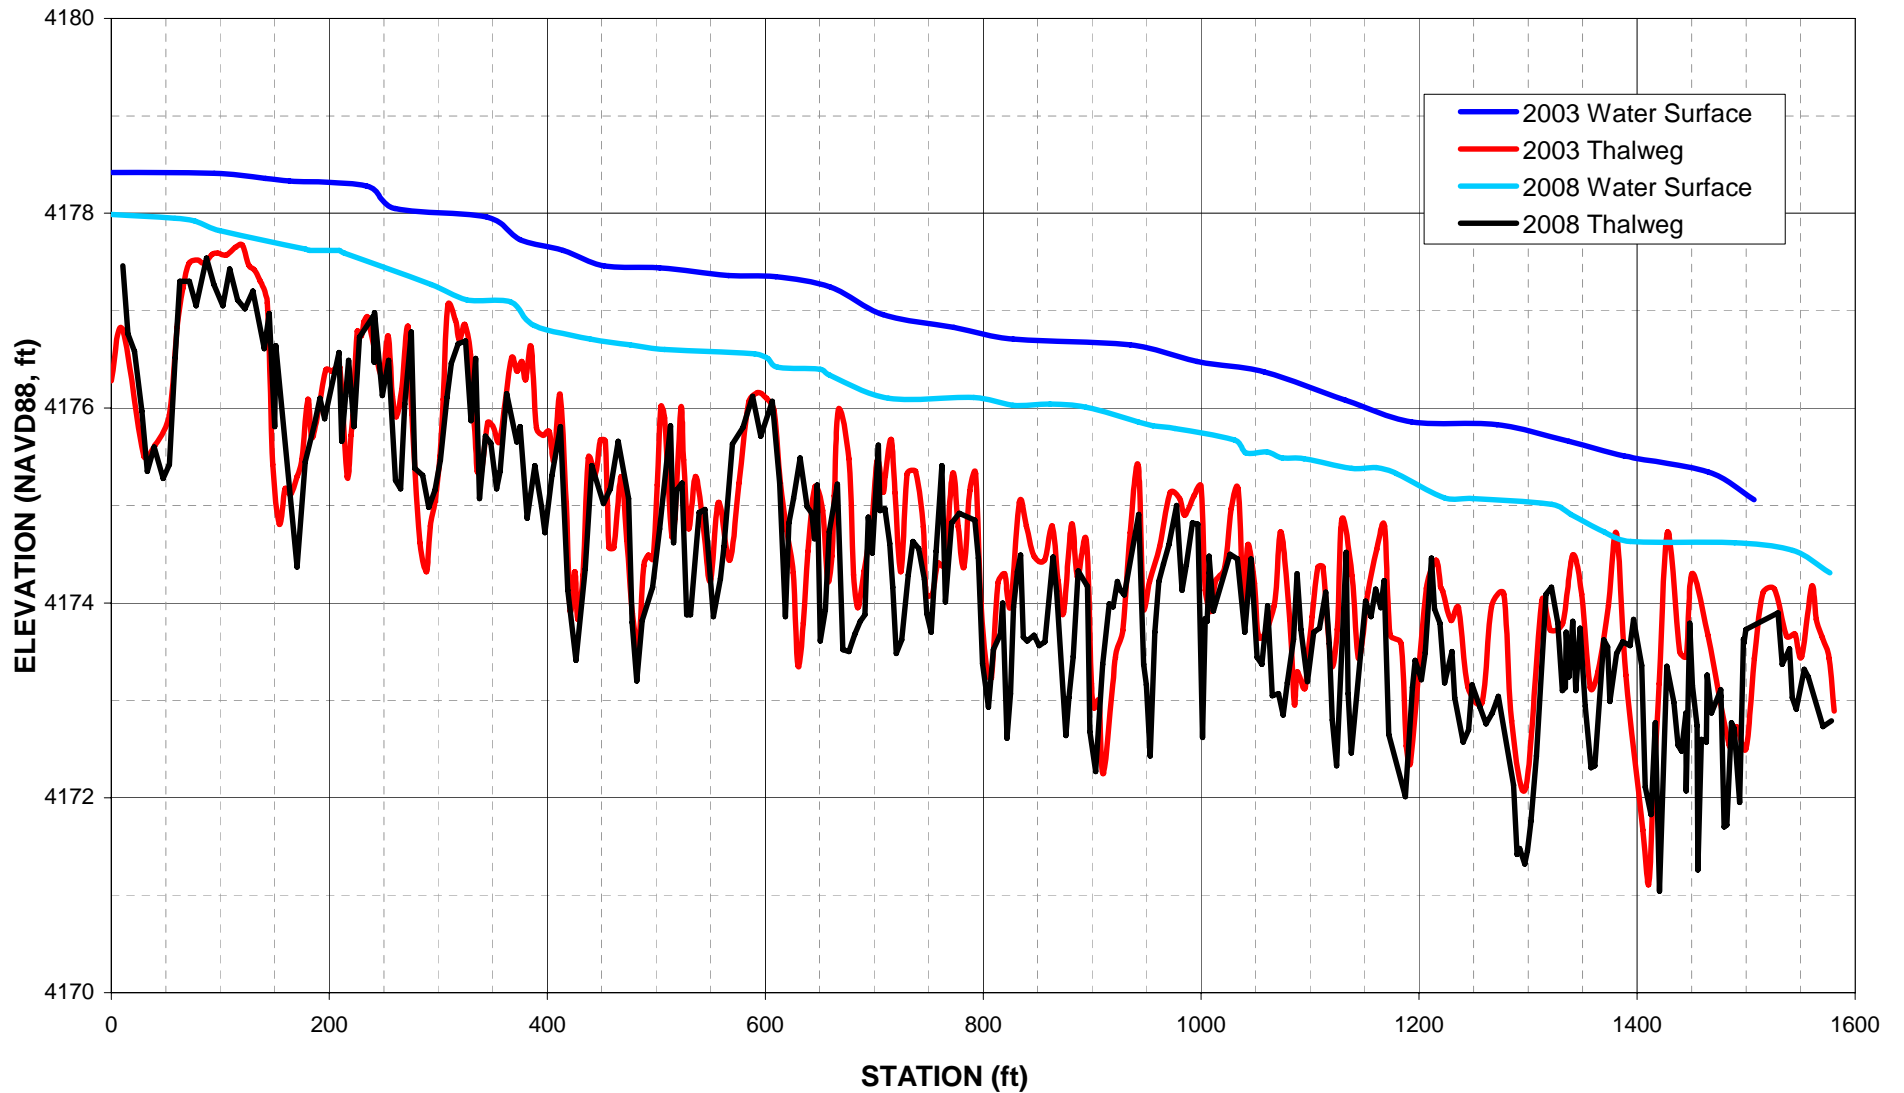
Reach 6: Longitudinal Profile, 2003 and 2008

The Reach 6 longitudinal profile (Figure 6) documents a noticeable thalweg deepening as evidenced in Table 1. The downstream end of Reach 6 has steepened as virtually all of the higher points of the channel (not technically riffles) in the lower 800 feet of the reach have dropped in elevation in 2008. The average bed slope has increased from .0023 to .0026, while the water surface slope has remained the same. The number and depth of pools has also increased. Data in Table 1 show that the mean channel depth has increased by 0.33 feet,

primarily in the lower half of the reach, and that the percent of channel thalweg deeper than 4 feet has doubled from 0.76% to 1.53%. The thalweg length increased by 57 feet, or 0.38%, from 2003 to 2008, although this change could be an artifact of survey methods.

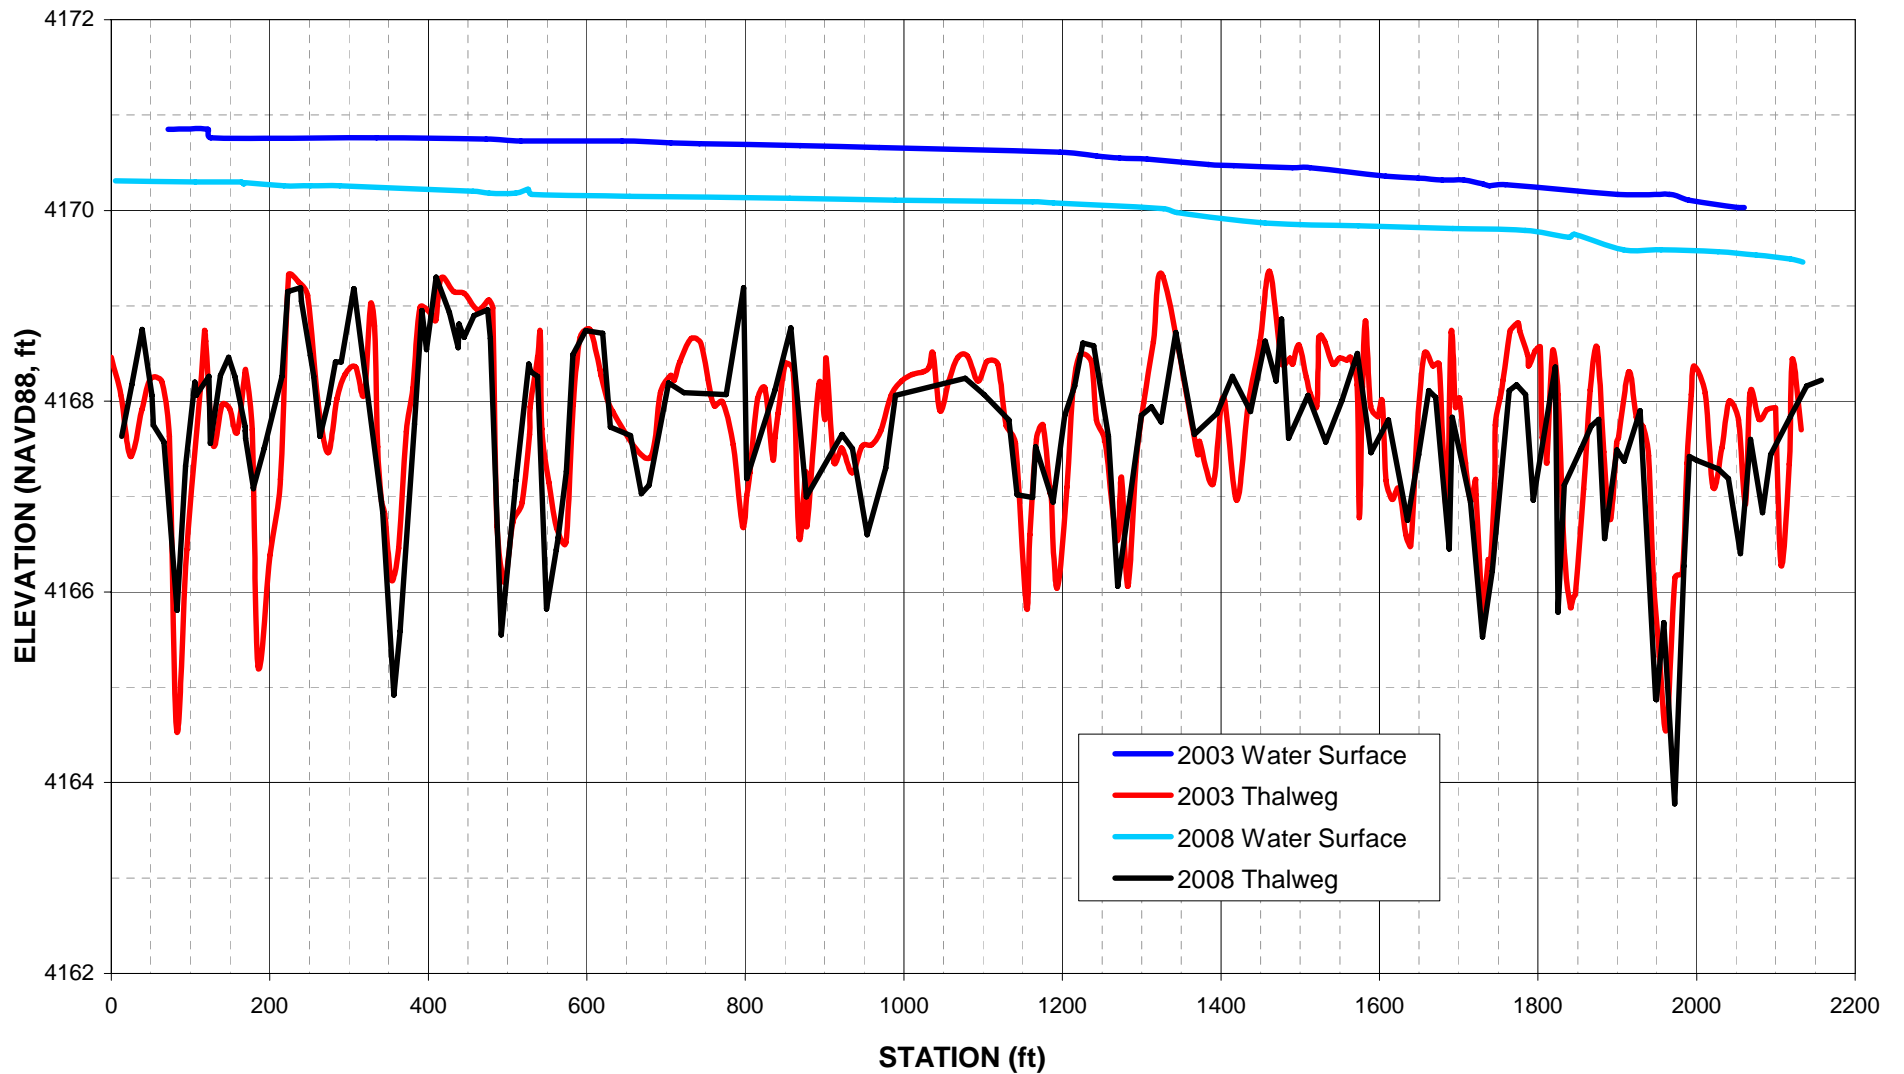
Reach 5: Longitudinal Profile, 2003 and 2008

The Reach 5 longitudinal profile (Figure 7) has experienced a similar drop in elevation at the "riffles" in its lower section. The mean bed slope of this quite low-gradient reach has more than doubled from .0002 to .0005, while the water surface slope remained the same at .0004. Four pools deepened, while three filled in a little. Overall, though, there was essentially no change in mean depth (Table 1). The percentage of the channel thalweg greater than 4 feet deep decreased from 8.9% to 5.4%.

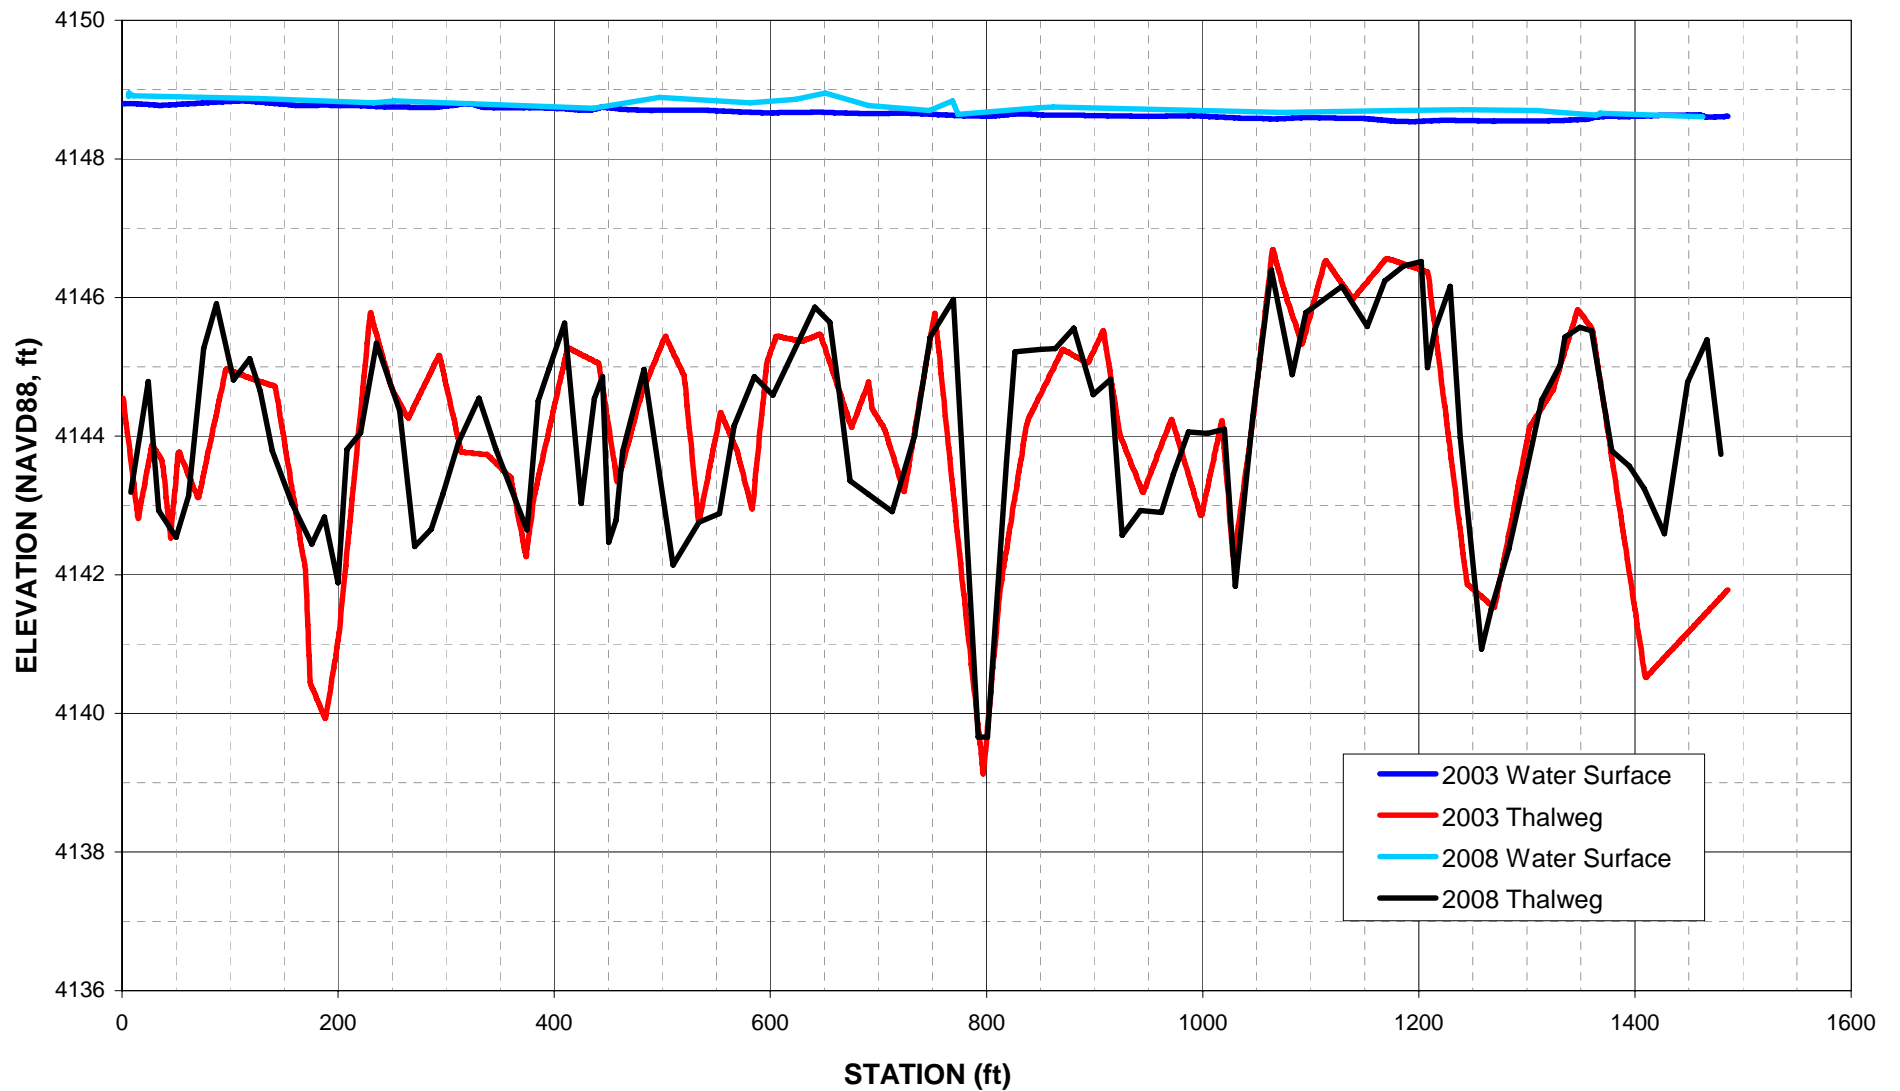
Reach 2: Longitudinal Profile, 2003 and 2008

There is little change in the longitudinal profile of Reach 2 (Figure 8) except several of the deeper pools have filled in and some bed features in the upper half of this reach have shifted around somewhat, resulting in a thalweg length 65 feet (4%) longer than in 2003. Overall, mean channel depth declined from 4.68 feet to 4.44 feet.

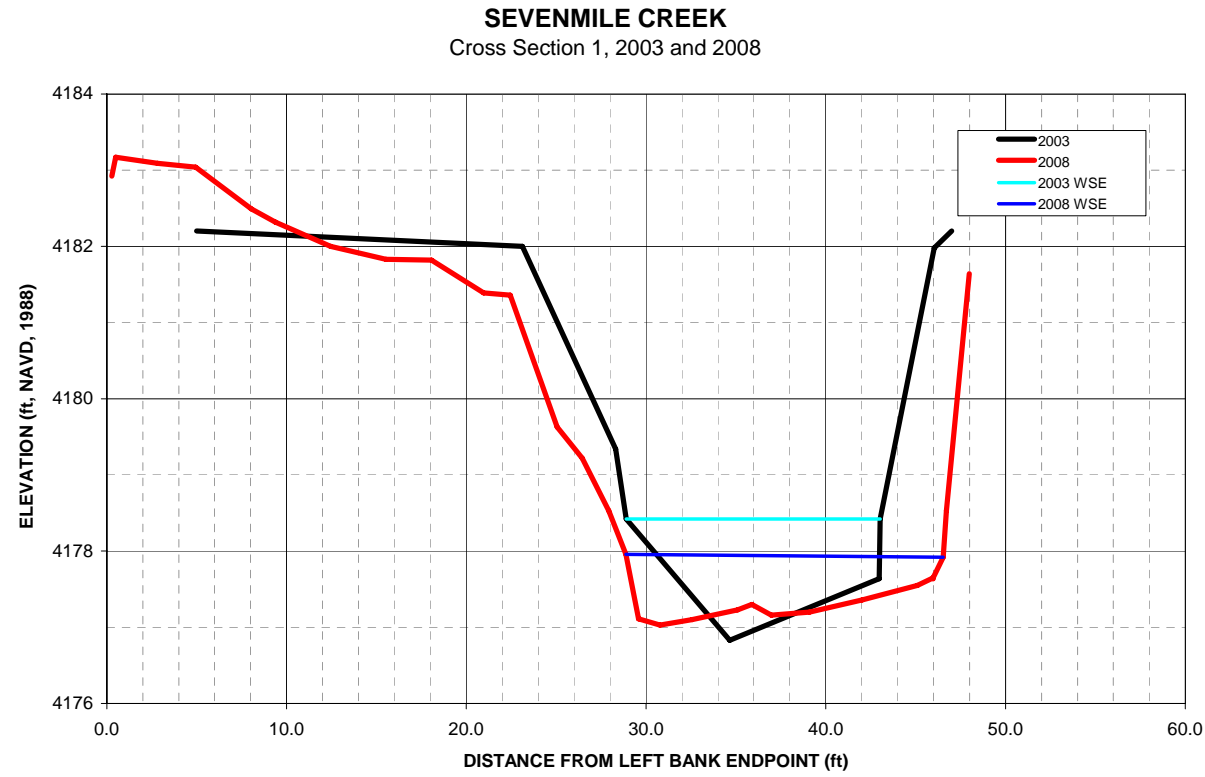
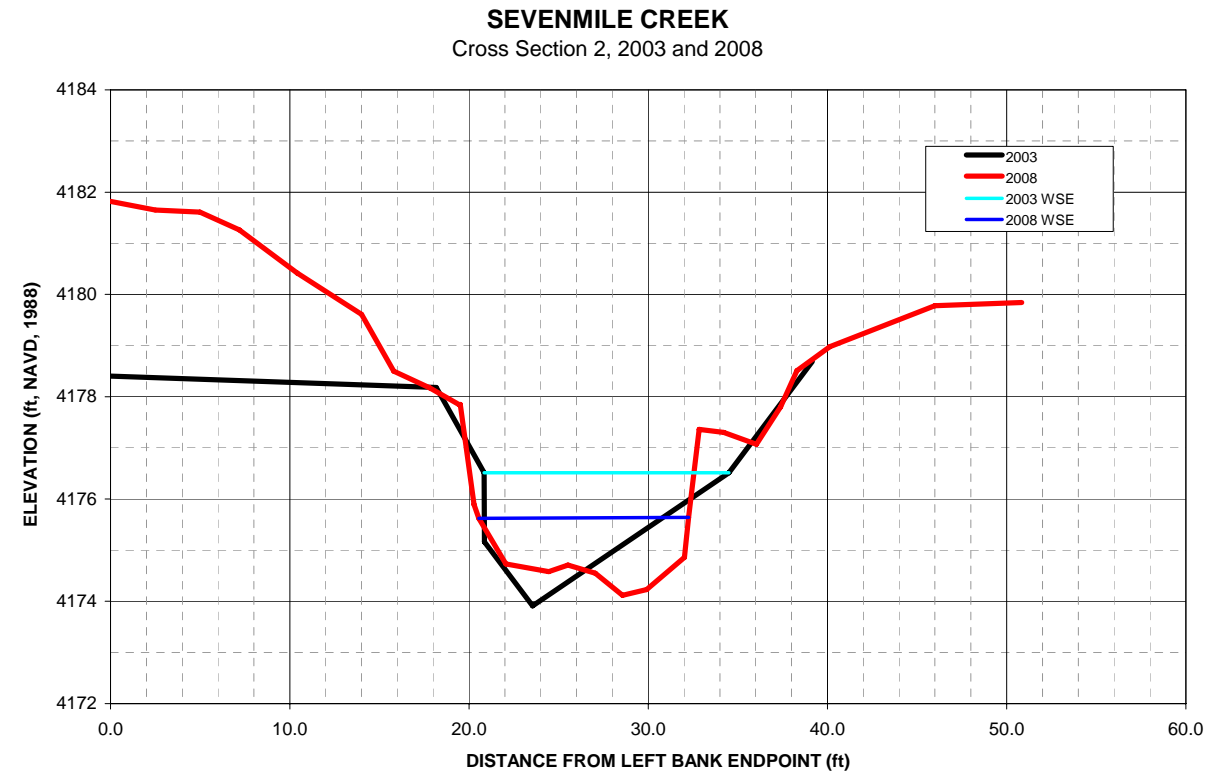
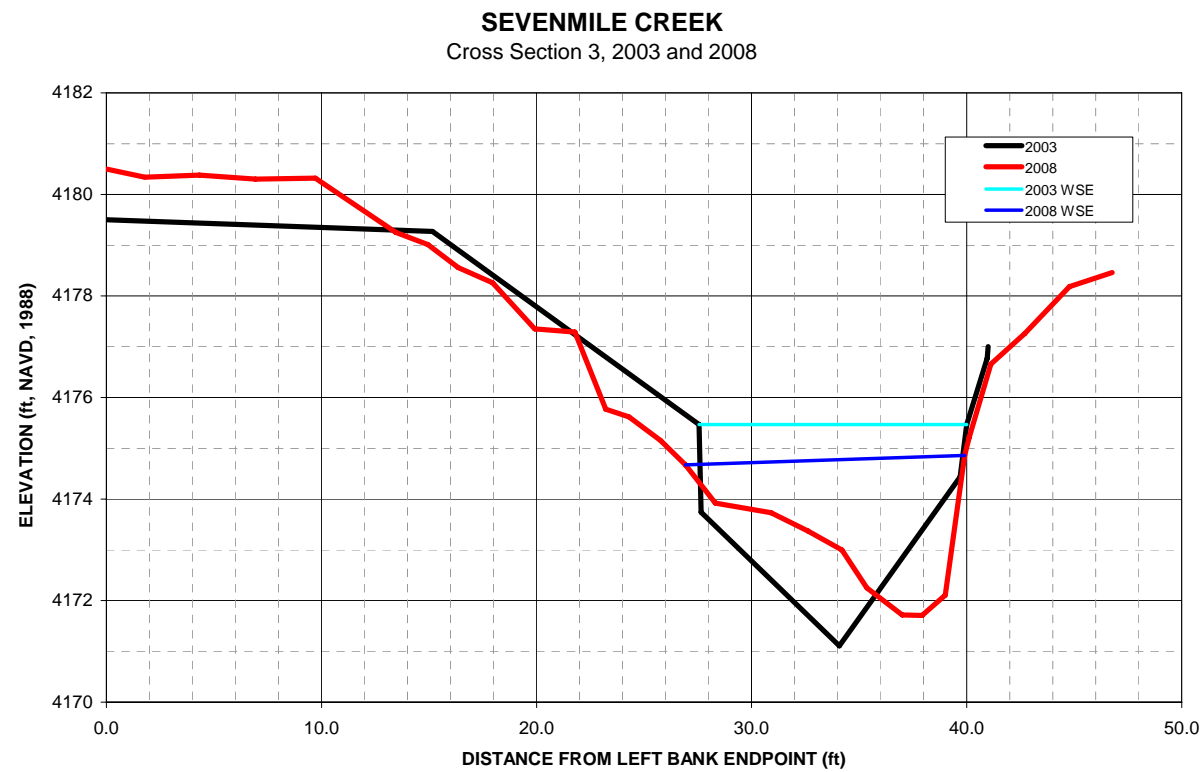
SEVENMILE CREEK, REACH 6 CROSS SECTIONS, 2003 AND 2008

Comparison of the cross sections (Figures 9a, 9b, and 9c) from all three reaches do not provide any useful trends since they were generated in much different manners between the two study periods. The following section on channel geometry involves analysis of reach-wide depths, widths, and width to depth ratios, which reveal changes over time better than the present cross sections. Future monitoring can take more advantage of the improved cross section survey methods.

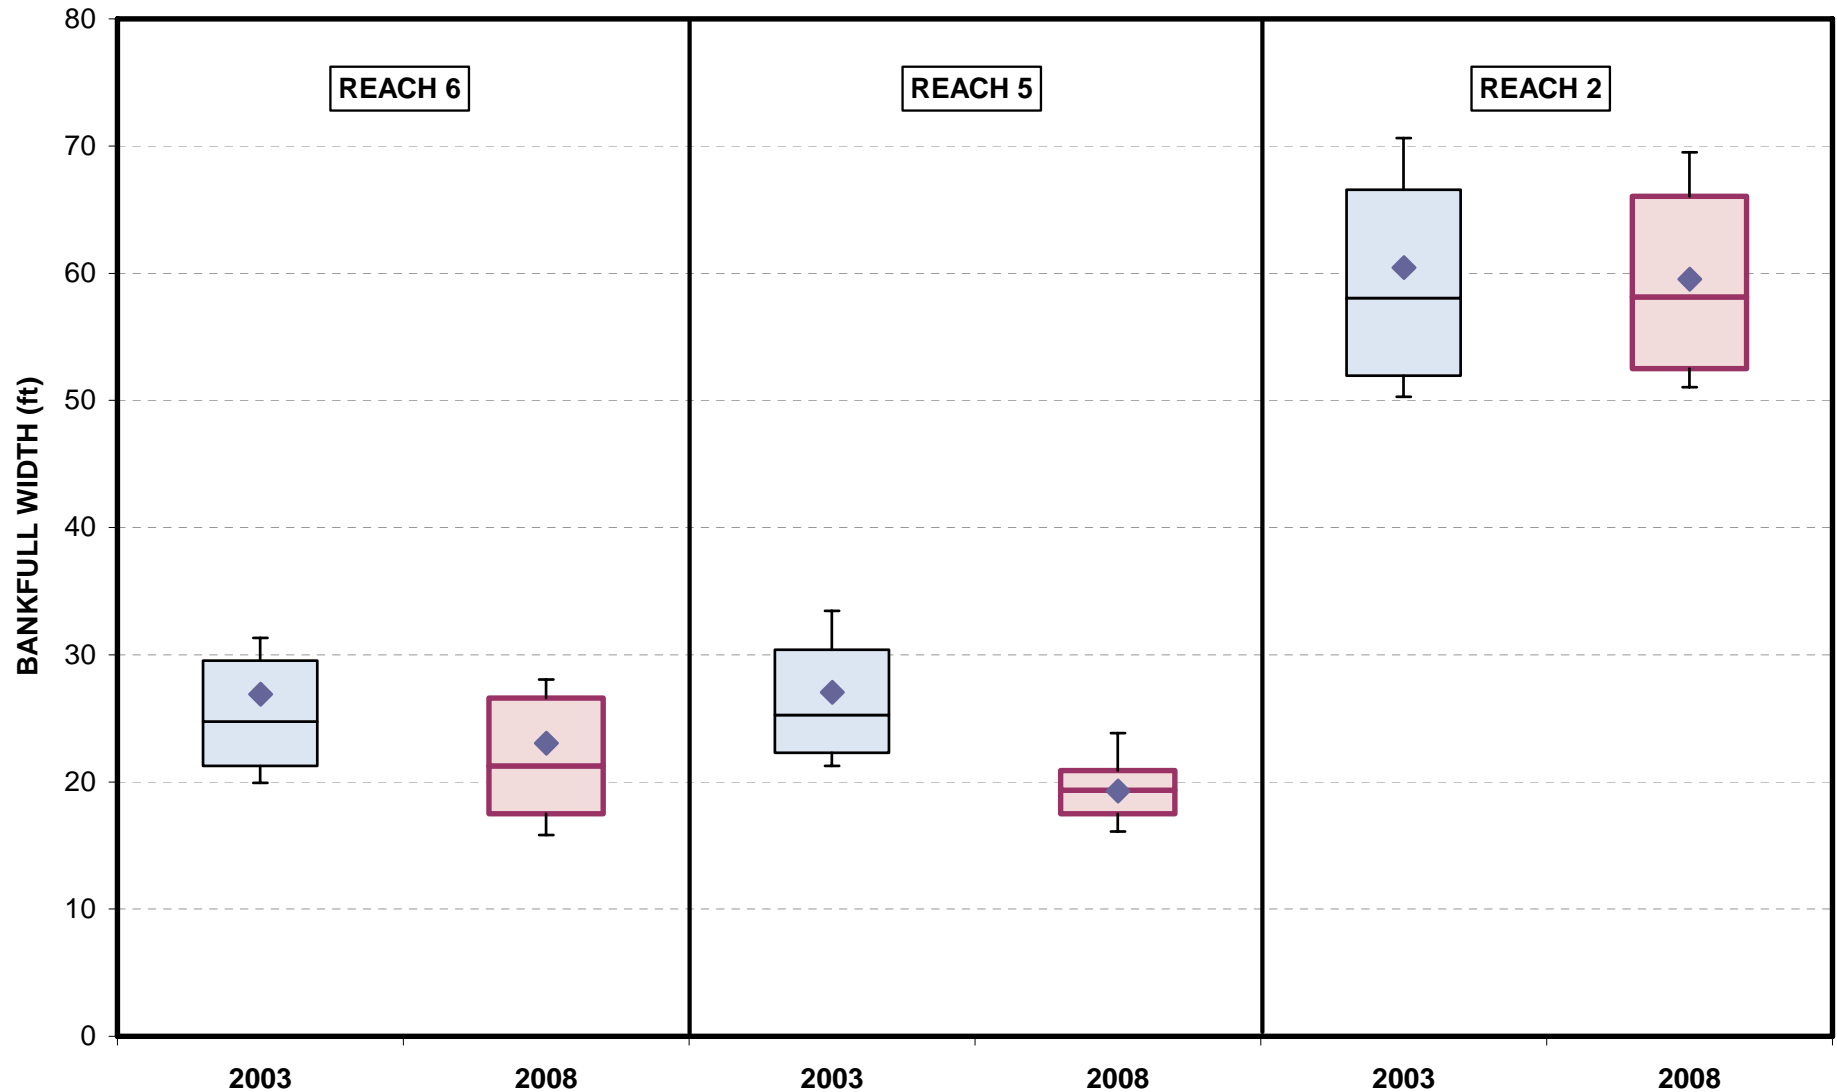
Comparison of Bankfull Channel Widths by Reach, 2003 and 2008

In 2003, Reach 6 and Reach 5 both had mean bankfull channel widths around 27 feet and in both the channel width has decreased: to 23 feet in Reach 6 and 19 feet in Reach 5 (Table 1 and Figure 10). Photo comparison also demonstrates this channel narrowing which is likely a result of reduced or eliminated grazing pressure, encroaching vegetative growth, and consequently less bank erosion. Reach 2 had a slight (less than 1 foot) decrease in mean channel width. Figure 11 shows the shift in the frequency histogram towards narrower widths in Reach 6 and 5. This is particularly noticeable for Reach 5, where 63% now are in the 20 foot width bin, while only 15% had been in 2003.

Figures 10 through 15 chart the distribution and changes of depths, widths, and width to depth ratios for the three reaches over the monitoring period from 2003 to 2008. Figures 10, 12, and 14 are box and whisker plots, where the outsides of the box are 25 and 75 percentile values, the line through the box is the 50% value or median, the blue diamond is the mean, and the whiskers are the maximum and minimum values. Figures 11, 13, and 15 are frequency plots, showing the relative frequency of computed values that have been divided into various bins.

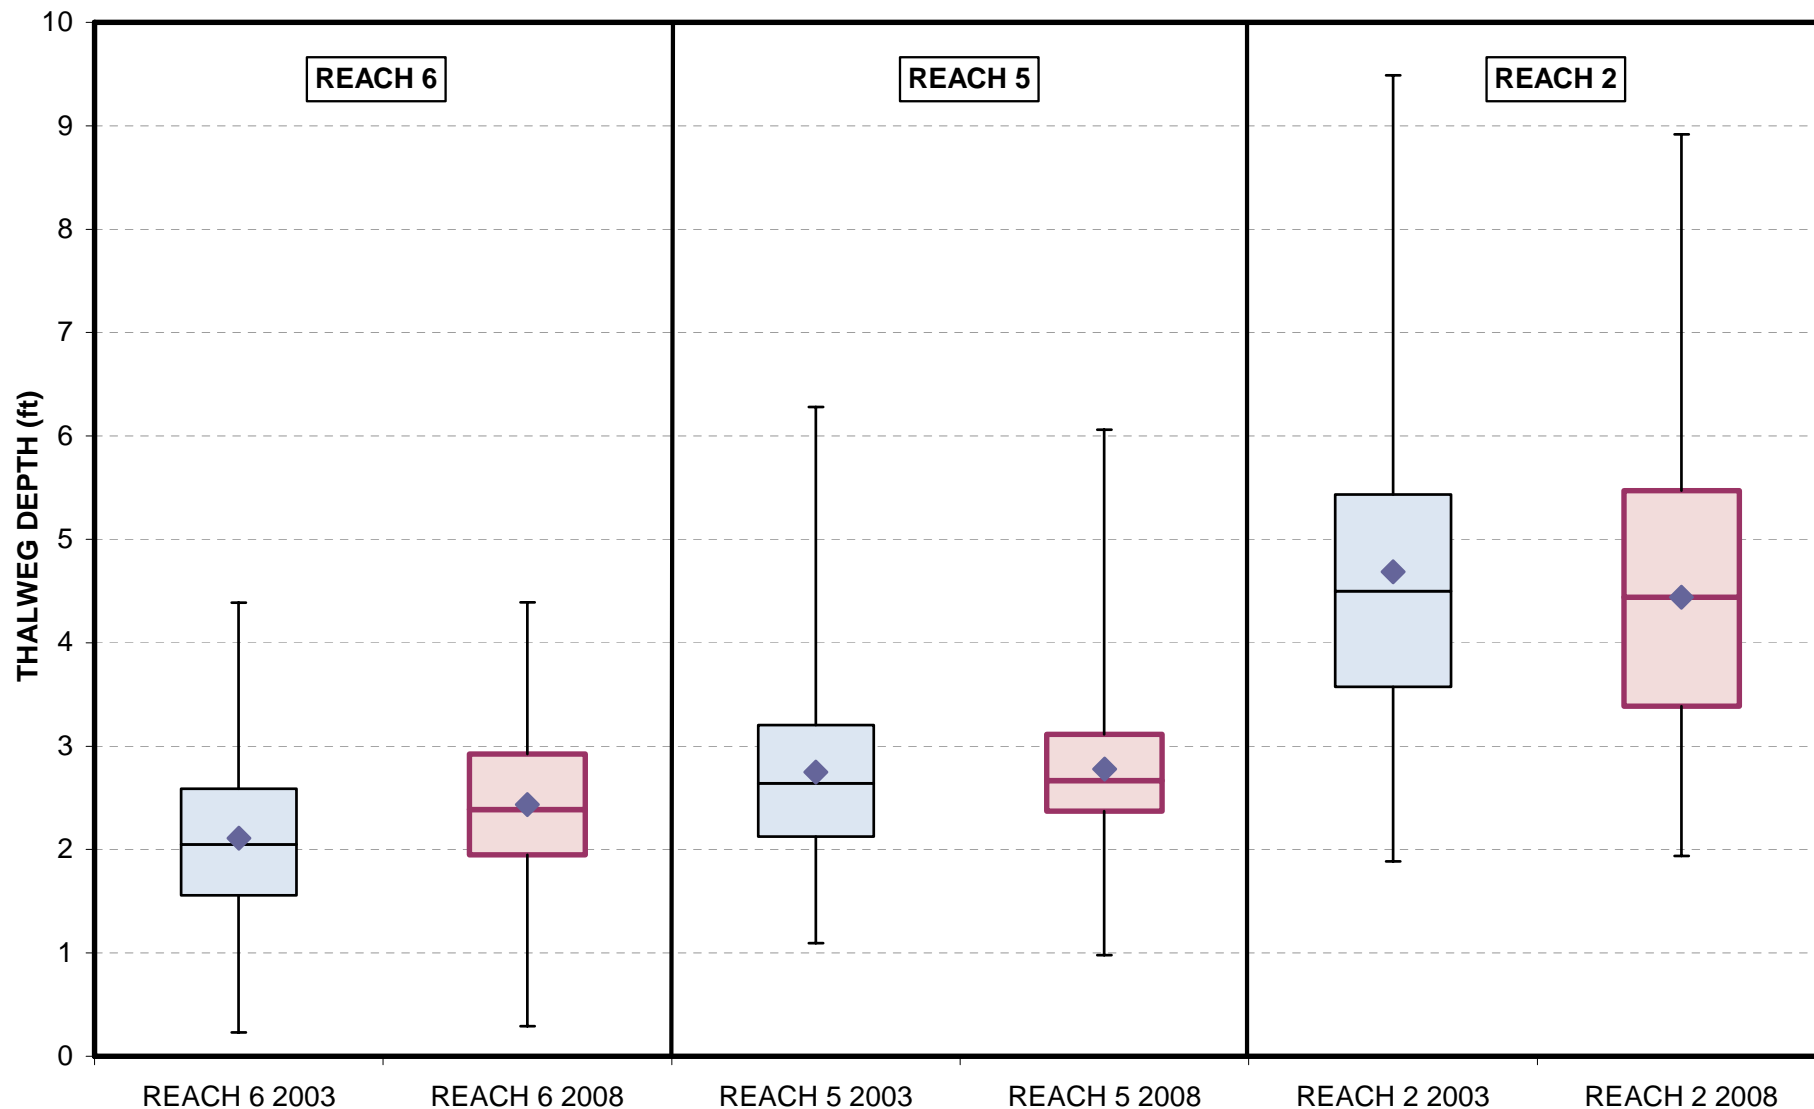
Comparison of Thalweg Depths, 2003 and 2008

Overall, depths still increase downstream from Reach 6 to Reach 2 (Table 1 and Figure 12). Pools >3' deep are important for large adult trout (KBRT 2003) and the percentage of thalweg depths greater than or equal to 3' deep has increased in Reach 5 (80% to 88%) and 6 (52% to 72%) since 2003 (Figure 13). Depths increased in Reach 6, remained essentially constant in Reach 5, and declined slightly in Reach 2, over the study period.

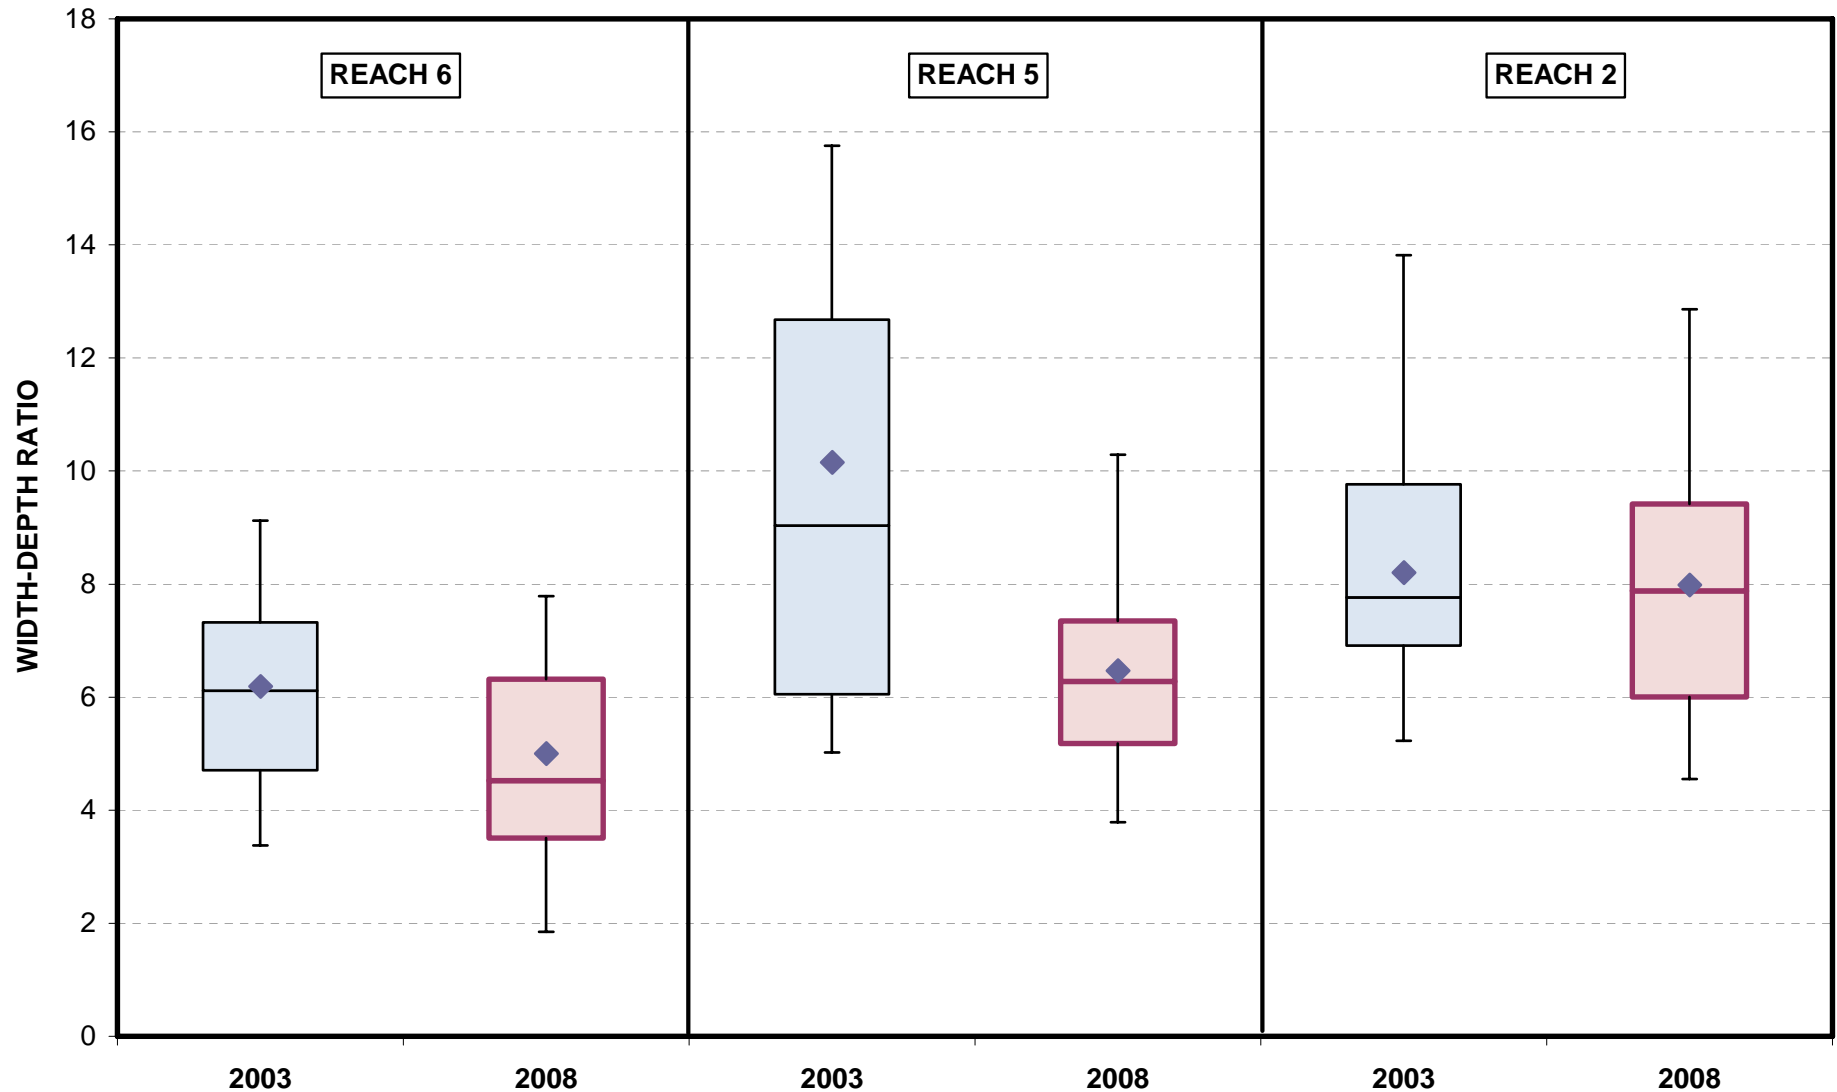
Comparison of Width-Depth Ratio by Reach, 2003 and 2008

The width to depth ratios follow accordingly with the narrowing of Reach 6 and 5 (Table 1 and Figure 14). The mean ratio has dropped slightly from 6 to 5 in Reach 6 but significantly from 10 to 6.5 in Reach 5 indicating a narrower, deeper channel in 2008. In addition, the range of width to depth ratio values was much greater (Figure 14) in Reach 5 in 2003 compared to 2008. 73% of the ratio values are now in the 6 and 8 bins (Figure 15).

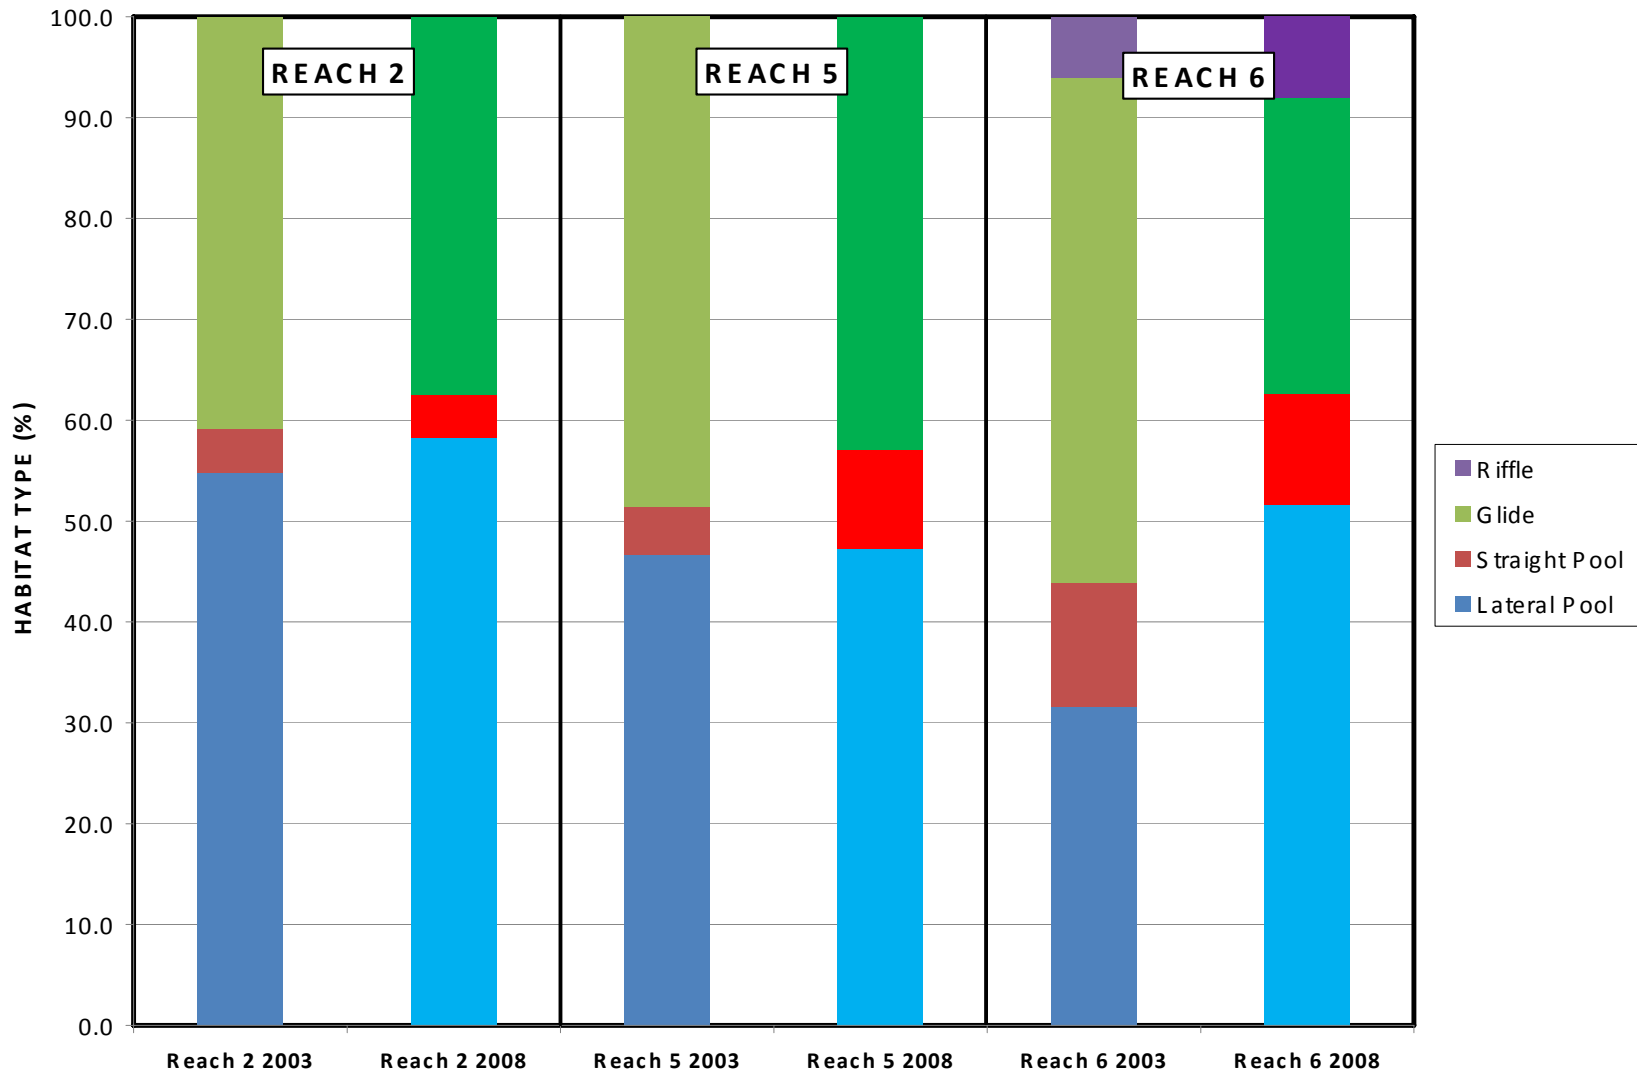
Distribution of Habitat Units by Reach, 2003 and 2008

The results of habitat typing are presented in Table 2 and Figures 16 and 17. The most significant changes in fish habitat between 2003 and 2008 occurred in Reach 6 where large woody debris (LWD) increased substantially, rising from 2.8 to 18.9 pieces per 1000 feet (Table 2). This large wood presence resulted in glides (50% of the habitat units in 2003, but only 29% in 2008) changing into lateral scour pools (formerly 31%, now 52%) (Figure 16). Pool numbers increased sharply from 19 to 32 and their quality also increased from 2 to 2.5. Bank stability improved as evidenced by a doubling of the percentage of undercut banks and a large decrease in the percentage of bank erosion (Table 2). Coupled with less erosion is a coarsening of the substrate, as gravel and sand now dominate with a large reduction in silt and aquatic vegetation. Figure 17 shows that in Reach 6, gravel substrate increased from 2.8 to 22%, while combined silt and aquatic vegetation dramatically declined from 54.6 to 15.6%.
