WOOD RIVER VALLEY AQUATIC HABITAT STUDY 2008 MONITORING REPORT

**USDA -- Natural Resources Conservation Service
1201 NE Lloyd Blvd, Suite 900
Portland, OR 97232**

December 2008

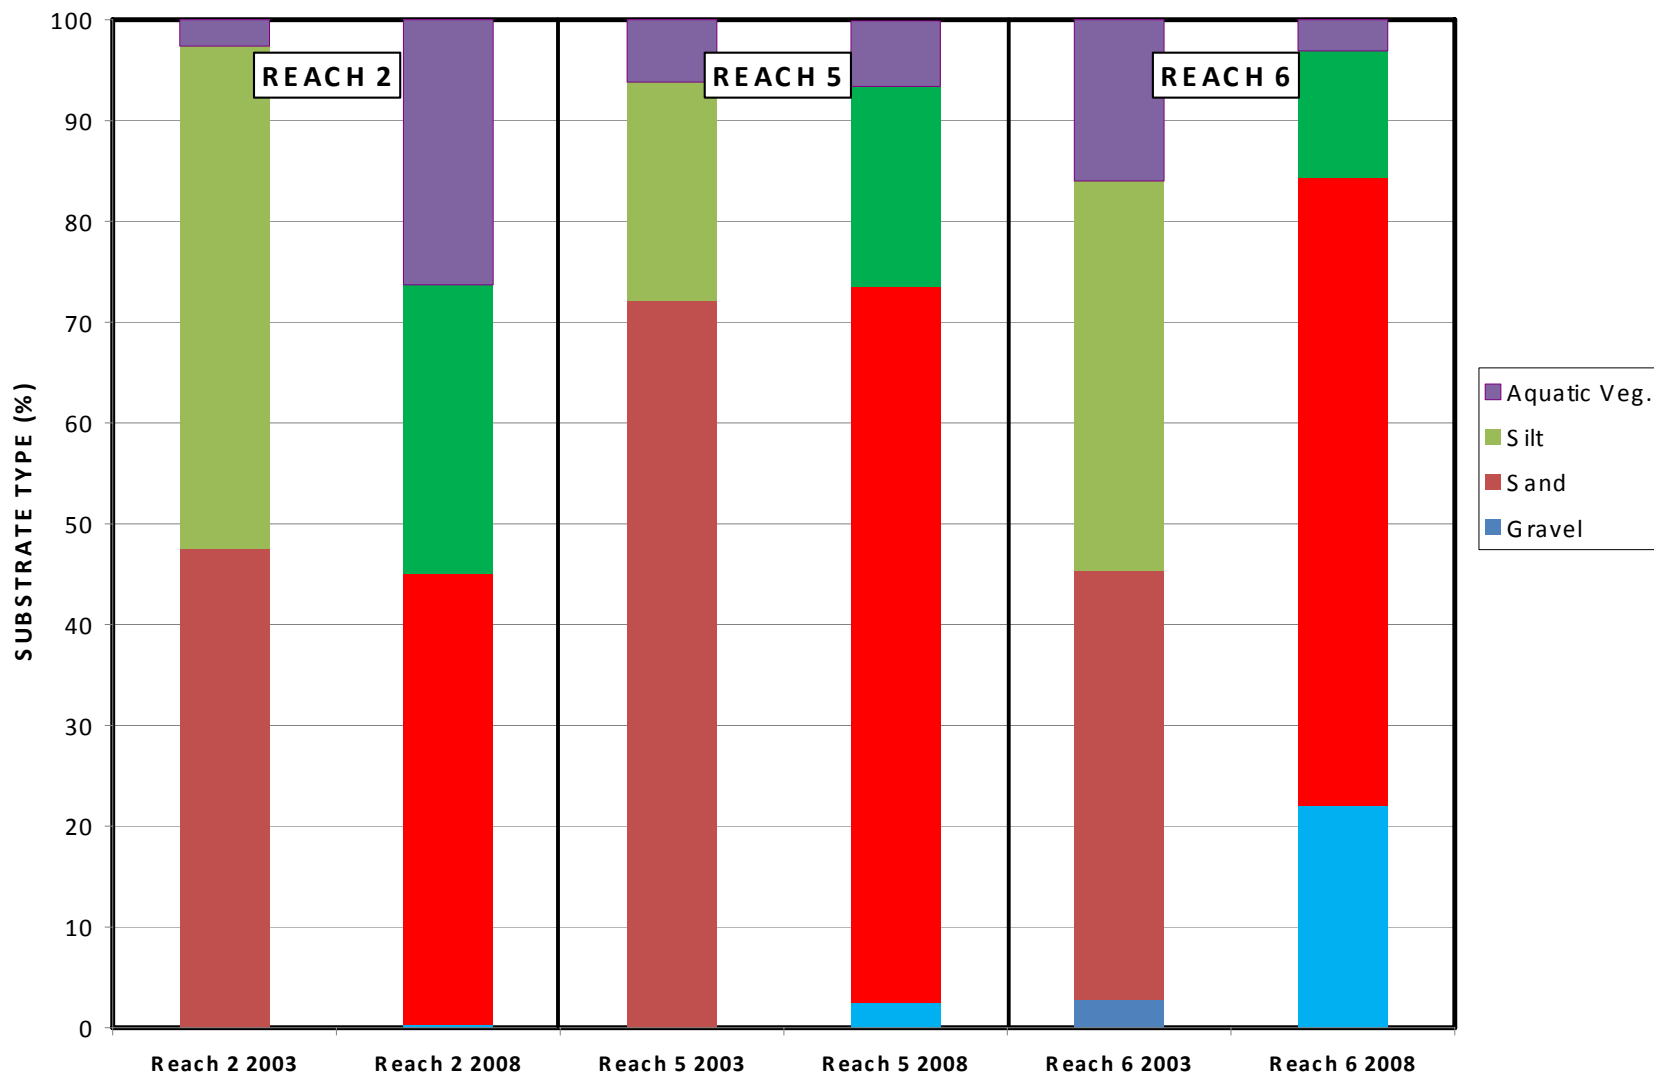
Distribution of Substrate Types by Reach, 2003 and 2008

The results of habitat typing are presented in Table 2 and Figures 16 and 17. The most significant changes in fish habitat between 2003 and 2008 occurred in Reach 6 where large woody debris (LWD) increased substantially, rising from 2.8 to 18.9 pieces per 1000 feet (Table 2). This large wood presence resulted in glides (50% of the habitat units in 2003, but only 29% in 2008) changing into lateral scour pools (formerly 31%, now 52%) (Figure 16). Pool numbers increased sharply from 19 to 32 and their quality also increased from 2 to 2.5. Bank stability improved as evidenced by a doubling of the percentage of undercut banks and a large decrease in the percentage of bank erosion (Table 2). Coupled with less erosion is a coarsening of the substrate, as gravel and sand now dominate with a large reduction in silt and aquatic vegetation. Figure 17 shows that in Reach 6, gravel substrate increased from 2.8 to 22%, while combined silt and aquatic vegetation dramatically declined from 54.6 to 15.6%.

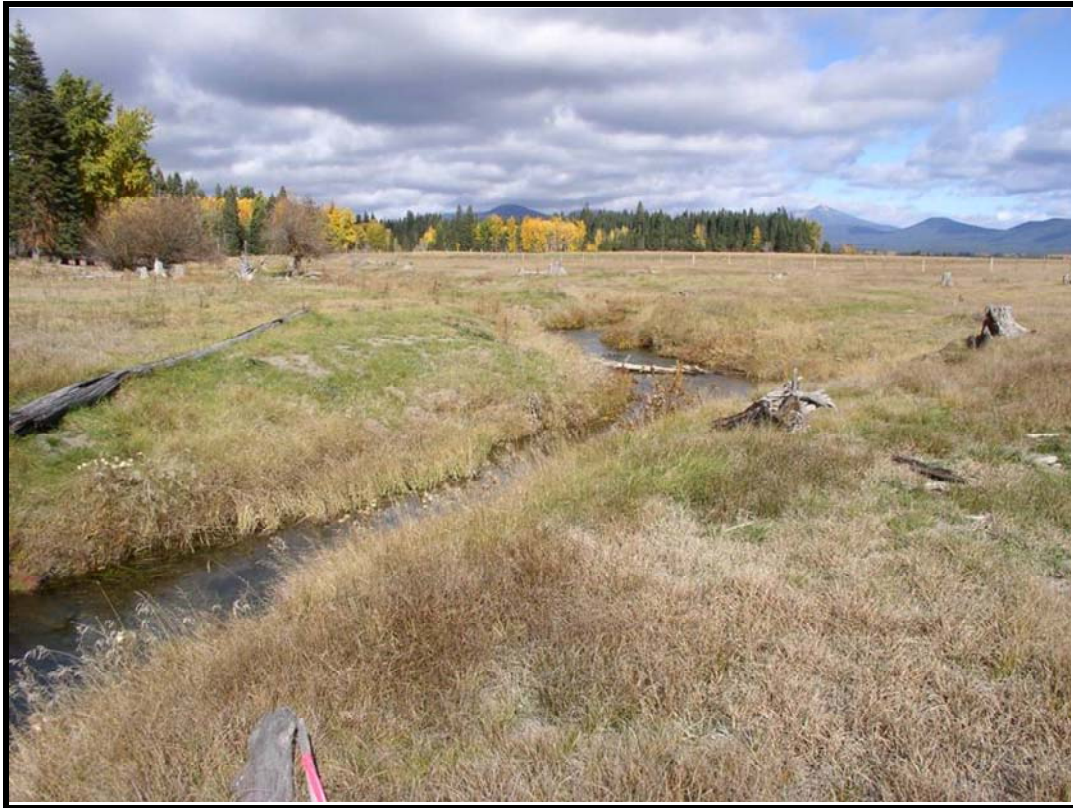
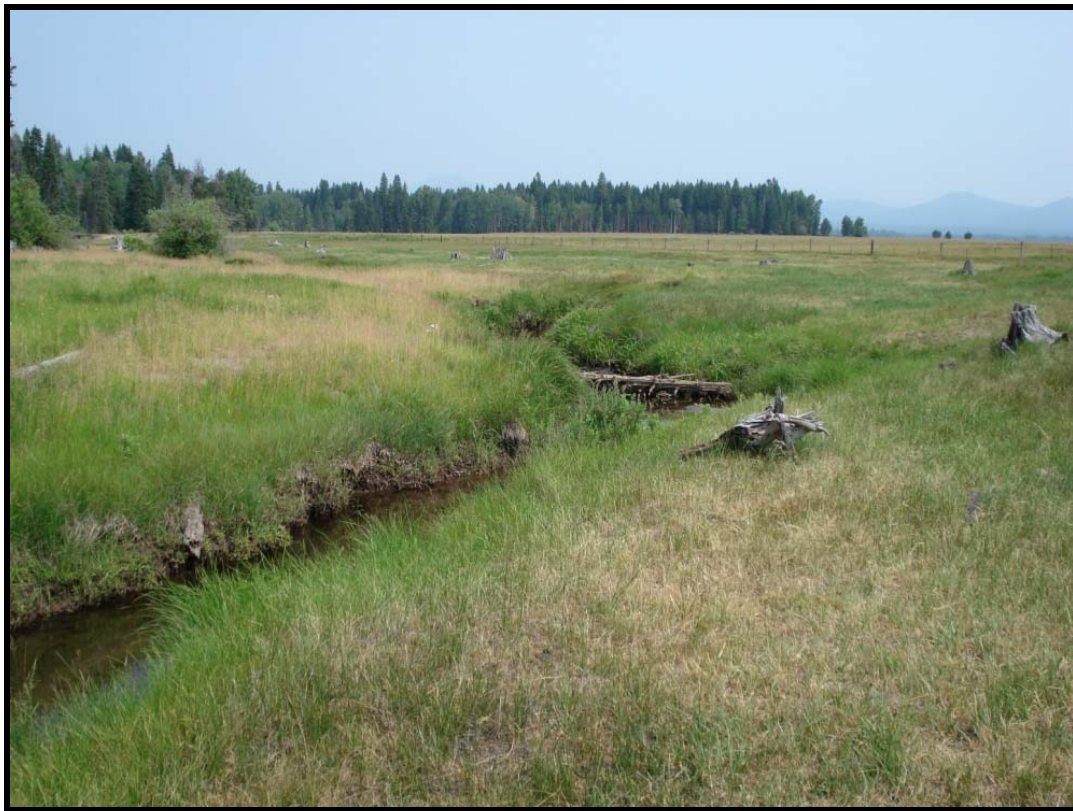
TYPICAL SEVENMILE CREEK PHOTOPOINT COMPARISON

The photos are assembled in two PowerPoint files (Appendix 1), for 2003 and 2008. Photos from the nine photopoints along the three reaches suggest a general trend of channel narrowing, increased vegetative cover, and reduced bank erosion, particularly in Reach 6. Figure 18 shows an example of the photo point comparisons.

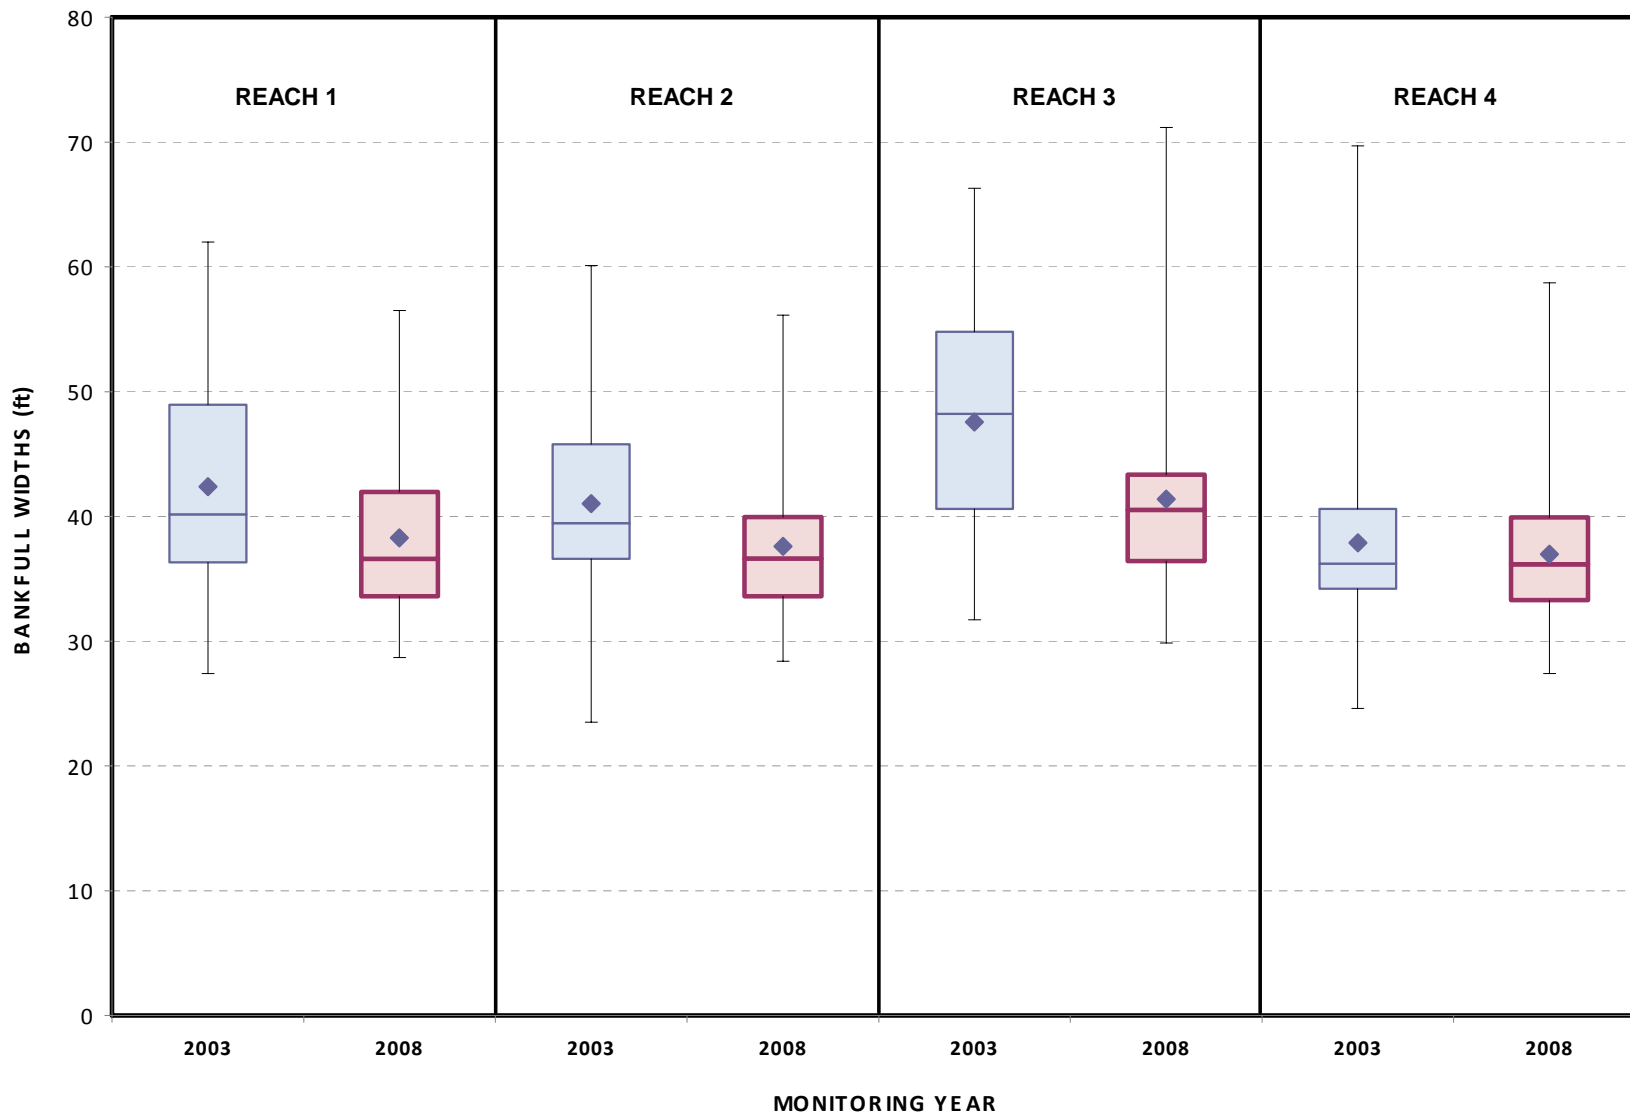
Comparison of Bankfull Channel Widths by Reach, 2003 and 2008

Channel widths decreased in all four reaches (Table 3 and Figure 25) indicating the reduction in grazing under the KBRT program has helped to stabilize banks. Mean widths decreased about 10% in Reaches 1 and 2, almost 15% in Reach 3, but only 2% in Reach 4. Reach 4 remains the narrowest section but only slightly now that the other reaches have narrowed over the past 5 years. In addition, it should be noted that the Reach 4 channel widths are taken from the channel toes because the tops of the banks are in many places under water and difficult to distinguish. Figure 26 compares Reaches 4A and 4B and shows very slight changes from 2003, with un-restored areas slightly decreasing in width and restored areas slightly increasing in width. These values are well within the range of measurement error. The frequency distribution of channel widths for the 4 reaches (Figure 27) show that the range of the population of widths has been reduced as the channel narrowed, many of the

Table 3 summarizes the 2003 and 2008 thalweg lengths, channel widths, depths from water surface, width to (channel) depth ratio, and percent thalweg greater than 4' deep. Figures 25 through 32 chart the distribution and changes of depths, widths, and width to depth ratios for the four reaches over the monitoring period from 2003 to 2008 and also include comparisons within Reach 4 of restored (4B) versus un-restored areas (4A). It should be noted that the 2003 channel dimensions for reach 4 were actually surveyed in 2001, soon after the channel restoration was completed. In some cases, the channel width was reduced by more than 30' during the project construction. Figures 25, 26, 28, 30, and 31 are again box and whisker plots. Figures 27, 29, and 32 are frequency plots, showing the relative frequency of computed values that have been divided into various bins.

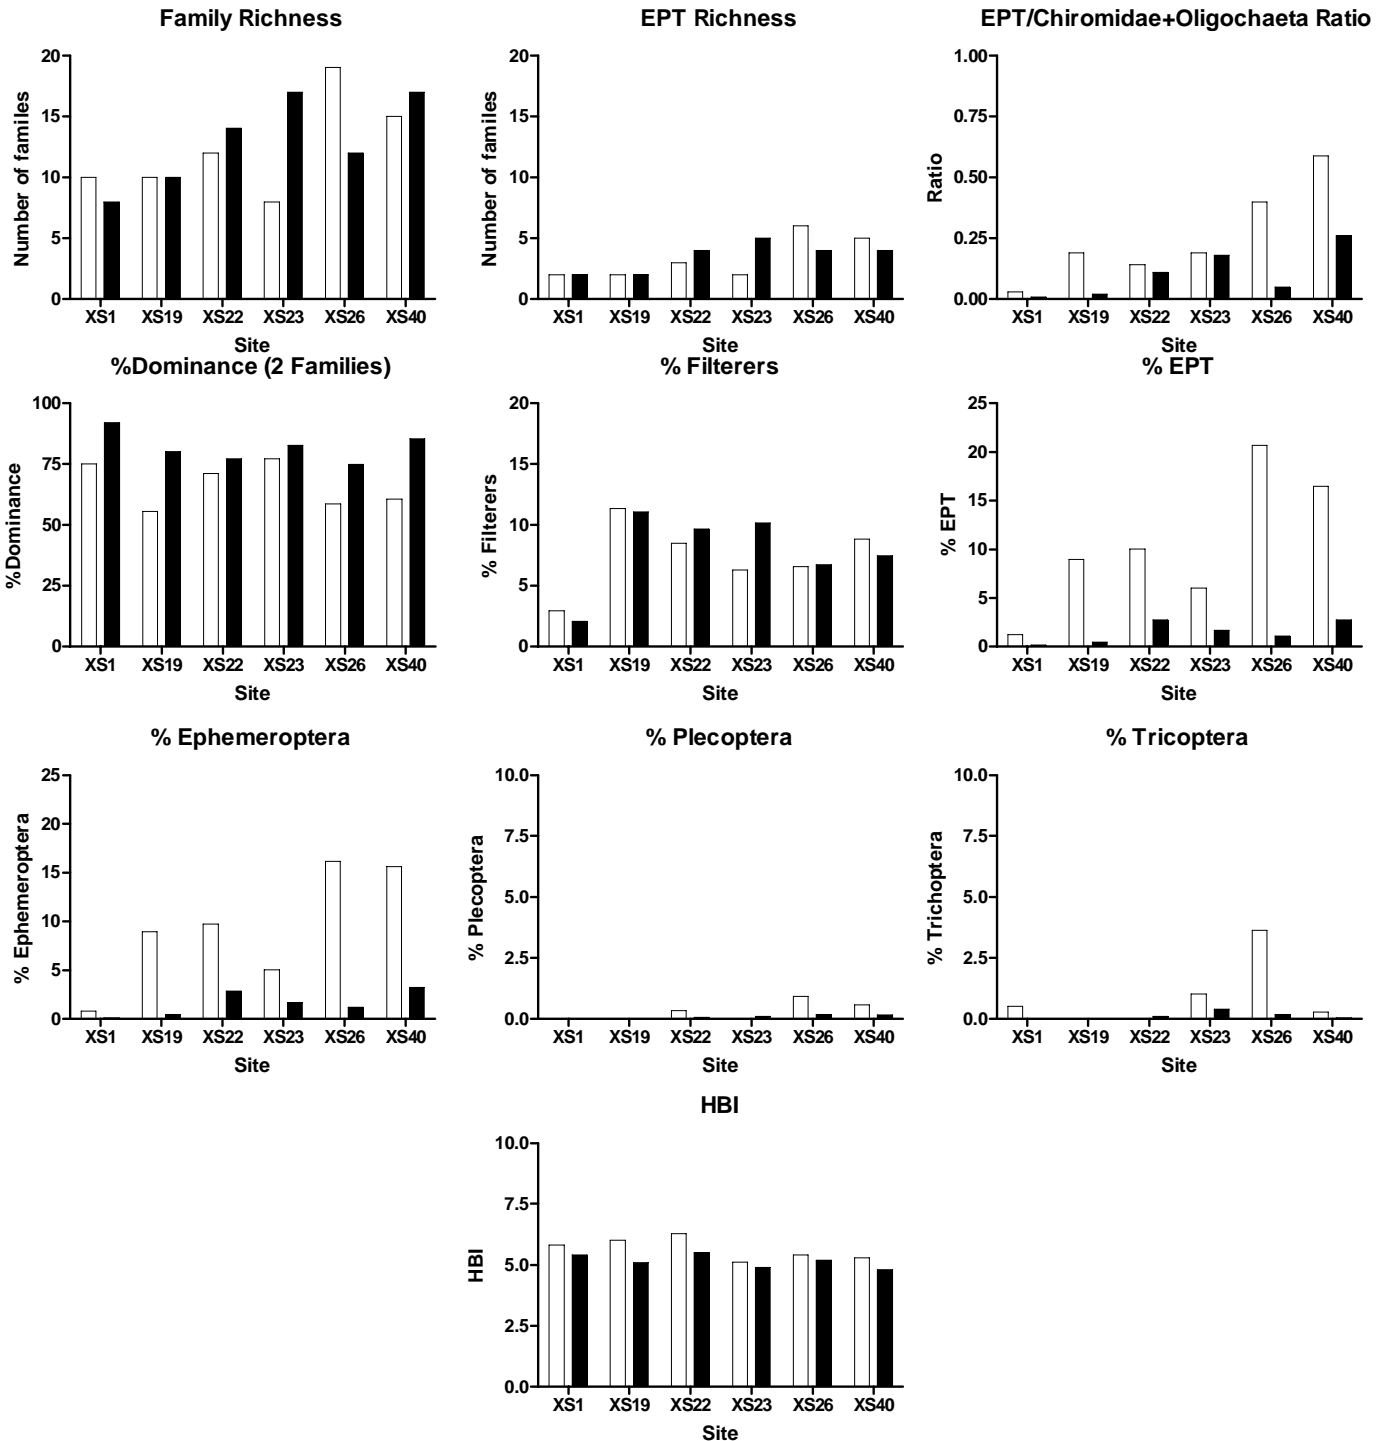
Macroinvertebrate Community Metrics

All sites were numerically dominated by Amphipoda, Oligochaeta, Chironomidae, and Pelecypoda. Treatment reach sites XS #22, XS #23, and XS #40 also supported moderately high densities of Baetidae mayflies and Simuliidae. Community dominance by the two most abundant families was high across all sites, ranging from 75% at XS #26 to 92% at XS #1 (Table 7). These values are generally higher than those reported in 2002 (Figure 36) and are likely the result of the significant increase in abundance of Amphipoda. The contribution of EPT orders to the observed assemblage (% EPT) was generally lower in 2008 than in 2002, also a result of the increased Amphipoda abundance (Figure 36). Among all sites, % EPT was lowest in XS #1 and highest in XS #26.

Metrics calculated from samples collected from six Crooked Creek sites in August 2002 (white bars) and August 2008 (black bars).

Collectively, results of the 2008 macroinvertebrate sampling suggest that benthic conditions have not significantly changed since the 2002 sampling; the significant increase in Amphipoda densities was the only noteworthy deviation from 2002 assemblage conditions. Furthermore, 2008 results once again suggested that the restoration area potentially supports a higher taxonomic richness and higher EPT richness than do the upstream reference sites.
