## HELP STAMP OUT SUSPECTS/COUNTERFEITS

CH2MHILL Plateau Remediation Company

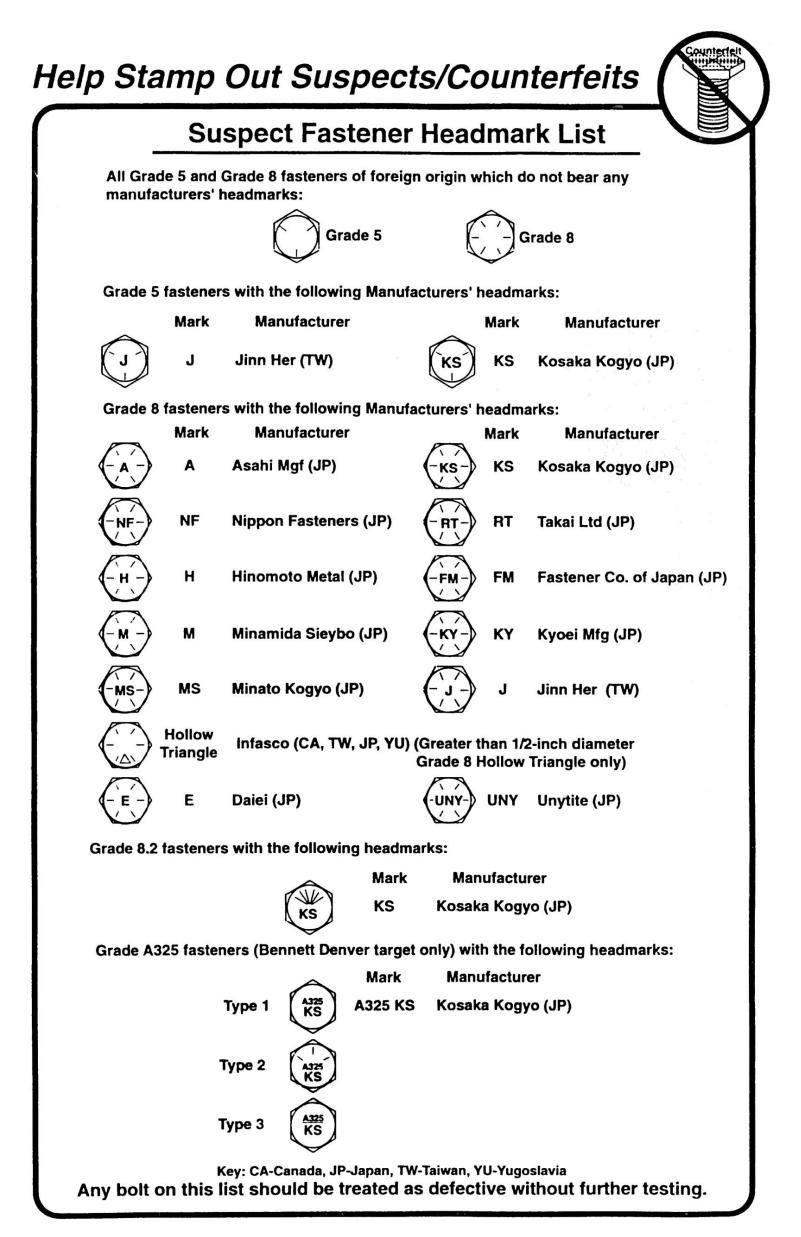
Examples of stainless steel fasteners that have been upgraded from 18-8 to ASTM A320 or ASTM A193 Grade B8 after hand stamping. The last three examples show samples of fasteners to indicate conformation to two noncompatible standards, ASTM A193 and ASTM F 593C.

Any bolt on this list should be treated as defective without further testing and process in accordance with PRC-PRO-QA-301. Note: This list was originally published by DOE/EH-0196, Issue No. 97-6.

If any of these fasteners are located, contact your facility S/CI Point of Contact (POC) for instructions. The POC list is on the Hanford Intranet at: <u>http://prc.rl.gov/rapidweb/QA/i</u> <u>ndex.cfm?PageNum=58</u>.
