### Performance of engineered soil and trees in a parking lot bioswale

Qingfu Xiao<sup>a\*</sup> and E. Gregory McPherson<sup>b</sup>

<sup>a</sup>Department of Land, Air, and Water Resources, University of California, Davis, USA; <sup>b</sup>USDA Forest Service, Pacific Southwest Research Station, Urban Ecosystems & Social Dynamics Program, Davis, CA 95618, USA

A bioswale integrating an engineered soil and trees was installed in a parking lot to evaluate its ability to reduce storm runoff, pollutant loading, and support tree growth. The adjacent control and treatment sites each received runoff from eight parking spaces and were identical except that there was no bioswale for the control site. A tree was planted at both sites. Storm runoff, pollutant loading, and tree growth were measured. There were 50 storm events with a total precipitation of 563.8 mm during February 2007 and October 2008. The bioswale reduced runoff by 88.8% and total pollutant loading by 95.4%. The engineered soil provided a better aeration and drainage for tree growth than did the control's compacted urban soil. The superior performance of the bioswale demonstrated its potential use for large-scale applicat

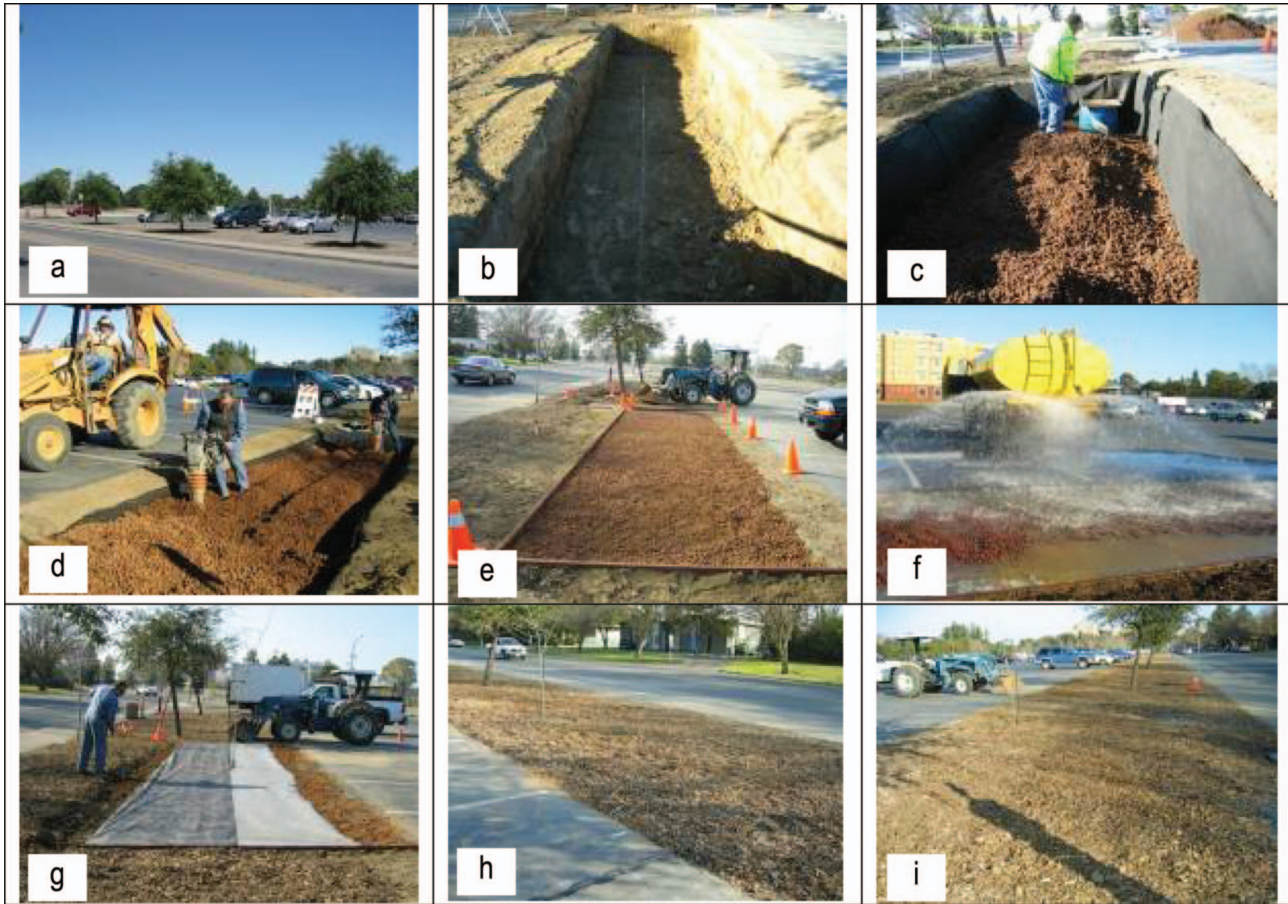
Figure 3. Field installation. Photos were taken at different stage of the field installation. a) Before the bioswale installation, b) excavated pit, c) filled with engineered soil, d) compacted the soil, e) leveled the pit, f) tested the soil settlement, g) added tree to the system, h) finished site, i) both control and treatment sites were covered with mulch to match the surrounding land cover.

MT-65H). A 19.0 litre Bloodgood London Plane (*Platanus x acerifolia* 'Bloodgood') tree was planted in the centre of the bioswale. Initially, the bioswale was designed to be 1.2 m deep, but was reduced to 0.9 m depth during field installation to avoid damaging utility and communication cables that were underground.
