CHAPTER 5 – RETAINING WALL DEMONSTRATION PROJECT

OVERVIEW

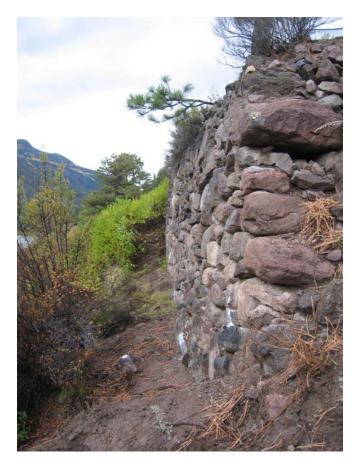
The PUR demonstration project focused on an equally unstable, approximate 18-m (60-ft) long section of the dry-stack wall immediately north of the micropile section. This wall section ranges in height from 1.8 to 3.6 m (6 to 12 ft) and is in a state of pending major failure evidenced by wall face rotation/bulging (approaching negative batter) and numerous sinkholes/depressions just behind the top of the wall, as shown in Figure 15.

Figure 15. Photo. Bulging dry-stack wall, looking northwest along the test section.

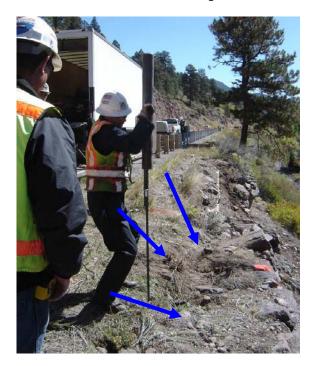
similar manner to driving fence posts in the ground, as shown in Figure 17. The small diameter of the rod and granular nature of backfill enabled the rod to be driven relatively easily.

Figure 17. Photo. Driving jam-rod just behind visible wall settlement zone with fence post driver. Arrows indicate areas of wall displacement and settlement.

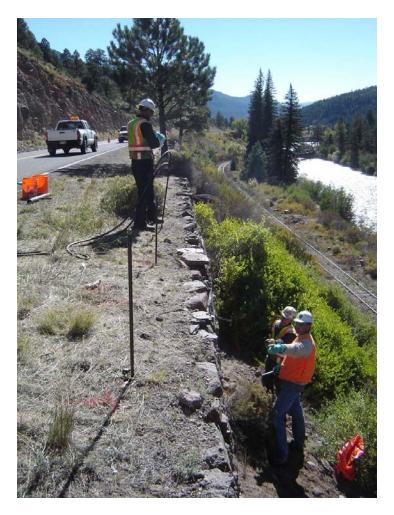
The injection locations varied from (0.6 to 1.5 m (2 to 5 ft) behind the face of wall as shown in Figure 18, and consisted of driving the jam-rod to depths ranging from 0.9 to 2.4 m (3 to 8 ft). Once the rod had been placed, pump lines were attached to the jam-rod, as shown in Figure 19, and the two-component product was pumped at pressures between 0 to 0.15 MPa (0 to 25 psi). Pumping time intervals ranged from 2 to 60 minutes, and resulted in 22 to 250 kg (50 to 500 lb) of product being injected. Pumping ceased when either slight wall movements were visually detected or product flow was spotted from the wall face or ground surface. Small rocks and/or screwdrivers were used as crude "tell-tales" to monitor when PUR injection pressures were beginning to outwardly deflect the wall structure as shown in Figure 20.

Figure 18. Photo. Jam-rods placed along the top of a well-built, well performing section of the study wall. No signs of wall settlement allowed placement of the injection rods closer to the wall face.

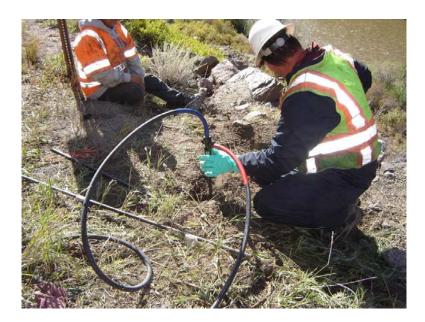
Figure 19. Photo. PUR A and B components are pumped separately to the top of the jam rod assembly. Mixing occurs within the injection rod assembly via a spiraled insert prior to product injection within the rock mass.

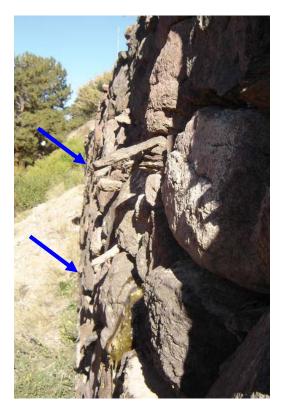
Figure 20. Photo. Blue arrows indicate location of balanced rocks used as "tell-tales" to detect outward wall deflection.

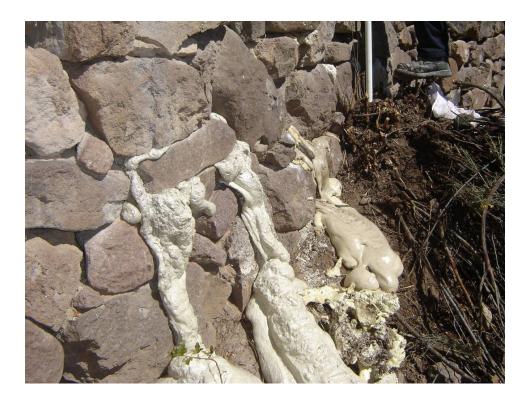
Cleanup of PUR overrun, if done prior to full set (within a few minutes after the PUR injection), consists of simply peeling the materials off the rock face and placing into garbage bags for disposal. PUR materials that encounter water will foam to a certain degree and are easier to peel off than non-foamed resin (foamed PUR prior to cleanup shown in Figure 21). PUR products that do not encounter water will peel off easily in the first few minutes of set; however, after a few minutes or hours the material will have to be chipped off with a hammer. The dry-stack walls at the demonstration site had large void areas, which enabled viewing of the PUR product inside the interlocking boulders as shown in Figure 22. The PUR product was injected after a period of heavy precipitation and the product did foam for one to two days when it encountered the subsurface moisture. After a few days the PUR product foamed much less as the subsurface began to dry out.

Figure 21. Photo. PUR that has foamed due to high moisture within the wall rock mass. This material can be readily peeled off the rock face and bagged for disposal.

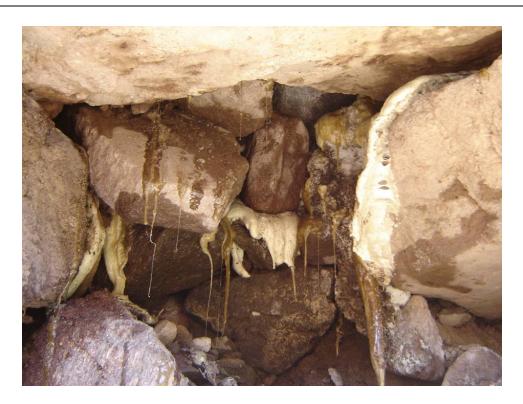
Figure 22. Photo. PUR product distribution within large void in dry-stack wall. This location was initially injected via jam-rods behind the wall the day after steady rains passed through the area, resulting in foaming of the PUR. Subsequent face injection days later, when the wall rock had dried substantially, resulted in non-foamed resin coverage of the interior rocks. The foamed PUR provides for consolidation, whereas the non-foamed product provides for rock-on-rock adhesion.

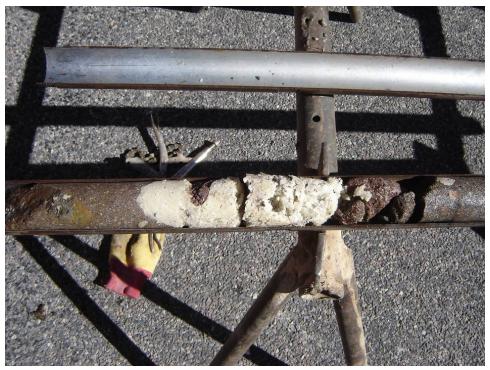
Two coreholes were advanced behind the wall to characterize PUR coverage deeper in the wall mass. In one boring, foamed PUR was visible in the core sample and illustrated the permeation of the product between the backfill boulders as shown in Figure 23.

Figure 23. Photo. Light-colored, foamed PUR in core sample.

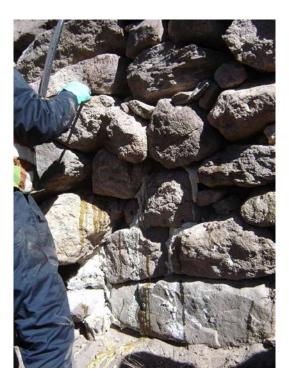
PUR product was also injected between the facing rocks with a hand-held injection nozzle. This method led to numerous product overruns and required additional cleanup as shown in Figure 24. Figure 25 depicts an elevation view of the dry-stack wall at the end of mitigation.

Figure 24. Photo. PUR injection directly between wall facing rocks using a hand-held injection nozzle.

- 5. Injection directly into the face was also evaluated using a short 450 mm (18 in) injection "wand". This method can very quickly inject resin throughout the wall mass, but resulted in significant face drips and overruns as the injection gun was moved from one placement to the next. Improvements to the injection tooling could overcome much of this problem

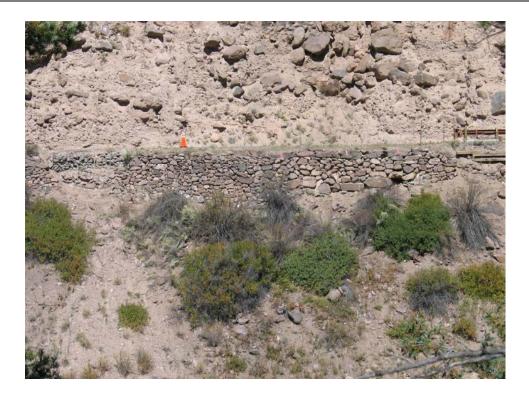
Figure 25. Photo. Elevation view of the South Fork dry-stack wall following completion of PUR injection. PUR overruns are nearly invisible from this distance.

- 8. Wall cleanup required vigilance during resin injection to quickly locate and remove PUR overruns, to the extent possible. The hard, non-foamed resin could be seen as drips, runs and small area coatings over a significant portion of the wall face. It is anticipated that this material will eventually weather away due to the strong southern exposure of the wall face and UV susceptibility of PUR. The foamed PUR was easier to remove, but left a

visual impact along the wall where it fully filled face voids. Overall, the PUR overruns are only visible when standing directly in front of the wall. No signs of the injection program were visible from below the wall along the Rio Grande River or from nearby pedestrian access points.
