# DRILLED SHAFT FOUNDATION DEFECTS

## Identification, Imaging, and Characterization

Publication No. FHWA-CFL/TD-05-007

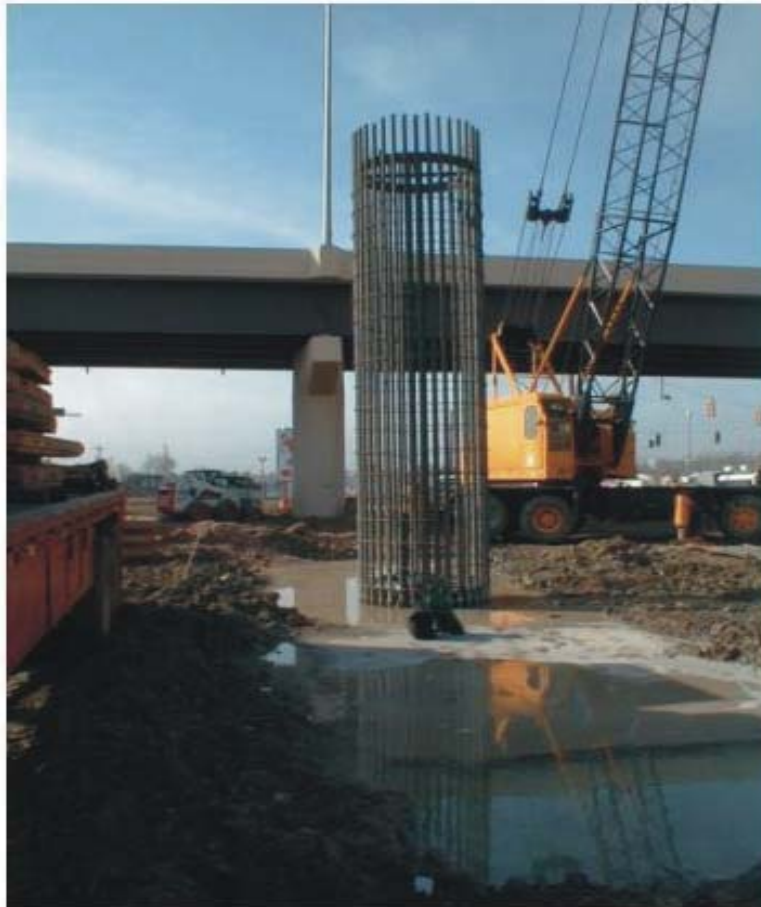
**Figure 2. Photo. Drilled Shaft Construction.**

Drilled shafts range from diameters of 46 cm (18 in) to greater than 3.6 m (12 ft) and to depths of 50 m (164 ft). The variation of shaft diameter is dependable on excavation depth. As the depth of excavation becomes greater, the diameter normally must increase. Several factors that influence the ratio of depth to diameter are: the nature of the soil profile, the position of the groundwater table, whether or not a rebar cage is required, the design of the concrete mix, and the need to support lateral loading. Ordinarily, the aspect ratio of drilled shaft, or its length divided by its diameter, should not exceed about 30. Cylindrical holes can be drilled with diameters of up to 6 m (20 ft), to depths of up to 73 m (243 ft), and with underreams up to 10 m (33 ft) in diameter, although such sizes are unusual. A typical schematic of drilled shaft construction with the loading is presentation in Figure 1 and a typical drilled shaft operation during construction is shown in Figure 2.

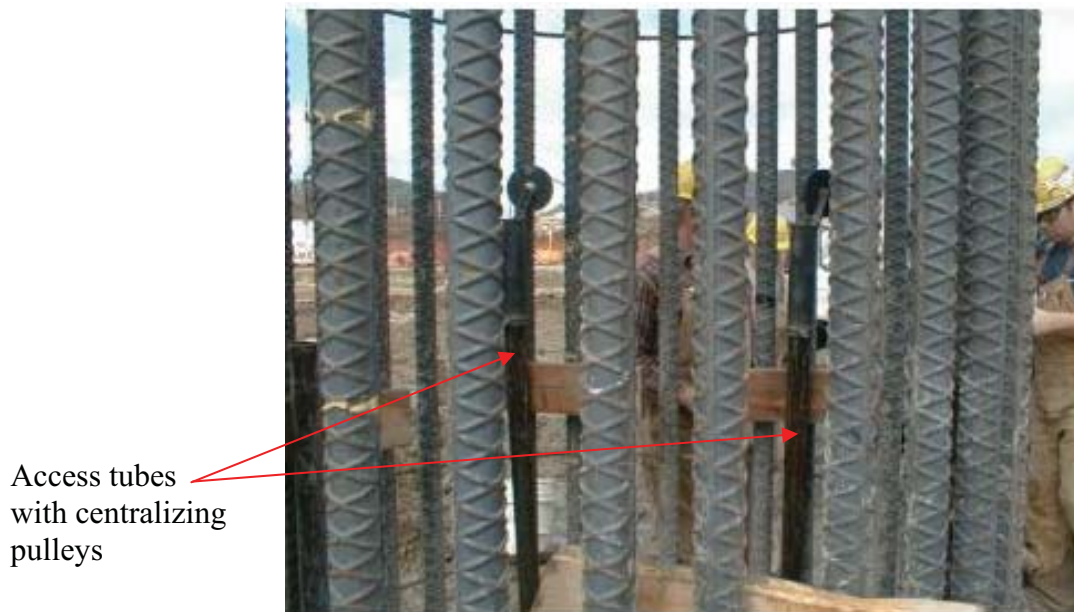
**Figure 3. Photo. Rebar Cage and CSL Tubes of Completed Drilled Shaft.**

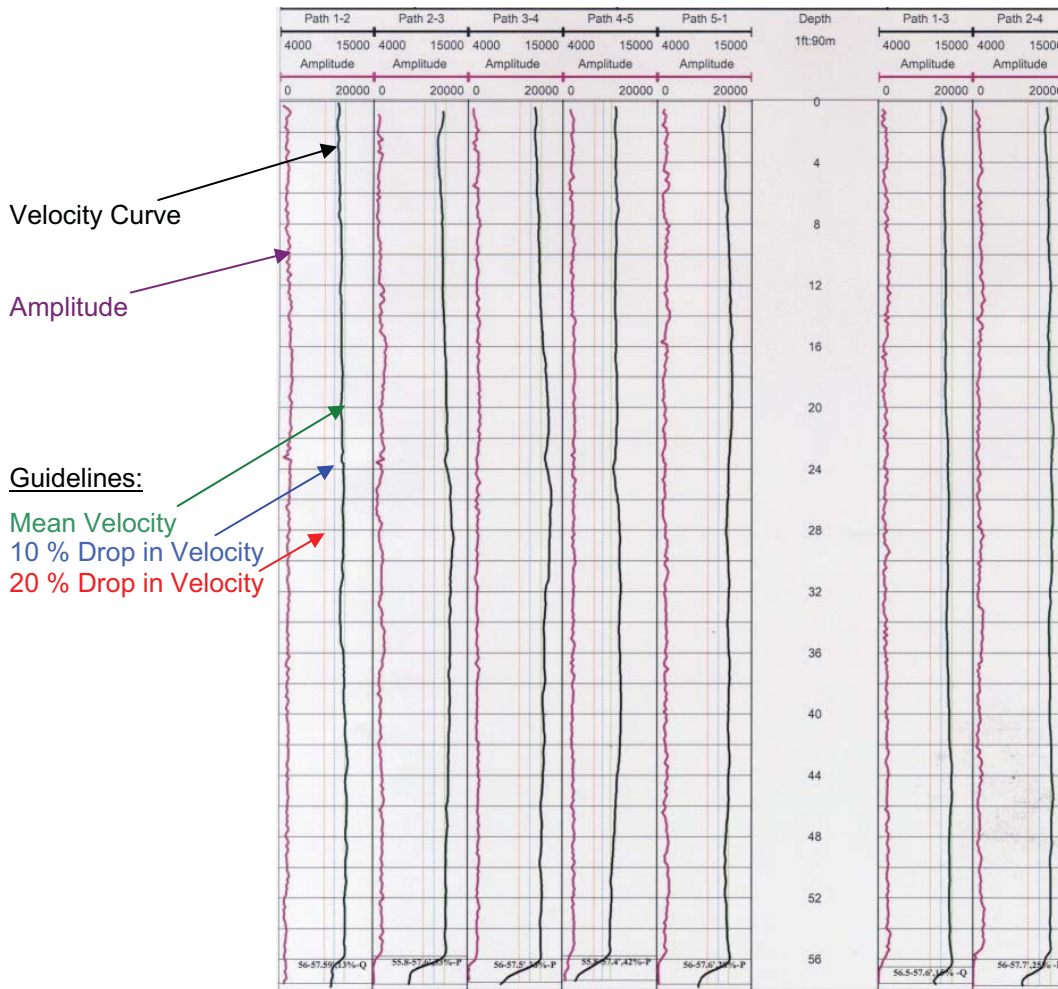
**Figure 6. Graph. Single Plot Display Format for the CSL Data from a Drilled Shaft Foundation. Green Vertical Guideline Indicate Average Velocity and Blue and Red Vertical Guidelines Denote 10% Drop and 20% Drop in Velocity, Respectively.**

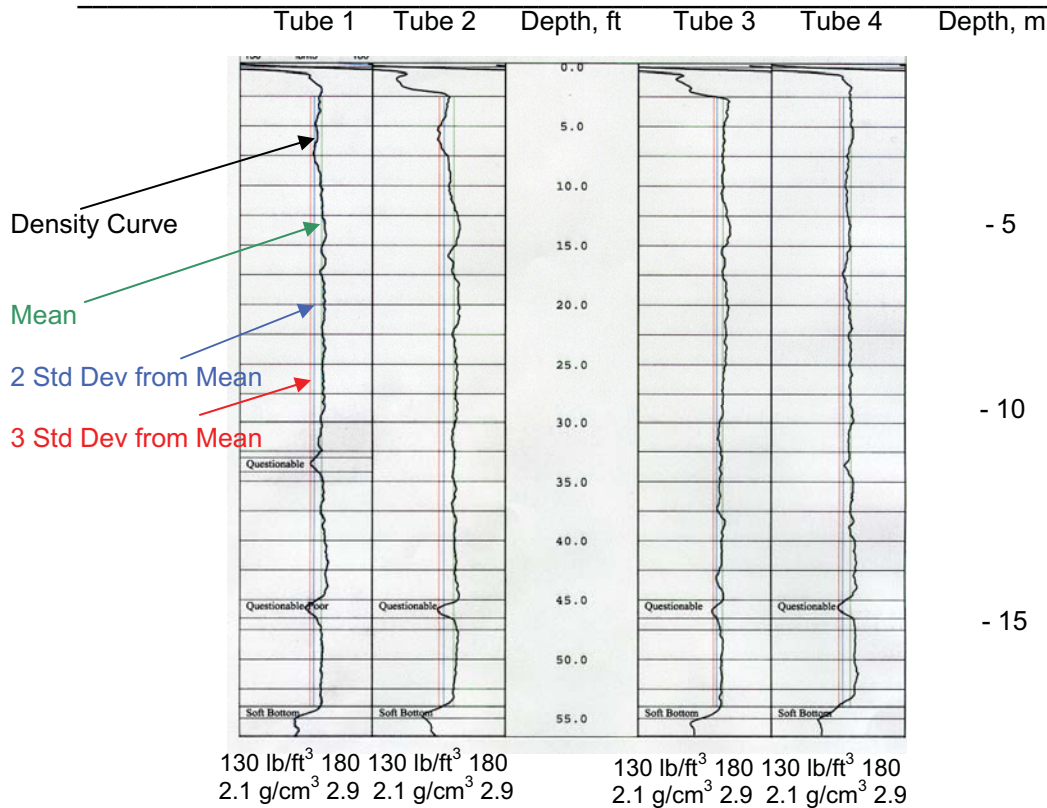
**Figure 11. Graph. Gamma-Gamma Density Logging (GDL) Data Display Format.**

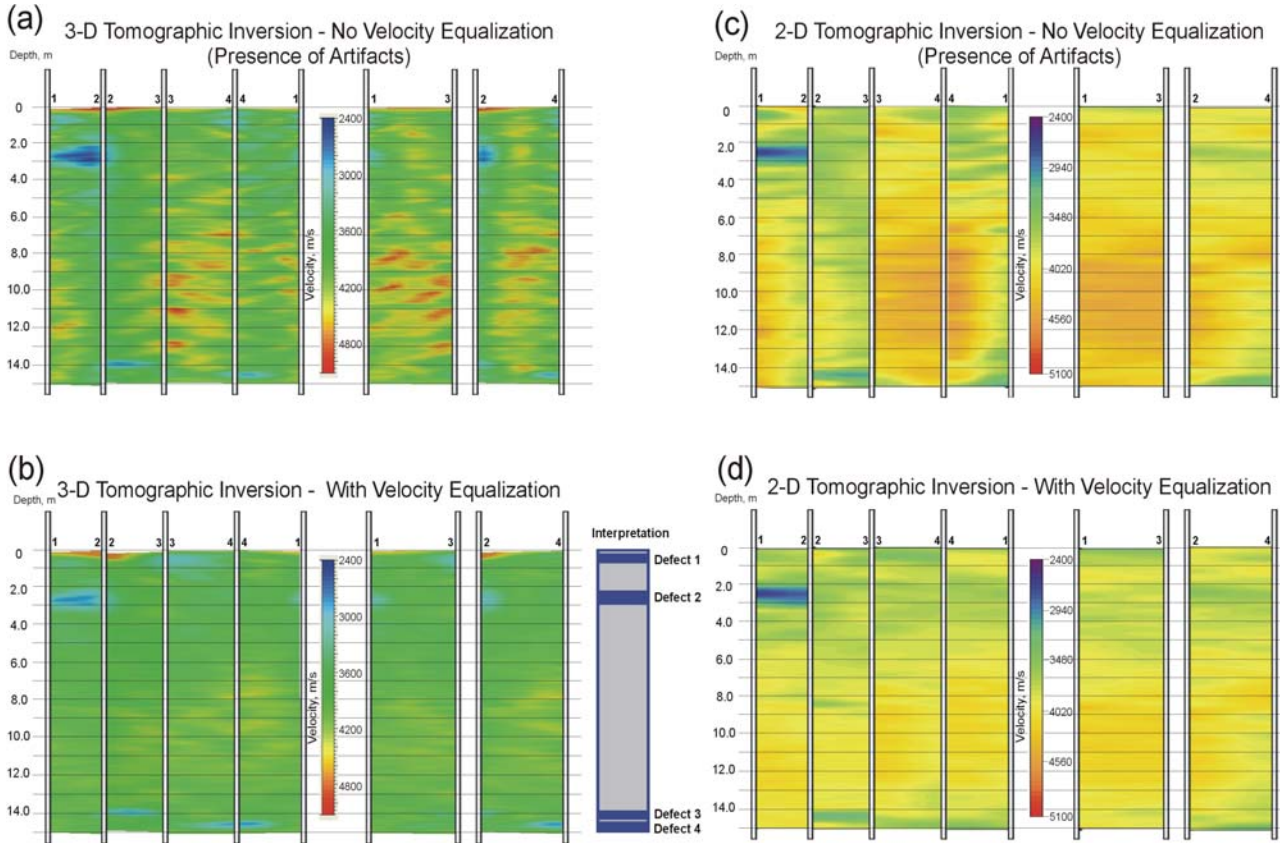
**Figure 12. Schematic. Comparison of 2-D and 3-D Tomographic Imaging With and Without Velocity Equalization- Shaft 1, NGES, Amherst, MA.**

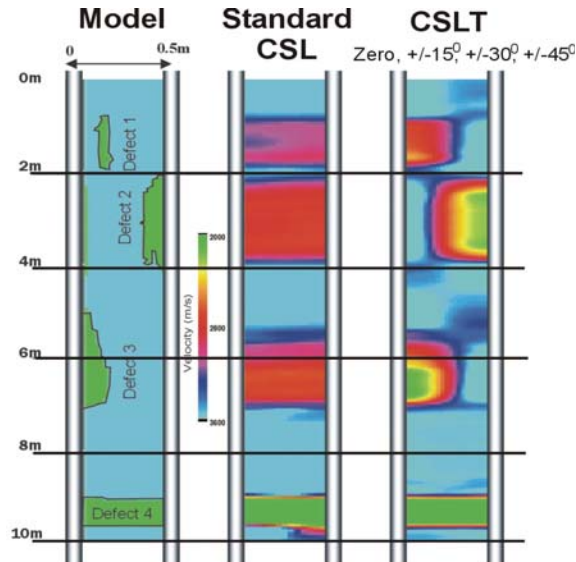
**Figure 16. Schematic. Synthetic Modeling of a Shaft with Multiple Levels of Defects. Tomographic Imaging Results Comparing Standard Zero-Offset CSL Image With Multi-Offset CSLT Image.**

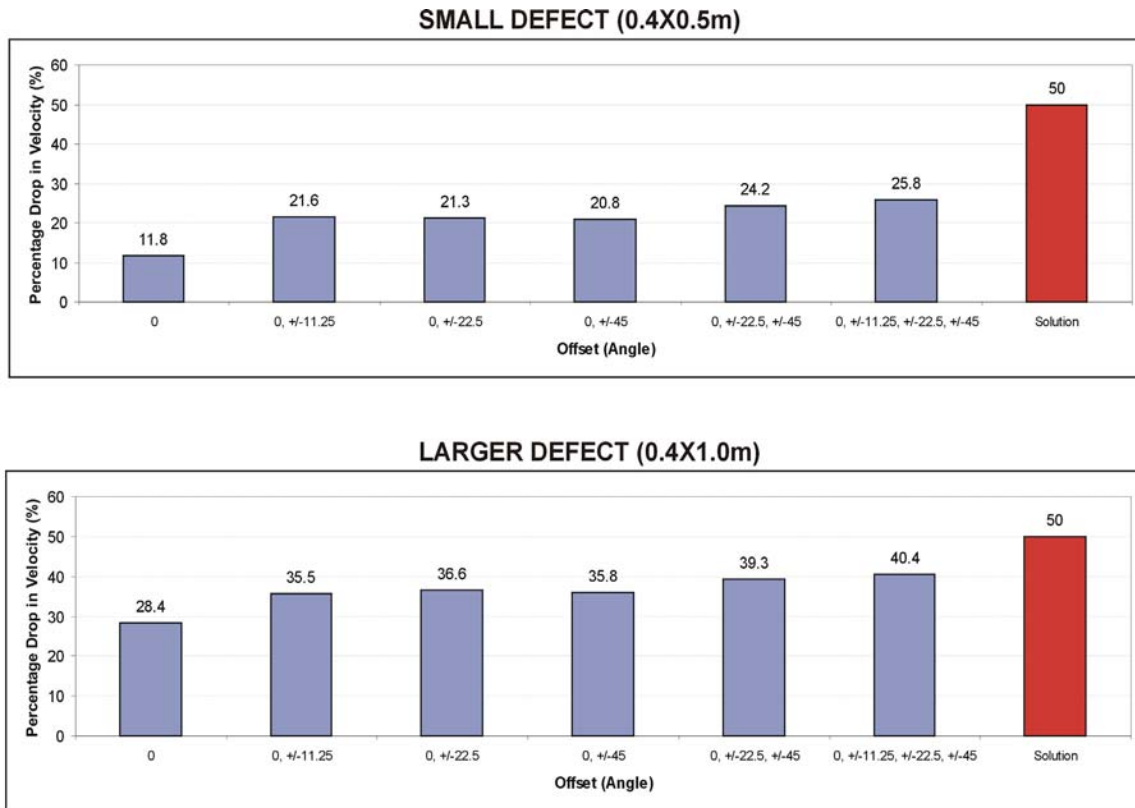
**Figure 17. Schematic. Correlation between Percentages Drops in Velocity of Standard CSL Versus Number of Combination of CSLT Tomography.**

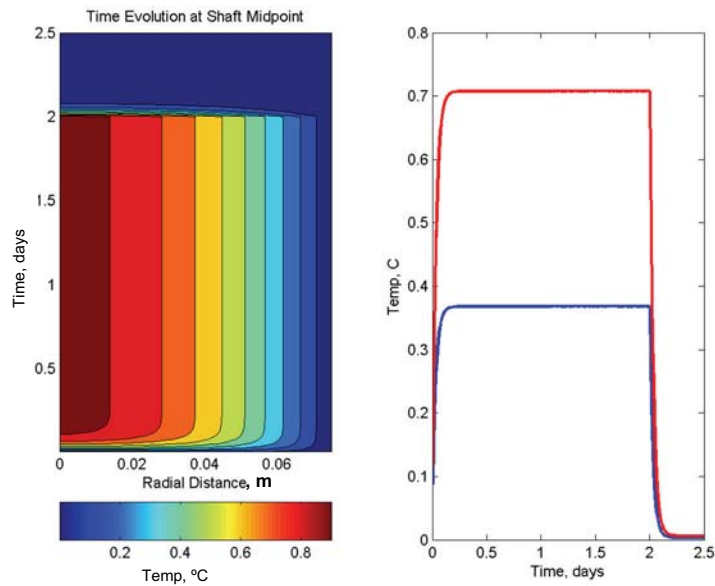
**Figure 25. Chart. As Figure 24, but with Constant-Temperature Outer Boundary Condition, Appropriate to Maximally Efficient Convective Cooling to Surrounding Air. Note Strong Radial Temperature Gradients and Large Difference in Central Vs. Mean Temperatures because of Fixed-Temperature Boundary Condition. Maximum Temperature Increase is < 1°C.**

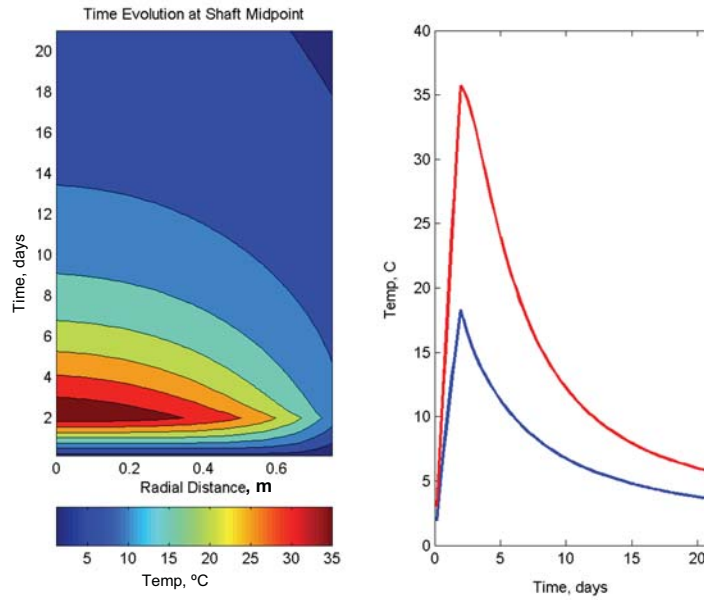
**Figure 26. Chart. Thermal Evolution of Nominal Drilled Shaft. Maximum Temperature Increase ~35°C, Mean Temperature Increase ~18°C, Temperatures in Excess of Maxima (Peak) in Sample Persist for > 3 Weeks.**

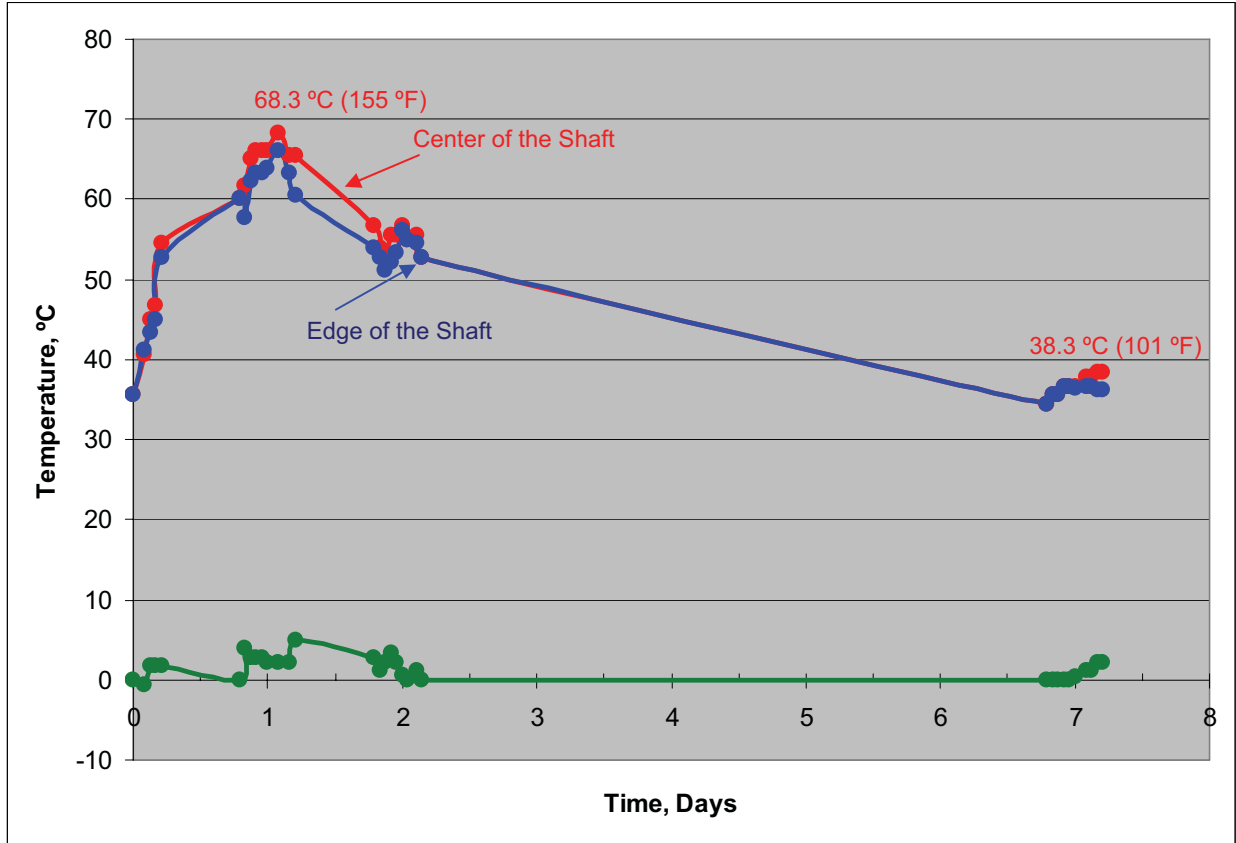
**Figure 34. Graph. Temperature Monitoring of Abutment 2 Shaft 2 Using Embedded Thermocouples. The Red Curve Displays the Temperature Readings at the Center of the Shaft at 2.4 m (8 ft), Blue Curve Displays Temperature Reading Near the Rebar Cage at the Same Depth, and the Green Curve Displays the Temperature Differential Between the Two Stations. Hagerman National Wildlife Refuge, TX.**

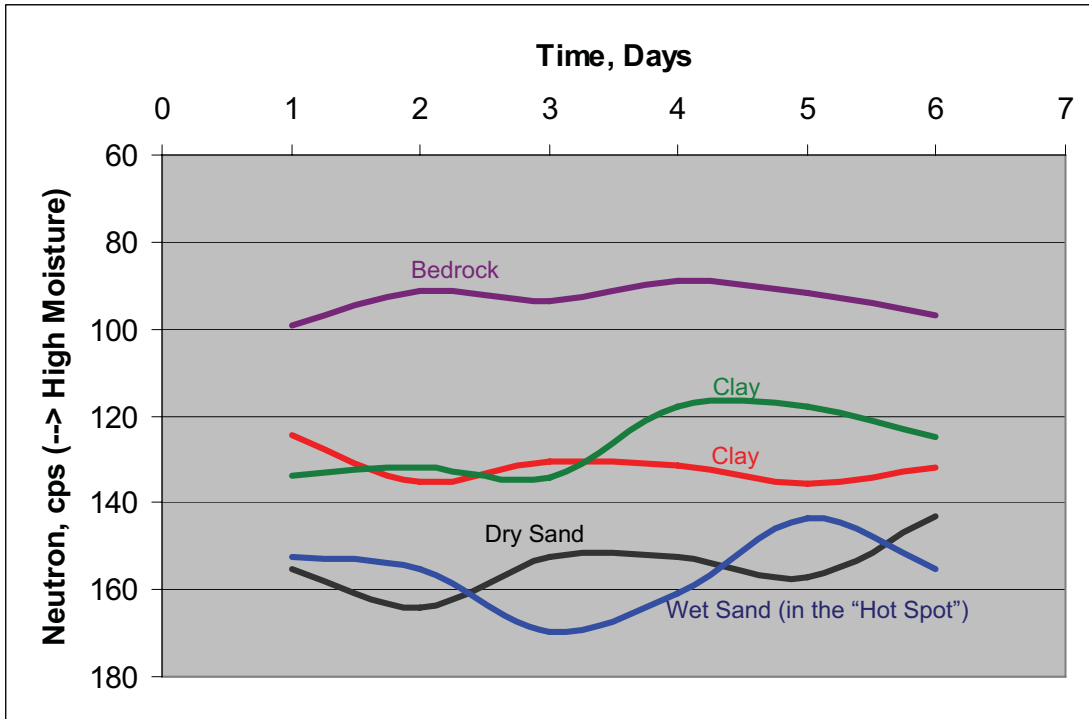
**Figure 44. Graph. Moisture Monitoring of Abutment 1 Shaft 1. Hagerman National Wildlife Refuge, TX. Temperature Values are Averaged from the Four Access Tubes at 3m (Black), 6 m (Blue), 9 m (Red), 12 m (Green), and 15 m (Magenta) Depth Points.**
