ROAD STABILIZER PRODUCT PERFORMANCE

Seedskadee National Wildlife Refuge

Publication No. FHWA-CFL/TD-08-005

September 2008

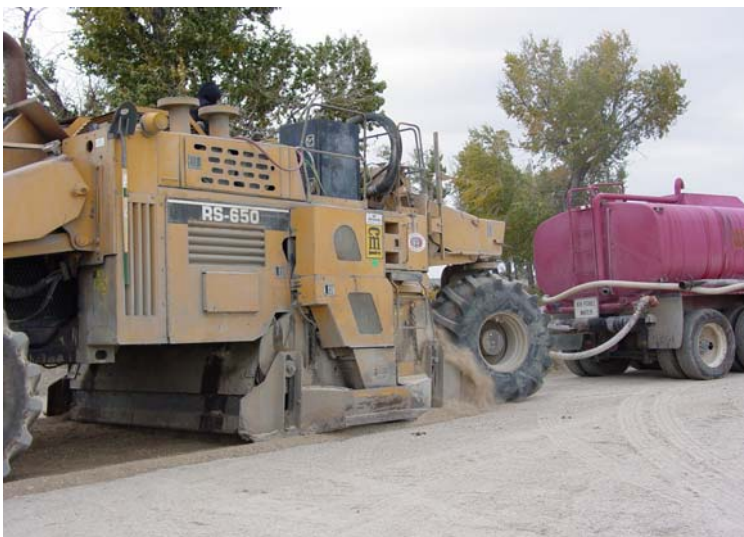
Figure 4. Photo. CMI 650 pulverizer following water truck.

CMI 650 pulverizer to mill the aggregate to a 125-mm (5-in) depth and mix in the various products as shown in Figure 4. Desert Mountain Corporation delivered their products (DCA-2000 Caliber and DMC 820 Lignosulfonate/Magnesium Chloride) accompanied by a product representative to oversee the application of their products. They used a 17,000-L (4,500-gal) distributor truck to apply the products. The CMI pulverizer, grader, and roller were then used to process, grade, and compact the treated aggregate.

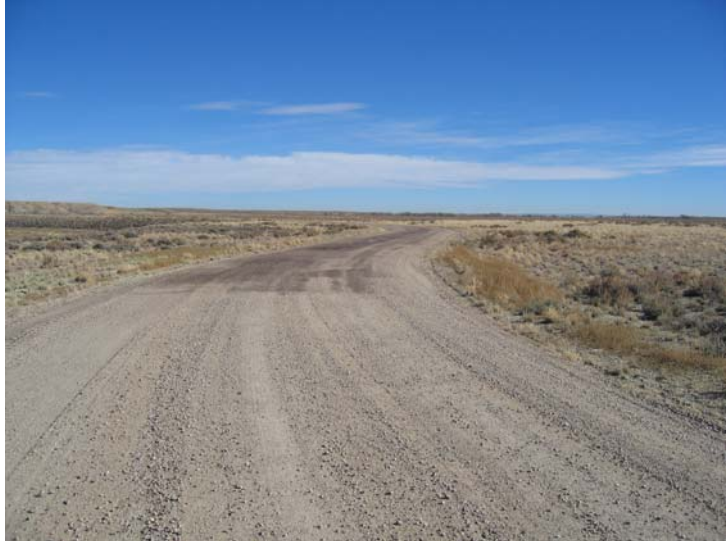
Figure 5. Photo. The change from Section I (TerraZyme) to Section II (Lignosulfonate).

The clear concentrate TerraZyme stabilizer was applied in two batches using 19 L (5 gal) of concentrate for each 15,000 L (4,000 gal) of water. Mixing was accomplished by running the mixture through the 100-mm (4-in) hose and back into the water truck through the topside portal. The water truck was then hooked up to the front of the pulverizer where the solution was introduced into the aggregate surface course through liquid dispersion nozzles as it was milled to a 125-mm (5-in) depth. The right lane was processed first, and then the left lane. The middle 0.6 m (2 ft) of the 5.5-m (18-ft) roadway received a double application due to the overlap of the 3-m (10-ft) wide milling machine. The mixture was then graded and rolled for the final appearance as shown in Figure 5.

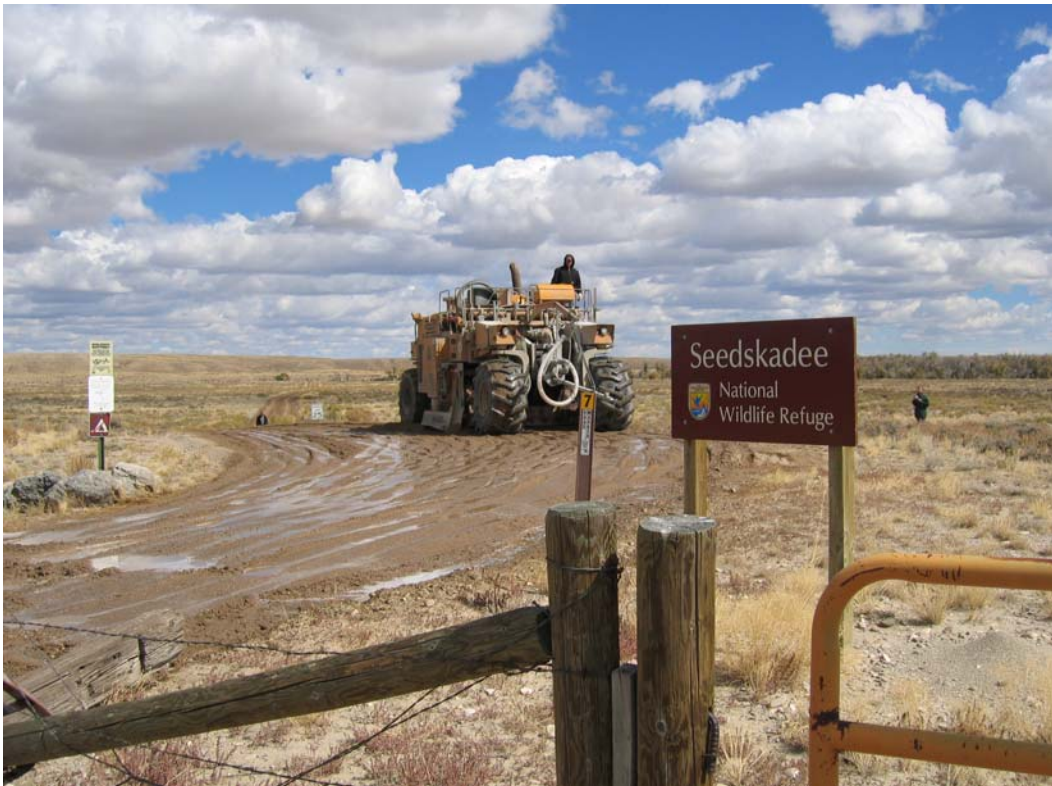
Figure 6. Photo. 650 CMI pulverizer mixing Caliber product into Section V.

The 3.7-m (12-ft) wide roadway was watered, the top 50 mm (2 in) of the road scarified, and then the Caliber stabilizer applied using the Desert Mountain distributor truck at a rate of 3 L/m² (0.75 gal/yd²). After allowing the solution to marinate for approximately twenty minutes, the CMI pulverizer was used as shown in Figure 6 to thoroughly mix the product into the aggregate surface course to a 125-mm (5-in) depth. The 3.7-m (12-ft) wide roadway was then graded and rolled, at which time a topical application of the solution was sprayed at a rate of 1 L/m² (0.25 gal/yd²).

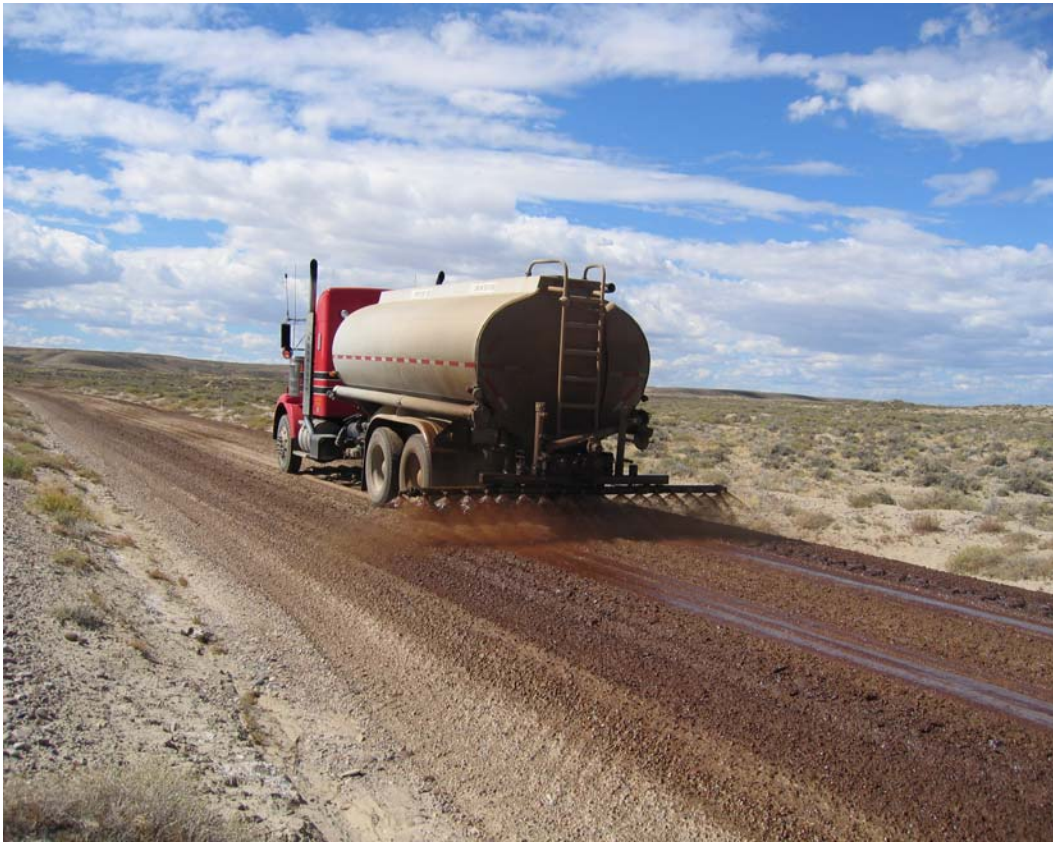
Figure 7. Photo. Distribute truck applying DMC-820 Ligno/Mag to Section VI.

The 5.5-m (18-ft) wide roadway was watered as shown in Figure 7, the top 50 mm (2 in) of the road scarified with the motor grader, and after watering again, the Mag/Lig mixture was applied with the Desert Mountain distributor truck at a rate of 3 L/m² (0.75 gal/yd²). After allowing the solution to marinate for approximately twenty minutes, the CMI pulverizer was used to thoroughly mix the product into the aggregate surface course to a 125-mm (5-in) depth. This section was processed one lane at a time, and then the entire 5.5-m (18-ft) roadway was graded and rolled. This was followed by a topical application of the solution sprayed at a rate of 1 L/m² (0.25 gal/yd²).

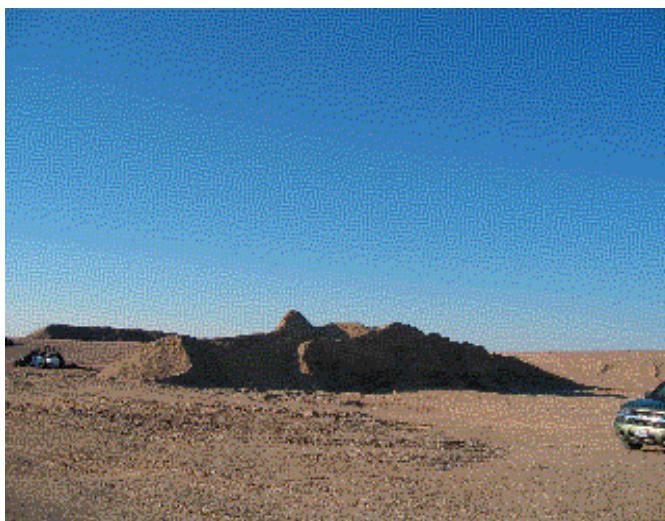
Figure 8. Photo. Materials stockpile at Seedskadee Pit.

The construction contract specified a surface course aggregate for the Seedskadee project. Test results of the sampled material show that the material was within the contract tolerances. Despite differences in plasticity that are discussed in the following subsection the soil classification results show only minor variations across the samples. As shown in Table 4, under the AASHTO M 145 classification system, the aggregate surfacing material was an A-1-b material defined as well-graded finer stone fragments, gravel, and sand with a plasticity index (PI) less than or equal to 6%. Under the ASTM D 2487 classification system, the aggregate surfacing material fell into three different classifications of course-grained soils: SP-SM (poorly graded sand with silt), SP-SC (poorly graded sand with clay), and SC-SM (silty clayey sand.) The monitoring team did not consider these ASTM classification differences to be significant.

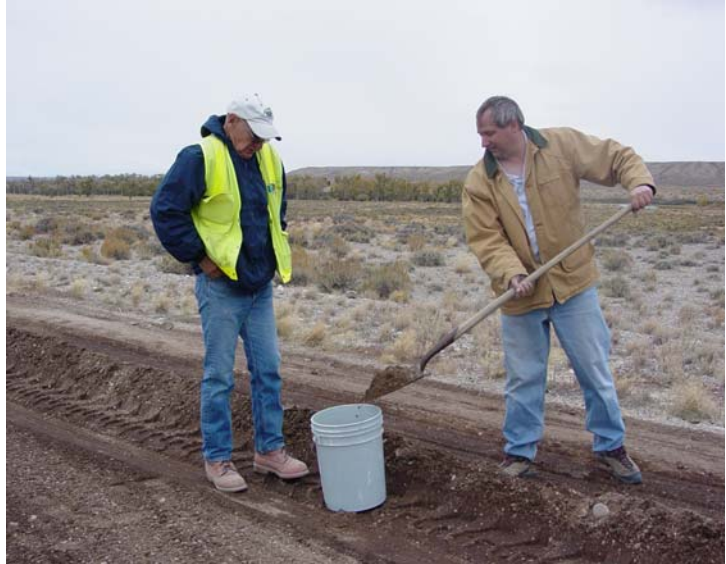
Figure 9. Photo. Collecting treated samples for laboratory testing.

The material was sampled before and after treatment as shown in Figure 9. The test results in Table 4 above for the untreated material show that a commercial laboratory determined the material was non-plastic (NP), whereas the CFLHD laboratory found it to have a plasticity index (PI) of 4%. Since the contract specified a PI target value of 8% plus or minus 4%, the CFLHD laboratory test results were used to initially determine that the material met the specifications.

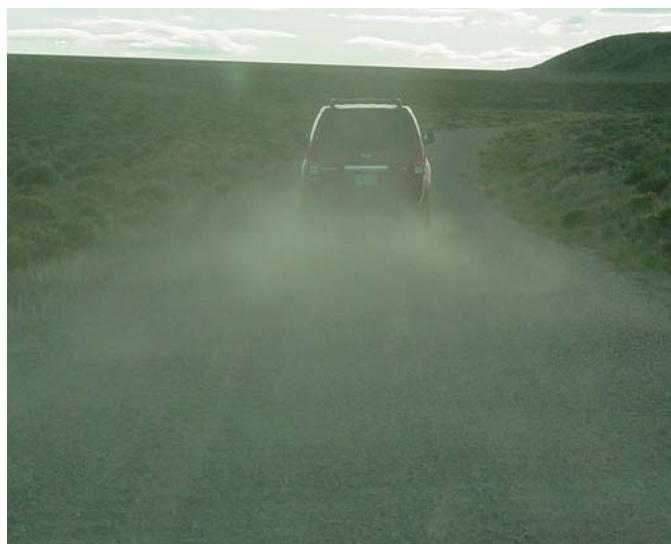
Figure 11. Photo. Monitoring for dust.

During all of the monitoring events – at 8, 11, 20, and 23 months following the September 2004 construction completion - the weather was dry. This was fortunate as it enabled the observers to distinguish the various levels of dust generation in each section.

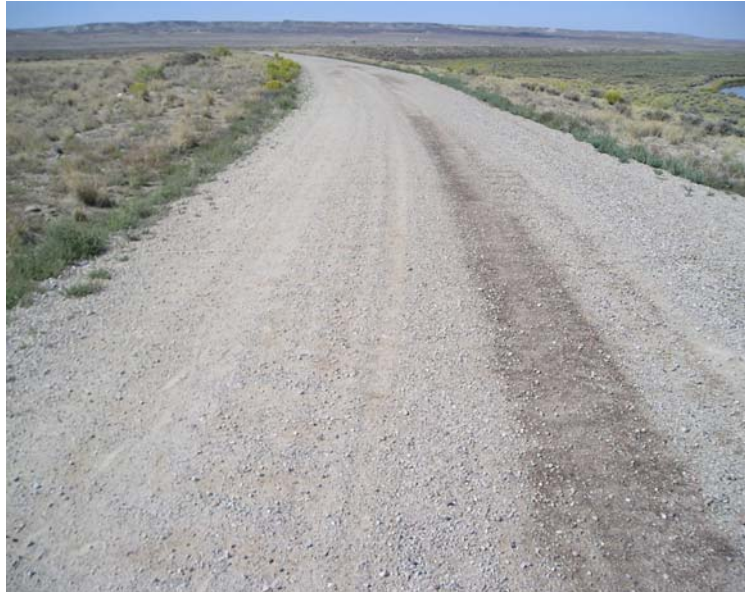
Figure 15. Photo. Lignosulfonate Section II product still showing two years after application.

By the 11-month event in August 2005, no product was visible in the TerraZyme, PermaZyme, or Soil Sement sections. The Lignosulfonate section was showing a lot of product in the wheel paths. The Caliber section showed product in a few areas, and the Mag/Lig section showed product at the beginning of its length.

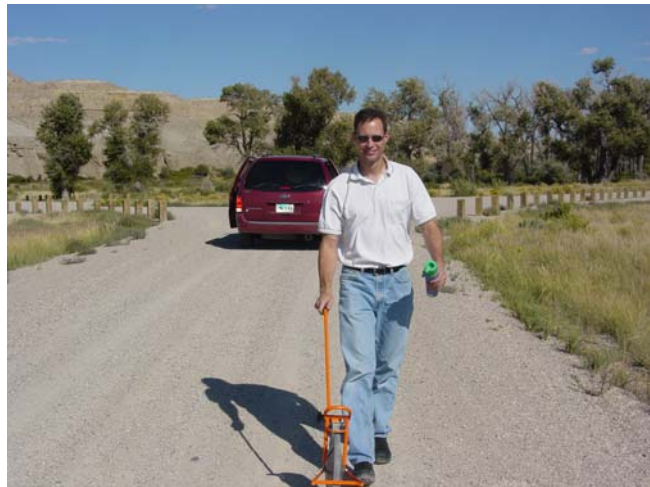
Figure 16. Photo. Locating specified monitoring area.

During each monitoring event, four 7.6-m (25-ft) long locations were monitored in each of the six sections. To assist in finding the prescribed monitoring locations, the beginning of each treated section was semi-permanently marked with a steel fence post. The 7.6-m (25-ft) long monitoring locations were located by driving to the beginning of each section, setting the vehicle's trip counter to zero, driving to the tenth-of-the-mile point, and using a surveyor's wheel as shown in Figure 16 to find the hundredth-of-a-mile location specified in the Monitoring Order and Mileposts Plan. A 7.6-m (25-ft) long area was then measured off behind the point location to set the boundaries for the data collection.

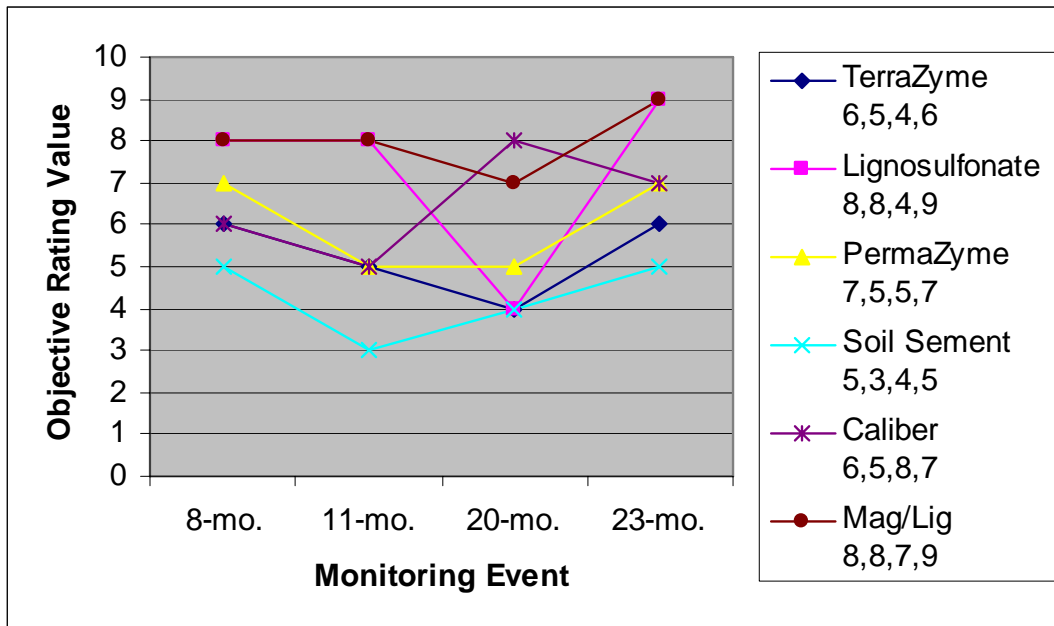
Figure 17. Plot. Dust trends.

The plot in Figure 17 shows how the products rated over time for dust abatement. The products remained in approximately the same order of effectiveness over time except for the 20-month

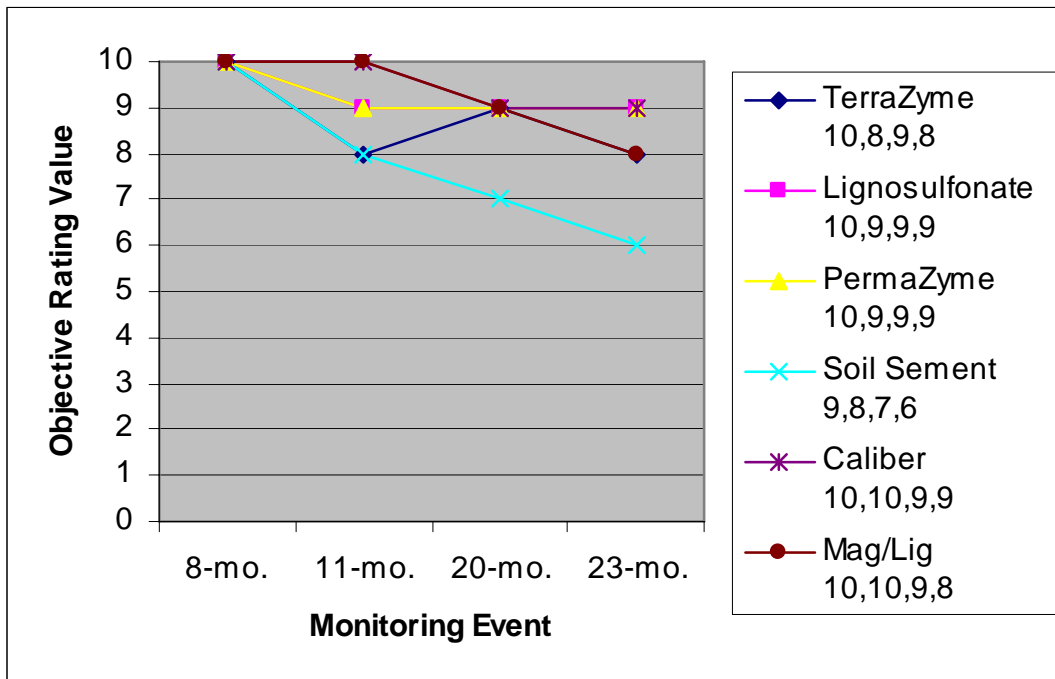
Figure 18. Plot. Washboarding trends.

The plot in Figure 18 shows how the six products compared over time for washboarding. As would be expected due to the low traffic volumes over the winter months, there was no measurable washboarding at 8 months. By the 20-month event, a year later, all of the sections showed some washboarding. Five products - TerraZyme, Lignosulfonate, PermaZyme, Caliber, and Mag/Lig - had an average rating of 9 and washboarding was barely visible. The four measurement locations within each of these five sections had washboard troughs that were slight

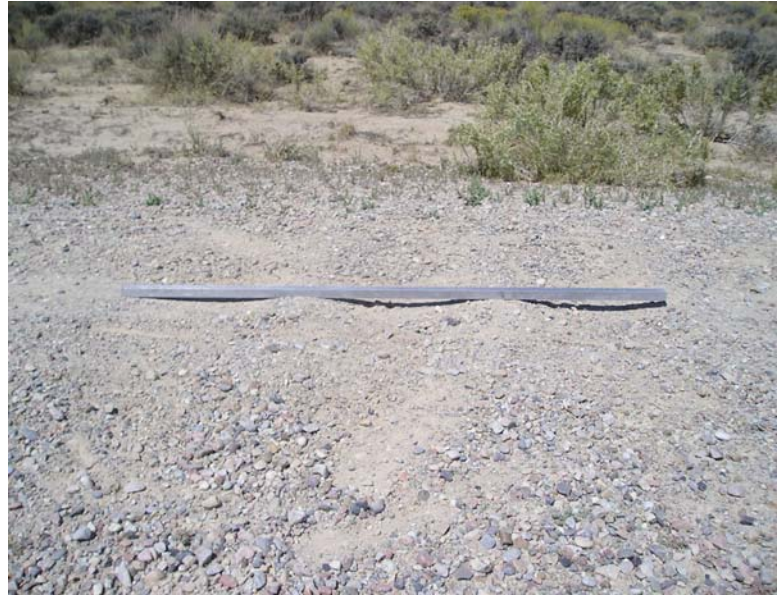
Figure 19. Photo. Measuring washboarding depths.

In the final monitoring event at 23 months, washboarding was more prevalent and pronounced than previously measured. The Soil Sement section received the lowest scores over time for washboarding which was observed to be consistent and significant throughout the entire section. The average measured depth of washboarding troughs, which is illustrated in Figure 19, from the four monitoring locations in this section was 17 mm (0.7 in) that converts to a rating of 6. It is notable that both the Soil Sement section and also Caliber section are only 3.7 m (12 ft) wide and therefore typically experience traffic concentrated to only two tracks, yet the Caliber section's average measured depth of washboarding troughs was less than 1 mm (0.04 in) which gave it a rating of 9.

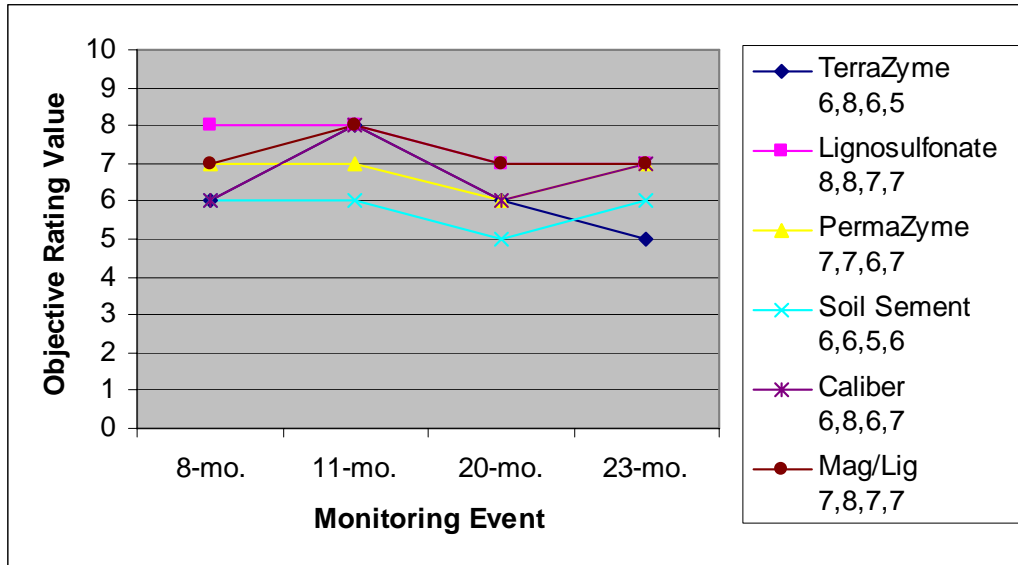
Figure 20. Plot. Raveling trends.

The plot in Figure 20 shows how the products rated over time for raveling. In general, the scores for raveling were lower than for washboarding, though most motorists would probably complain about washboarding long before they complained about raveling. As shown in Figure 20, the amount of raveled material generally increased over time resulting in lower scores over time. Raveling of roadway material appeared to be significant as the average depth of raveled material in a section, as shown in Table 9, ranged from 7 to 23 mm (0.3 to 0.9 in). Again the scores that each section received were dependent on the specific locations of the four 7.6-m (25-ft) long measurement areas within each section. It also should be noted that both curves and travel speeds are important factors in kicking loose material to one side or the other, and there was

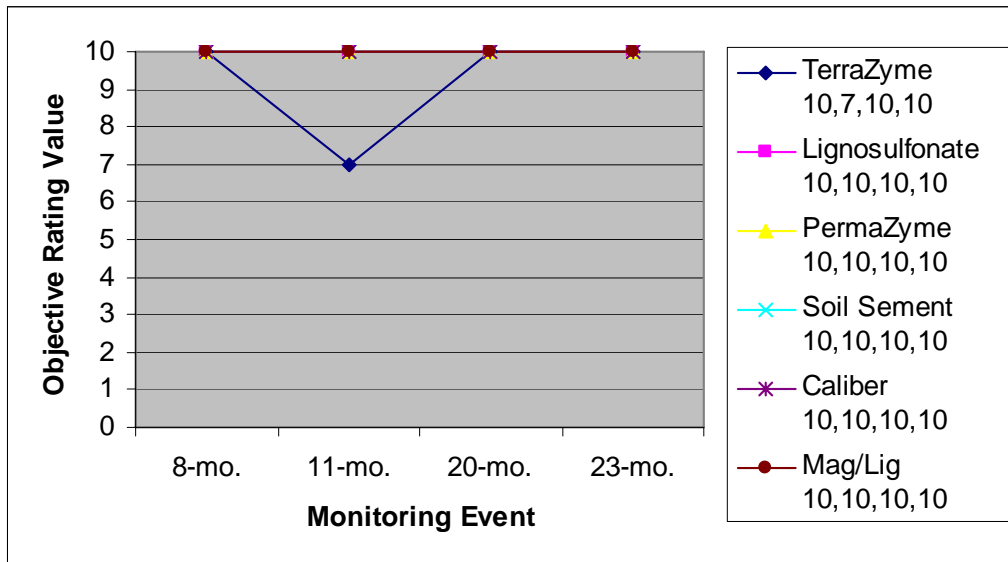
Figure 22. Plot. Potholing trends.

The plot in Figure 22 shows how the products rated over time for potholing. It was not known at the beginning of the study whether there would be potholing or not. Potholes on this project were few and far between, and a score of 10 indicated that potholes were not evident at any of the four monitoring locations within a section. At the 11-month event, the TerraZyme section received a score of 7 because a pothole, measured to be 48 mm (1.9 in) deep, was found within one of the 7.6-m (25-ft) long measurement areas. There was no rating criterion that actually fit this occurrence of one pothole, but the fact that it occurred within a monitoring area was recognized with a score of 7.

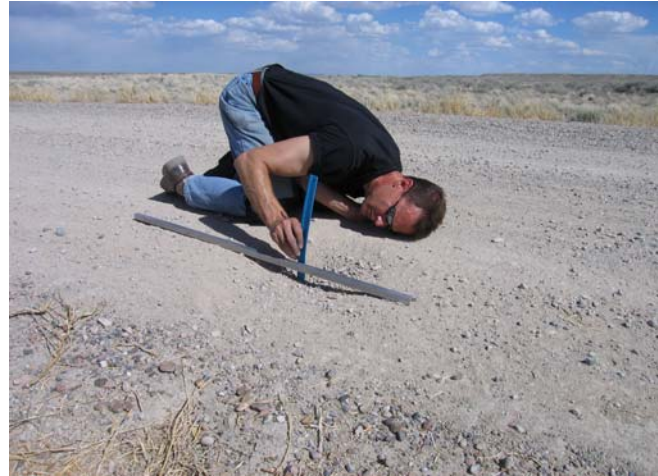
Figure 23. Photo. Measuring Pothole Depth.

diameter and depth at each subsequent event after they were discovered as shown in Figure 23. The pothole rating criteria may need to be revised later on for other monitoring projects.

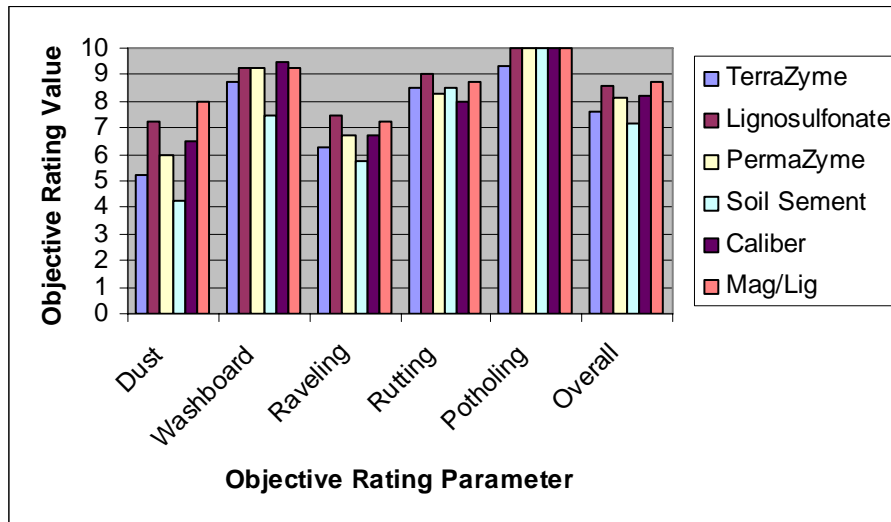
Figure 24. Plot. Relative product standings from objective rating system.

In Table 9, there is an overall rating covering the entire monitoring period for each product and parameter. These parameter ratings are plotted in Figure 24 along with an objective overall rating showing an averaged value of all of the parameters. From objective measurements, four groups of product performance are evident. In the first group were Lignosulfonate and Mag/Lig

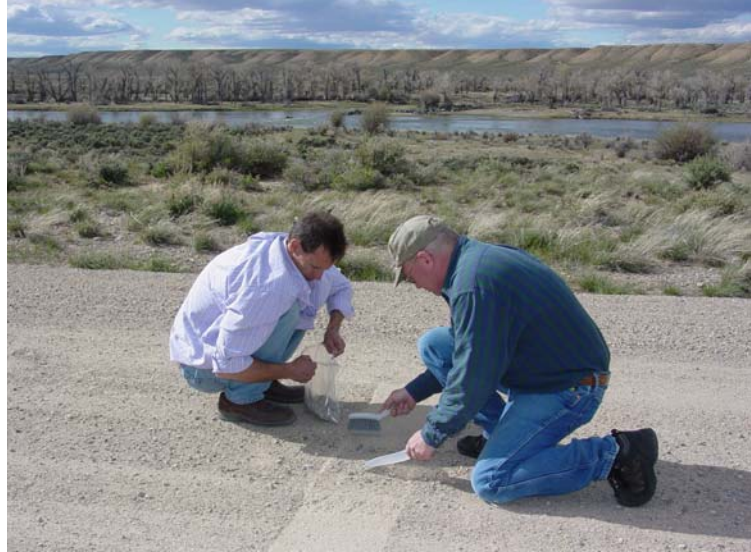
Figure 25. Photo. Sampling for Silt Load Test.

Testing of silt samples provided moisture content information for each monitoring event. This data confirmed consistency within one event so products could be compared. Additionally, if the moisture content was consistent between the various events, it would allow additional reasonable comparisons to be made. As can be seen in Table 11, all moisture test results over the entire 24 months of monitoring showed that the average moisture content was less than one-half of one percent. It seems reasonable, therefore, that the amount of dust observed at any given time would correlate with the amount of silt available. Based on this, Chapter 7 presents a comparison of Silt Test results and the agreed objective dust ratings for each product.

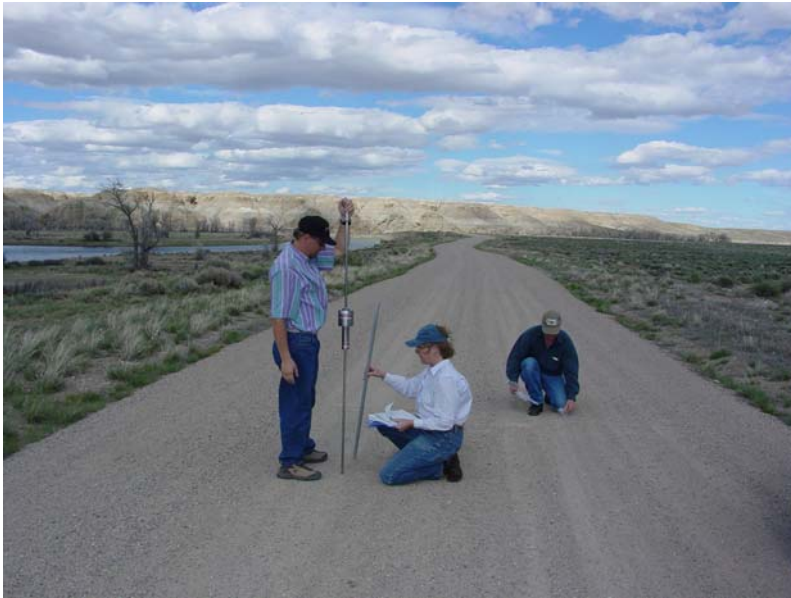
Figure 26. Photo. DCP testing.

While the ASTM D 6951 procedure for the DCP recommends recording the depths of penetration every 10 hammer blows, the evaluation team used a modified method. Since the roadway was consistently treated to a depth of 125 mm (5 in), the total blows to penetrate to this depth were recorded as shown in Figure 26. The overall average blows per inch were used to calculate the average CBR for the treated depth.

During the October 2004 DCP testing, the ground was wet, and, though the averaged data presented in this report does not illustrate it, the individual test results showed that the deeper the penetration the stiffer became the material. It is interesting that, in the initial October 2004 testing, the upper parts of each section were wet, and the resulting field CBR results were similar to the laboratory CBRs which are obtained using saturated material. Several inches down in the in-situ material where it was drier, the field CBR values were higher than the laboratory CBRs. By

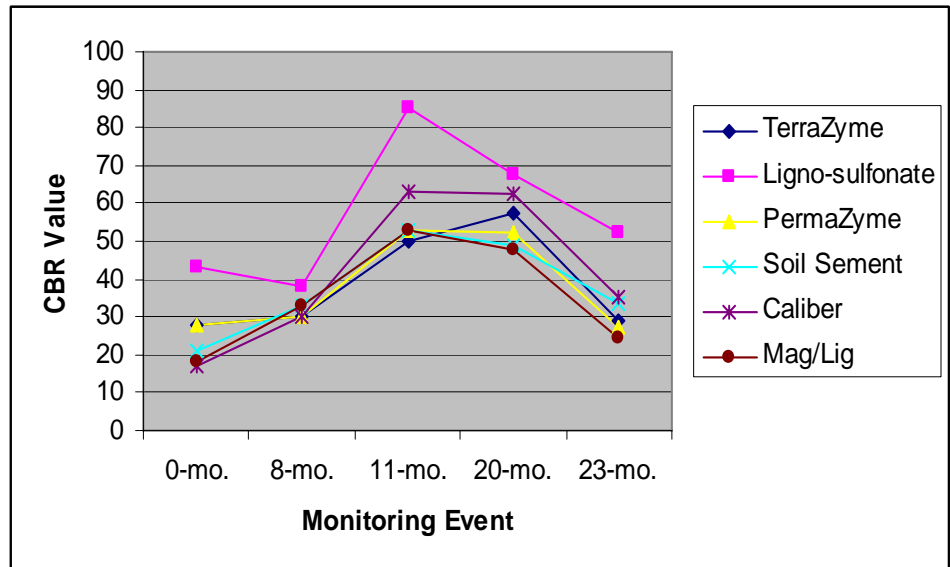
Figure 27. Plot. CBR values derived from DCP testing.

In Figure 27, the average CBR for each product is plotted through time. All the tests were performed in the wheel paths, and all the aggregate for the project met the same specifications. The higher the resulting CBR, the higher the road's load carrying capability. All DCP data and conversions to a CBR value are detailed in Appendix F.

In addition, the road had some traffic over the summer which contributed to the compaction and density of the material. The fact that all the CBR values decreased may indicate that the effectiveness of the applied products were diminishing, or that there was insufficient clay material present in the aggregate to

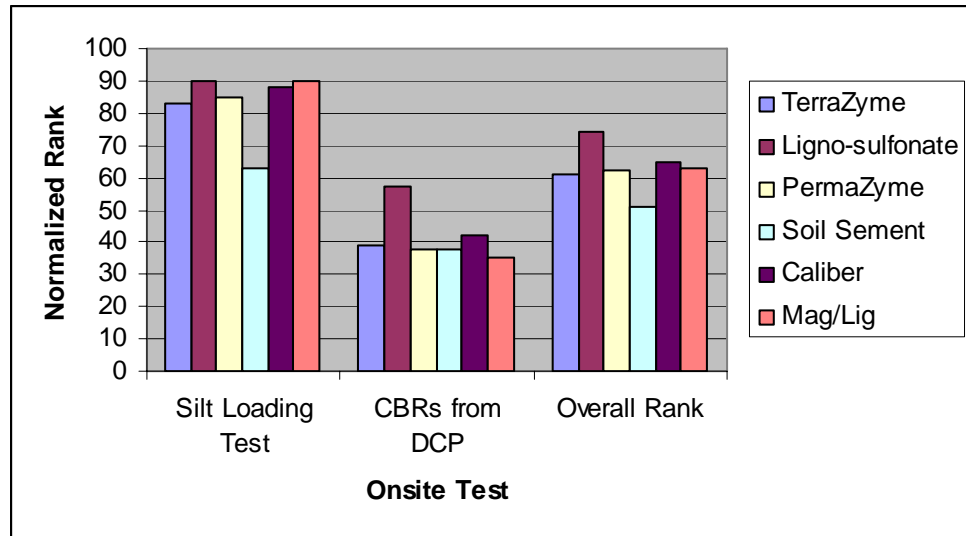
Figure 28. Plot. Product ranking from onsite tests.

The ranking of the products from the two on-site tests is plotted in Figure 28. The overall rank from on-site tests is also shown. Looking at the normalized rankings in Figure 28, one might conclude that the road performed better for dust than it did for stability. This is not necessarily true because the normalized silt load results in Table 11 only rate a product’s performance against the other five products. On the other hand, the calculated CBR values are based on directly measured values. The overall rank averages the values resulting from the two test procedures and is valuable to the extent of comparing the products’ performances at Seedskadee NWR.

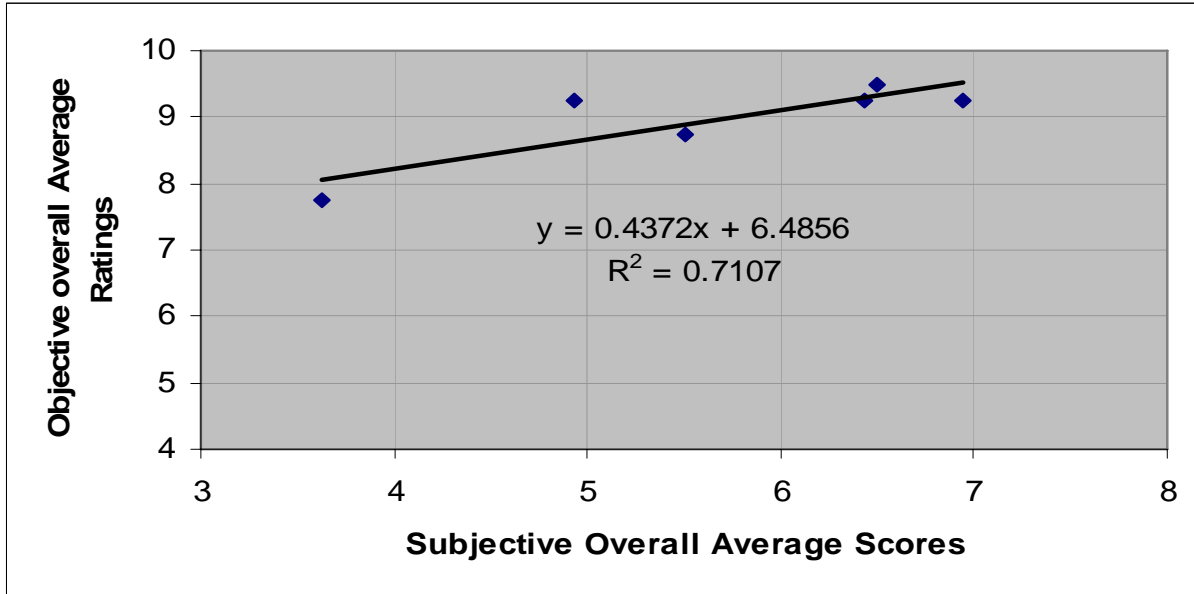
Figure 38. Plot. Correlation of results for washboarding.

For wash boarding, Figure 38 shows a surprisingly good correlation at $R^2 = 0.7107$. This is also true for raveling shown in Figure 39 with a correlation value of $R^2 = 0.8179$. The reason this degree of correlation is surprising is that the pre-selected 7.6-m (25-foot) long monitoring areas were randomly selected such that information was not recorded from some of the perceived
