CHAPTER 5 - OBJECTIVE MEASUREMENTS

FIELD MEASUREMENTS AND OBJECTIVE RATING SYSTEM

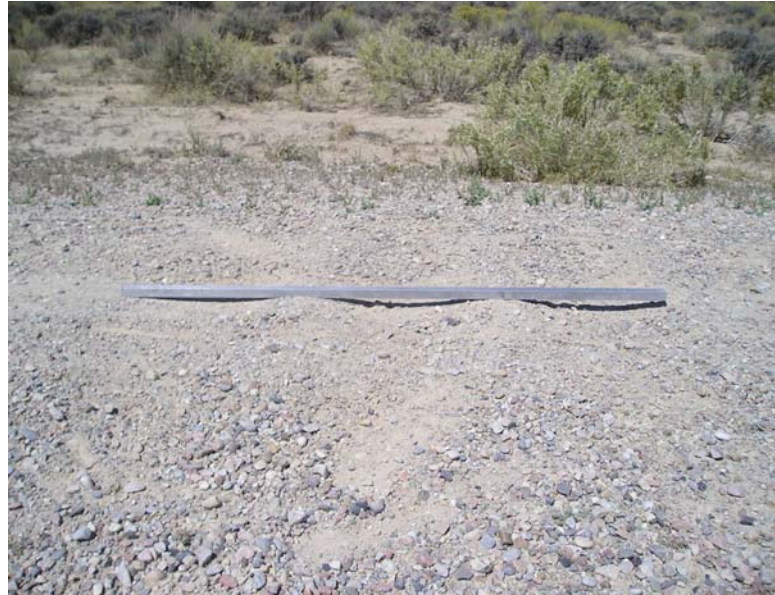
Figure 19. Photo. Measuring washboarding depths.
