# Current Practices in Aquifer Storage and Recovery

ASR Meeting, Chicago May 2009

*Erin Cole*  
Las Vegas Valley  
Water District

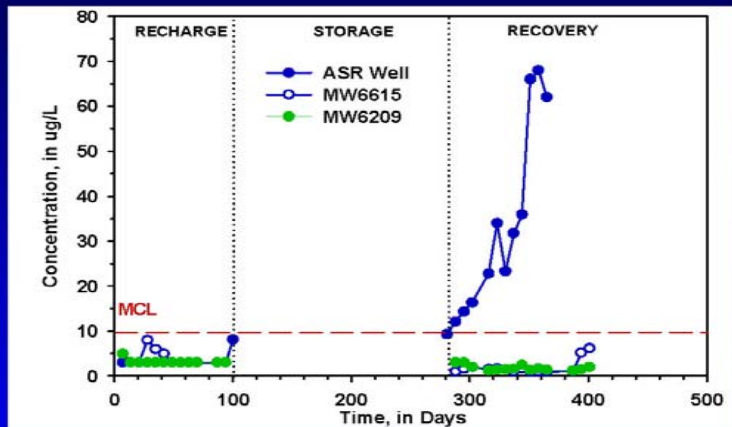
#### Olga – Lee County ASR System Cycle 3

Arsenic exceeds MCL in ASR Well, not monitor wells during recovery

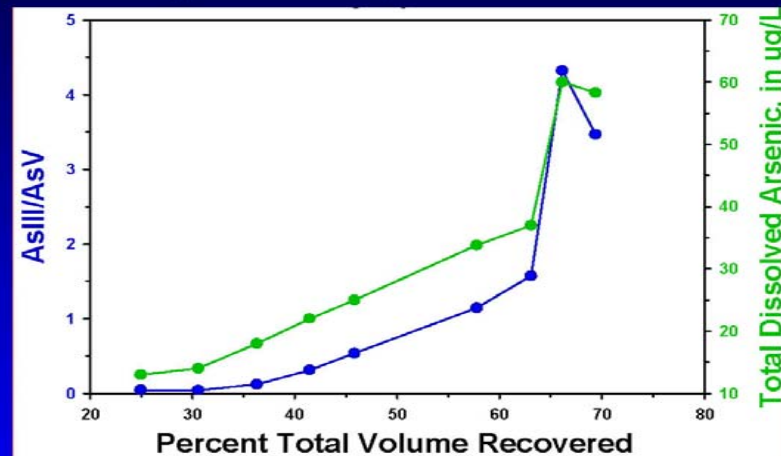
Arsenic occurs primarily as arsenite ( $H_2AsO_3^-$ ) as recovery proceeds

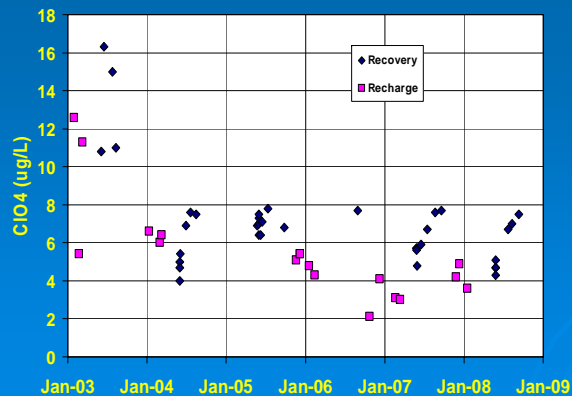
# ASR “Bubble”

Perchlorate in Recharge and Recovery Water

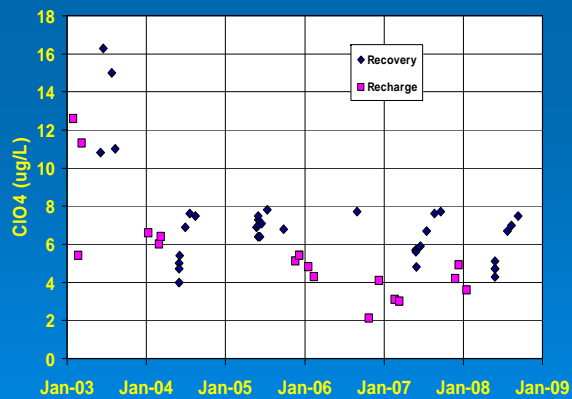
# Is the Bubble not really just a Bubble?

-slow bleeding of AR water from low permeability aquifers/aquitards

Perchlorate in Recharge and Recovery Water
