# Fatigue Testing of 9 m Carbon Fiber Wind Turbine Research Blades\*

Fatigue testing was conducted on Carbon Experimental and Twist-Bend Experimental (CX-100 and TX-100) 9-m wind turbine research blades. The CX-100 blade was designed to investigate the use of a carbon spar cap to reduce weight and increase stiffness while being incorporated using conventional manufacturing techniques. The TX-100 blade used carbon in the outboard portion of the skin to produce twist-bend coupling to passively alleviate aerodynamic loads. In the fatigue tests, the CX-100 blade was loaded by a single hydraulic cylinder while the TX-100 blade was loaded via a hydraulically-actuated resonant loading system called the Universal Resonant Exciter. The blades were outfitted with approximately 30 strain gages as well as displacement and load sensors. Both blades survived to cycle counts sufficient to demonstrate a 20-year operational life. The CX-100 blade failed at approximately 1.6 million cycles because of a buckle and crack that formed and grew just outboard of max-chord. The TX-100 blade failed because of a crack that grew from the termination point of the spar cap at the midspan of the blade. This pap

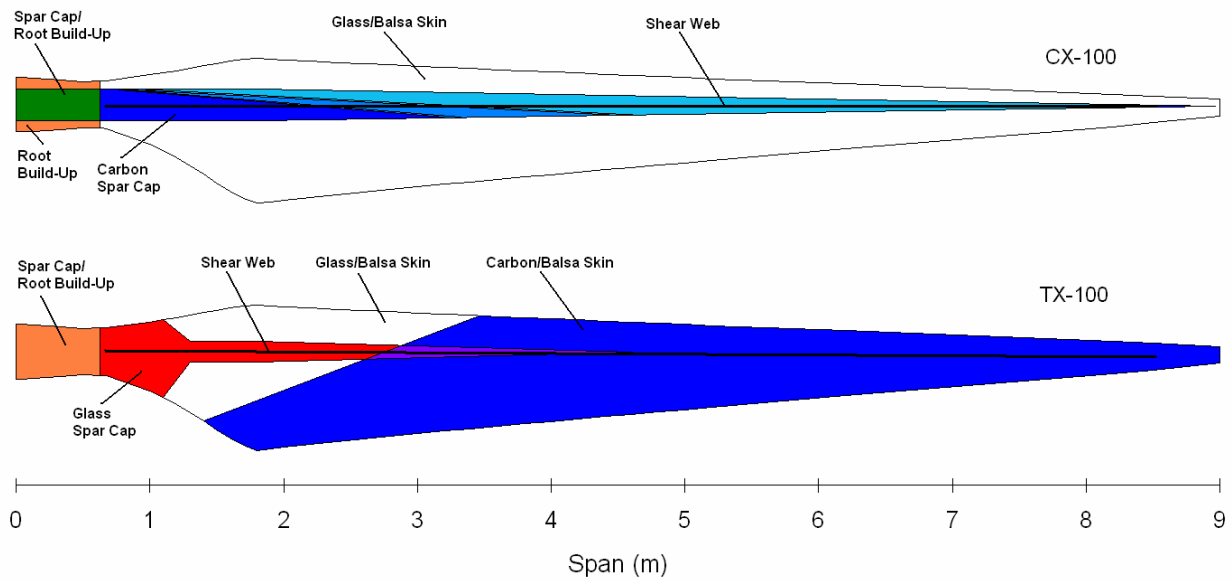
**Figure 1: CX-100 (top) and TX-100 (bottom) blade plan forms and major material regions.**

blades were designed for a 100 kW, constant-speed, stall-controlled turbine. The first blade set was called CX-100 (Carbon Experimental 100kW), and contained a full-length carbon spar cap, a relatively new concept at the time. The geometry of the CX-100 was based on the design of the ERS-100<sup>3</sup> blade at outboard span stations, but with a completely round (un-scalloped) root section. The second blade design, the TX-100 (Twist-Bend Experimental 100kW), had the same geometry as the CX-100, but featured a significantly different laminate design. The blade was designed to have passive aerodynamic load reduction by orienting unidirectional carbon plies 20° off the pitch axis in the skins from approximately 3500-mm outward. Studies<sup>4,5,6,7,8,9</sup> had indicated the possibility of such a method of passive aerodynamic load alleviation with material-induced twist-bend coupling; 20° was determined to be the optimum angle. Other methods of twist-bend coupling have also been suggested<sup>10,11,12,13</sup>. The TX-100 also contained a fiberglass spar cap that terminated at the midspan of the blade. The plan form of these blades is shown in Figure 1 with the major laminate regions shown in different colors. Visible are the carbon spar caps of the CX-100 and the carbon outboard skins of the TX-100. The unidirectional fiberglass spar cap of the TX-100 is shown in red and extends only to the midspan of the blade. It was determined that the large amount of carbon contained in the skin was adequate to carry loads outboard in this design, making a full-length spar cap unnecessary. Shear webs are represented by a black line on both drawings and were identical in dimension, placement, and layout.

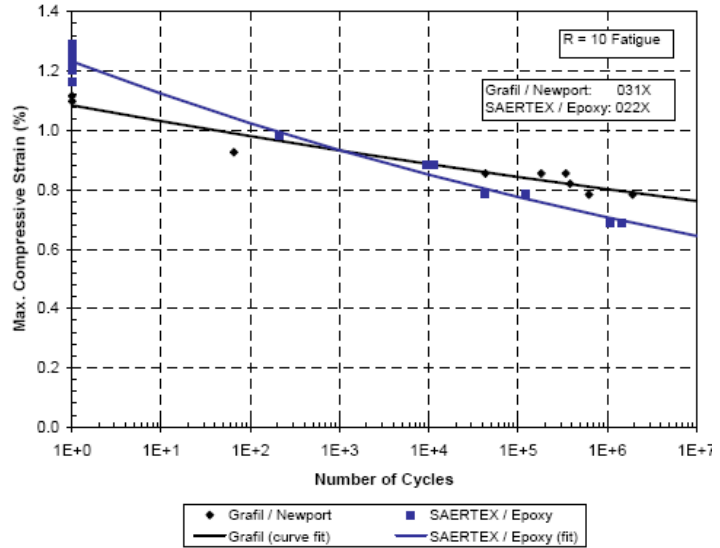
Figure 2: R=10 fatigue data for prepreg and infused (epoxy) panels (GEC).

The carbon spar cap of the CX-100 blade carries a majority of the flapwise bending loads and thus was the focus of the loads analysis. Figure 2 shows a comparison of thin-specimen S-N data for  $R=10$  for infused SAERTEX/Epoxy, which makes up the CX-100 spar cap and a prepreg carbon material (Grafil/Newport)<sup>14</sup>. The  $R=10$  data were used, as they produced a more conservative result than the  $R=0.1$  data. The slopes are approximately 25 for the infused material and 45 for the prepreg material.

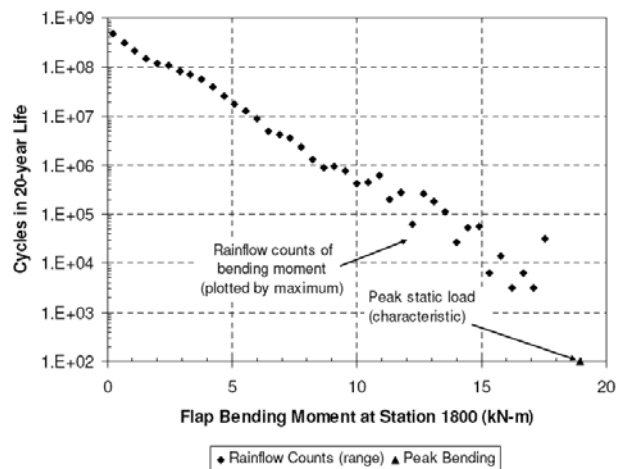
Figure 5: Rainflow counts at 1800 mm station of TX-100 blade (GEC).

The fatigue load for the TX-100 blade was analyzed similarly to that of the CX-100 blade, originating from Equation (1). However, a slope coefficient of 12 was used instead of 14, as in the previous analysis, to account for the flap loads being oriented at 20° from the carbon fiber direction. In addition, the blade was to be loaded via a resonant loading method that allowed the target loading to be better approximated along the blade span and did not restrict the twist dynamics of the blade. Like for the CX-100, rainflow counts of load cycles acquired from system dynamics simulations were used to compute 20-year damage fractions. The cycle counts from the max-chord station are shown in Figure 6. For the TX-100 blade, the 50-year gust load was removed from design consideration, as this caused

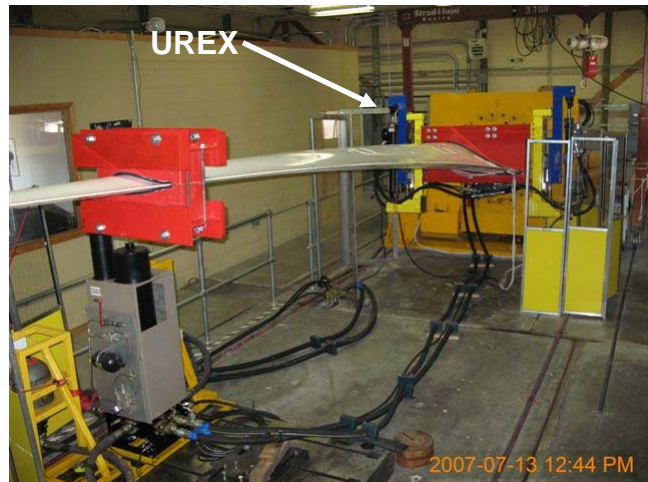
**Figure 9: TX-100 Test setup photograph.**

A novel resonant test apparatus was developed at NREL for this test. The UREX (Universal Resonant EXciter) was used to apply the test loading. The UREX was developed specifically for the unique aspects of testing bend-twist coupled blades. The UREX uses a pair of hydraulic actuators mounted to the blade through a ballast saddle. The actuators are located on each side of the blade (see Figure 8). This sidesaddle arrangement has advantages over previous single-actuator designs. The primary advantage of the UREX is that the rotational inertia is minimized in comparison to mounting the actuator and resonant mass above the center of the blade, which could impart undesired torsional loading, thus distorting the bend-twist response of the test article. Figure 9

provides a photograph of the TX-100 test setup. In addition, although not employed for the TX-100 test, the UREX can tune an applied torsional loading by adjusting the displacements, relative phases, and associated oscillating masses for the two independent actuators.

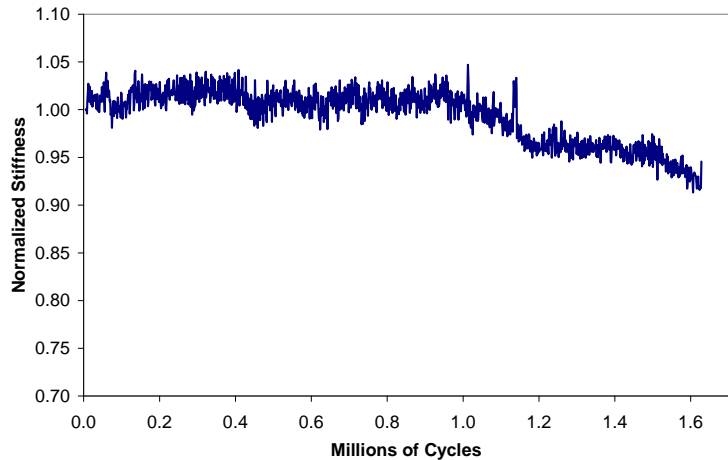
**Figure 12: Normalized stiffness at saddle for CX-100 fatigue test.**

The global stiffness of the CX-100 blade during the fatigue test is shown in Figure 12. The data is normalized by the initial value. Evident in the plot is softening beginning around 1.0 million cycles. The total amount of stiffness degradation was approximately 10% at the end of the test.

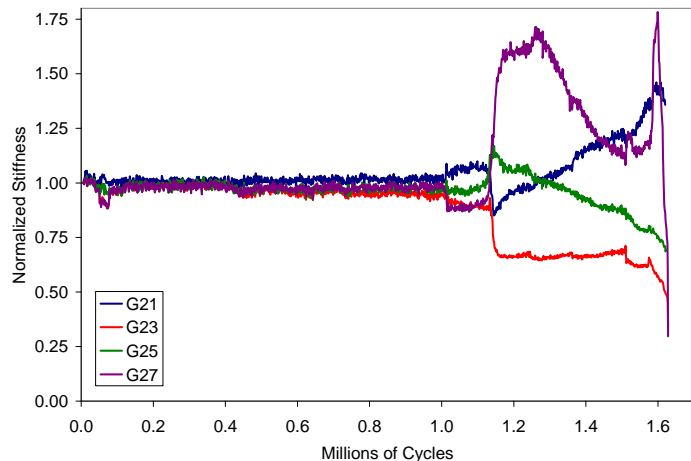
**Figure 14: Normalized stiffness at CX-100 strain gages 21, 23, 25, and 27.**

Figure 14 shows the results from the strain gages located on the spar cap from 25% to 50% of the blade span. These strain gages display more dramatic changes beginning at about 1.1 million cycles. Increases in local stiffness can be attributed to changes in load path.

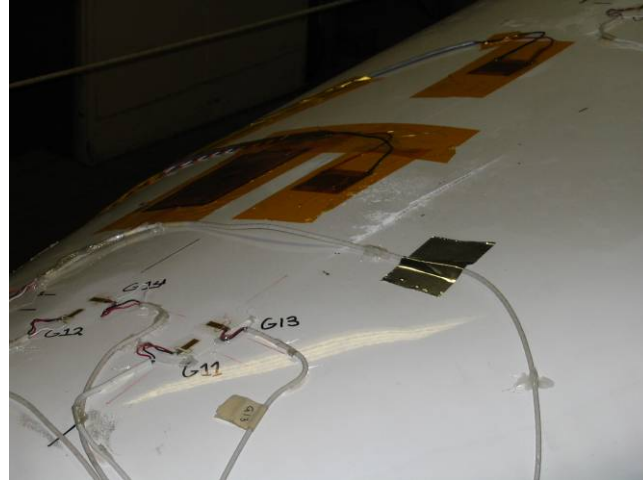
Figure 16: CX-100 low-pressure skin damage area.

The CX-100 test proceeded without significant damage until the 1.5-million cycle count. Throughout the test, a notable dimple in the blade was apparent in the low-pressure skin, at the 1100-mm station toward the trailing edge of the blade. The out-of-plane depth of the dimple progressed during testing. Spanwise surface cracks were noted at the 1.5-million cycle count between the 1200-mm and 1400-mm stations. These surface cracks formed at the junction of the carbon spar cap and the trailing edge panel. By the 1.6-million cycle level, the cracks had progressed through the thickness of the skin and the test was stopped. The out-of-plane movement of the skin once the crack had fully penetrated the skin became progressively larger. In addition, the blade stiffness had decreased by approximately 12% from the initial stiffness, and the lead-lag motion of the blade progressively

increased. Subsequent investigations indicate the increased crack length and development of a disbonding between the LP skin and spar cap led to increasing larger out of plane panel deformation leading to gross panel buckling. Figure 15 provides a photograph of the damage area of the CX-100.

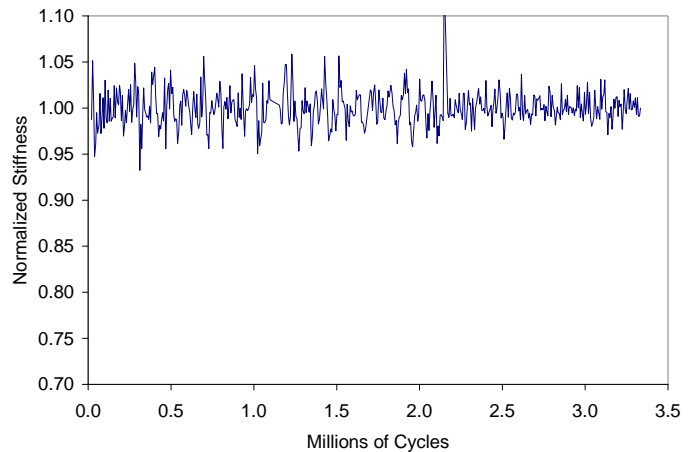
Figure 15: Normalized stiffness at blade tip for TX-100 fatigue test.

The global stiffness of the TX-100 blade was measured with a different method because displacement data from a load application point were unavailable. Multiple sensors were mounted on this blade as the TX-100 served as a test bed for structural health monitoring sensors<sup>19</sup>. Among the health monitoring sensors were several accelerometers at the blade tip which were used by a team from Purdue University<sup>20</sup>. Double-integrating the response from tip accelerometer provided test displacements. Using these displacements along with the moment from root-mounted strain gages, and then inputting the results into Equation (2) provided the stiffness of the blade measured at the tip. The results are shown in Figure 16.

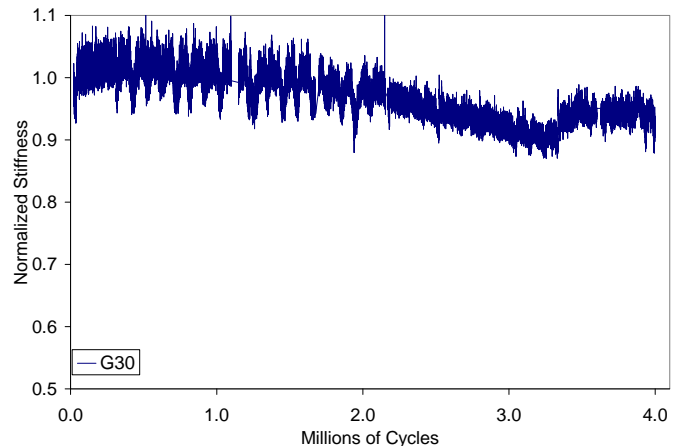
Figure 17: Normalized stiffness of TX-100 at strain gage 30.

The strain gage results can be examined to look for signs of damage occurring earlier than what might be seen in the aggregated data taken at the tip. Figure 17 provides the response from a strain gage mounted just outboard of the tip of the glass spar cap (see Figure 11). The gage shows that this area began to experience softening before 1 million cycles and gradually progressed throughout the test.

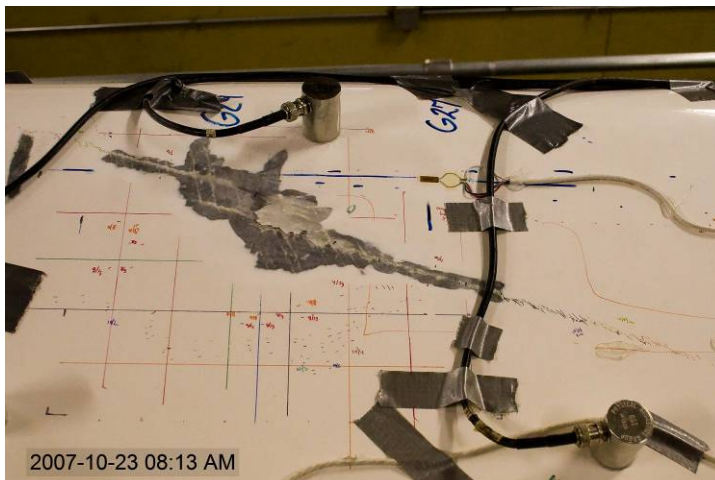
Figure 18: TX-100 high-pressure skin damage area.

Damage to the TX-100 manifested itself as fine gel-coat cracks on the high-pressure side of the blade, running at an angle of 65° with respect to the spanwise axis of the blade. These cracks occurred throughout much of the span of the blade, but were most apparent in the 4000-mm to 5600-mm span of the blade. The 65-degree angle coincides with the principal axis of the ±45-degree fiberglass laminate. These gel-coat cracks progressed in length and gap width from the 723k cycle count to the 2.4-million cycle count until out-of-plane movement of the skins abutting the crack was apparent. The length and gap of the crack increased, and the principal axis of the crack front deviated from 65 degrees to 20 degrees, which is the same as the principal direction of the carbon fiber laminate. Once the principal direction of the crack coalesced to the principal direction of the carbon fiber, the crack-length rate and out-of-plane distortion became progressively larger. The test was stopped at the 4-million cycle count because of excessive torsional motion of the blade tip and an accelerated increase in rate of crack length. Figure 18 provides a photograph of the damaged area on the high-pressure surface of the blade at the 4500-mm station; the gel coat was removed to expose the fiberglass and carbon fiber laminate. The incipient cause of damage to the TX-100 was the outboard

termination of the spar cap, which ends at the 4500-mm station. The spar cap termination caused a stress riser in the stressed-skin laminate.
