# Fatigue Testing of 9 m Carbon Fiber Wind Turbine Research Blades

46th AIAA Aerospace Sciences Meeting and Exhibit

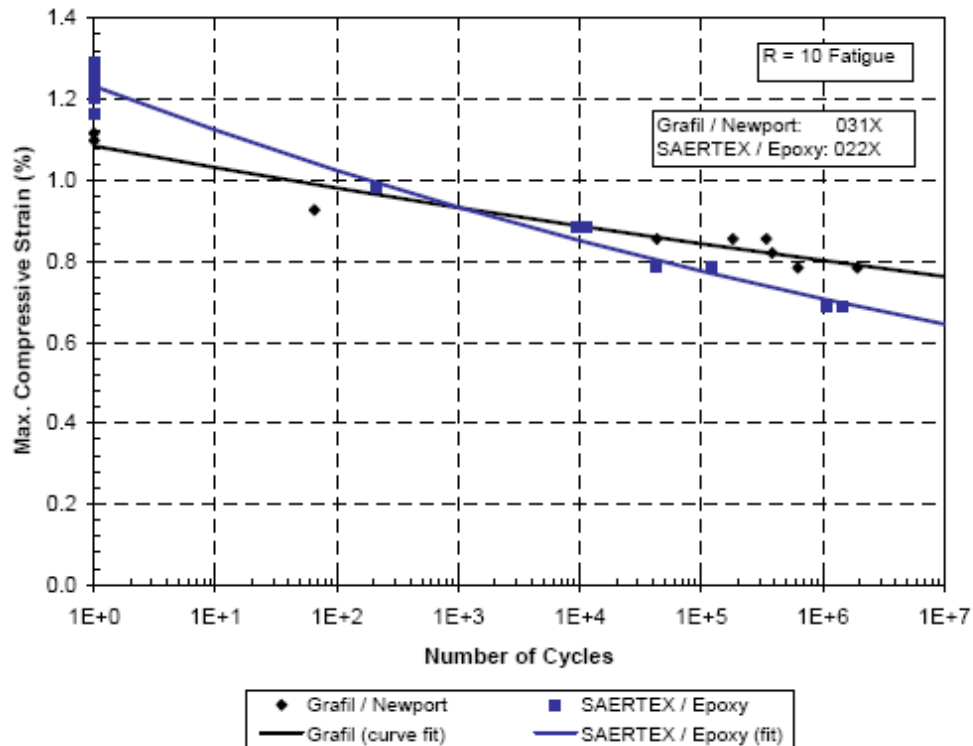
# SAERTEX Carbon Tri-ax Fatigue Performance

Source: Montana State University

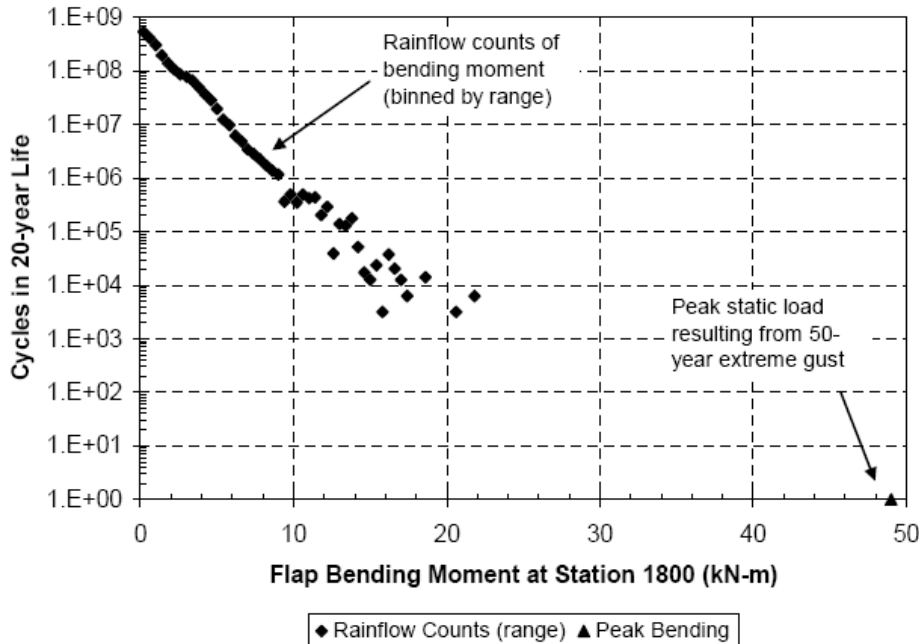
## CX-100 (Static Driven Design)

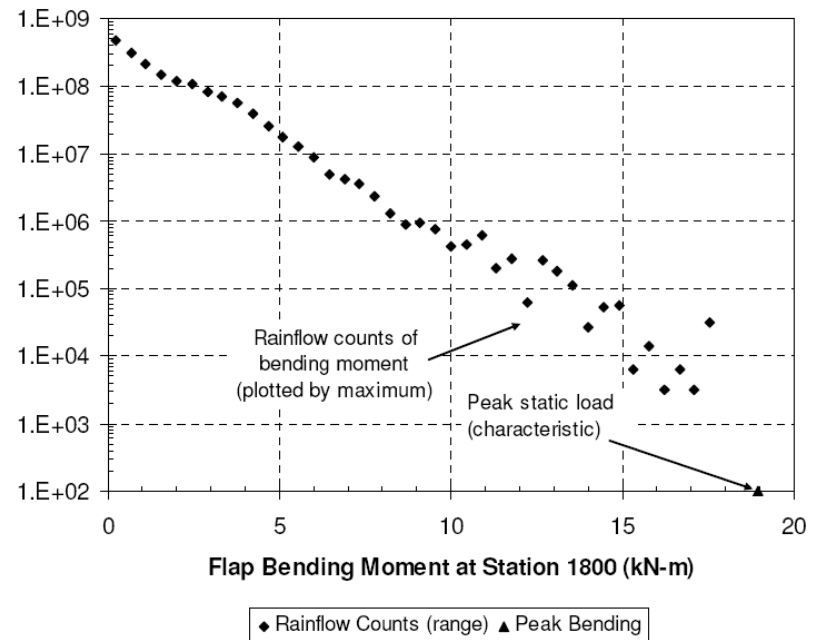
## TX-100 (Fatigue Driven Design)

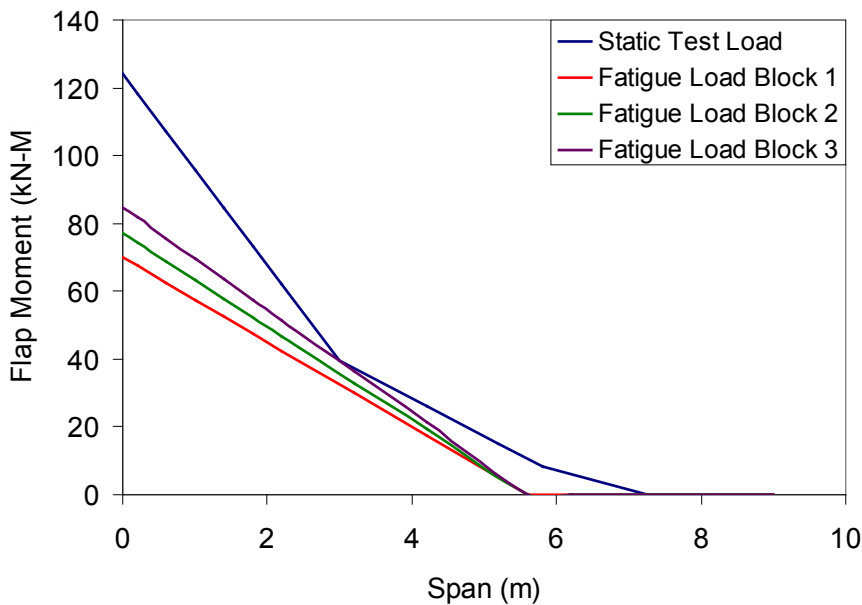
**CX-100  
(Single Point Loading)**

**TX-100  
(Resonant Loading)**

Fatigue Test Applied Loads

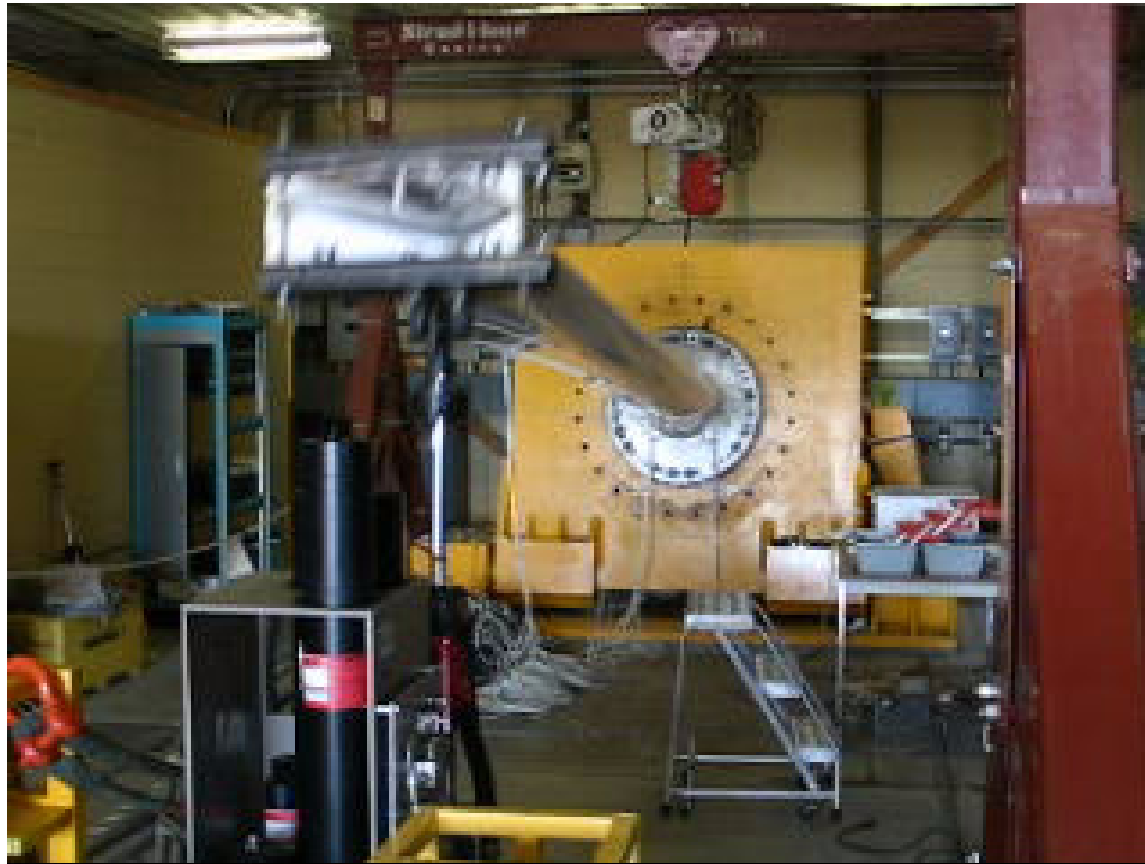
CX-100 Early in Fatigue Test

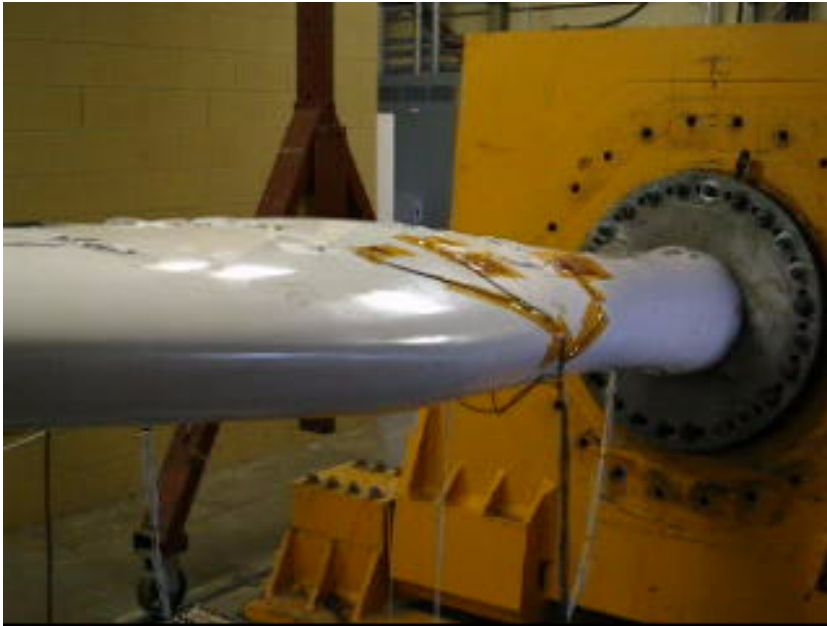
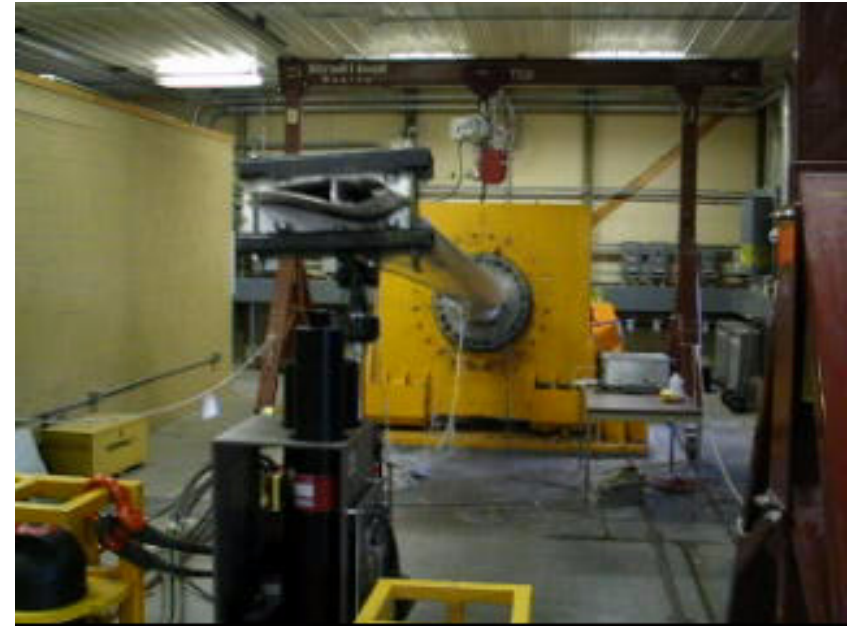
CX-100 Dimple (left) and Tip Movement (right) just before Failure

- Dimple formed early during test around max chord
- Low pressure skin pushed outward aft of sparcap and inward forward of sparcap
- At 1.5M cycles, crack began to grow along sparcap/aft-panel intersection
- Crack resulted in greatly decreased stiffness in the area and cause severe edgewise movement

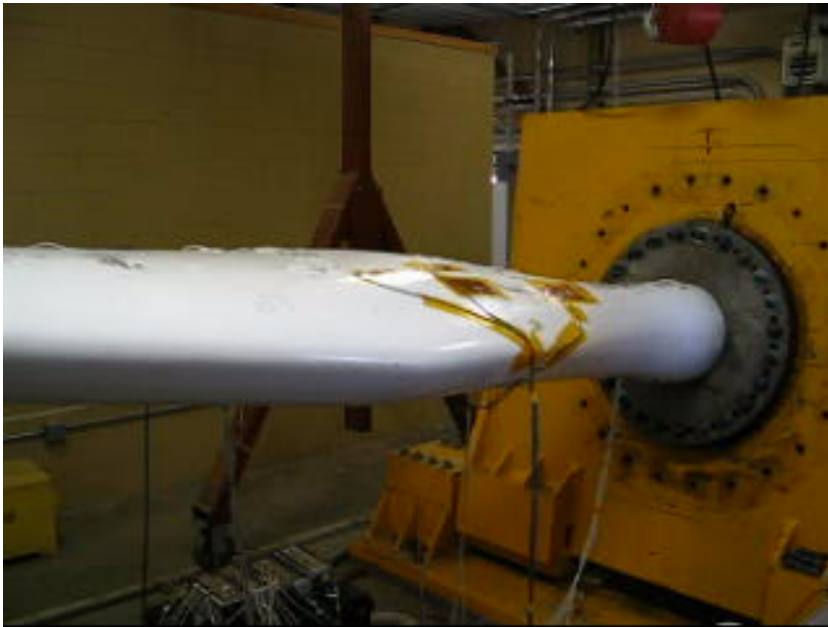
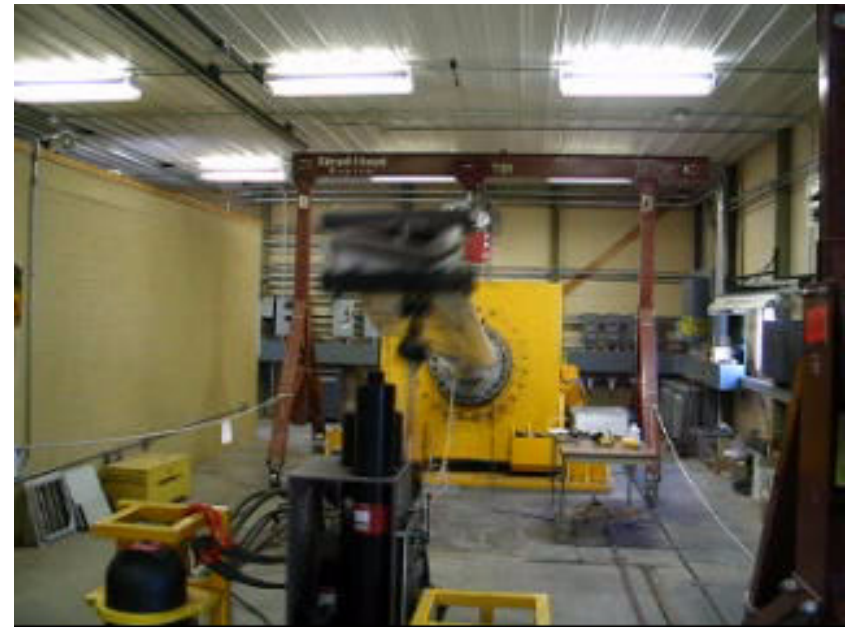
CX-100 Dimple (left) and Tip Movement (right) at Failure

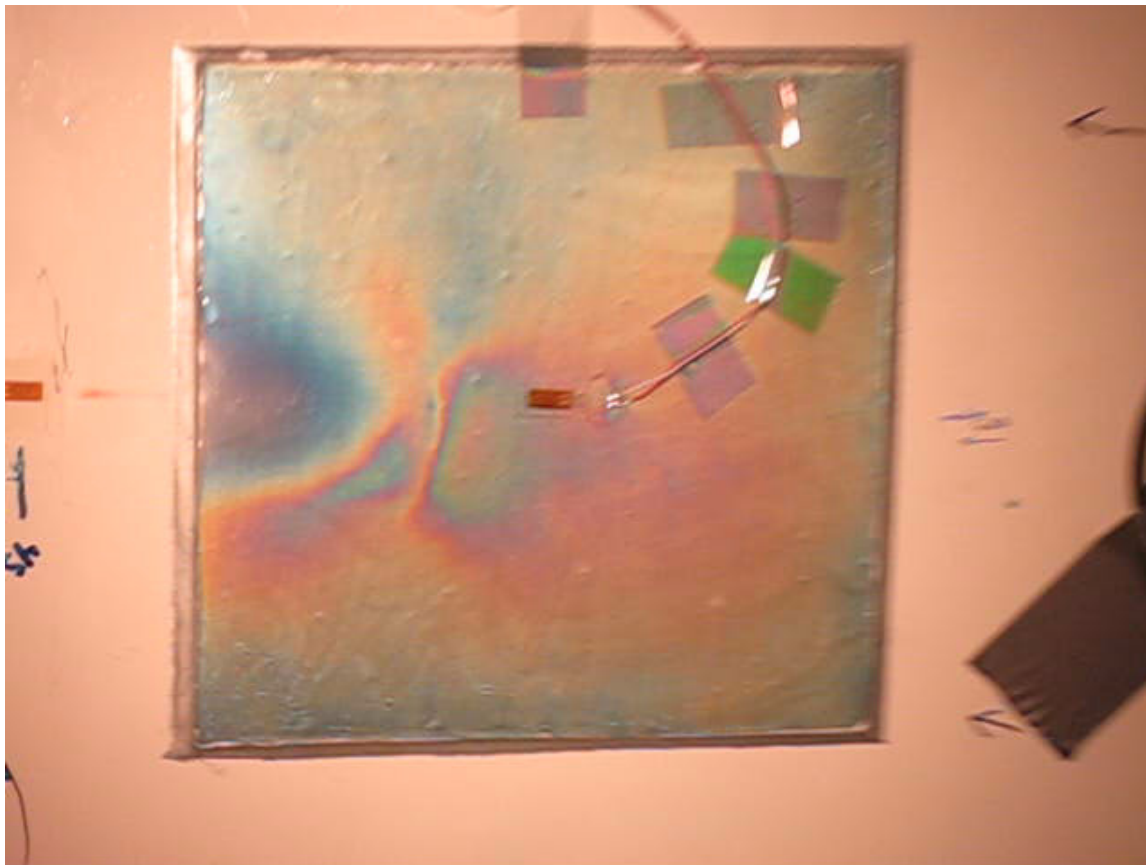
TX-100 Sparcap Tip Stress Contours
