Monitoring Series No. CS-22-MSTY-0301-1

THREE-YEAR COMPREHENSIVE MONITORING REPORT  
For the period March 01, 1997 to March 31, 2001

**CLEAR MARAIS SHORELINE PROTECTION  
CS-22**

**Second Priority List Shoreline Protection Project  
of the Coastal Wetlands Planning, Protection, and Restoration Act  
(Public Law 101-646)**

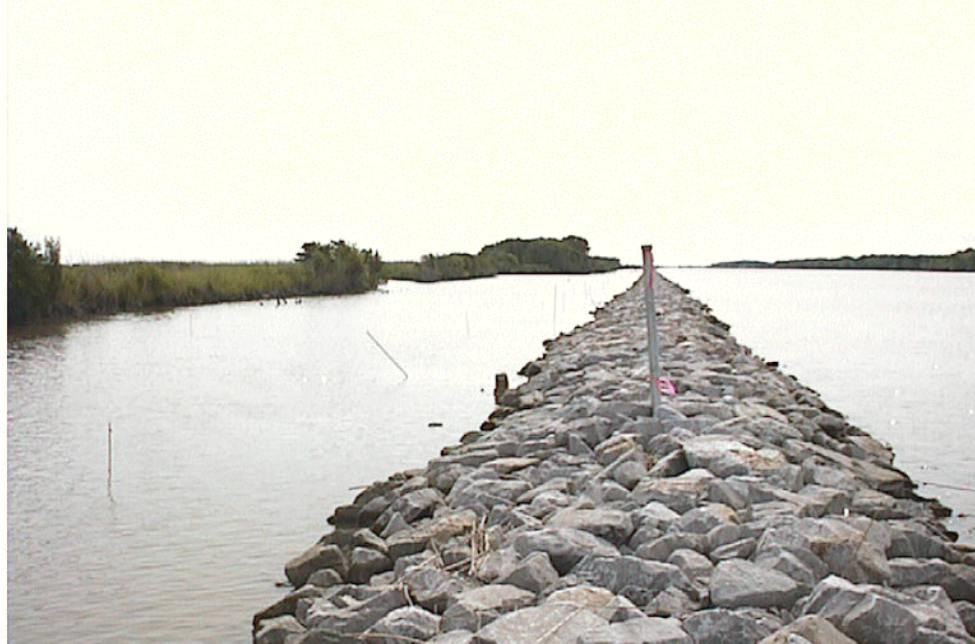
**Figure 2.** Photo of the rock breakwater looking W to E showing settlement plate (center), shoreline position (left side) and the GIWW Canal (right side).

In March 1997, 35,000 linear ft (10,668 m) of rock breakwater were constructed along the north shore of the GIWW to protect the integrity of the Clear Marais freshwater wetlands north of the GIWW (figures 2 and 3). No connections for fishery exchange existed from the GIWW into the interior marsh prior to construction; therefore, the breakwater will have no impact on existing fishery access into the project area. The project objectives are to maintain and protect approximately 35,000 linear ft (10,668 m) of a management levee along the north bank of the GIWW that will contribute to protecting the integrity of the freshwater marshes of Clear Marais adjacent to the GIWW.

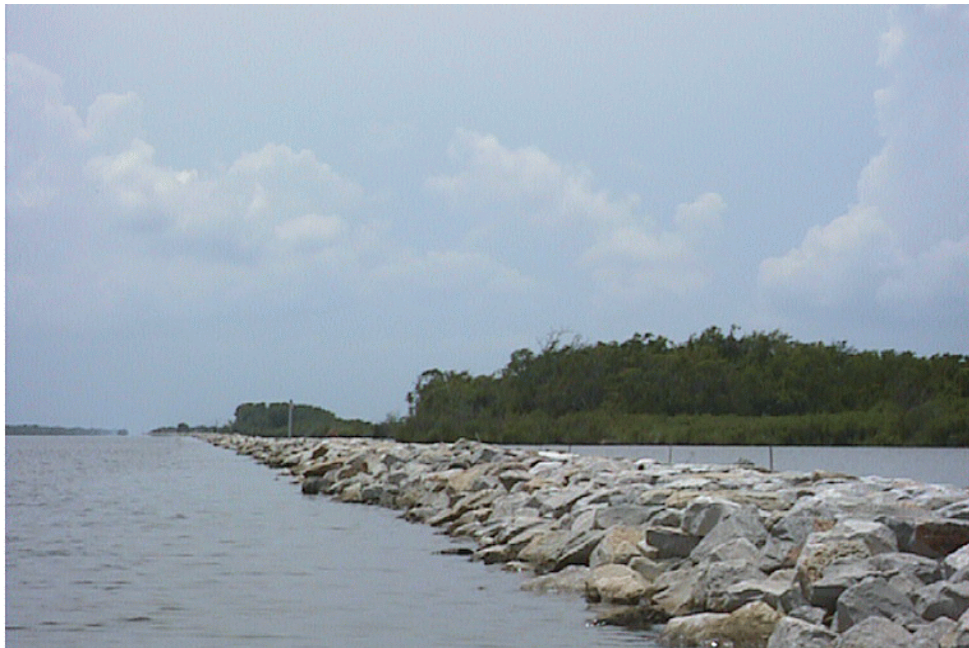
**Figure 3.** Photo of the rock breakwater looking E to W showing shoreline position (right side) and the GIWW Canal (left side).

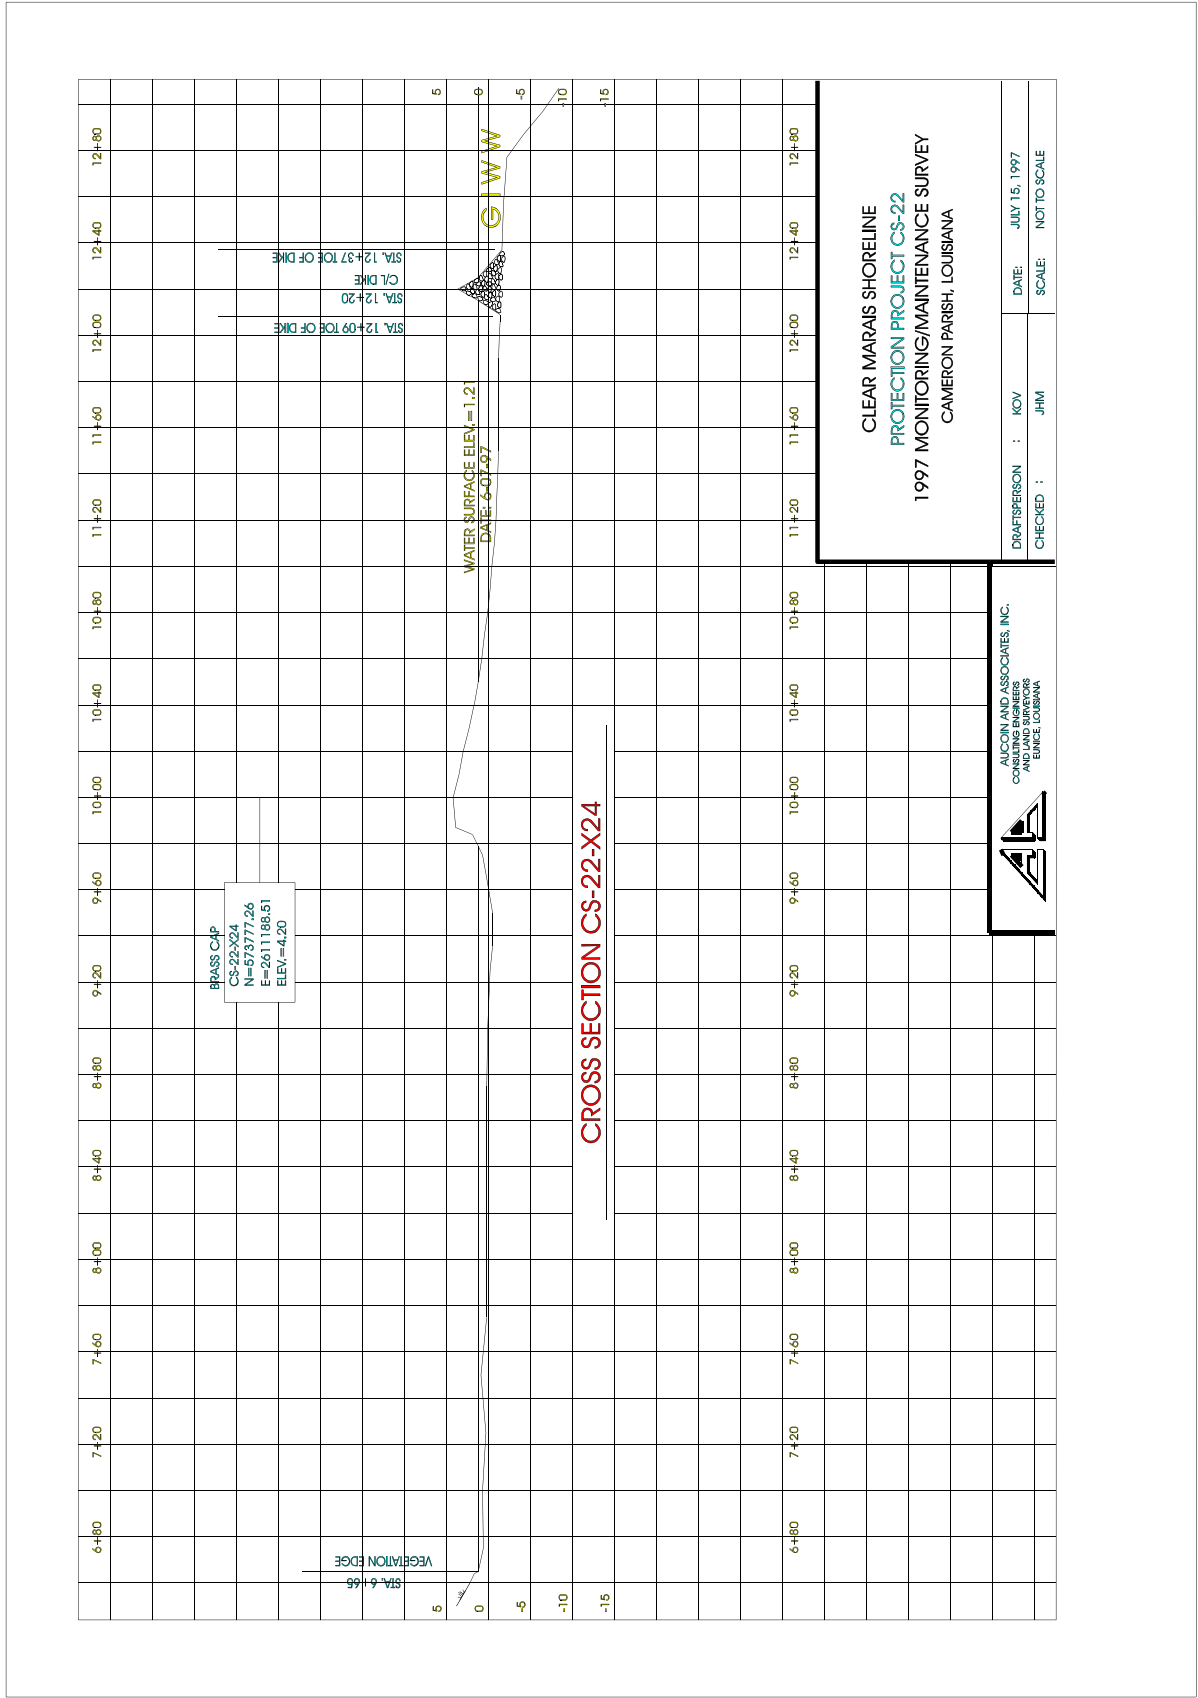
Figure A-3. Representative cross-section from land type 1 (station 24) in the project area.
