**2005 Operations, Maintenance, and
Monitoring Report**

Clear Marais Shoreline Protection

State Project Number CS-22
Priority Project List 2

June 2005
Calcasieu Parish

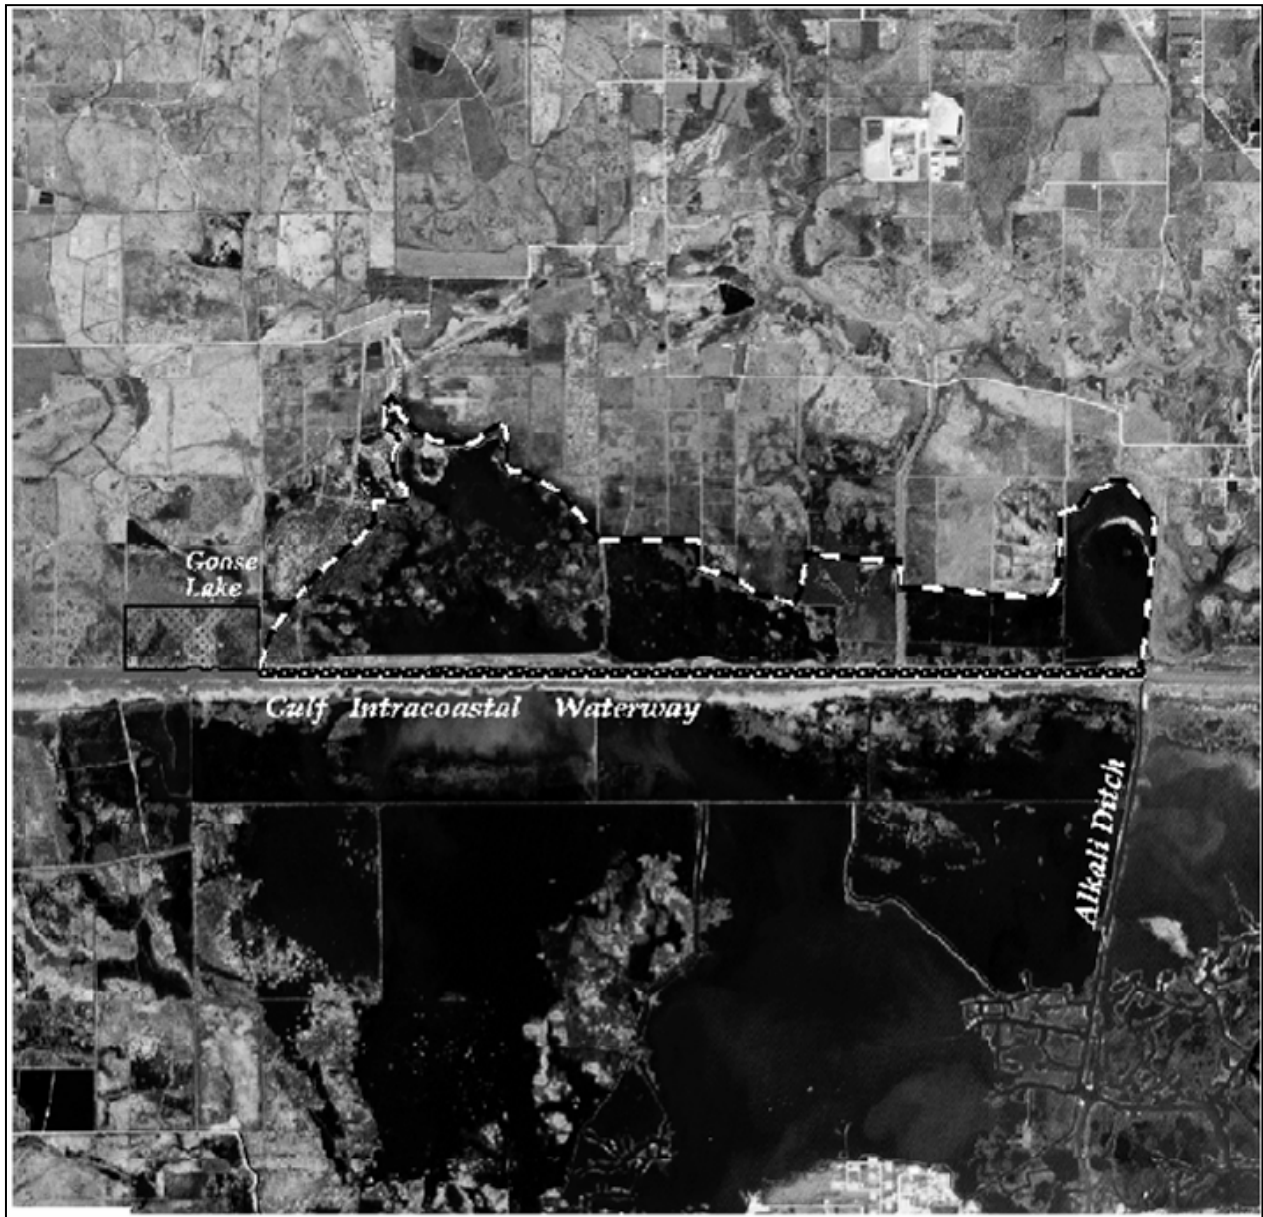
Figure 1. Clear Marais Shoreline Protection (CS-22) project boundary and features.

The project design includes a 35,000 ft (10,668 m) rock dike along the north shore of the GIWW to protect the integrity of the Clear Marais freshwater wetlands north of the GIWW. Construction on the project was completed on March 4, 1997.

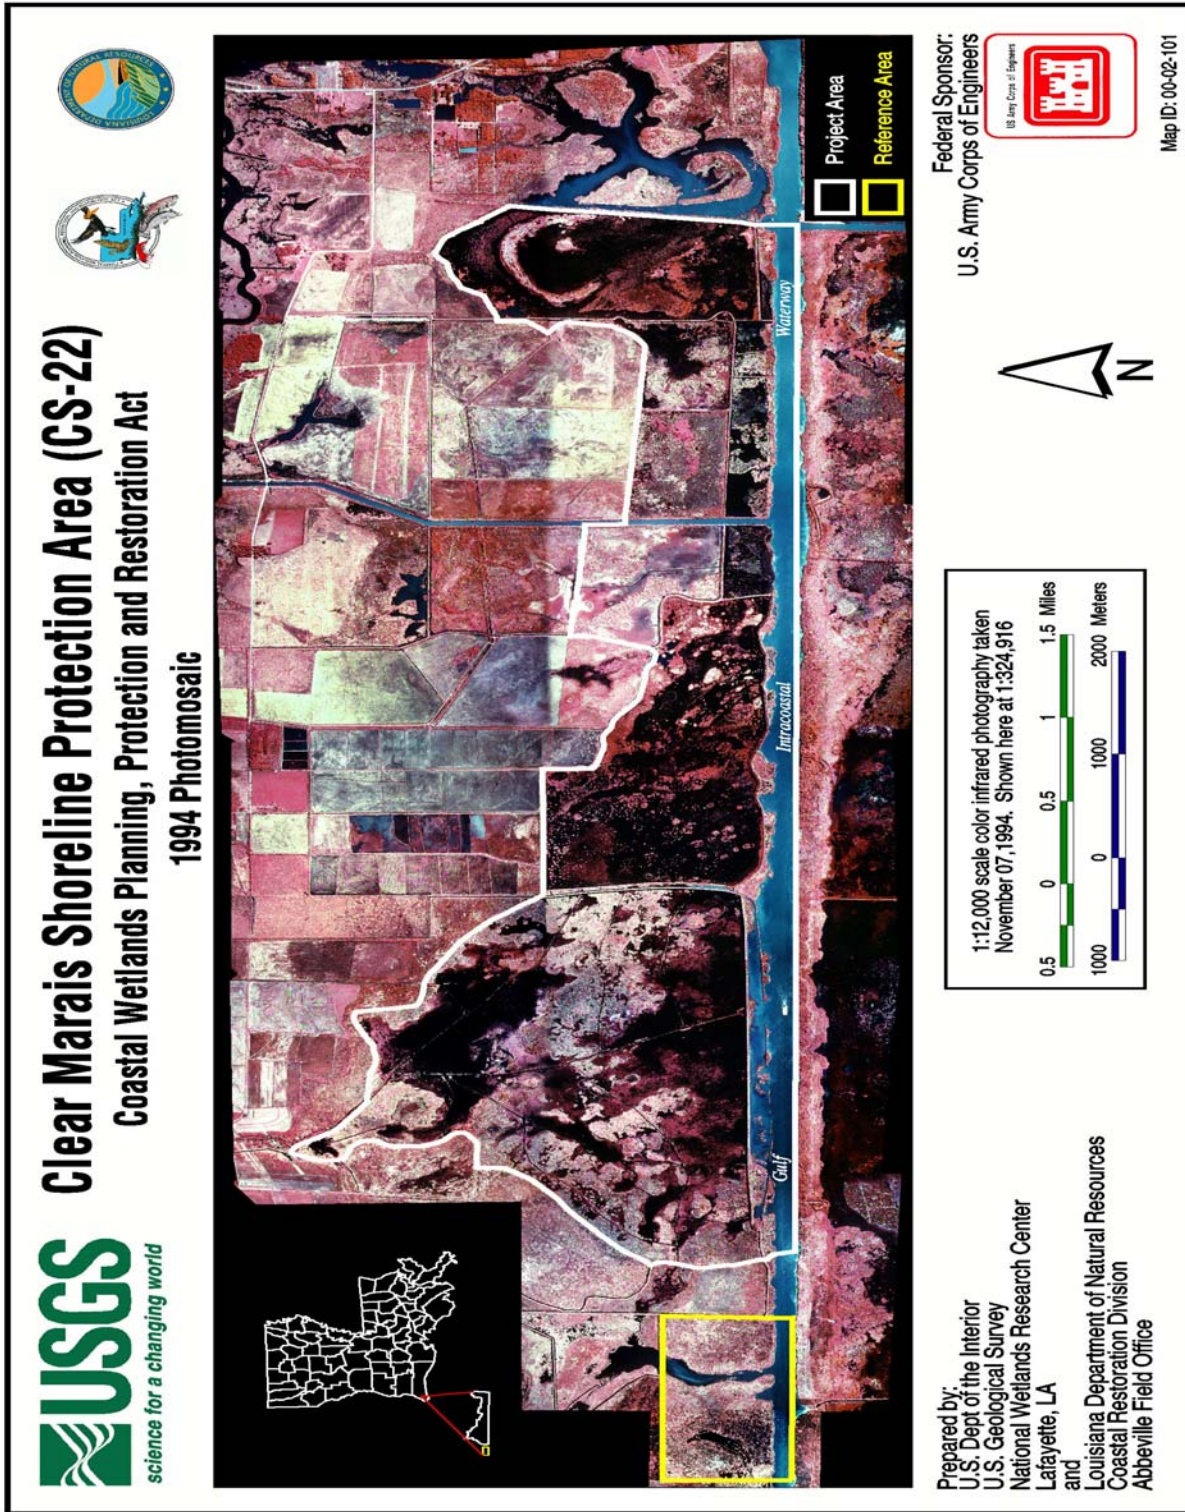
Figure 3. Photo-mosaic of the Clear Marais Shoreline Protection (CS-22) project and reference areas from aerial photography taken on November 7, 1994.

The 1994 land/water analysis indicated that the project area had a ratio of 32.4% land to 67.6% water. The reference area had a ratio of 74.0% land to 26.0% water (figures 2 and 3).

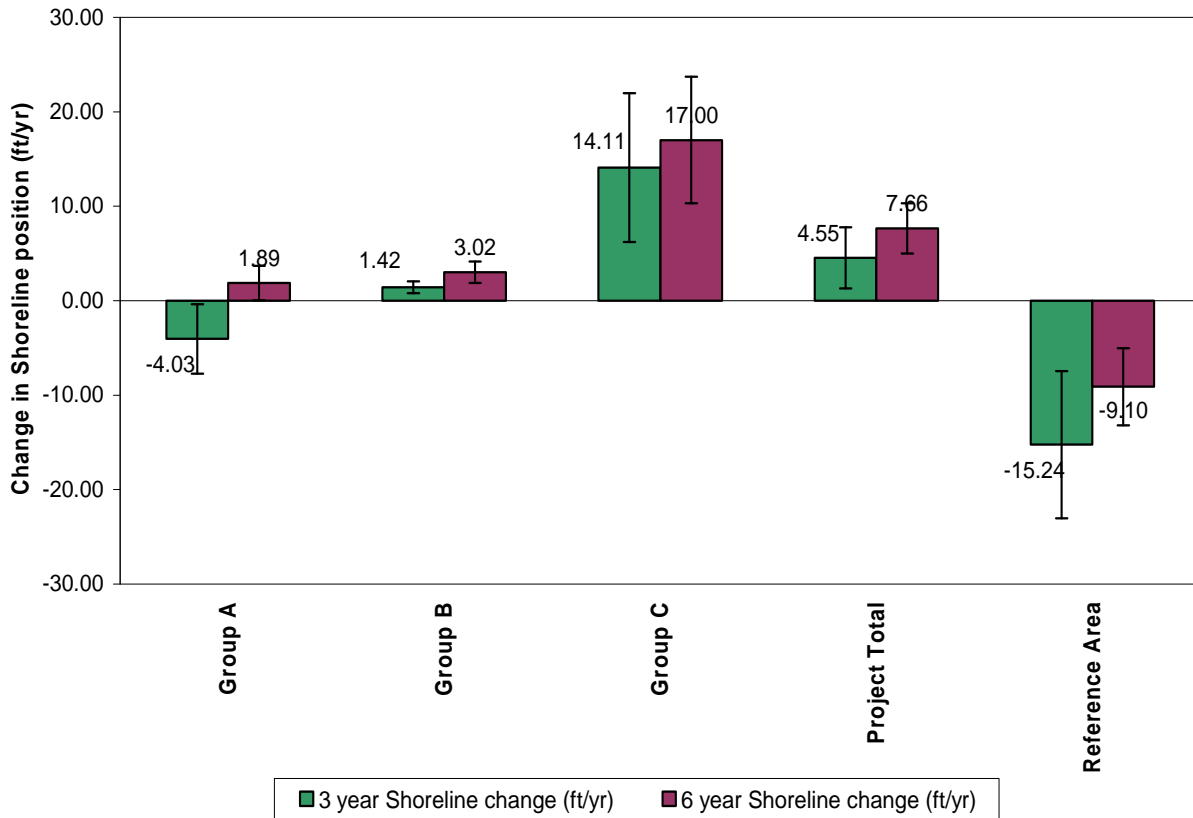
Figure 5. CS-22 Shoreline position change within each group, project, and reference area, 1997-2003. 1997–2000 represents the 3-year shoreline change (ft/yr), and 1997–2003 represents the 6-year shoreline (ft/yr) change.

Data were collected in May 1997 (as-built), May 2000, and May 2003. The data indicate that after 6 years, the project has been effective in preventing erosion within each group (figures 4 and 5). Group A, which was experiencing mild erosion prior to construction, gained 1.89 ft/yr (0.57 m/yr) (table 1). Group B, which was experiencing moderate erosion, gained 3.02 ft/yr (.92 m/yr). Group C, which was experiencing severe erosion, gained 17.00 ft/yr (5.18 m/yr). Overall, the project area gained an average of 7.66 ft/yr (2.33 m/yr), as compared to the reference area, which is losing 9.10 ft/yr (2.77 m/yr).

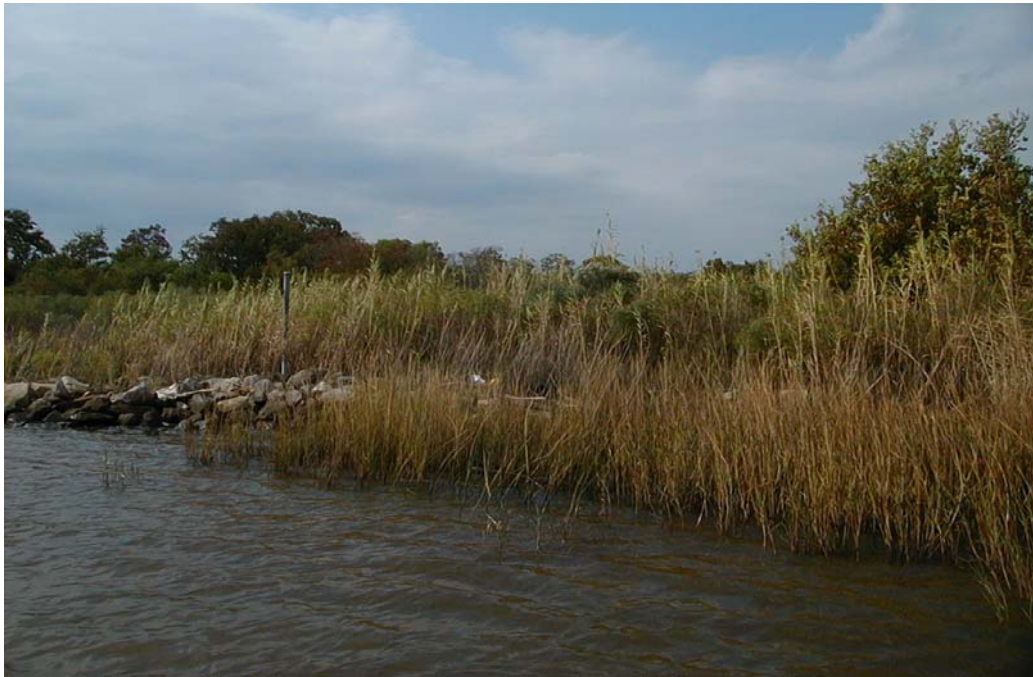
Photo 1—East tie-in at Alkali Ditch

The dike is in good condition. Approximately 4,000 to 5,000 linear feet (1,219–,1524 m) of dike is below construction elevation. This appears to be the result of slight settlement rather than displacement. Several of the settlement plates placed during construction are broken/leaning/damaged, etc., and are no longer useful. One section of dike, approximately 0.5 mile (0.8 km) from the Alkali Ditch, has apparently been removed by hunters and or fishermen. This section is only about 4 ft (1.2 m) wide with rock removed to an approximate +0.5 ft NAVD 88 elevation. Three random stops were made along the dike. At these three locations, the dike appears to be stable with no signs of toe-scour. There is no apparent need for any maintenance at this time. The original O&M budget called for capping 25% of the dike in year 10. While this is accounted for in the attached 3-year budget as part of this inspection, in all probability, this maintenance event will not be necessary. (Photos: Appendix A, Photos 1-4.)

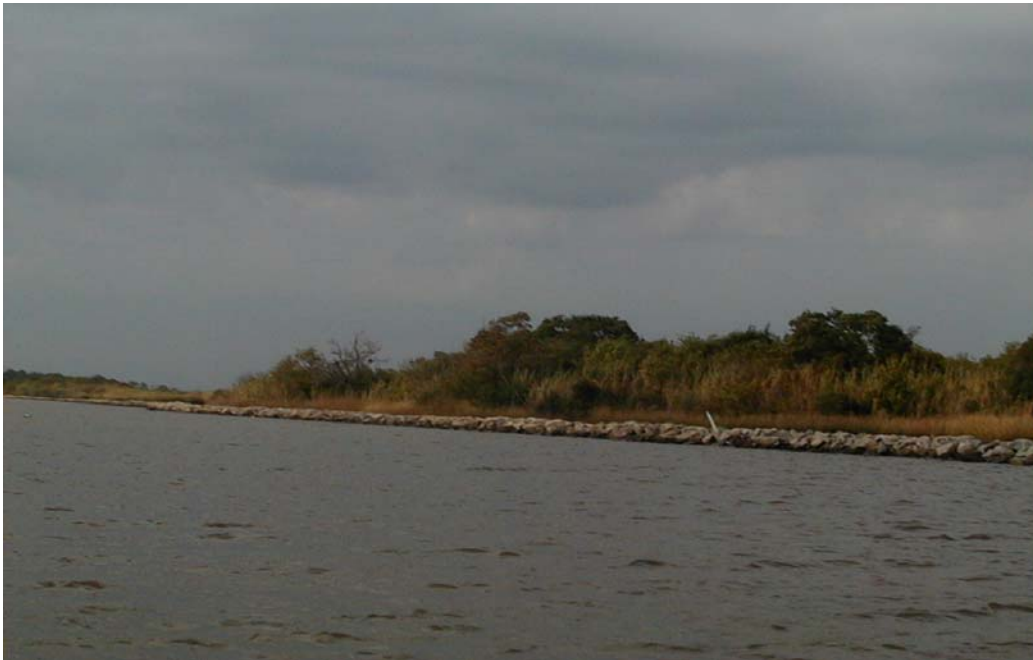
Photo 2—Typical section of dike including damaged settlement plate

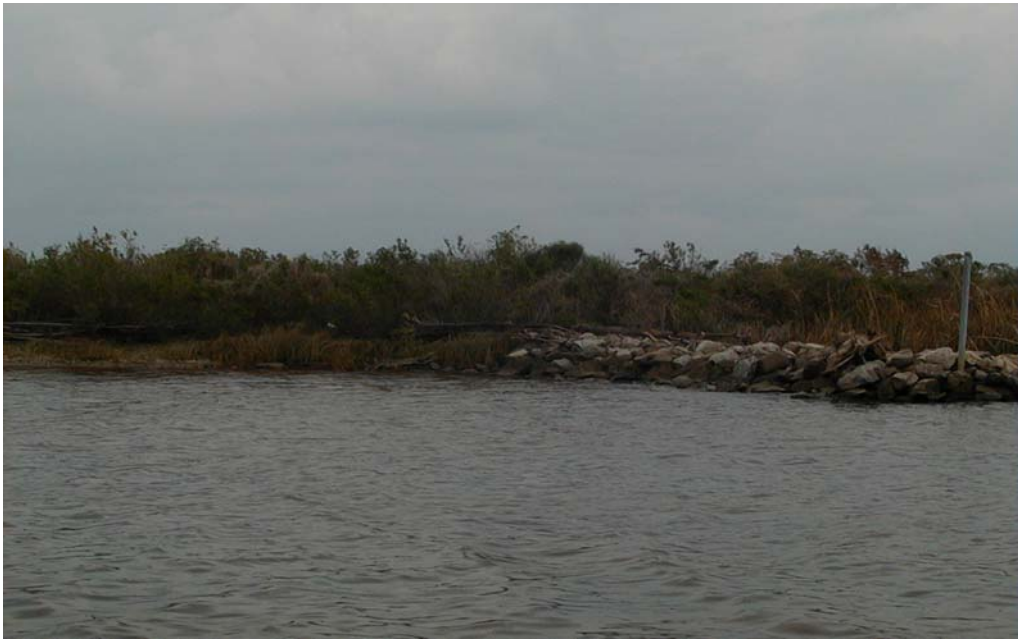
Photo 3—West tie-in

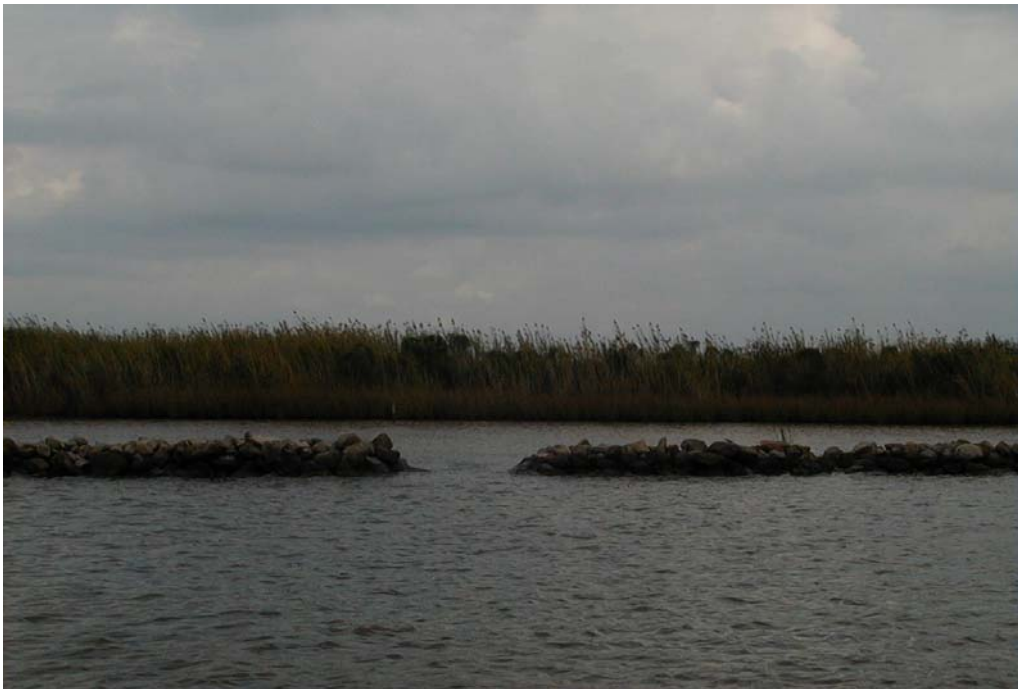
Photo 4—Area apparently damaged by hunters/fishermen
