**2004 Operations, Maintenance,
and Monitoring Report**

Clear Marais Shoreline Protection

State Project Number CS-22
Priority Project List 2

May 2004
Calcasieu Parish

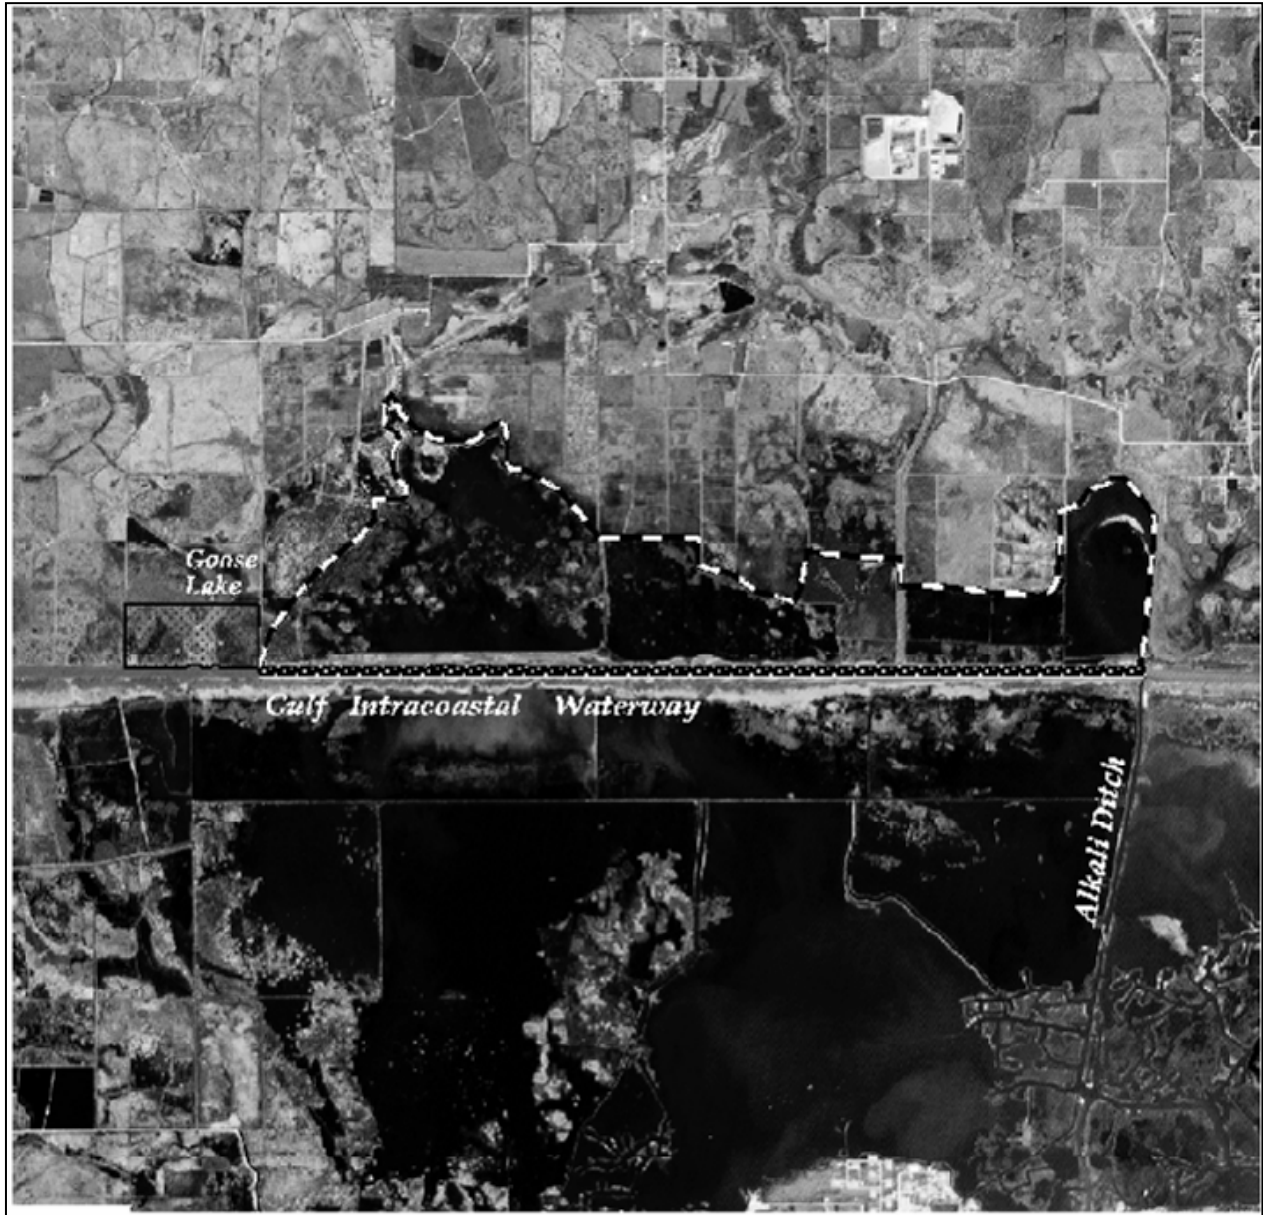
Figure 1. Clear Marais Shoreline Protection (CS-22) project boundary and features.

The Clear Marais shoreline protection project area is located along the north bank of the Gulf Intracoastal Waterway (GIWW) in Cameron Parish between the Alkali ditch and Goose Lake (figure 1). The project provides features to protect 3,827 ac (1,531 ha) of freshwater marsh that are threatened by saltwater intrusion and marsh loss from breaches in the GIWW shoreline. Of the 3,827 ac of fresh marsh, 1,179 ac (472 ha) are vegetated marsh and 2,648 ac (1,059 ha) are open water, with the dominant marsh plant species including *Sagittaria lancifolia* (bulltongue), *Schoenoplectus californicus* (bullwhip), and *Juncus effusus* (soft rush).

The project design includes a 35,000 ft (10,668 m) rock dike along the north shore of the GIWW to protect the integrity of the Clear Marais freshwater wetlands north of the GIWW. Construction on the project was completed on 03/04/97.

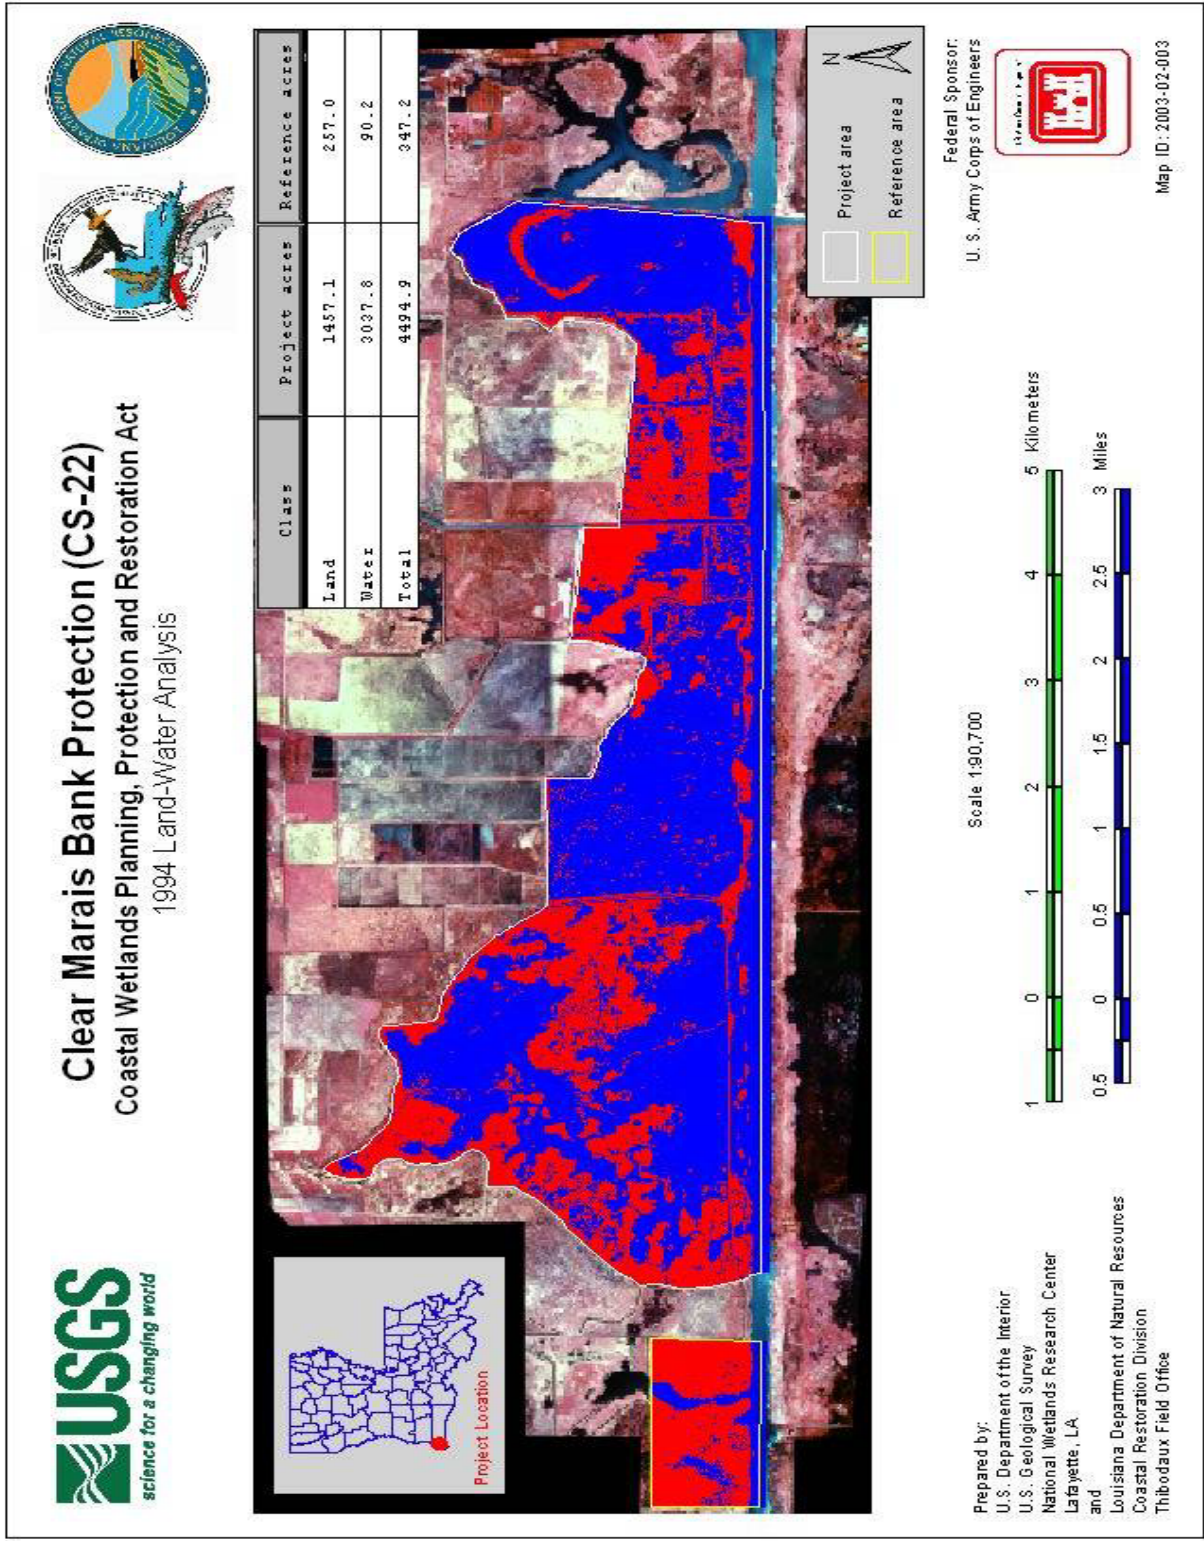
Figure 2. Land/water analysis of the Clear Marais Shoreline Protection (CS/22) project and reference areas from aerial photography taken on 11/07/94.

The 1994 land/water analysis indicated that project area had a ratio of 32.4% land to 67.6% water. The reference area had a ratio of 74.0% land to 26.0% water (figures 2 and 3).

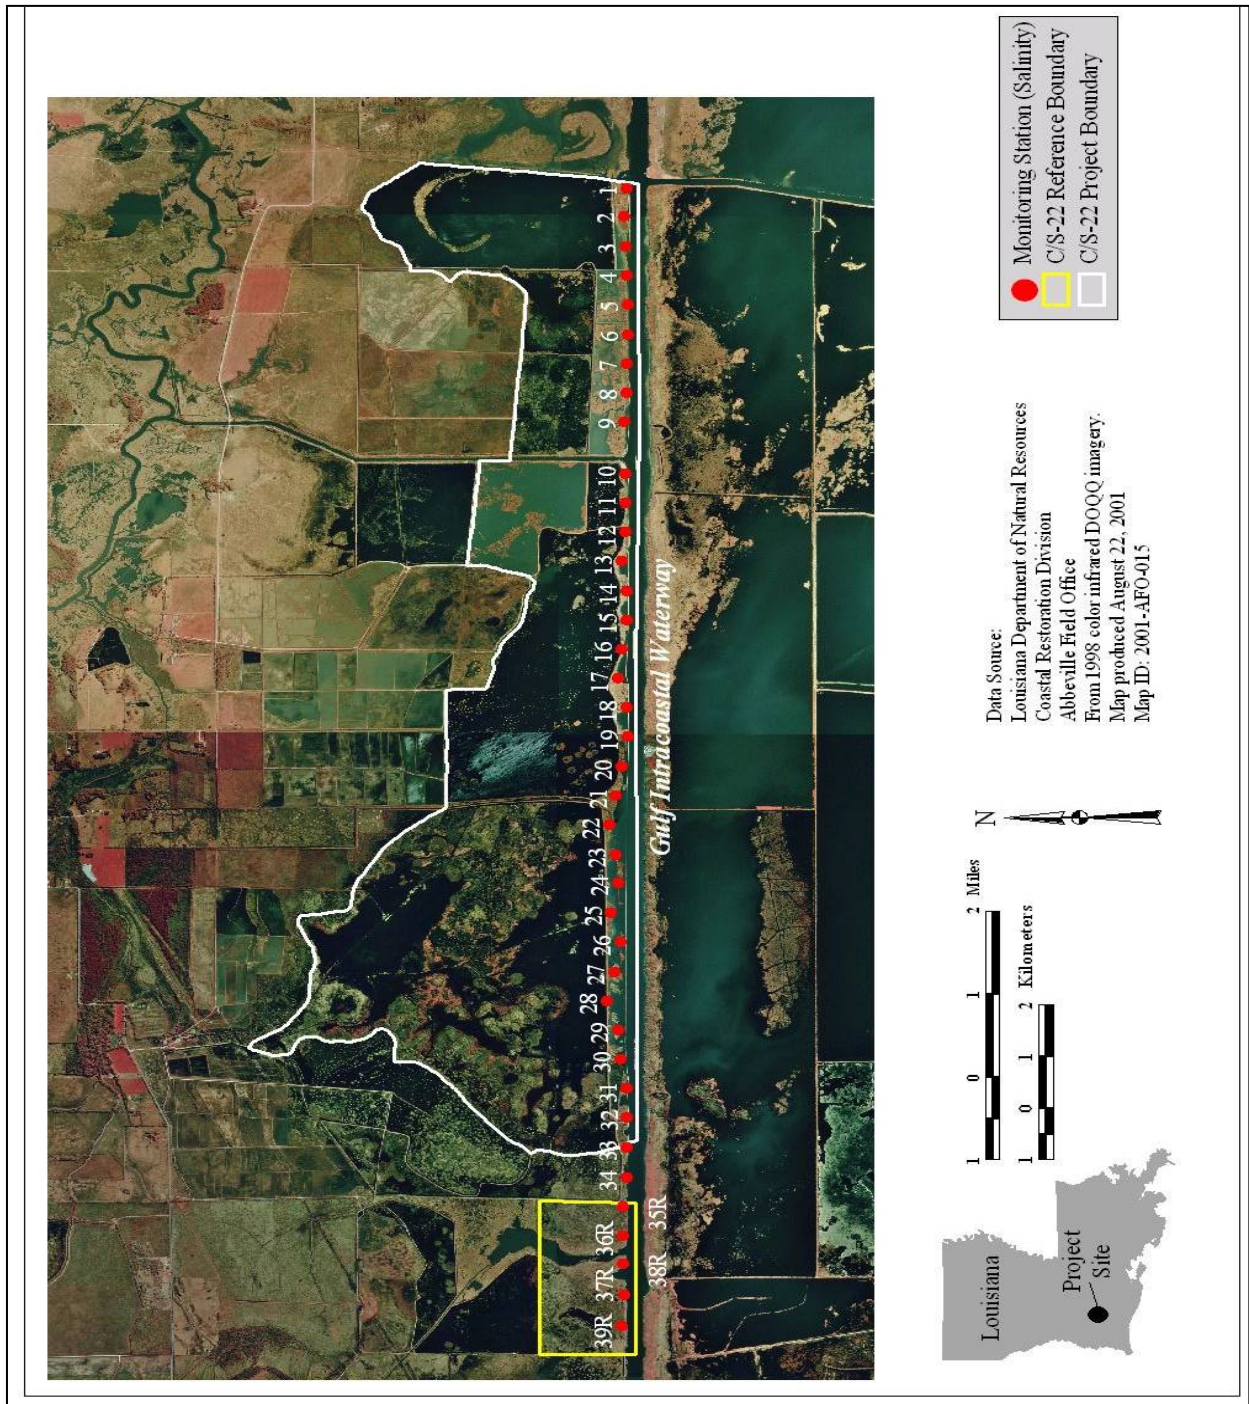
Figure 4. Project map showing the location of shoreline marker stations within the project (N=34) and reference (N=5) areas.

To document shoreline movement, 35 shoreline markers were placed at points along the vegetated marsh edge adjacent to the rock breakwater at a maximum interval of 1000 ft (305 m). Five shoreline markers were placed at the same 1000 ft intervals 1 mi (1.6 km) west of the proposed breakwater in the reference area. The position of the shoreline relative to the shoreline markers was documented in 1997, 2000, and 2003. Future shoreline surveys will be documented in 2006, 2010, and 2015 by direct measurement. A GPS coordinate was obtained for each shoreline marker placed to maintain baseline condition over time. The shoreline was stratified into three different groups: Group A had mild erosion and was located east of Brannon ditch to the Alkali ditch, group B had moderate erosion and was located from the Brannon ditch to the end of the management levee and group C which had severe erosion from the end of management levee to directly adjacent to the Clear Marais wetlands. Determination of land types were made through evaluation of aerial photography.

Data were collected in May 1997 (as-built), May 2000 and May 2003. The data indicate that after six years, the project has been effective in preventing erosion within each group (figures 4 and 5). Group A which was experiencing severe erosion prior to construction gained 1.89 ft/yr (.57m/yr) (table 1). Group B which was experiencing moderate erosion gained 3.02 ft/yr (.92 m/yr). Group C which was experiencing mild erosion gained 17.00 ft/yr (5.18 m/yr). Overall the project area gained an average of 7.66 ft/yr (2.33 m/yr) as compared to the reference area which is losing 9.10 ft/yr (2.77 m/yr).

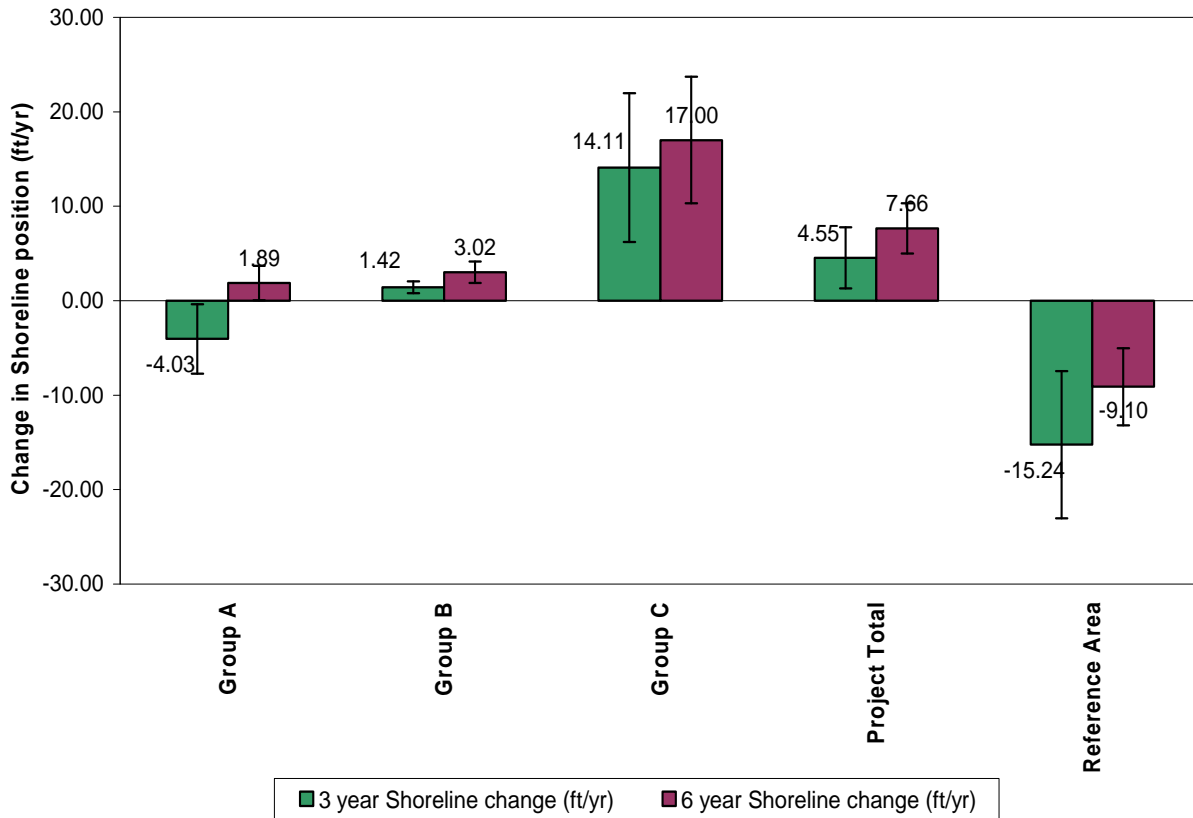
**CS-22 Clear Marais
Shoreline Position Change 1997-2003**

Figure 5. CS-22 Shoreline position change within each group, project and reference area from 1997-2003. 1997–2000 represents the 3 year shoreline change (ft/yr) and 1997–2003 represents the 6 year shoreline (ft/yr) change.

The data indicate that after six years, the project has been effective in preventing shoreline erosion within each group, Group A which was experiencing severe erosion, Group B which was experiencing moderate erosion and Group C which was experiencing mild erosion. Overall the project area gained an average of 7.66 ft/yr (2.33 m/yr) as compared to the reference area which is losing 9.10 ft/yr (2.77 m/yr). Visual observation indicates vertical accretion of the wetland area at many locations between the foreshore rock dike and the shoreline
