## **Evaluation of Retro-Reflective Beads to Increase Airport Surface Marking Conspicuity**

May 2010

DOT/FAA/AR-TN10/10

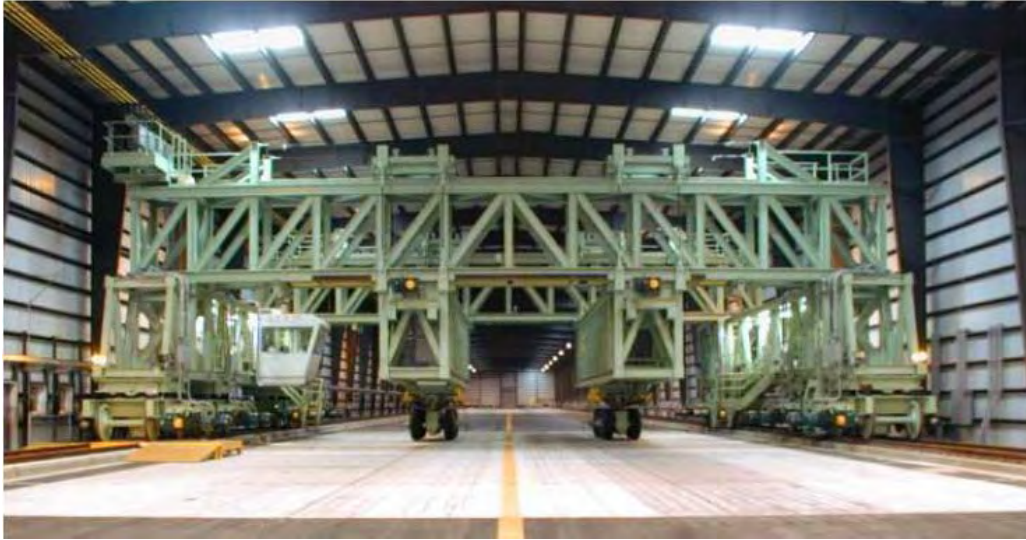
Figure 1. National Airport Pavement Test Vehicle

Test Site One was located inside the FAA William J. Hughes Technical Center NAPTF. This fully enclosed instrumented test track is 900' long by 60' wide and is designed to accelerate the wear on runway materials from aircraft operations to determine useful life of various materials. During this retro-reflective bead project, the National Airport Pavement Test Vehicle (NAPTV), as shown in figure 1, was configured to simulate the taxi loading of a Boeing 747 and 777 aircraft. Using this site added the benefit of providing accelerated operations and provided wear data from two different aircraft.

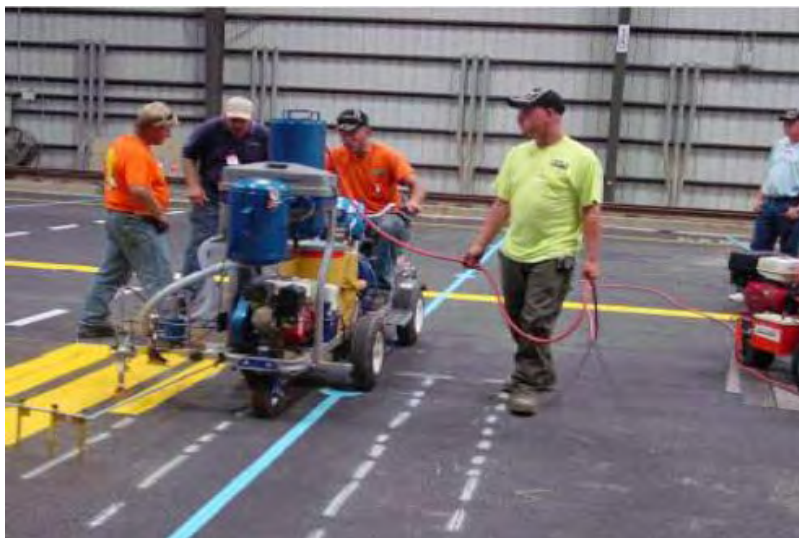
Figure 3. Application of Edge Lines on new HMA at Test Site One Inside the FAA William J. Hughes Technical Center NAPTF

Six yellow test edge line markings were applied on new HMA. Each edge line was 12" wide x 6' long. Table 1 shows test marking number, type of bead (if any), type of marking, and paint thickness. Figure 2 shows a representation of Test Site One, while figure 3 shows the application of the test markings at Test Site One on new HMA.

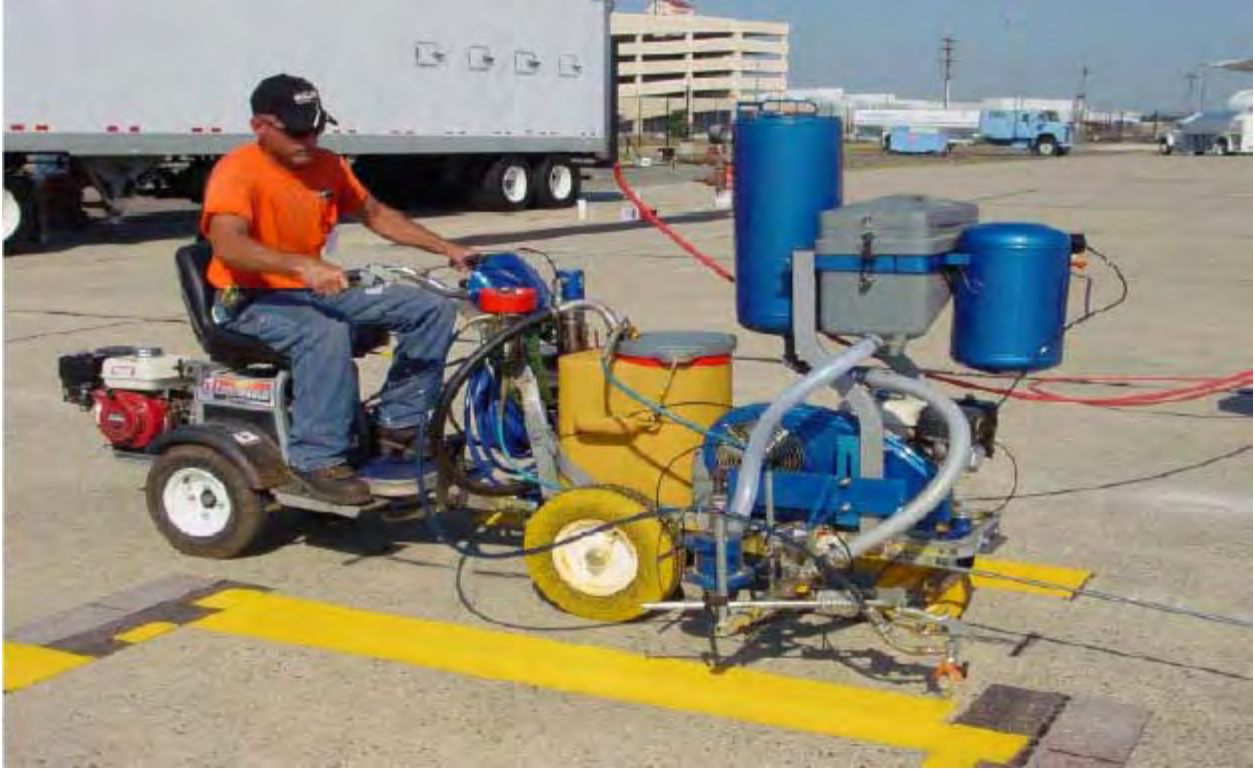
Figure 6. Applying 12" x 6' Edge Lines on Aged PCC at Test Site Two

Figure 5 shows the edge and friction lines at Test Site Two on the FAA William J. Hughes Technical Center Aircraft Parking Apron. Six 12" x 6' edge lines were applied, as shown in figure 6, and six 18" x 150' friction lines were applied, as shown in figure 7.

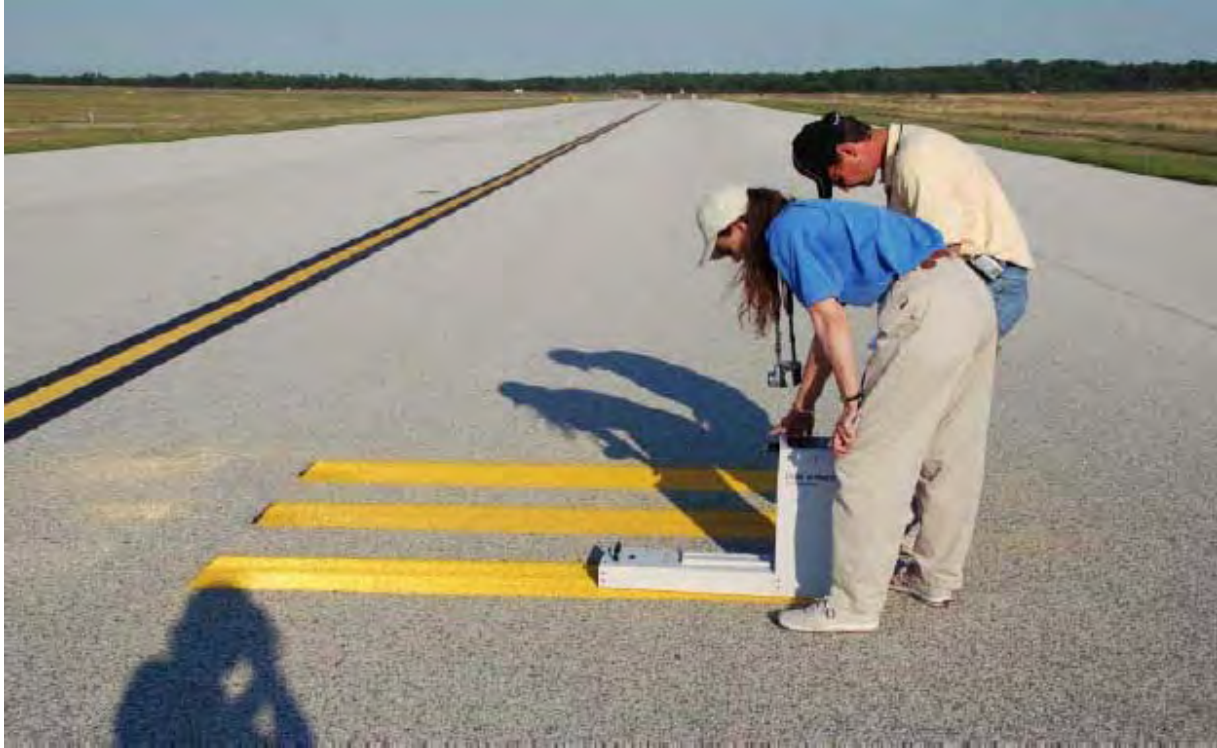
Figure 9. Applying 12" x 6' Edge Lines on Aged HMA at Test Site Three Using a Delta LTL-X Retrometer

Figure 8 shows the edge and friction lines at Test Site Three. Figure 9 shows the 12" x 6' edge lines, and the 18" x 150' friction lines are shown in figure 10.

A Delta LTL-X Retrometer was used (figure 9), in accordance with ASTM E 2176-01 [6], to measure the coefficient of retro-reflected luminance of pavement markings during continuous wetting (simulated rain). This test simulated continuous wetting or rain on pavement markings to observe the retro-reflective readings during a rainfall and to determine if the pavement marking could be seen during a rain event.

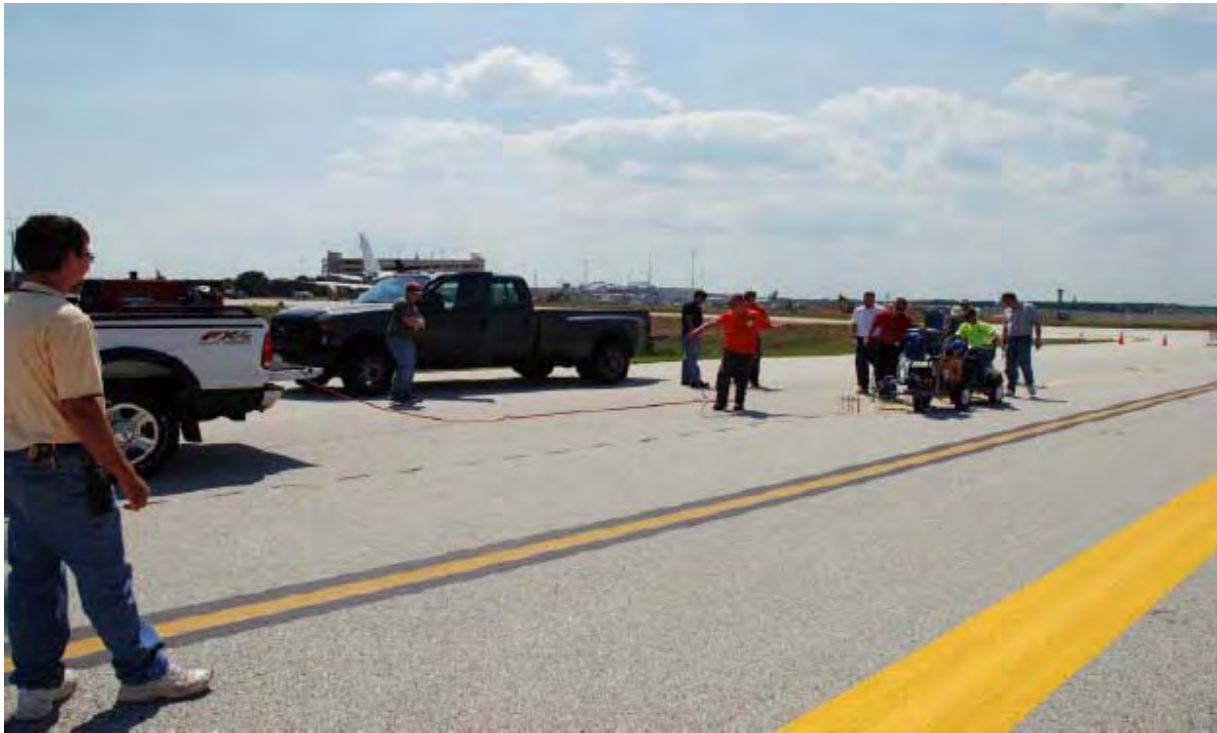
Figure 10. Applying 18" x 150' Friction Lines on Aged HMA at Test Site Three

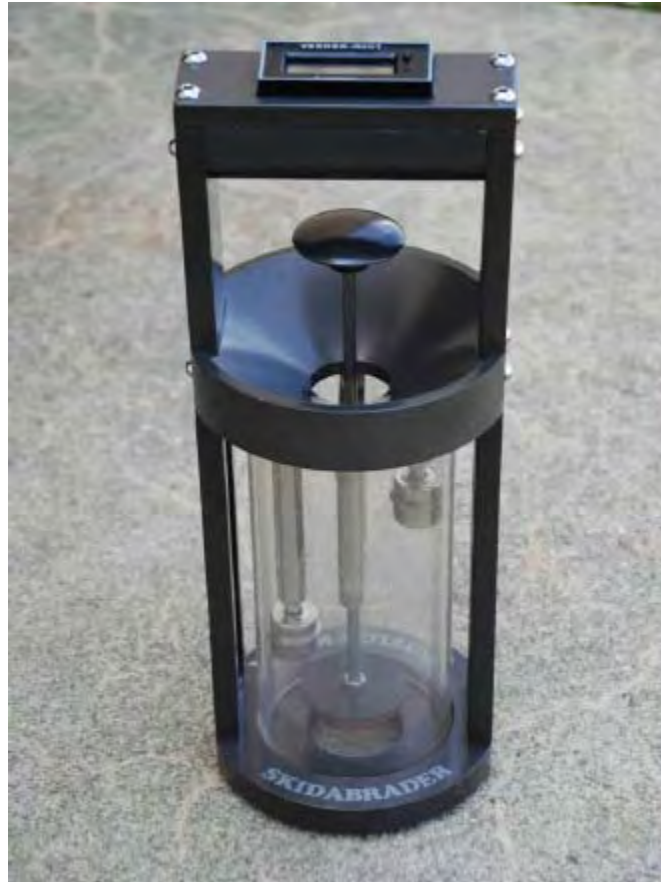
Figure 12. Skidabrader Out-Flow Meter

WATER TEST. A water test was conducted in compliance with ASTM standards. Using a Skidabrader Out-Flow Meter (figure 12), the dynamic permeability and hydrodynamic drainage characteristics of the surface were measured in accordance with ASTM E 2380-05 [5]. This procedure demonstrated the amount of time it took for a known quantity of water, under

gravitational pull, to escape through the voids in the pavement surface. A faster escape time indicated a thinner film of water may have existed between a tire and the pavement surface.

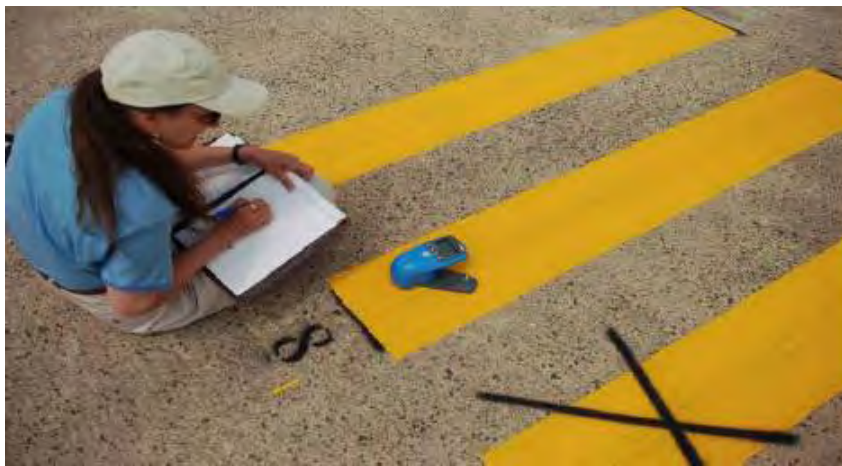
Figure 15. An FAA Airport Safety Technology R&D Sub-Team Member Taking Chromaticity Readings

Color readings were taken with a Spectro Guide, which produces three coordinates (Y = depth, x = width, and y = height) for its readouts. The standard coordinate system CIE 1931 XYZ color space, created by the International Commission on Illumination (CIE), was used. The readings obtained were compared to the color coordinate boundaries for FAA in-service yellow. The boundaries of FAA in-service yellow are not the same as aviation yellow. The region for FAA in-service yellow is documented in appendix A of reference 2, "Development of Methods for Determining Airport Pavement Marking Effectiveness." The readings were also charted on the CIE standard illuminant D<sub>65</sub> chromaticity chart, as shown in figure 14. This chart has been modified to address the FAA in-service yellow used on airports. Color readings were collected after the initial application of the paint marking material and continued monthly thereafter for 1 year. Figure 15 shows chromaticity readings being taken.

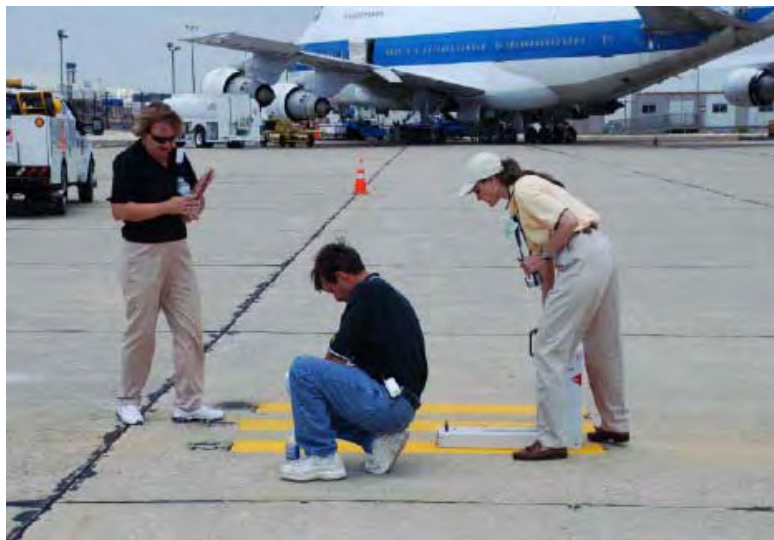
Figure 17. The FAA Airport Safety Technology R&D Sub-Team Members Taking Retro-Reflectivity Readings

Using the retrometer, six readings per marking were taken by placing the instrument on the pavement marking and activating the device. Prior to each use, the instrument was calibrated. Readings were taken after the initial application of the paint marking, and then monthly thereafter for 1 year. Figure 17 shows retro-reflective readings being taken. (See appendix C for the readings.)

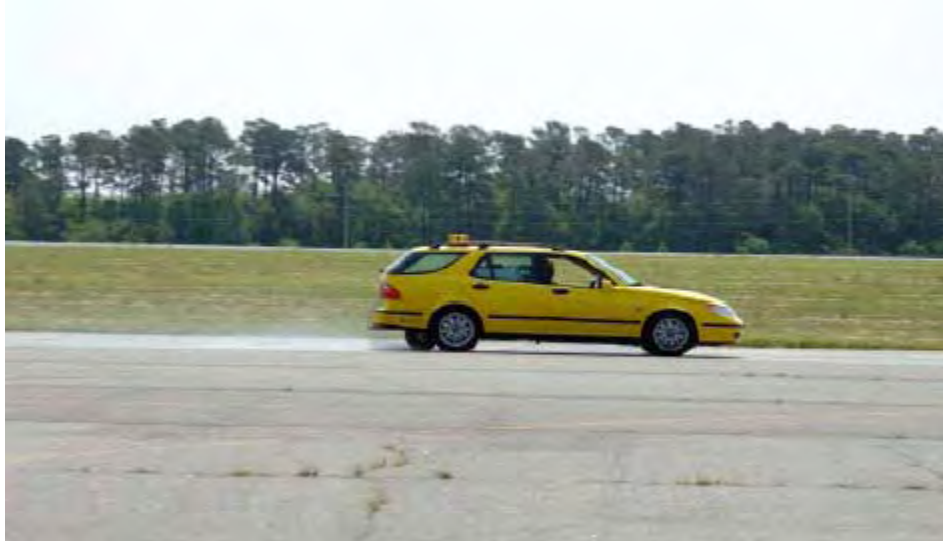
Figure 18. Saab Sarsys Friction Tester in Action

Using a Saab Sarsys Friction Tester, multiple friction test runs were conducted, as shown in figure 18. Tests were conducted at Test Site Two on aged PCC and at Test Site Three on aged HMA, where friction lines, 150' long, were located. The friction test runs were conducted with a self-watering system on at a speed of approximately 40 miles per hour.
