# Naval Base Kitsap at Bangor Test Pile Program

## **Final** Marine Mammal Monitoring Report

**BANGOR, WASHINGTON**

**April 2012**

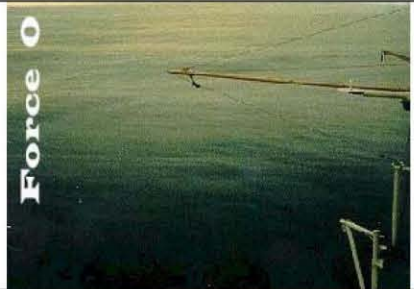
Beaufort SS	Wind speed (knots)	Wind description	Wave height (ft) Beaufort	Sea State – Beaufort	Notes specific to on-water seabird observations	Photos indicating Beaufort Sea State
0	<1	Calm	0	Calm; like a mirror	Excellent conditions, no wind, small or very smooth swell. You have the impression you could see anything.

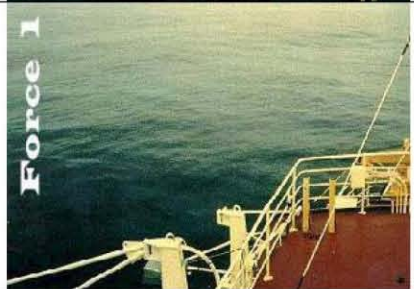
Force 1

Force 0
1	1-3	Light air	¼ < ½	Ripples with appearance of scales; no foam crests	Very good conditions, surface could be glassy (Beaufort 0), but with some lumpy swell or reflection from forests, glare, etc.

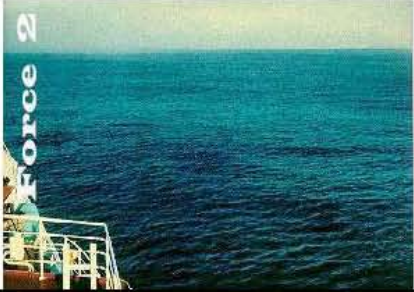
Beaufort SS	Wind speed (knots)	Wind description	Wave height (ft) Beaufort	Sea State – Beaufort	Notes specific to on-water seabird observations	Photos indicating Beaufort Sea State
2	4-6	Light breeze	½ – 1 (max 1)	Small wavelets; crests with glassy appearance, not breaking	Good conditions, no whitecaps; texture/lighting contrast of water make murrelets hard to see. Surface could also be glassy or have small ripples, but with a short, lumpy swell, thick fog, etc.

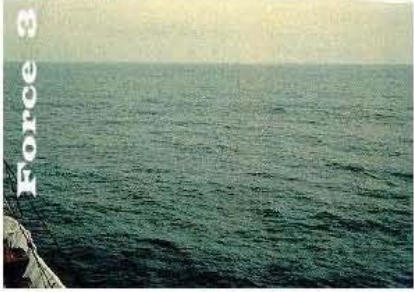
3	7-10	Gentle breeze	2 – 3 (max 3)	Large wavelets; crests begin to break; scattered whitecaps	Fair conditions, scattered whitecaps, detection of murrelets definitely compromised; a hit-or-miss chance of seeing them owing to water choppiness and high contrast. This could also occur at lesser wind with a very short wavelength, choppy swell.  <b>Poor conditions, end surveys.</b>

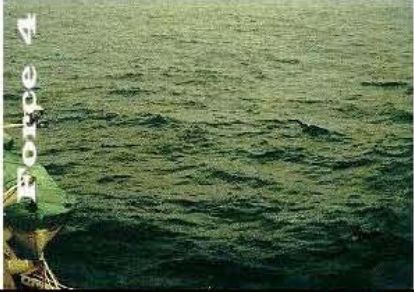
Beaufort SS	Wind speed (knots)	Wind description	Wave height (ft) Beaufort	Sea State – Beaufort	Notes specific to on-water seabird observations	Photos indicating Beaufort Sea State
4	11-16	Moderate breeze	3 ½ – 5 (max 5)	Small waves becoming longer, numerous whitecaps	Whitecaps abundant, sea chop bouncing the boat around, etc.

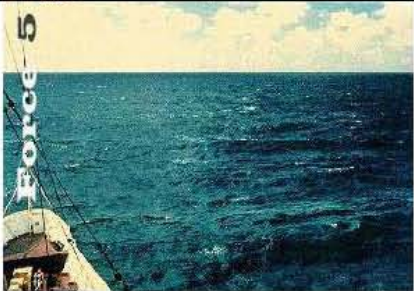
A photograph showing a more turbulent sea surface with larger, more defined waves and many whitecaps. The water is a deep blue color. The text 'Force 5' is written vertically on the left side of the image.

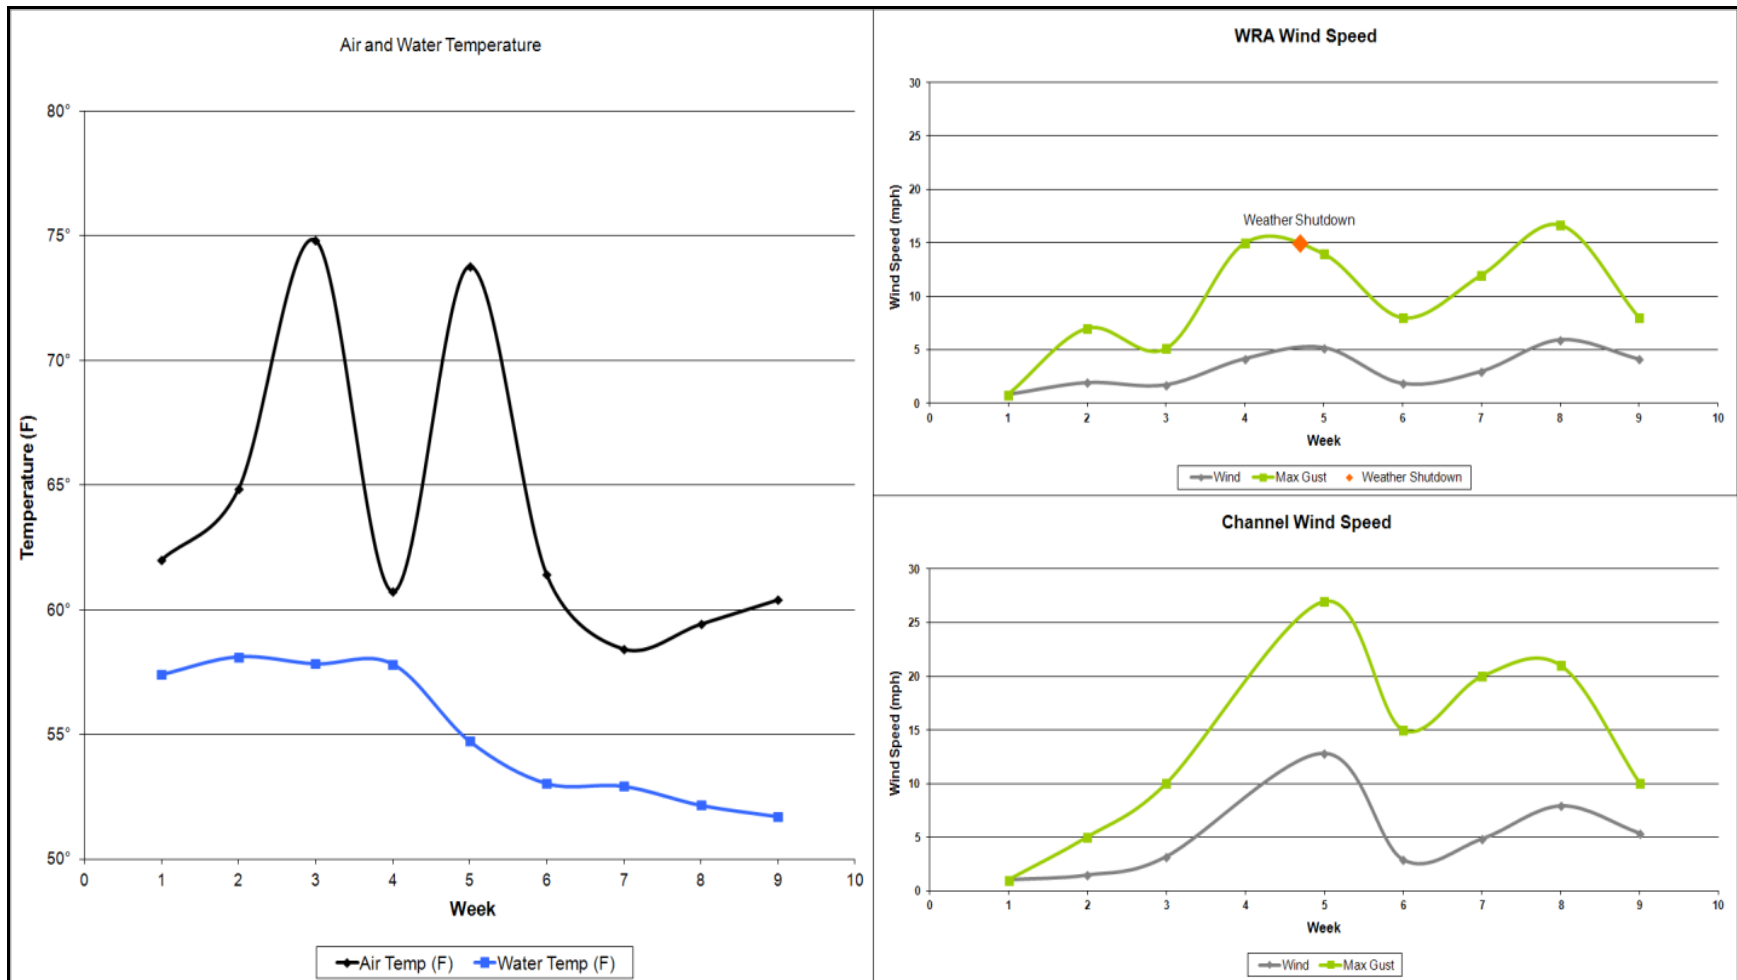
Figure C-1. Air and Water Temperature and Wind Speed

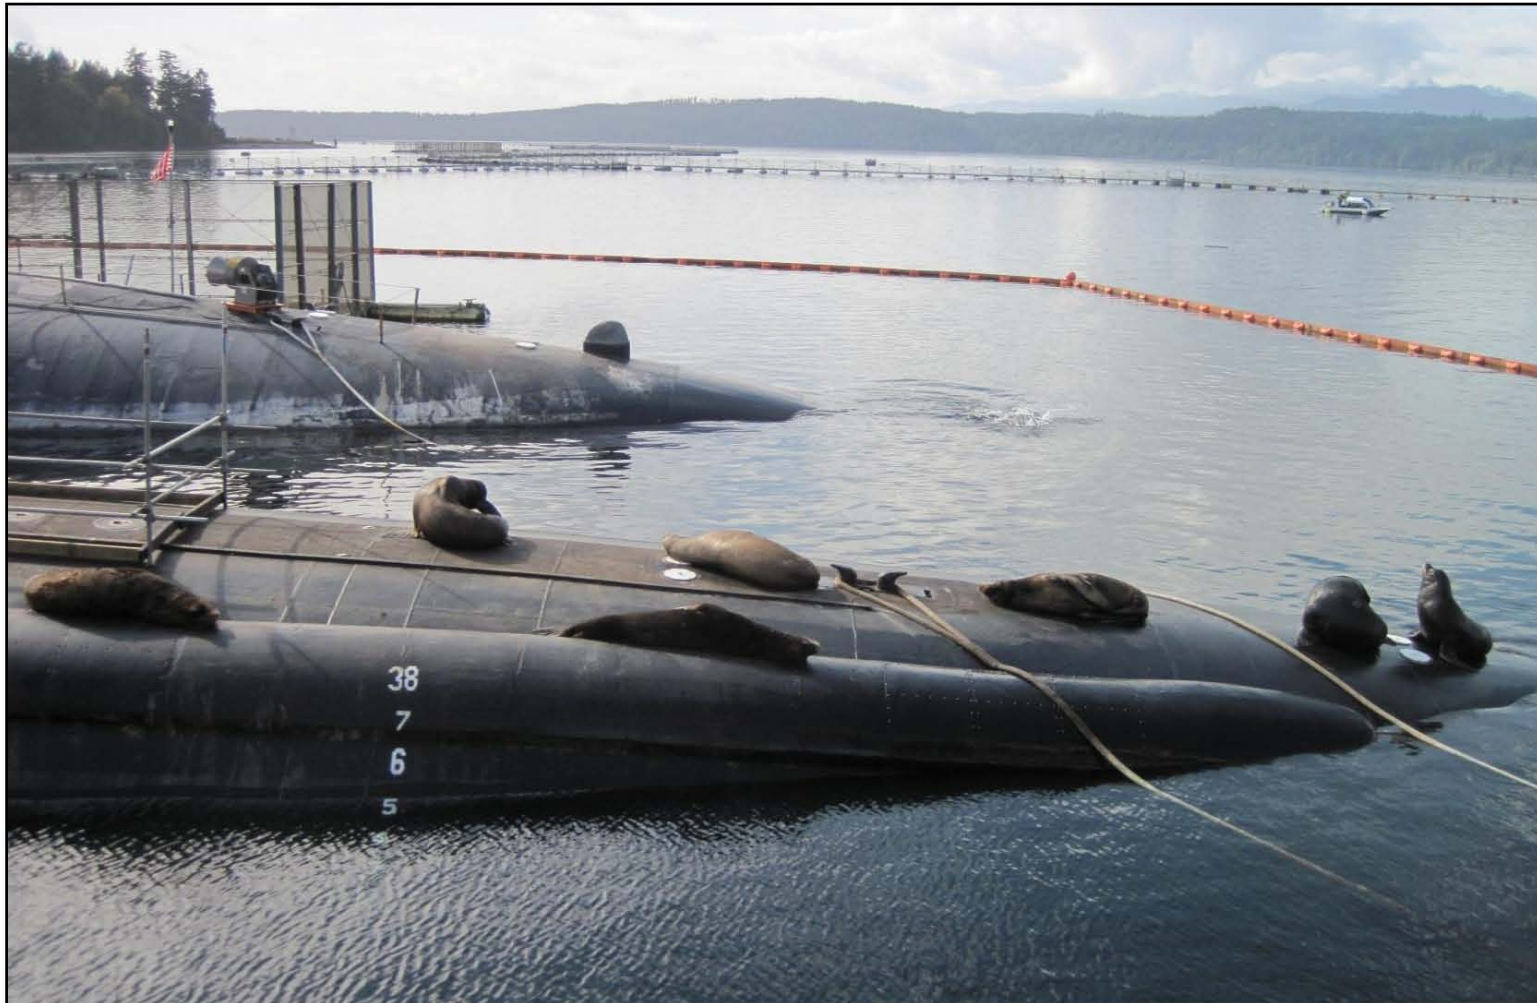
**Figure I-1. Delta Pier South and port security barrier.  
Photographed 12 October 2011 by A. Balla-Holden, U.S. Navy.**

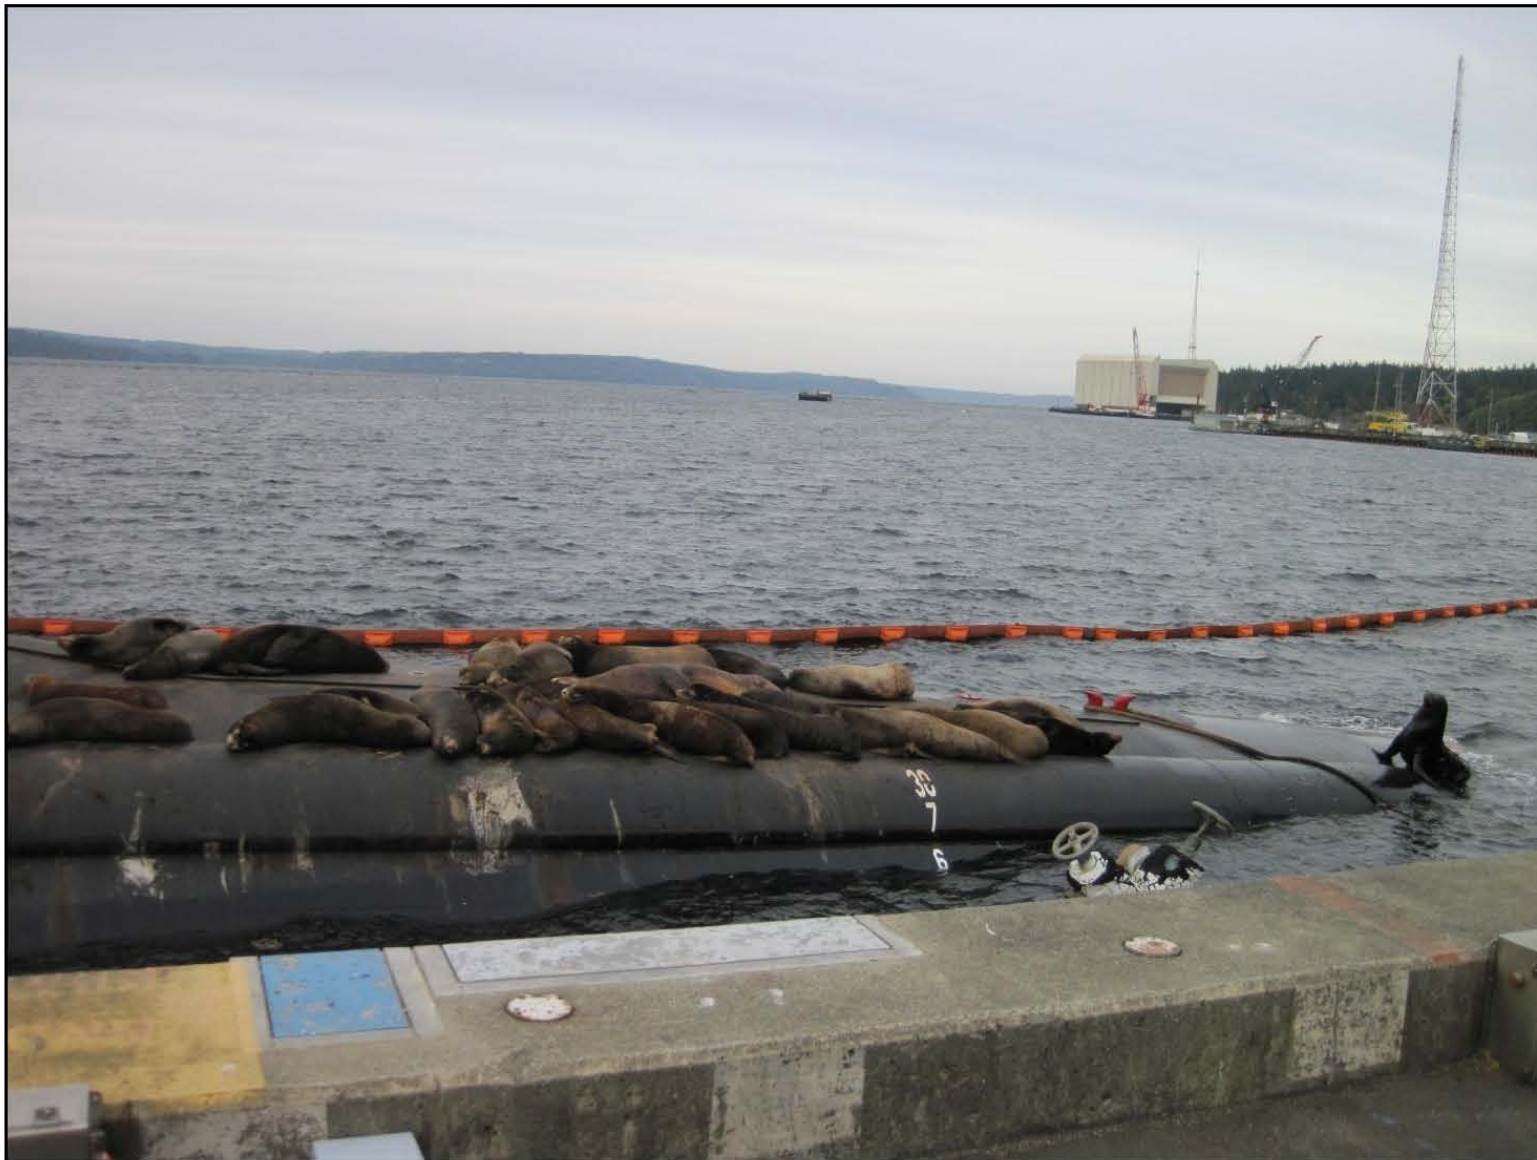
**Figure I-2. Delta Pier North, looking towards EHW-1.  
Photographed 13 October 2011 by A. Balla-Holden, U.S. Navy.**
