Final Report

**Design Data Report
for Conveyance of
Refuge Water Supply to
Gray Lodge Wildlife Area**

Prepared for
Bureau of Reclamation

August 2009

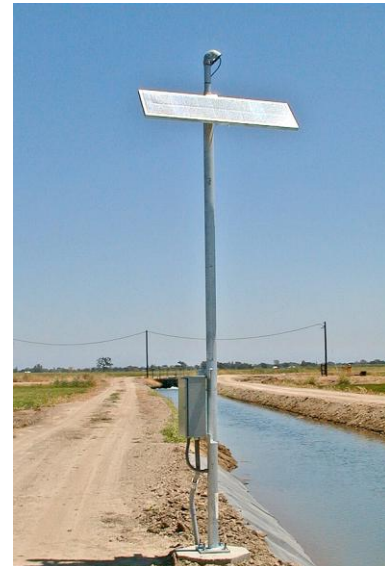
FIGURE 3-2
Flow Measurement Site on the
Belding Lateral

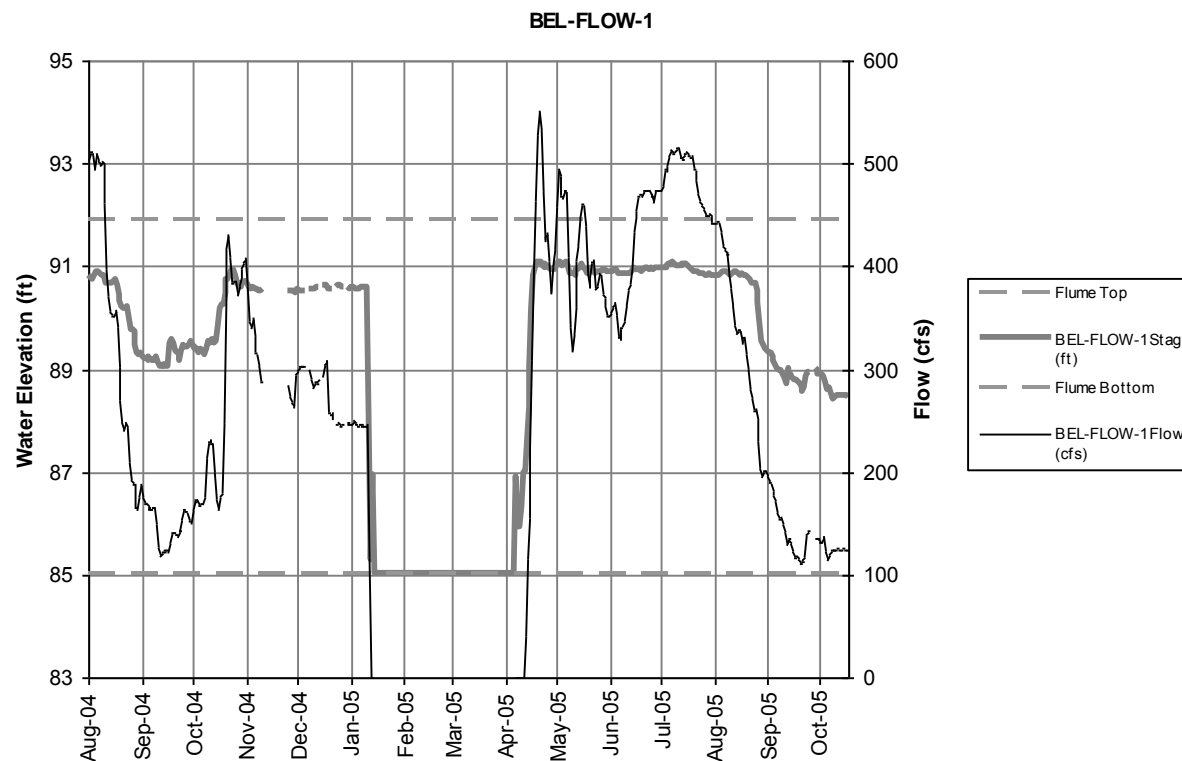
FIGURE 3-4
Flow and Water Level Data from the Belding Lateral

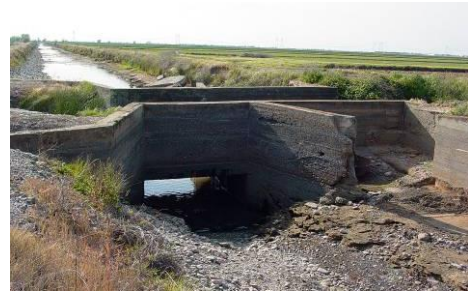
Remove the Razorback Siphon and replace with a trapezoidal earthen canal section to increase capacity and reduce head loss across this structure. Install two 8-foot-by-6-foot cross-drainage box siphons for the Dietzler Ditch (RD 833 drain). Design and construction of this improvement will require coordination with RD 833. The capacity of the drainage structure will be assessed during subsequent design phases.

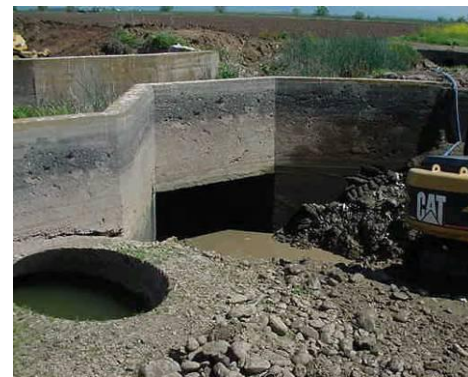
Remove the Garcia Siphon and replace with a trapezoidal earthen canal section to increase capacity and reduce head loss across this structure. Install two 8-foot-by-6-foot cross-drainage box siphons for the RD 833 drain. Design and construction of this improvement will require coordination with RD 833. The capacity of the drainage structure will be assessed during subsequent design phases.

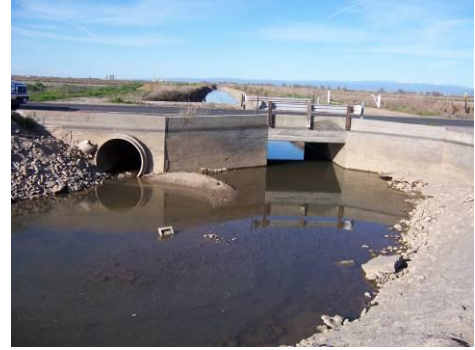
Remove existing bridge and replace with 2-foot-deep flat slab bridge with asphalt concrete (AC) driving surface to reduce flow restriction and add additional freeboard. Culvert depth below bridge should be at least 7 feet.

*Afton Road Bridge***B-9: Canal Modifications (Freeboard) from Station 546+47 to 535+13**

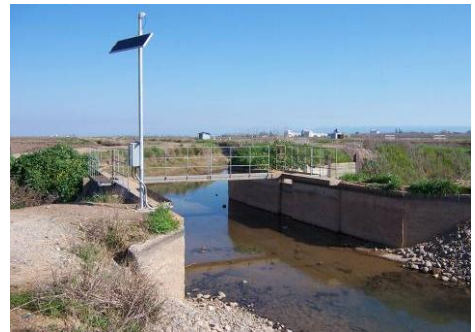
Remove and replace the Fields Flume with a higher capacity 26-foot-by-8.5-foot concrete flume to increase freeboard. Install 2-foot-wide walkways. Widening of the structure and a wasteway to spill excess water will be evaluated during final design.

*Fields Flume***B-14: Canal Modifications (Widening) from Station 535+32 to 405+24**

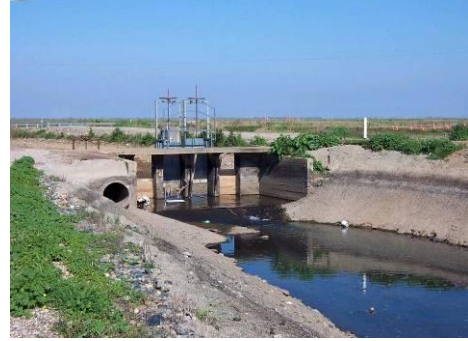
Remove and replace the North Weir with a 67-foot long-crested weir with two 4-foot-wide overshot gates.

*North Weir***B-16: Division 2 Headgates Replacement**

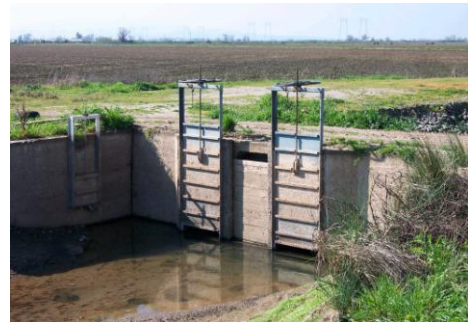
Remove and replace the Division 2 Headgates at the Belding/Traynor Split with three new 4-foot-wide sluice gates to improve control. Replace the farm crossing with 2-foot-thick flat-slab deck and at least 7-foot culvert opening. Increase height of adjacent canal banks to achieve 18 inches freeboard.

*Division 2 Headgates***B-17: Canal Modifications (Freeboard) from Station 381+70 to 346+70**

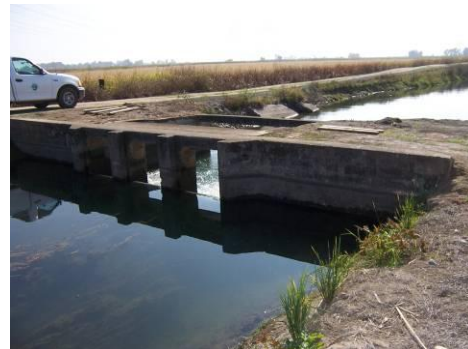
Remove and replace Check #1889 structure with a new 45-foot long-crested weir and 4-foot-wide overshot gate.

*Check #1889***B-19: Canal Modifications (Freeboard) from Station 343+10 to 309+72**

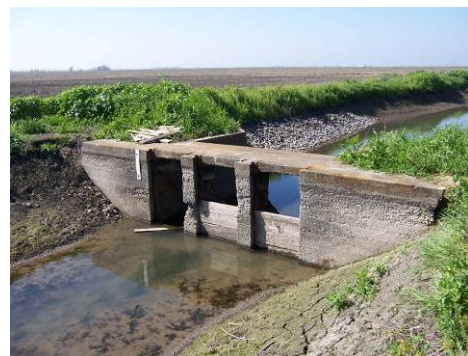
Remove and replace Check #1845 structure with a new 83-foot long-crested weir and two 3.5-foot-wide overshot gates.

*Check #1845***B-21: Canal Modifications (Freeboard) from Station 300+32 to 211+71**

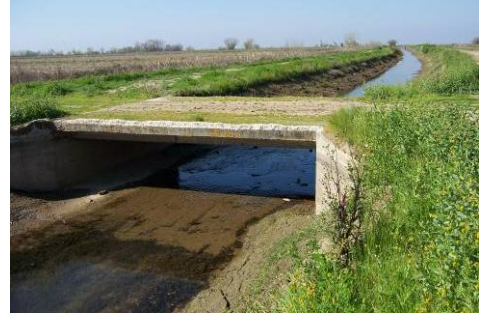
Farm Crossing #1786

Remove existing Farm Crossing at Station 300+20 and replace with 2-foot-deep flat slab bridge with aggregate base backfill for driving surface to reduce flow restriction and add additional freeboard.

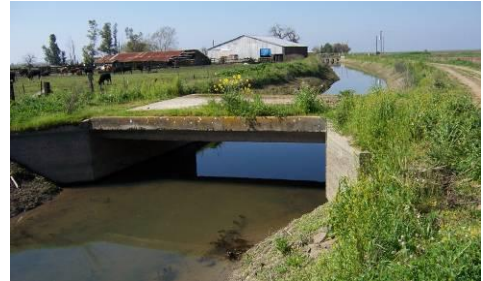
Farm Crossing #1719

Remove existing Farm Crossing at Station 264+20 and replace with 2-foot-deep flat slab bridge with aggregate base backfill for driving surface to reduce flow restriction and add additional freeboard.

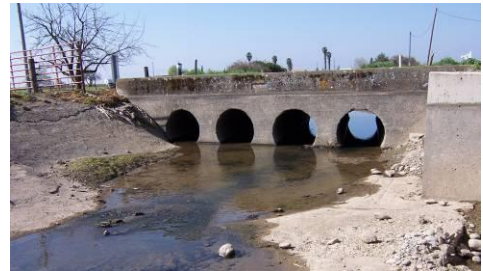
Remove existing Farris Road Bridge and replace with 1.7-foot-deep flat slab bridge with asphalt concrete driving surface to reduce flow restriction and add additional freeboard. Opening under bridge should be 8.5 feet high.

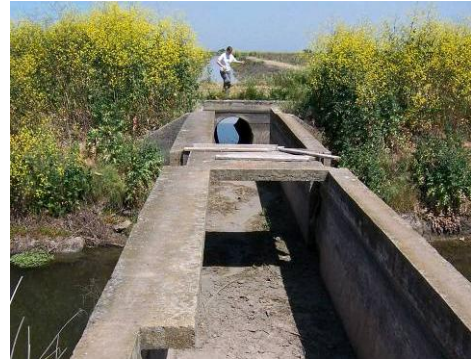
Remove and replace the Schwind Flume structure with a similar flume, 60 feet long by 8 feet wide by 5 feet deep to increase capacity and freeboard while decreasing head loss across this structure. Integrate check bays on both sides of flume structure to allow for spill.

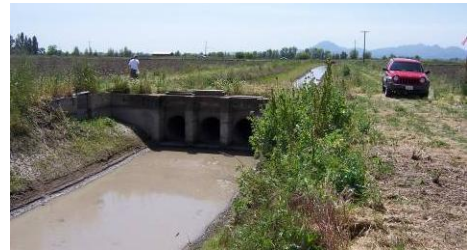
Farm Crossing #1522

Remove existing farm crossing at Station 161+03 and replace crossing with a 37-foot long-crested weir with a 3-foot-wide overshot gate to reduce flow restriction and add additional freeboard. Integrate new flat slab deck crossing.

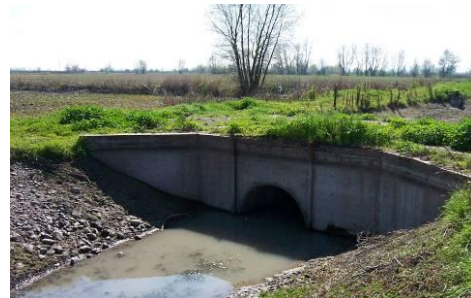
Farm Crossing Downstream of Colusa Highway

Remove and replace farm crossing culvert just downstream of Colusa Highway with a 9-foot-by-4-foot concrete box culvert under crossing to increase capacity and decrease head loss across this structure.

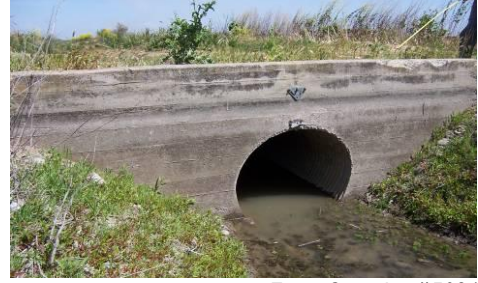
Farm Crossing #5021

Remove existing farm crossing at Station 100+12. Replace Crossing #5021, Culvert #5006, and Culvert south of West Liberty Road with 162-foot-long by 6-foot-diameter siphon. See improvements S-10 and S-11.

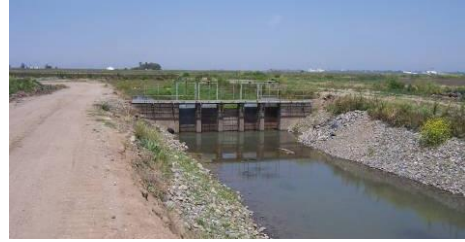
Remove and replace the Traynor Headgates with a 62-foot long-crested weir with two 3-foot-wide overshot gates to increase freeboard and improve control.

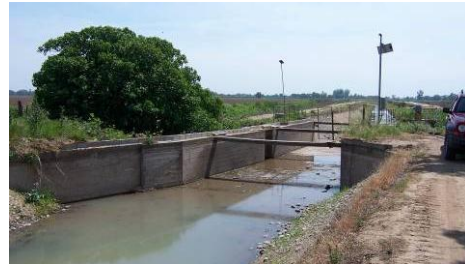
Remove and replace the Nugent Flume with a higher-capacity 60-foot-long by 22-foot-wide by 10.5-foot-deep concrete flume. Improve canal 500 feet upstream and downstream of new flume to match the freeboard of the flume. Install two check bays, one on either side of flume, for spill. Maintain a box culvert under flume for RD 833 drainage.

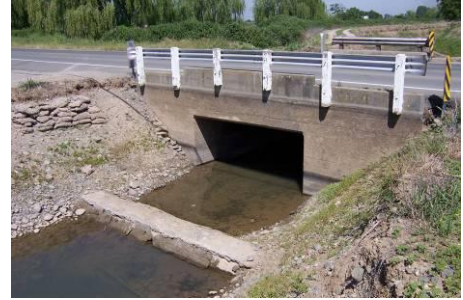
Remove existing Colusa Highway Bridge and replace with 3-foot-deep flat slab bridge with 2-foot-thick center pier and asphalt concrete driving surface to reduce flow restriction and add additional freeboard.

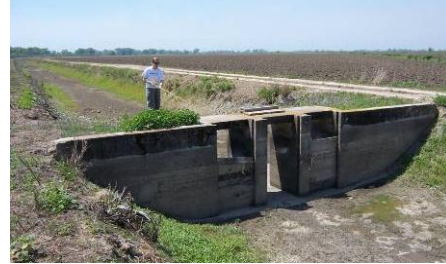
Flashboard Check #2802

Remove and replace the flashboard check structure with a 19-foot long-crested weir with one 4-foot-wide overshot gate to increase capacity and freeboard while decreasing head loss across this structure.

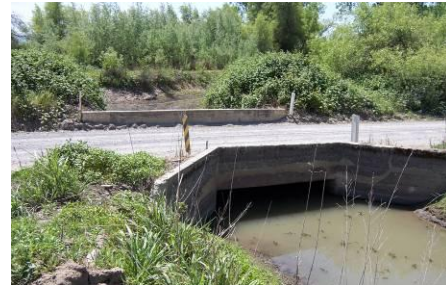
Evans Reimer Road Bridge

Remove existing Evans Reimer Bridge and replace with 2-foot-deep flat slab bridge with 1-foot-thick center pier and asphalt concrete driving surface to reduce flow restriction and add additional freeboard.

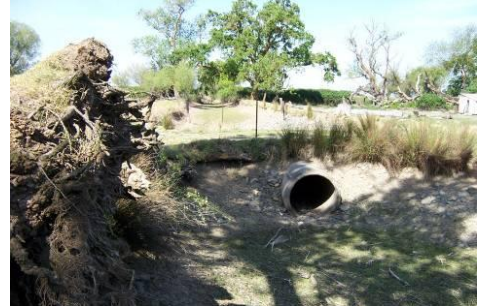
Culvert Upstream of Bonslett Driveway

Remove and replace Farm Crossing #1226 at station 394+00 upstream of Bonslett's driveway with an 8-foot-by-4-foot concrete box culvert with integrated farm crossing to increase capacity and reduce head loss across this structure.

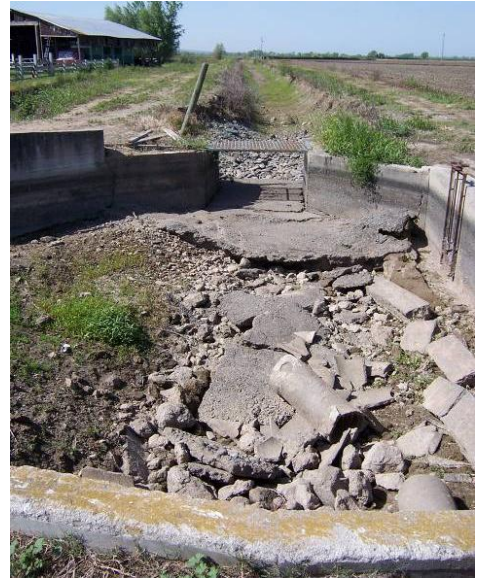
Bonslett Weir #1198

Remove and replace the farm crossing culvert at Bonslett's driveway with a 7-foot-by-4-foot concrete box culvert and flashboard weir with a 56-foot long-crested weir and a 3-foot-wide long overshot gate to increase capacity and reduce head loss across this structure. Replace customer turnouts and provide a concrete apron downstream of the weir to control erosion.

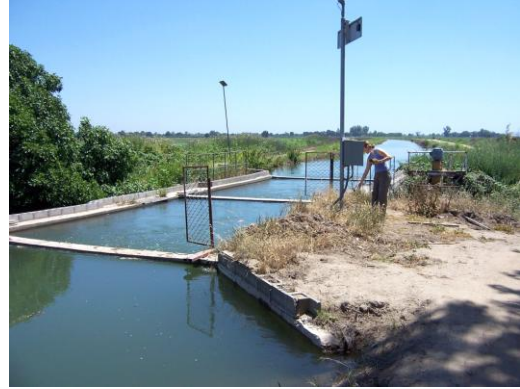
FIGURE A-6
Nugent Flume on Traynor Lateral at Near-Peak Flow Condition Showing High Water Levels

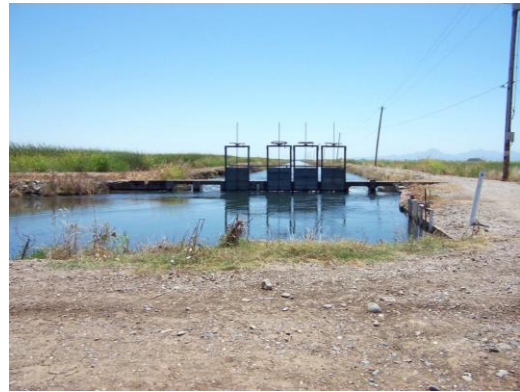
FIGURE A-7
Banion Check Structure on Belding Lateral Showing High Water Levels

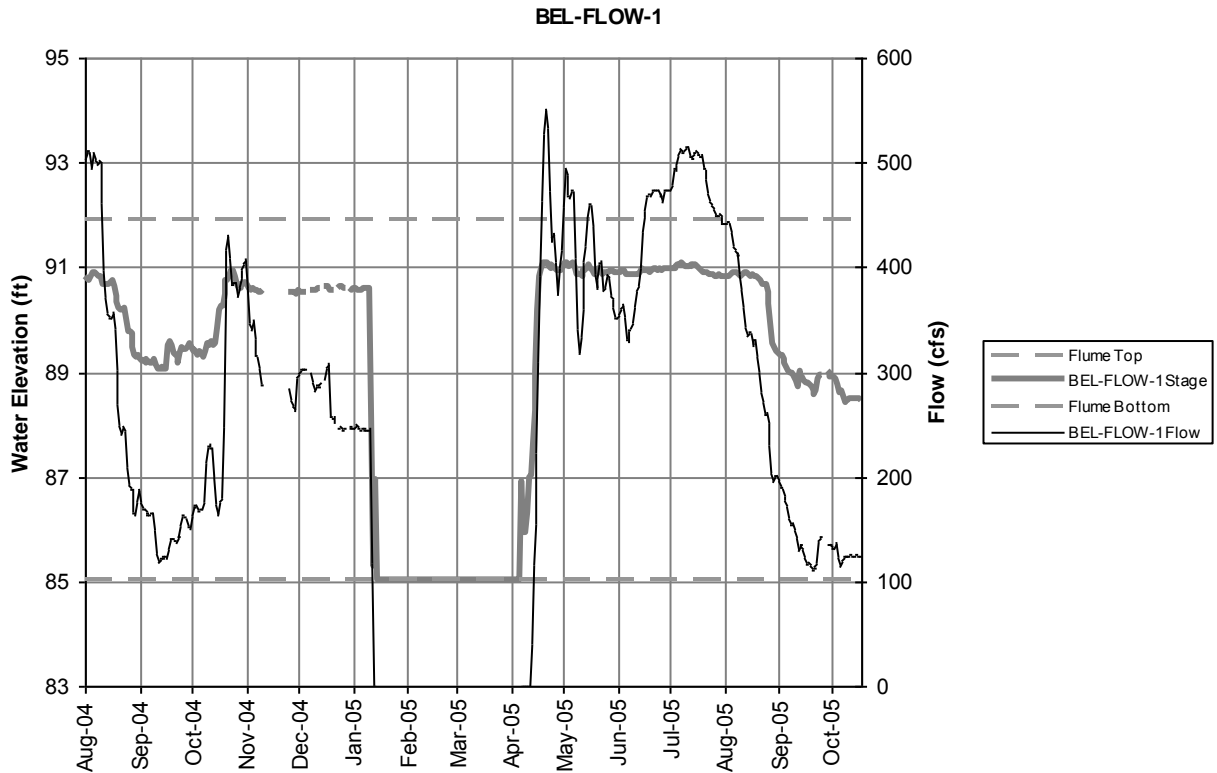
FIGURE A-11
 Flow and Water Level Data from the Belding Lateral

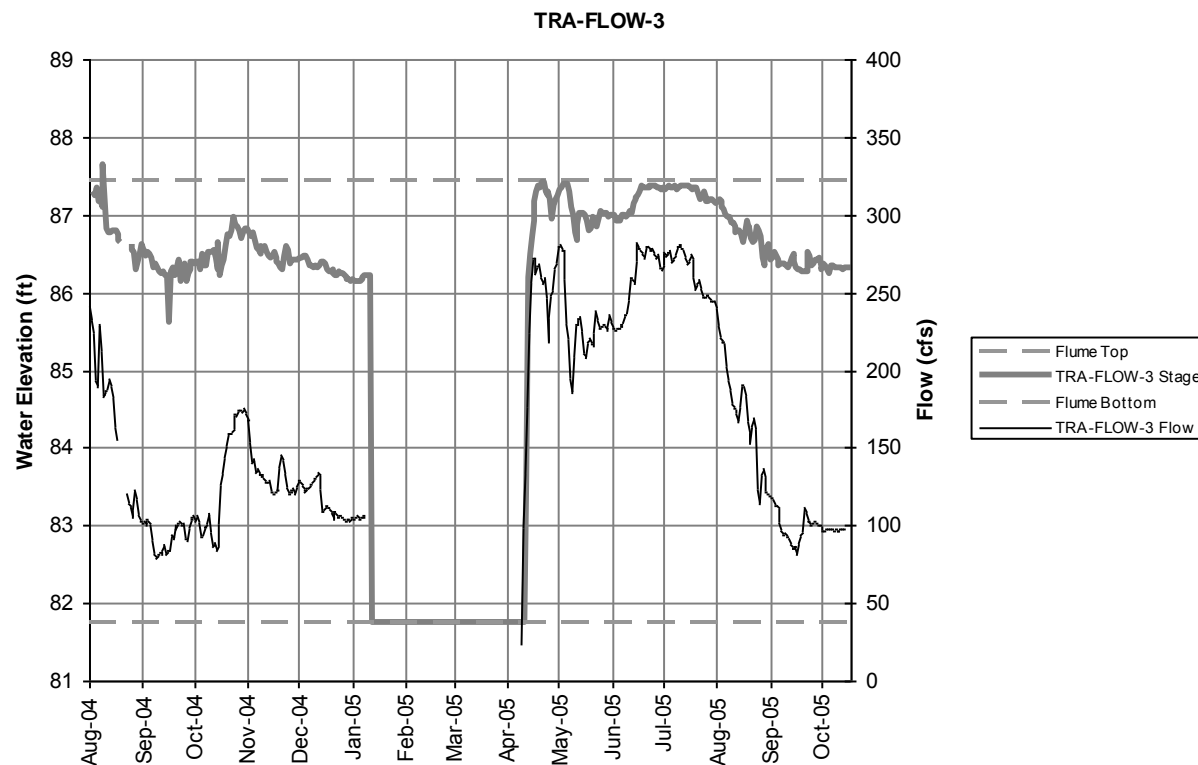
FIGURE A-12
 Flow and Water Level Data from the Traynor Lateral

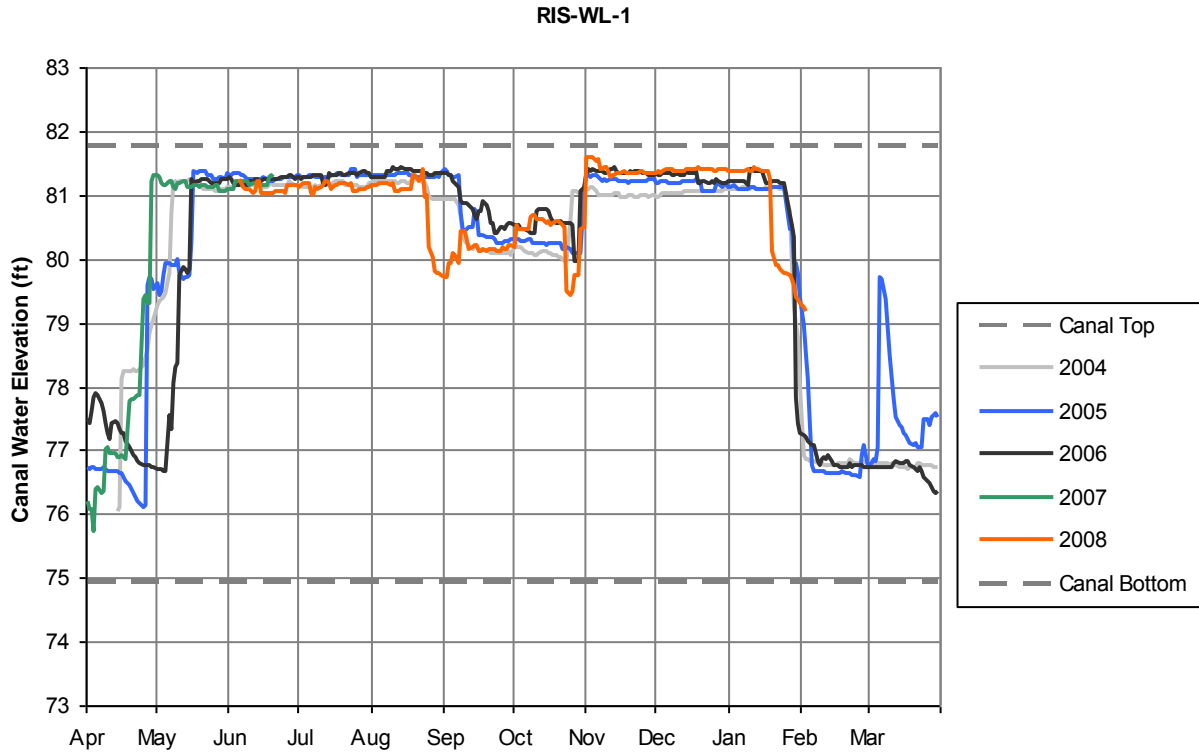
FIGURE A-13
 Water Level Data from the Rising River

RIS-FLOW-1 recorded inconsistent data during the study because silt frequently blocked meter sensors in this area. Available data from this meter are provided in Attachment A-1, Figure A1-11.
