Tennessee Valley Authority
Regulatory Submittal for Kingston Fossil Plant

TVA Kingston Fossil Plant Release Site On-Scene Coordinator Report for the Time-Critical
Removal Action May 11, 2009 - December 2010
EPA-AO-030

Date Submitted:
03/31/2011

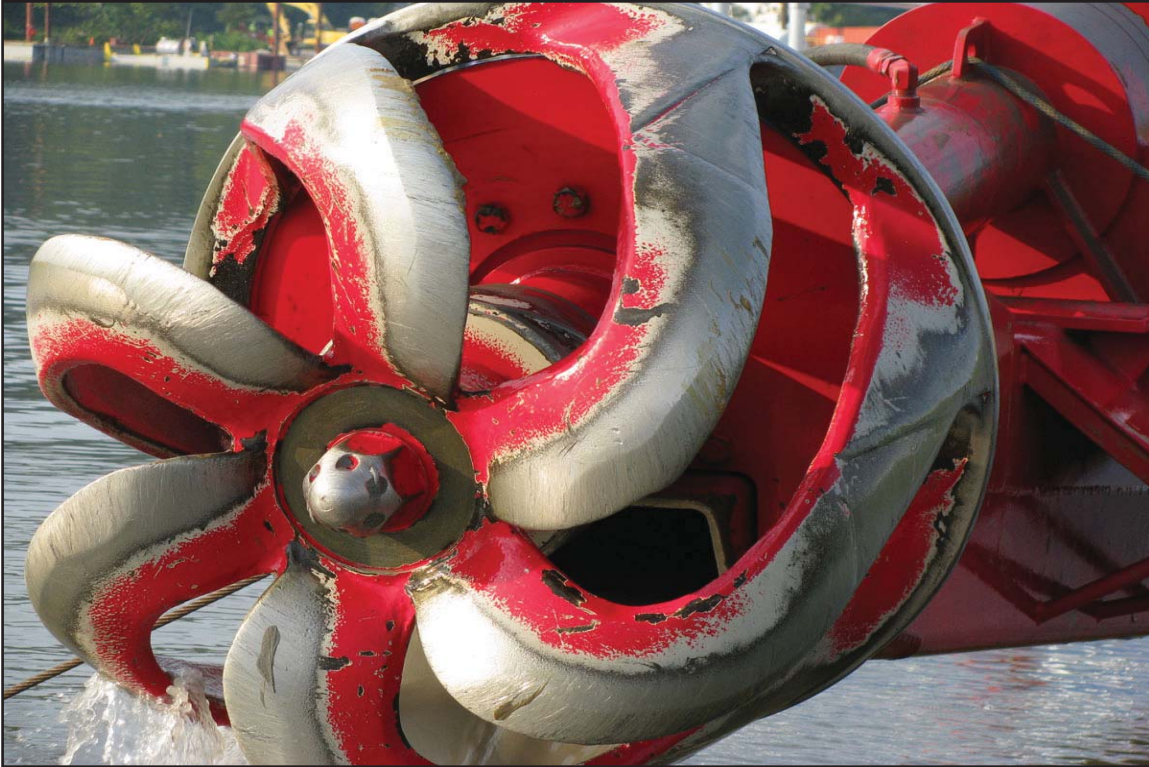
2G - Severson 14-inch dredge cutter head showing wear due to dredging. August 1, 2009.

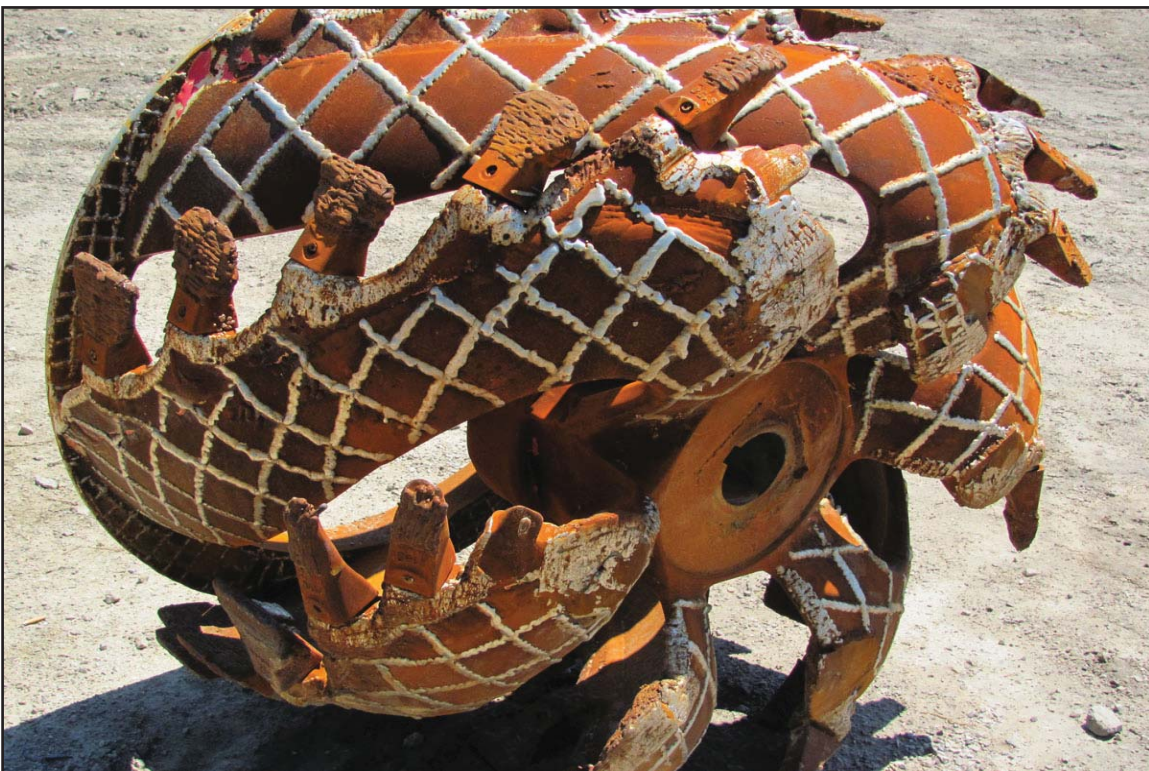
2H - Severson 20-inch cutter head with hard facing and teeth for hard dredging. May 5, 2010.

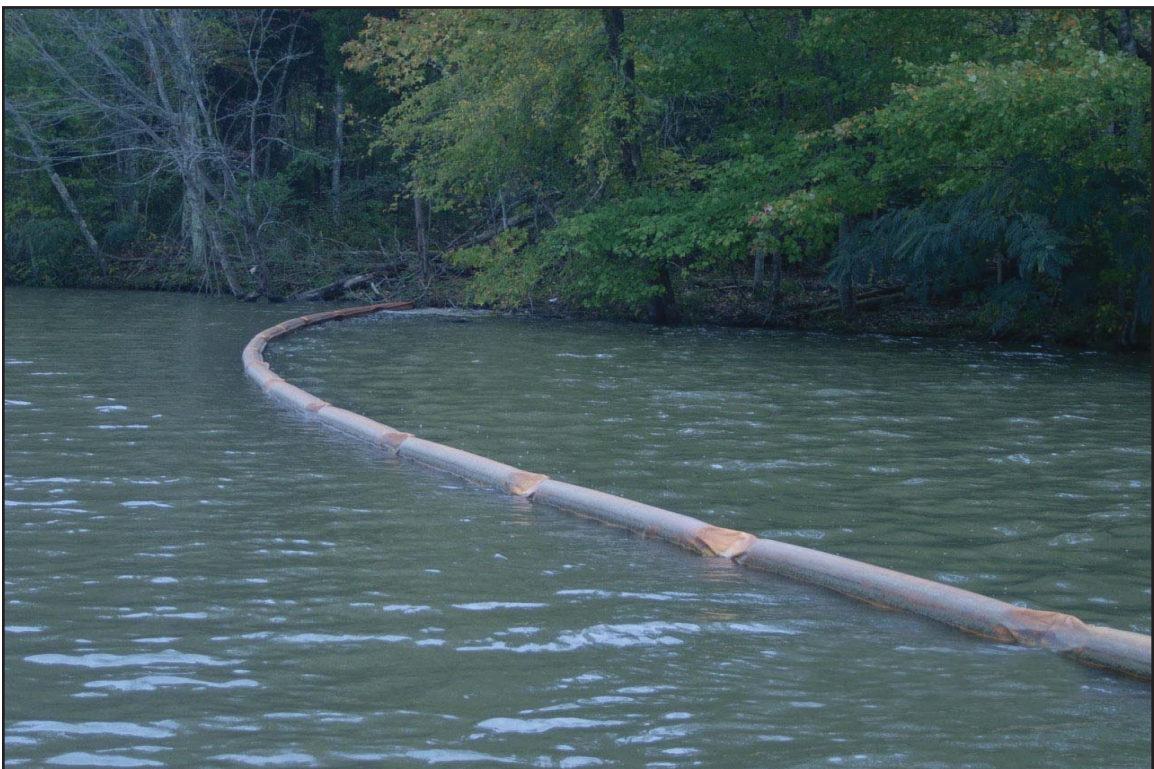
2V - Debris boom downstream of dredging used to collect cenospheres or debris.
October 17, 2019.

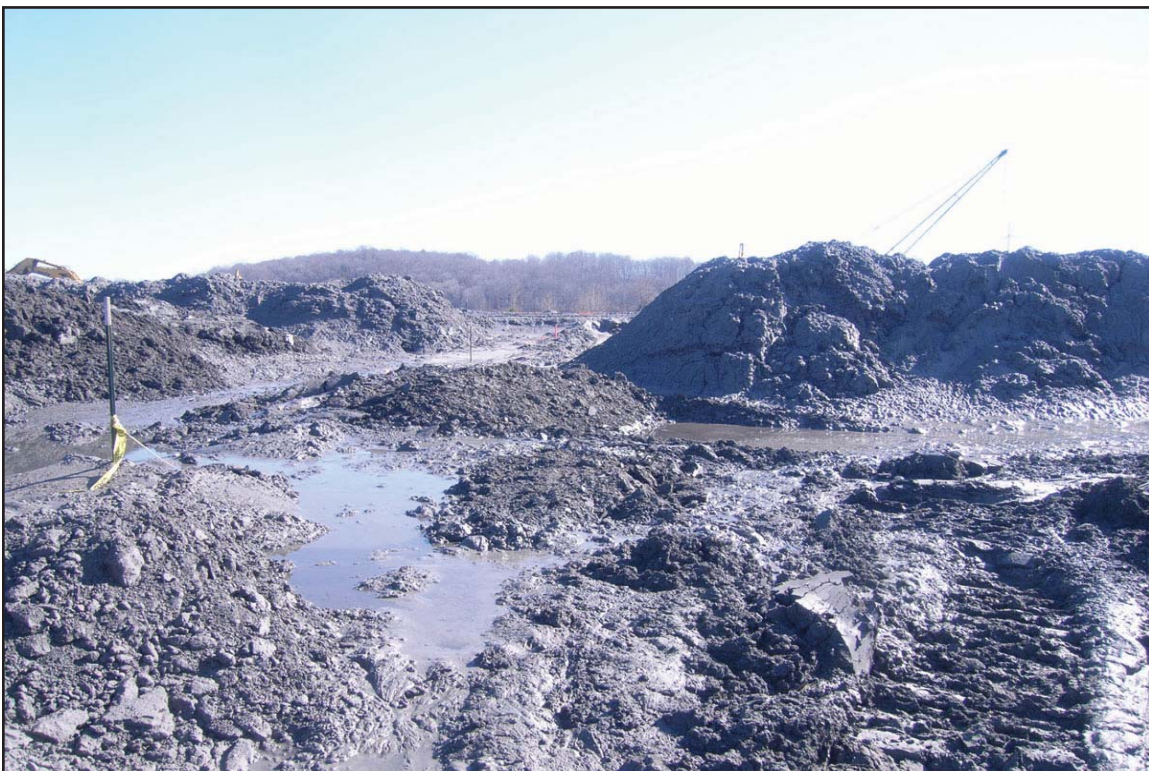
3J - Very wet conditions in Ball Field ash processing area during extended rainy weather.
January 18, 2010.

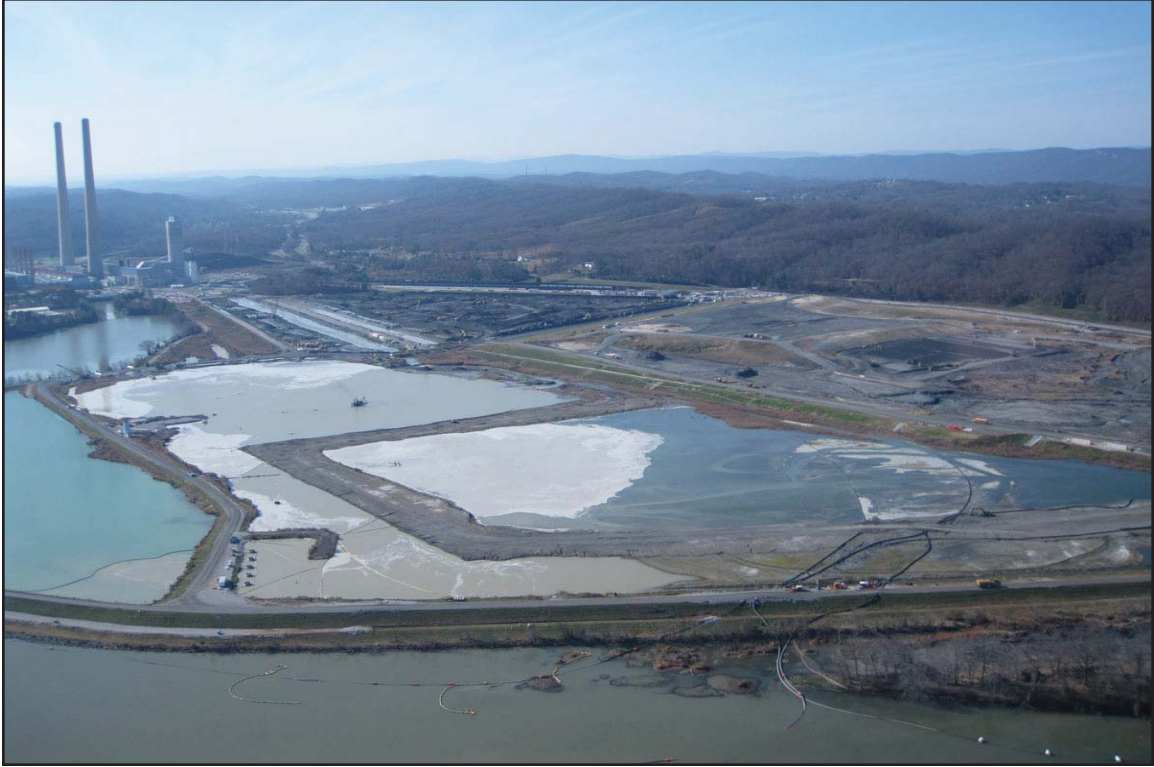
3K - Water treatment in settling ponds, including Ash Pond (top), Stilling Pond (left), and Lateral Expansion (right). November 20, 2009.

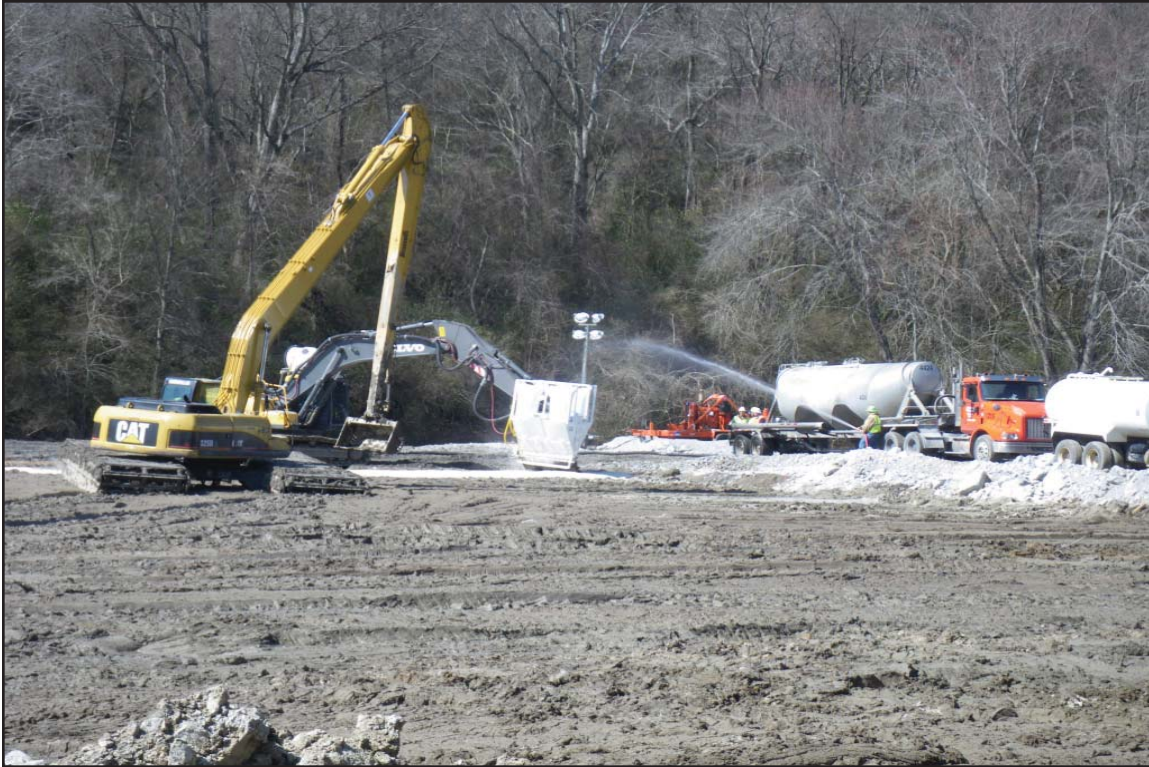
4O - Addition of lime during excavation of East Embayment to reduce moisture content in the ash. March 4, 2010.

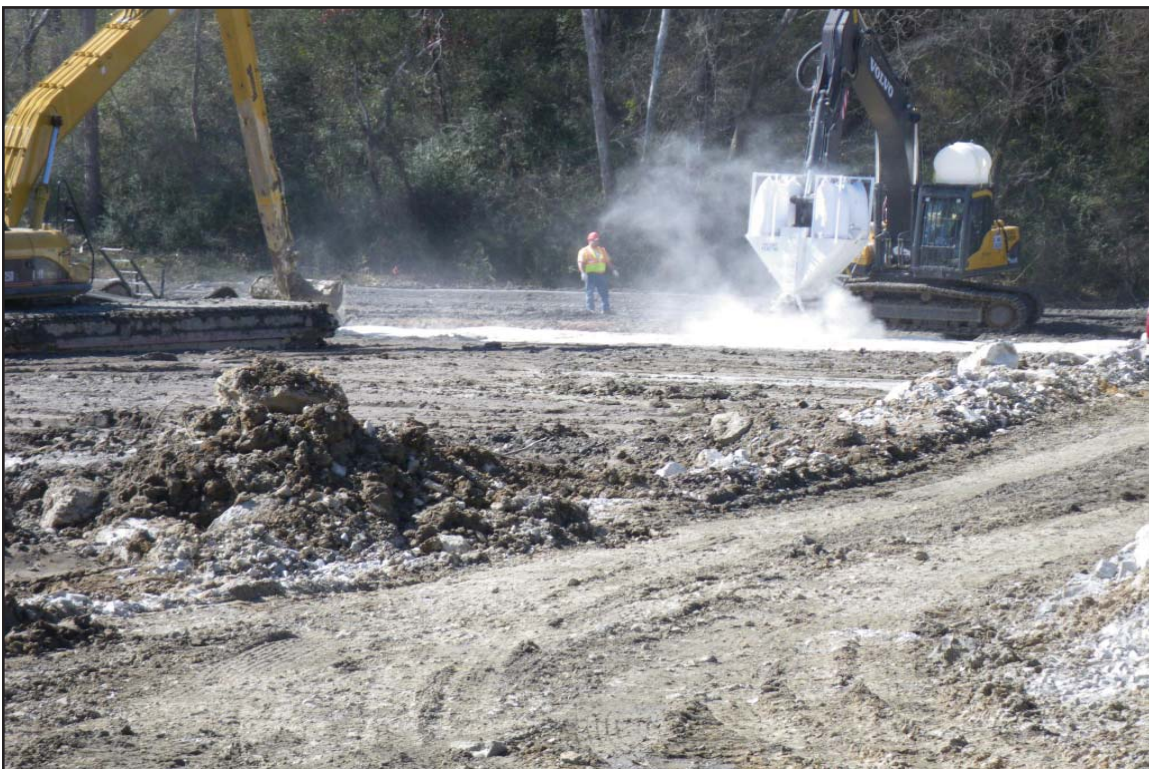
4P - Addition of lime to surface of excavation. March 4, 2010.

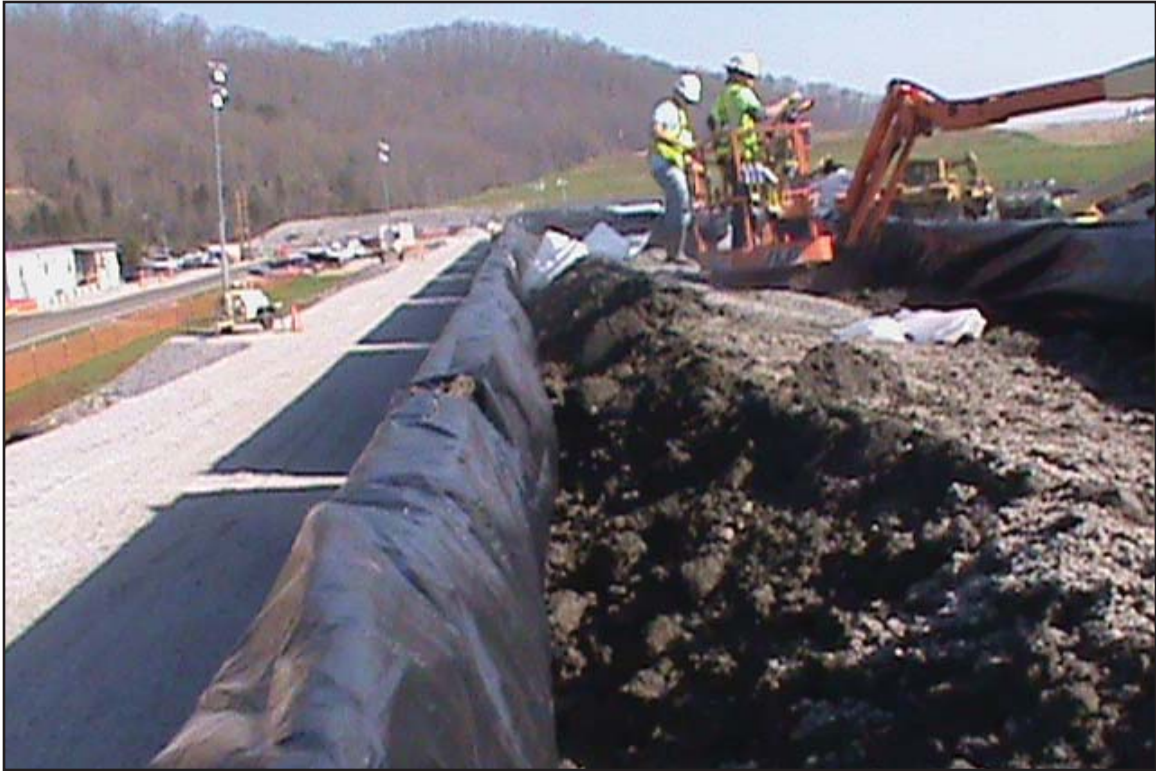
6C - Cherry picker inspecting "burrito bags" in railcars. April 1, 2010.

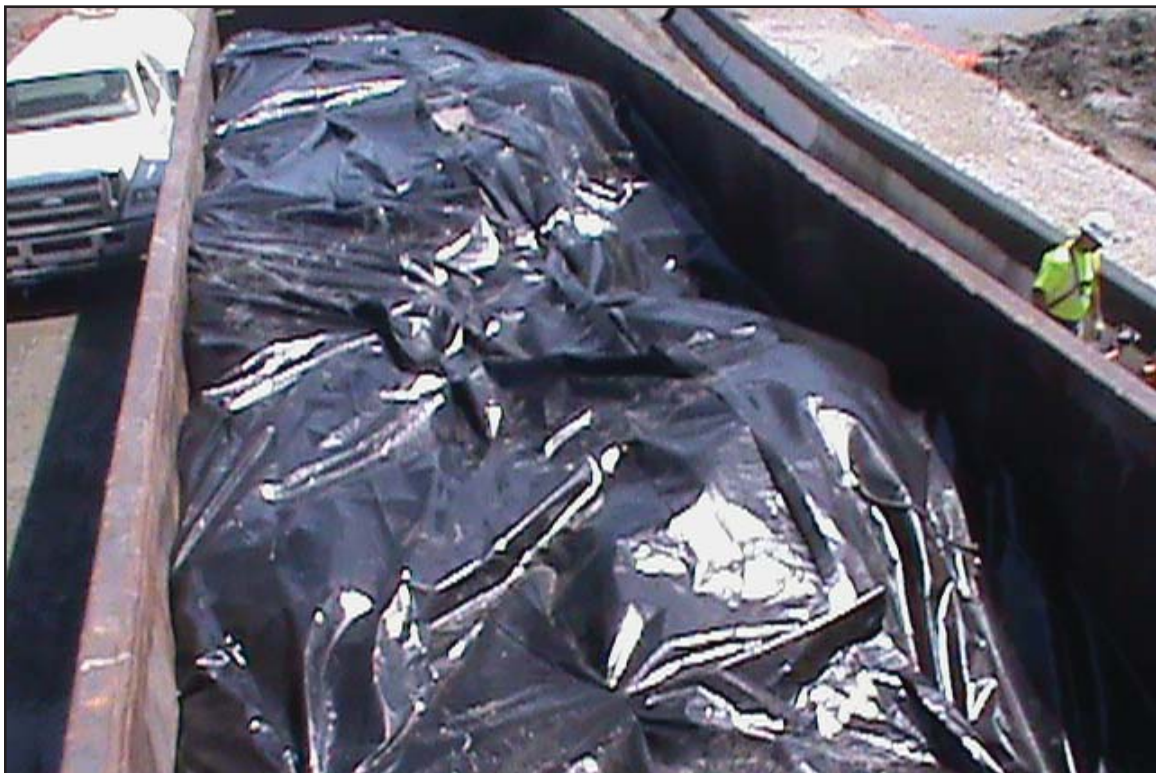
6D - Sealed "burrito bag." April 1, 2010.

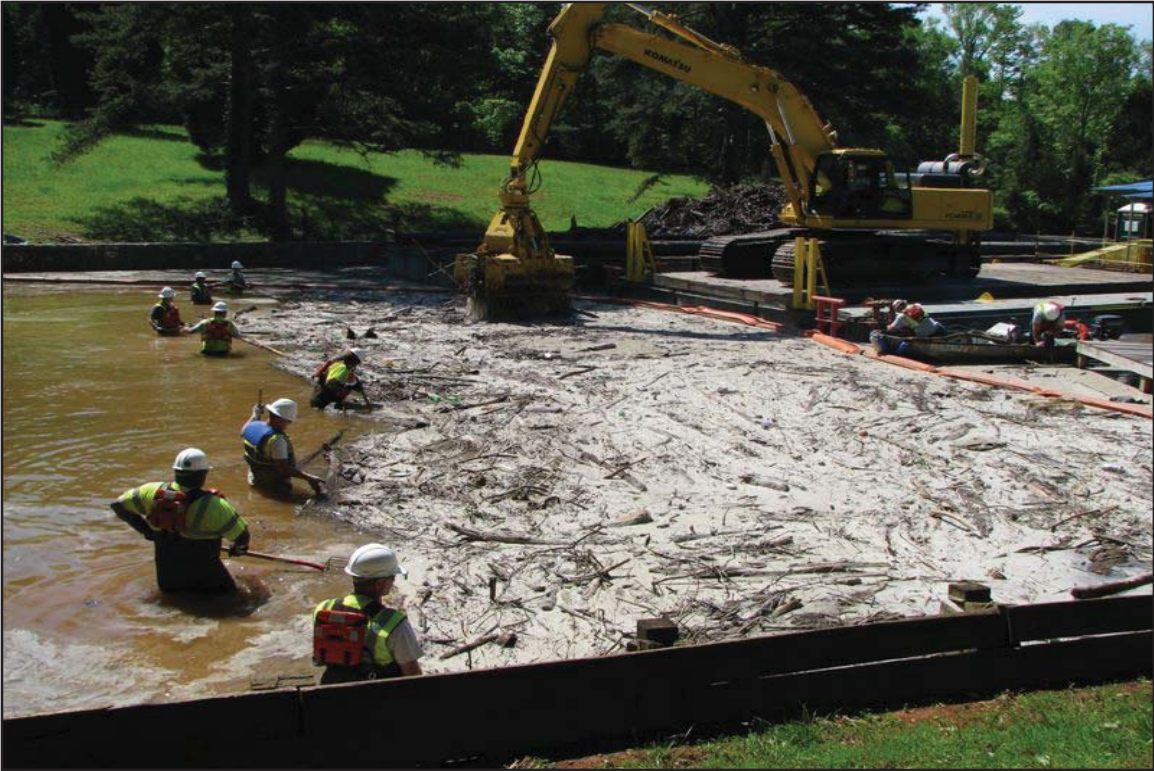
7C - Workers and mechanical excavators used to remove trapped cenospheres and debris from cove. May 11, 2009.

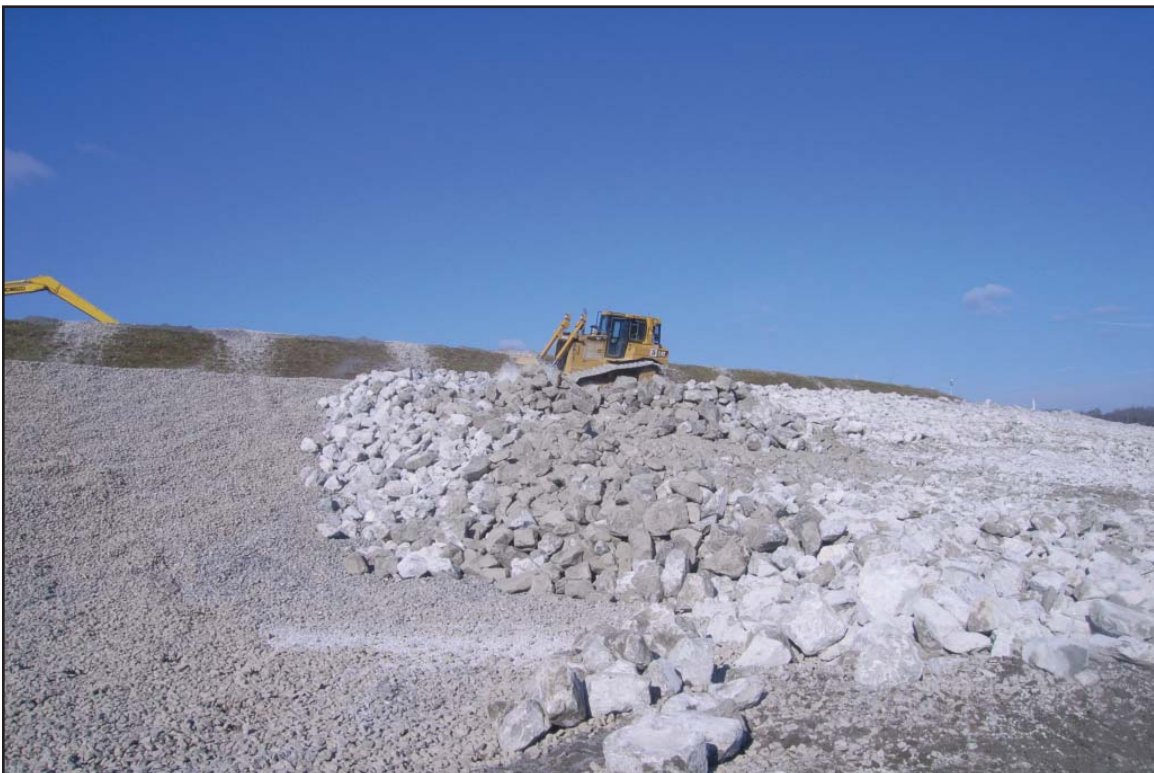
8D - Placing riprap on top of gravel material. December 27, 2009.

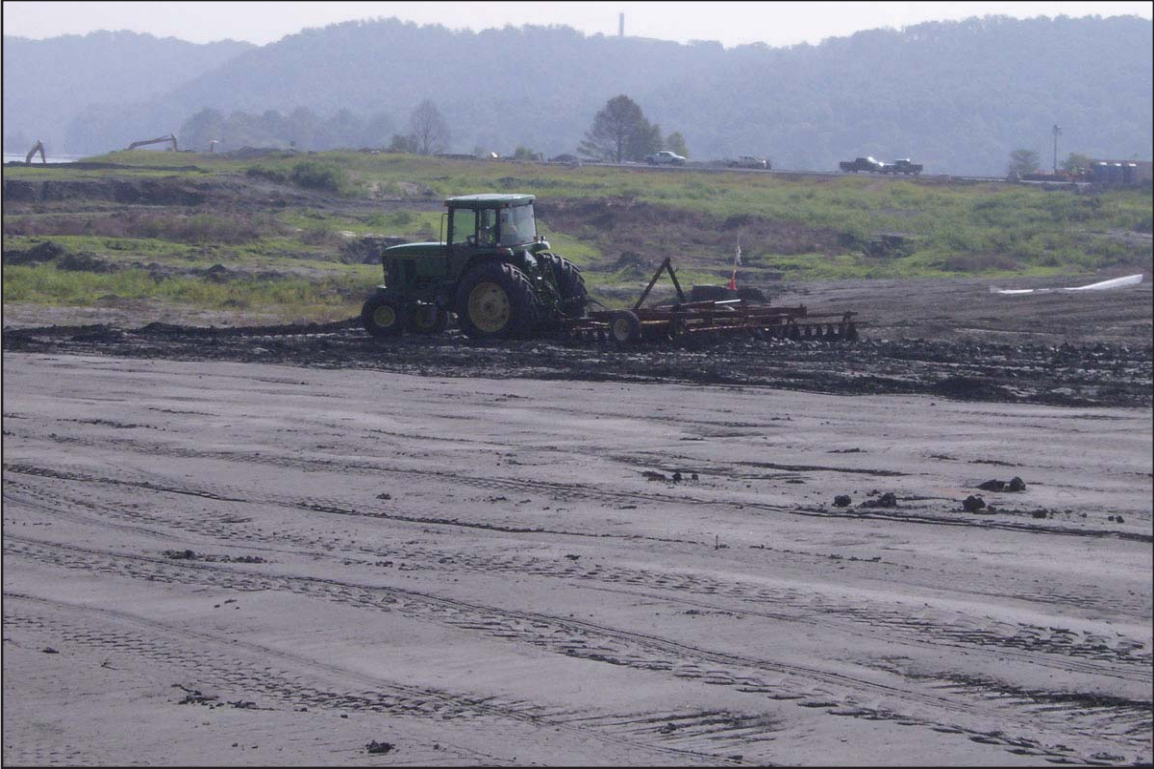
9C - Disking ash in lifts for moisture conditioning. August 14, 2009.

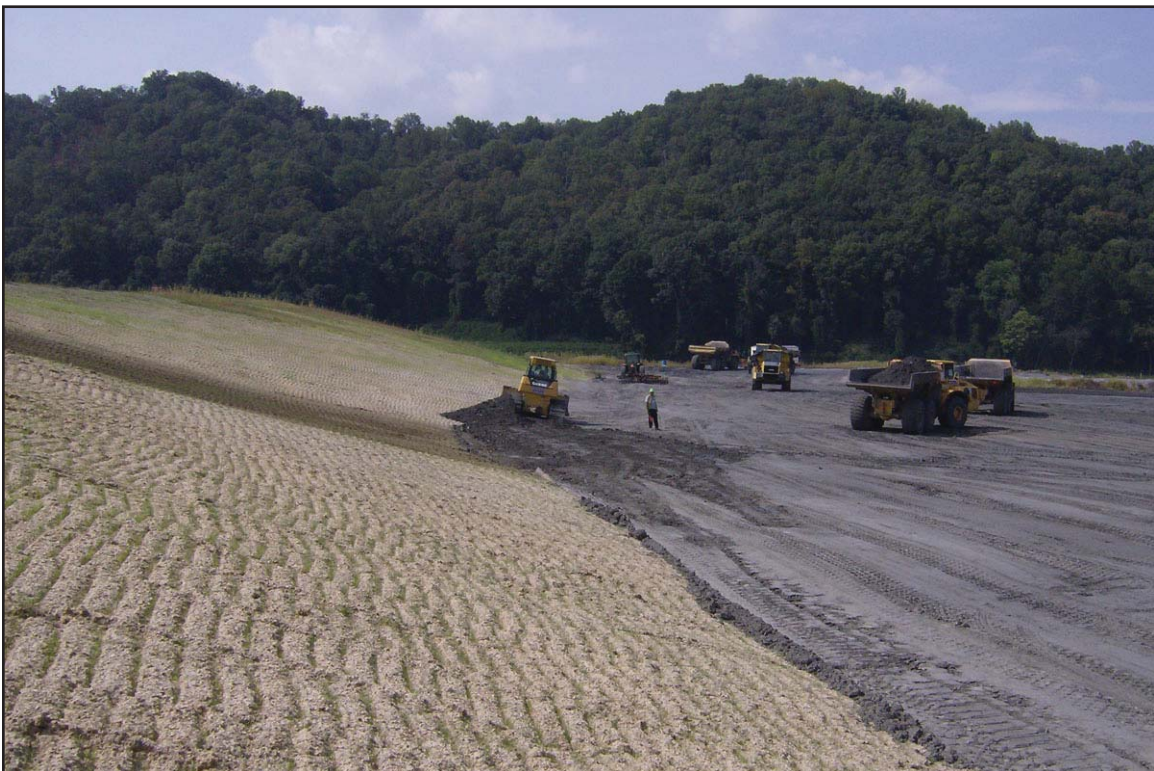
9D - Filling embankment against former relic dike. September 14, 2009.

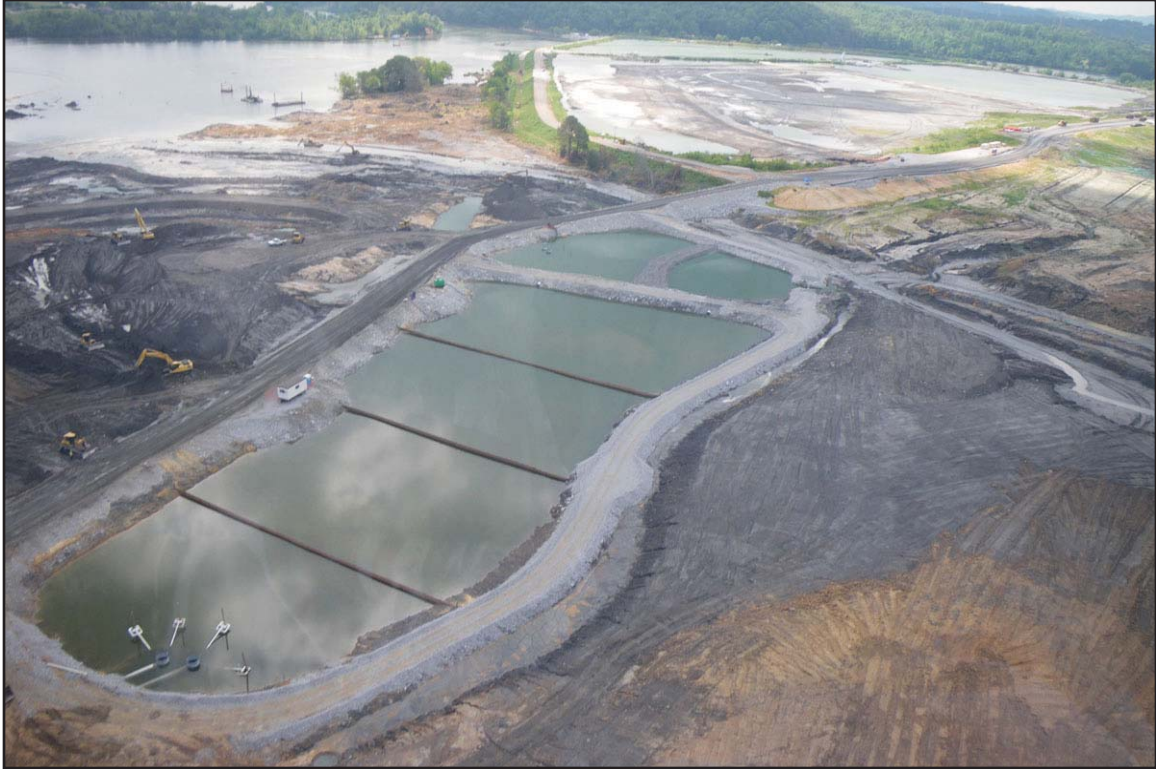
10C - Sediment basins used to settle out ash particles from dirty water ditch stormwater flows. July 2, 2009.

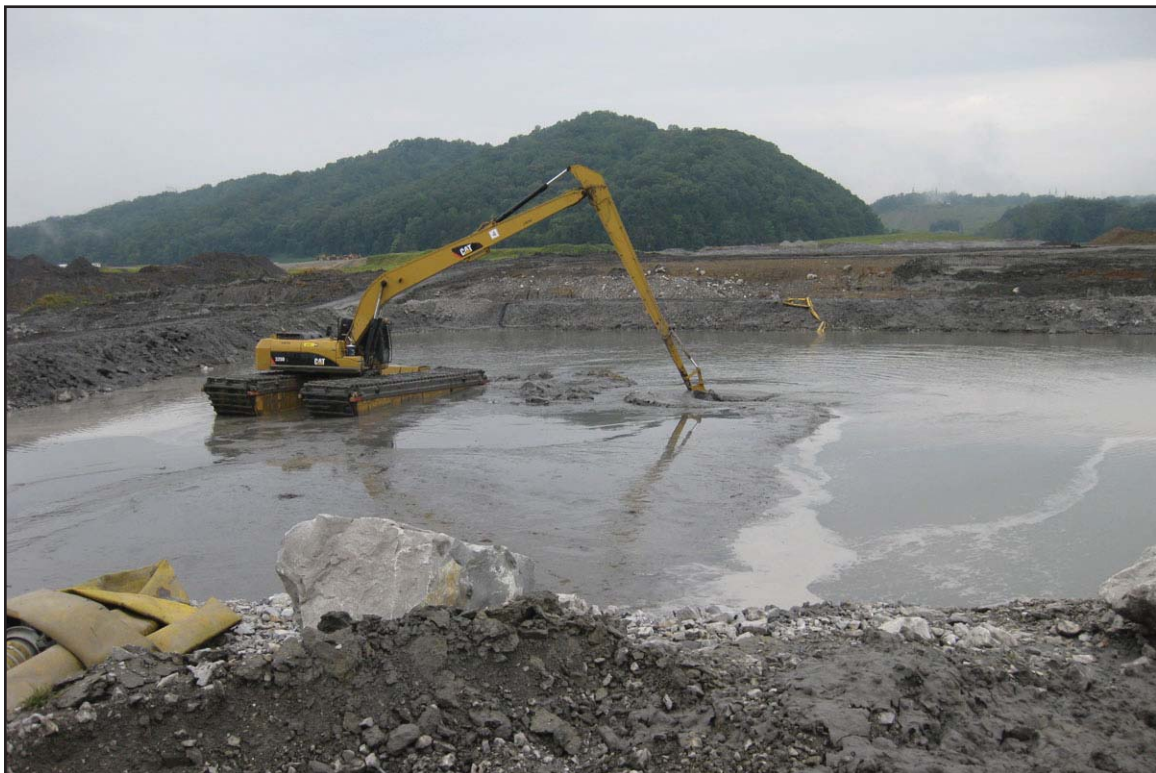
10D - Cleaning out accumulated sediment from the sediment basins. September 4, 2009.

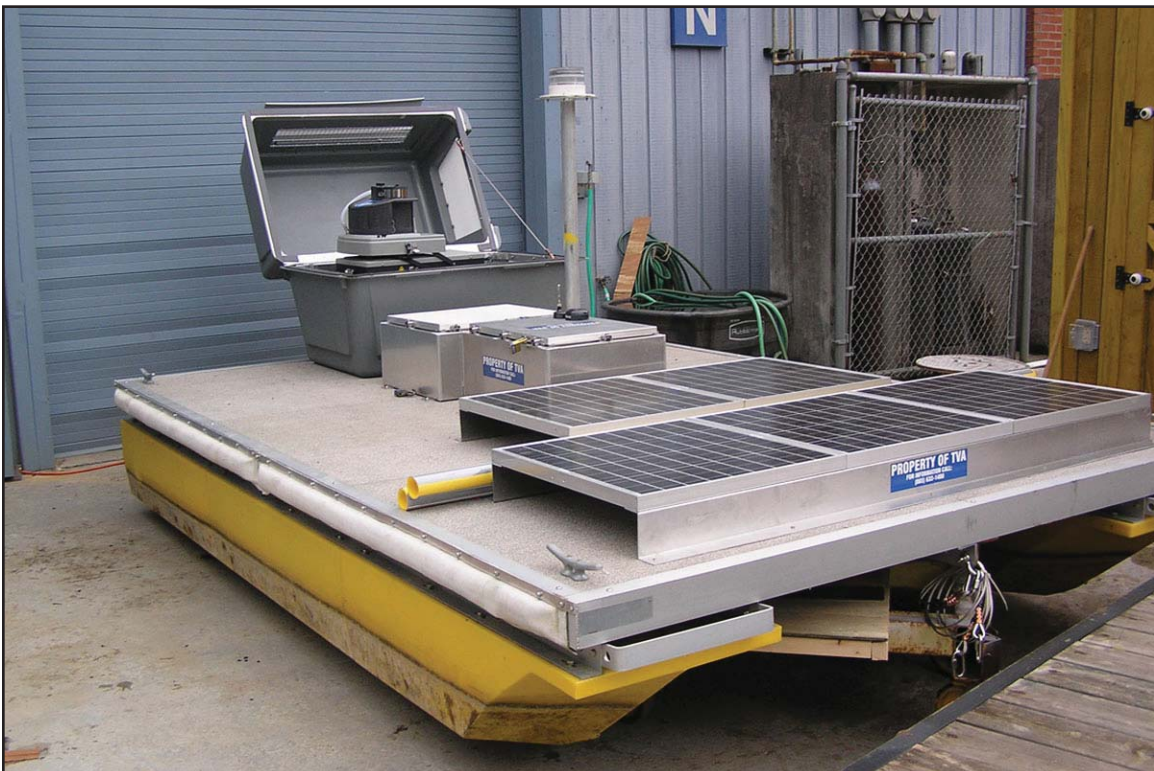
10L - Hydrolab equipment used to collect surface water samples in Watts Bar Reservoir.
December 15, 2009.
