**Event Analysis
Kingston Fossil Plant Ash Deposition Incident September 18, 2009**

Revision: 1

October 20, 2009

Tennessee Valley Authority
Fossil Power Group
Technical Support

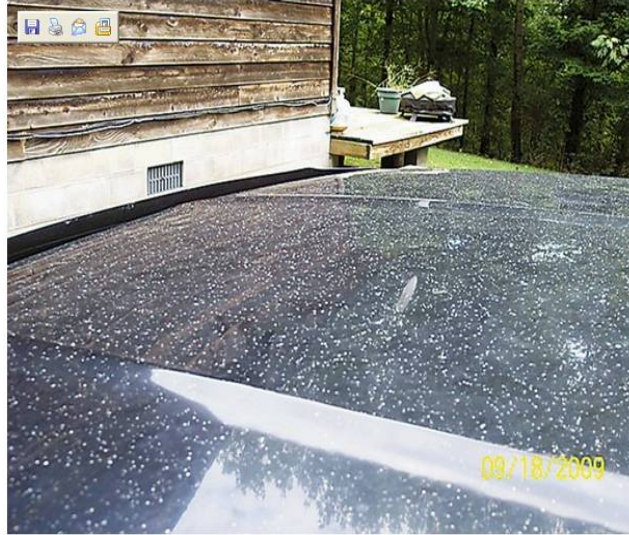
Randy Ellis, vice chairman of the Roane County Community Advisory Group, took this photo of fly ash on a vehicle at his home after TVA test-burned coal Friday at the Kingston Fossil Plant.

Figure 1.1-1 [1] This is the material recorded by a local resident on September 18, 2009. A sample of this material was not collected by TVA's investigation team. However, TDEC did take a sample of the material around 2:30 pm local time. This analysis is given in the appendix.

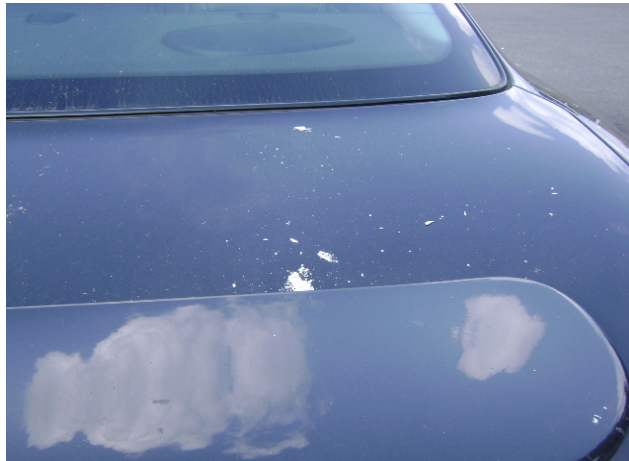
Figure 1.1-2 This is the first material observed during the test burn on September 10, 2009. This material was located on an employee's car in the Kingston Fossil Plant parking lot.

During the investigation, a prior event was discovered in which a flake-like material was found on an employee's car on 9/10/09 but was not reported to TVA management. Therefore, a sample was not collected for analysis. This event is pictured in Figure 1.1-2.

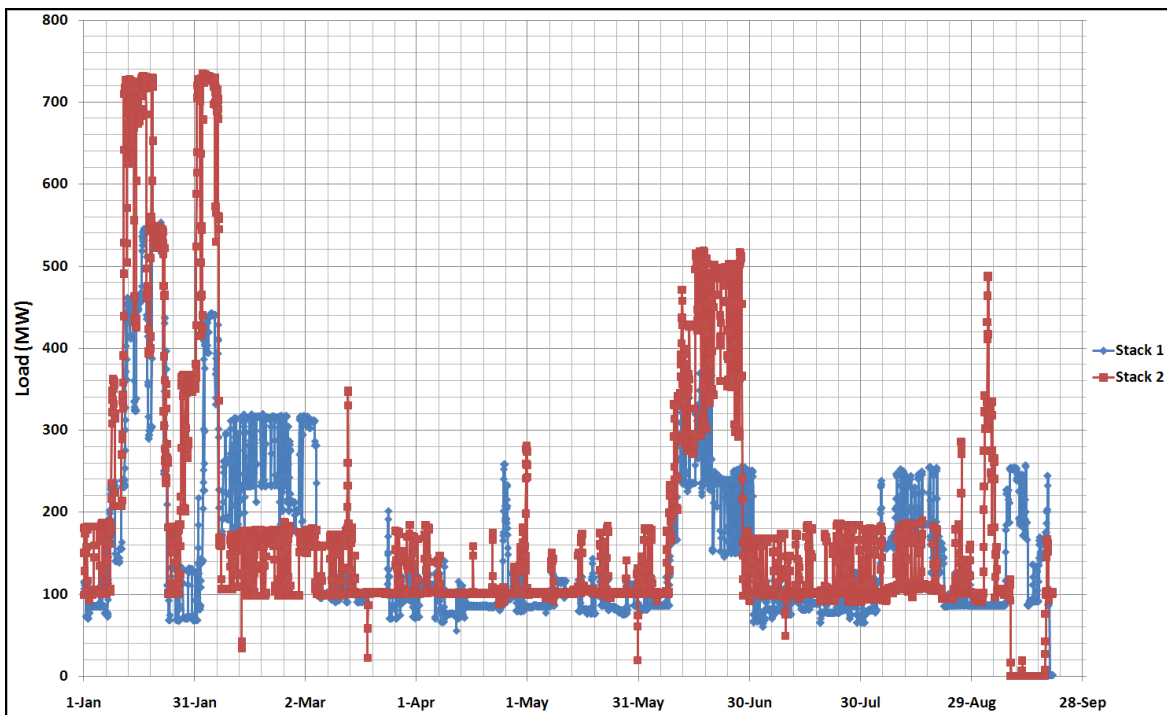
Figure 1.2-1 This graph shows the load for each stack since January 1st, 2009.

Kingston has been operating at lower than historical generation due to the current low demand for generation and impacts from the ash spill. Figure 1.2-1 shows the load generation on each stack for the calendar year. The load on each stack has been limited to one unit except for a few occasions throughout this year.

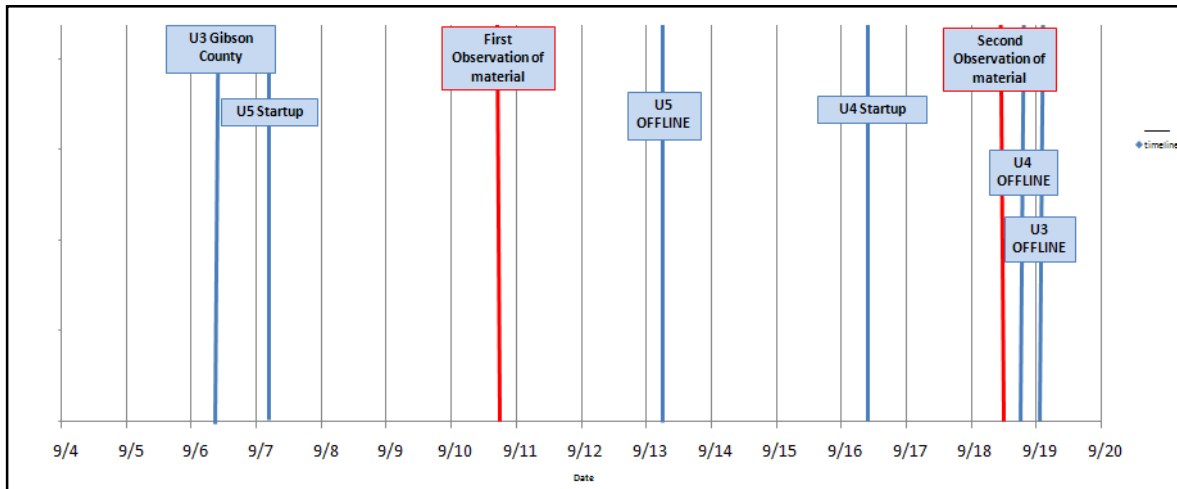
Figure 1.2-2 Timeline of events for Stack 1 during the test burn period.

As discussed earlier, a test burn was being conducted during the event. A timeline was generated and is shown in Figure 1.2-2. As will be discussed later in this document, we have sufficient evidence that the material originated from Stack 1, therefore only Stack 1 events are shown on the timeline. A sequence of events is detailed as follows:

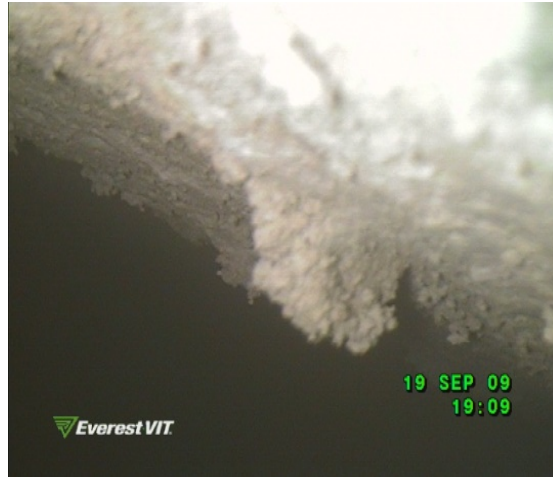
Using a borescope, (see Figure 2.2-1) S1 was initially investigated at the 330 foot elevation (both stacks are approximately 1000 ft tall). During this inspection, it was observed that the stack liner had a 1/8 inch to 1/4 inch thick coating. This same inspection on S2 revealed no such coating.

Figure 2.2-1. This picture was taken with a borescope of S1 at the 330 foot elevation. A similar inspection of S2 showed no such buildup.

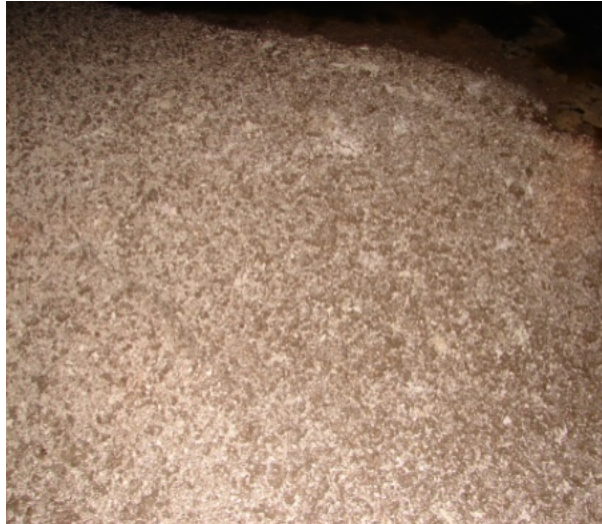
Once S1 was cleared for entry on September 29, 2009, there was evidence of a large amount of material in the bottom of the stack as seen in Figure 2.2-2. During the inspection, flake-like material was found on top of the existing buildup and was falling on inspectors. These flakes appeared similar to the material noticed on September 10th. Another inspection of the top of S1 revealed more deposits as seen in Figure 2.2-3. Prior to the event on September 18th, a similar inspection of S2 was completed as a part of the scrubber project on September 16th, revealing only a minimal amount of material in the bottom of the stack.

FINDING : The investigation focused on S1 due to the overwhelming deposits on the stack liner, bottom, and top of S1.

Figure 2.2-2. This picture was taken at the bottom of S1. The white material is presumed to be the flake material that exited the stack on September 10th and 18th.

The most immediate action for Kingston is to clean the stack and trunk duct to remove all of the buildup. This work is complete. When the units return to service, the stack will be maintained above the SO₃ dewpoint to prevent future condensation within the stack.

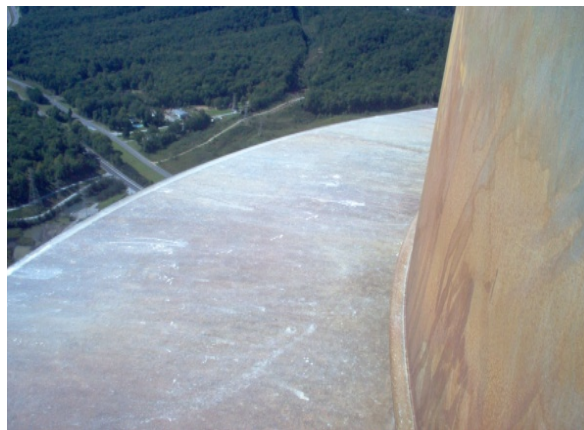
Figure 2.2-3. This picture was taken at the top of S1. Again, white material deposited here is presumed to be the flake material that exited the stack on September 10th and 18th.

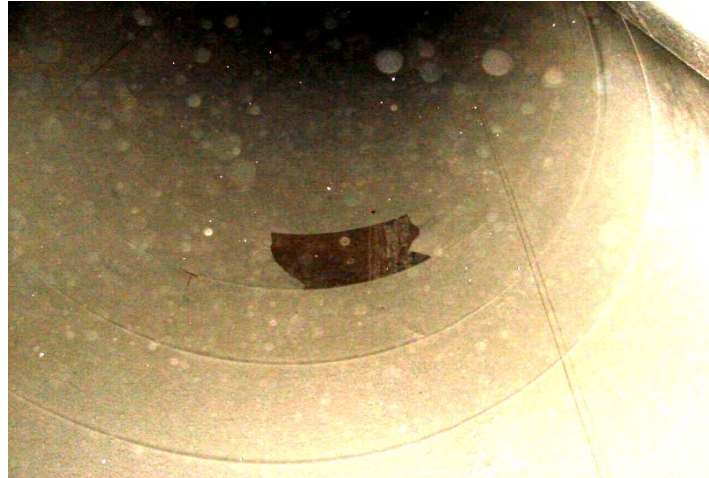
Two separate types of samples were collected during the September 29, 2009 inspection inside the base of S1. One sample was collected from an area of ash buildup as shown in Figure 2.2-4 where an approximate 4'x 8' section had sloughed off the liner inside the stack. The second sample was a lighter/thinner sample of material which was on top of the previously deposited material and was similar to material that was still falling during the inspection. Figure 2.2-5 shows the differences in appearance between the two materials. The material which had fallen off the side of the stack liner was about 1/8" thick and was hard and dense. The flake-like material was thin, light, and friable. Analysis of the two materials indicated both to be primarily fly ash with higher than normal amounts of sulfates. When compared to ash samples from the precipitators, which are typically about 95 percent ash and about 3 percent sulfates, the stack material was about 75 percent ash and had sulfate levels of about 23-29 percent sulfates. The stack material samples had an

Figure 2.2-4. Inside of stack 1 approximately 30 ft from the bottom. The dark brown area exposes the liner where a 4ft x 8ft section of buildup had fallen off.

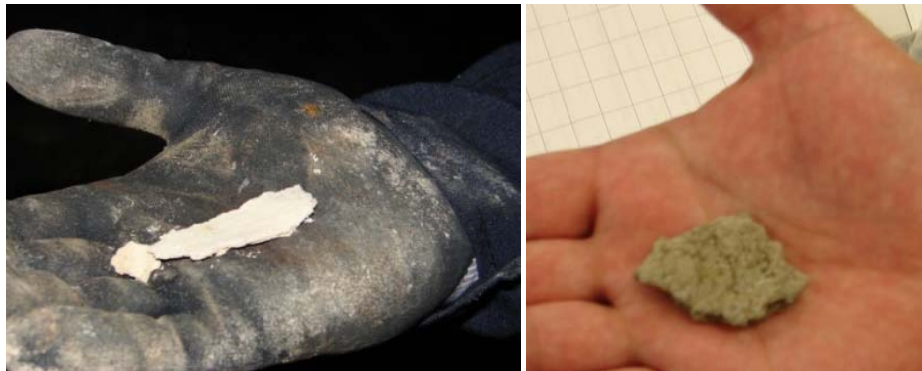
Figure 2.2-5. This is a picture of the two types of material found on the stack liner and on the stack floor. The material on the left is the light friable material while the picture on the right is the more dense buildup.

FINDING : There are two physically distinct materials found in S1. One material was light and friable and resembled the material reported in the events.

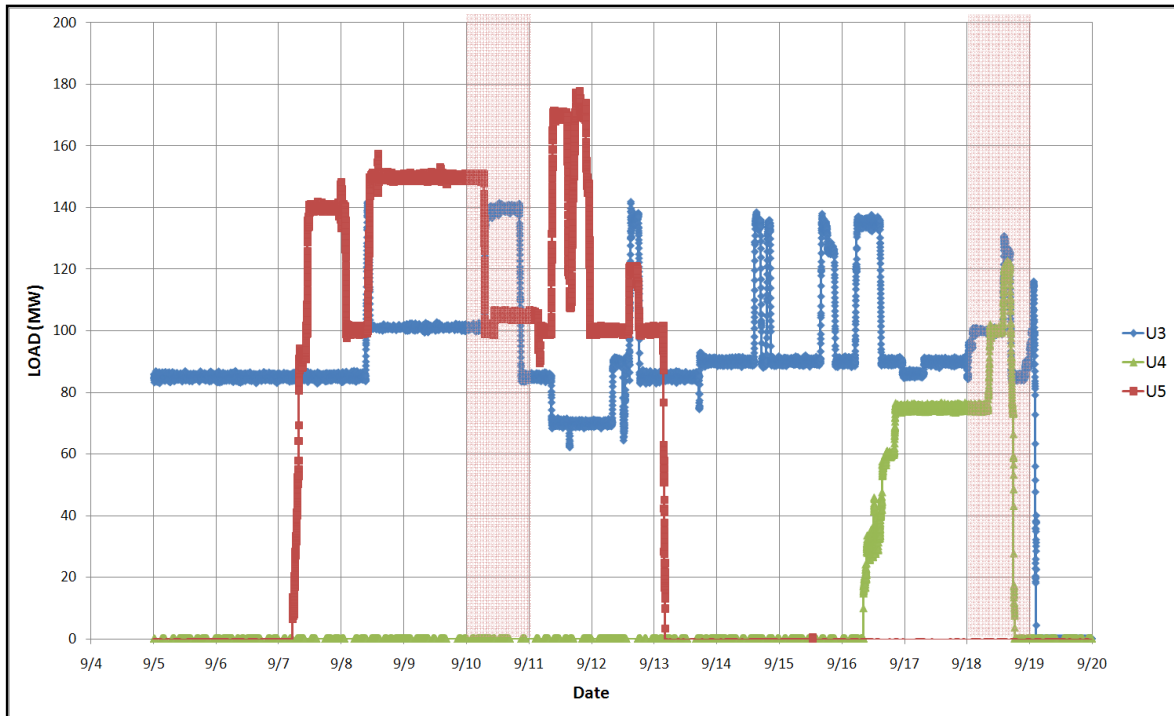
As seen in Figures 2.3.1-1 and 2.3.1-2, ammonia injection spikes during load changes. During load changes the ammonia flow control logic is not adequate to maintain reasonable ammonia levels. This likely causes the ammonia slip to temporarily be in excess of 2 ppm. The samples collected on S1's liner and bottom contained ammonia, most likely in the form of ammonium sulfate and/or ammonium bisulfate. Samples

Figure 2.3.1-1 Load changes on Stack 1 during the week of the test burn.

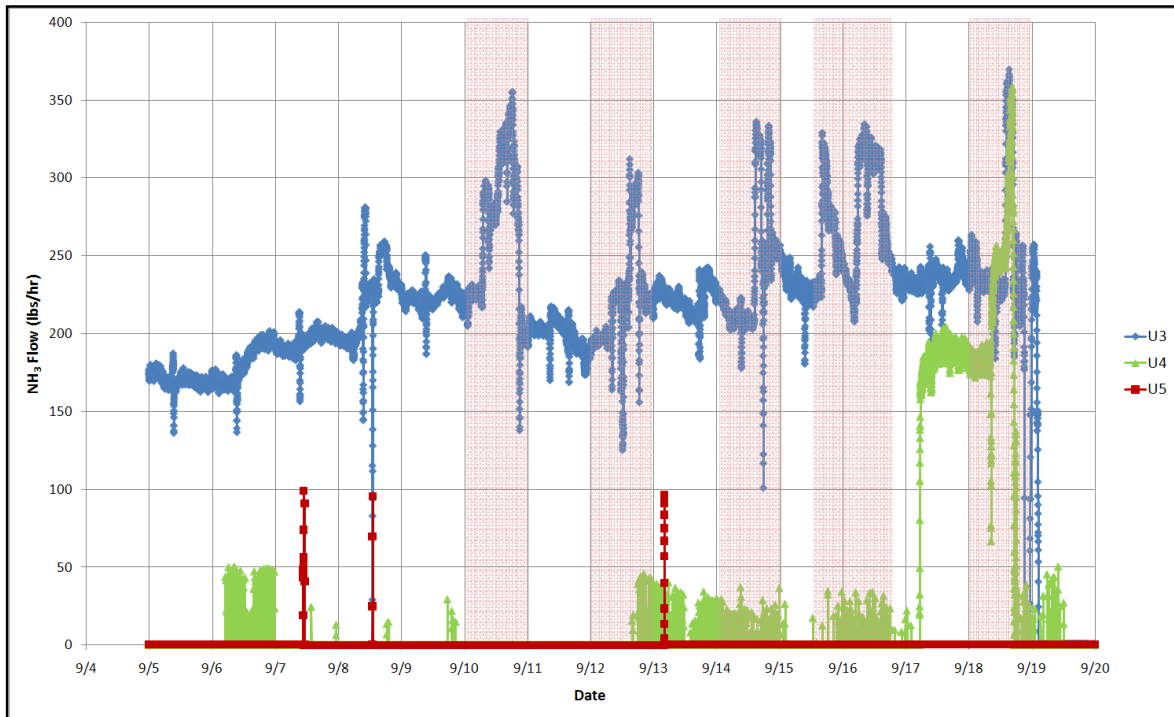
Figure 2.3.1-2 Ammonia injection on units 3-5 during the week of the test burn. Suspected events are shown in the shaded areas.

As seen in Figure 2.3.1-2, there were five events that are highlighted on the 10th, 12th, 14th, 16th-17th, and 18th, that resulted in ABS and AS formation. The ABS and AS formed on these days may have adhered to the stack liner or exited the stack if they weren't collected by the PPTRs or were formed downstream of the precipitators.

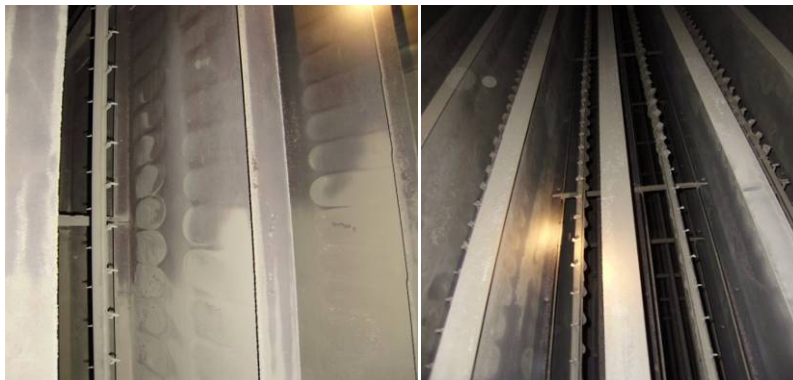
Figure 2.3.1-3 shows the inside of the PPTR which was relatively clean upon inspection. Upon further inspection of data collected by the PPTR's with regard to performance, there did not appear to be any malfunction that would cause excessive emission of particulates during the events on the 10th and 18th.

Figure 2.3.1-3 Unit 3's and 4's PPTR plates and electrodes

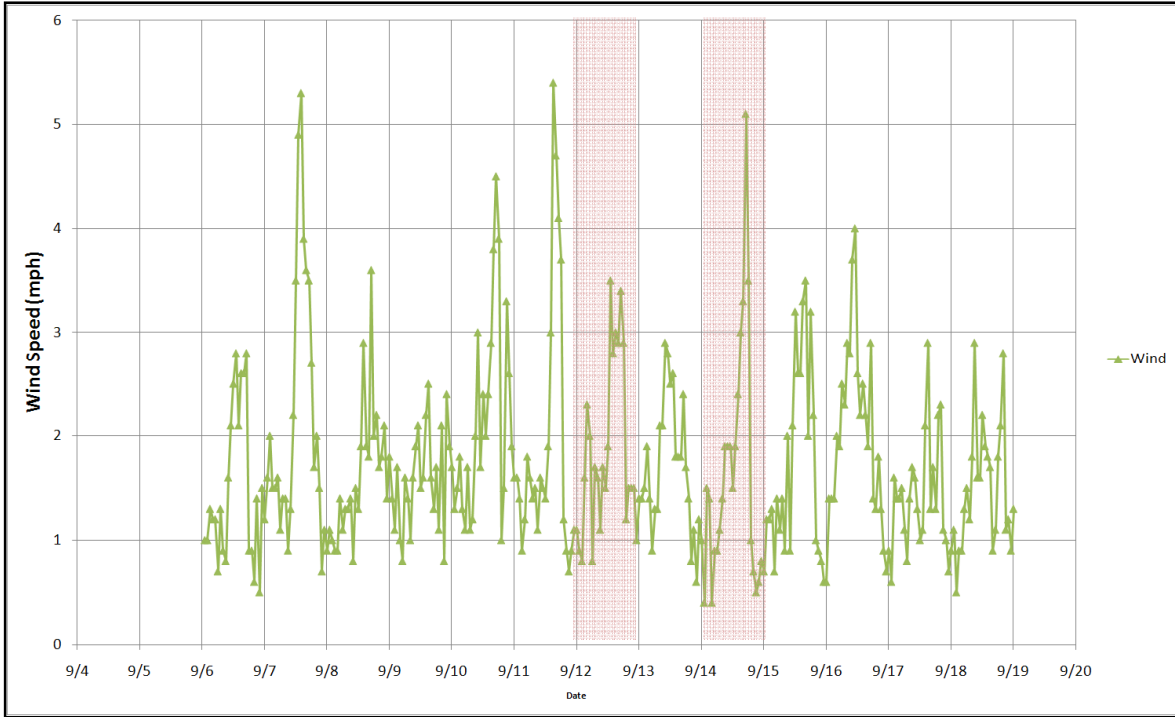
The ammonia slip events on the 10th and 18th correlate to the reported observations of material leaving the Kingston stack. No incidents were reported on the days of the other three ammonia slip events, and it is believed that the weather (wind and rain) masked these events. As seen in Figures 2.3.1-4 and 2.3.1-5, there were prevailing winds and rain on those three events.

Figure 2.3.1-4 Winds on the 12th and 14th likely masked the suspected emissions.

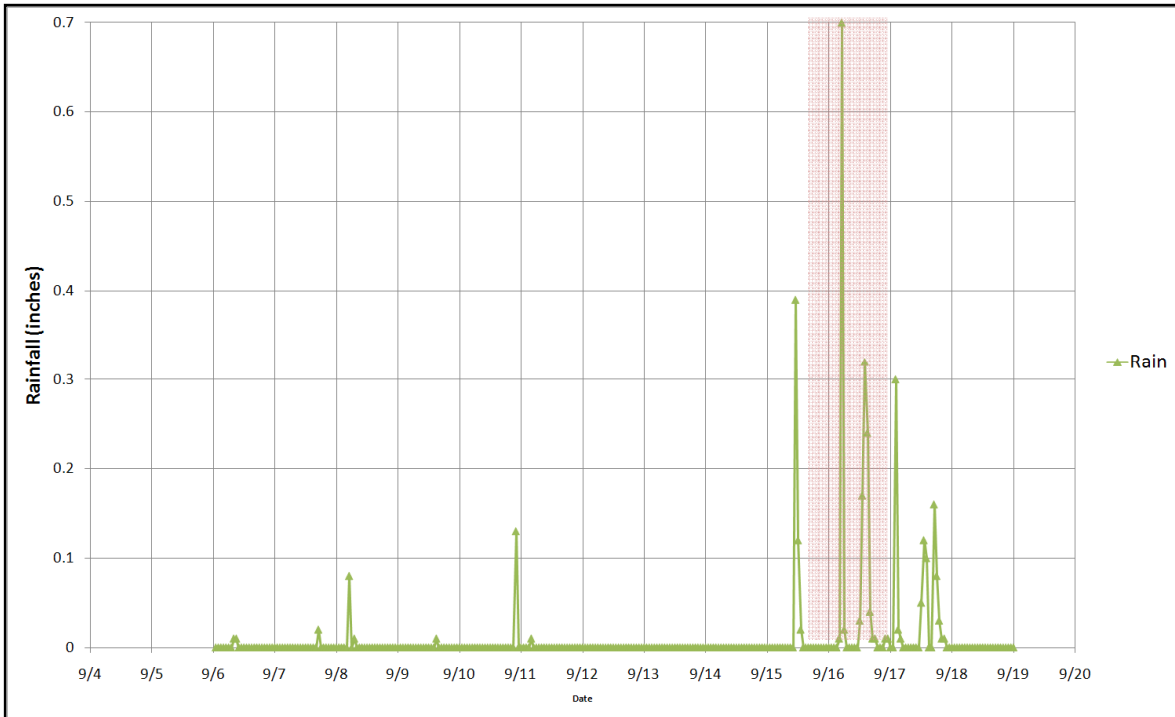
Figure 2.3.1-5 Rain on the 16th - 17th likely masked the other suspected emissions.

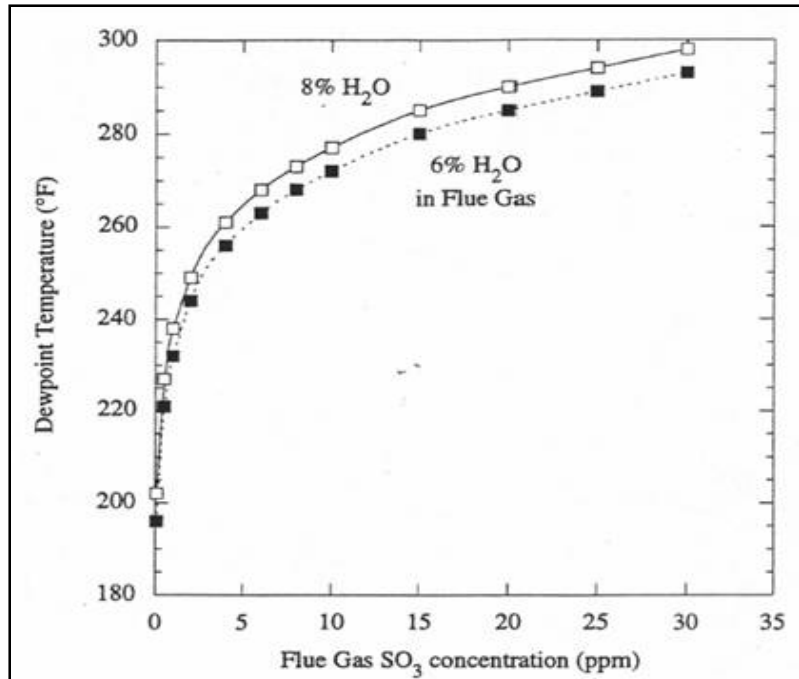
As stated in the previous section, the SCR catalyst will oxidize a percentage of the SO_2 to SO_3 . There is a relationship between SO_3 concentrations and temperature commonly referred to as the dew point temperature (see Figure 2.3.2-1). As the gas temperature drops the SO_3 in the gas will condense. When it condenses it will either condense on fly ash particles or it will self nucleate as an aerosol. The aerosol particles and the fly ash particles with the condensed sulfates would tend to stick to internal surfaces (duct and stack liner). The condensed SO_3 would be a source of sulfated ash.

Figure 2.3.2-1 [2]. The dewpoint temperature of SO_3 increases as the concentration of SO_3 in the flue gas increases.

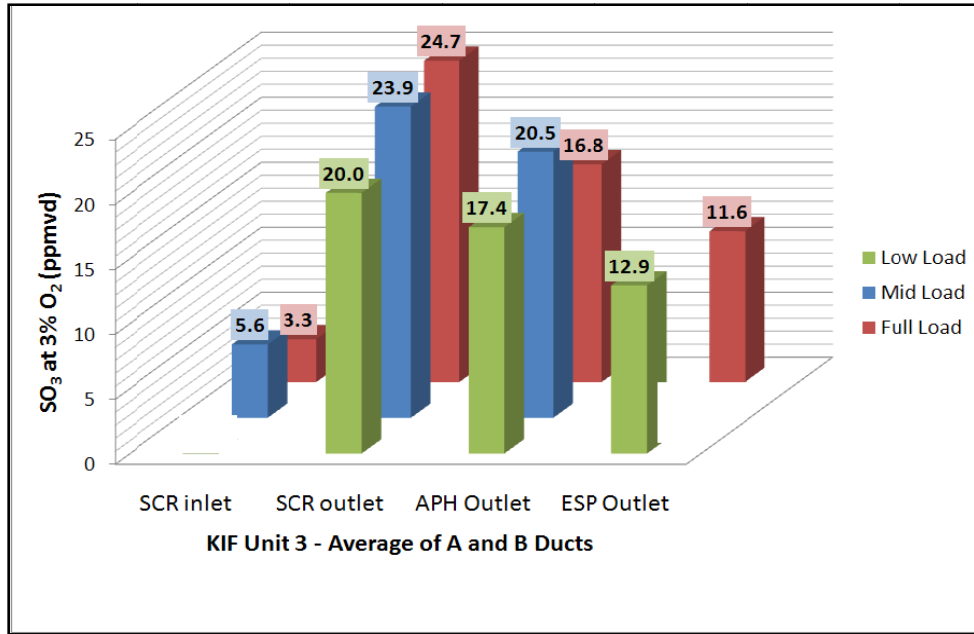
The analysis of the material indicated higher levels of sulfates (22% - 29%) than typical fly ash (2% - 3%). This increase in sulfates is most probably formed by a combination of the higher than normal sulfur trioxide concentration by burning the higher sulfur fuel and the lower than normal duct and stack temperatures. Sulfur trioxide levels were measured at the PPTR outlet of unit 3 during the higher sulfur test burn at concentrations of 13 ppm, as shown in Figure 2.3.2-2.

Figure 2.3.2-2. Unit 3 SO₃ Data Collected During Coal Test Burn

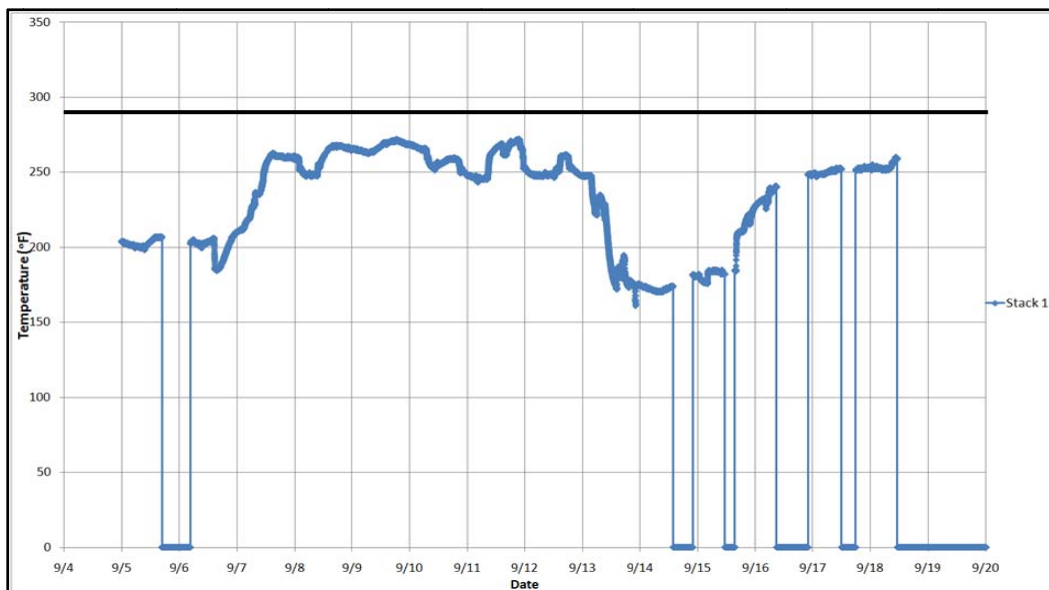
The dew point (the temperature which the material will condense) at this SO₃ concentration is about 285 F. The actual stack temperature was about 250 F during the test burn as shown in Figure 2.3.2-3. Air infiltration from offline units mixing with flue gas from the operating unit(s) cooled the flue gas in the stack liner below the SO₃ dew point. This lower temperature would cause a significant amount of sulfur trioxide to condense into a liquid aerosol or condense on fly ash particles as detailed in Figure 2.3.2-4.

Figure 2.3.2-3 The black line represents the approximate dewpoint temperature during the test burn. The blue line represents the actual stack temperature. As seen in the graph, the stack temperature was below the dewpoint of SO₃ for the duration of the test burn.

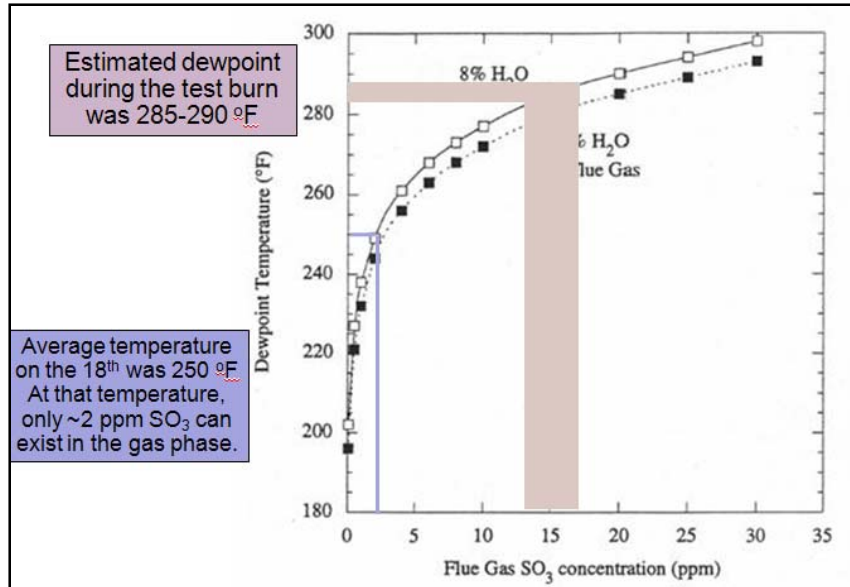
Figure 2.3.2-4 Estimated Dewpoint During Test Burn
