Fleet Study of Brake Performance and Tire Pressure Sensors

**U.S. Department of Transportation
Federal Motor Carrier Safety Administration**

July 2009

1. Report No. FMCSA-PSV-09-001	2. Government Accession No.	3. Recipient's Catalog No.	
4. Title and Subtitle Fleet Study of Brake Performance and Tire Pressure Sensors		5. Report Date July 2009

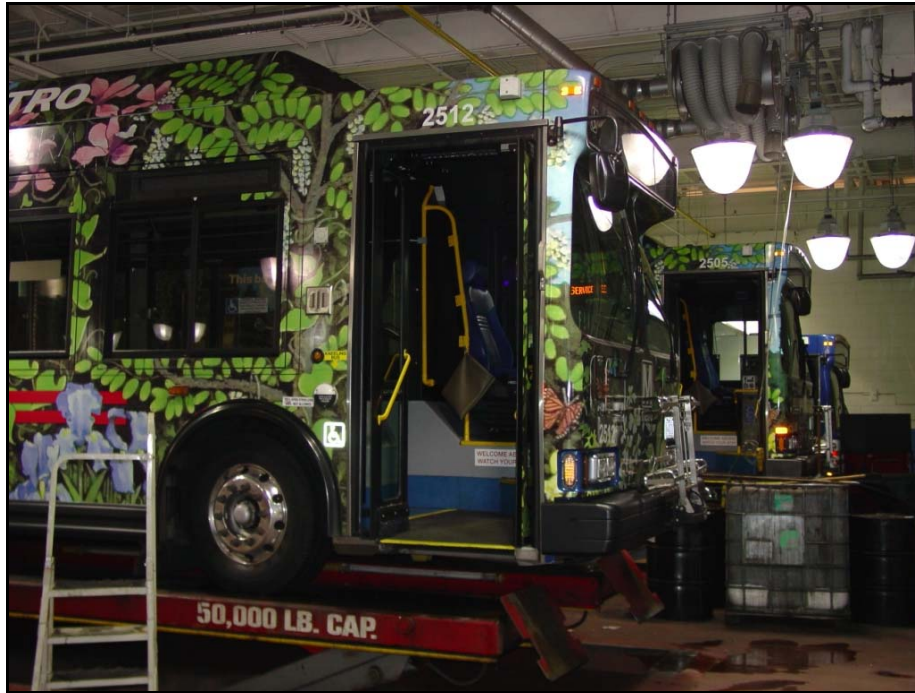
Buses were driven to an area that WMATA had designated for study activities and inspected individually. Figure 1 shows several test buses undergoing weekly program inspections.

Figure 1. Buses on Lifts During an Inspection

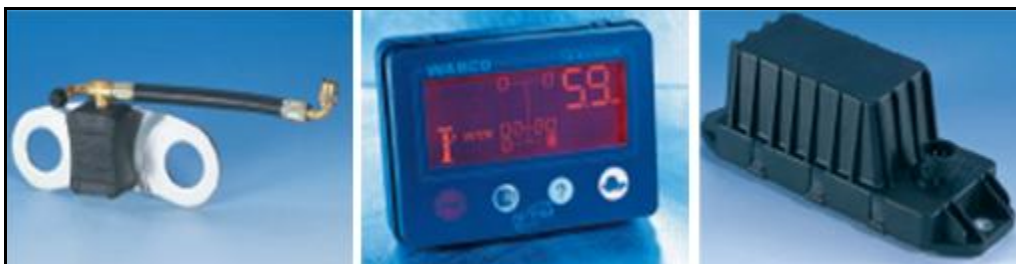
- Tire pressure sensor wheel module (left).
- Display unit (center).
- ECU (right).

Figure 3. WABCO IVTM Components

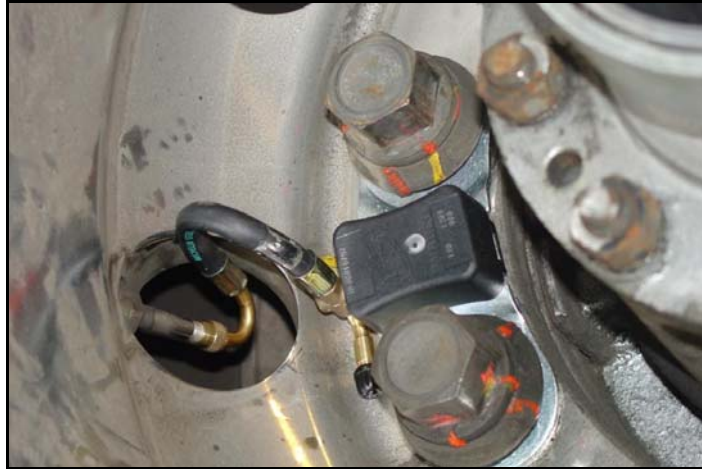
Each tire and wheel assembly is equipped with a sensor unit which contains a pressure transducer and a transmitter. Power for the sensor unit is supplied from a built-in lithium battery with a 5-year service life. The sensor unit is secured to the wheel rim at a location adjacent to the valve stem using the two closest lug nuts. A pneumatic hose runs between the sensor and valve stem (Figure 4).

Figure 4. WABCO IVTM Sensor Unit Mounting

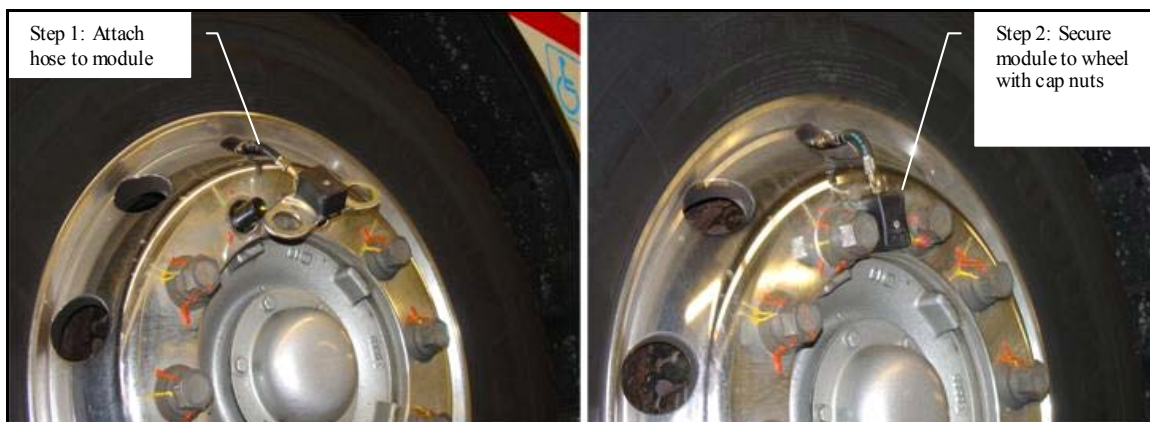
To install the sensor unit, the pneumatic hose should first be connected to the sensor module and then connected to the tire’s valve stem. With the hose already connected to the valve stem, the sensor unit can be slipped over the wheel lugs and secured in place with the cap nuts. Attaching the sensor unit to the valve stem with the short hose before securing it to the wheel proved to be the quickest way to mount the wheel module to the steer tires. Figure 6 illustrates the wheel module installation process on a steer tire.

Figure 6. Wheel Module Installation on a Steer Tire

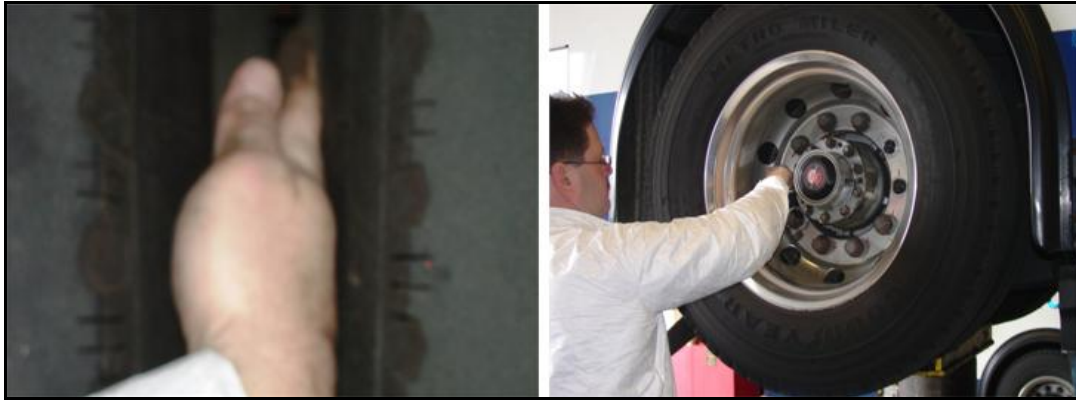
To create access to the inner tire's valve stem, WABCO recommends loosening all 10 cap nuts on the outer rear wheel and removing only the two cap nuts nearest the valve stem on each tire. Loosening all of the cap nuts allowed the outer wheel to separate from the inner wheel. This creates a gap wide enough to reach a hand in-between the inner and outer rear tires without having to remove a wheel from the bus. Figure 7 shows the tight gap between dual tires and the cap nuts being loosened and removed from the rear wheel lugs.

Figure 7. Wheel Gap and Cap Nut Removal on a Rear Wheel

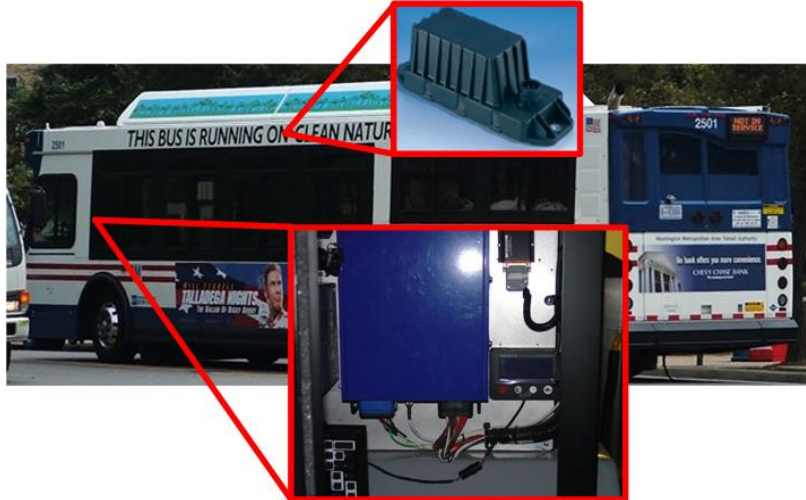
The IVTM ECU and display were both installed inside the bus's passenger compartment and hidden from view of the driver and passengers. Figure 8 illustrates the mounting locations for the ECU and the display unit. The ECU was mounted to a support beam above the lighting track on the street side of the bus. The ECU mounting location is hidden behind an access panel. It was important to install the system's ECU in a location near the center of the bus to enable the best possible signal reception broadcast from the sensor modules at the wheel ends. The ECU was electrically protected by a 5-ampere circuit breaker and hardwired to a terminal strip in the I/O cabinet located behind the driver's seat.

Figure 8. WABCO ECU and Display Unit Locations

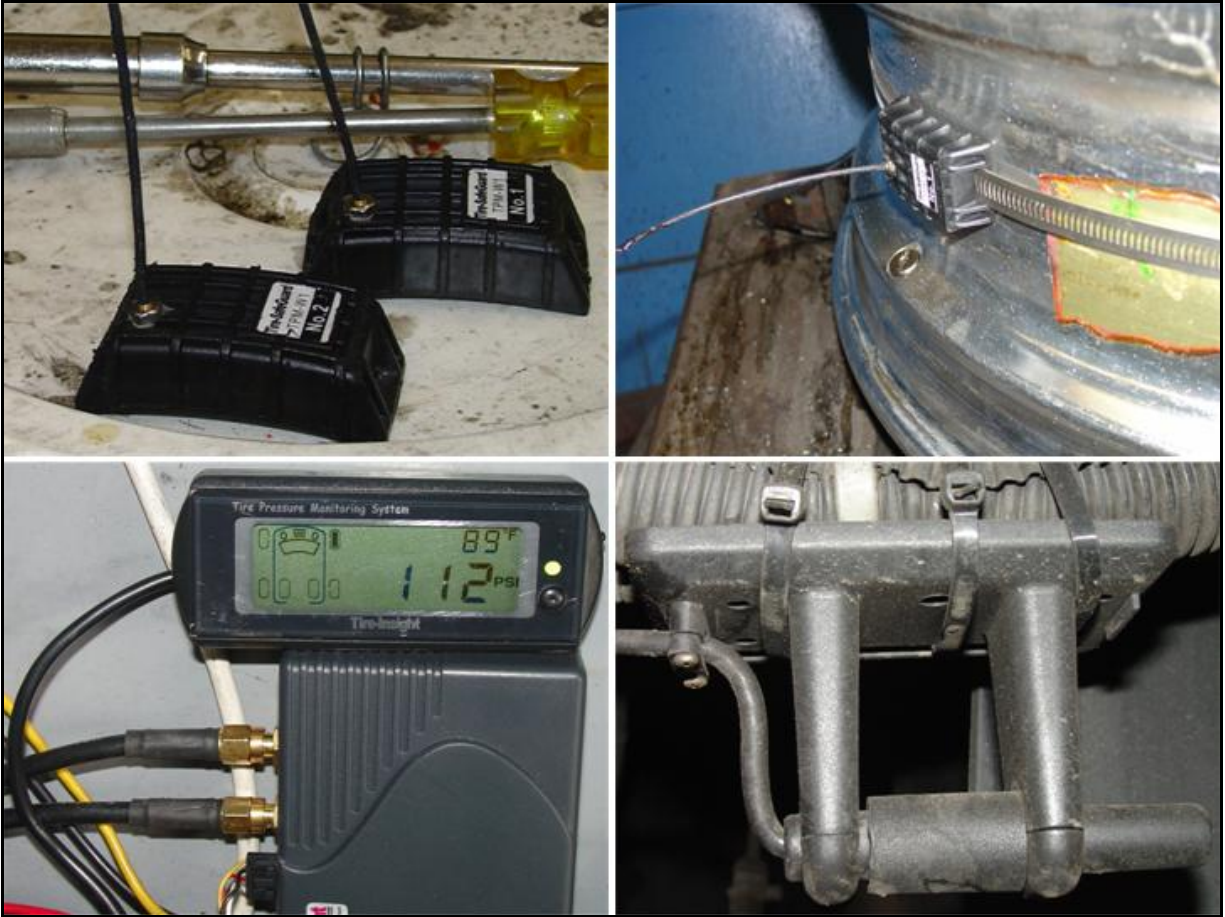
Figure 10 shows two wheel modules (top left), a wheel module secured to a wheel by a hose clamp (top right), the ECU and display unit (bottom left), and one of three antennas (bottom right).

Figure 10. HCl Tire-SafeGuard Components

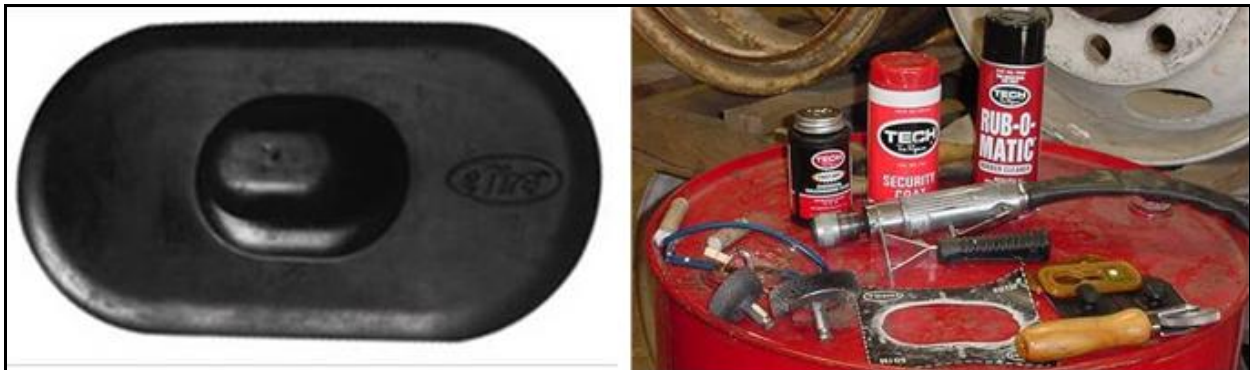
SensorDock. The sensor unit attaches to the truck tire inner sidewall using a docking type station called the SensorDock, (Figure 14, left). The SensorDock, which itself is molded rubber, attached to the inside sidewall through a chemical curing process similar to the process used to repair tires. The eTire kit includes a variety of tools and adhesives to attach the SensorDock to the tire, (Figure 14, right).

Figure 14. eTire SensorDock and Installation Kit

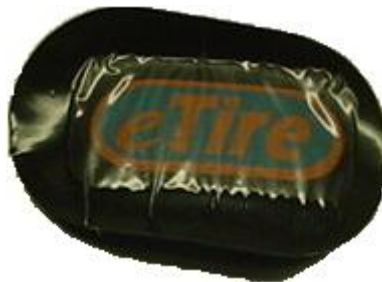
eTire Location Label. The eTire sensors are read (or queried) using external transceivers (see next section). The handheld reader requires the operator to wave the device over the exact location of the sensor. Michelin has made finding the location of the sensor easier by providing an eTire label that is installed on the outside of the tire at the location of the eTire sensor, (see Figure 15)

Figure 15. eTire Location Label

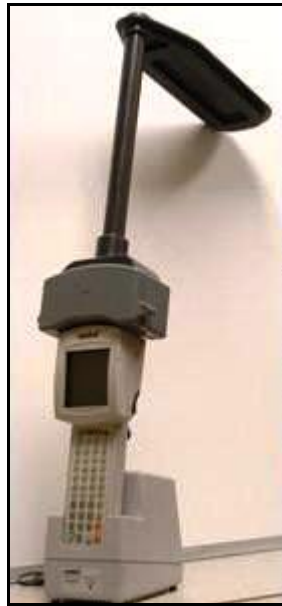
Tag Readers. Two options are available to read the sensors—a handheld reader, or a gate reader. The handheld sensor tag reader uses RFID technology to read and record the tire pressure in each tire (see Figure 16).

Figure 16. eTire Handheld Tag Reader

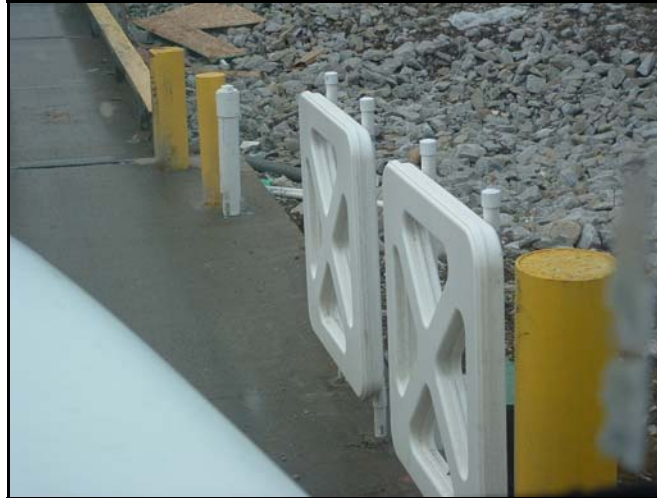
The eTire sensor units affixed to each tire can also be read using a gate reader in a more time efficient manner—and indeed this method is preferred if a location and other operational logistics support such an arrangement. A gate reader, as installed at a refuse facility near Indianapolis, IN, is shown in Figure 17.

Figure 17. eTire Gate Reader

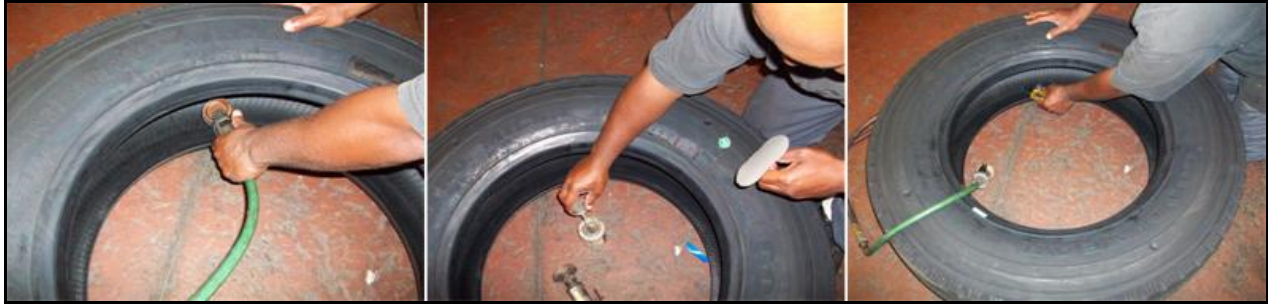
The eTire installation at WMATA’s Four-Mile Run bus maintenance facility began with training the study team and technicians on installing a sensor dock to the inside sidewall of a tire. The procedure includes scraping the inside wall of the tire to remove the ridges left behind by the tire mold process, buffing the inside wall smooth using a grinder, adhering the sensor dock to the tire wall using vulcanized paste, and installing the sensor onto the sensor dock using a soapy-water mix to reduce friction between the two surfaces. The Michelin engineer demonstrated the installation procedure on one tire and then observed the tire technician and the study team engineer as they took turns installing the sensor dock on other tires. Figure 19 shows the tire technician smoothing a small area of the inside sidewall of the tire (left), applying vulcanizing paste to the sensor dock (middle), and installing the eTire sensor over the sensor dock (right). The sensors were installed near the valve stem to make them easier to locate with the handheld reader.

Figure 19. Michelin eTire Sensor Dock Installation Process

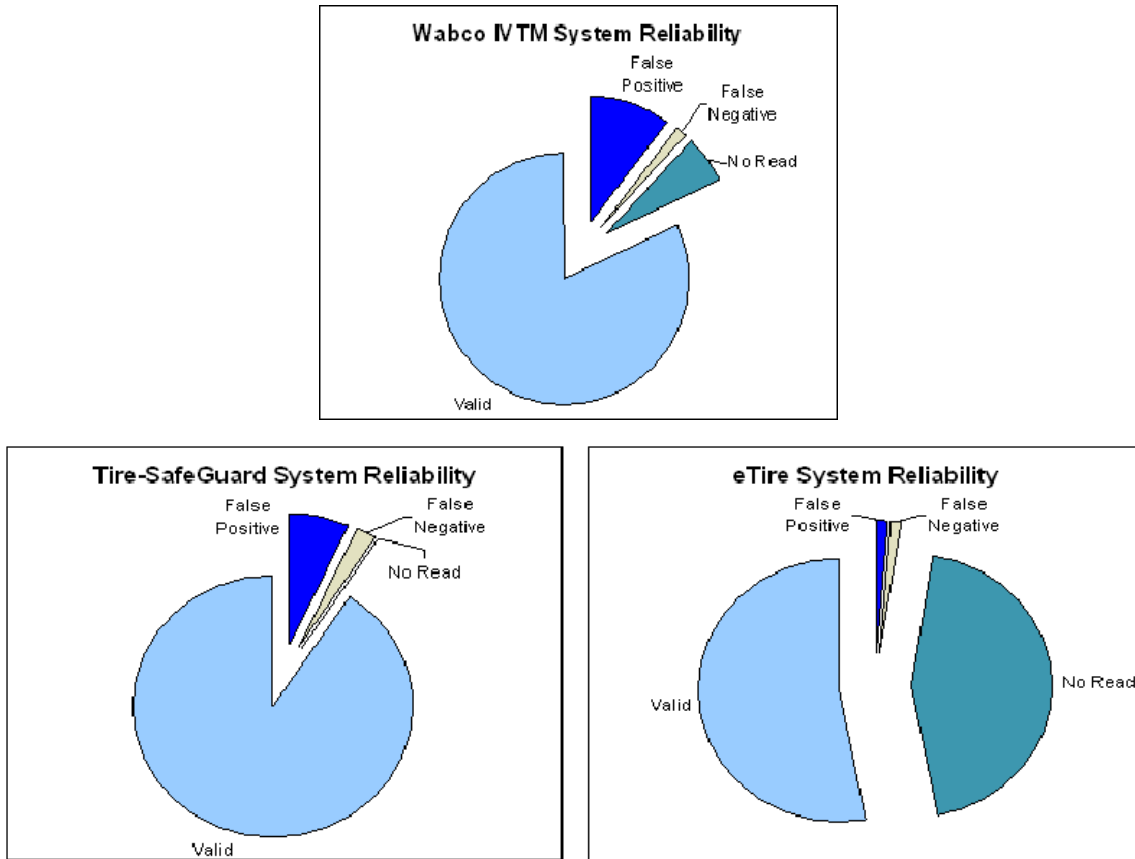
Another measure of reliability of TPMSs was whether the sensor systems were deemed to be “operational” during visual inspections and system checks by WMATA technicians and/or study team staff. The status of the sensor was identified as “operational” if a tire pressure reading was obtained at the control unit. If a sensor could not read the tire pressure, it was deemed “non-operational.” A sensor may be non-operational for several reasons, including communication failures, disconnected components, missing components, and broken components. An analysis of the entire field test showed the sensors were operational during 83.6 percent of the visual inspections.

Figure 20. Individual System Reliability Charts

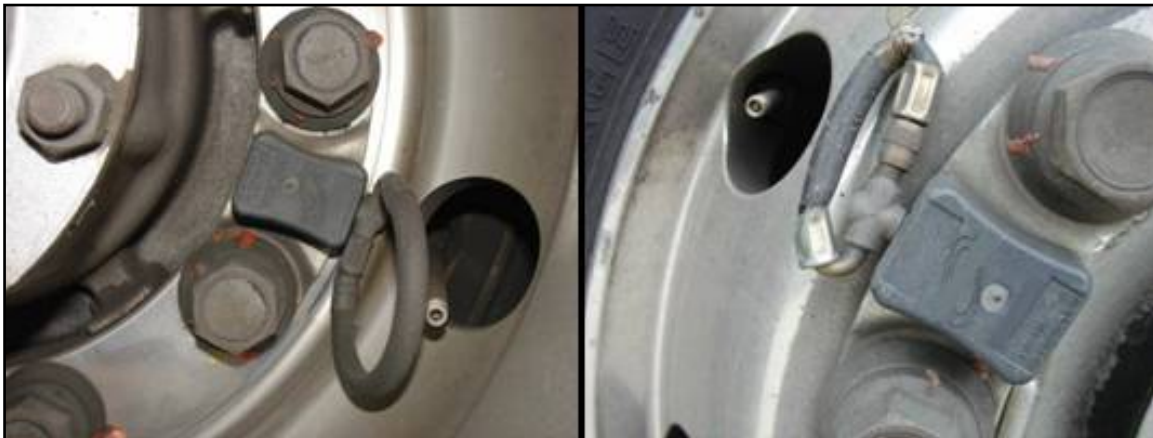
Another example of an improper installation is shown in Figure 22. The hose that connected the wheel module to the tire valve stem was improperly connected on two different tires on a particular bus. On both tires, one end of the hose was connected to the Schrader valve at the hose's other end, instead of the tire's valve stem.

Figure 22. Improper IVTM Hose Connections

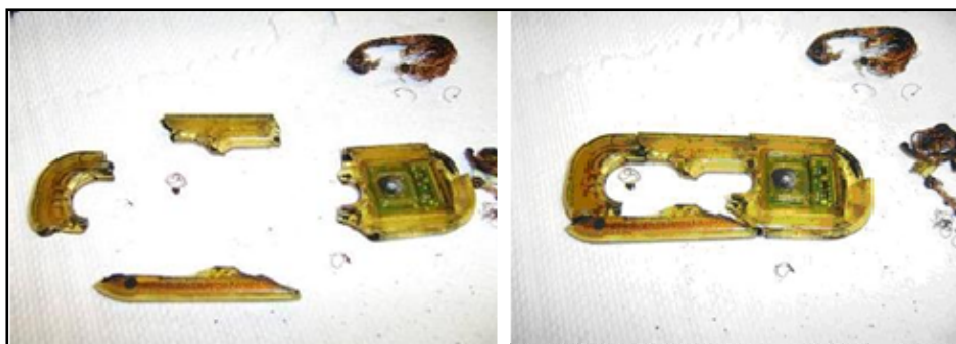
The eTire system had the most prevalent durability issue among the TPMSs tested during the fleet test. Damaged eTire sensors were initially identified in November 2006. Maintenance technicians noticed that the eTire system's handheld sensor reader did not detect sensors in several tires on bus numbers 2509, 2510, 2511, and 2512. A closer look revealed that 14 tires contained sensors that did not communicate with the handheld reader. The tires were removed for inspection. In each tire, the sensor unit had separated from the SensorDock mounted onto the inside sidewall of the tire. In only one case did the SensorDock separate from the tire wall itself. Figure 23 shows one of the sensors discovered in the inspection.

Figure 23. Damaged eTire Sensors

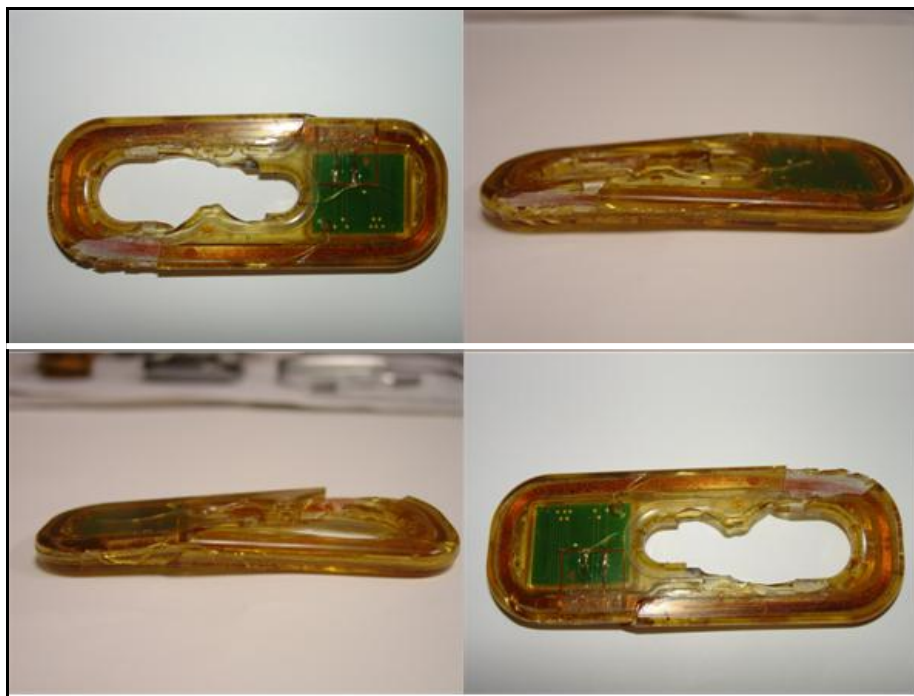
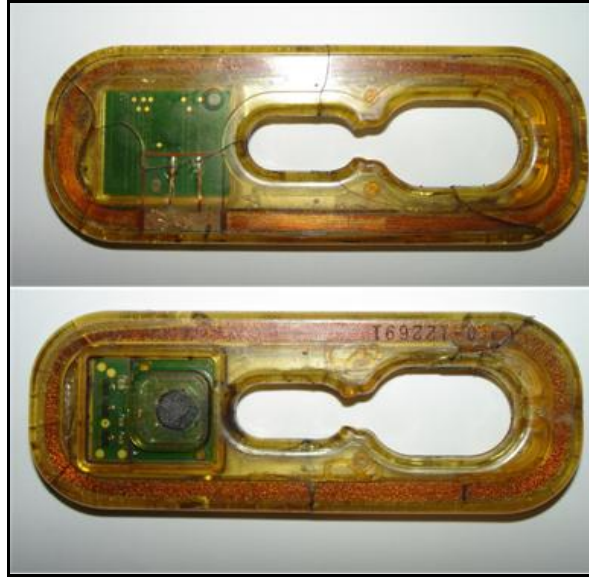
In May 2007 additional damaged sensors were identified during the replacement of the rear tires of bus number 2512 (see Figure 26 and Figure 27). Each of the four sensors exhibited similar patterns of cracking and damage as the other eTire sensors. Despite the visible damage to the sensor casing, three of the four sensors were still functional. These four sensors were found to be from the same defective manufacturing batch identified earlier by the eTire representative.

Figure 26. Damaged eTire Sensor, Bus Number 2512

Figure 27. Cracked eTire Sensors, Bus Number 2512

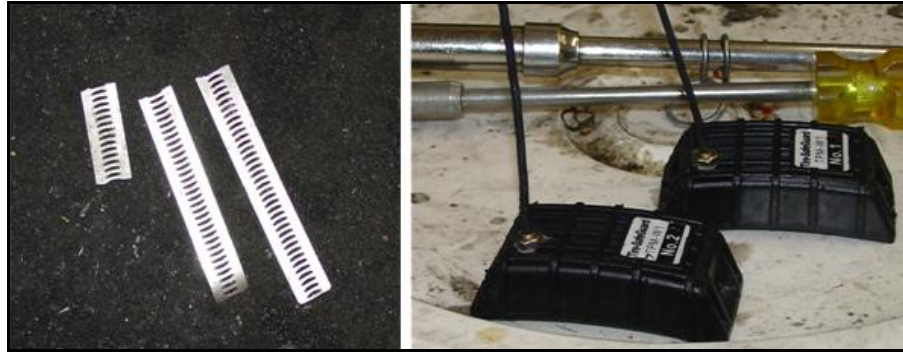
metal appeared to have broken free of the metal band while the bus was in service, fracturing into smaller pieces while moving freely within the tire and ultimately damaging the sensors. As Figure 28 shows, the metal fragments were part of the metal strap used to retain the sensors to the wheel.

Figure 28. Tire-SafeGuard Band Fragments and Damaged Sensors, Bus Number 2508

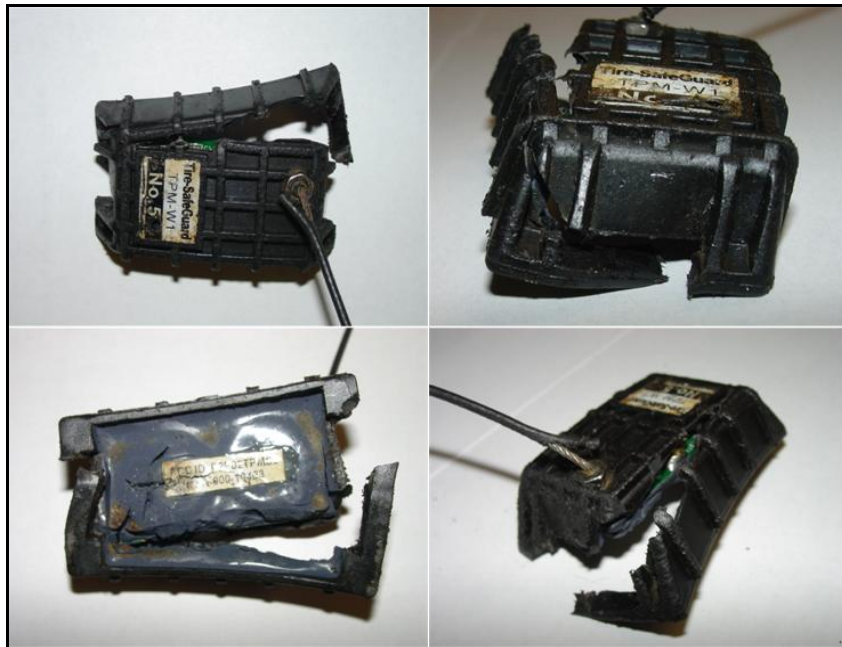
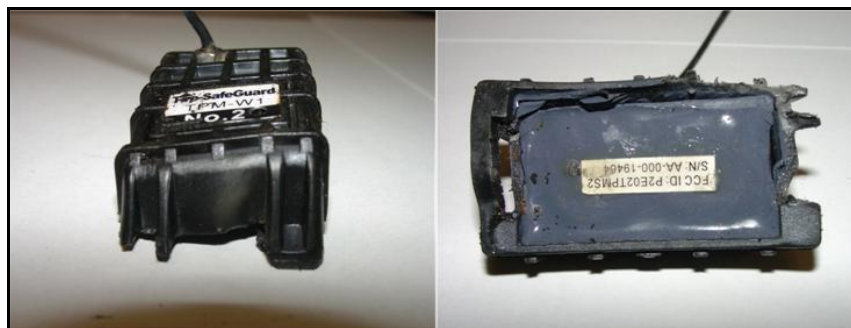
In July 2007 five additional damaged sensors were identified. Four of the damaged sensors were removed from bus number 2507. Unlike the earlier failure, the damaged sensors were still secured to the wheel rim by the metal strap. As Figure 30 and Figure 31 show, the sensors exhibited casing cracks and casing failures (i.e., plastic casing was broken and missing). In each of the failed sensors, the failure location was identified at the underside of the sensors. Large portions of the plastic casing were missing from the underside of the sensor. In addition, two of the sensor casings had split open completely. The sensors were replaced, and the manufacturer conducted an analysis to determine the cause of the problem.

Figure 30. Additional Damaged Tire-SafeGuard Sensors

Figure 31. Additional Damaged Tire-SafeGuard Sensors

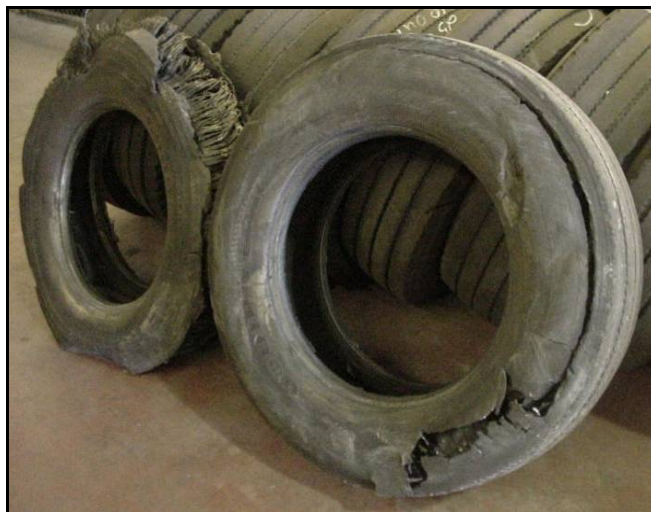
One incident occurred on July 18, 2007. While traveling on I-395 in Virginia, both right rear tires on bus number 2503 went flat. The outer tire, shown on the right in Figure 32, seemed to experience a small puncture from a foreign object, causing it to lose air. The inner tire, shown on the left in Figure 32, appeared to fail shortly after the outer tire failure and sustained the most extensive damage. The photograph indicates that the failure likely occurred at the 2 o'clock position on the outer tire. At this position, a piece of rubber was identified as missing from the tire, possibly after contacting a piece of construction debris. In the interviews, technicians identified construction debris, such as concrete rebar, as a common cause of tire failures on buses maintained at the Four-Mile Run facility.

Figure 32. Damaged Tires From Bus Number 2503

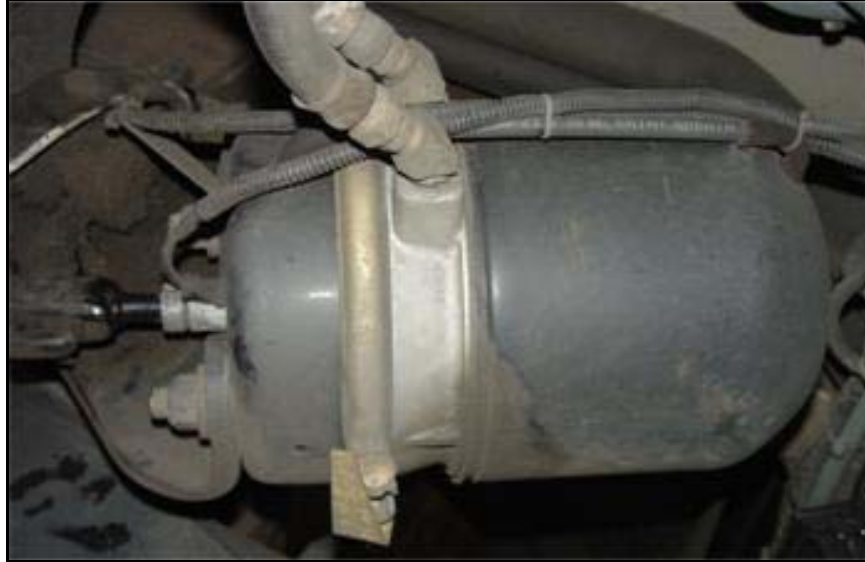
The Hall-effect sensor itself is contained within the air brake chamber thereby eliminating packaging interference with chassis and suspension components. This “internal chamber” design also serves to protect the sensor components from exposure to the harsh environmental conditions in the wheel end area. Figure 35 shows the MGM brake chamber.

Figure 35. MGM Brake Chamber and Display

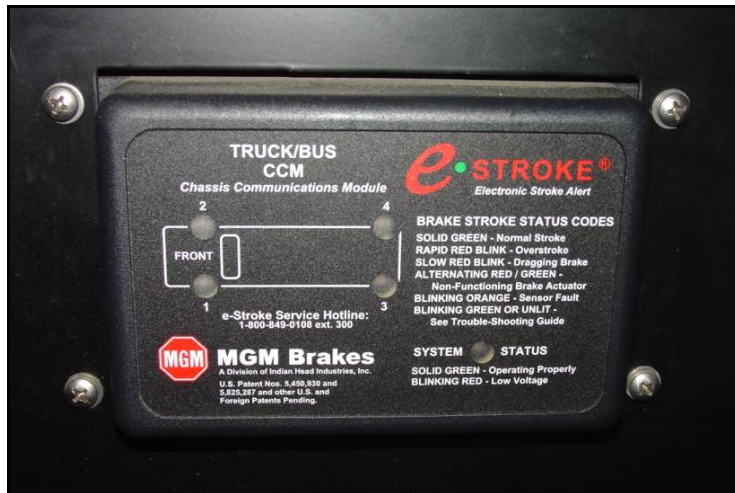
As noted in Section 3, the eStroke brake monitoring system is capable of storing brake alarms, warnings, and faults. These events are recorded by the ECU/display unit along with a date and time stamp and a description of the fault(s) detected. The system reports on problems with the brakes or with the system itself. For example, brake problem descriptions (fault codes) include brake overstroke, dragging brake, or brake actuator not working. Examples of system fault codes include: sensor out of alignment; communication failure; failed sensor; low voltage reading; and missing sensor. The system is capable of storing over 2000 separate incidents (or fault codes). The data can be exported onto the vehicle's SAE J1587 or J1939 electronic databus which can then be displayed on "smart" dashboards or transmitted to off-board vehicle monitoring devices.

Figure 36. eStroke System Display

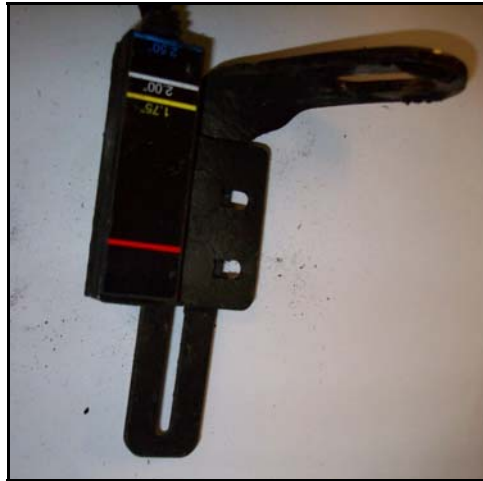
Each brake stroke actuator sensor is mounted on a bracket that allows the unit to be adjusted for various brake chamber designs and stroke lengths (from 1.75 inches to 3.0 inches). Figure 38 shows a wheel-end sensor before mounting on a brake chamber. The two bolts that secure the sensor to the bracket can be loosened, and the sensor can slide along the bracket to line up with the magnet on the pushrod.

Figure 38. Brake Insight Wheel-End Sensor and Mounting Bracket

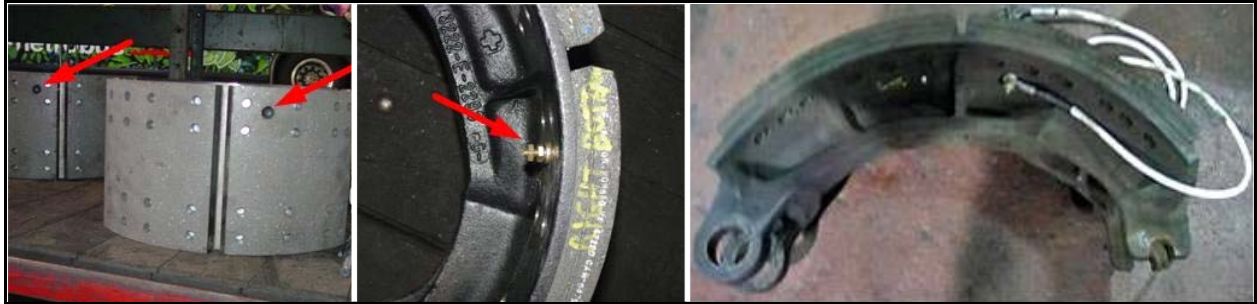
The left photo (Figure 39) shows the wear side of the sensor, and the center photo shows the mounting hardware where the thermocouple connects to the wear sensor and shoe. A single cable is connected to the sensor unit (right photo) to route information to the ECU (S-box). This cable contains three leads (one for the thermocouple and two for the lining wear sensor).

Figure 39. Lining Wear Sensor Installed in Brake Shoe

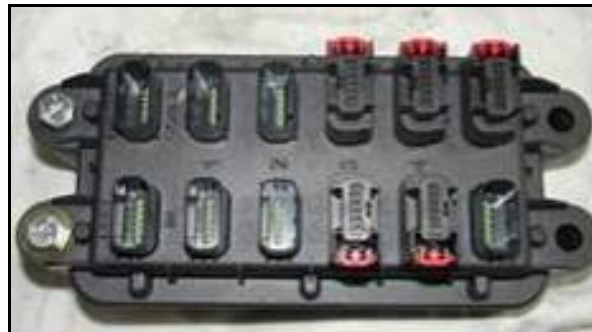
Figure 40. Brake Insight ECU (S-box)

S-box ECU. The brake stroke actuator sensors and the lining wear/temperature sensor units at each wheel-end were hardwired to the S-box control unit (or ECU, see Figure 40). The Brake Insight monitoring system is designed to store fault codes associated with various brake system abnormalities and events, as well as fault codes associated with the system itself (self diagnostic codes). The various fault codes are recorded along with a date and time stamp and a description of the problem or issue. For example, brake problem descriptions included brake overstroke, dragging brake, brake out of adjustment, brake out of service, high brake temperature, and worn shoe lining. There are unique fault codes to identify each wheel-end (i.e. for each sensor unit installed on the vehicle) and for each type of occurrence. Examples of a “system” problem include sensor out of alignment, communication failure, failed sensor, low voltage reading, and/or missing sensor. The system is capable of storing 2,700 fault codes. The data could be exported via a RS-232 connection located on the faceplate of the display unit.

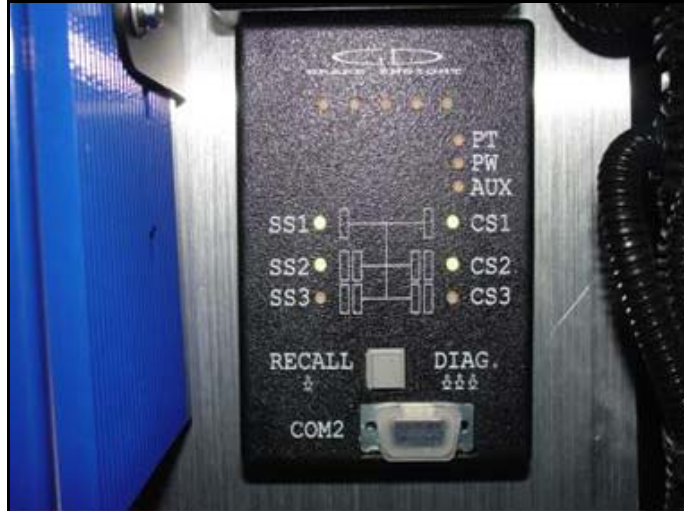
Display Unit. The S-box is hardwired to the Display unit (Figure 41) which was located in the I/O box behind the driver’s seat. The Display can be programmed to operate in “Driver Mode,” or in “Maintenance Mode.” In Driver mode the software will display only critical faults to the driver as defined by the customer. In maintenance mode all fault conditions are displayed.

Figure 41. Brake Insight Display Unit

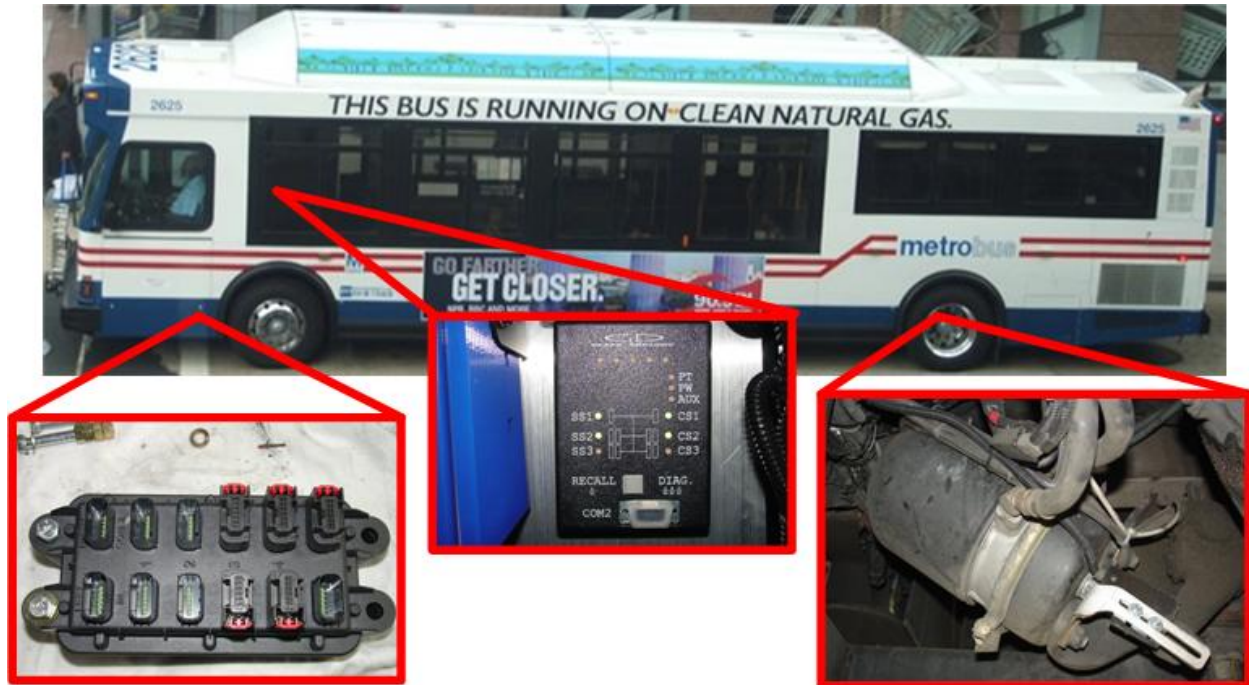
Figure 42. Brake Insight Component Mounting Locations

Cabling was routed from the sensors mounted at each brake chamber along the underside of the bus to the S-box located just forward of the front driver's side wheel well. The S-box was mounted to the underside of the bus, near the air reservoir, and protected from road debris. Figure 42 shows the location of the S-box, display unit, and wheel-end sensors.

The GeoDevelopment Brake Insight system was installed on WMATA bus numbers 2505, 2506, 2507, and 2508. Truck Trailer Transit Inc., a distributor of Brake Insight, provided three service technicians to lead the installation. The factory technicians began by installing the magnetic clevis pins on the pushrods extending from the brake chambers. Normally, the original clevis pins that link the pushrod to the slack adjuster are removed and replaced with the magnetic pins. However, the clevis pins used with the MGM brake chambers on the WMATA buses were welded in place and could not be removed. To overcome this issue, the technician installed a pipe clamp with a magnetic end on the pushrod near the existing clevis pin. Once the magnets were installed on the pushrods, the technicians mounted the wheel-end sensors to the brake chambers using the supplied brackets.

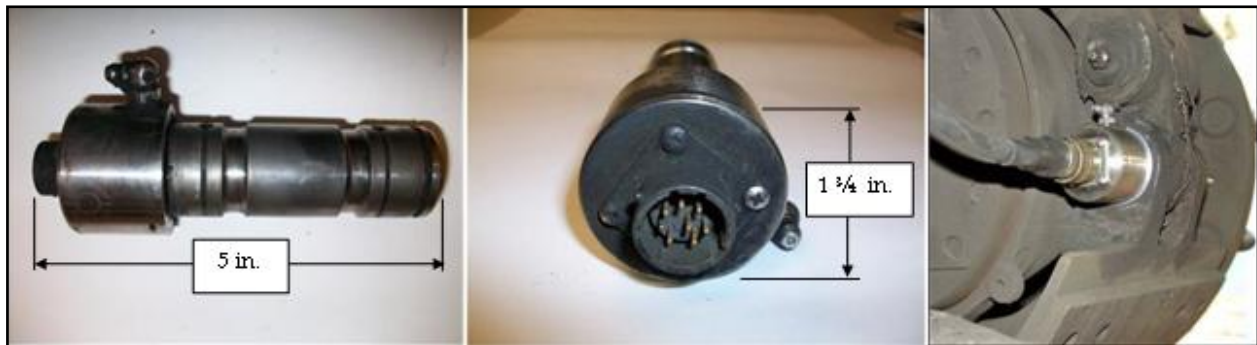
Figure 44. StrainSert Anchor Pin

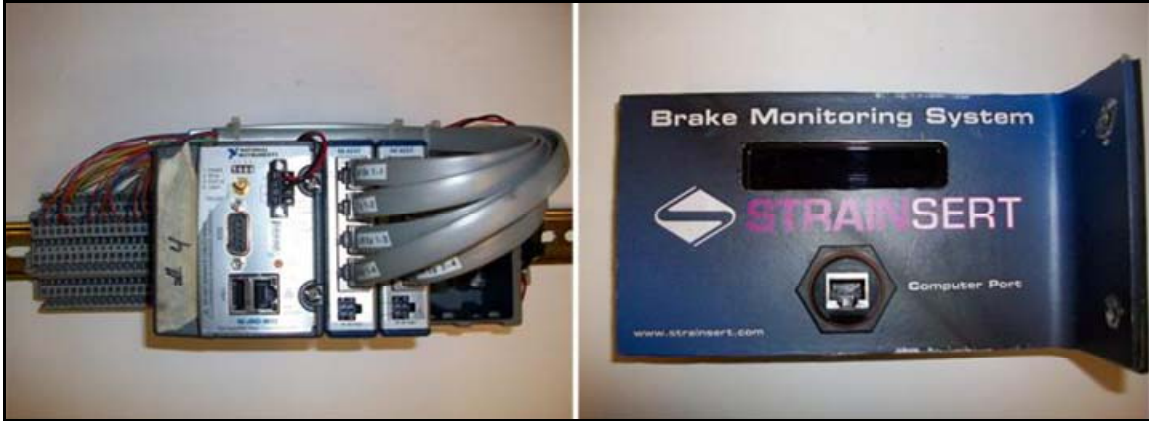
Figure 45. StrainSert ECU and Display Unit

ECU and Display. Sensor units are hardwired to an ECU, which is then connected to a Display Unit (Figure 45). The various threshold warning parameters and fault code algorithms are customized for specific applications by an authorized technician (see Installation, next section.) The system is designed to detect out-of-adjustment brakes, dragging brakes, oil-soaked linings, and disconnected shoe linings.

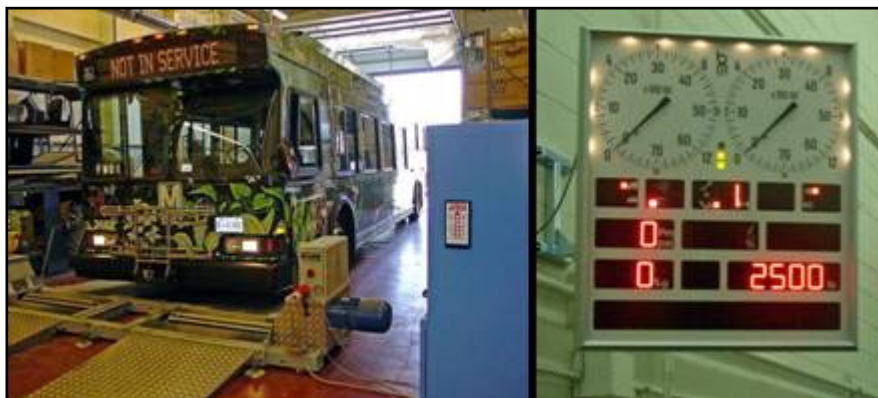
Figure 48. PBBT and Operators Display

The Link Radlinski Model 20200 portable Performance Based Brake Tester (Figure 48), also known as a PBBT, was incorporated into the program to serve as a reference measurement tool for evaluating the accuracy of the on-board brake performance monitoring systems, and more generally to assess the pros and cons of off-board brake system testing relative to integrated onboard BPMS. This roller dynamometer-based system, with two 11 kW three-phase drive motors with mechanical brakes, can dynamically measure the rolling resistance; brake threshold pressure; service brake force; parking brake force; and antilock braking systems (ABS) sensors, valves, and wiring. The PBBT provides an industry-accepted reference measurement of brake performance. Basically, the vehicle’s front or rear wheels are positioned on top of the roller dynamometer. An electronic alpha-numeric message board is positioned in front of the bus and provides the operator with instructions for executing various braking maneuvers. The rolling resistance of the dynamometer is pre-programmed to simulate the weight and rolling inertia of the bus itself.

The large wall-mounted display, shown in the right photo of Figure 48, was provided with analog dials to indicate: left and right brake forces; percent brake force differences; digital displays of brake system control air pressure; axle weight; and overall deceleration rates.

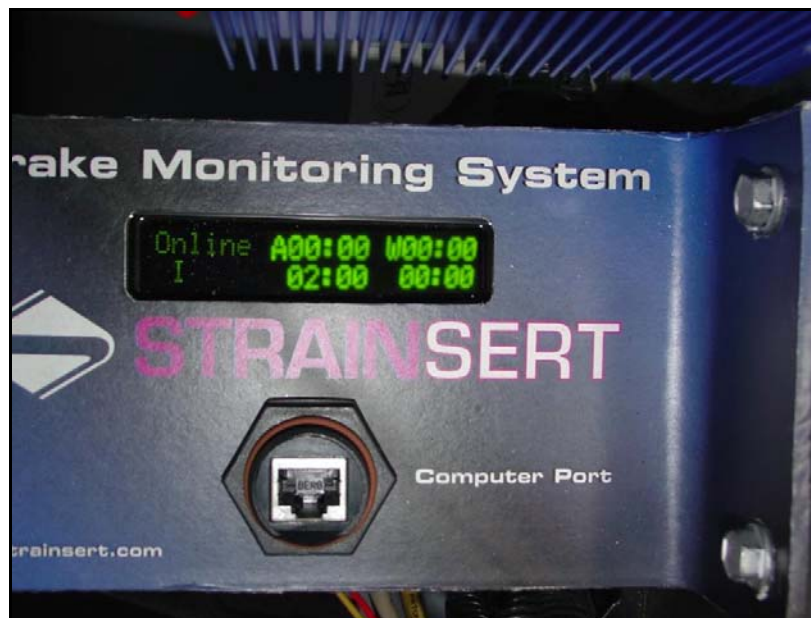
Figure 50. StrainSert Display

The StrainSert system is designed to identify out-of-adjustment brakes, dragging brakes, oil soaked linings, and/or disconnected brakes. The weekly visual inspection of the StrainSert-equipped buses included identifying and logging the presence of any alerts or warnings at the system display. The display, shown in Figure 50 consists of two counters and a scrolling display.

- **Alarm.** The alarm indicator is triggered if the system detects a difference greater than or equal to 40 percent in brake force between brakes on the same axle. (The out-of-service brake criteria used by the Commercial Vehicle Safety Alliance defines the alarm criteria). The system's algorithm is able to identify the specific wheel location that is likely to have a brake problem by comparing brake forces between axels (as well as between wheel-ends on the same axle), and determining which wheel-end (on each axle) deviates the most from the average of all wheel-ends. In Figure 50, the display shows that the system detected two instances of the brake force differential exceeding 40 percent between the left and right rear brake assemblies, with the brake problem likely in the left rear brake assembly.

- **Service Required.** The "service required" message indicates that a wheel-end has exceeded a pre-determined threshold limit for the number of alarms or warnings within a given timeframe. For the WMATA field test, a warning or alarm must have occurred 10 times at a single location during the same trip before the "service required" message appears on the display. The message indicates the wheel-end of the assembly requires immediate servicing.

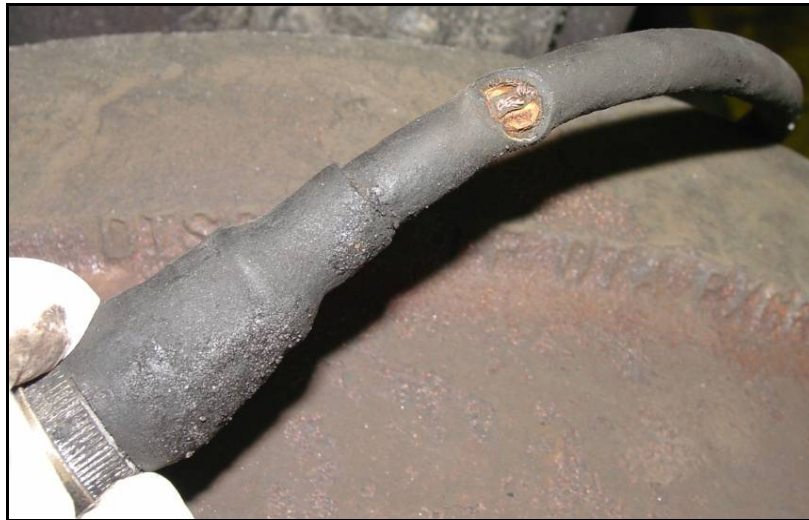
Figure 51. StrainSert Anchor Pin Cable Failure
