## Calendar Year 2011 Report to the Rio Grande Compact Commission

U. S. Department of the Interior  
Bureau of Reclamation  
Albuquerque Area Office  
Albuquerque, New Mexico

March 2012

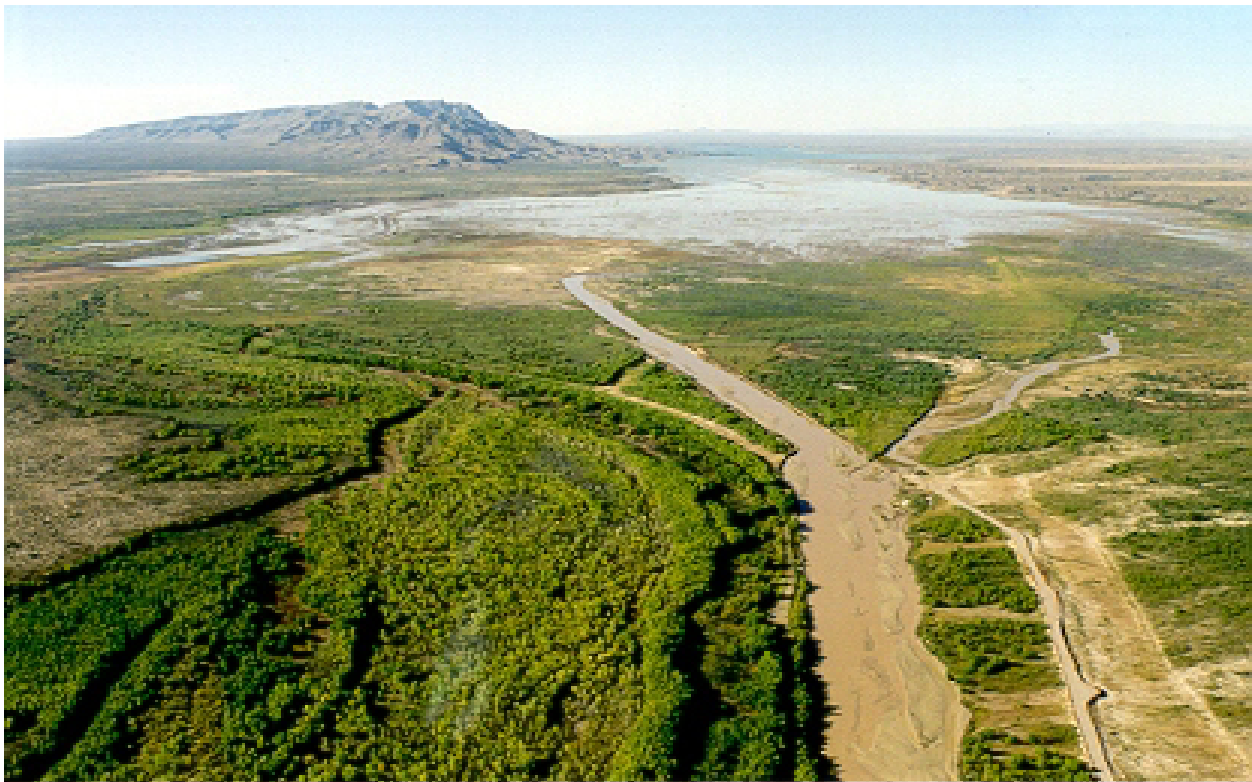
Photo 1: Headwaters of Elephant Butte Reservoir, prior to construction of the Temporary Channel (1998)

River disconnection has been an issue at the headwaters of Elephant Butte Reservoir since the early 1950s. The contributing factors for the disconnection are many: the valley slope is very slight, the incoming sediment load is high, the clay deposits are highly cohesive, and vegetation growth is extremely aggressive. During drought periods when the reservoir pool decreases rapidly, all of these factors make it difficult for the river channel to maintain a connection with the reservoir pool (Photo 1). The latest incidence of disconnection began in the late 1990s, and construction of the Temporary Channel began in 2000. The channel was constructed in three phases:

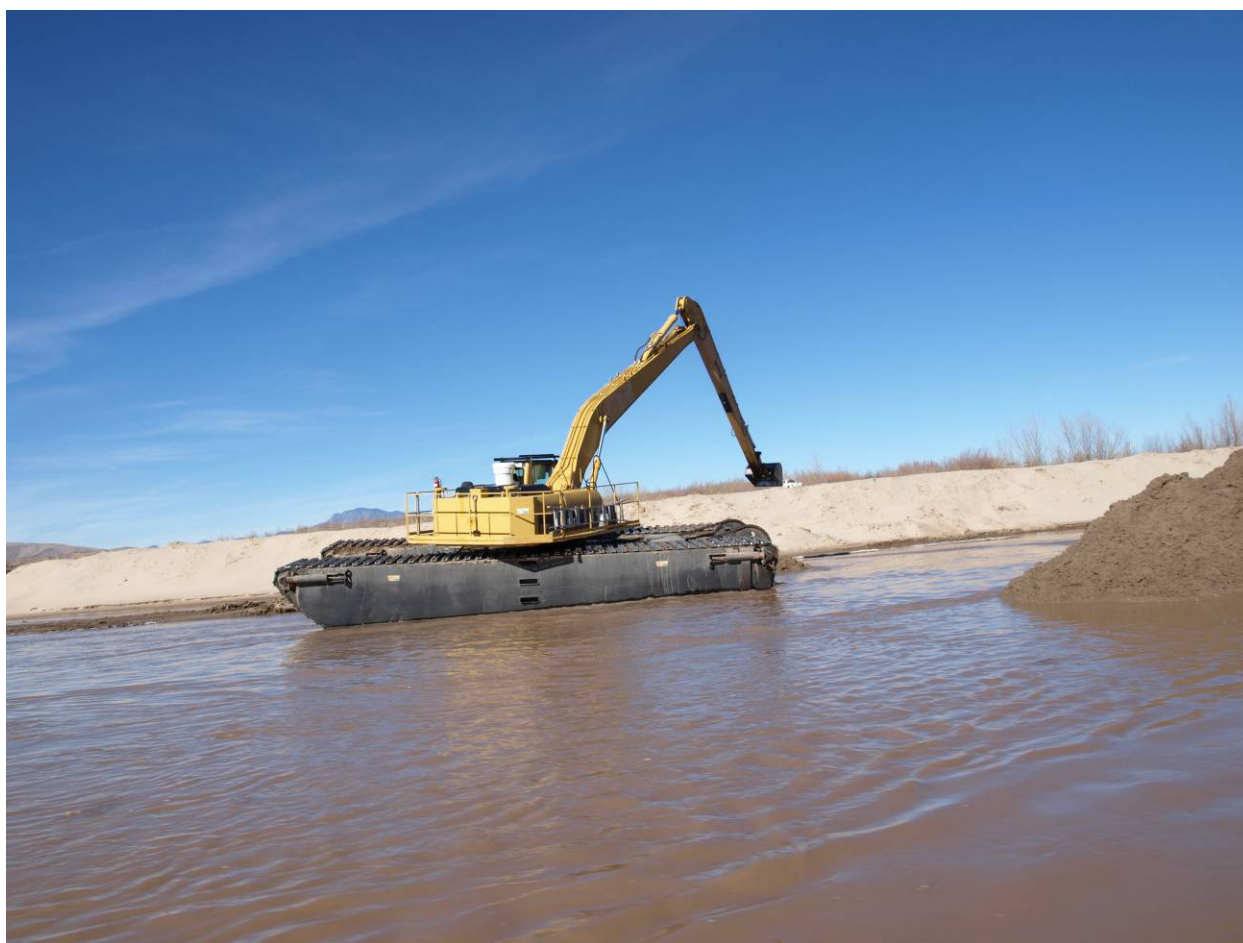
Photo 2: Amphibious excavator working on breach south of the Red Rock Staging Area (November 2010, Holste)

The repaired berms have not proven stable, as they are composed of fine cohesionless sand. The Socorro Field Division monitors and repairs the berms, as they are continually eroding. Maintenance of these berms continued until April 15, 2011.

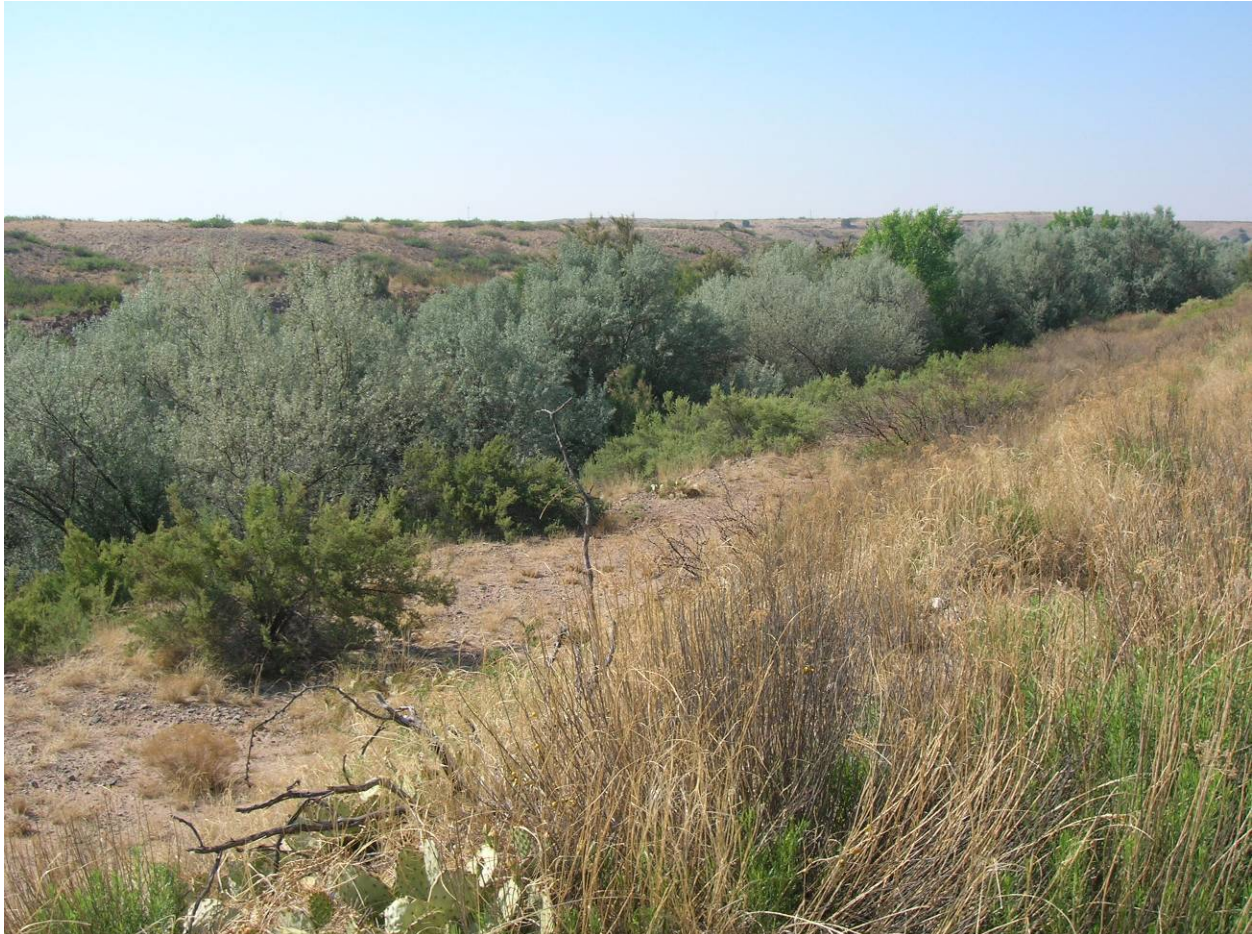
Photo 3: Vegetation growing in Lower San Juan Drain downstream of Salas Arroyo (June 2011, Nemeth)

- The La Joya Drain needs extensive maintenance. State and federal wildlife refuges in the area have noted the maintenance need.
- NMISC has expressed interest in funding maintenance on the Lower San Juan Drain, between Salas Arroyo and the drain's downstream terminus (Photo 3). Reclamation is in the process of performing analysis necessary to obtain environmental compliance for this work.

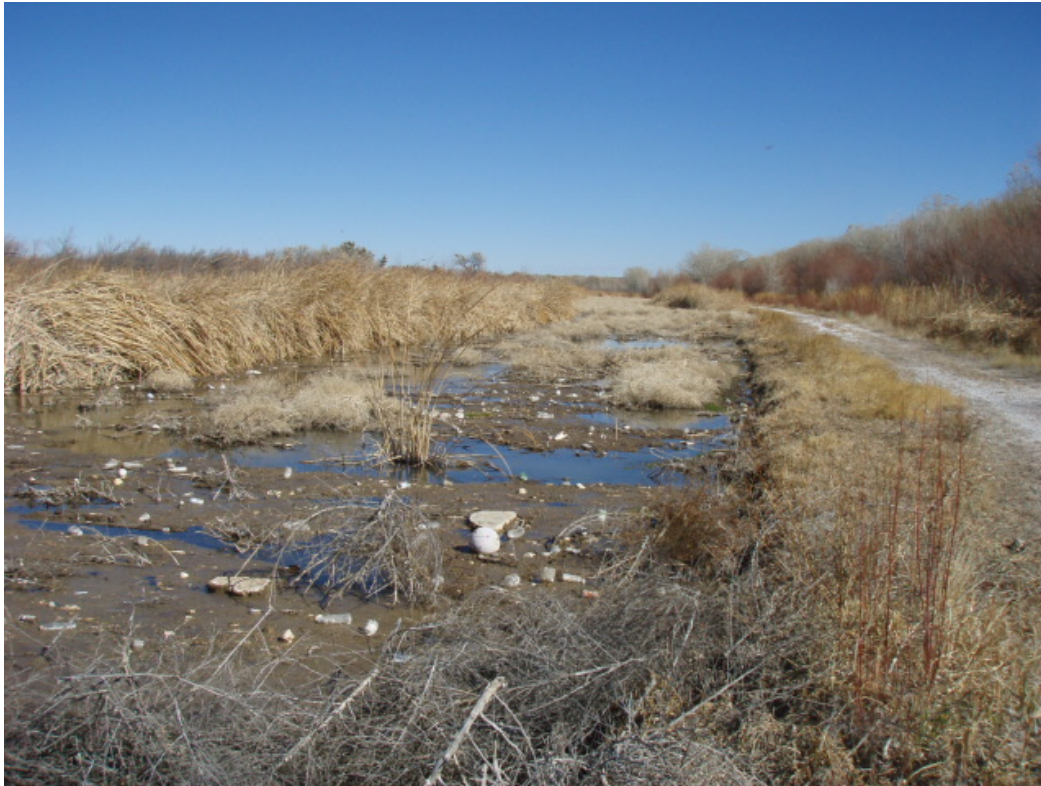
Photo 4: Tumbleweed plug within the LFCC (February 2011)

- In February 2011, the Bureau of Reclamation, using funds from the NMISC, initiated maintenance activities in the Low Flow Conveyance Channel (LFCC) south of Ft. Craig. Maintenance activities were intended to restore an amount of flow in the LFCC sufficient to remediate channel overtopping immediately upstream of the “tumbleweed plug” (Photo 4) and relieve groundwater swelling in the Reclamation-owned Valverde Borrow Pit. Underlying sediment deposition in the LFCC has created shallow surface flow over time. High wind events in the Ft. Craig area during the winter of 2010-2011 dislodged and deposited debris in the LFCC, the majority of which migrated to the low velocity and highly vegetated area south of Ft. Craig. This migration created a “plug” which resulted in overbanking flow or flooding upstream of the plug. Significant issues with environmental compliance restricted Reclamation to removing only the newly deposited debris, which restored flows to pre-plug conditions and alleviated flooding upstream. Work was completed

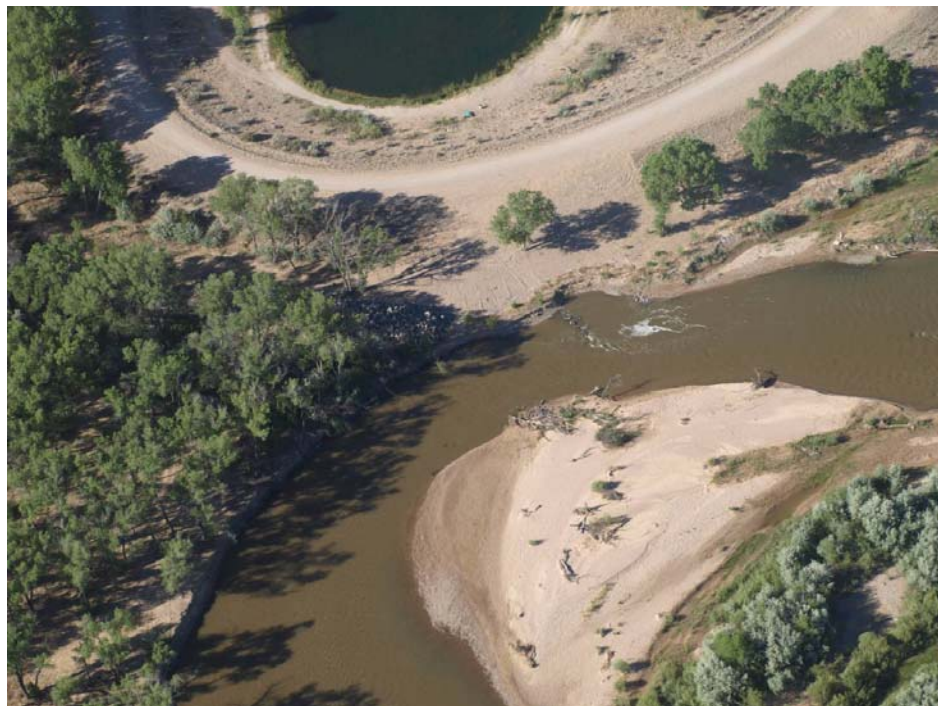
Photo 5: San Ildefonso bankline erosion, riprap windrow, and exposed rock vanes (June 2011, Benoit)

This bank erosion exposed and threatened to flank three of the buried rock vanes. Reclamation worked with the Pueblo de San Ildefonso to construct a temporary solution prior to the 2010 spring runoff. The project consisted of a buried trench riprap revetment and a riprap windrow (Photo 5). This temporary protection allows time for the development and permitting of a longer term solution.

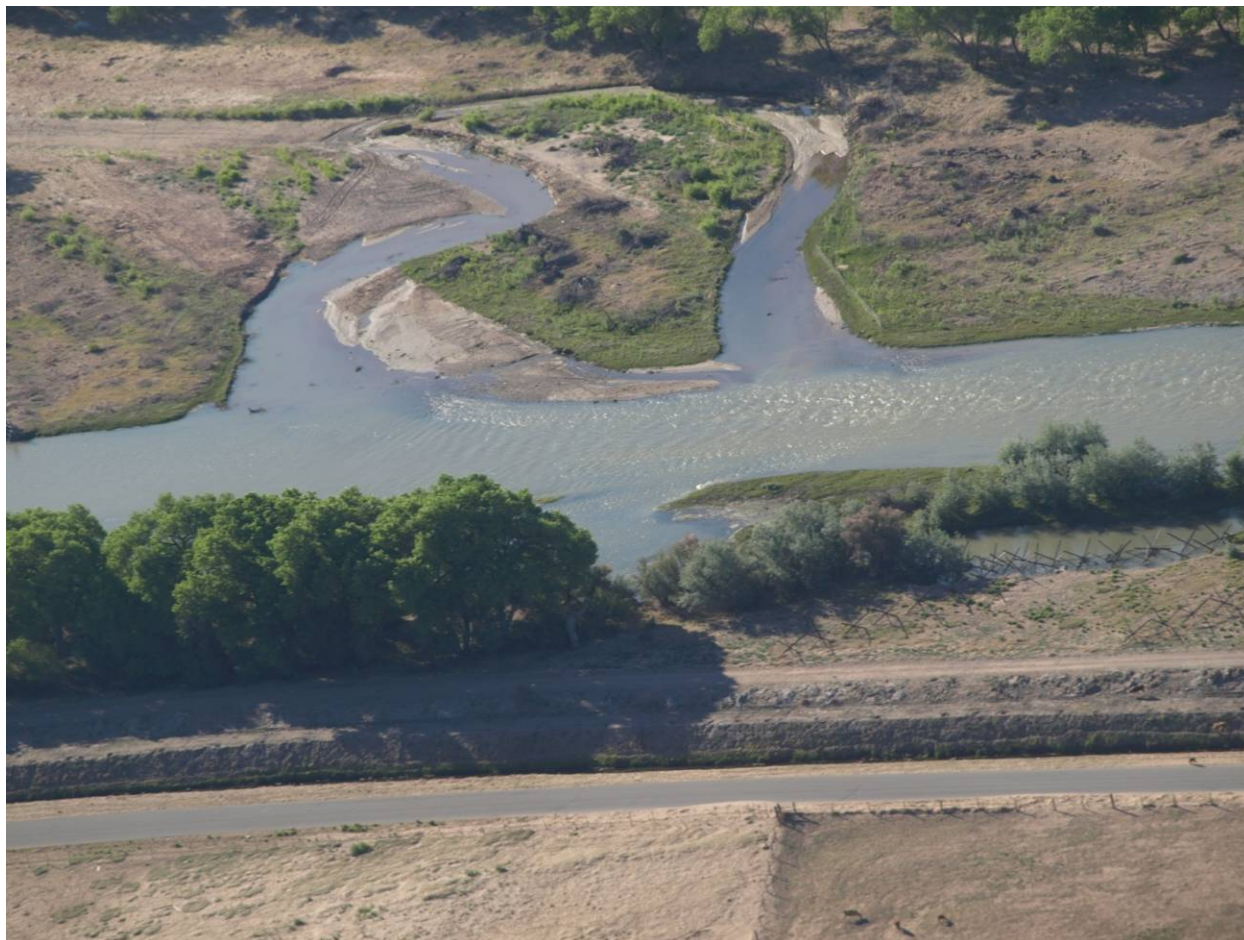
Photo 6: Santo Domingo Pueblo RM 224.6 (Galisteo Creek) Priority Site (June 2011, Benoit)

There are currently three priority sites on the reach of the Rio Grande passing through Santo Domingo Tribe lands (RM 225.1, RM 224.6, and RM 223.9). Bankline erosion on the west side of the river is cause for concern because of the close proximity to the levee and riverside drain. RM 224.6, which is across from the confluence of the Rio Galisteo, is shown in Photo 6. A Data Collection and Confidentiality Agreement was executed between the Santo Domingo Tribe and Reclamation in August 2007 to allow collection of design data for the three priority sites. Reclamation has reached preferred alternatives for the three priority sites in cooperation with the Pueblo of Santo Domingo, and construction may begin in late 2012.

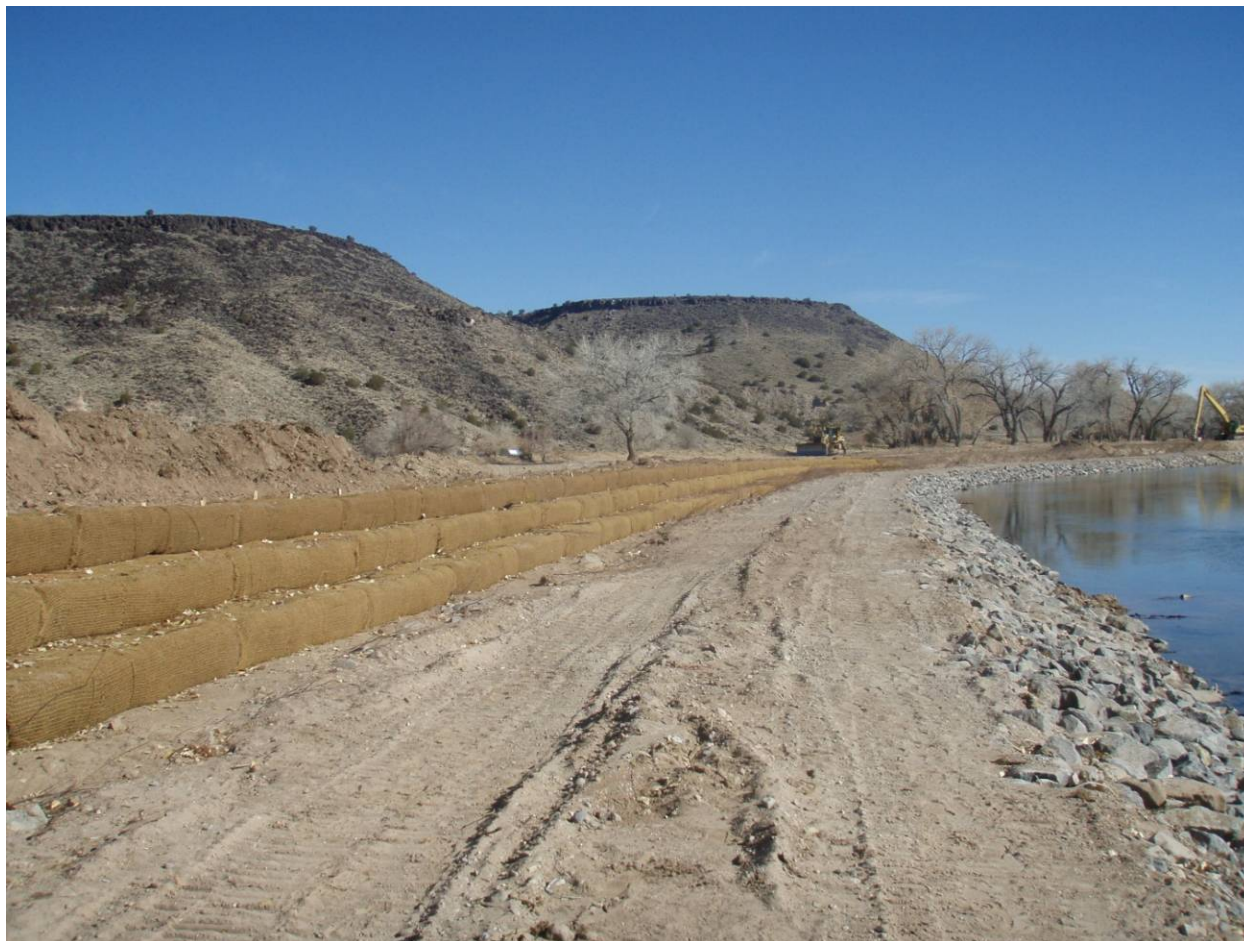
Photo 7: Rock toe and Bio-D blocks at Priority Site RM 213.4, San Felipe (February 2011, Benoit)

There are currently 10 river maintenance priority sites on the Pueblo of San Felipe. Current conditions at these sites could lead to damage of levees, irrigation infrastructure, roads, and a residential area of the Pueblo. In late 2006, Reclamation obtained permission from the Pueblo to collect cross-section and bed material data for use in designs to address these sites. Construction was completed on two sites, RM 213.4 and RM 213.7, in 2011. Construction at RM 212 is expected to be finished in early 2012. Photo 7 shows the site at RM 213.4. Seven sites have yet to be completed.

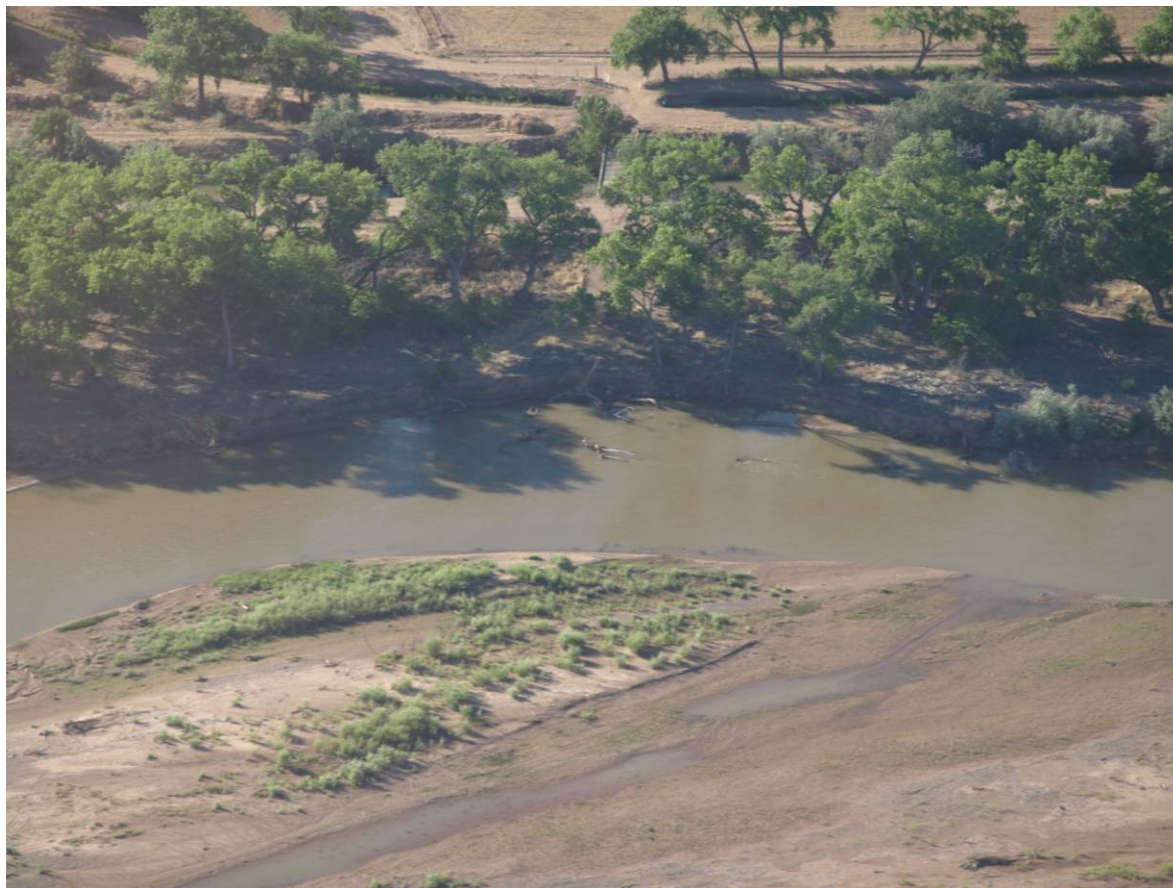
Photo 9: Increased wetted width at higher flows (approximately 1310 cfs) from the Corps of Engineers' bar lowering at the Pueblo of Santa Ana, looking at the RM 205.8 priority site (June 2011, Benoit)

This site was upgraded to river maintenance priority site status following the 2008 spring runoff. The site is within the Pueblo of Santa Ana, on the east bank of the Rio Grande across from the Tamaya Resort special events tent. An island and bar lowering project, undertaken by the Corps of Engineers through their Section 1135 project authority, has helped reduce the active bank erosion at this site by increasing the conveyance capacity at high flows (Photo 9). Reclamation is working with the Pueblo of Santa Ana to implement an Information Sharing Agreement and to develop a preferred alternative to provide protection at this site. A Public Law 93-638 contract was initiated with the Pueblo of Santa Ana in 2010 and amended in 2011 to pursue the geomorphic and hydraulic analyses at this site, develop suitable alternatives, and produce final designs. Designs are expected in June 2012, with maintenance construction in January 2013.

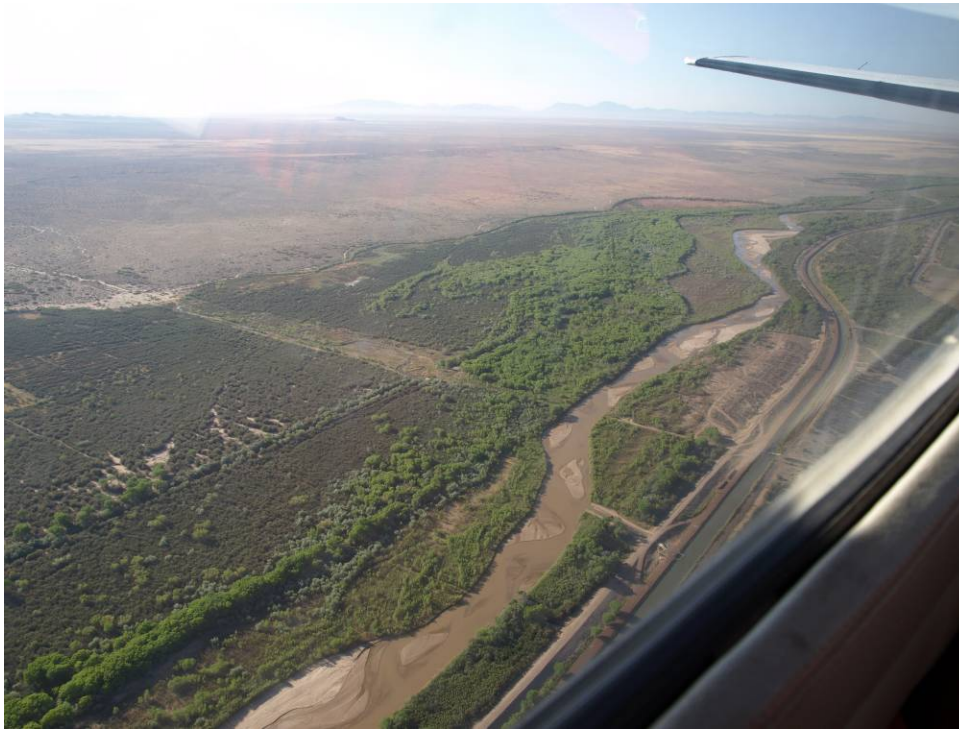
Photo 10: A portion of the reach of river currently considered most prone to sediment plug formation, looking south (May 2011, Lopez)

Reclamation completed and submitted the *Bosque del Apache Sediment Plug Management: Alternatives Analysis* to the Service in September 2011, in accordance with Service's 2008 Biological Opinion, for the 1.5 mile pilot channel work. The analysis included 13 alternatives to address the recurring sediment plug formation between RM 87.1 and RM 68.6. The alternatives list was developed through interagency coordination between Reclamation, the Service (BDANWR, NMESFO, and Fisheries Branches), NMISC, USACE, and NMDGF. The area thought to currently have the greatest potential for sediment plug formation is shown in Photo 10.

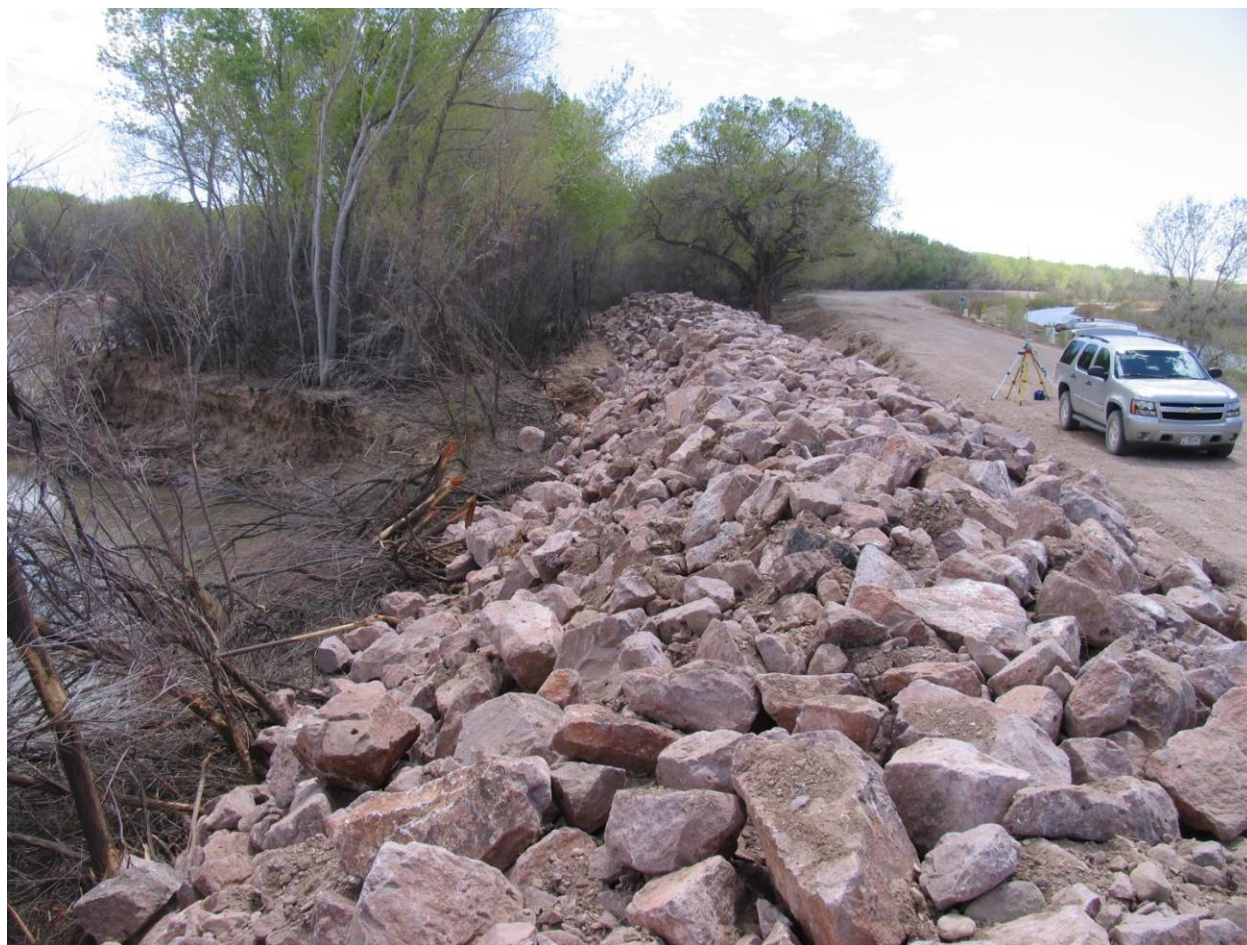
Photo 11: Fort Craig Bend riprap windrow, looking downstream (April 2011, Holste)

The river bend at this site has been fairly stable in past years, but became active during the 2008 runoff, with even more erosion during the 2009 runoff. The upper portion of the bend was stable during the 2010 runoff, although the erosion continued to progress downstream and almost 50 feet of bank was lost at one location. The amount of potential erosion in a given year is greater than the distance between the river and levee, so a riprap windrow was constructed in March and April 2011 (Photo 11). Approximately 3,900 cubic yards of rock was placed at the site with a nominal diameter of 16 inches. The windrow is 630 feet long and provides a short term countermeasure against erosion continuing to the west and breaching the levee.

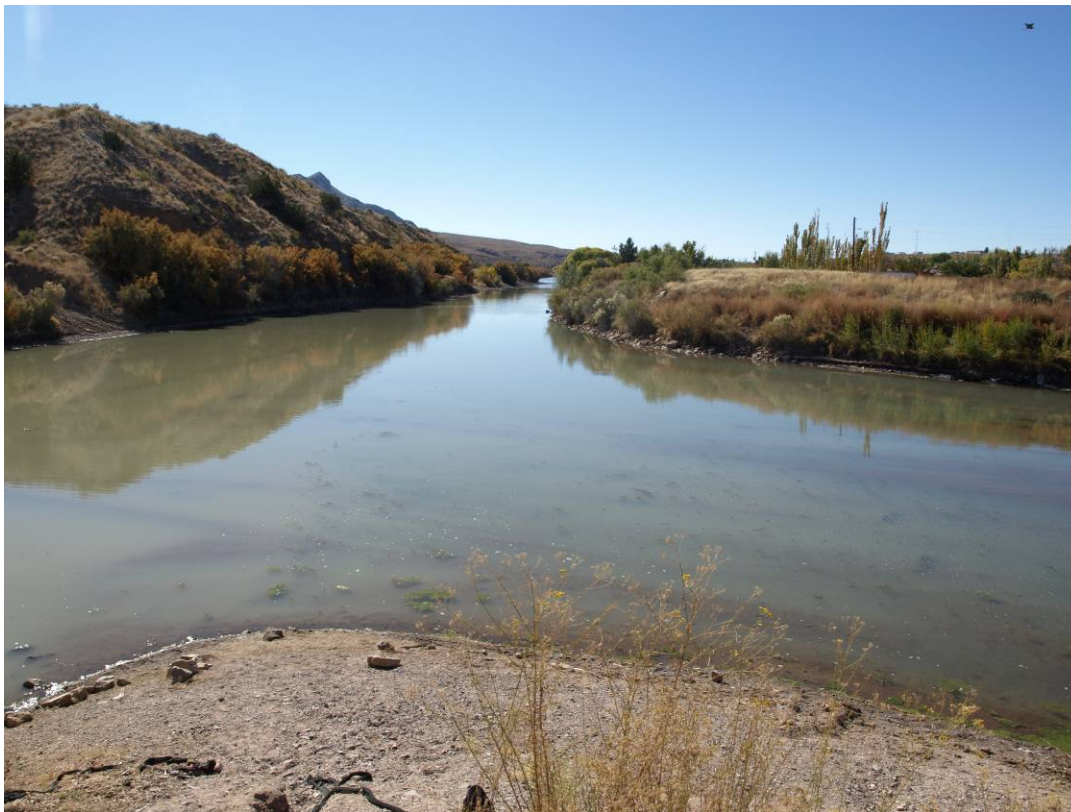
Photo 12: Rio Grande and Mescal Arroyo confluence before sediment excavation (September 2011, AuBuchon)

Sediment excavation was performed in 2011 at arroyo mouths (Photo 12) and various reaches of the river channel, with a total volume of approximately 13,900 cubic yards removed.
