March 8, 2007

TENNESSEE VALLEY AUTHORITY (TVA) - KINGSTON FOSSIL PLANT (KIF) - FLUE GAS  
DESULFURIZATION (FGD) DISPOSAL PROJECT - TENNESSEE AQUATIC RESOURCE  
ALTERATION AND CORPS OF ENGINEERS (COE) - APPLICATION FOR PERMIT FOR  
ALTERATION OF WETLAND AREAS IN PROPOSED GYPSUM DISPOSAL AREA

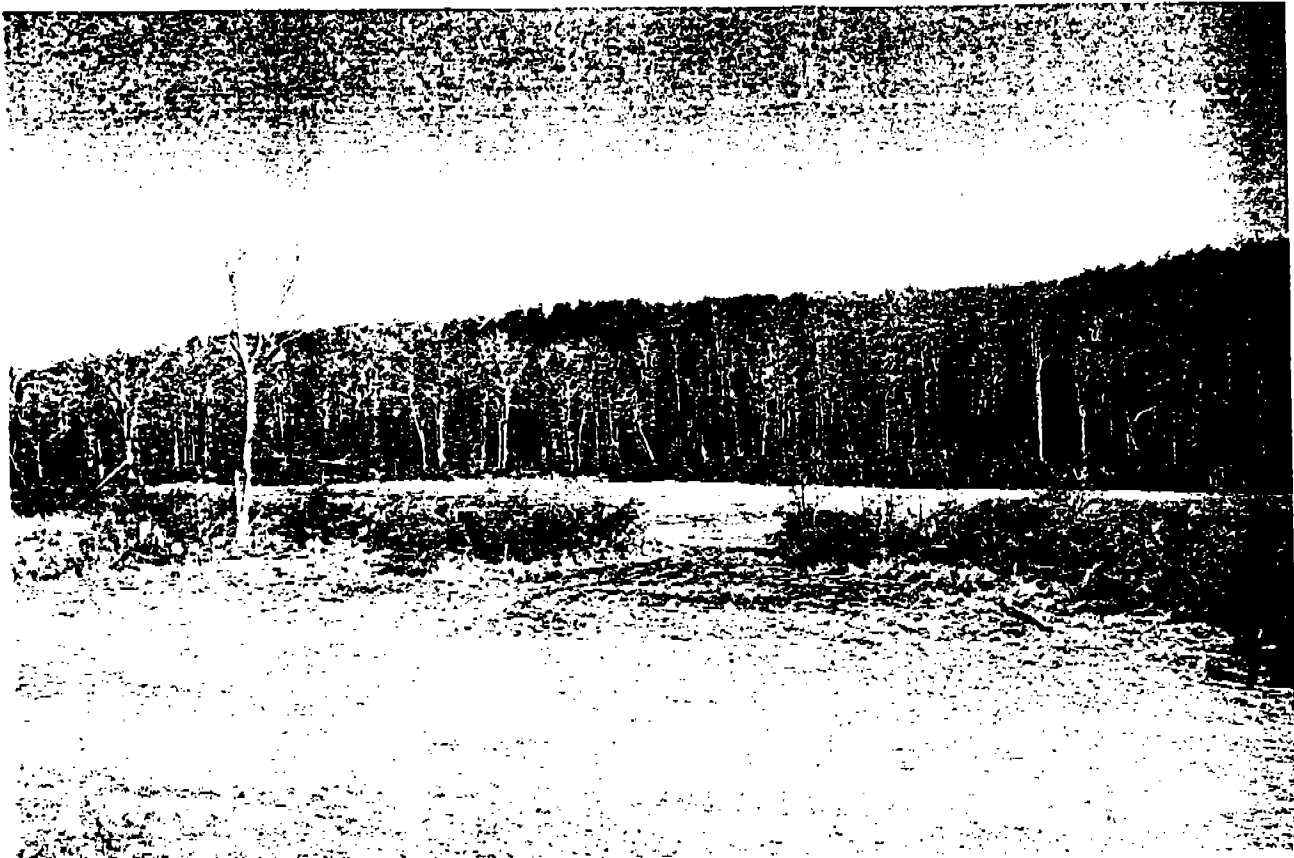
Figure 2. View of site showing grazed pasture. Excavated and ditched areas are indicated by taller vegetation in the center of the photo.

The site, which is in the floodplain of Drowning Creek, historically was forested but has been cleared and converted to pasture (Figure 2). Portions of the site are drained by rim ditches that intercept overland flow from uplands, and by internal ditches that convey floodwaters to the creek. The majority of the site (approximately 19.5 acres) is degraded wetland, although small inclusions of upland habitat do occur. These upland areas likely were the natural levees and ridges that were formed as the creek meandered back and forth across its floodplain and deposited material during flood events. Such upland features are natural and integral components of most riverine systems.

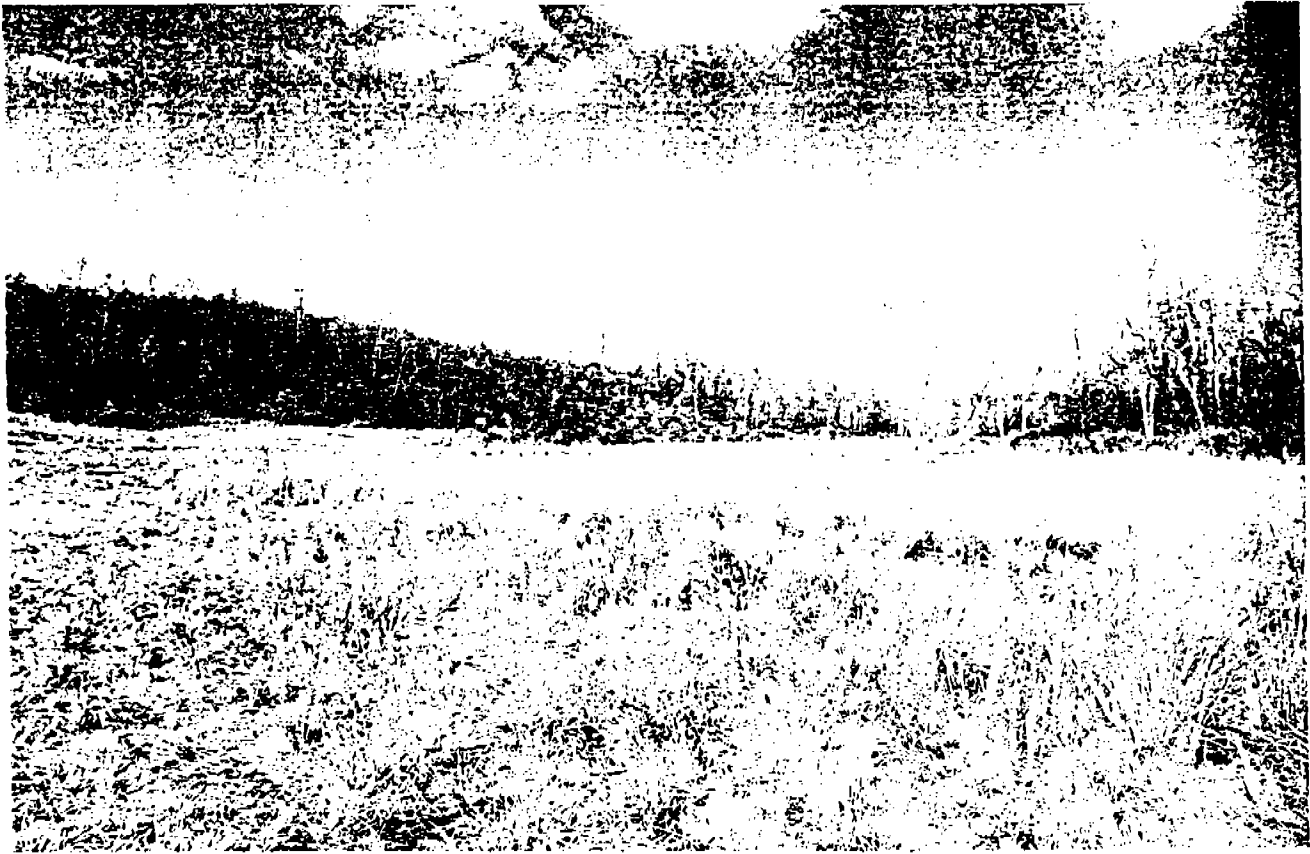
Figure 3. View of site showing grazed pasture dominated by fescue and various species of sedges and rushes.

The entire site currently is dominated by herbaceous species including tall fescue (*Festuca arundinacea*) in higher areas, with soft rush (*Juncus effusus*), fox sedge (*Carex vulpinioidia*), and other species tolerant of soil saturation in areas where the water table is near the surface (Figure 3). Cattail (*Typha latifolia*) and woolgrass (*Scirpus cyperinus*) are found in several areas that had been excavated to create watering areas for livestock (Figure 4). Giant cane (*Arundinaria* sp.), panic grass (*Panicum* sp.), goldenrods (*Solidago* spp.), blackberry (*Rubus* spp.), and other weedy species occur in a narrow strip between the pasture and Drowning Creek (Figure 5).

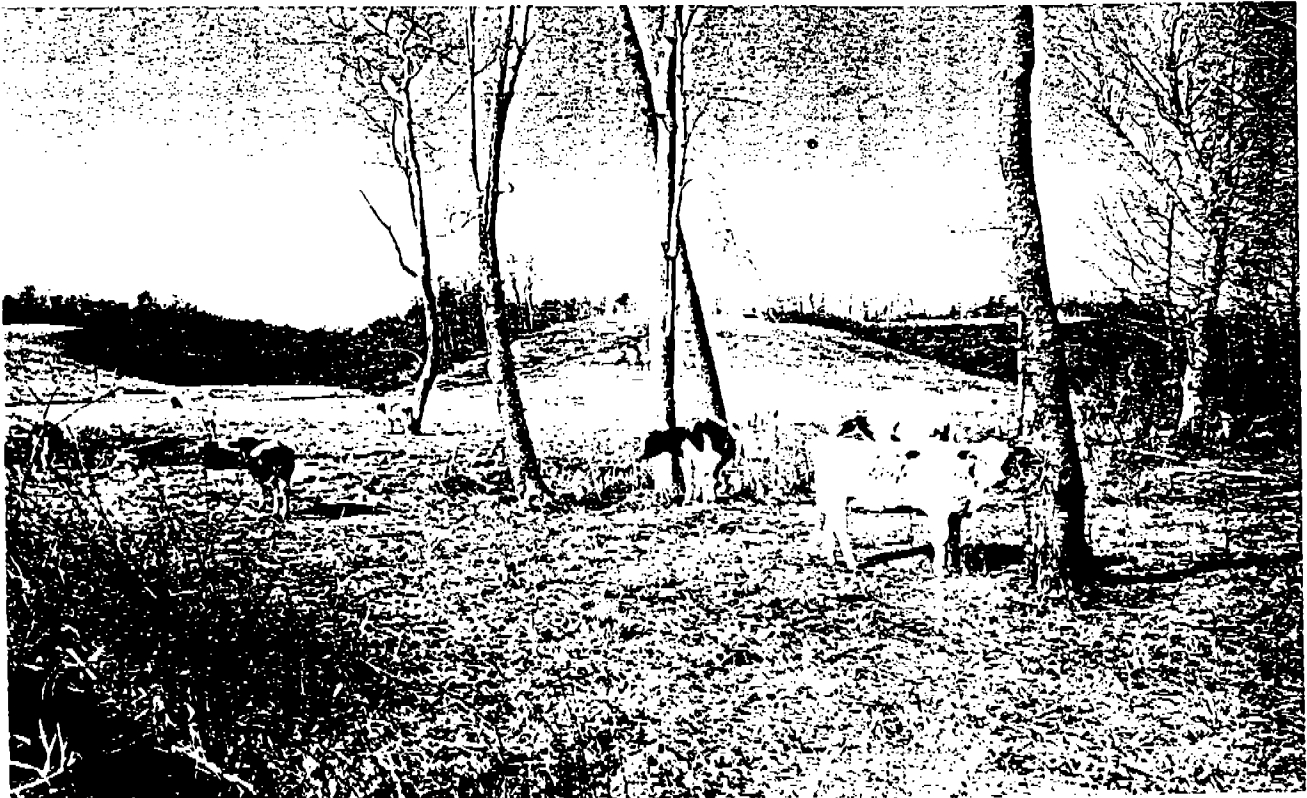
Figure 4. View of site showing excavated watering areas being used by livestock.

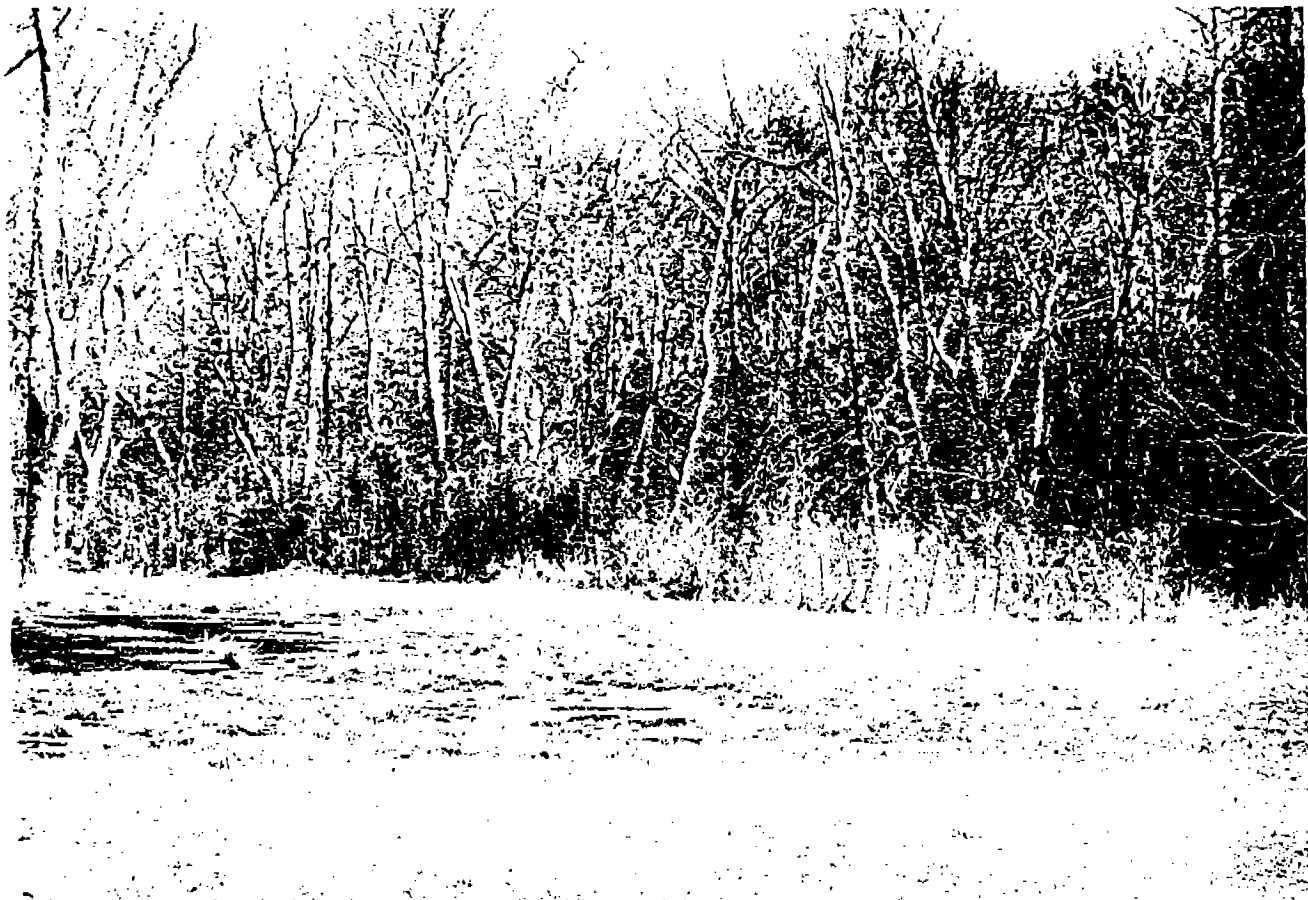
Figure 5. View of site showing strip of vegetation between pasture and Drowning Creek.

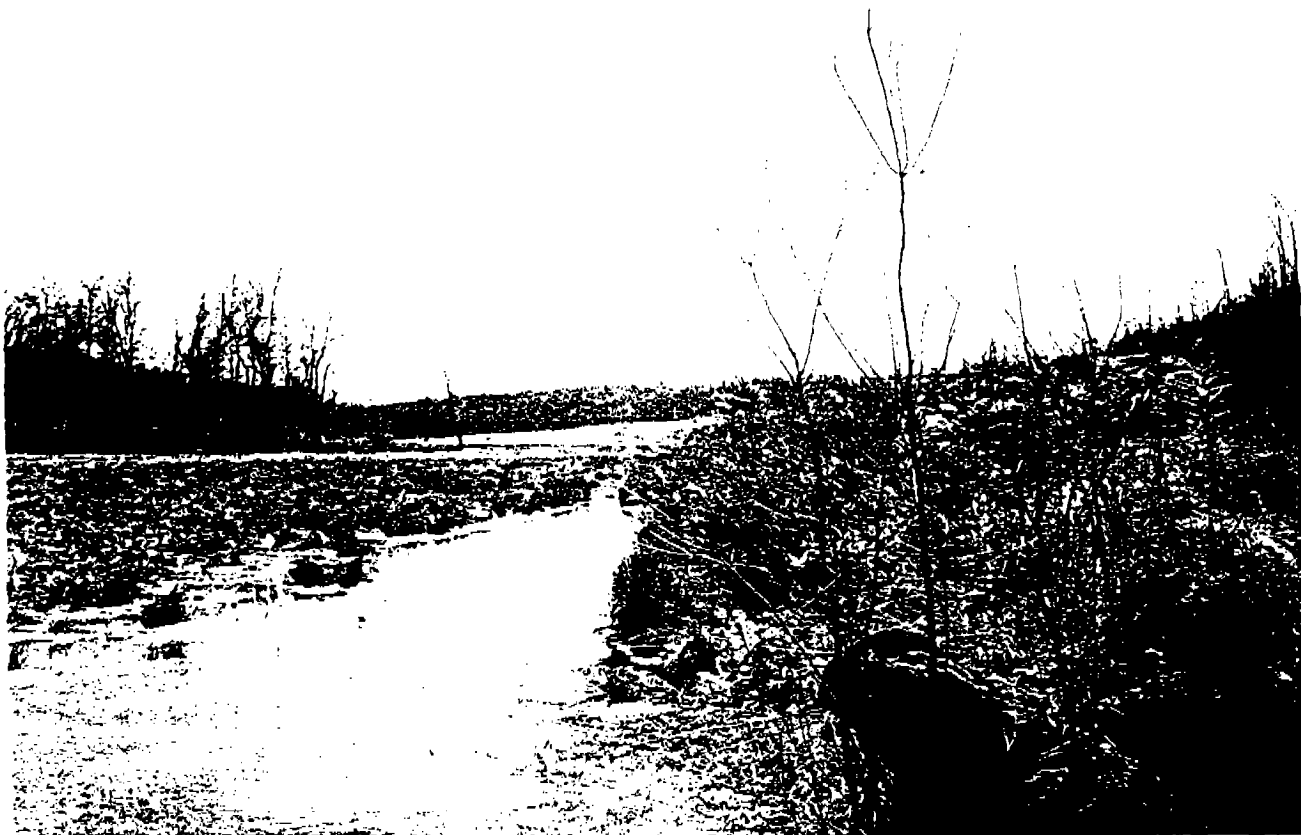
Figure 6. View of rim ditch that runs across most of the site, eventually conveying surface water into Drowning Creek.

The hydrology of the site has been altered by a series of ditches that were excavated to facilitate the production of livestock forage. Along the western boundary of the site, a rim ditch that runs approximately North – South (Figure 6) intercepts runoff that would flow across the site from the adjacent uplands and channels it to Drowning Creek. Other ditches (Figure 7) have been dug in the internal portions of the site for the purpose of removing surface water following rainfall events. Ditches and drainage tiles can be somewhat effective in lowering groundwater levels in soils such as Atkins as subsurface water flows laterally toward them. Whereas deep ditches can lower the groundwater table for a considerable distance, those at the proposed mitigation site are quite shallow and have not had a significant effect of groundwater hydrology. Based on wetland indicator status of the dominant plants and field observations of the water table, almost all the site that historically had been wetland apparently has retained sufficient hydrology to

To enhance the hydrology of the site and return it to pre-alteration conditions, the ditches on the site will be filled. This will prevent the drainage of surface water and will restore groundwater hydrology
