Final Report

Dike D Buttress Construction and
Slope Inclinometers
Kingston Fossil Plant
Harriman, Roane County,
Tennessee

Prepared for:
Tennessee Valley Authority
Chattanooga, Tennessee

June 23, 2009

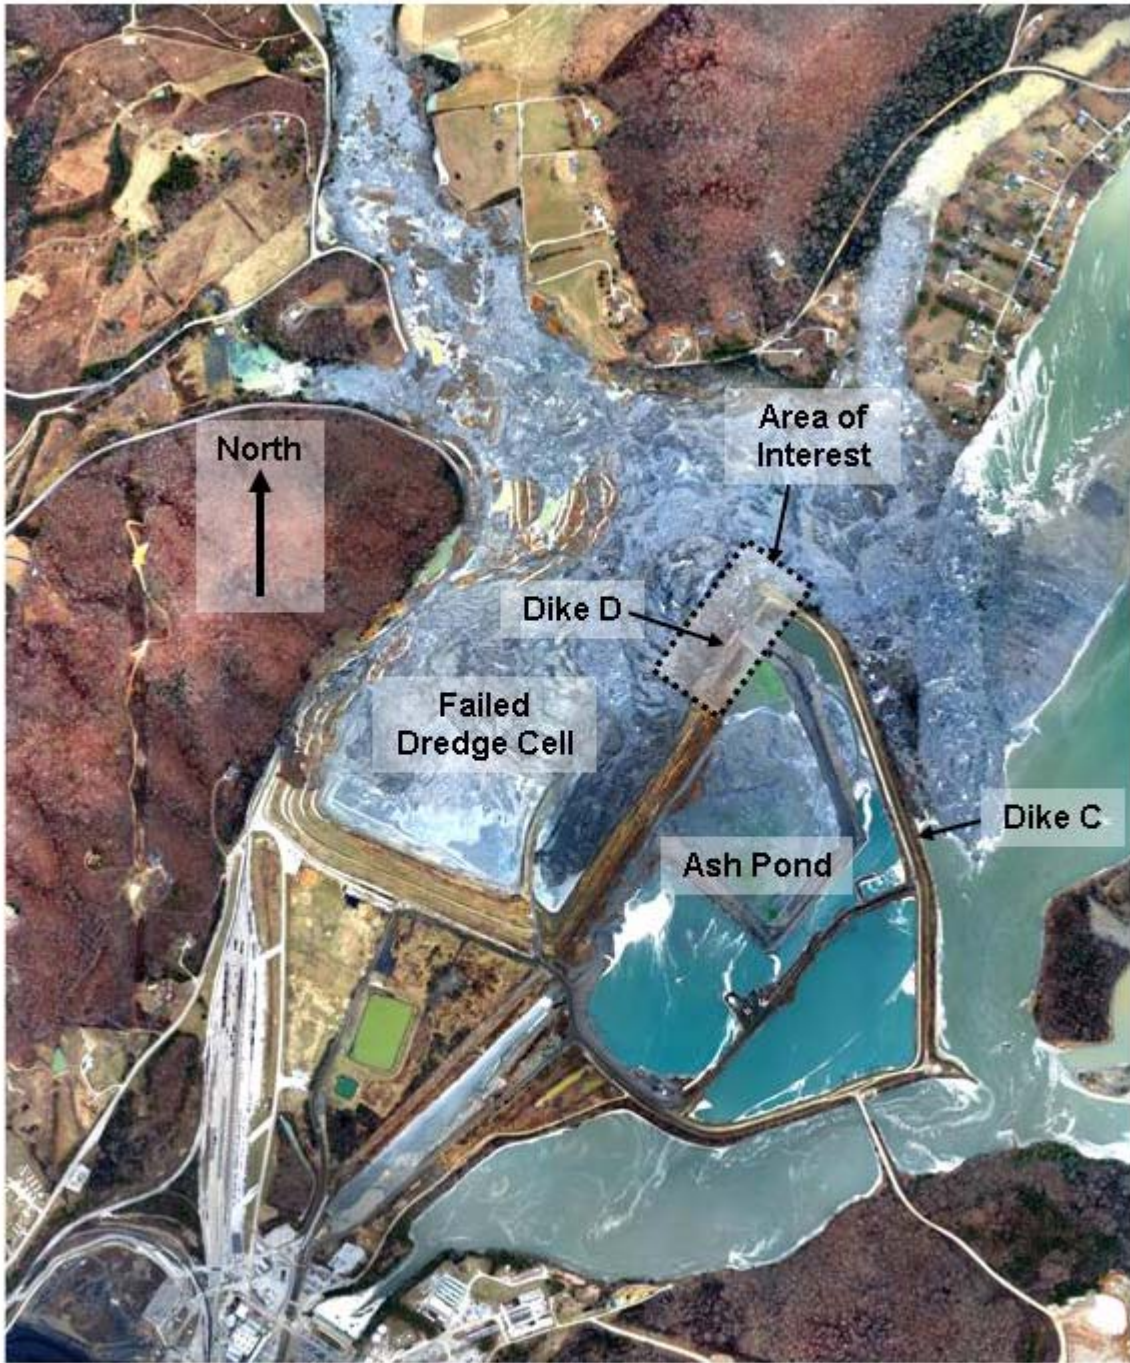
**Figure 1. Kingston Fossil Plant
Dredge Cell Failure (photo from
TVA)**

During the early morning hours of December 22, 2008, a failure occurred at the northern portion of the ash dredge cell at the Kingston Fossil (KIF) Plant in Harriman, Roane County, Tennessee. The failure resulted in a release of significant amounts of coal ash slurry into the adjacent Emory and Clinch Rivers.

The failed dredge cell is located on the northeastern side of the KIF property, just north of the main ash pond (Figure 1). Dike D trends northeast-southwest and separated the dredge cell from the ash pond. Although Dike D did not fail (i.e., the ash pond was not breached), a significant portion of the embankment was eroded during the failure of the dredge cell. The movement of material out of the dredge cell removed large portions of the dike cross section on the dredge cell side of the crest. Post failure, the dredge cell side of this portion of Dike D exhibited near vertical scarps roughly 8 to 15 feet in height and tension cracks parallel and perpendicular to the dike alignment at various locations along the crest. Additionally, the dredge cell failure damaged the northern end of the remaining portion of Dike C (which surrounds the other sides of the ash pond) near its intersection with Dike D.

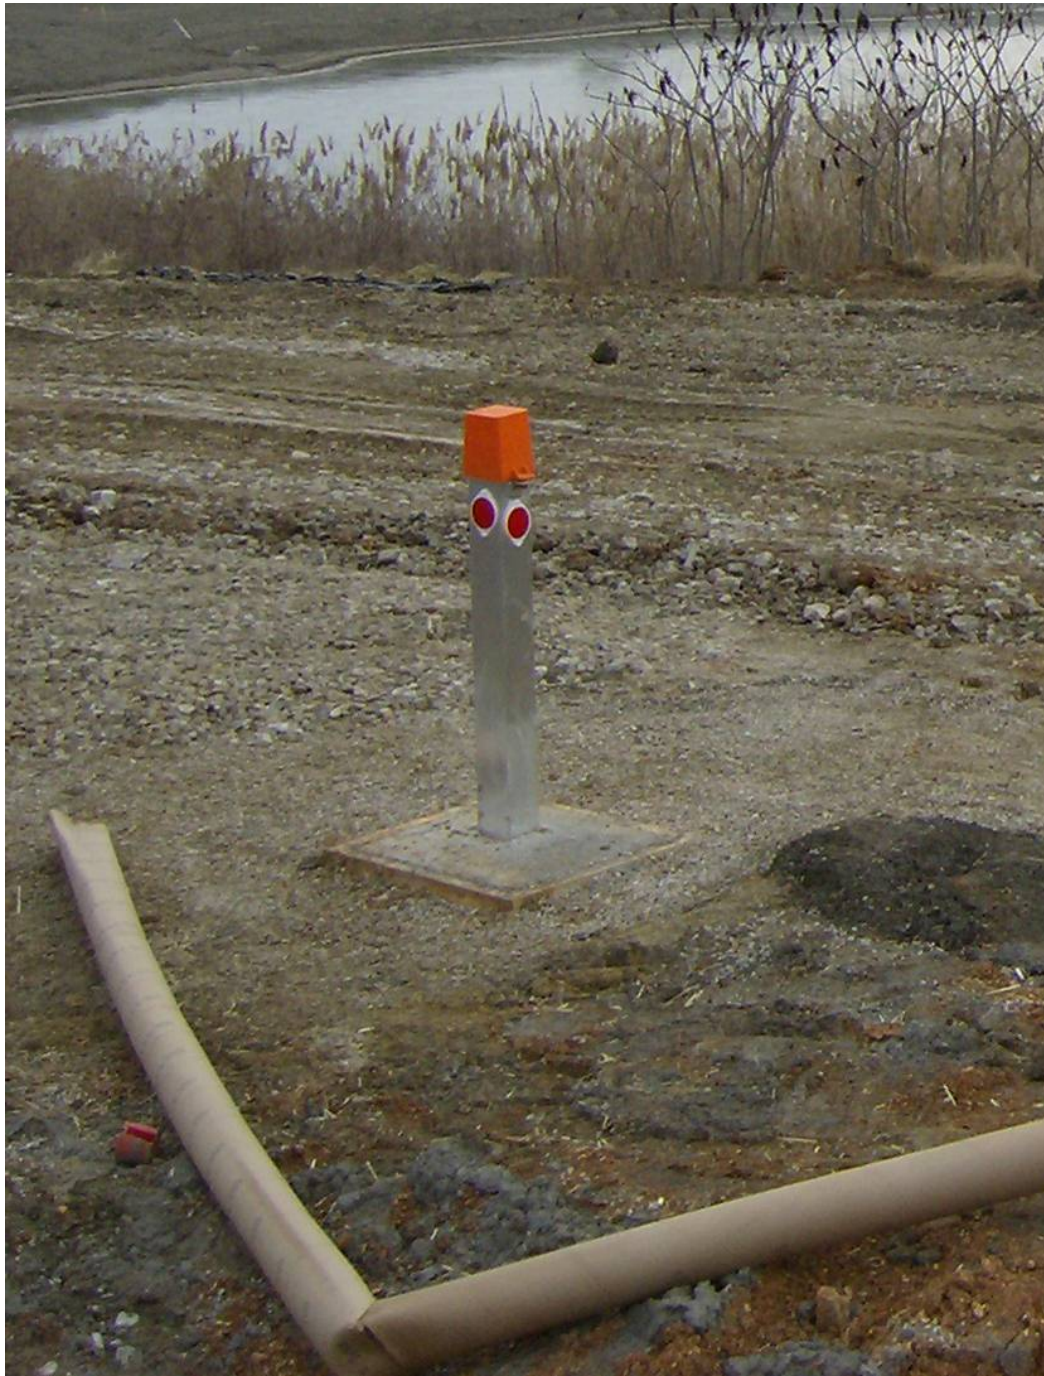
A 2.75-inch (ID) plastic inclinometer casing was then placed through the hollow stem auger to within a few inches of the bottom of the boring. The inclinometer casing includes two perpendicular tracks (A-axis and B-axis) to accommodate the inclinometer probe. Measurements can then be reported in terms of movement in the A-direction (for this project, A0 is positive direction, A180 is negative) and B-direction (for this project, B0 is positive, B180 is negative). The orientation (bearing) of the A0 axis was noted using a magnetic compass. The annulus between the casing and the borehole wall was backfilled using No. 4 gravel. After backfilling, slope inclinometer construction was completed with a concrete surface seal and locking steel protective cover (see Figure 3).

**Figure 3. Typical Slope Inclinometer
Surface Protection**

As described in Section 2, on February 5, 2009, the surface protection for slope inclinometer B-4 was damaged due to impact from a Contractor's piece of equipment. B-4 was temporarily unavailable for data collection. On February 24, Stantec removed the damaged surface protection and installed a new flush mount manhole and concrete pad. The installation was renamed B-4A for future data collection.

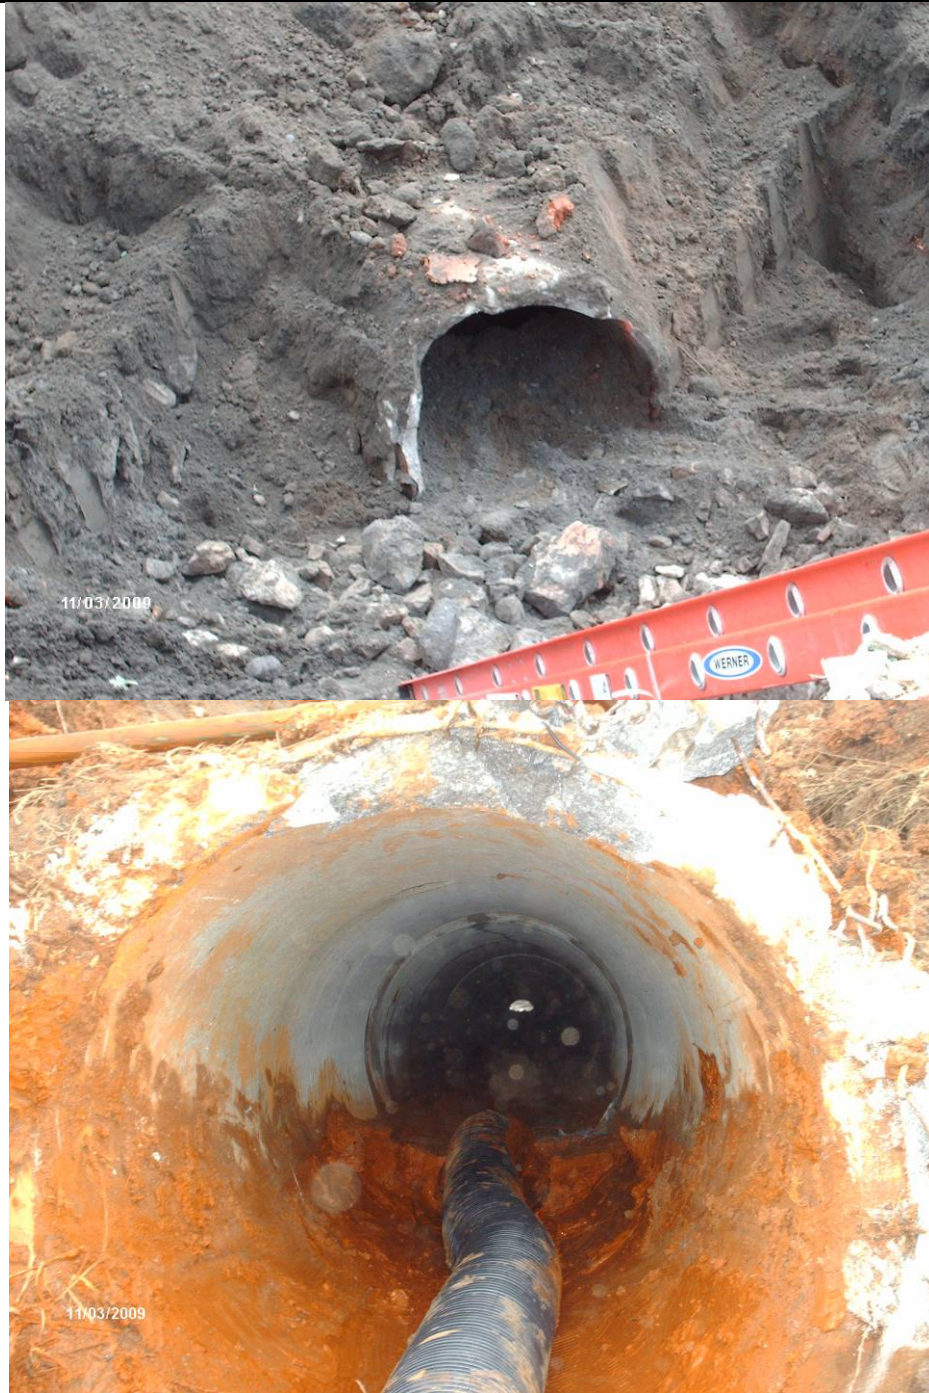
**Figure 10. Exposed Buttress End of
Concrete Pipe (top) and Vacuum
Cleanout of Concrete Pipe
(bottom)**

As mentioned previously, two pipes penetrated Dike D along the length of the buttress. It is our understanding that the pipes were not actively used at the time of dredge cell failure, but had been used previously to convey surface water from the dredge cell to the ash pond. After considering various options to abandon or remove the pipes, TVA directed Stantec to develop construction documents (see Appendix C) to temporarily grout the two pipes in place, with grout being pumped in from the uphill (dredge cell) ends of the pipes. TVA planned to return in the future, as part of the closure plan, to remove both pipes and replace with an engineered backfill. Due to the sequence of construction, grouting from the uphill end required a rather large excavation through the recently placed buttress material, followed by backfilling to replace the buttress material and regrading of the surface. In general, the pipe grouting efforts consisted of the following major components:

- Excavate soil and ash to expose both ends of each pipe.
- Clean the pipe interior by jetting or other method, to remove loose sediment and/or debris.
- Install a sacrificial bulkhead at the downhill (ash pond) end of each pipe
- Insert tremie pipe(s) from the uphill end into the pipe, terminating at the downhill end (near the bulkhead). Pump cement-bentonite grout into the pipe, until the pipe is full (based on grout return at the uphill end).
- After the grout is set, backfill excavations and restore surfaces to match adjacent grades.

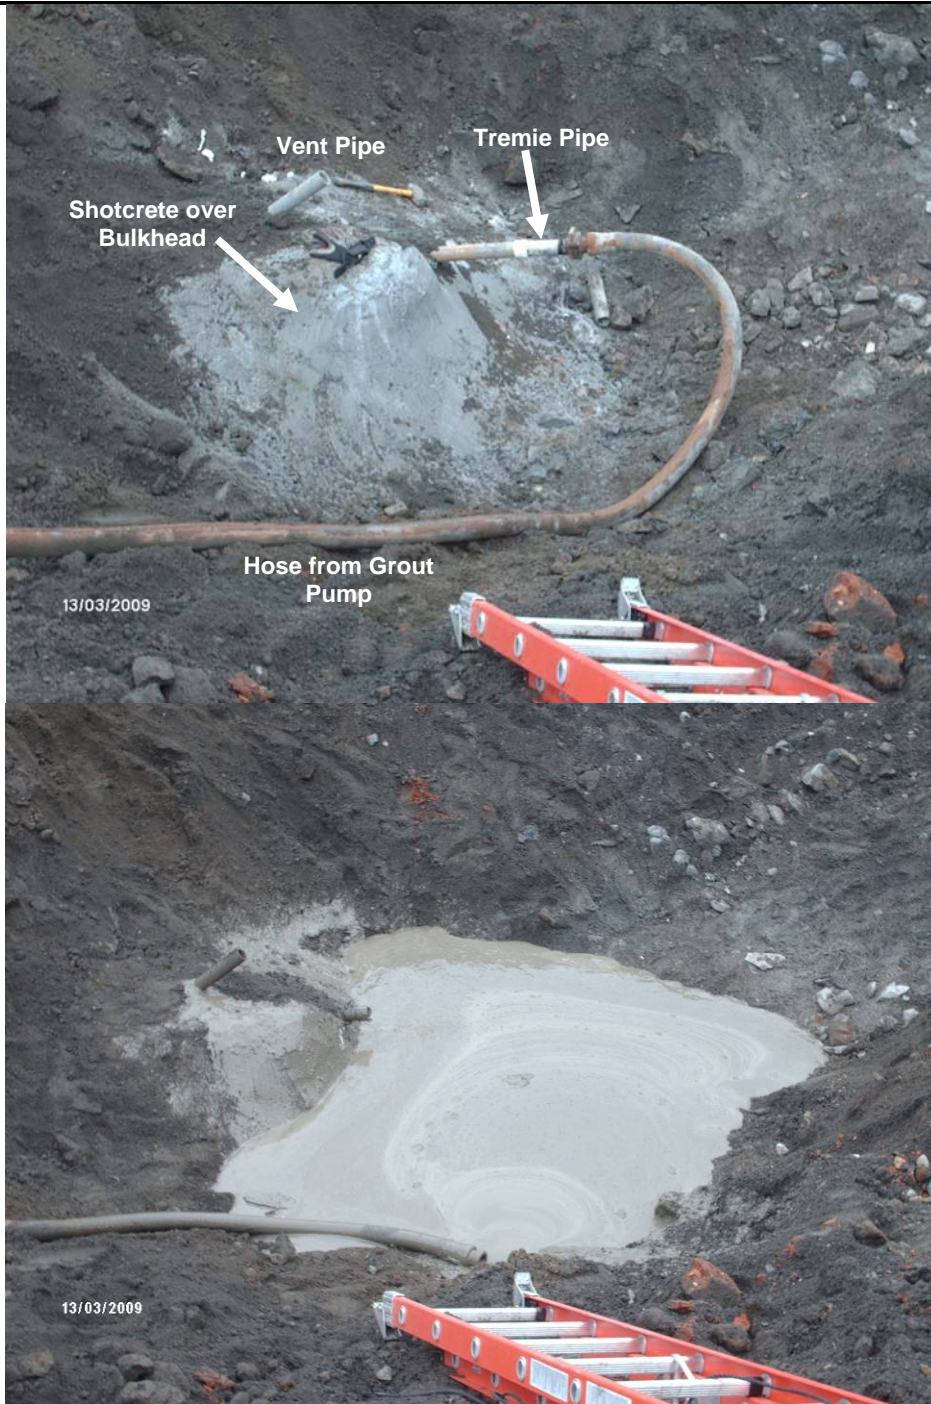
**Figure 12. Grout Pumping (top) and
 Grout Return at Uphill End
 (bottom)**

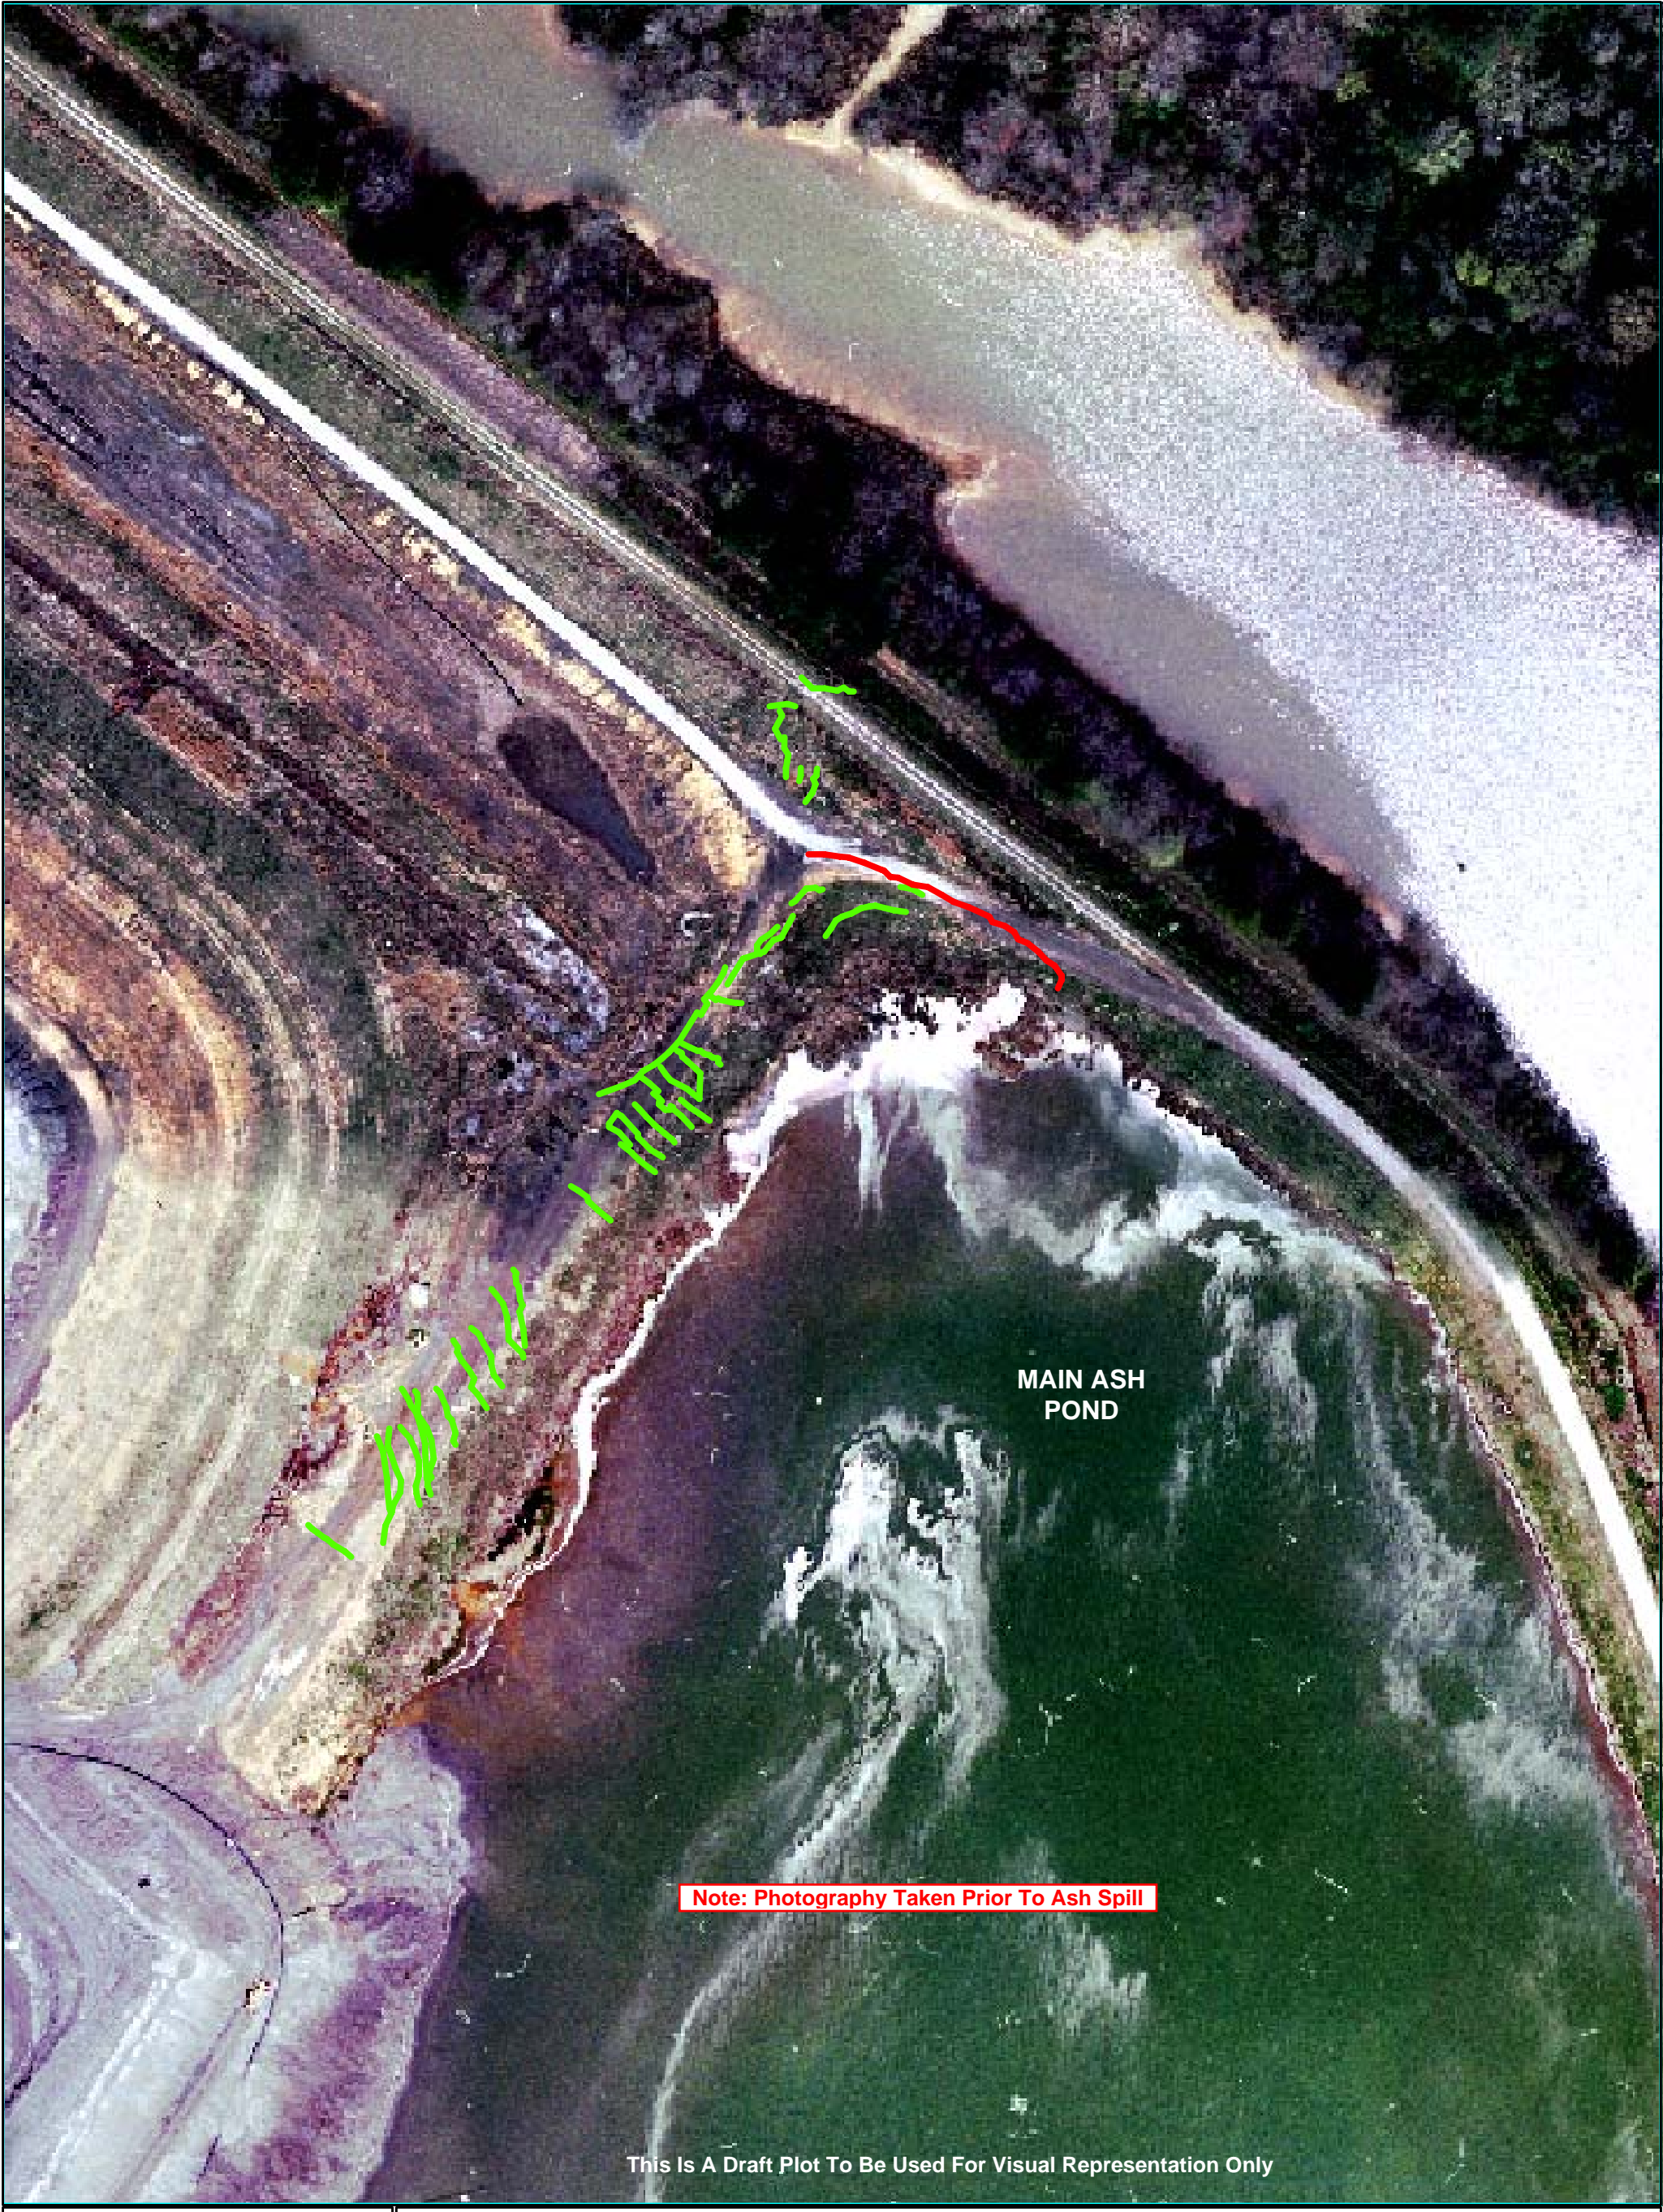
KINGSTON FOSSIL PLANT
 DECEMBER 2008 DREDGE CELL FAILURE
 LOCATION OF SURVEYED TENSION & COMPRESSION CRACKS
 29 DECEMBER 2008 - PROJECT: TBK776

As a result of the dredge cell failure, the adjacent segments of Dikes C and D sustained many visible tension and compression cracks, which was one factor in TVA's decision to provide for emergency monitoring and stabilization of this area. TVA surveyors mapped these cracks on December 22-23, 2008, and provided a sketch of the cracks and the survey data to Stantec, as shown in Appendix A.

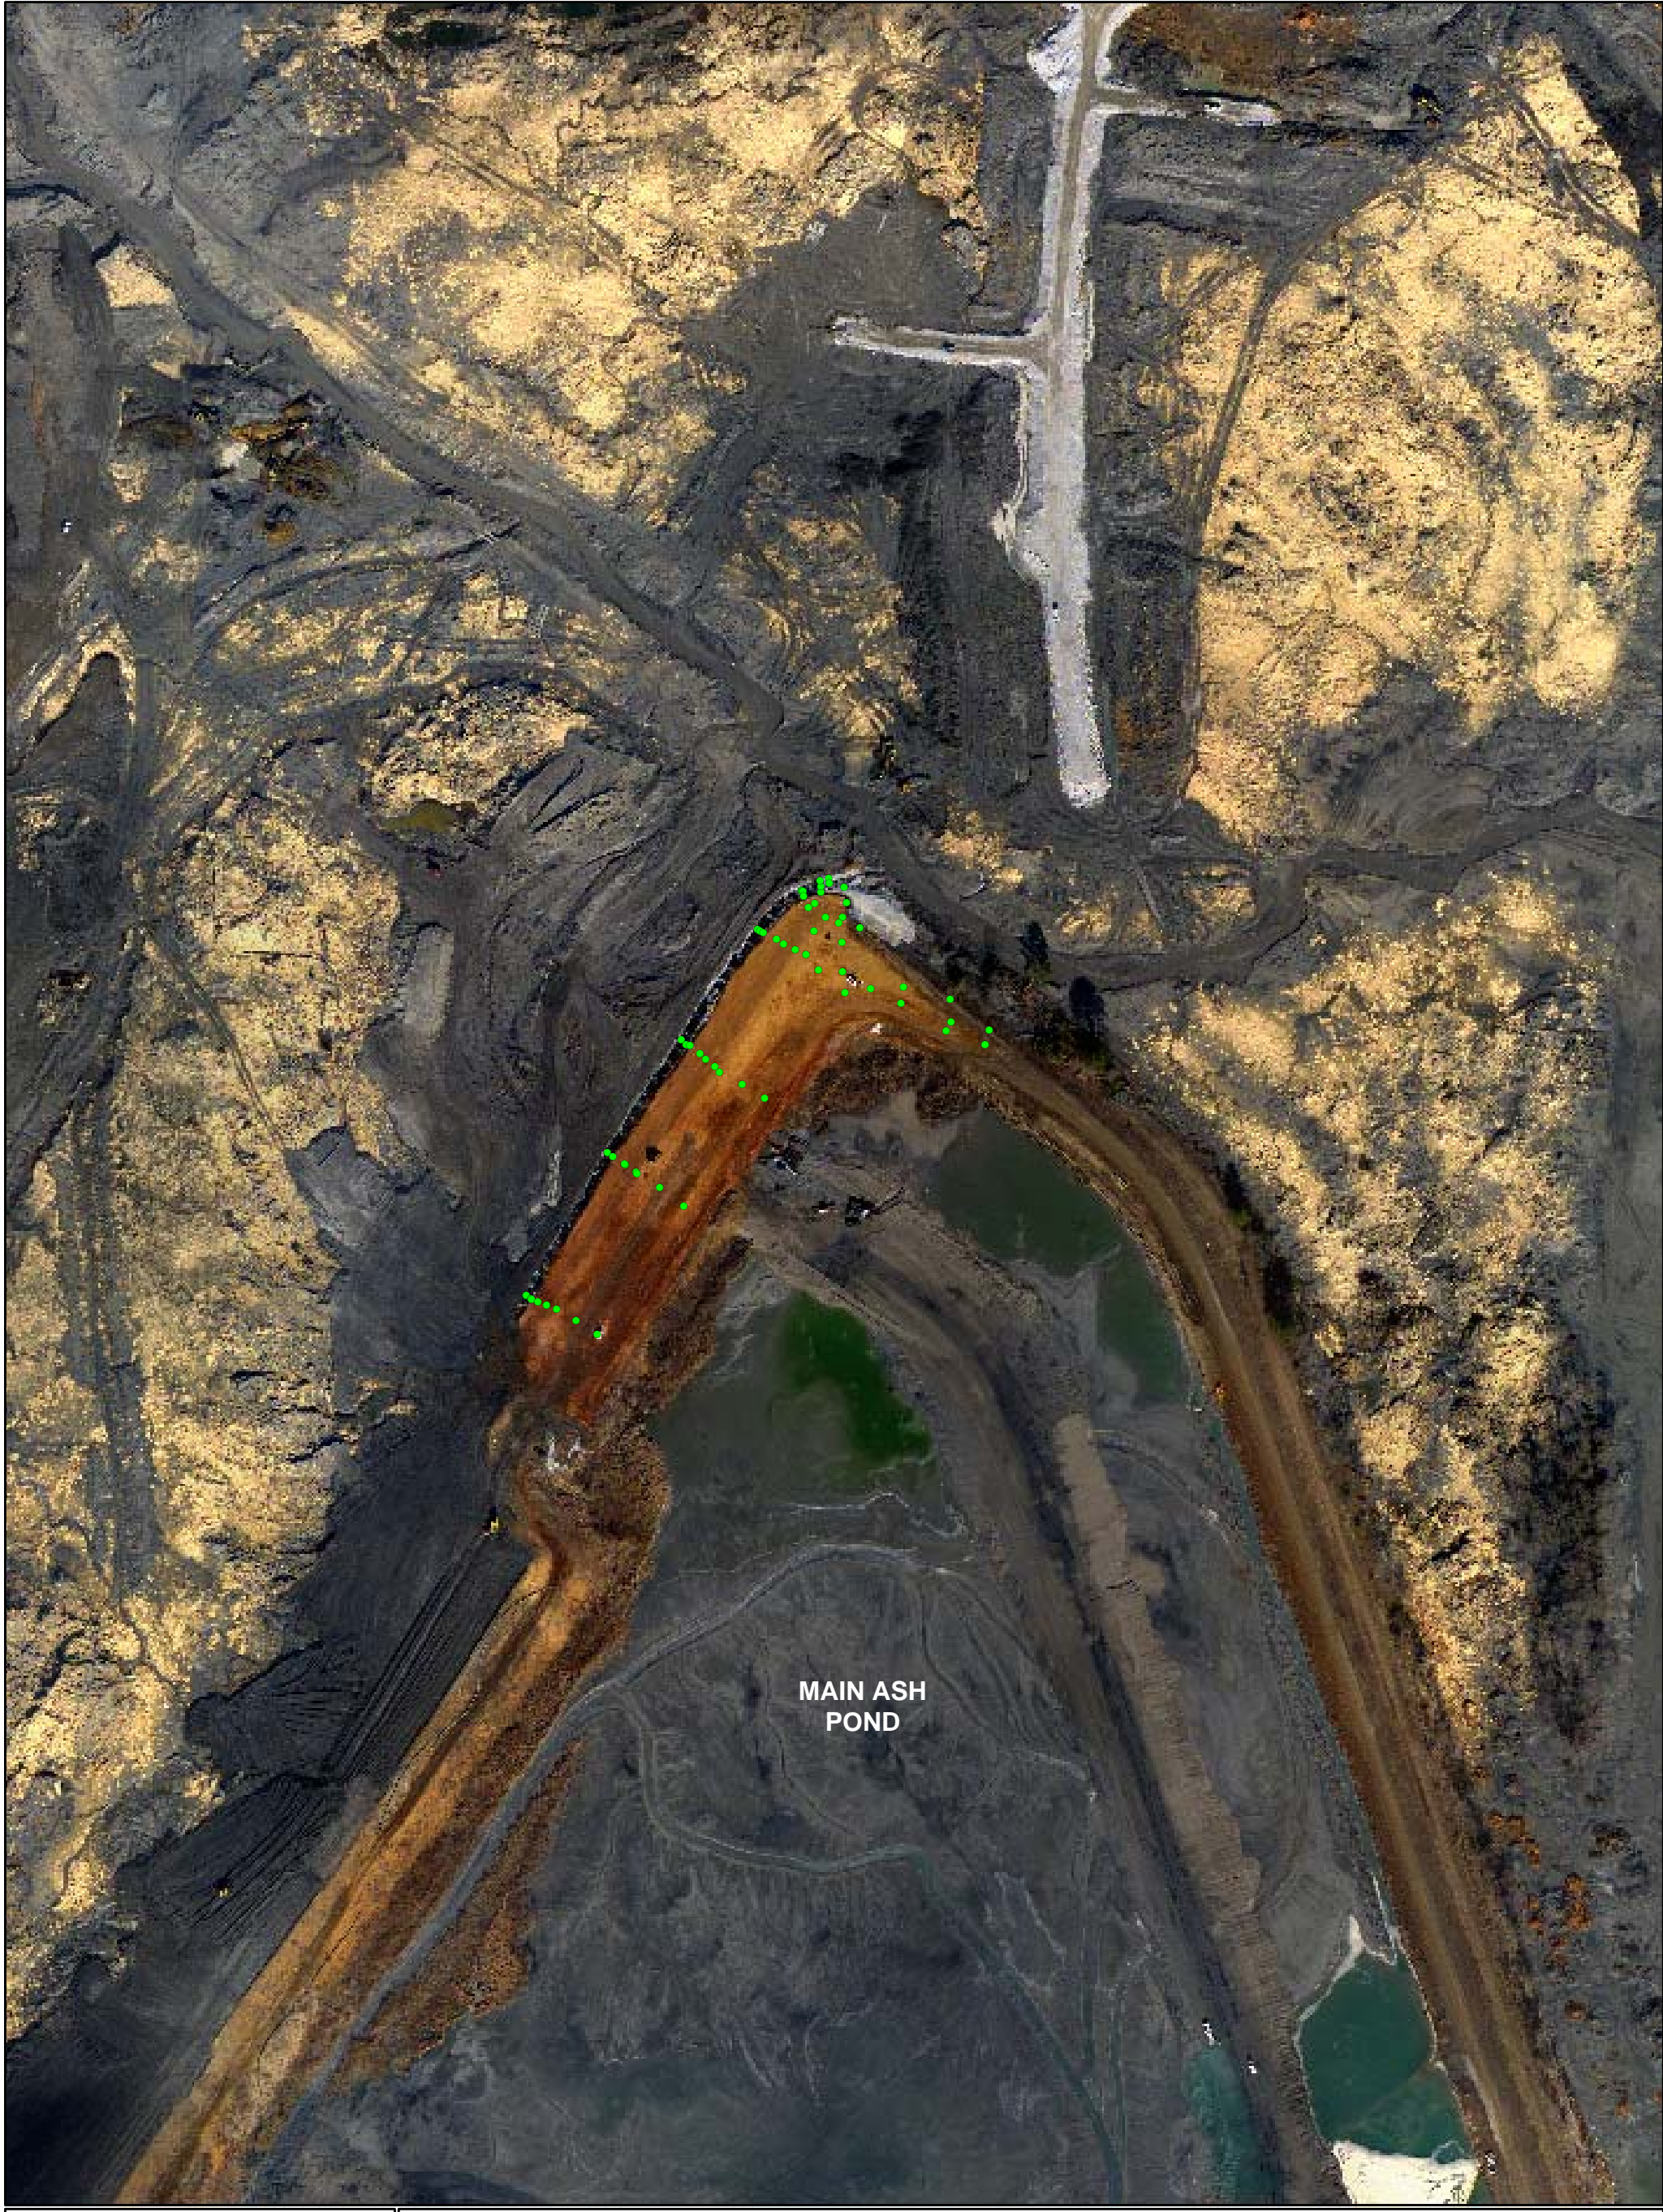
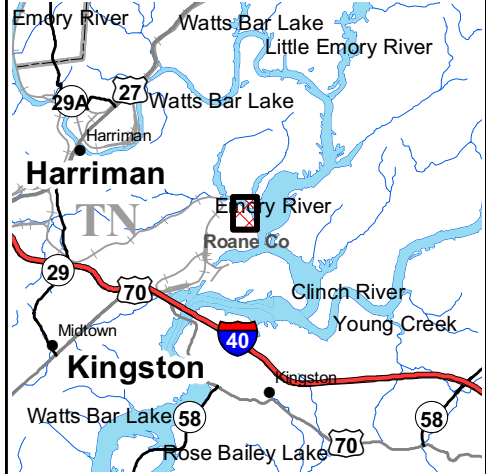
KINGSTON FOSSIL PLANT
 DECEMBER 2008 DREDGE CELL FAILURE
 AS BUILT INTERIM STABILIZATION BERM (DIKE D)
 TOPOGRAPHY
 24 JANUARY 2009 PROJECT: TBK776
