Report of Phase 2
Geotechnical Exploration
Ash Pond Complex
Widows Creek Fossil Plant
Stevenson, Alabama

Prepared for:
Tennessee Valley Authority
Chattanooga, Tennessee

February 4, 2010

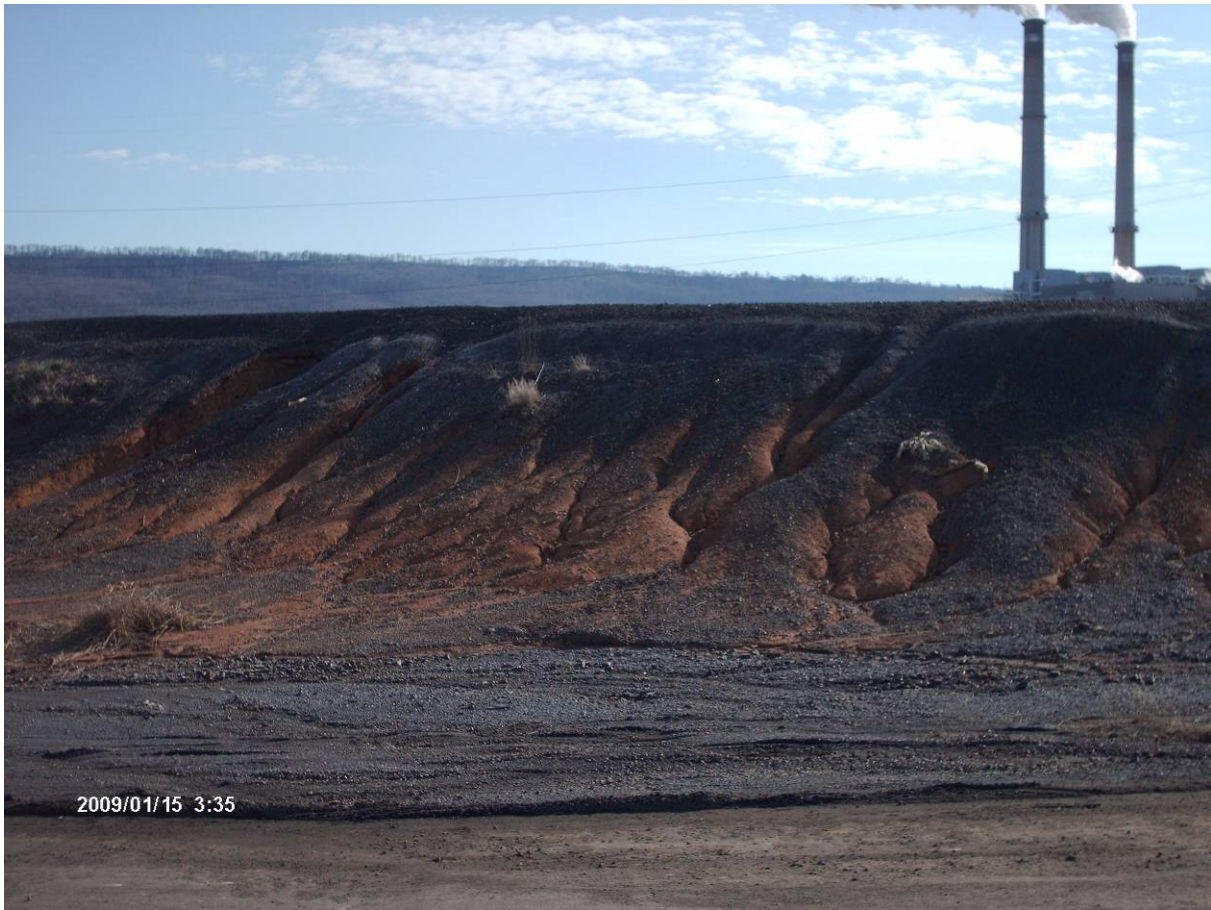
At this time, the only surface water control located around the ash pond complex is along the Scrubber Road. The perimeter side slopes show signs of erosion along the crest and perimeter dikes due little or no surface water control. The current dike conditions are depicted below in Figures 12 through 16.

Figure 12. Typical Rill Erosion, 2009

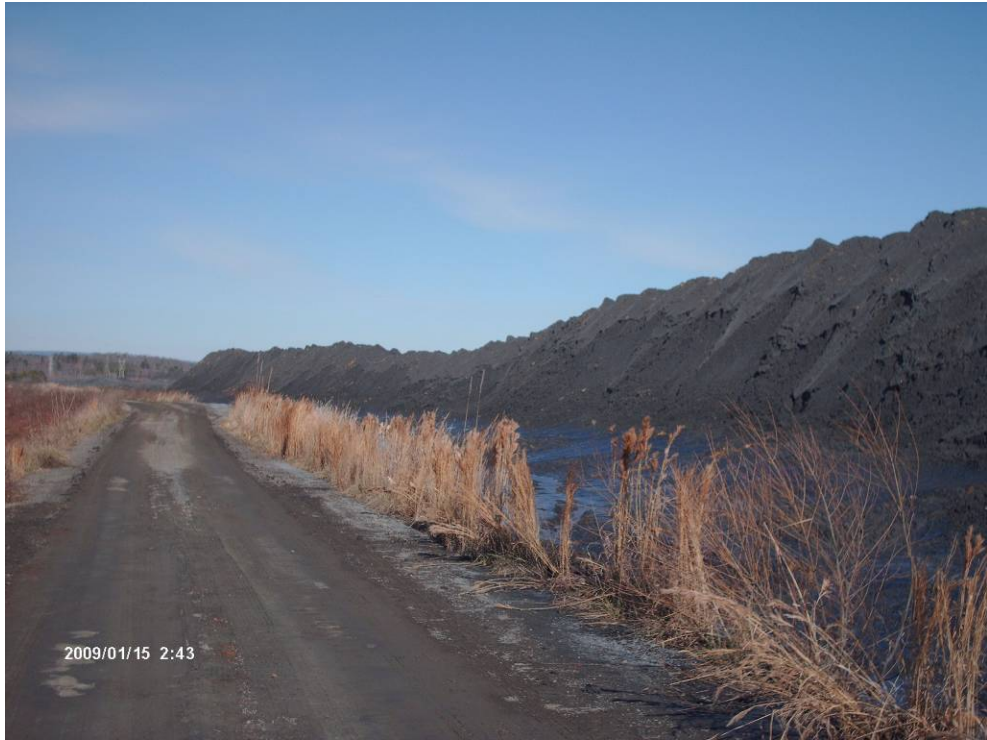
Figure 13. Typical Surface Ditch, 2009

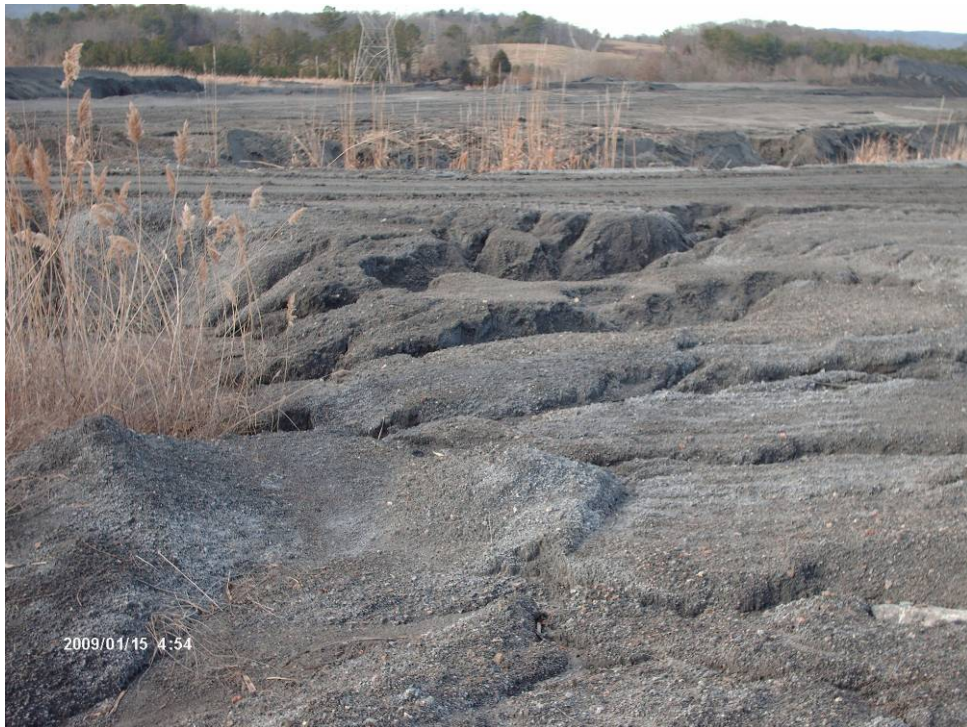
Figure 14. Typical Roadway/Surface Rills, 2009

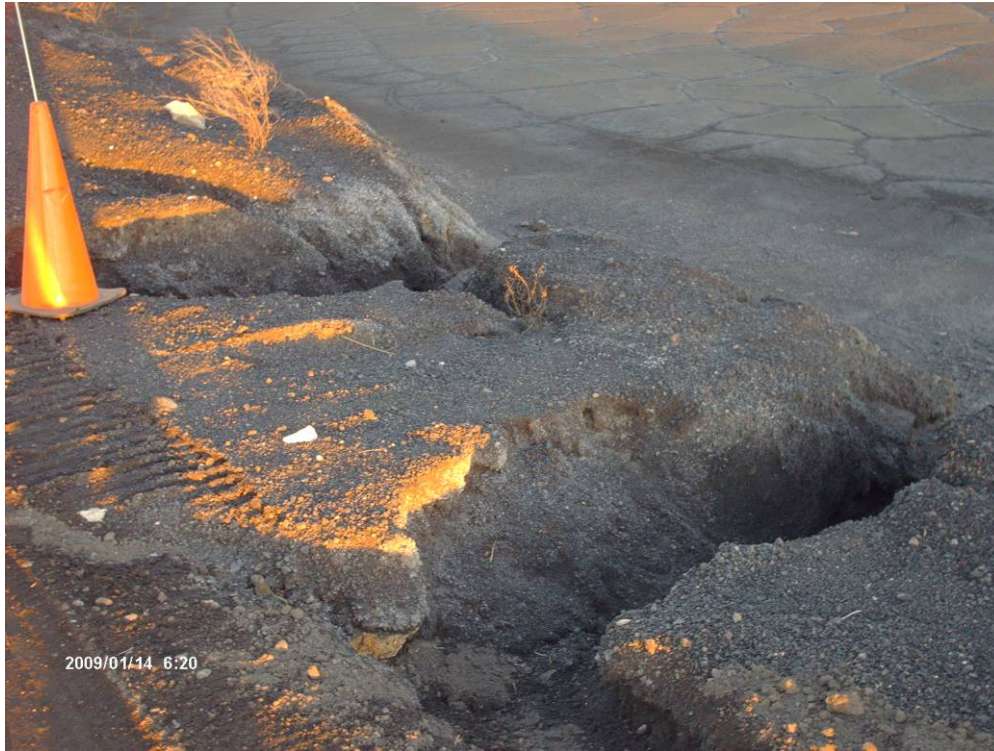
Figure 15. Erosion Along Crest of Dredge Cell, 2009

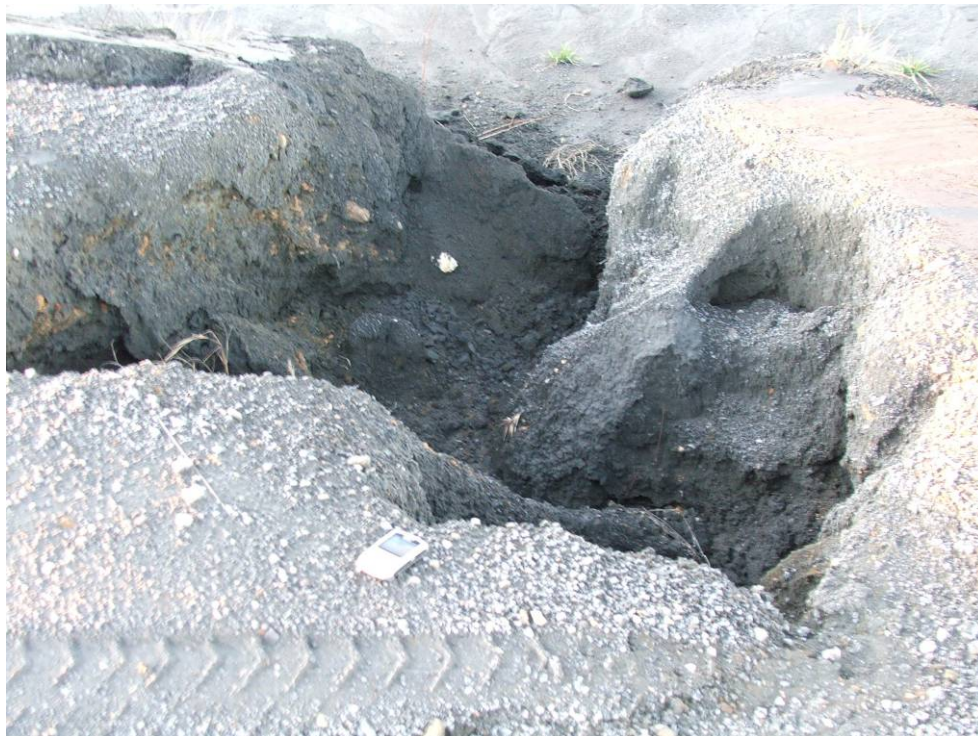
Figure 16. Erosion Along Crest of Dredge Cell, 2009

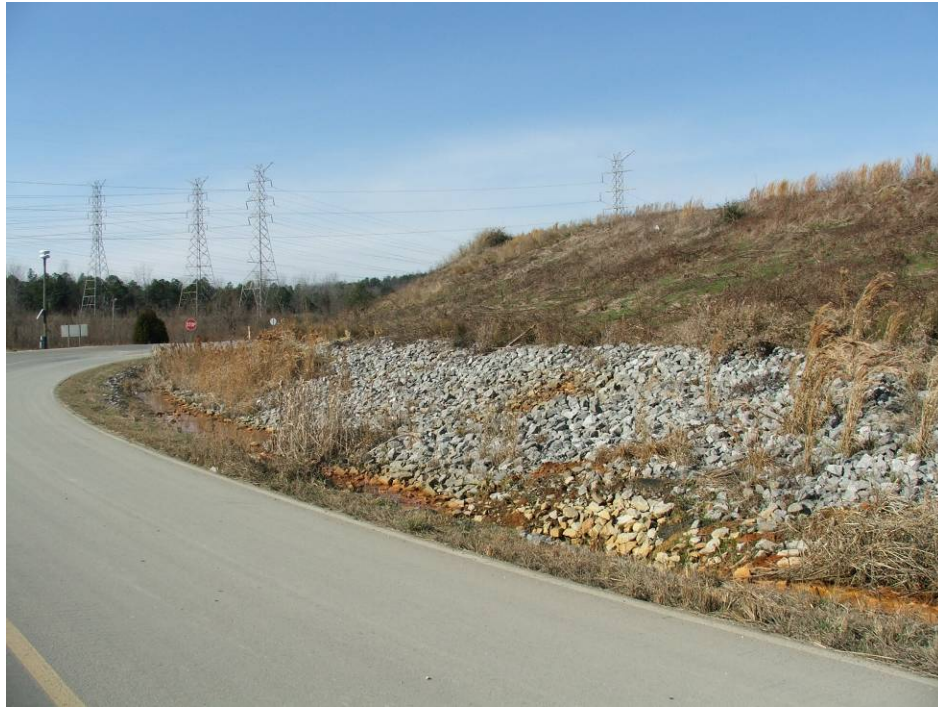
As discussed above, excessive seepage and high pore water pressures have been reported around the southern embankment of the Bottom Ash Stack near the Chemical Ponds. As a result of the excessive pore pressures, a slurry cutoff wall was installed in 1984 and ongoing seepage monitoring has been performed by TVA. This area continues to be a recurring problem, as noted in the annual inspections and as observed by Stantec during the 2009 field exploration. A mitigation work plan is currently under development to control the observed seepage using a graded media filter and rock toe buttress, which will increase the slope stability and control drainage in the area. The as-found site conditions for this area are shown in Figures 17 through 21.

Figure 17. Ditch/Seepage Conditions along Scrubber Road, 2009

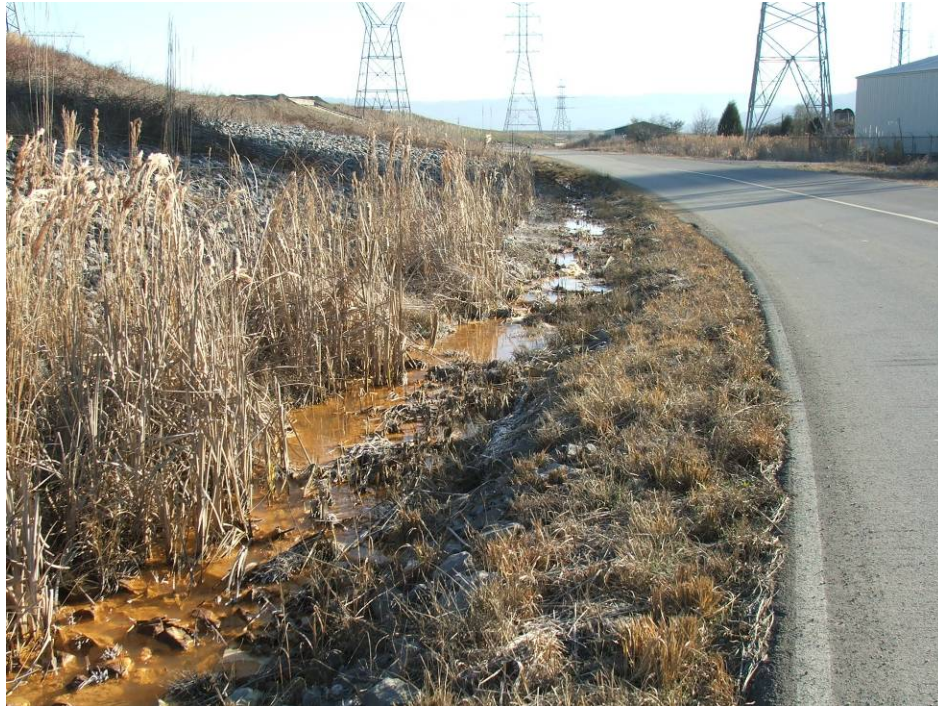
Figure 18. Ditch/Seepage Conditions along Scrubber Road, 2009

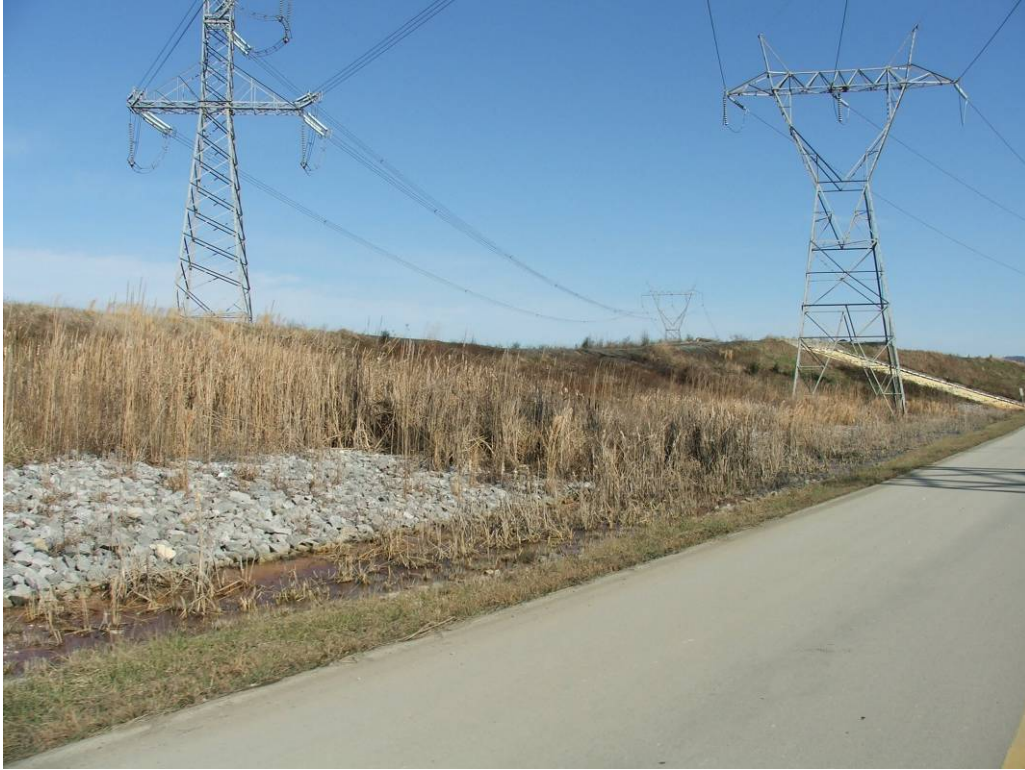
Figure 19. Ditch/Seepage Conditions Scrubber Road, 2009

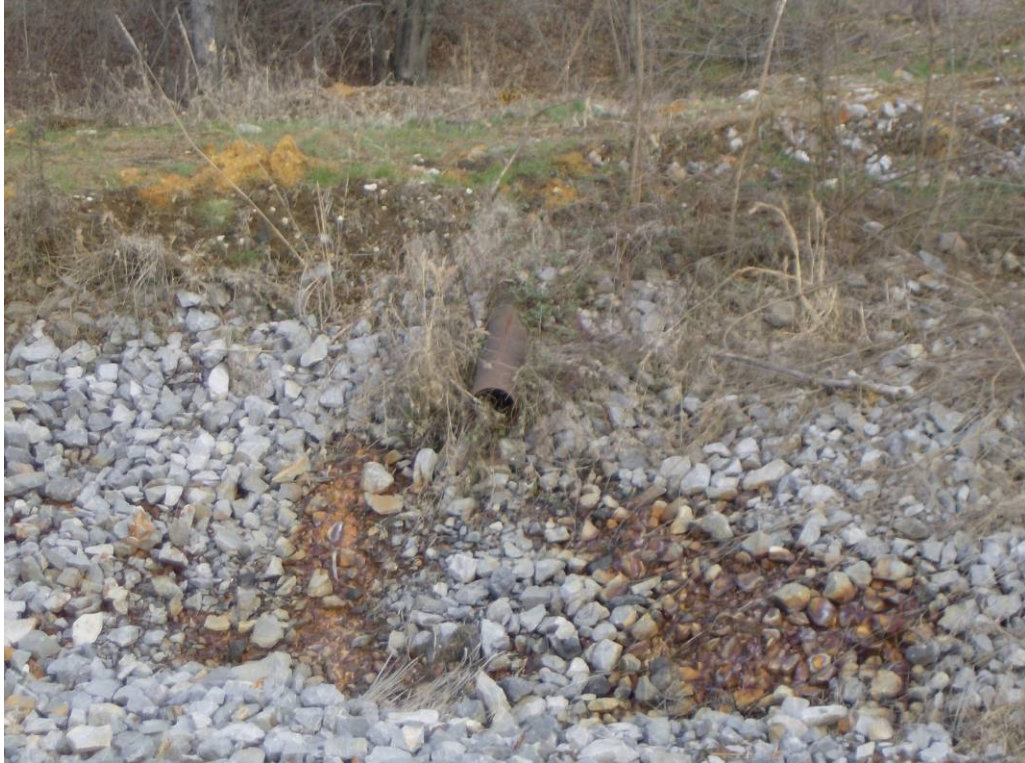
Figure 20. Discharge Pipe along Scrubber Road, 2009

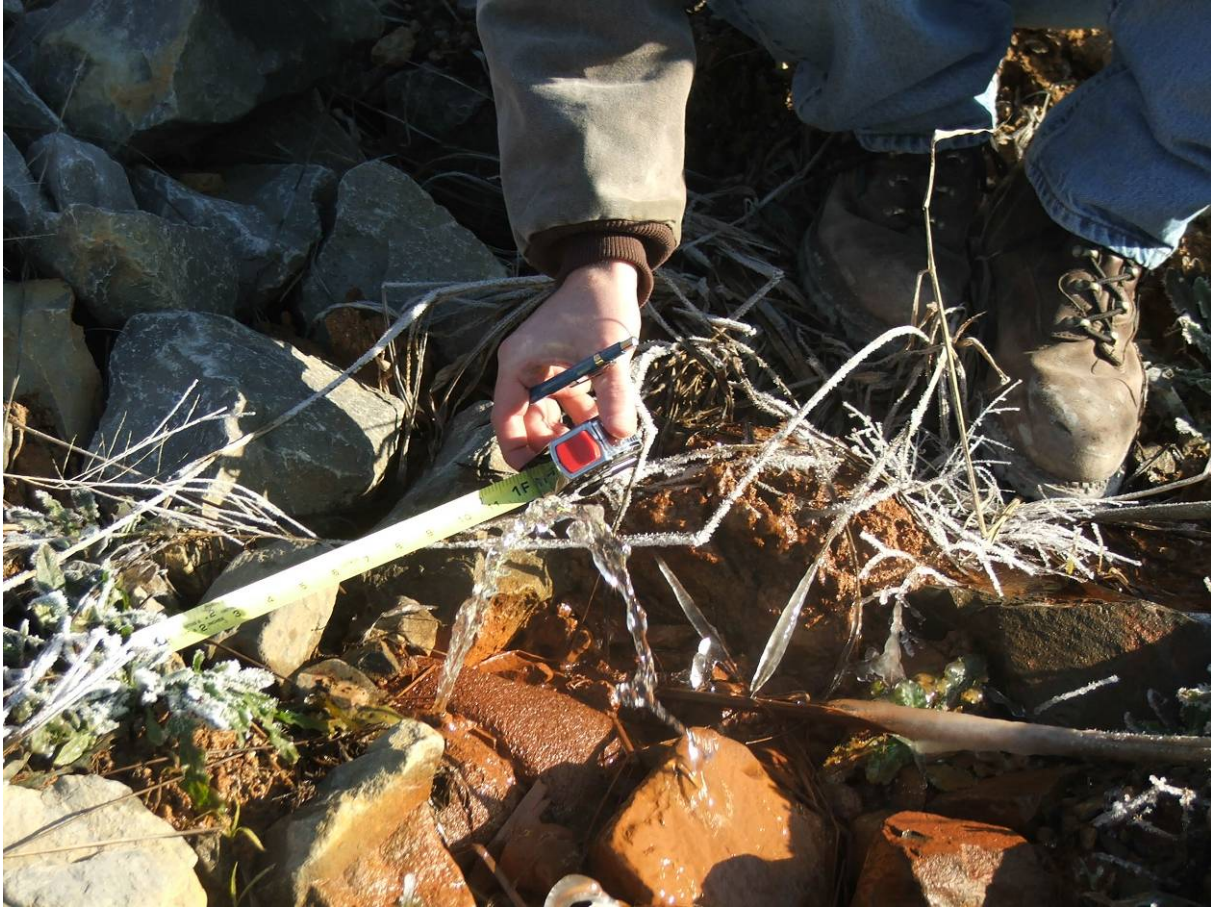
Figure 21. Seepage/Excessive Pore Pressures along Scrubber Road, 2009
