Report of Phase 2
Geotechnical Exploration
Gypsum Stack
Widows Creek Fossil Plant
Stevenson, Alabama

Prepared for:
Tennessee Valley Authority
Chattanooga, Tennessee

February 5, 2010

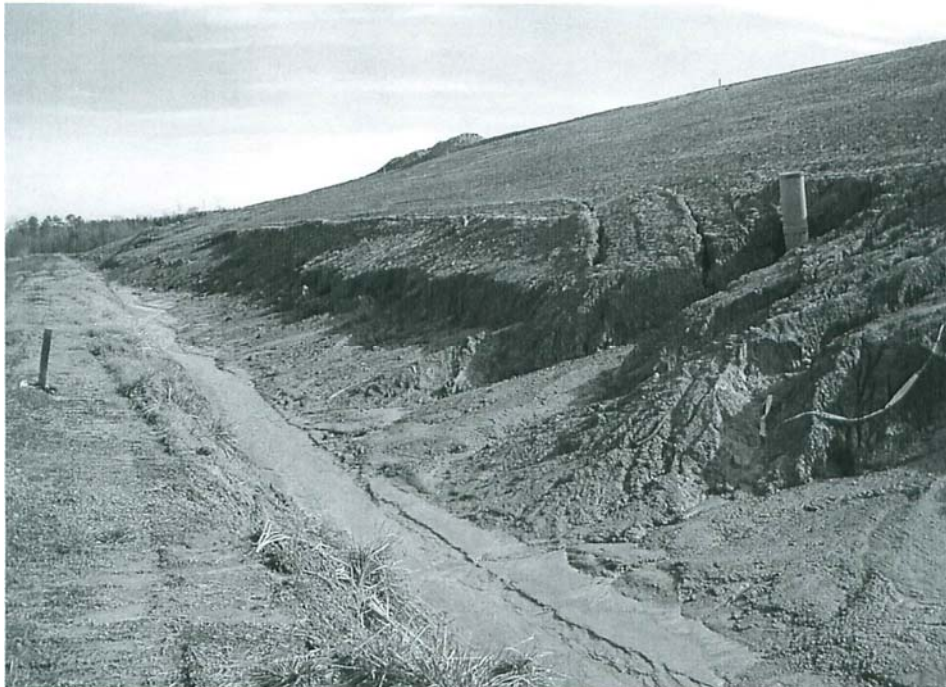
Figure 4. 2005 Site Conditions Photograph

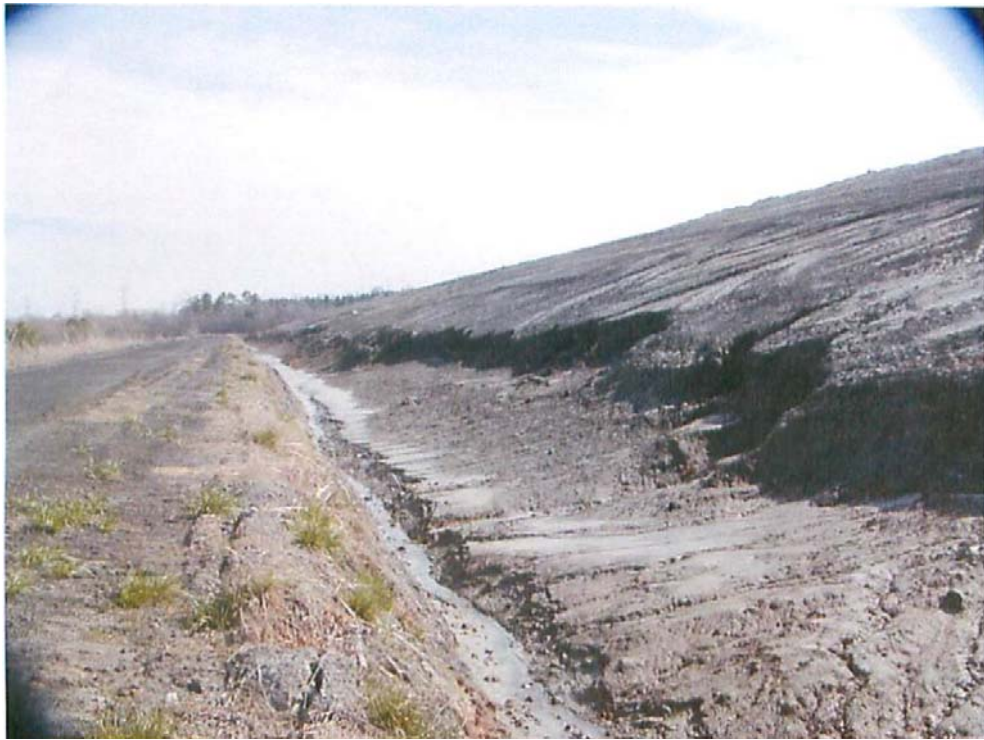
Figure 5. 2006 Site Conditions Photograph

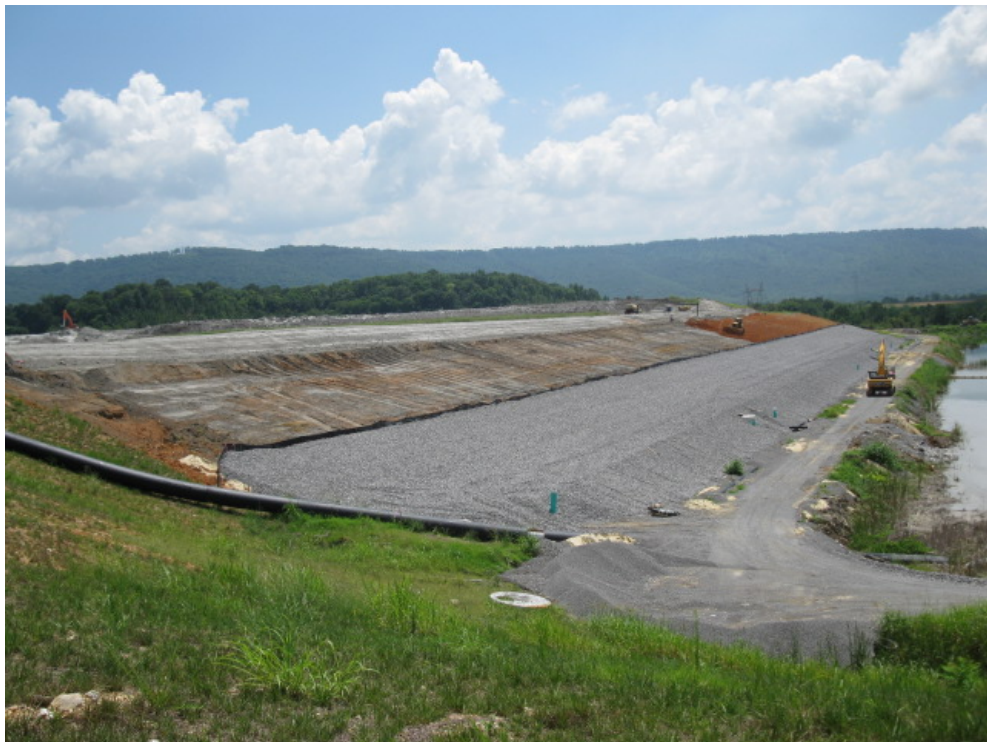
Figure 6. 2009 Site Conditions Photograph

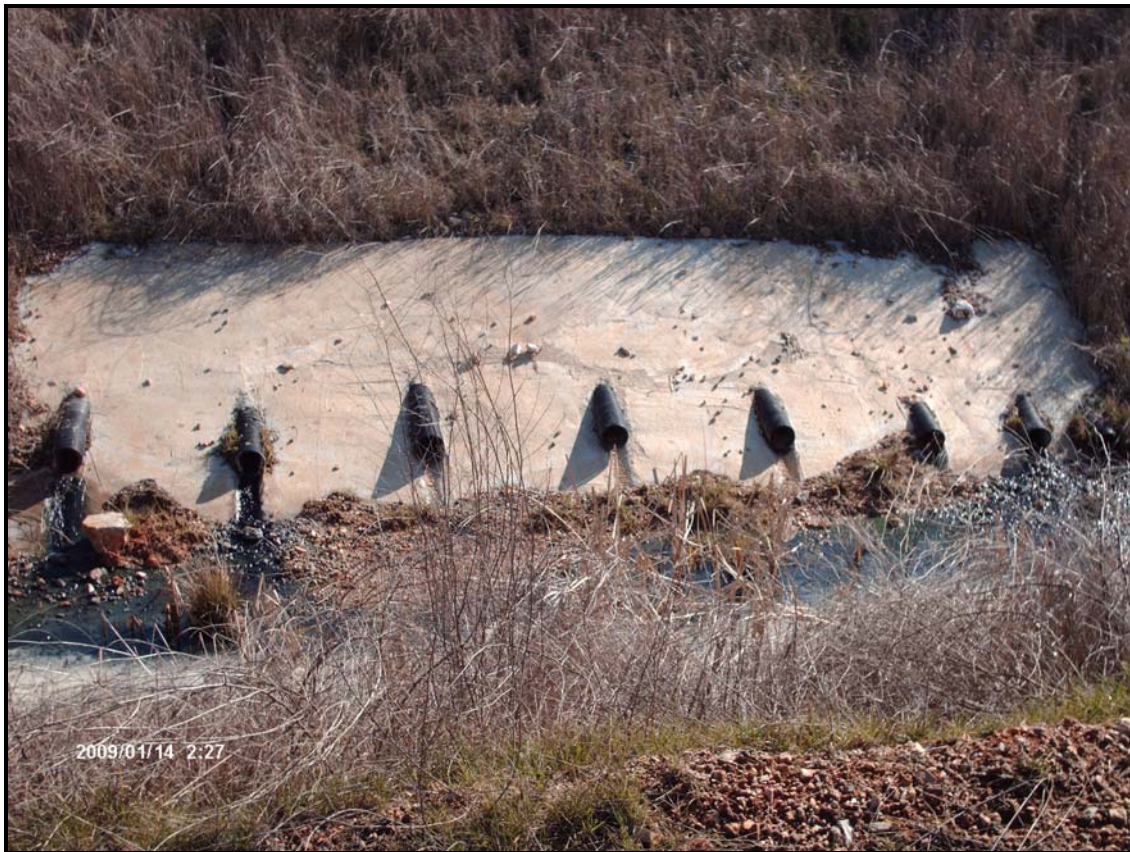
At the surface, a series of fifteen outlet structures are planned. There are eight outlet pipes for each outlet (see Figure 14). Based on the design of the slope drain and toe drain system, the two outside outlet pipes (1 and 8 as shown left to right) are connected to the toe drains, and the next two (2 and 7) are connected to the 655 bench slope drains. The middle four outlet pipes (3, 4, 5 and 6) are for the planned 685 bench and 720 bench slope drains which have not been installed.

Figure 14. Typical Outlet

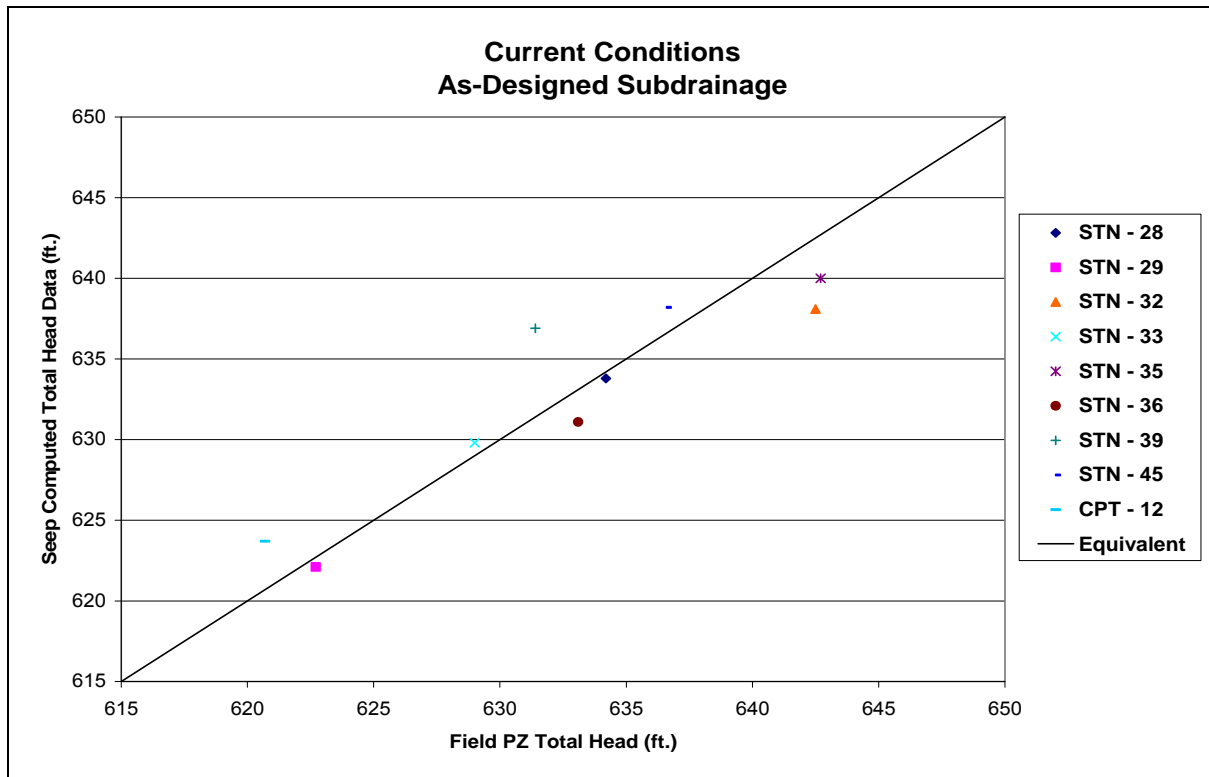
After the initial seepage parameters were estimated, results from the SEEP/W model were compared to the pore water pressures measured in piezometers installed along the Gypsum Stack. Data from nine piezometers along all five critical cross sections were used in this evaluation. Nodes were placed in the model at the same location as the piezometer tip and then the total predicted head at the node was compared to the corresponding piezometer reading.

After reviewing/comparing the results for all nine piezometers, the material properties in each modeled cross section were varied (if necessary) until a reasonable match was obtained between the predicted SEEP/W elevation and the actual field piezometer readings. The comparison between the field piezometer readings and the predicted SEEP/W values at each piezometer are plotted in Figure 16. The maximum difference between the predicted and field measured is 5.5 feet (STN-39), while most differ by less than 2 feet. Given the typical differences between the modeled cross section and the unknown the subsurface soil conditions, Stantec believes this difference is acceptable.

Figure 15. Comparison between Field Piezometer Readings and Pore Water Pressures predicted in SEEP/W Model

The predicted SEEP/W values presented above, assume that the planned subdrains have been installed and are functioning properly. Every section evaluated, excluding Section K, had toe drains and slope drains installed according to the current inspection report. The seepage was also modeled without subdrains; however the piezometer data indicates that the model including subdrains is a better reflection of the actual field conditions.
