An Evaluation of High-Visibility Crosswalk Treatment - Clearwater, Florida

REPORT NO. FHWA-RD-00-105

August 2001

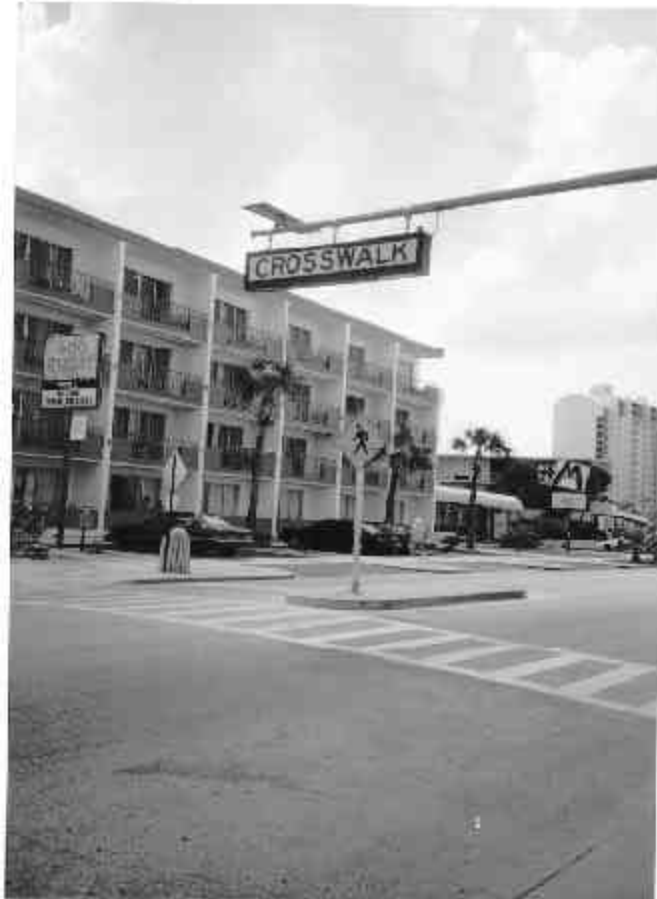
Figure 1. Experimental Site—Daylight, Gulfview Boulevard at 5th Street, Looking South.

Pedestrian facilities installed at the south legs of S. Gulfview Boulevard included 2.4-m- (8-ft-) wide, high-visibility ladder crosswalks and pedestrian refuge islands measuring 1.5 m (5 ft). At both sites, the refuge island was perpendicular to the crosswalk markings. Three crossing signs (MUTCD W11A-2) were located on both sides of the roadway and on the refuge islands. In addition, a novel internally illuminated overhead crosswalk sign was suspended directly over the crosswalks in the middle of the intersections. The rectangular signs were bright yellow with bold black letters that said “CROSSWALK.” At night, two large lamps shined onto the crosswalk markings and onto pedestrians crossing the roadway. Sidewalks were installed on both sides of the street. Except for sidewalks there were no pedestrian facilities on the stop controlled north legs of the intersections, and the crossings were unmarked.

Both experimental sites were in the heart of a beach community and resort area where pedestrians traveled to the beach on the Gulf of Mexico. Numerous motels, restaurants, and shops were located on the east side of the street; parking lots and the beach were to the west. Pedestrian and vehicular traffic was nearly continual all day until about midnight. Figure 1 shows the experimental overhead crosswalk sign and crosswalk markings during daylight. Figure 2 shows the illuminated crosswalk sign and downward facing lamps at night.

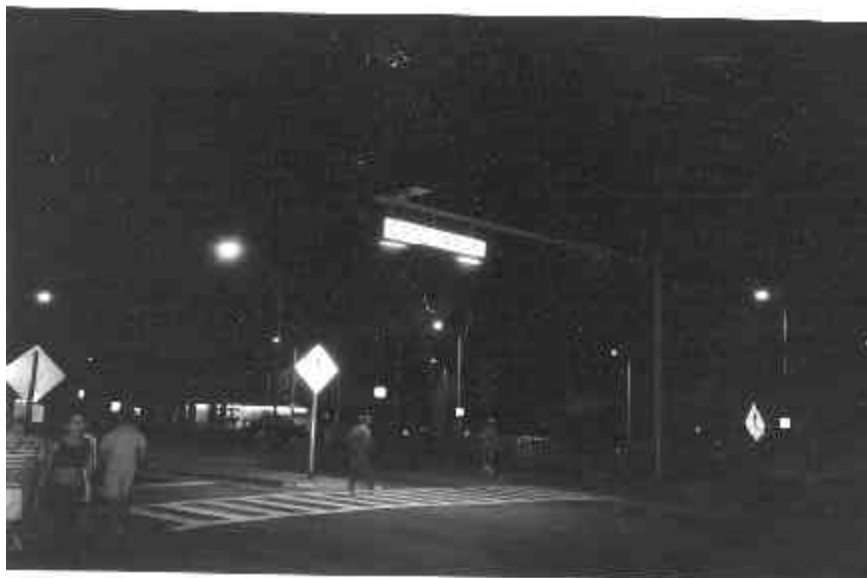
Figure 2. Experimental Site—at Night, Gulfview Boulevard at 3rd Street, Looking South.

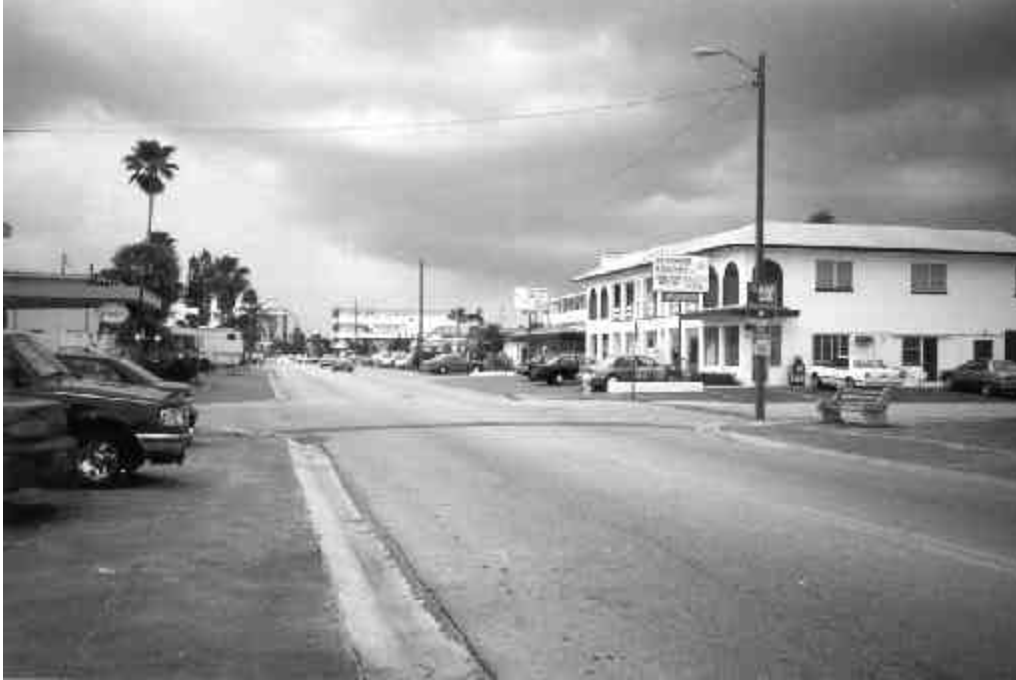
Figure 3. Control Site 2,
Coronado Drive at 3rd Street, Looking South.

Coronado Drive was a north/south arterial through street with one lane in each direction, no turn lanes, no refuge island, and a posted speed limit of 40 km/h (25 mi/h). The stop-controlled cross street, 3rd Street, was a two-way road with one lane in each direction. Parking was not permitted on any of the four legs of the intersection. Numerous motels and restaurants and some private cottages were located nearby. Pedestrian and vehicular traffic was nearly continual all day until midnight and was beach and vacation oriented. Control Site 2 is shown in Figure 3.

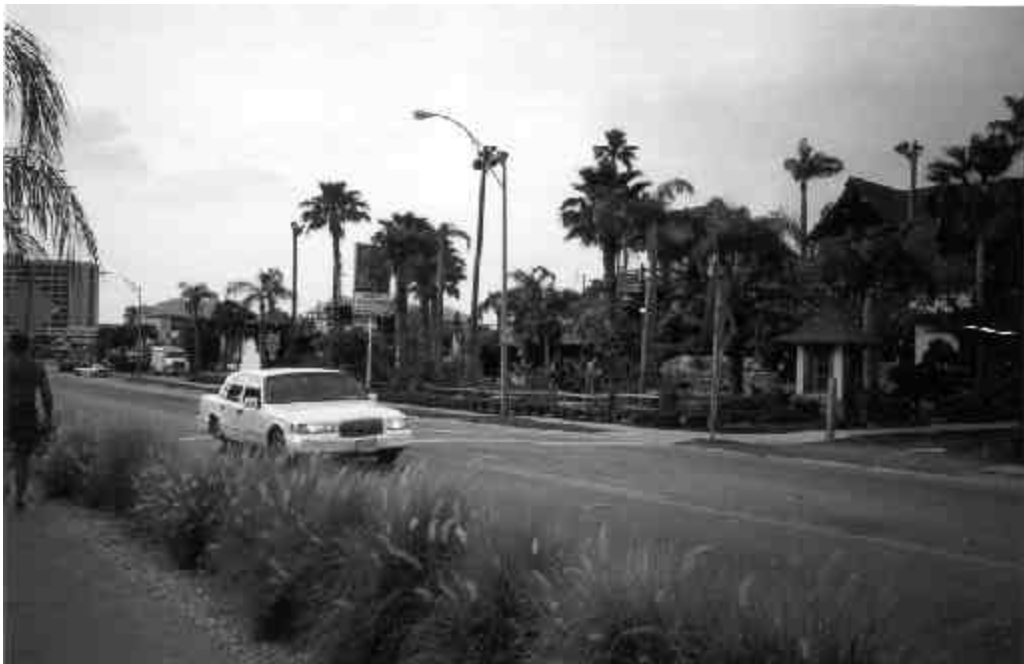
Figure 4. Control Site 4,
Mid-Block S. Gulfview Boulevard, Looking North.

The other control site was a mid-block marked crosswalk location on S. Gulfview Boulevard about 0.8 km (0.5 mi) south of experimental Site 1. Gulfview Boulevard was a major arterial with one southbound through lane and one southbound lane turning into a miniature golf course parking lot. There was neither a raised median nor a refuge island. There was one northbound through lane and the speed limit was 40 km/h (25 mi/h). There were sidewalks on both sides of the street, and the crosswalk was marked with standard parallel lines. Curb cuts were provided at both sides of the crossing. There were two crosswalk signs (MUTCD W11A), one facing each direction posted at the marked crosswalk, as well as advance warning signs (MUTCD W11s) upstream from the crosswalk.
