Evaluation of the Effects of City of Middleton Stormwater-Management Practices on Streamflow and Water-Quality Characteristics of Pheasant Branch, Dane County, Wisconsin, 1975–2008

Scientific Investigations Report 2012–5014

By Warren A. Gebert, William J. Rose, and Herbert S. Garn

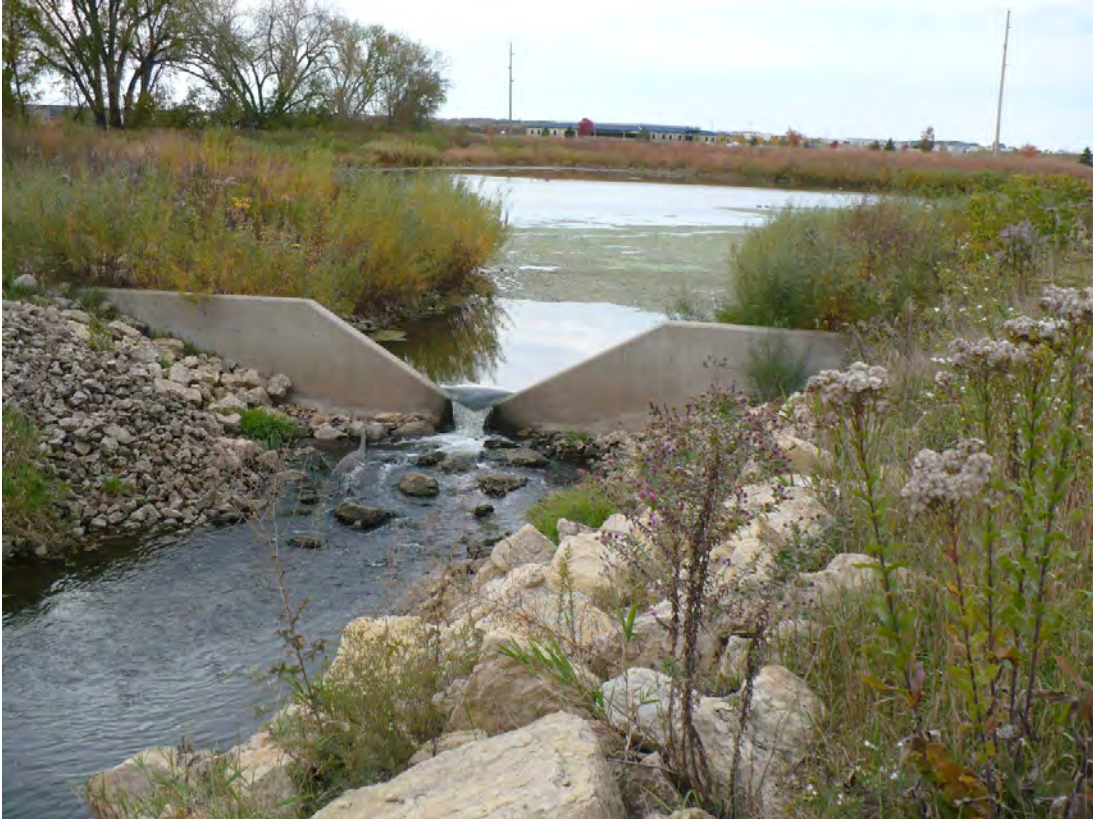
Figure 2. Confluence Pond on Pheasant Branch in Middleton, Wis., in 2008, with a view of the outlet structure. (Photo by W.A. Gebert)

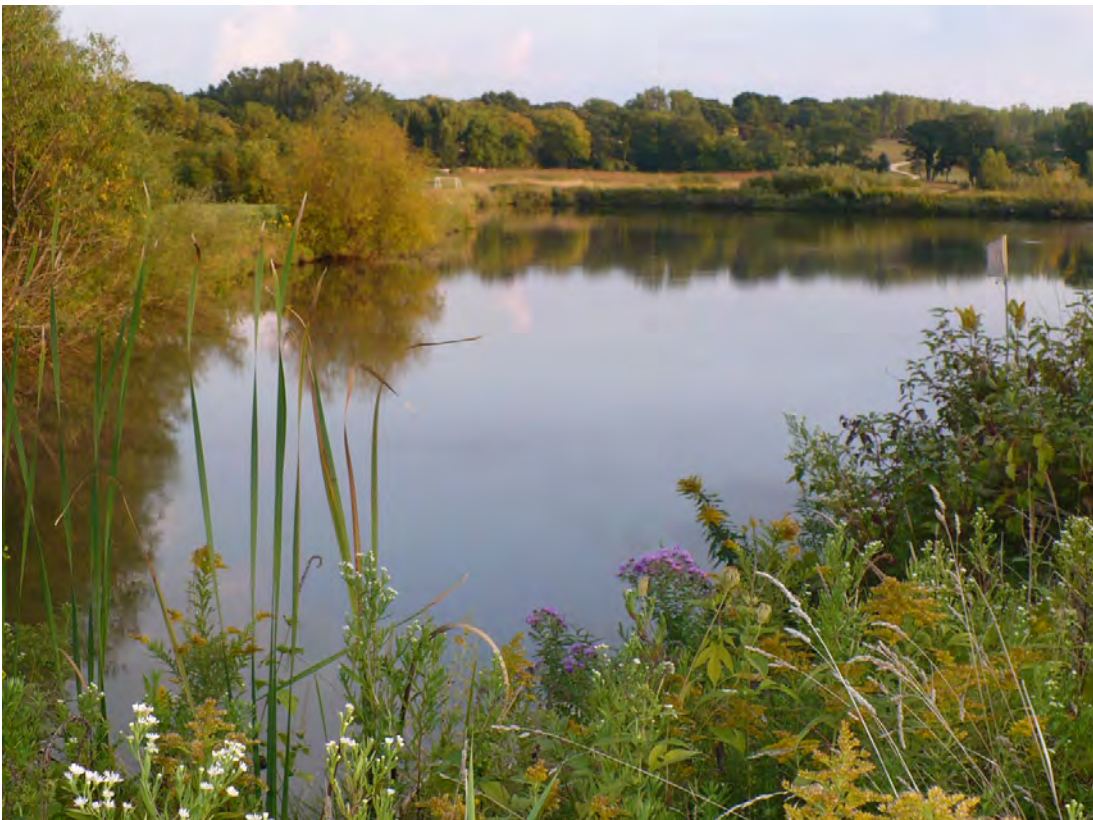
Figure 3. Northlake Pond water-quality detention basin in Middleton, Wis., in 2008. (Photo by W.A. Gebert)

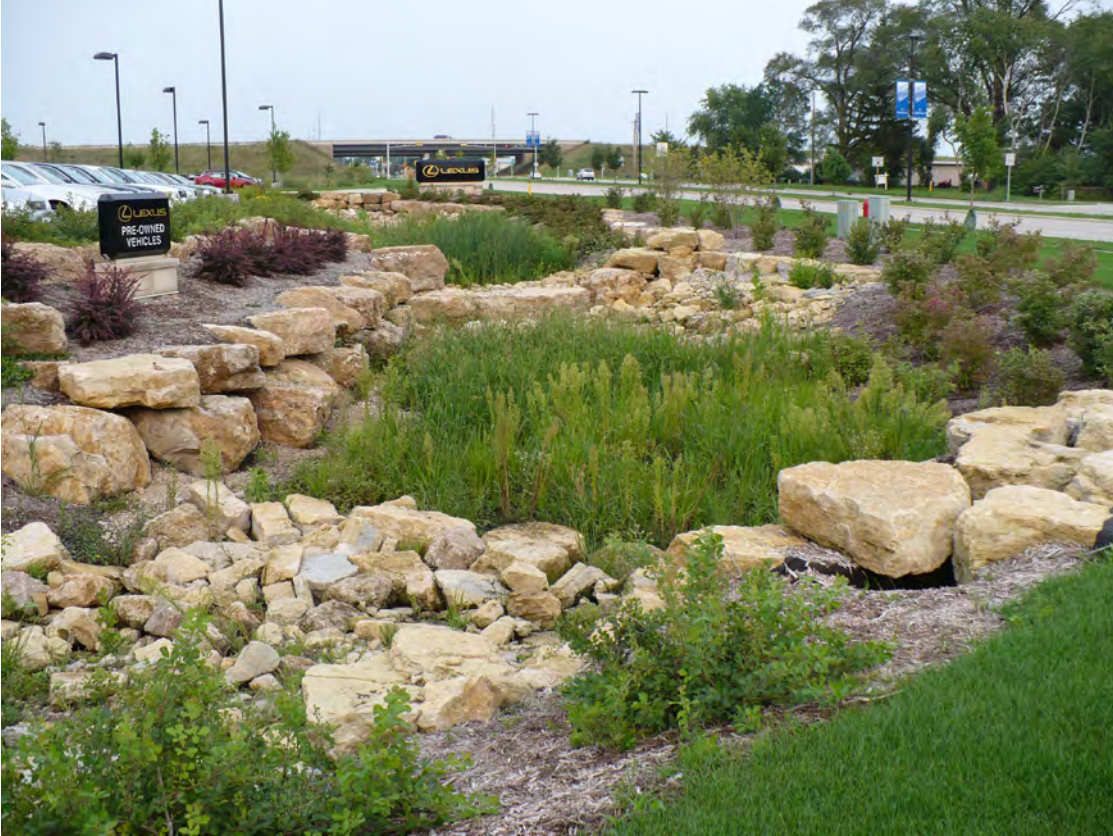
Figure 4. Infiltration basin at retail dealership on Airport Road in Middleton, Wis., in 2008. (Photo by W.A. Gebert)

A commercial infiltration basin in Middleton (fig. 4) collects and infiltrates the runoff from an auto dealership parking lot and building roofs. The combined parking and roof impervious area at this location is close to 100 percent of the entire auto dealership area. Developments like this and all other retail and commercial developments, are required to meet the runoff-, infiltration-, and sediment-control requirements of Middleton's Storm Water Runoff Control Ordinance.

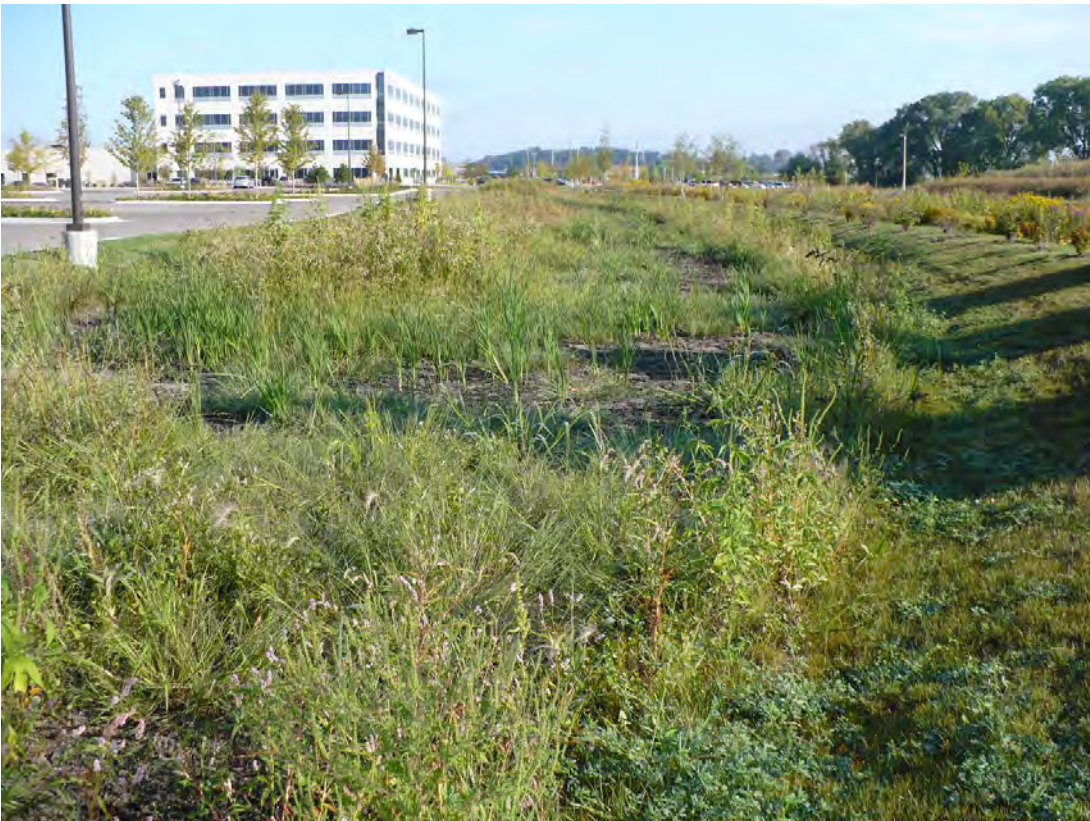
Figure 5. Bioretention facility at a commercial parking lot in Middleton, Wis., in 2008. (Photo by W.A. Gebert)

A bioretention facility (fig. 5) was constructed in 2007 to trap pollutants from a large retail parking lot. This facility was designed only to trap pollutants, because the soils in this area are not adequate for providing infiltration. To meet the infiltration requirement of Middleton's Storm Water Runoff Ordinance, the developer was therefore required to pay a fee in lieu of the implementation of infiltration practices. These fees contribute to funding for the construction of larger stormwater-management facilities elsewhere in the watershed. The Confluence Pond and South Pond are examples of facilities that were partly funded by fees in lieu of implementation

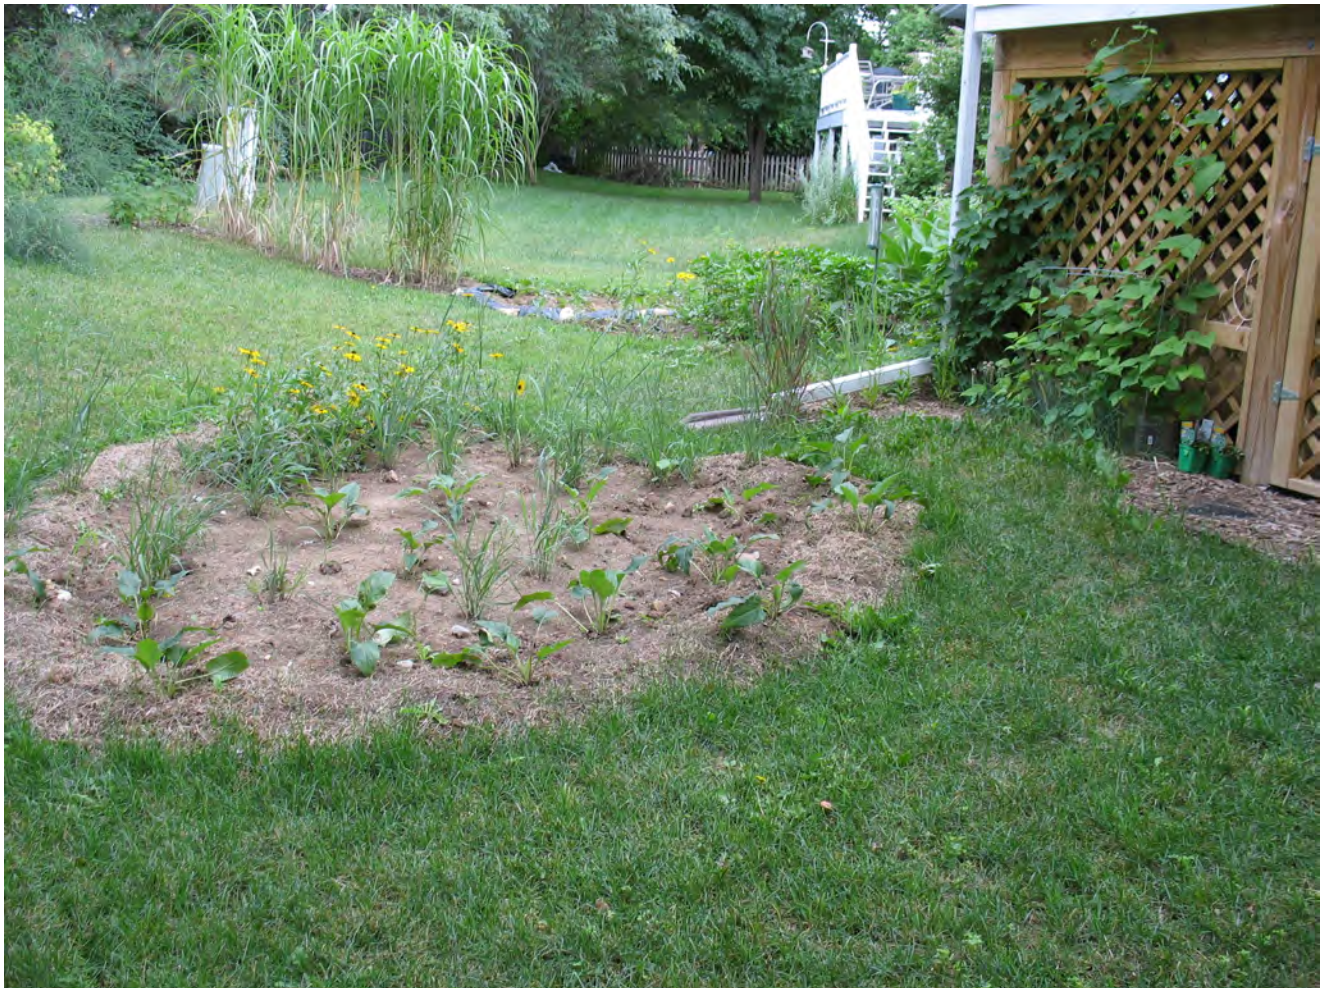
Figure 6. Photograph showing a residential rain garden in Middleton, Wis. (Photo by H. S. Garn)

In 2007, Middleton sponsored a program for developing residential rain gardens called “Plant Middleton” that solicited homeowners in Middleton who were interested in developing rain gardens to submit plans to the city for possible inclusion in the program. In 2007, 12 residences qualified for the program, and rain gardens were successfully constructed at all of the sites. Figure 6 shows one of the residential rain gardens. The program was started again in 2009, and 11 homeowners participated in it. The City program ended after 2009, because interest in it was low relative to the effort required for continuing it and because residents could also participate in a similar program sponsored by Dane County.

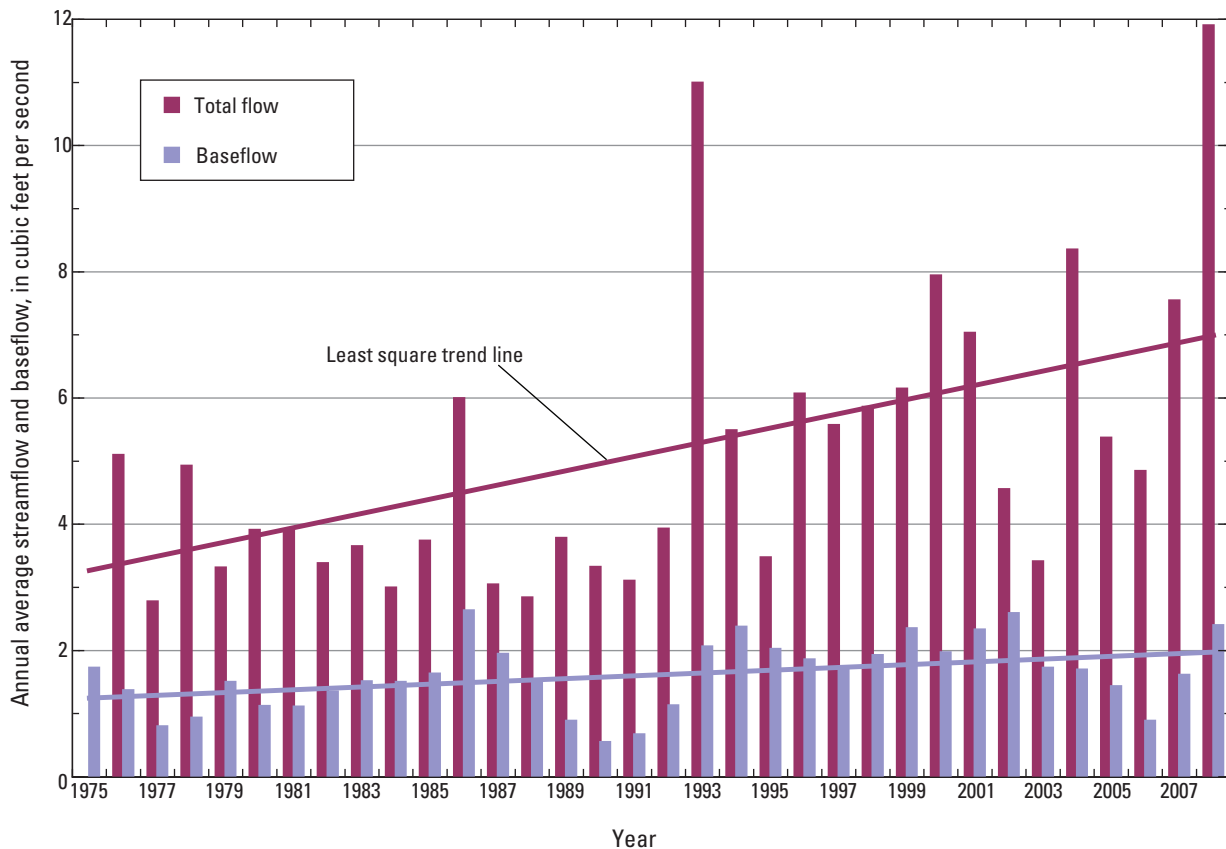
Figure 7. Annual streamflow and baseflow at Pheasant Branch at Middleton, Wis. (station 05427948), 1975–2008.

The average annual baseflow of 3.71 ft³/s for the period (fig. 7) was calculated by a baseflow separation technique (Gebert and others, 2007). Baseflow increased, as indicated by the least squares linear regression trend line shown in figure 7; however, the annual baseflow did not increase as much as annual streamflow (fig. 7). Although increased impervious area usually causes decreased infiltration, aquifer recharge, and baseflow, the increased baseflow in Pheasant Branch, is notable because a decrease in baseflow could have been expected with the increase in impervious area.

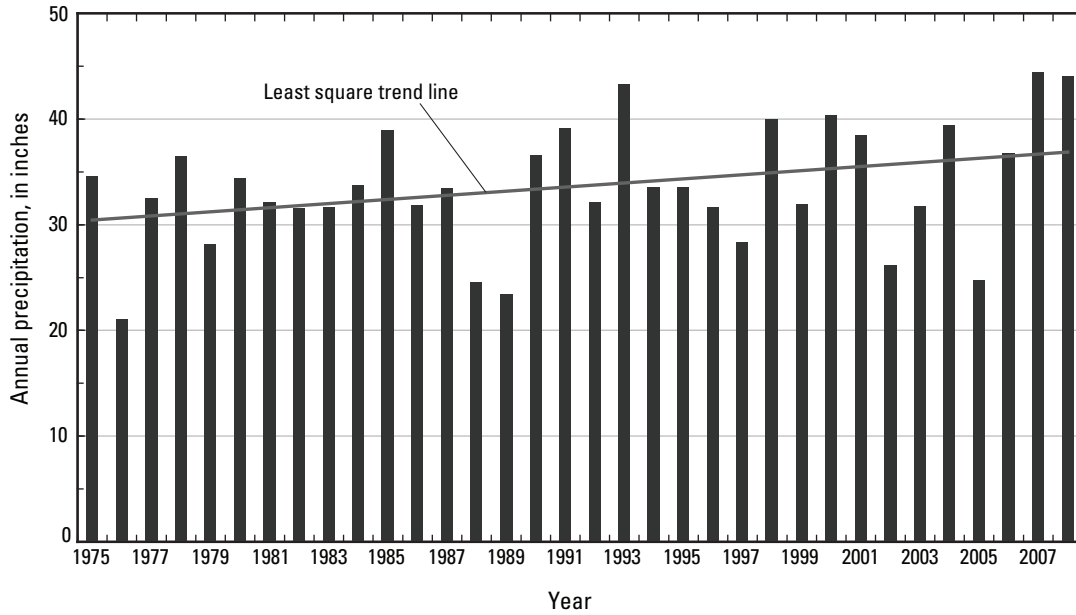
Figure 8. Annual precipitation at Madison, Wis., 1975–2008. (Data from U.S Department of commerce 2009)

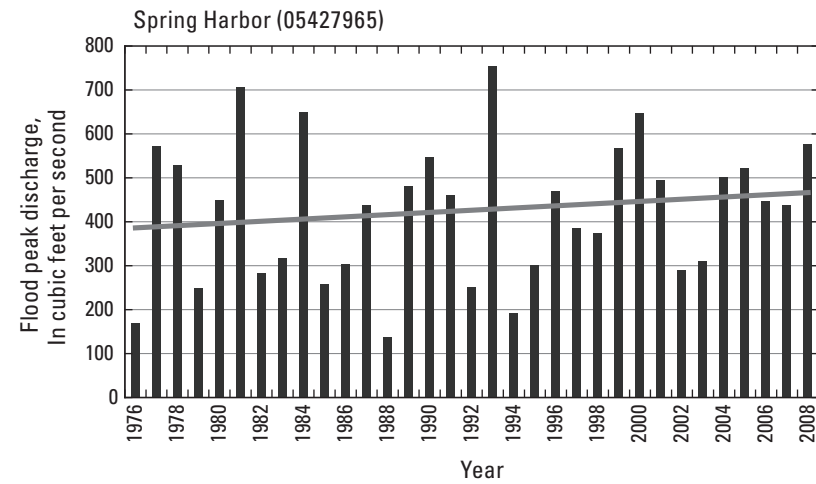
Figure 12. Comparison of annual flood peaks of Pheasant Branch at Middleton with annual flood peaks at three nearby streams at three gaging stations in Wisconsin for 1976–2008.

To evaluate likely causes for the increase in flood-peak discharges at Pheasant Branch, peak discharge data from the same periods at three nearby streamflow-gaging stations were compared to data from Pheasant Branch at Middleton (05427948). One station, Spring Harbor Storm Sewer at Madison (05429650), is a completely urbanized basin, and the other two, Black Earth Creek near Black Earth (05406500) and Yahara River at Windsor (05427718), are largely agricultural basins that have small urban areas. A plot of annual flood-peak discharges shows that the same trend of increasing flood peaks observed in Pheasant Branch also occurred in these watersheds (fig. 12) probably as the result of increased precipitation. Although the flood peaks increased at all four sites, a comparison of the slope of the trend lines shows the increase was much larger for Black Earth Creek and Yahara River, where the primary land use is agricultural, than for Pheasant Branch, where the land use is a mixture of agricultural and urban, and Spring Harbor, where the land use is mostly urban.

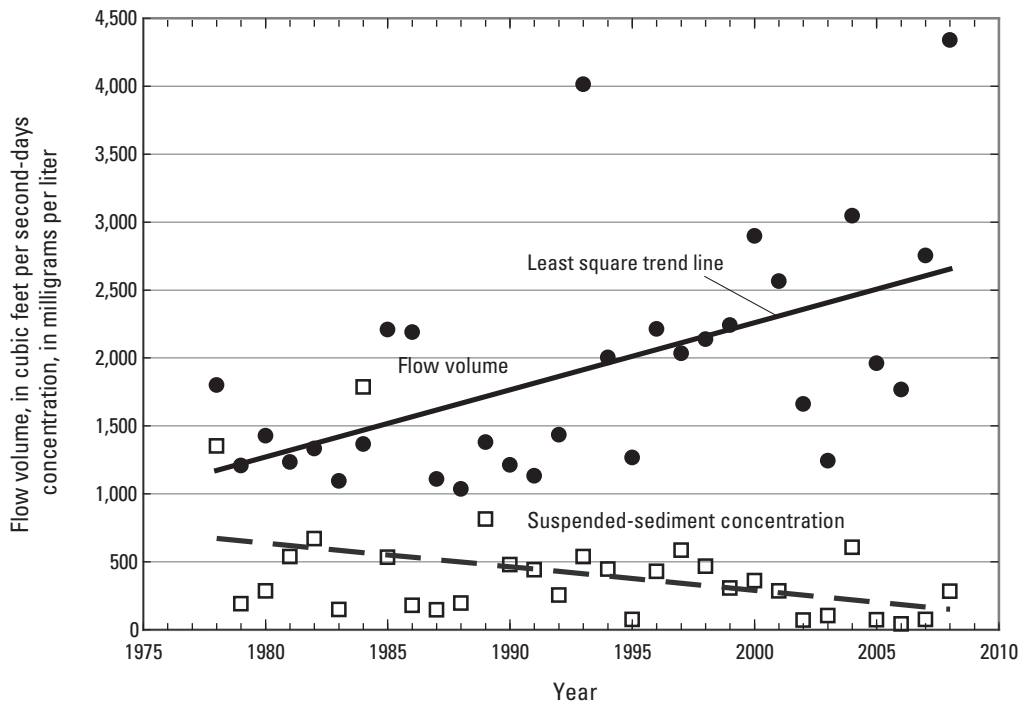
Figure 15. Annual flow volumes and annual average suspended-sediment concentrations for Pheasant Branch at Middleton, Wis. (station 05427948), 1978–2008.

construction of a bypass for U.S. Highway 12, several large storms struck when much of the construction area had bare soil, steep slopes, and few or no erosion-protection measures. The large sediment load in 2004 (fig. 14) was the result of those storms, and the relatively large load in 2008 was the result of many storms that produced the largest annual flow volume for the period of record. The annual suspended-sediment concentrations have been much lower than expected for the annual flow volumes since 2002, except for the unusual storm years of 2004 and 2008 (fig. 15).

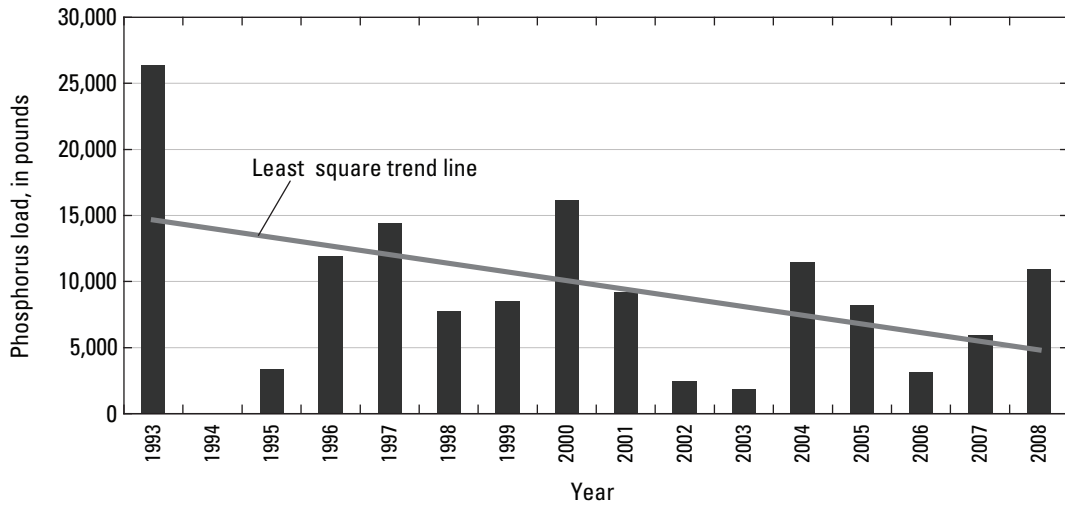
Figure 16. Annual phosphorus loads for Pheasant Branch at Middleton, Wis. (station 05427948), 1993, 1995–2008.

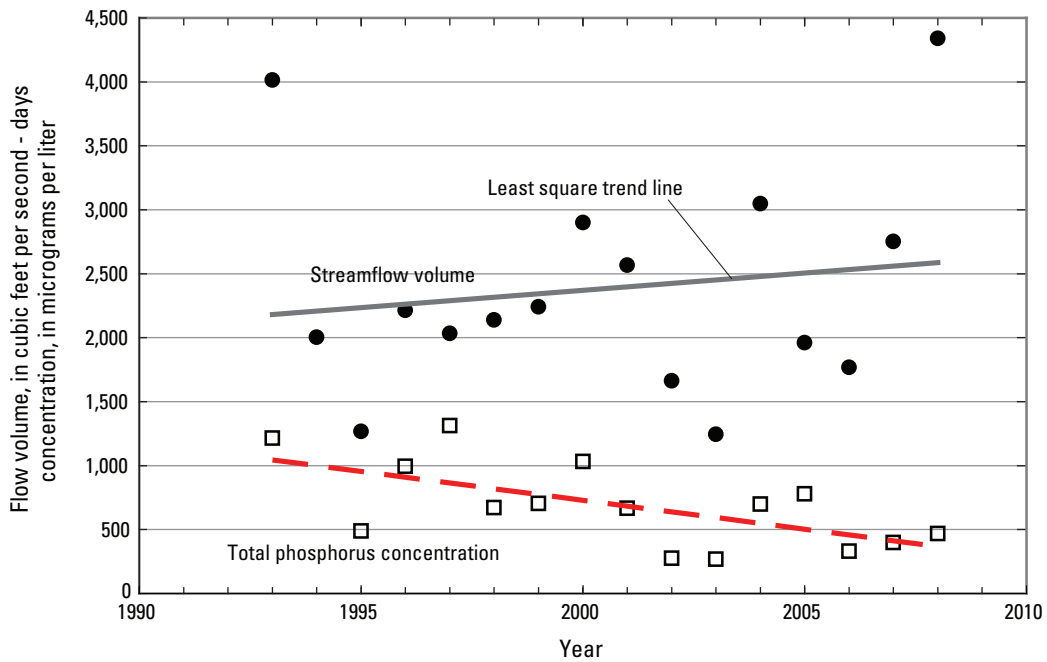
Figure 17. Annual flow volumes and annual average total phosphorus concentrations for Pheasant Branch at Middleton, Wis. (station 05427948), 1993, 1995–2008.

decreasing annual phosphorus concentrations, although flow volumes increased during the same period (fig. 17). The other part of the total phosphorus load is dissolved ortho phosphorus, which is not attached to the sediment load and, therefore, may not show the same decreasing trend.

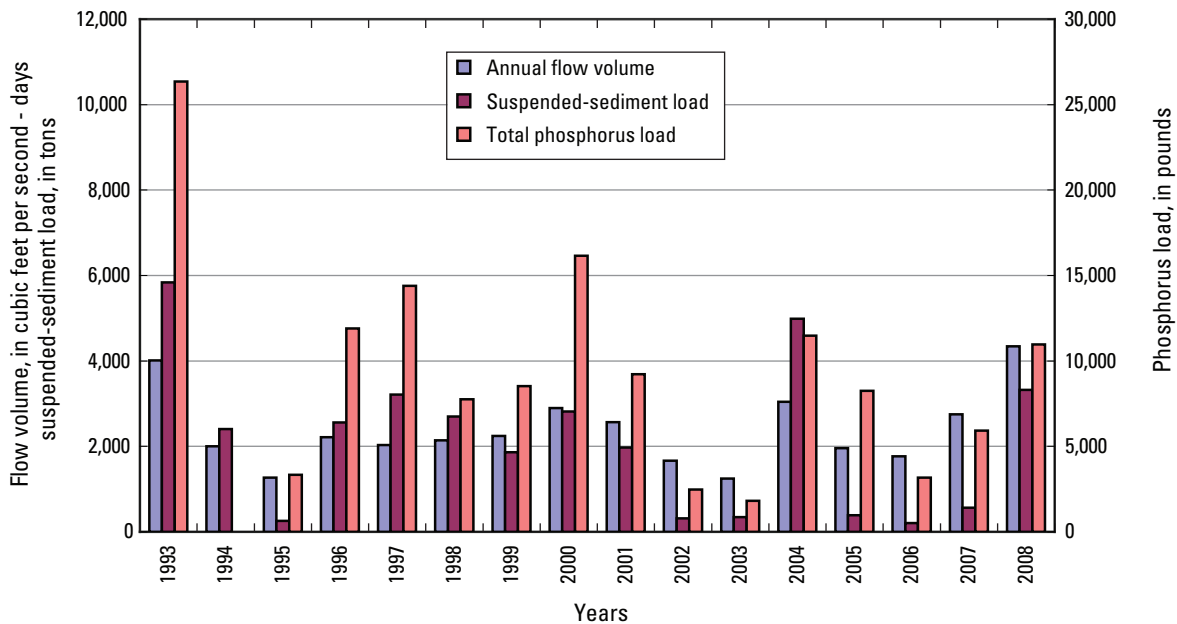
Figure 18. Annual flow volumes, suspended-sediment loads, and total phosphorus loads for Pheasant Branch at Middleton, Wis. (station 05427948), 1993–2008.

A good example of that divergence from the trend was in 2005 (fig. 18), when the annual phosphorus load was much larger relative to the annual sediment load. During February and March 2005, three rainfall events occurred over frozen ground, resulting in relatively modest increases in streamflow and sediment loads but very large total phosphorus loads. The total phosphorus load for those 2 months was 7,100 lb, or 87 percent of the annual load of 8,250 lb for the entire year. Normally the Confluence Pond would have reduced the total phosphorus and suspended sediment loads, but in 2005, most of the phosphorus load for February and March was dissolved ortho phosphorus that passed through the Confluence Pond because it was not attached to sediment. Agricultural runoff is usually the source of dissolved phosphorus, and in 2005 the rainfall events occurred when the ground was frozen, allowing a large amount of dissolved phosphorus to enter the stream system.

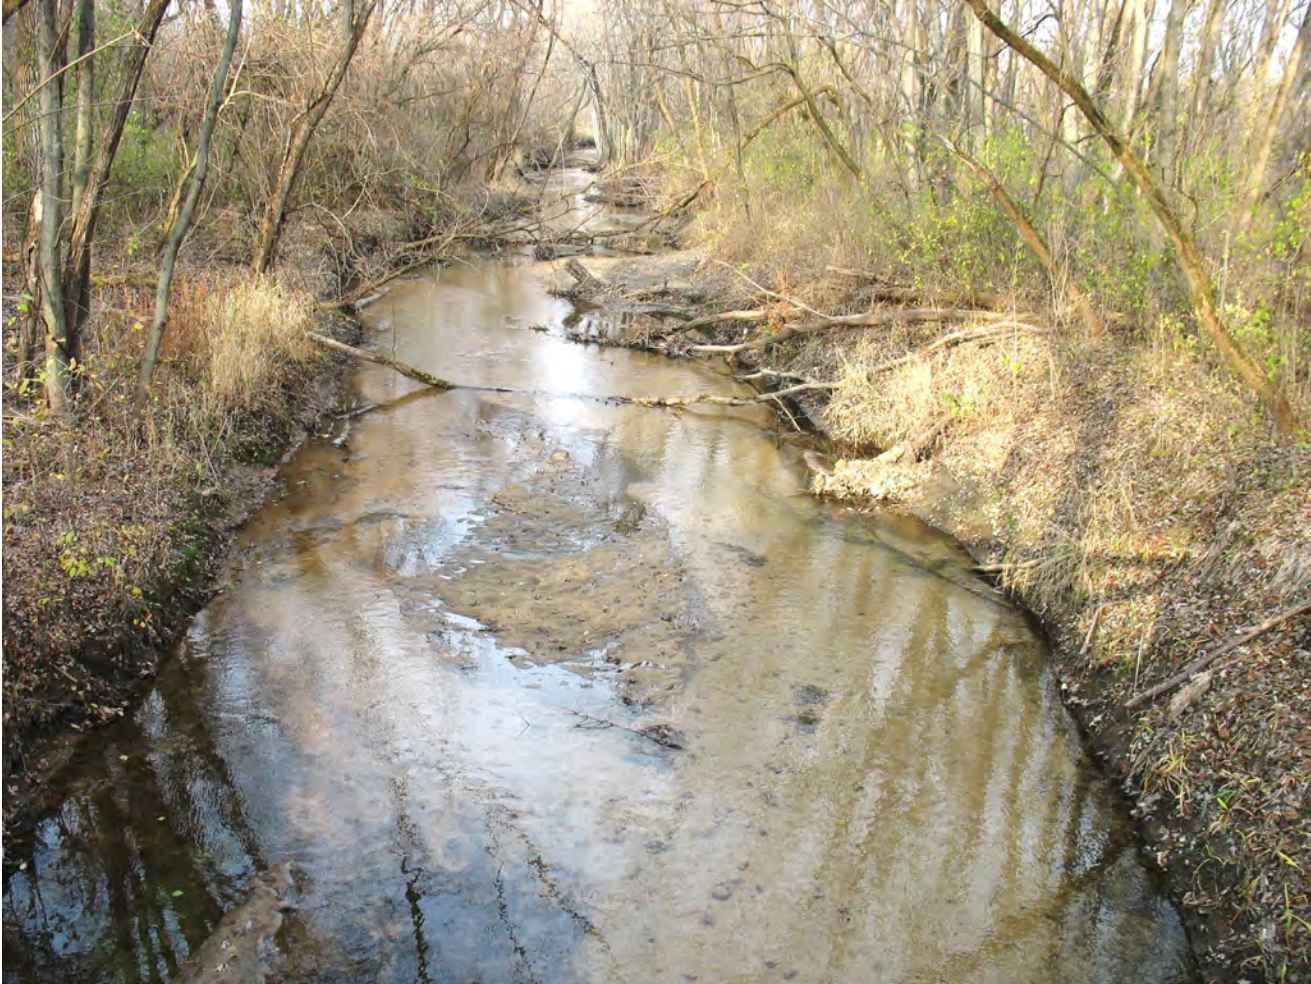
Figure 19. Pheasant Branch upstream from marsh showing sand deposition, channel widening, and overflow channels entering marsh. (Photo by H.S. Garn)

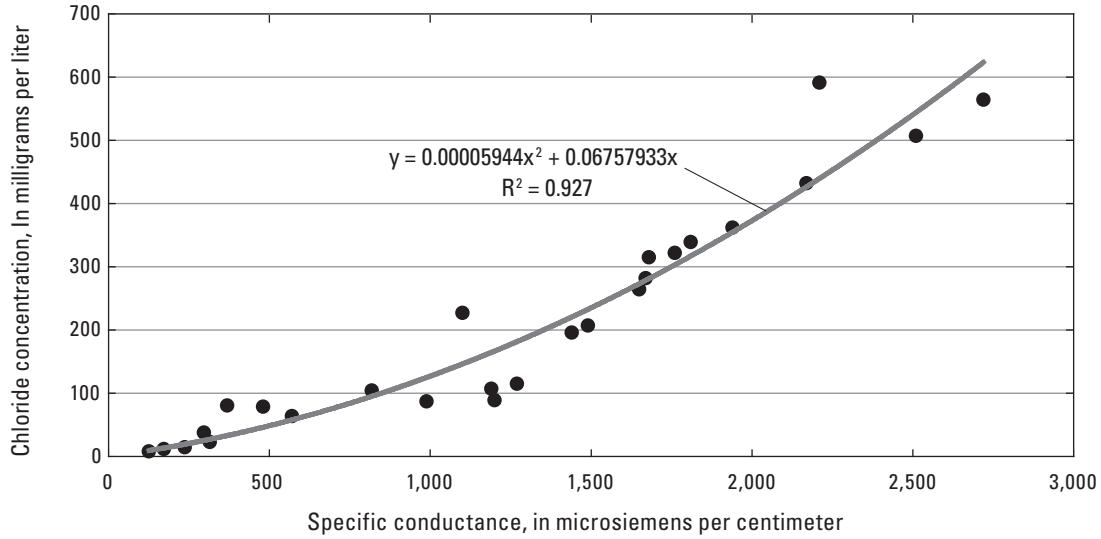
Figure 20. Regression relation of specific conductance and chloride concentration at Pheasant Branch at Middleton, Wis. (station 05427948).

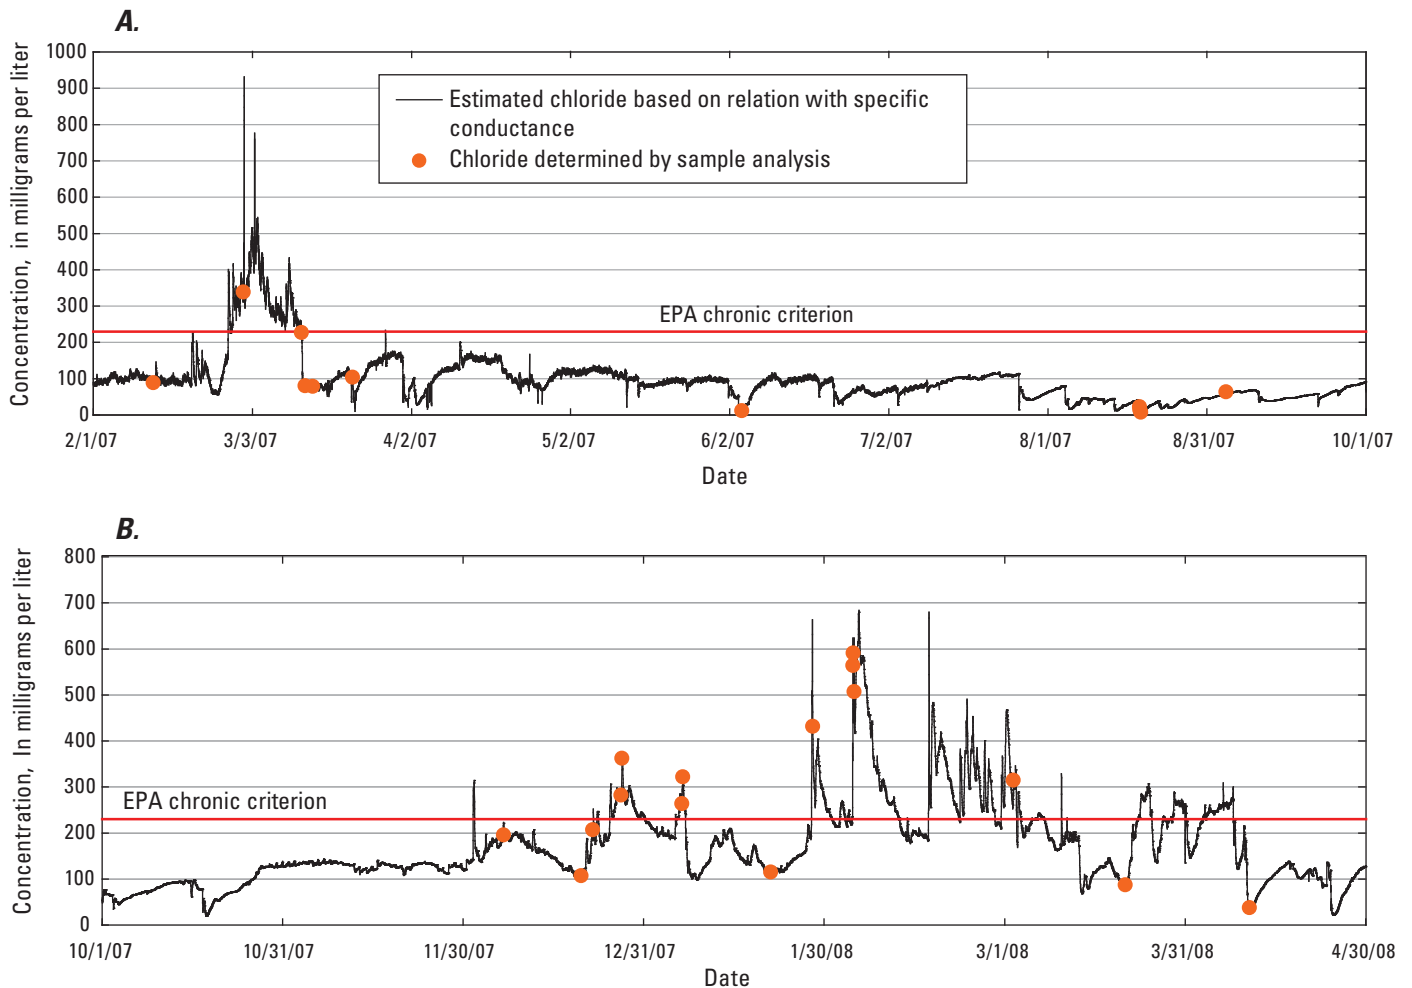
Figure 21. Measured and estimated chloride concentrations of Pheasant Branch at Middleton, Wis. (station 05427948) during February through September 2007 (A) and October 2007 through April 2008 (B). (EPA, U.S. Environmental Protection Agency)

The measured and estimated chloride concentrations of Pheasant Branch during the two winter seasons are shown in figure 21. The maximum estimated concentration of chloride during the monitoring period was 931 mg/L on March 1, 2007, and it exceeded the EPA acute criterion of 860 mg/L. Chloride concentrations exceeded the EPA chronic criterion of 230 mg/L for at least 10 days during February and March 2007 and for 45 days from December to the first week in April during the 2007–8 winter season. The maximum concentration in 2008 reached 680 mg/L twice during February. These high concentrations of chloride occurred in spite of the attenuating effect of the Confluence Pond about 0.3 miles upstream from the gaging station. Following the winter peaks, concentrations of chloride remained elevated above background concentration through April, long after all snow had melted. Chloride concentrations during the summer generally were about 50–100 mg/L, which may still be elevated above natural background concentrations. The average chloride concentration for the
