**SmartPark Truck Parking
Availability System:
Video Technology
Field Operational Test Results**

U.S. Department of Transportation
Federal Motor Carrier Safety Administration

January 2011

1. Report No. FMCSA-RRT-10-002		2. Government Accession No.		3. Recipient's Catalog No.	
4. Title and Subtitle SMARTPARK TRUCK PARKING AVAILABILITY SYSTEM: VIDEO TECHNOLOGY FIELD OPERATIONAL TEST RESULTS				5. Report Date January 2011

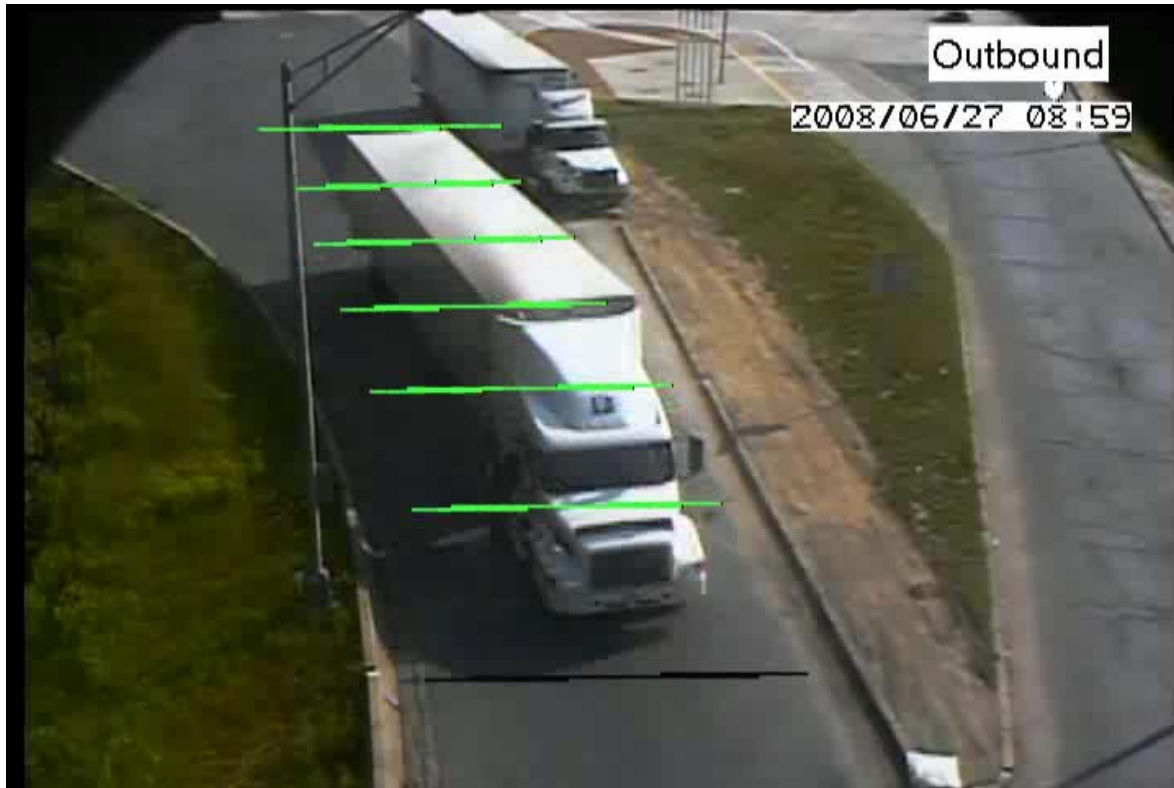
Figure 1. Autoscope Image of Tractor Trailer Exiting Charlton facility

The SmartPark video system counted vehicles entering and exiting the facility using video cameras that monitored the entrance and exit ramps. The cameras were equipped with image processing software designed to detect when a vehicle appears in the image. Figure 1 shows an image from a camera of a tractor-trailer exiting the Charlton service center. The black and green lines in the image are, respectively, inactivated and activated detectors used to count vehicles and

determine vehicle length. The image processing software distinguished between trucks, tractors, and other vehicles based on overall vehicle length. Vehicle detections were transmitted from the cameras to the onsite computer which recorded this information and made it available to authorized users via a secure Internet connection.

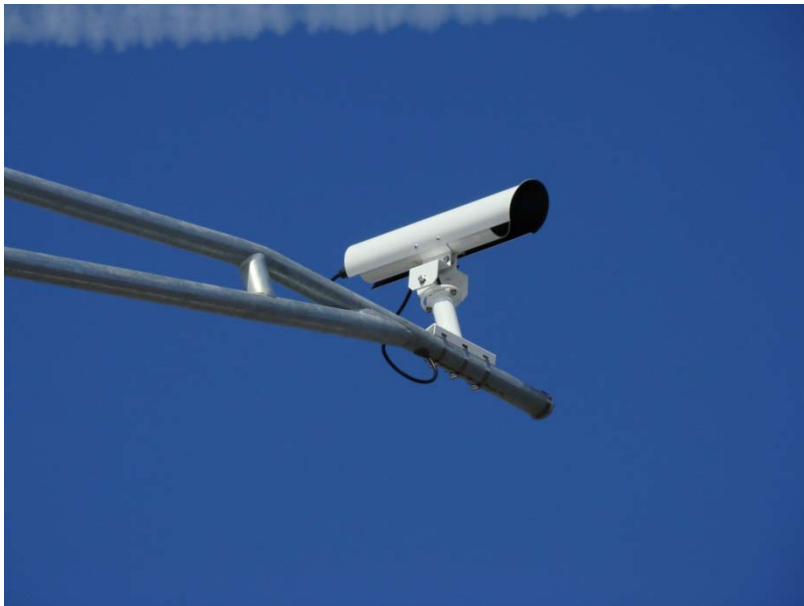
The video system is a field-proven video vehicle-detection system used in Intelligent Transportation Systems worldwide (See Figure 7). The initial camera selected for the system was the Solo Pro II, which was first released in 2002. However, once the project was under way, the video camera vendor released a newer model. The authors opted to use the new model primarily because it provided digital video from the camera, whereas the older model provided analog video output and would have required additional equipment to convert the analog video to digital video. The older equipment would have required an additional 15 watts of power as well as additional space and weight at the poles not only for the components, but also for larger batteries. The fact that the older model was transitioning to legacy status also influenced the decision to use the newer model. The vendor assured the image processing algorithms on the Solo Terra were superior to the older model algorithms and the newer model would be suitable for use in low-light conditions.

Figure 7. Video Camera

The image resolution of the video camera is 768×494 pixels. Video output from the camera is provided using MPEG-4 compression.

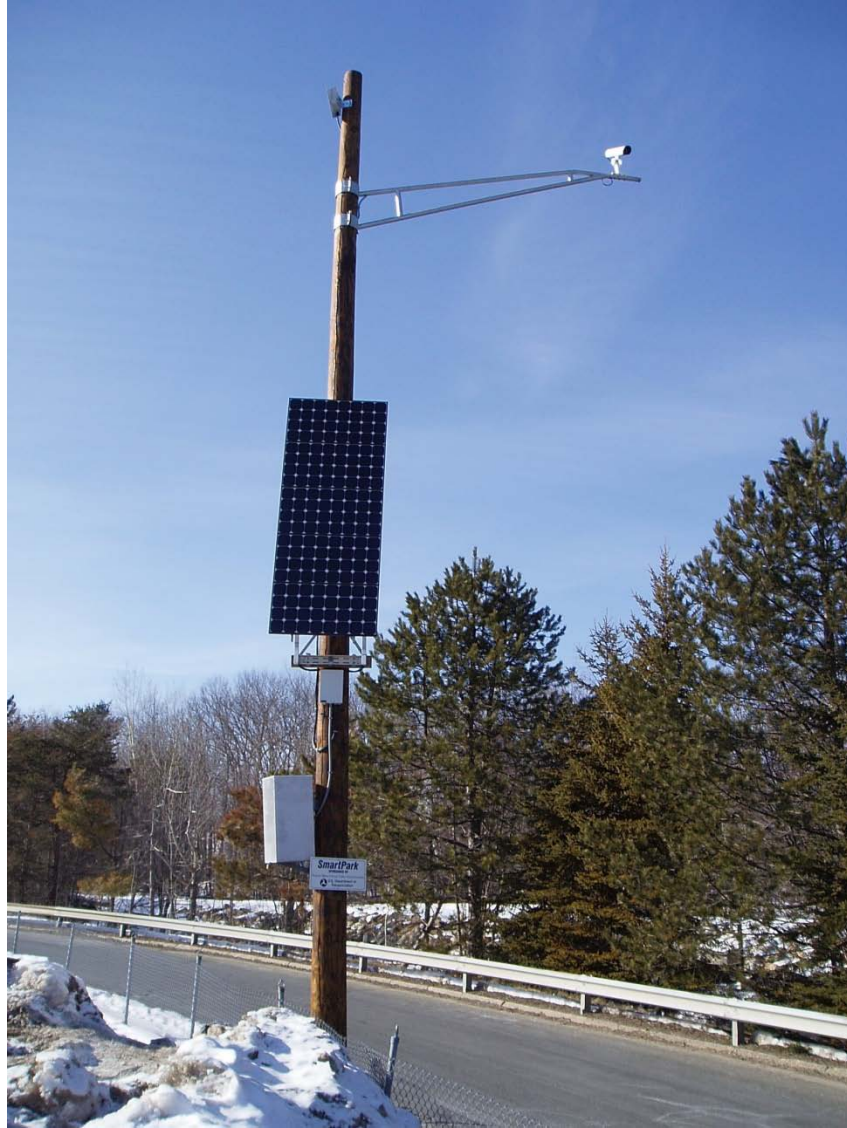
A rechargeable battery and solar panel unit powered each camera thus providing continuous operation (See Figure 8 and Figure 9). Vehicle recognition software and hardware were integrated with the camera, eliminating the need for a control box or dedicated computer to perform this function.

Figure 8. Inbound Pole Showing (from bottom) Ethernet Radio, Solar Battery Power Unit (SBPU), and Video Camera

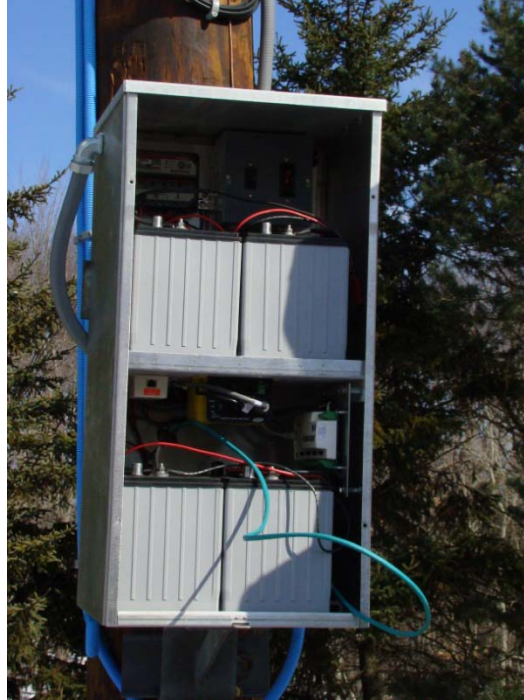
Figure 9. Batteries Used to Store Power from Solar Panels

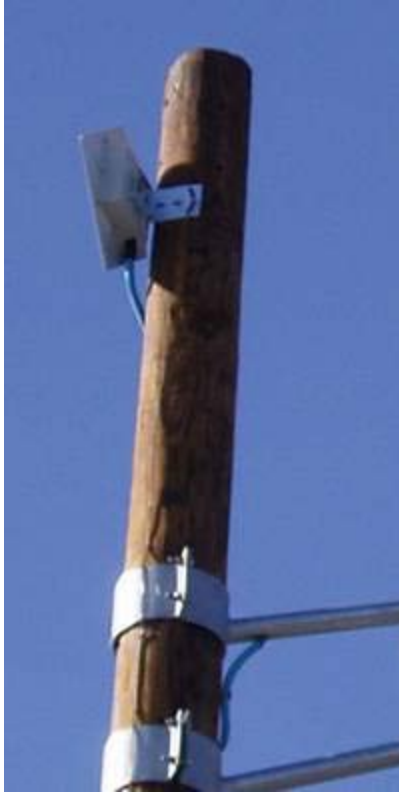
The SmartPark video system utilized Ethernet radios to transmit video images and data from the cameras to the Charlton service center computer. The radios use directional antennas to provide extended range and high data rates (See Figure 11). Using the 802.11 G wireless protocol (a wireless Ethernet standard), the radios provided sufficient throughput for live streaming video and event data from both video cameras simultaneously. The pole mounted radios used power-over-Ethernet provided by injectors powered by the solar-power units. A single roof-mounted radio communicated with both pole-mounted radios using two directional antennas (See Figure 12).

Figure 11. Pole-Mounted Ethernet Radio with Directional Antenna

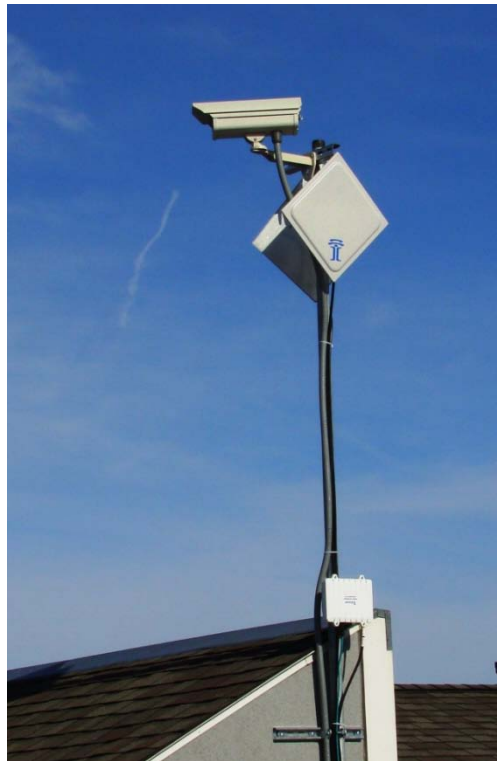
Figure 12. Single Roof-Mounted Ethernet Camera, Radio, and Directional Antennas

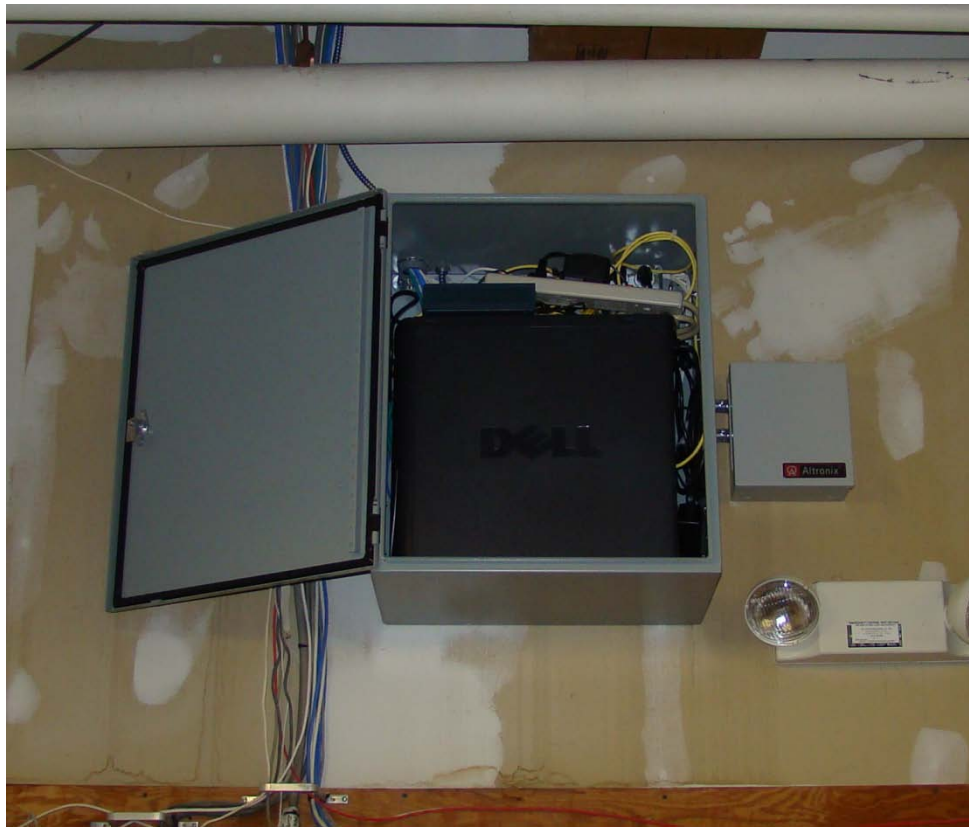
The onsite computer (see Figure 13) was installed in a secure enclosure located in a locked electrical room. The computer was connected to the video cameras through Ethernet radios and hardwired to the roof-mounted Web cameras. The computer was connected to the Internet via a Cisco router and high speed digital subscriber line (DSL) connection. One hour of continuous video data from all six cameras using medium data compression required approximately .8 gigabytes (GB) of data. The computer had local storage of 200 GB providing the ability to store approximately 200 h of continuous video data from all cameras. Video storage was only used for system performance evaluation and was not part of the detection, classification, and parking management functionality.

Figure 13. The Onsite Computer Mounted in the Electrical Room

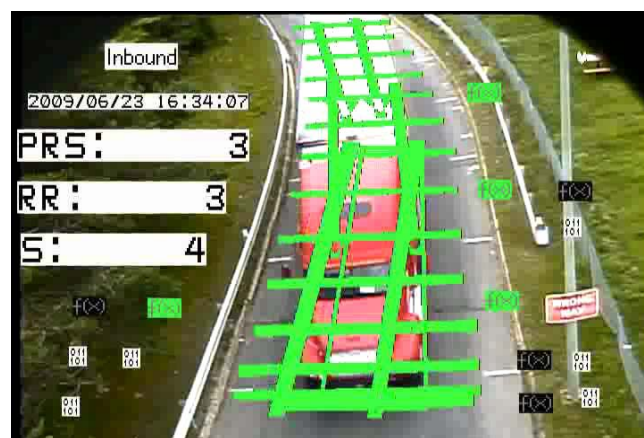
All of the detectors were based on the video system's image processing software. The software monitored camera images for changes in the background image of the roadway. Software algorithms removed variations in the image caused by weather conditions, shadows, and day or night artifacts. When a vehicle moved through an area of the image covered by a detector, the background was obscured and the software detected a vehicle (See Figure 14 and Figure 15).

Figure 15. Final Video Detector Configurations—Active

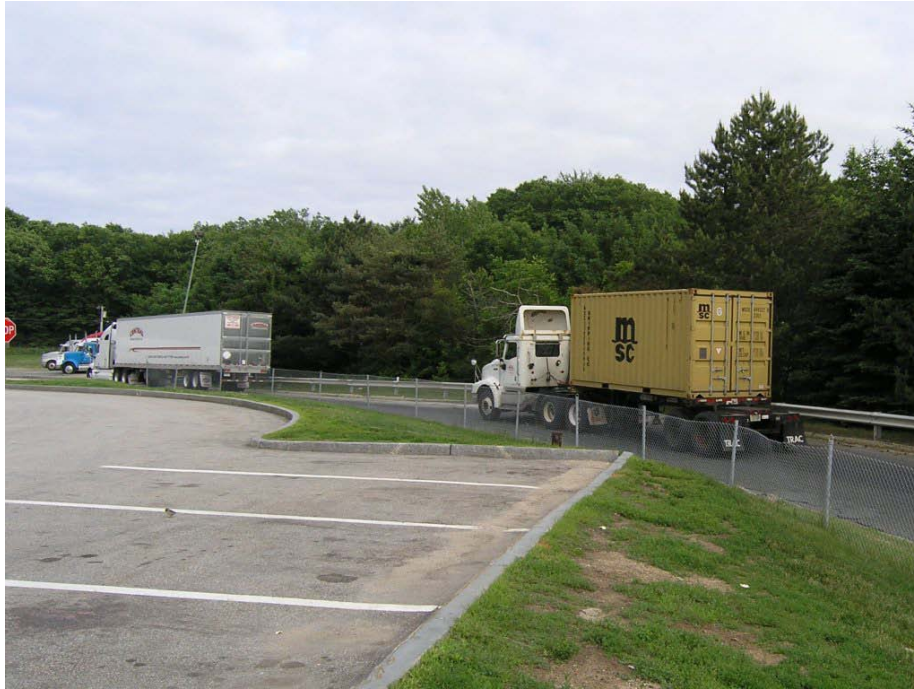
Figure 18. Trucks Entering Truck Parking Area at Charlton (Westbound) Service Center

The truck entrance road routes trucks to the truck parking and fueling areas at the back of the service center building. From here, trucks leave the service area via an exit road for both cars and trucks as shown in Figure 18. Occasionally, a passenger vehicle will enter via the truck route either due to error or because the driver needs diesel fuel and is not aware that there is an auto fuel island.

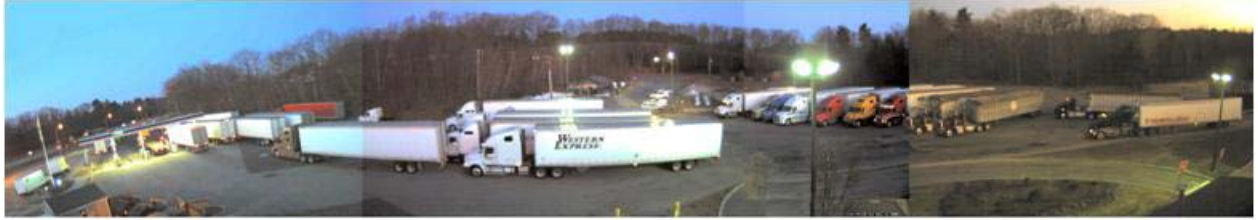
Figure 19 provides a composite view of the entire truck parking area as viewed via the four Web cameras on the service center roof. The Charlton facility experiences heaviest volumes 11 a.m–2 p.m. on weekdays. Truck volumes can exceed 60 vehicles per h and the facility is frequently at capacity. Truck traffic on both the inbound and outbound ramps can back up creating stop-and-go traffic. This is a particularly challenging situation for automated vehicle counting and classification. The site experiences most weather conditions including full sun, rain, fog, and snow (See

Figure 19. Composite View of Truck Parking Area from Four Web Cameras

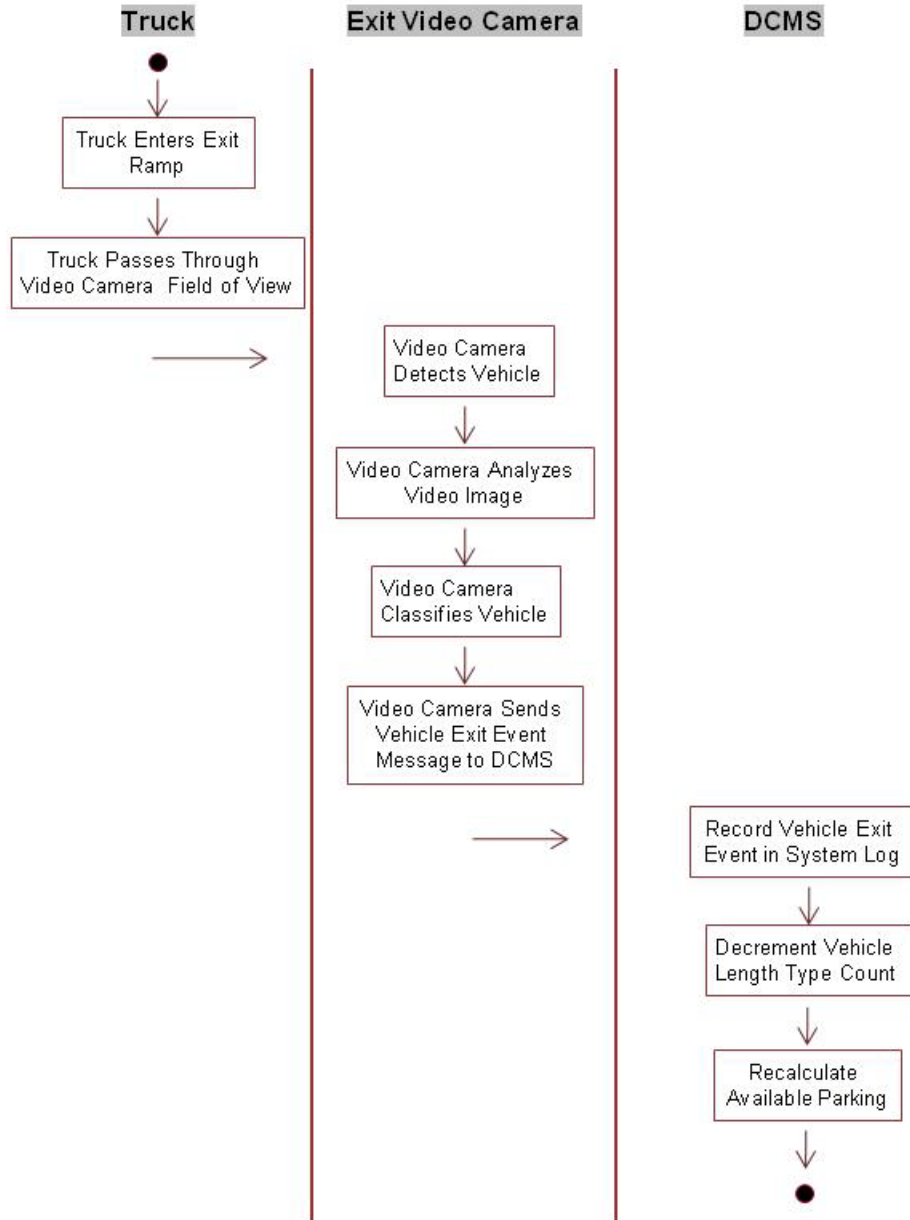
In this scenario, a truck or tractor-trailer leaves the parking area. The truck drives along the exit ramp at normal speeds and passes through the FOV of the video camera. The video camera analyzes the image, determines the vehicle length, and classifies it as either a truck or single, double, or triple tractor trailer. The camera sends a message to the onsite computer indicating a vehicle of the specific vehicle length category has exited the parking facility. The computer decrements the number of vehicles of that category and records the truck exit event in the system event log. It then recalculates the available parking as described in Section 2.7.2 (see Figure 25).

Figure 25. Activity Diagram—Truck Leaves Parking Area

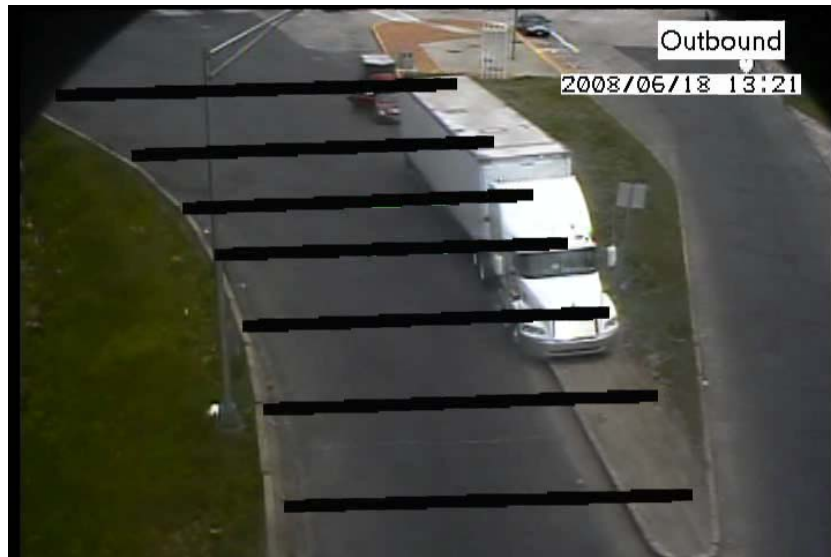
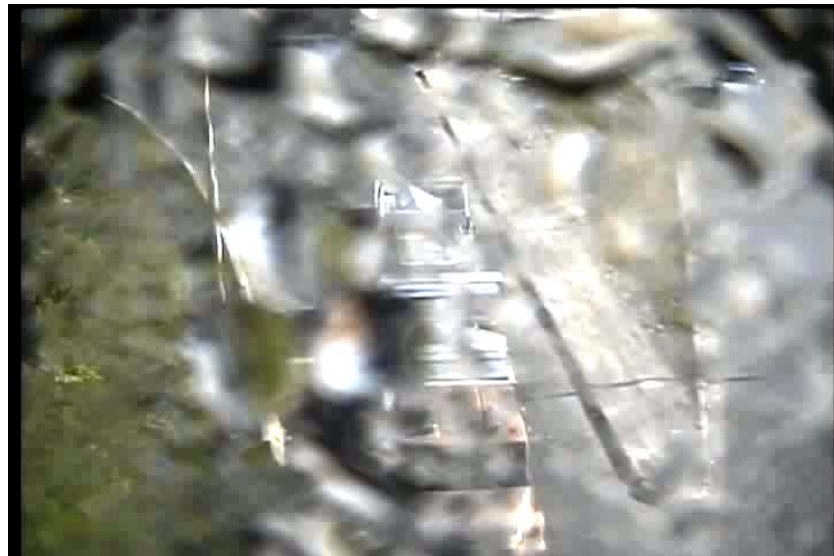
Figure 27. View through Outbound Camera, June 2008

Figure 28. View through Outbound Camera, June 2009

In May 2009, the vendor provided the beta version of its improved software. Final testing began once the new software was installed and tested. Detailed data for these tests appears in Appendix C. During review of the new software, the authors discovered the outbound camera had developed a leak allowing moisture to accumulate behind the lens. Additional moisture accumulated over time because of heavy rainfall in the area (compare Figure 27 and Figure 28). The result was that the camera image could not be accurately analyzed. The lead time required to obtain and install a replacement camera ruled out this option within the project performance period, therefore final tests were conducted with only the inbound camera.

With regard to reliability, the outbound camera developed a moisture leak approximately 14 months after it was installed.
