## **Alamance County Tornado**

Tornado: EF-0 Peak Wind: 75 mph

Time/Date: 454 pm Tuesday March 4, 2008

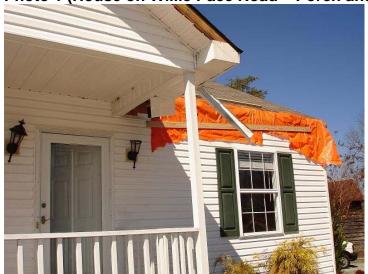
Photo 1 (House on Willie Pace Road – Porch and eave damage)

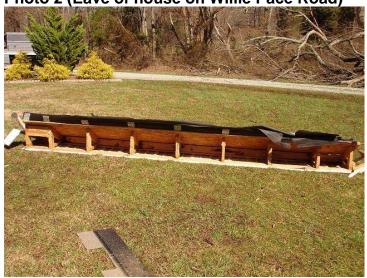
Photo 2 (Eave of house on Willie Pace Road)

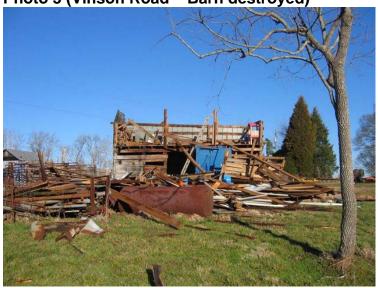
Further north the tornado destroyed a barn on Vinson Road and damaged a tractor and irrigation system. Numerous trees were also blown down in the area and the converging pattern of the downed trees was indicative of a tornado. Just to the northeast of this home on Blaney Road the tornado blew a large oak tree into a brick home resulting in substantial roof damage. A garage in the back yard was also destroyed. The walls from the garage were blown about 50 feet from and the entire garage was moved about 20 feet before it collapsed.

Photo 3 (Vinson Road – Barn destroyed)

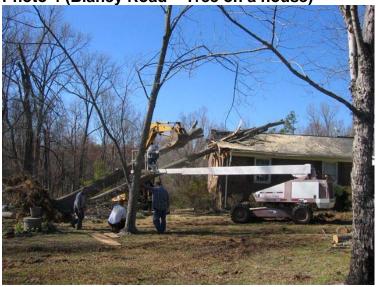
Photo 4 (Blaney Road – Tree on a house)

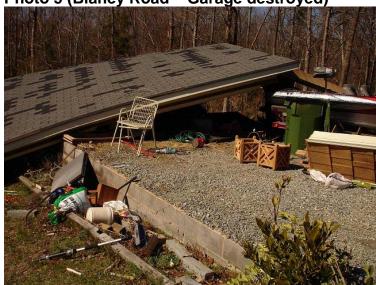
Photo 5 (Blaney Road – Garage destroyed)

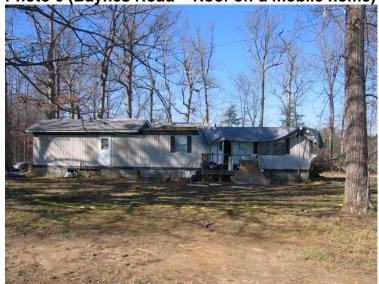
The last home to be damaged was on Baynes Road. A single wide mobile home on Baynes Road lost its roof from the high wind. The roof was tossed about 70 feet before becoming wrapped around a tree.

Photo 6 (Baynes Road – Roof off a mobile home)
