Preston Reach Assessment Entiat River

Chelan County, Washington

July 2009

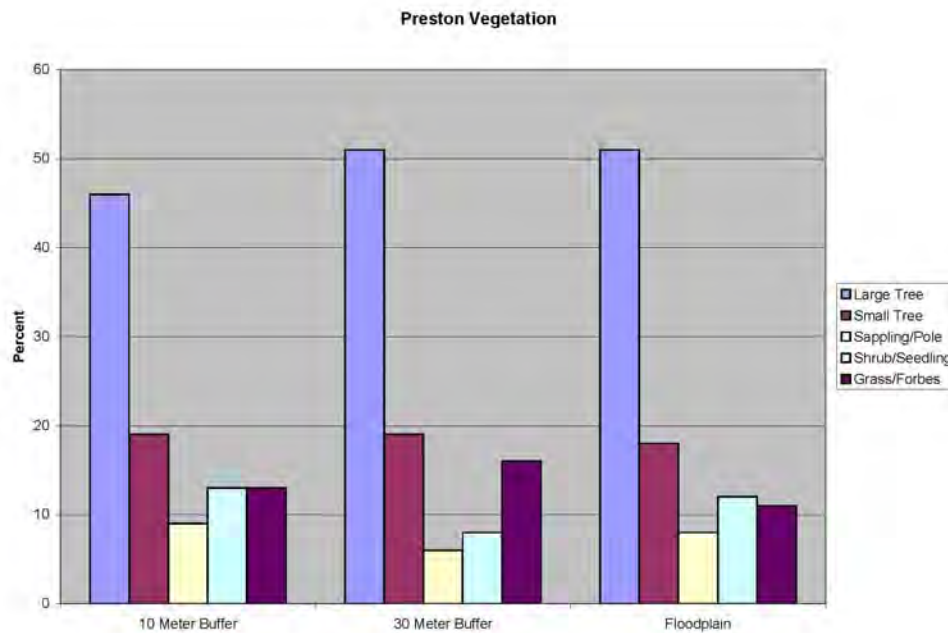
Figure 6. Percent of riparian vegetation seral stages based on classifications provided in the Stream Inventory Handbook (USDA 2008).

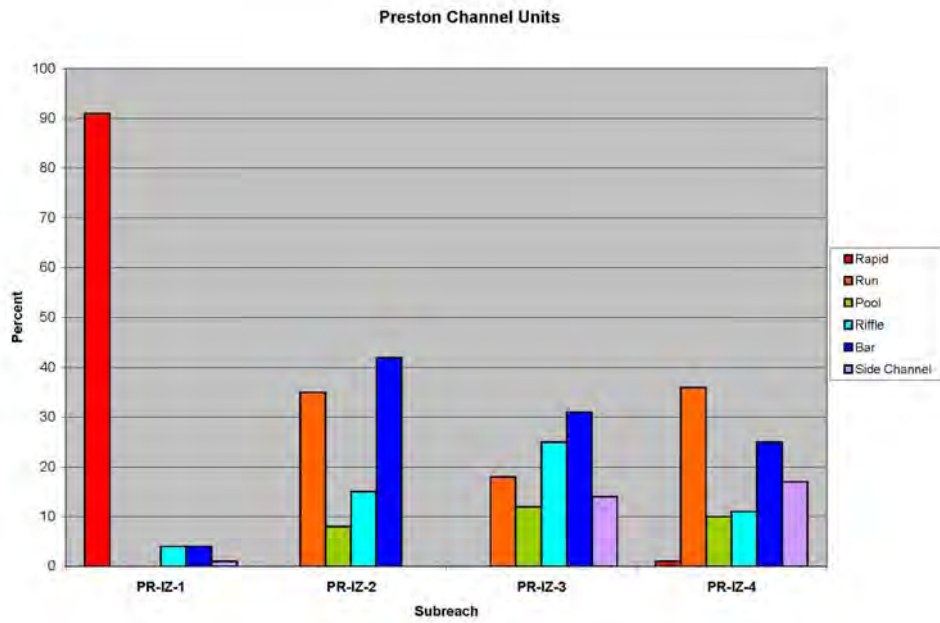
Figure 7. Percent of channel units for each inner zone subreach based on modified classifications from the Stream Inventory Handbook (USDA 2008).

Currently, there are four localized trends of sediment movement interpreted from channel unit mapping that are graphically illustrated in Figure 7. At the upstream extent of the reach, the channel unit mapping and the two-dimensional hydraulic model velocity map (for more complete information and results of the hydraulic model refer to Appendix E) suggest PR-IZ-1 is predominantly a transport subreach due to channel confinement by the Preston Creek alluvial fan (Figure 8). The Entiat River then transitions as the channel gradient becomes flatter (Figure 9), in subreach PZ-IZ-2 and trends toward depositional in subreach PR-IZ-3. The river then becomes predominantly transitional (not depositional) again for a short section where there are anthropogenic features that limit channel migration in subreach PR-IZ-4 (Figure 10) prior to becoming transport dominated as it exits the Preston reach and is naturally confined by the Dill Creek alluvial fan. These interpretations are based on channel unit mapping, two-dimensional hydraulic model results, channel confinement, channel gradient, and dominant substrate. In general, channel units found in transport segments are predominantly rapids with relatively high gradients and cobble/boulder substrate; transition segments have predominantly runs with flatter gradients and cobble/gravel substrate; and depositional segments have predominantly riffles and bars with flatter gradients and gravel/cobble substrate.

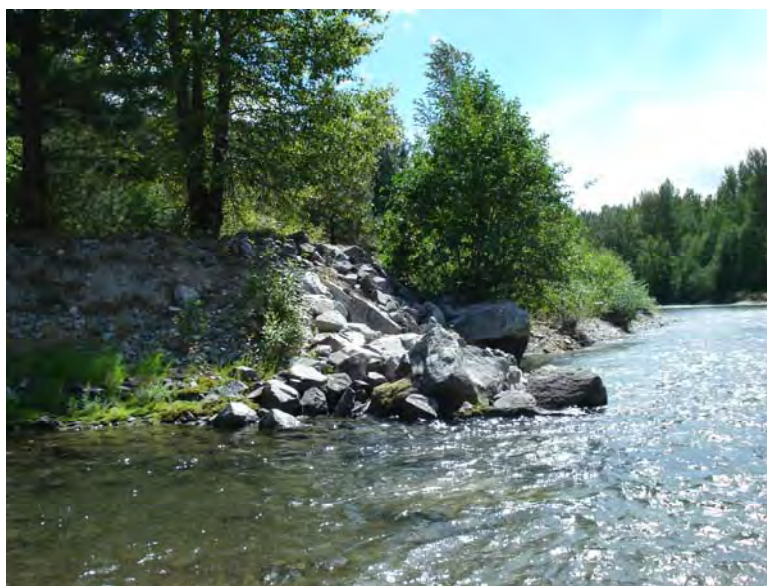
Photograph No. 5. View is to the south looking downstream along river left at the upstream end of a levee that is starting to fail. (Subreach PR-DOZ-5 – RM 22.3 – Reclamation photograph by R. McAfee, 2008).

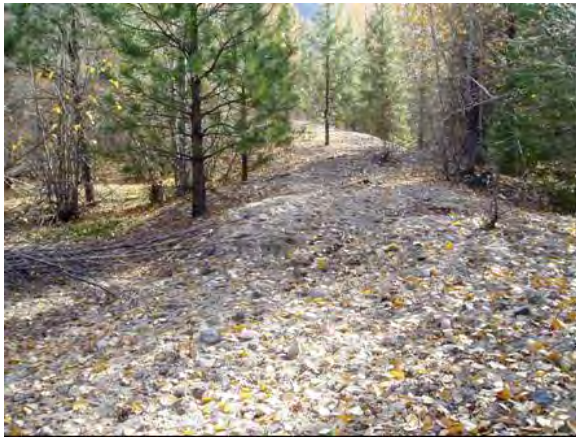
Dike above left bank at RM 22.4

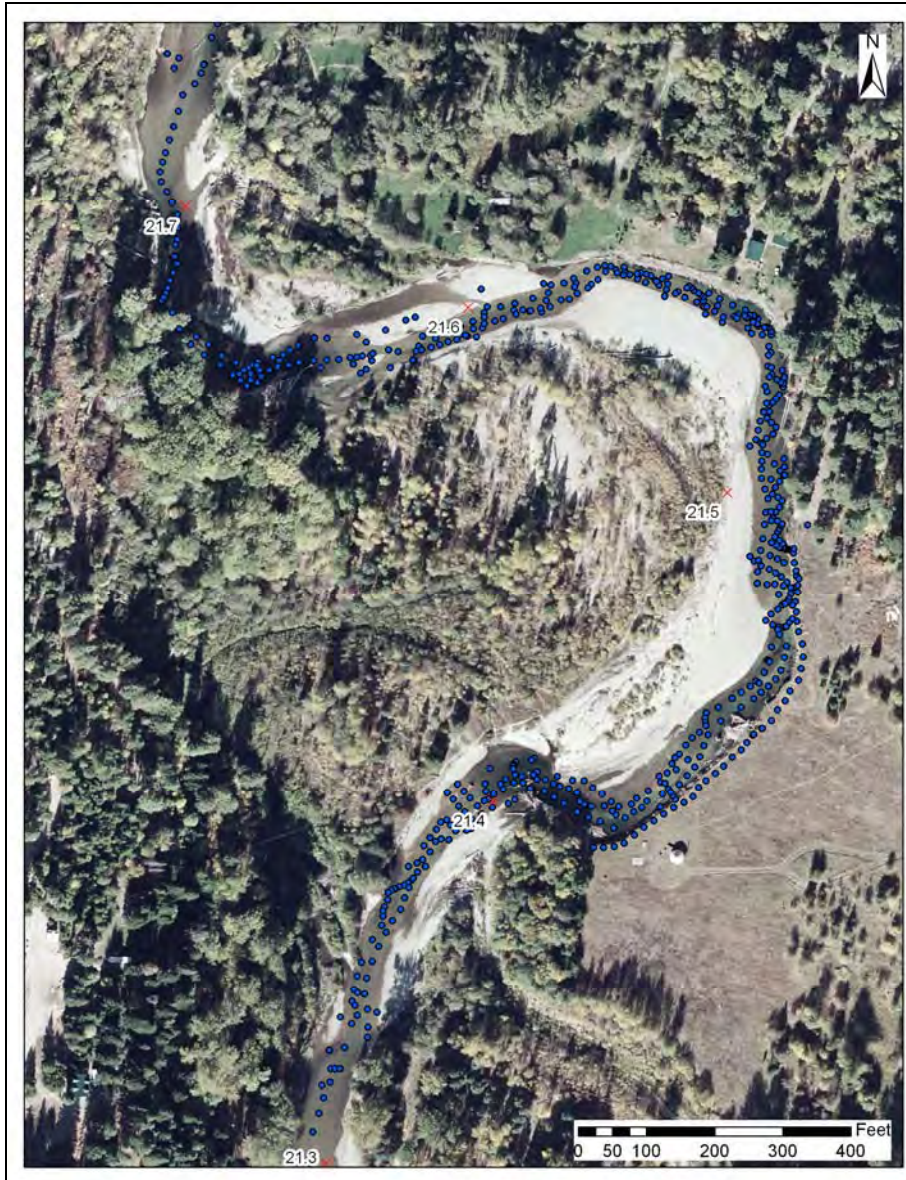
Figure 8. Example of on-the-ground survey data collected October 12-15, 2008.

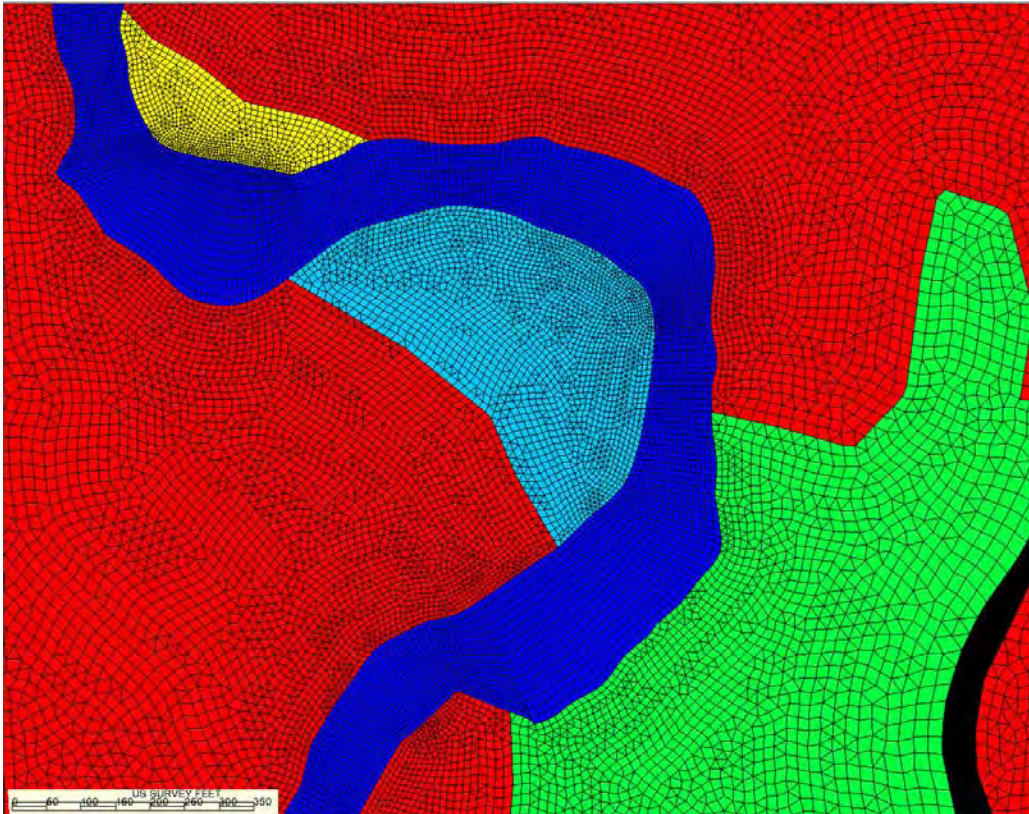
Figure 11. Example of model mesh in SMS. Colors represent various material types (dark blue = active channel, light blue = high flow bar, yellow = sparse vegetation, red = dense vegetation, green = cleared, black = road).

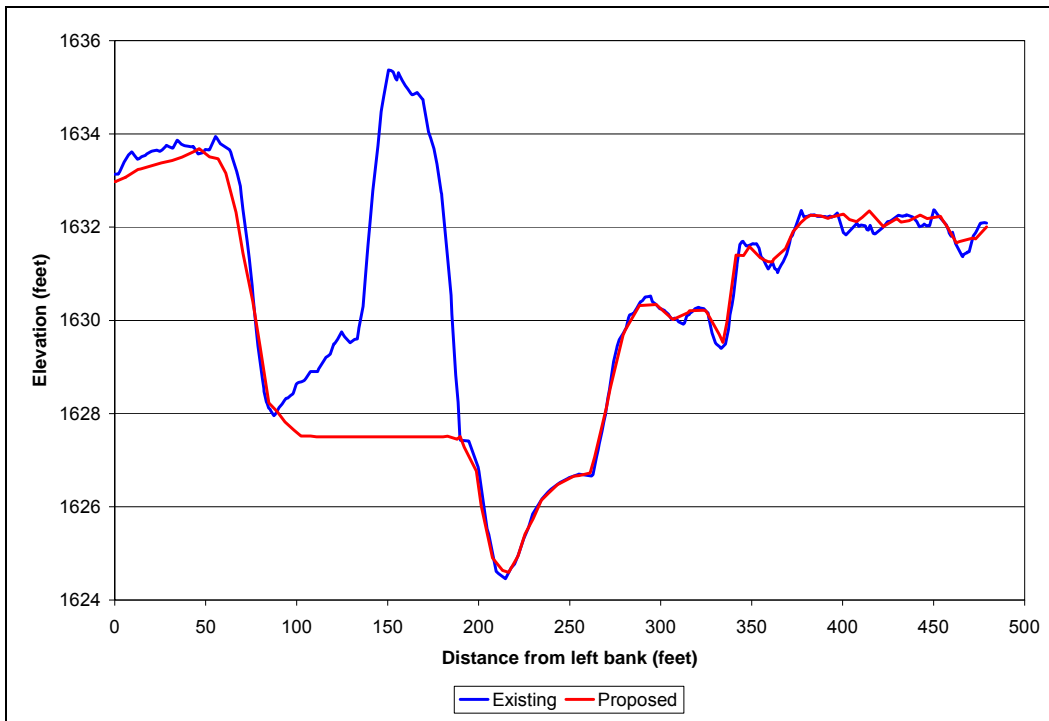
Figure 13. Existing versus proposed cross section profile at RM 21.85 showing levee removal.

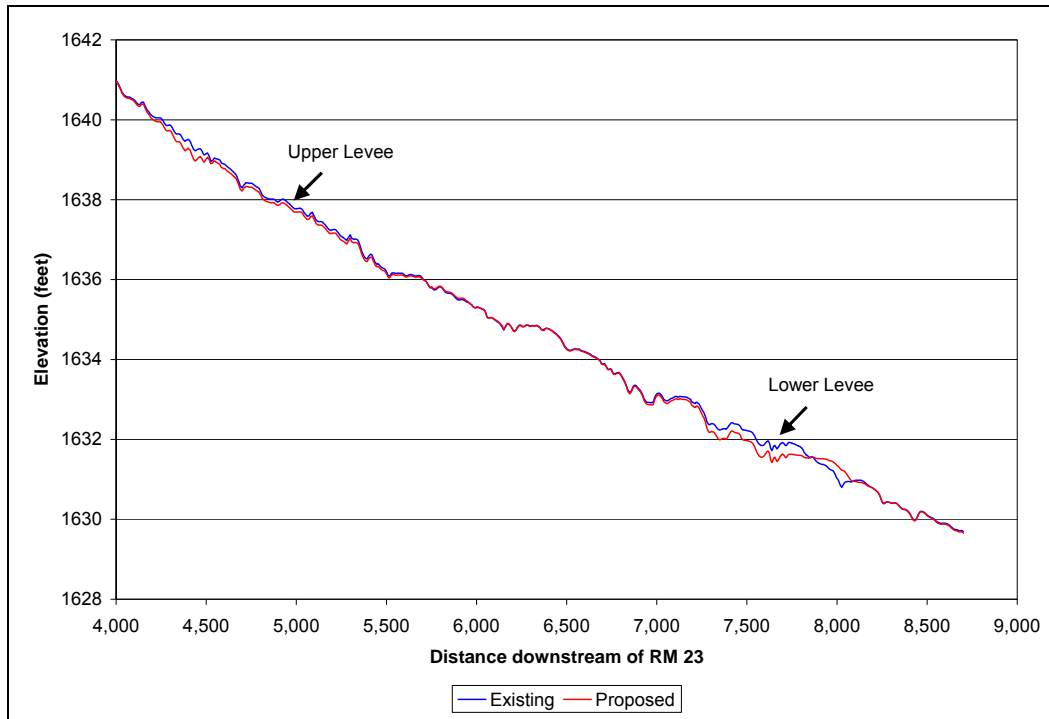
Figure 21. 2-year (2,620 cfs) water surface elevation profiles for the existing and proposed conditions.

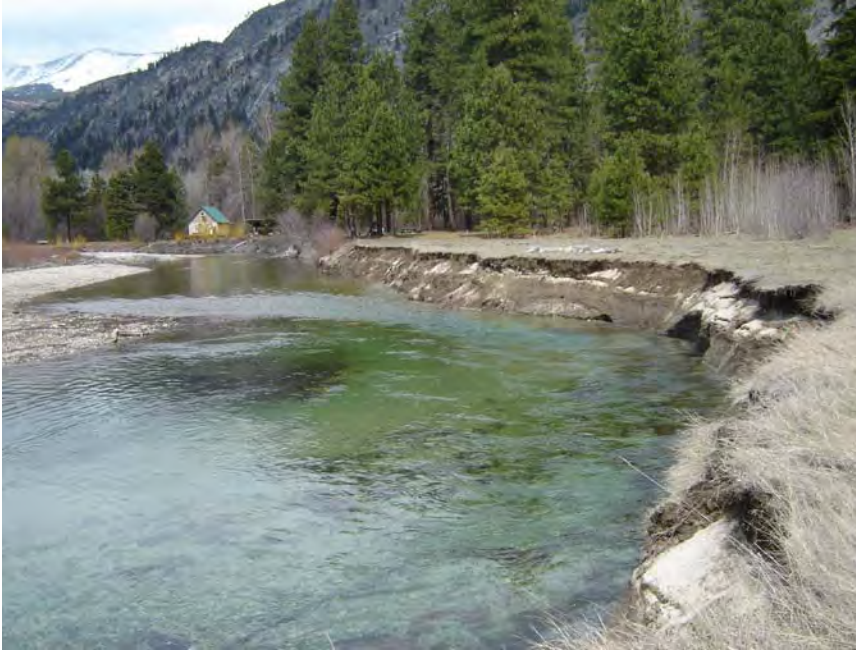
Figure 34. Bank instability at RM 21.5 (looking upstream).
