Lower Entiat Reach Assessment

U.S. Department of the Interior
Bureau of Reclamation
Pacific Northwest Region
Boise, Idaho

January 2012

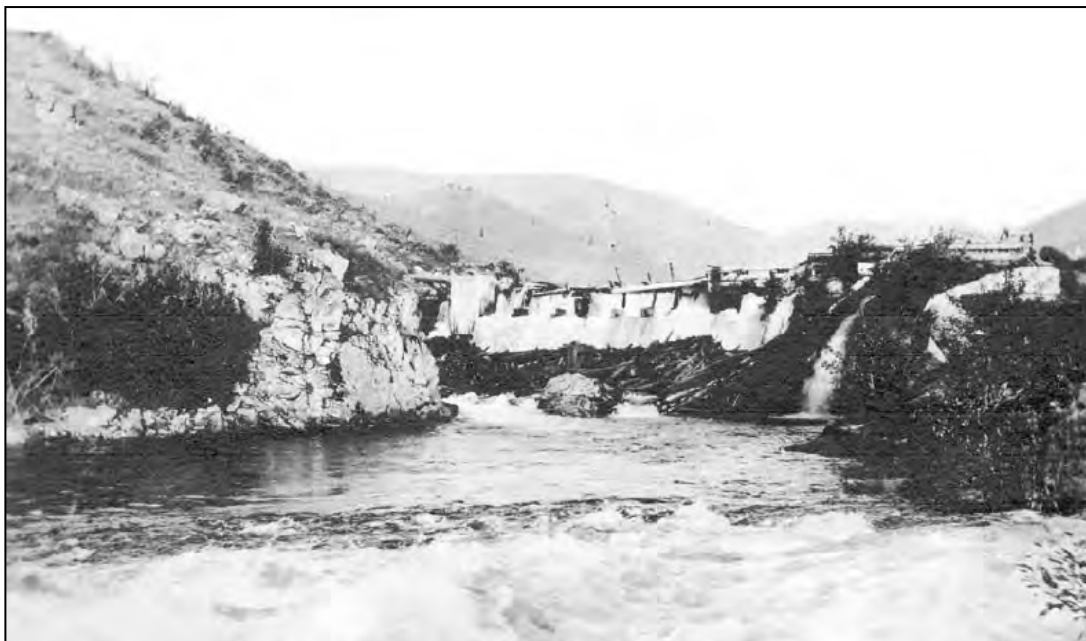
Figure 5. Formerly the T.J. Cannon, Cannon & Harris, and later the H.H. Gray & Son Mill Dam circa 1916 near RM 0.6 (Reclamation 2009a).

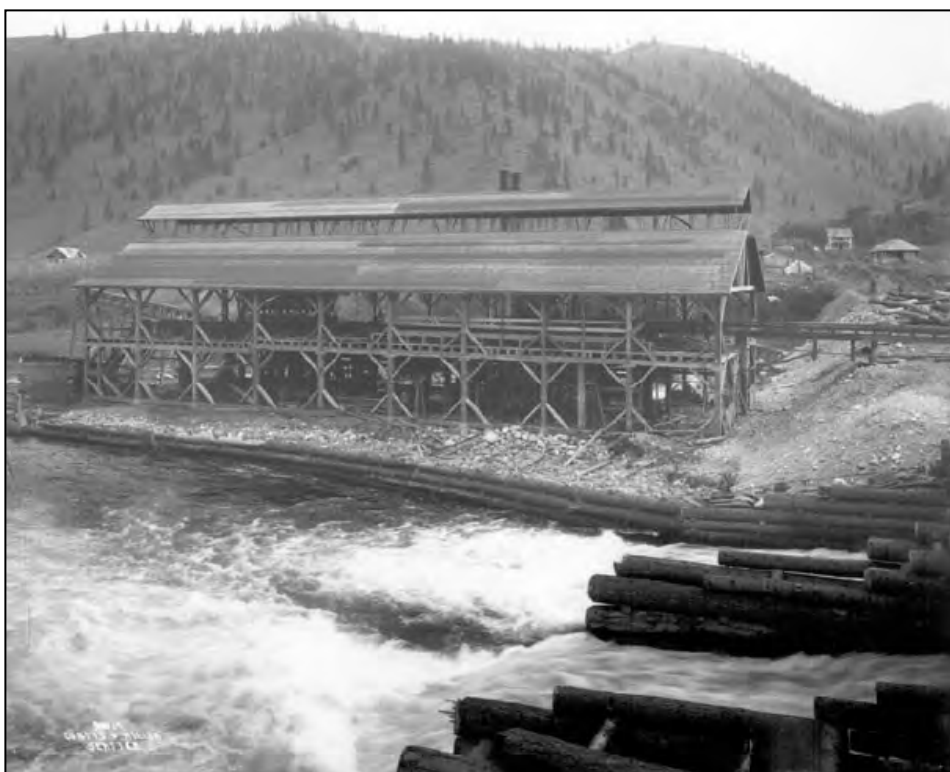
Figure 6. Kellogg Mill and dam circa 1914 near RM 3.6 (Published in Erickson 2004. Courtesy of Washington State Historical Society, Asahel Curtis Collection, #300117).

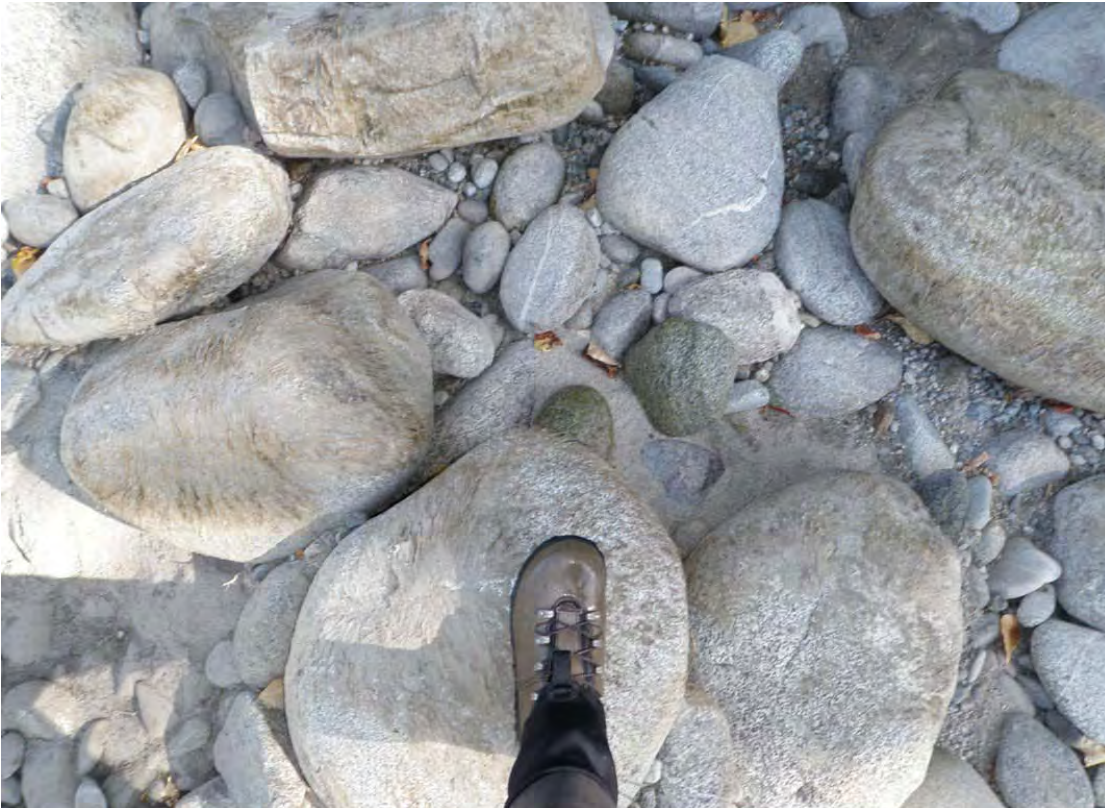
Figure 10. View of large boulders within the bankfull channel near RM 6.0.

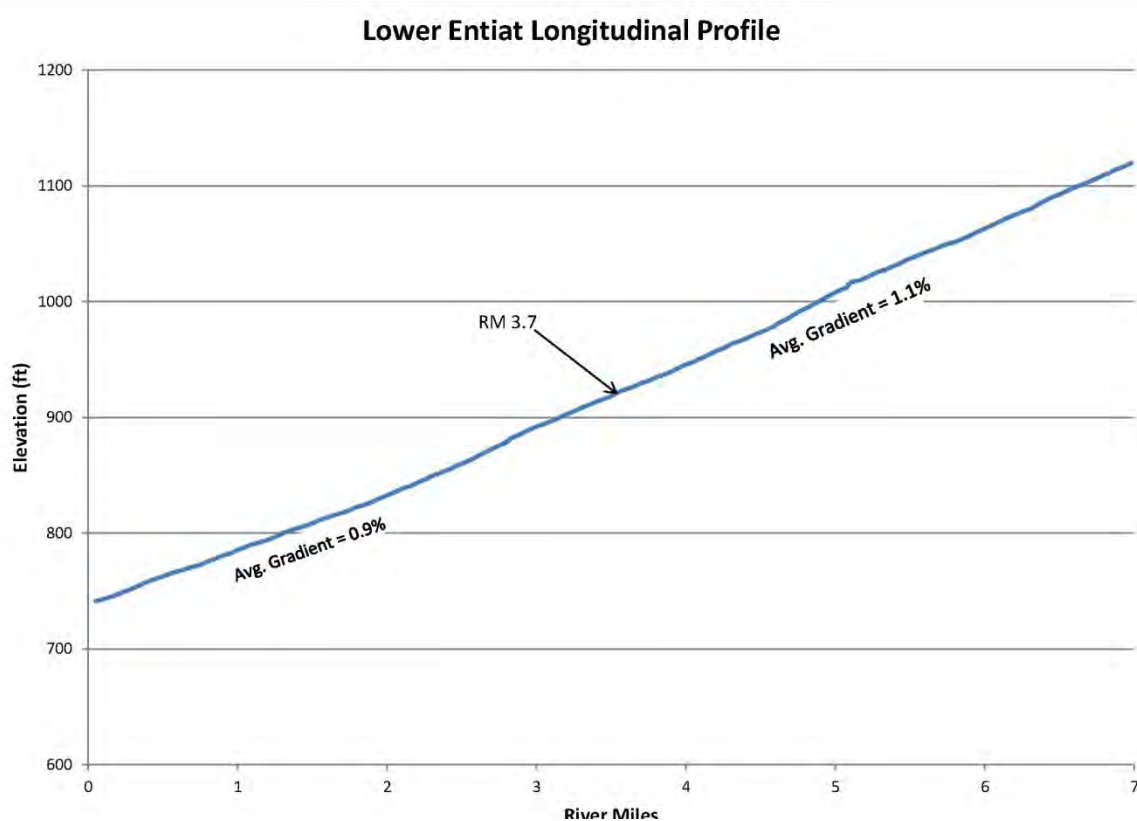
Figure 12. Longitudinal profile of the 2-year flood water surface from HEC-RAS for the lower 7 miles of the Entiat River. The average gradient decreases slightly near RM 3.7 from 1.1 percent to roughly 0.9 percent.

The bed of the river is described by its overall gradient and, on a finer-scale, by its grain-size distribution, armoring, and representative bed forms. Downstream of the terminal glacial moraine near Potato Creek, the gradient in the Entiat River is consistently fairly steep. Within the assessment area, the gradient was measured at 1.1 percent between RM 7 to RM 3.7 where it reduces to 0.9 percent downstream to the flat backwater of the Columbia River near RM 0.6 (Figure 12).

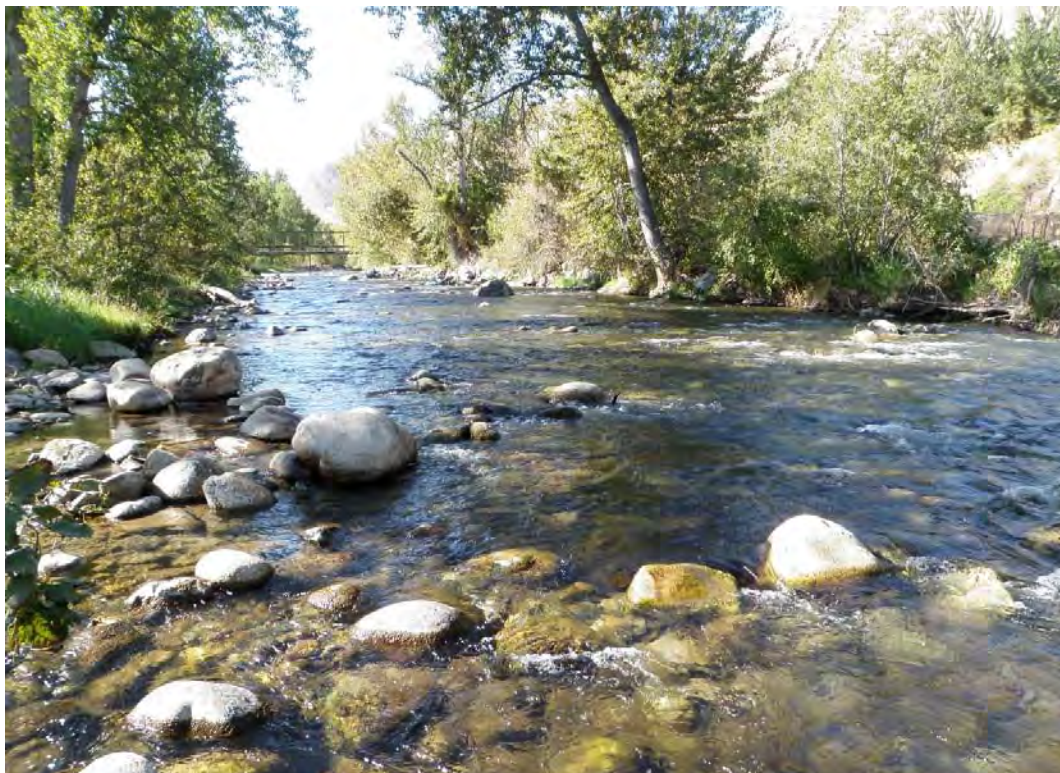
Figure 13. View of boulders in the lower Entiat riverbed near RM 1.4.

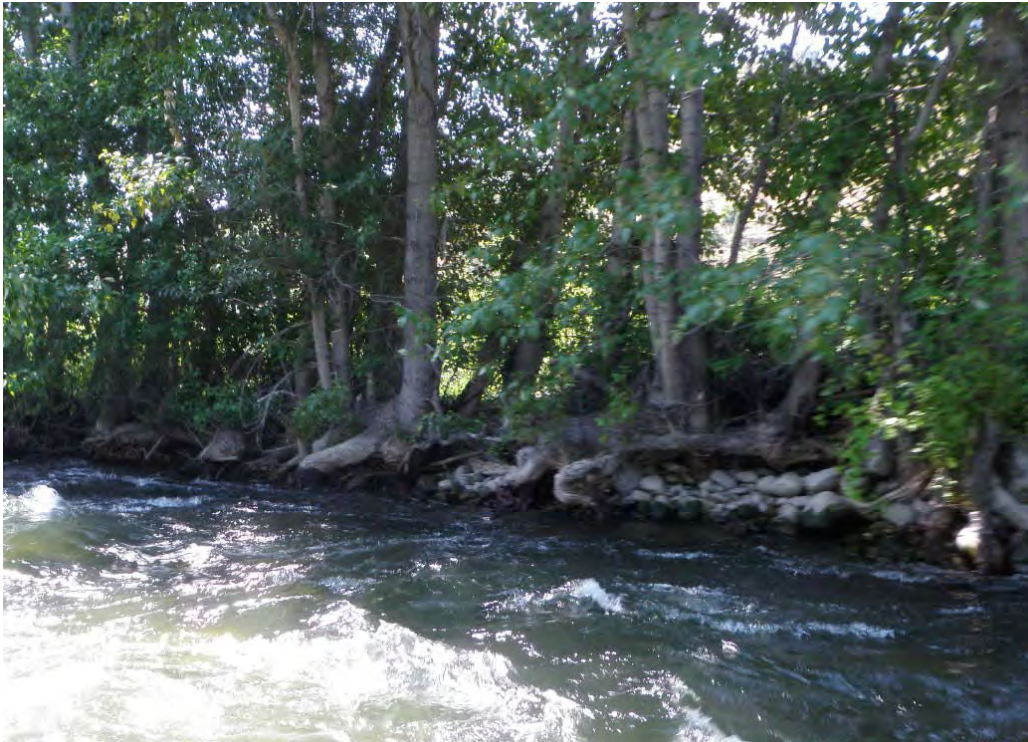
Figure 15. View of a bouldery bank held together with a dense root mat near RM 6.0.

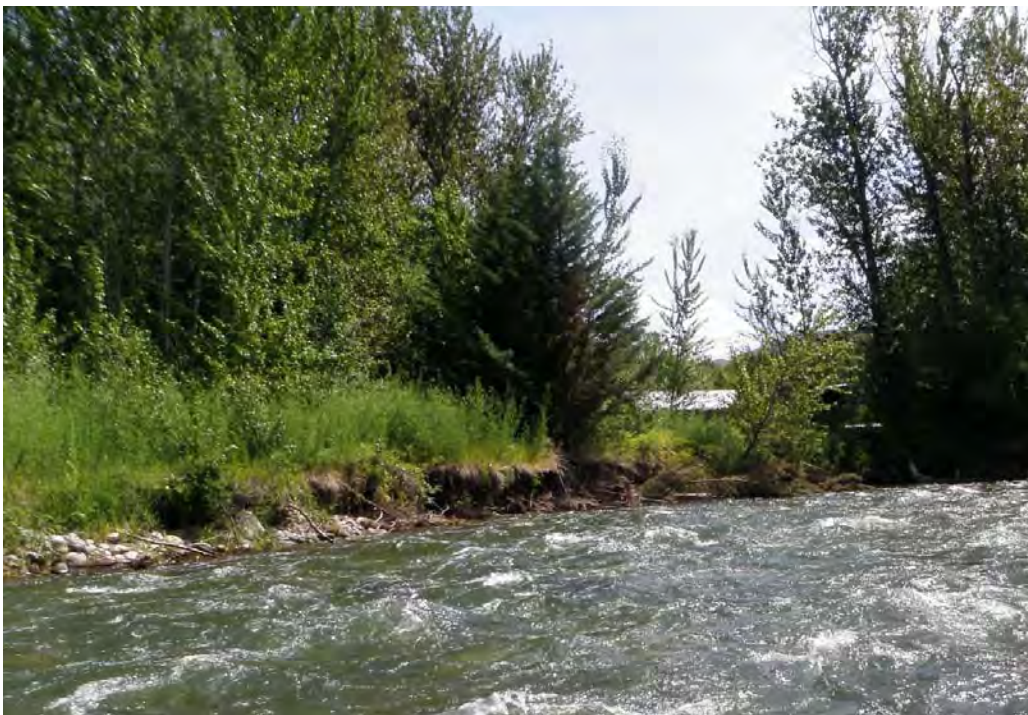
Figure 16. View of the bank erosion on the left bank near RM 5.0.

Bank composition is similar to the bed composition, composed primarily of coarse-grained, erosion-resistant glacial outwash consisting largely of boulders and cobbles. Where mature riparian vegetation is present, a dense root mat binds the bank material together, increasing the erosion-resistant properties of the banks (Figure 15). During multiple field visits to the lower Entiat River at high and low flows in 2011, only one minor area of bank erosion was observed along the left bank at RM 5.0. Roughly 250 feet of the bank has receded approximately 80 feet since 1975 in this location, which is one of the few places where the bank is composed primarily of sand and gravel with limited cobbles and boulders providing armoring (Figure 16).

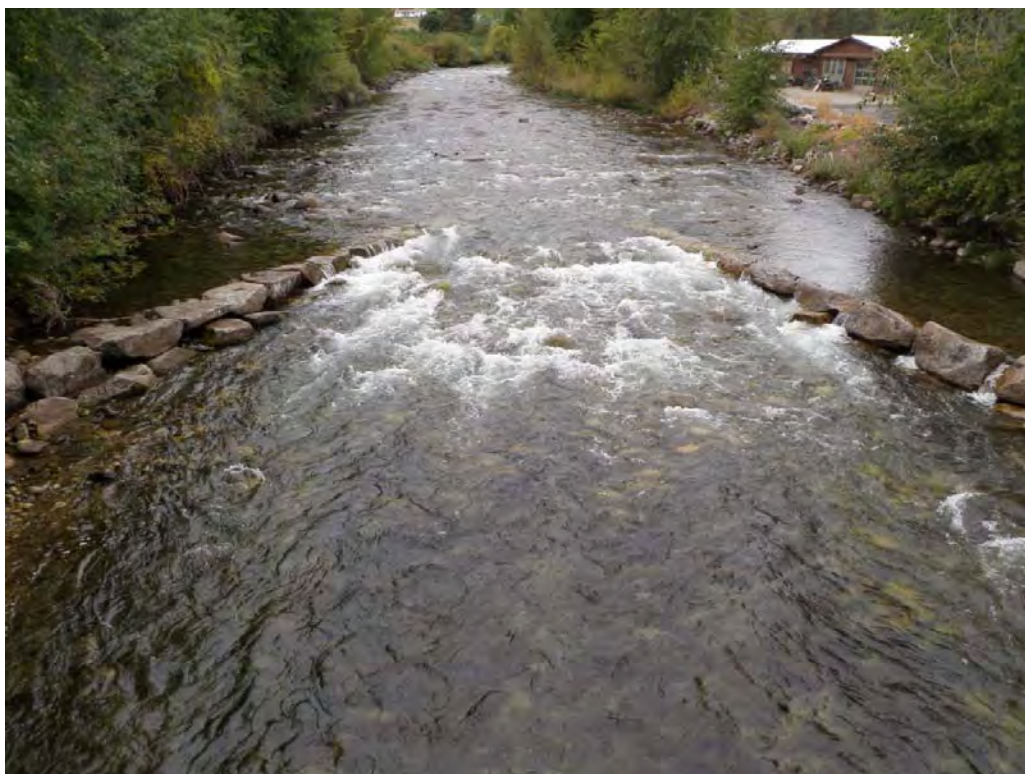
Figure 18. Dinkleman cross vane structure in the Entiat River at RM 4.6 in 2011, roughly 10 years after construction and one 10-year flood. As opposed to creating a scour pool as anticipated, most of the area near the apex of the weir has filled in with coarse bedload.

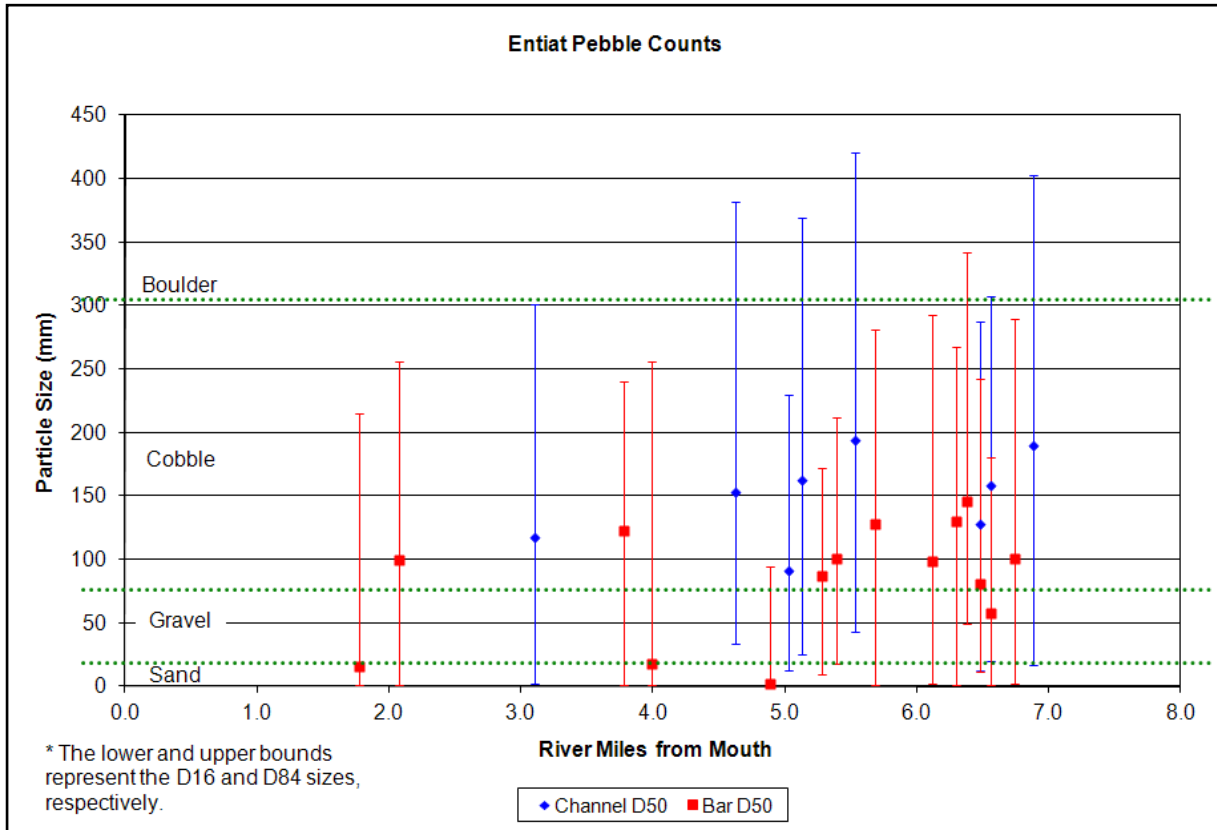
Figure 24. Pebble count data illustrating the large grain sizes comprising the surface material on the channel bed and bars of the lower Entiat River. Average channel bed D50 (median grain size) is 154mm (cobble) while average channel D84 (84th percentile grain size) is 343mm (boulder). Dotted green lines separate grain sizes between sand, gravel, cobble and boulders. The data was collected by Reclamation in 2005 as part of the Tributary Assessment effort.

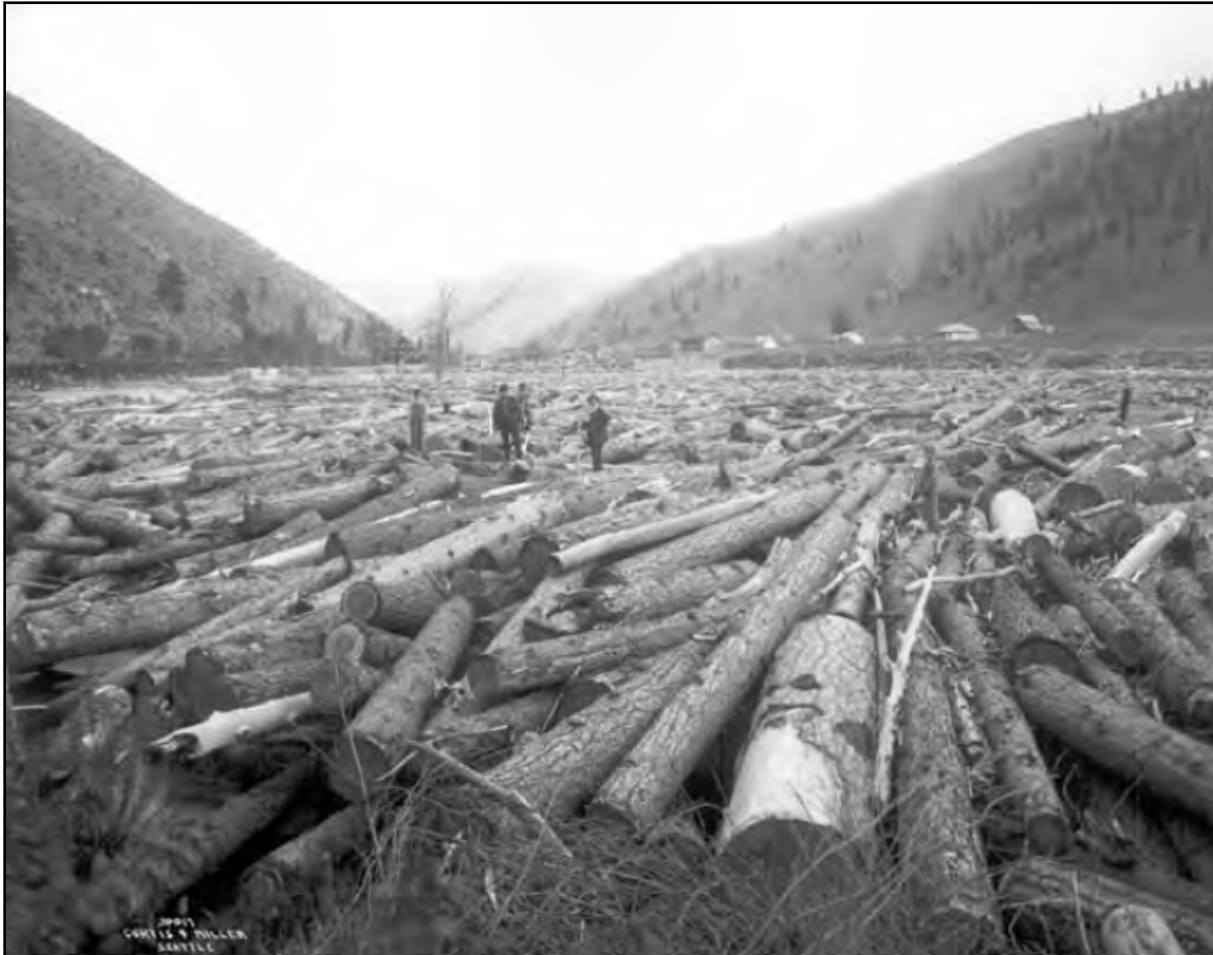
Figure 25. Photo of timber stockpiled at the Kellogg Mill near RM 3.4 in 1914. Note the large size of the timber and the general lack of standing trees both in the valley bottom and on the hillslopes (published in Erickson 2004).

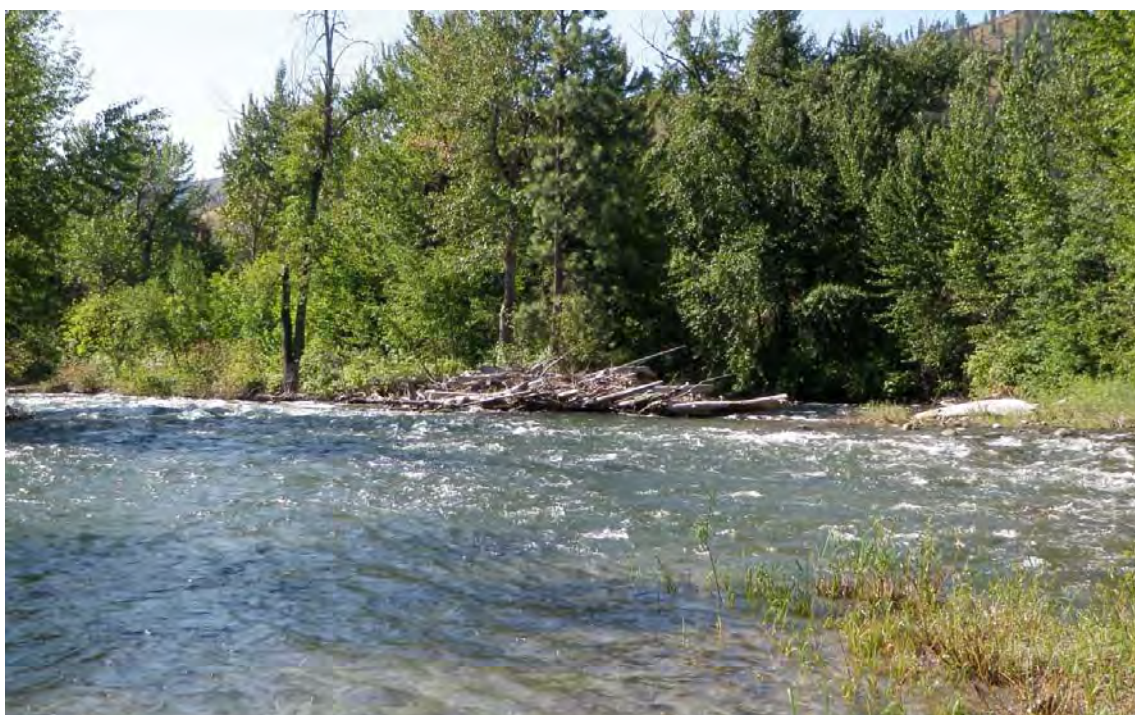
Figure 26. View of an existing naturally occurring logjam at the head of an island located near RM 6.4.

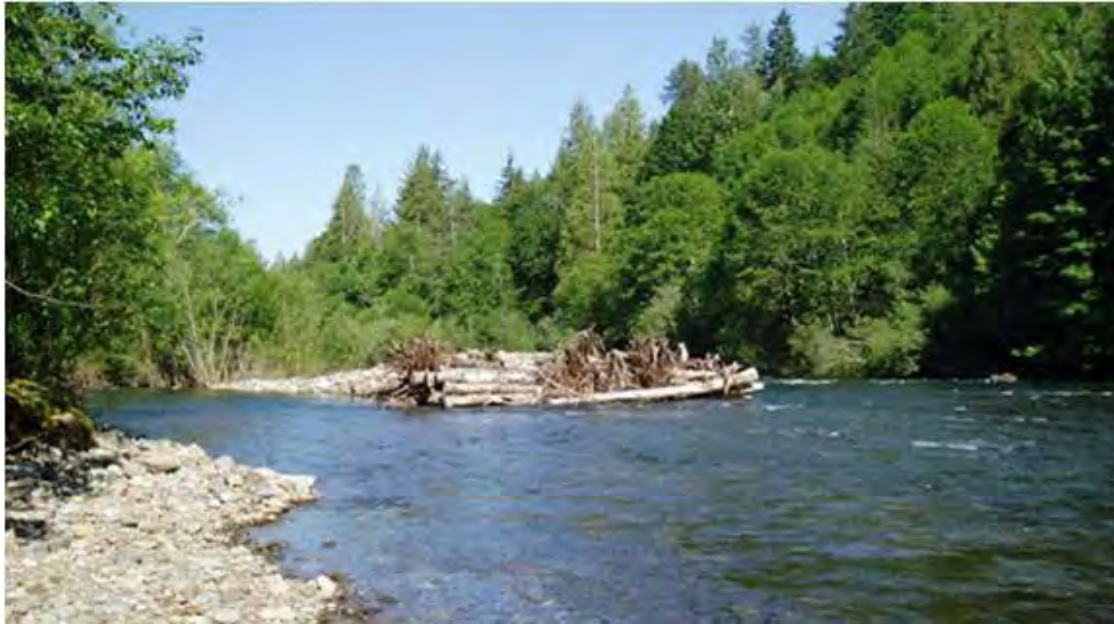
Figure 37. Constructed mid-channel ELJ located on the Green River, Washington (courtesy Anchor QEA).

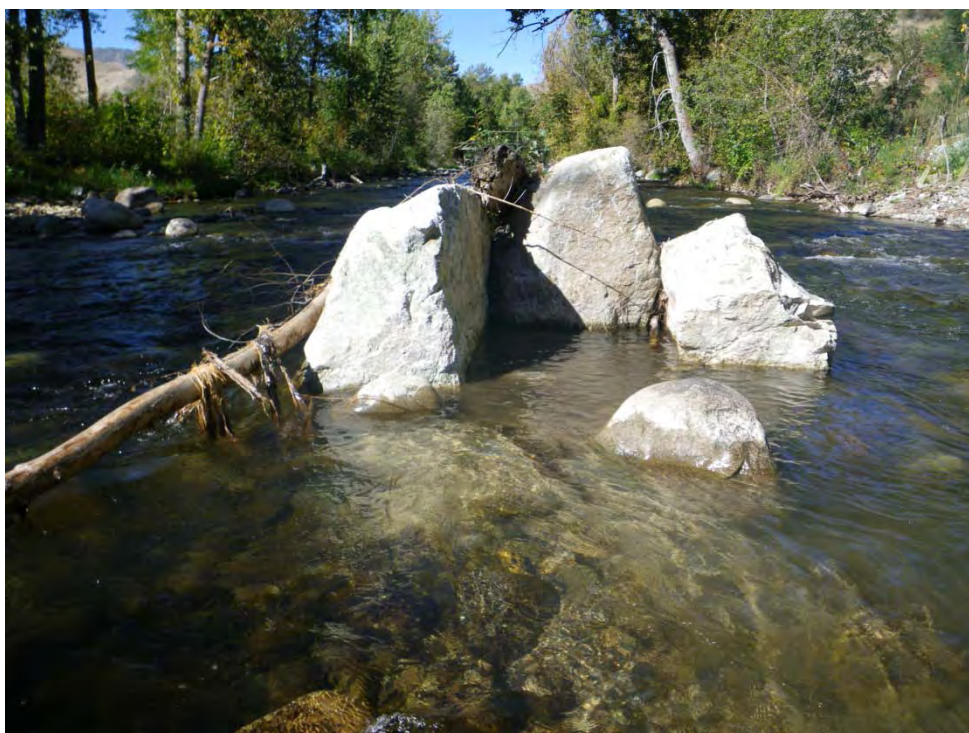
Figure 39. Constructed boulder cluster in the lower Entiat River near RM 1.4.

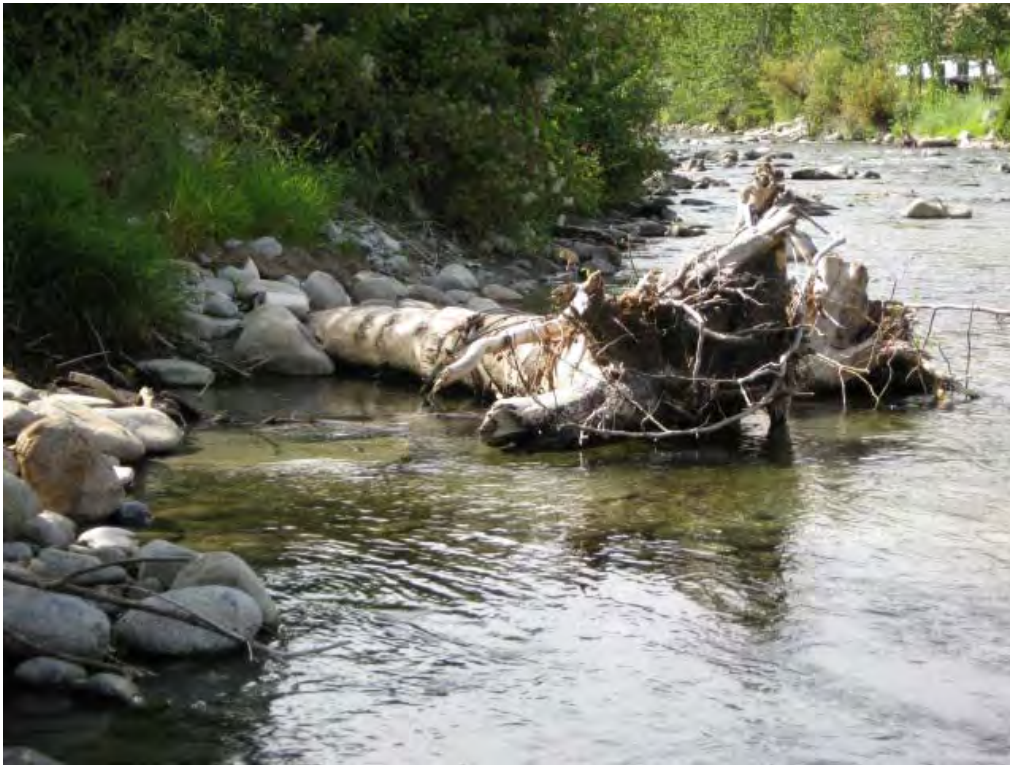
Figure 41. LWD Barb in the Entiat River near RM 3.0.

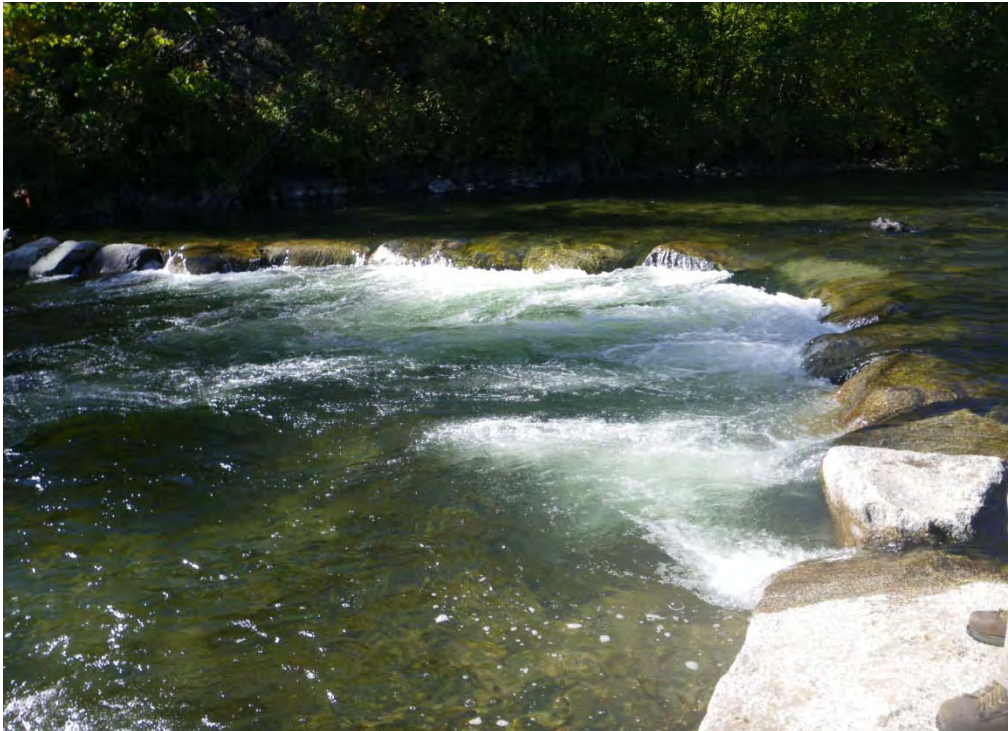
Figure 42. V-shaped weir on the Entiat River near RM 3.1.
