COMPLETION REPORT
THURLOW TRANSFER DITCH
FISH PASSAGE IMPROVEMENT PROJECT
BEAVER CREEK,
METHOW SUBBASIN, WASHINGTON
MAY 2004

Thurlow Diversion Fish Passage Improvement Project

Appendix A. Construction Photographs (color)

Appendix B. As-Built Drawings

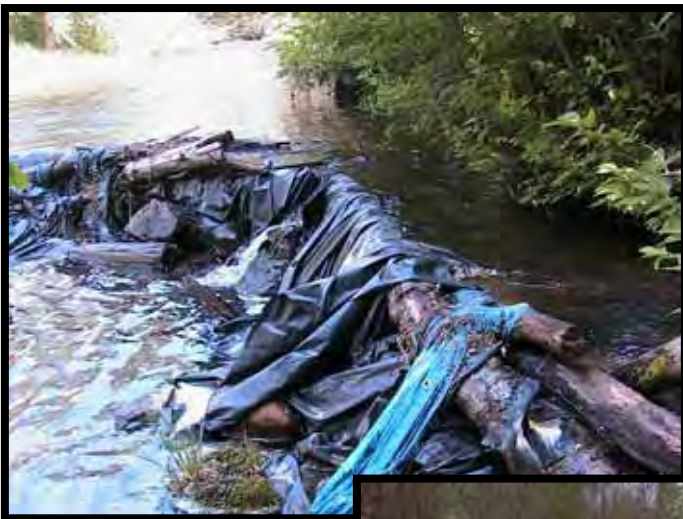
Cover Photo 1. Looking upstream at original Thurlow Transfer Ditch diversion dam. The ditch is on the left side of Beaver Creek, between the Upper Stokes and lower Stokes diversion. The arrow shows direction of flow of ditch water. (Photo A-1)

In the fall of 2003, the Thurlow Transfer Ditch Diversion Dam (cover photo 1), identified by the Washington Department of Fish and Wildlife (WDFW) as a barrier to fish movement, was replaced by two rock weirs (cover photo 2). The new weirs allow fish passage for all species and life stages, meet diversion flow requirements for the irrigators, and are less noticeable. The project, the last of three in the area,¹ is located on Beaver Creek, a tributary of the Methow River in Okanogan County, Washington. This report explains the design process and regulatory requirements leading to the new diversion and documents the construction that took place. To better illustrate what was accomplished, we have included two appendices. Appendix A shows a series of photographs documenting the work that was done. Appendix B contains a location map and “as-built” drawings of the project.

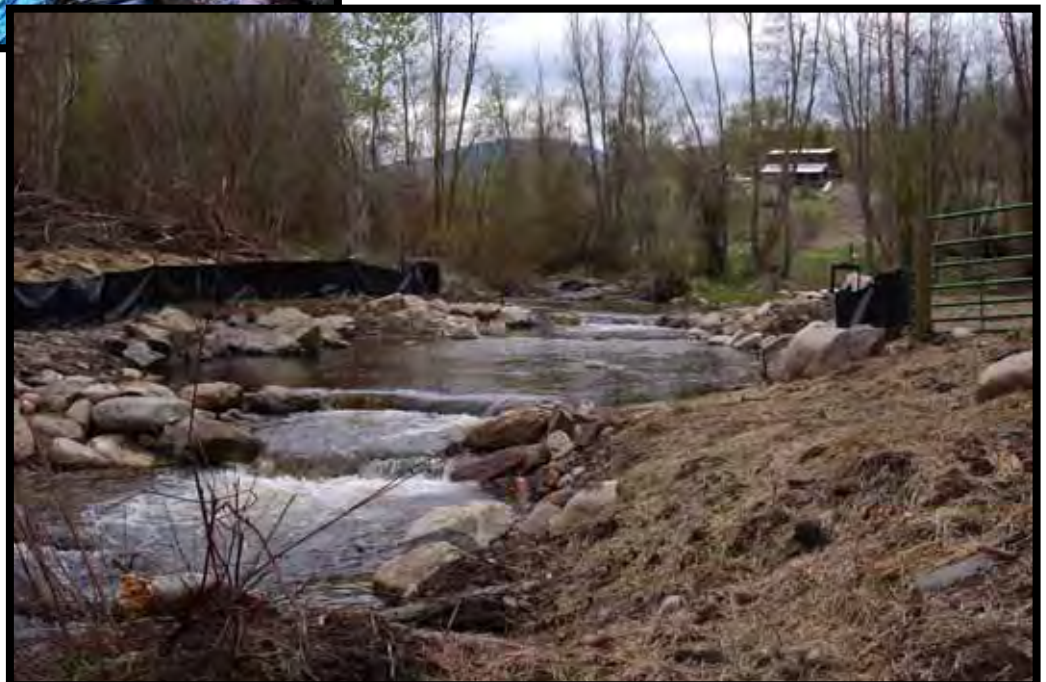
Cover Photo 2. Upstream view of completed weirs; Atype Weir No. 2 in foreground and V-type Weir No. 1 in background. Flows are normal for time of the season, about 15 cfs. (photo by Reclamation/Greg Knott; April 2004)

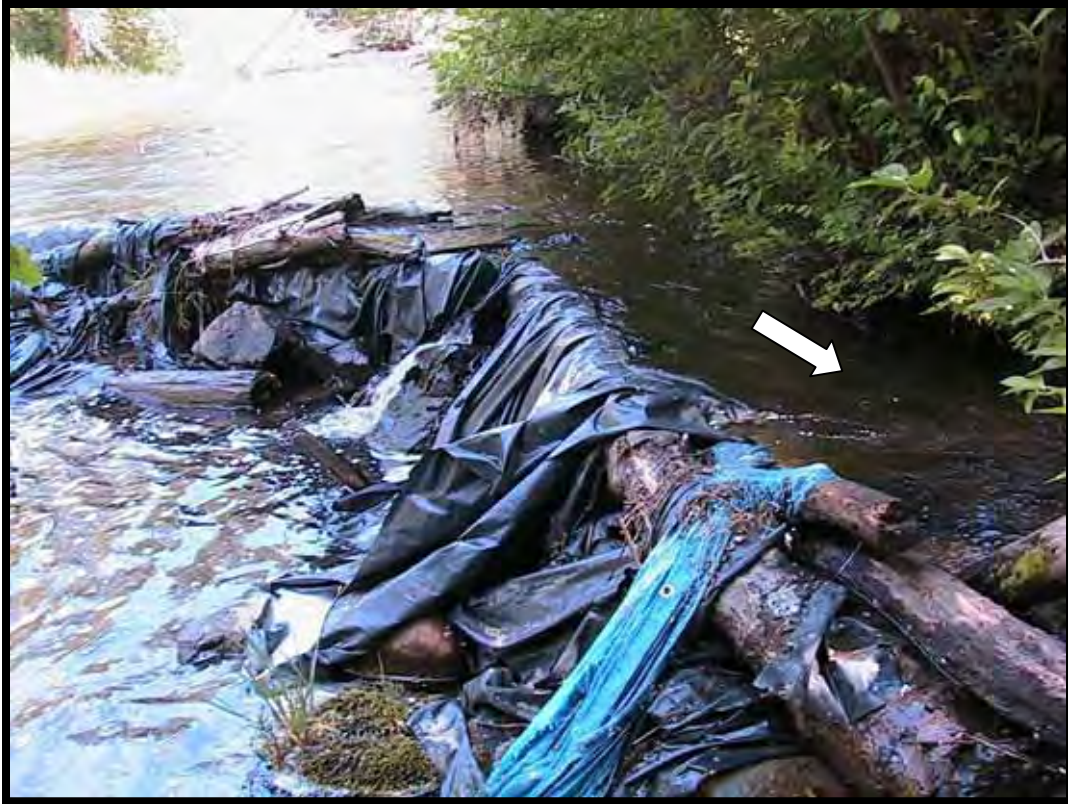
Photo A-1. Looking upstream at original Thurlow Transfer Ditch diversion dam. The ditch is on left side of Beaver Creek, between the Upper Stokes and Lower Stokes diversions. Arrow shows direction of flow of ditch water.

The existing 3½-foot-high diversion dam, made of stacked logs and lined with plastic (photos A-1, A-2, A-3, A-5, and A-6), was removed entirely; two weirs replaced it. Weir No. 1, a so-called Rosgen “V-type” vortex rock structure (photos A-27 and A-28), was installed about 70 feet upstream of the existing log structure. This new weir was designed to have a drop in the creek of no more than 0.8 foot, which meets WDFW standards for fish passage. Because the large rocks established a hardened point, Weir No. 1 provides “grade control;” this means the stream is unable to downcut its bed over time. It also forms a small pool at the new point of diversion sufficient to allow diversion of the water right. Weir No. 2, a Rosgen “A”-type (or double-drop) vortex rock structure, was constructed at the location of the previous dam to stabilize the channel, prevent downcutting, and provide a controlled drop to the existing streambed below the dam. Headcutting is a large, downward movement of a streambed created when a stream is steepened.

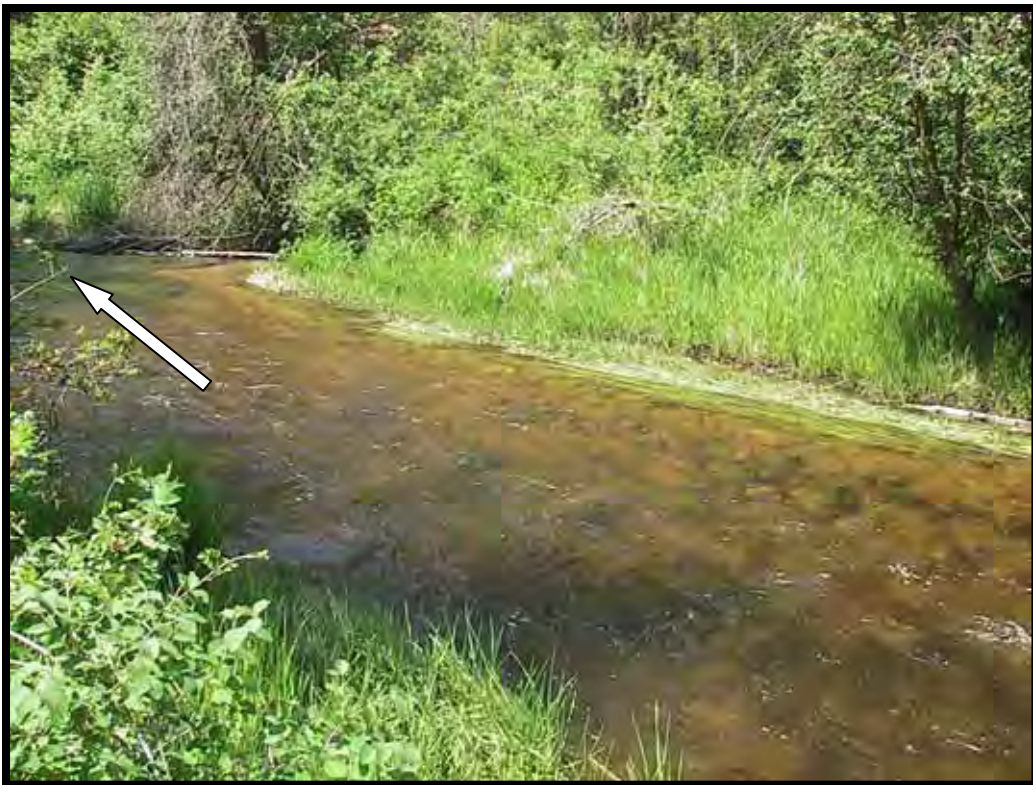
Photo A-2. Looking downstream at original diversion dam; the arrow indicates the head of the irrigation ditch. (*September 2003*)

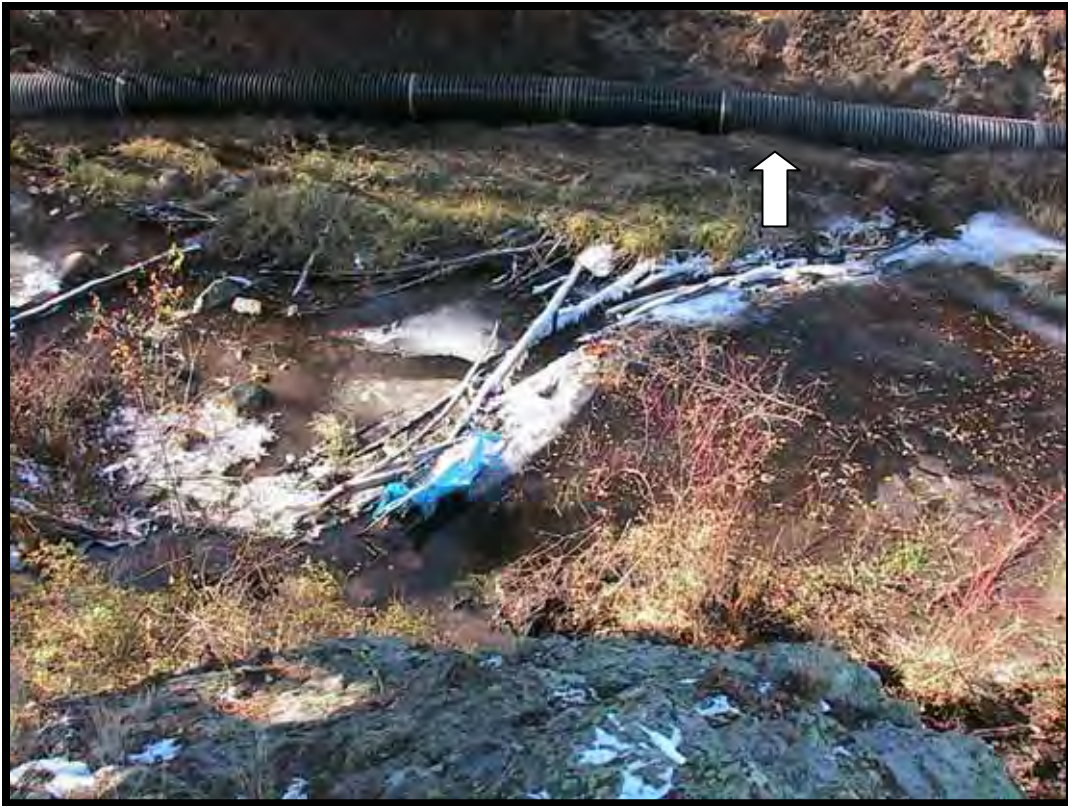
Photo A-3. Looking down at original diversion dam; the original ditch is in lower left of photo. The contractor-installed dewatering pipe is indicated by arrow.

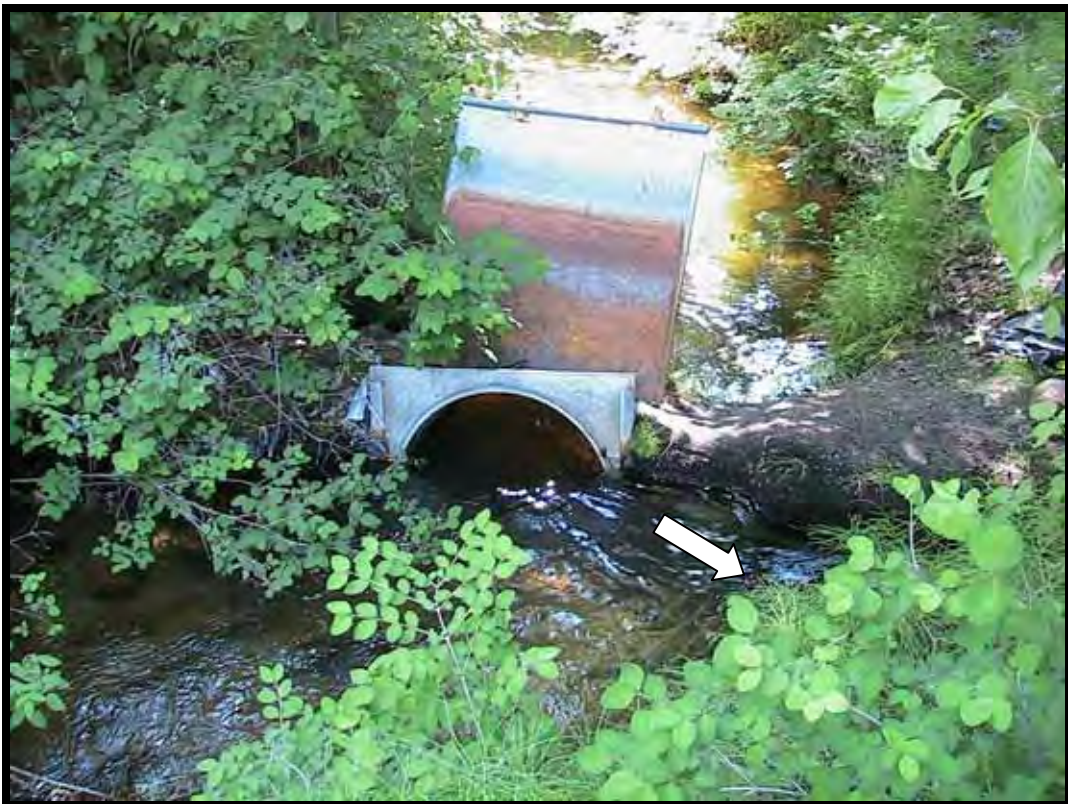
Photo A-4. Looking downstream at the original ditch headgate; the arrow indicates the direction of flow of the wasteway ditch. The former headgate was located about 50 feet downstream from the diversion dam. (September 2003)

A new diversion box and headgate was installed at Weir No. 1 (photos A-16, A-17, and A-18). About 90 feet of 36-inch-diameter conveyance pipe was installed from the diversion box to just upstream of the concrete wasteway/control structure. The new fish screen sits about 20 feet downstream of the wasteway/control structure (photos A-19 and A-20). It is a single, 3-foot-diameter drum screen with a paddlewheel drive. The old headgate (photo A-4) was removed.

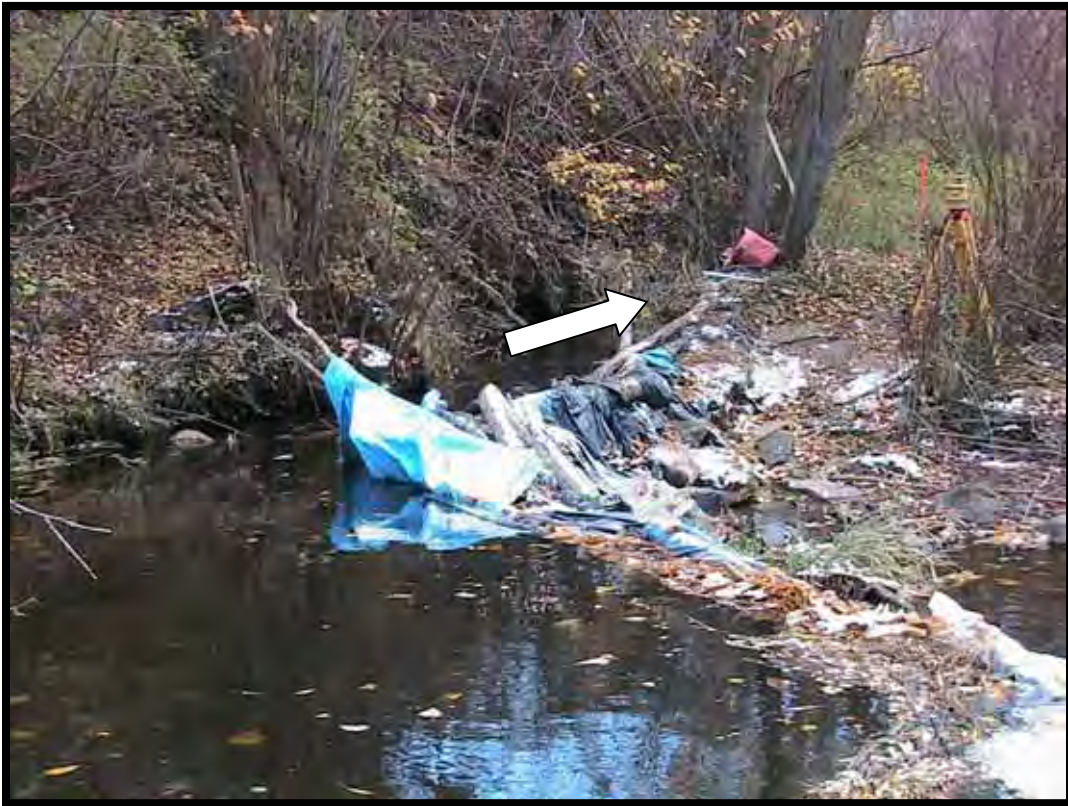
Photo A-5. Looking downstream at the original diversion dam; the arrow shows the direction of flow of the ditch.

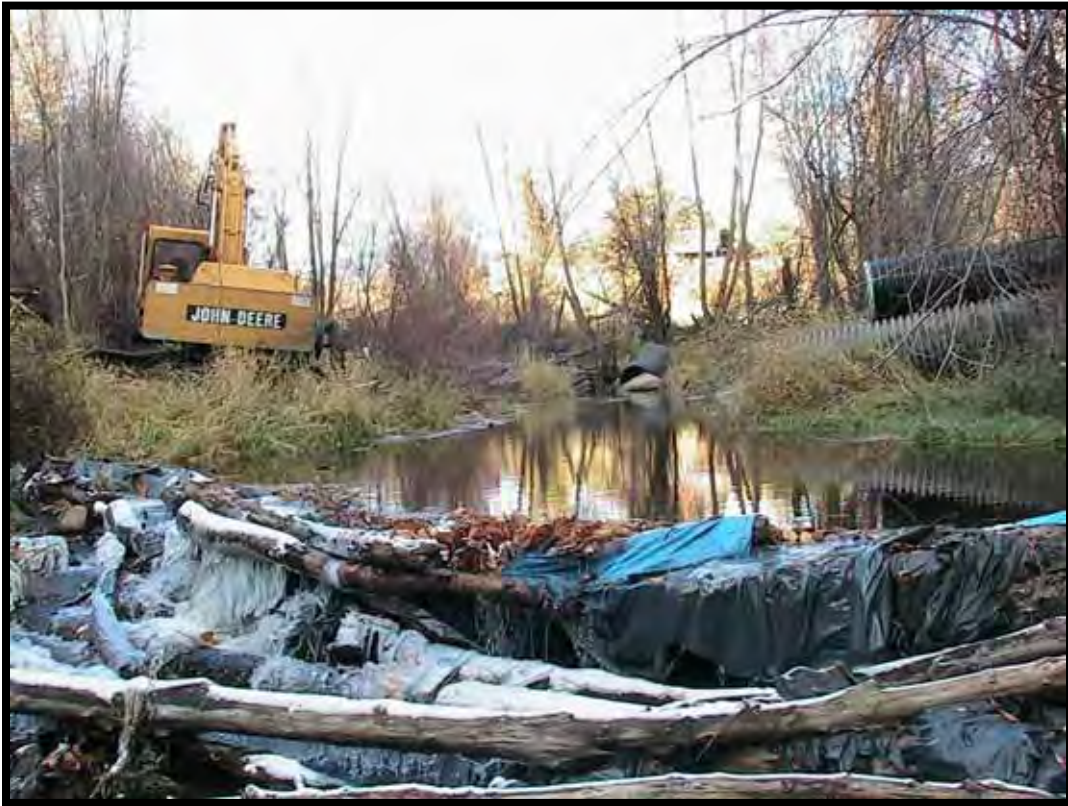
Photo A-6. The dewatering pipe just prior to installation; the pipe was to be installed on the right side of the creek, where the excavator is sitting.

Dewatering — The worksite was dewatered using 30-inch-diameter, double-walled, HDPE pipe, which was routed around the construction area (photos A-6 and A-10); the pipe and its watertight gaskets were also manufactured by the ADS Company. A total of 200 feet of dewatering pipe and two 45-degree fittings were purchased by OCD for use on several projects. About 150 feet of dewatering pipe and one 45-degree fittings was used for the Thurlow Transfer Ditch project. Surface excavation ranging in depth from 1 to 5 feet was needed to ensure proper grade. The dewatering pipeline was not backfilled unless necessary for weight on the pipe or where the equipment needed to cross. The dewatering pipe was used for other Beaver Creek projects.

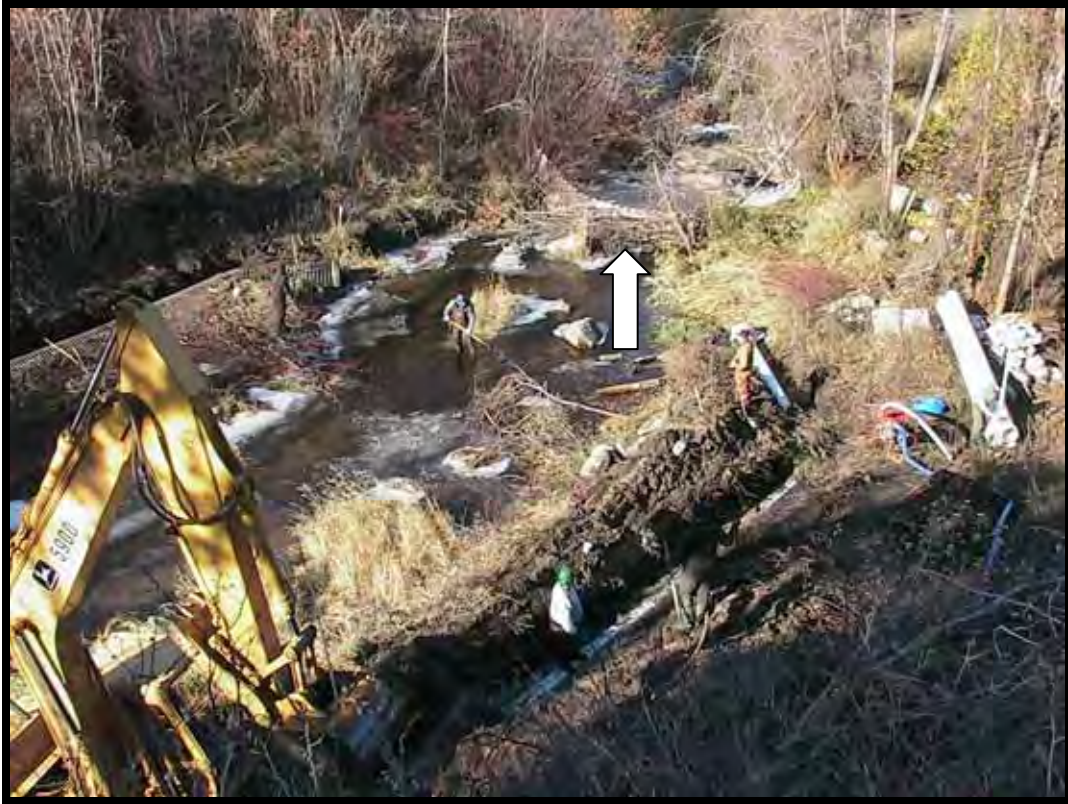
Photo A-7. Dewatering pipe in place (upper left); crew placing temporary irrigation pipe (lower right). Note fish-blocking net across stream (arrow). The cofferdam was built where the worker in the creek is standing.

1. Installation of 125 feet of dewatering pipe around site of both proposed weirs and the existing dam; Photos A-7, A-10, A-13, and A-25.
2. Temporary installation of 12-inch PVC pipe from upstream of cofferdam to the existing ditch to provide irrigation water during construction; Photo A-10.

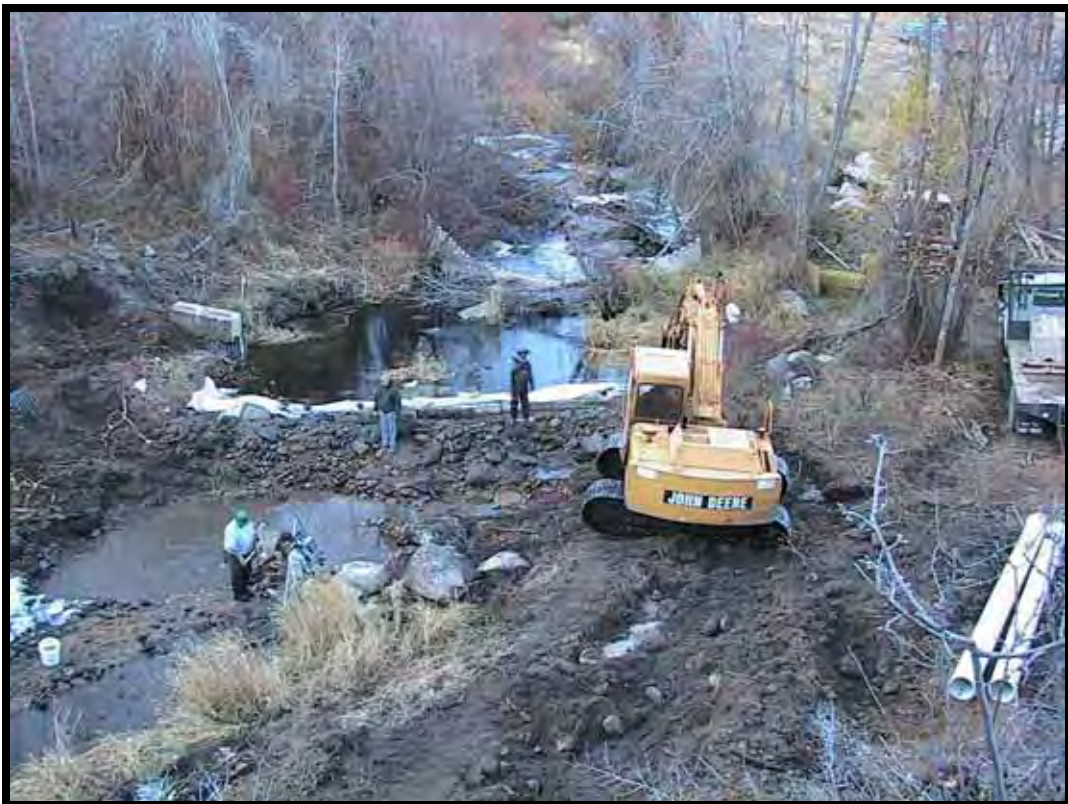
Photo A-8. Ecology-block-and-plastic cofferdam in place. Temporary irrigation pipe has been backfilled. Staff from WDFW are electroshocking fish.

3. Installation of ecology block cofferdam with plastic; electroshocking and removal of resident fish from site (1 day); Photos A-8 and A-9.
4. Deconstruction of log-and-plastic diversion dam.

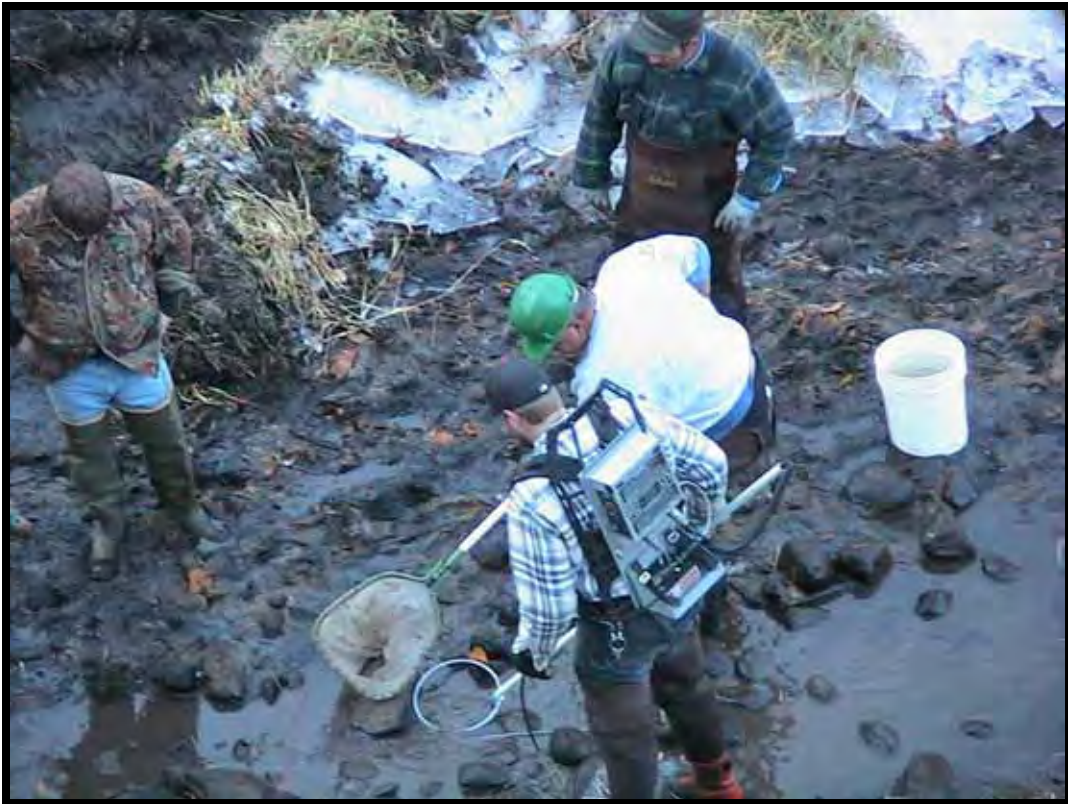
Photo A-9. USFS and Okanogan Conservation District staff electroshocking fish in construction area for release downstream.

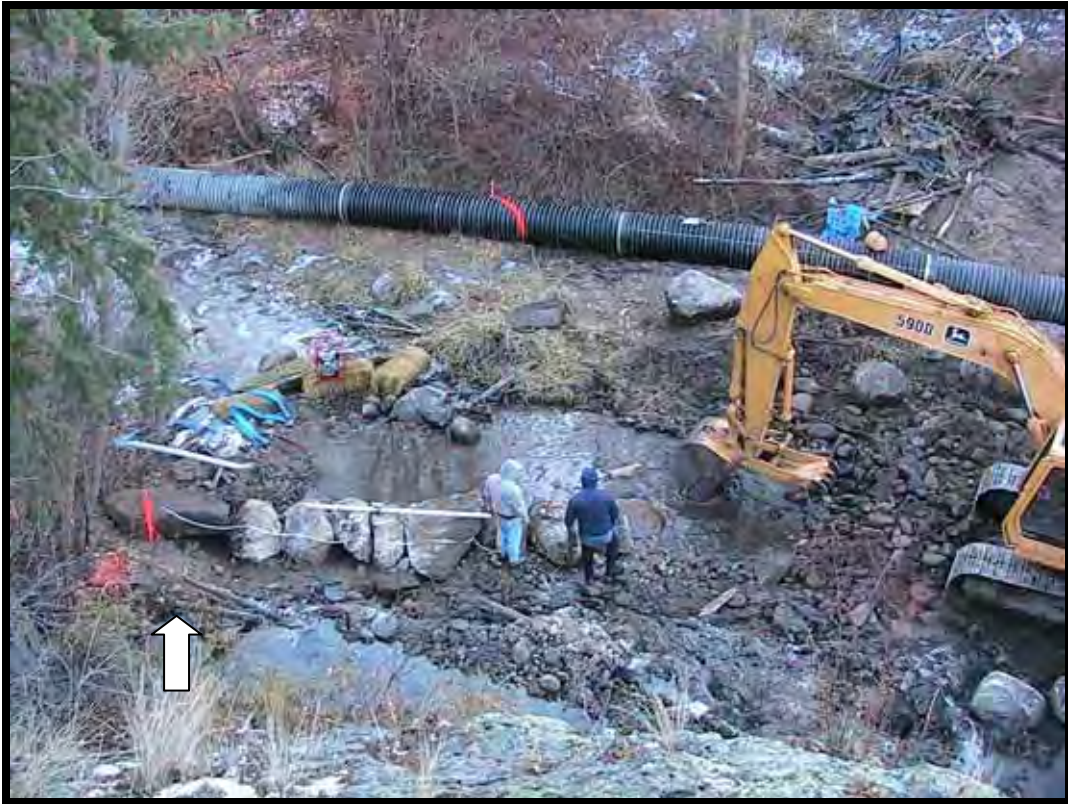
Photo A-10. Contractor constructing Weir No. 2, a double-drop A-type. Irrigation water is being supplied by temporary diversion pipeline (arrow).

Structural rocks — The large-diameter rocks used in this project came from two separate sources (photos A-10 thru A-13). The majority of the rocks were provided by the Stokes Ranch (which also uses water from the ditch) location several miles downstream of the Thurlow Transfer Ditch diversion. The remainder of the rocks were purchased from a family-owned quarry located about 30 miles east of the project site, near the town of Malott. After inspection and selection, about seventy-five rocks of various sizes were brought from the Stokes Ranch to the site in July 2003. The Malott pit rocks were delivered to the site in October 2003. The Malott rocks were angular and granitic ranging from just less than 2 feet in average diameter to over 4 feet; the Stokes Ranch Rocks were of similar size but more rounded. The estimated weights of the rocks ranged from 600 to 4,000 pounds.

5. Construction of most of Weir No. 2, including geocomposite liner and backfill (2 days); Photos A-10 A-11, A-13, and A-14. A small section is left uncompleted to allow equipment access.

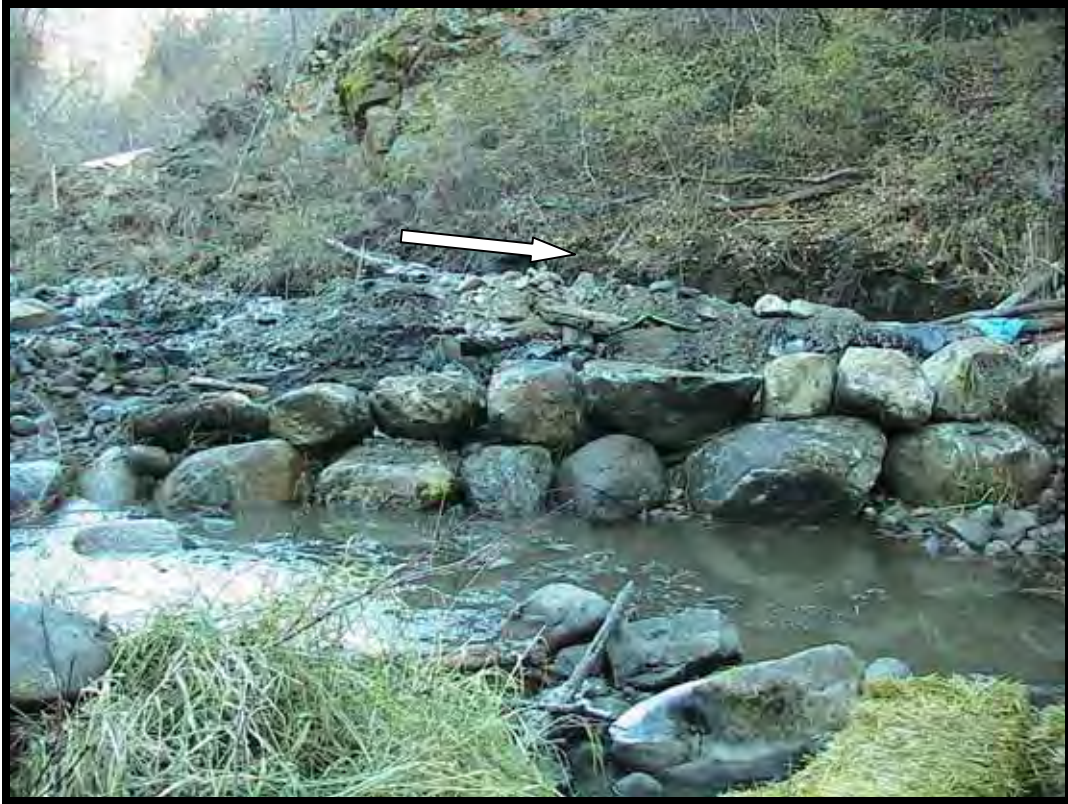
Photo A-11. Looking upstream at right arm of A-type Weir No. 2. The direction of flow of the temporary irrigation pipeline is indicated by the arrow. The cofferdam is out of view around the corner (upper left).

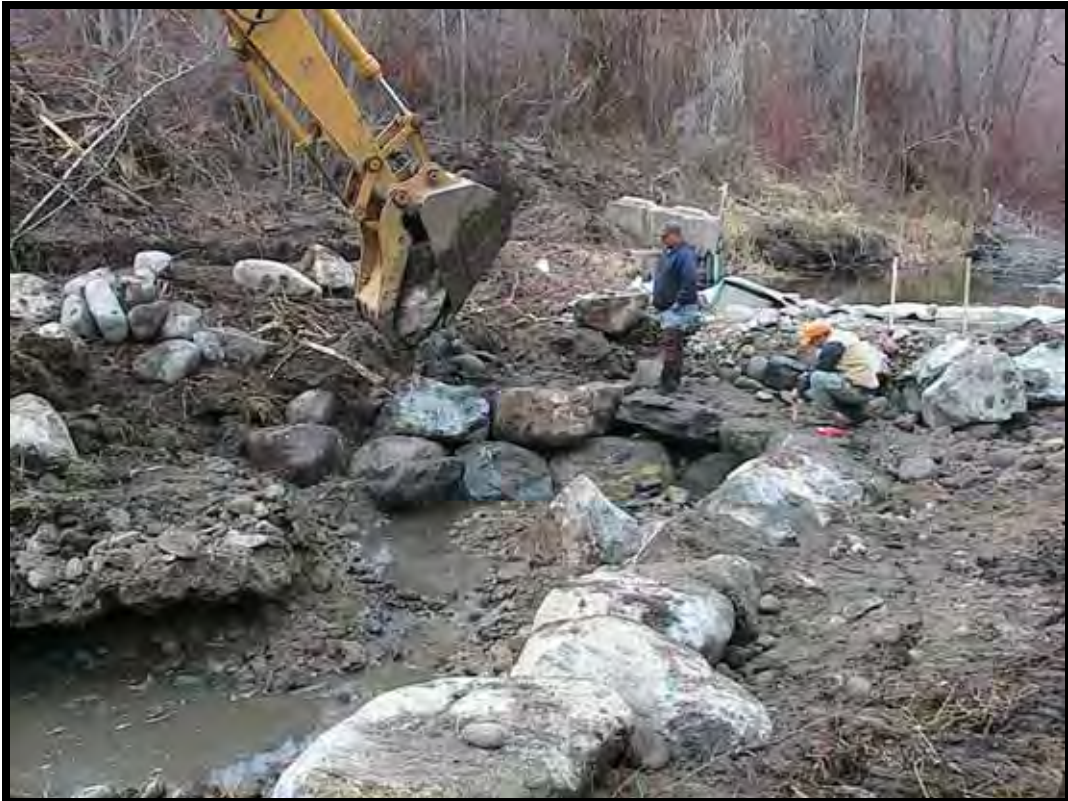
Photo A-12. Looking upstream at left arm of V-type Weir No. 1 under construction.

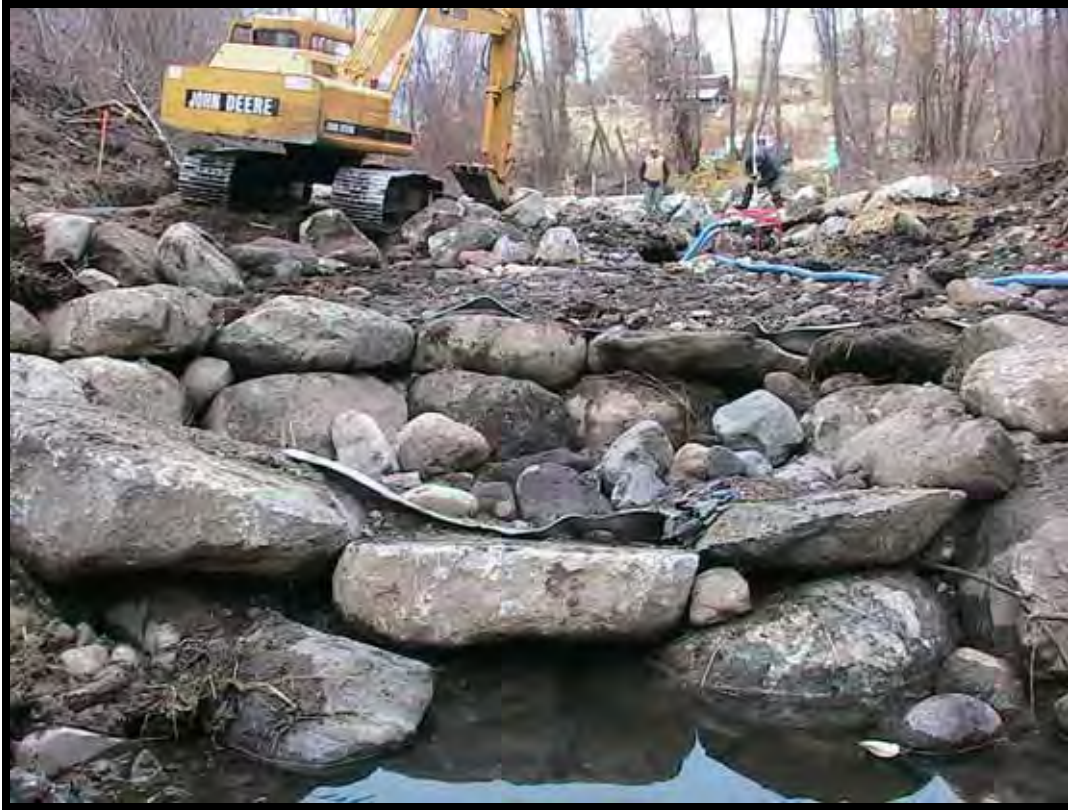
Photo A-13. Looking upstream at completed A-type Weir No. 2. Track hoe is working on upstream No. 1 “V” weir.

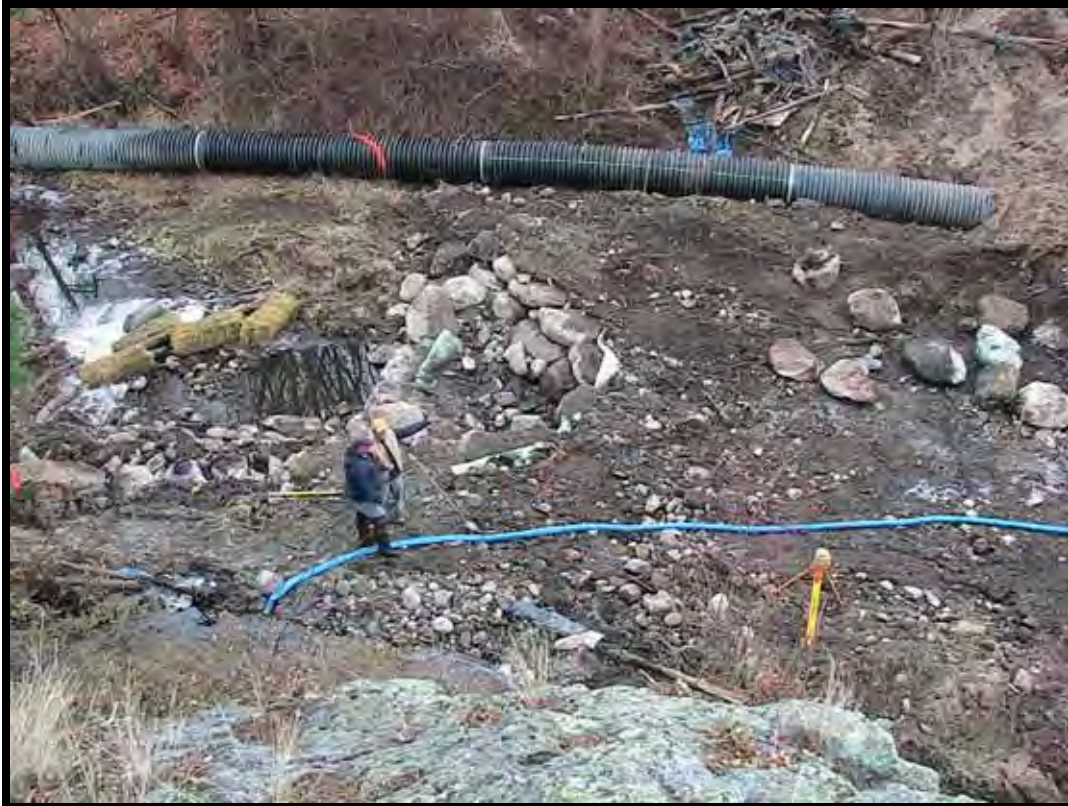
Photo A-14. Looking down at nearly completed Weir No. 2. The left arm of the weir will extend to the orange paint-mark on the pipe.

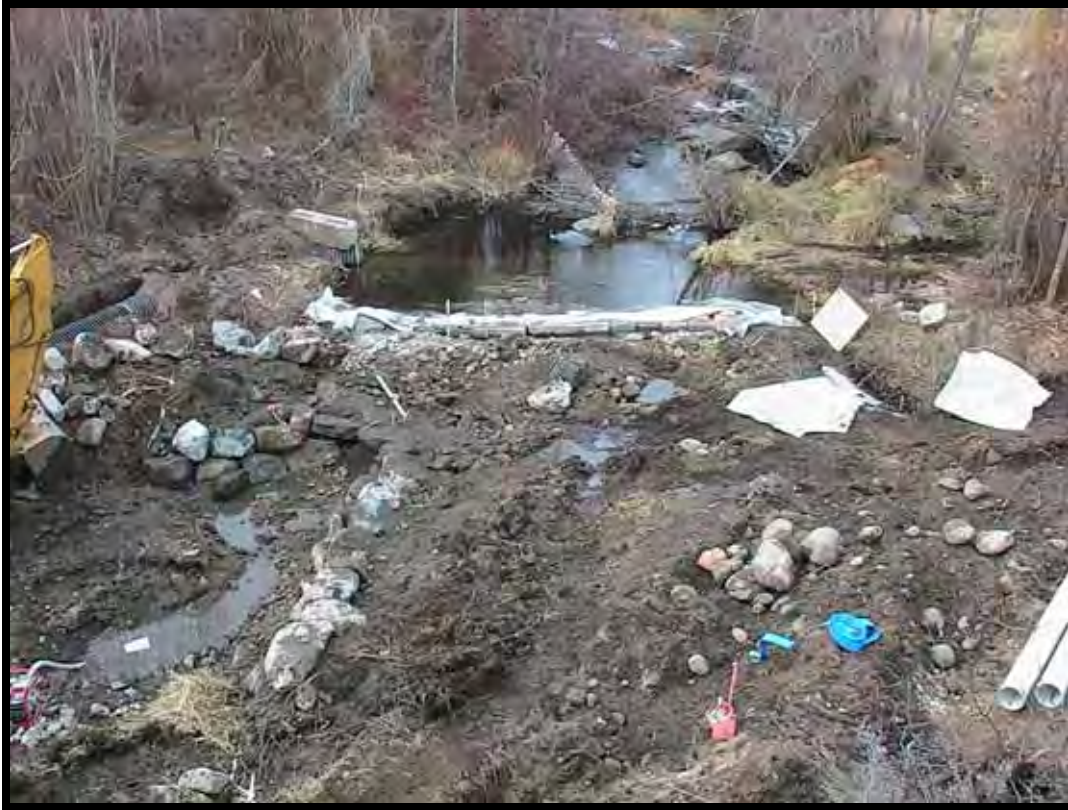
Photo A-15. Looking at site of V-type Weir No. 1 just downstream from cofferdam; contractor working on left side.

6. Deepen ditch and install new measuring weir. (1 day); Photo A-23.
7. Construction of most of Weir No. 1 and backfill (1 day); Photos A-15 and A-17. A small section is left uncompleted to allow equipment access downstream.

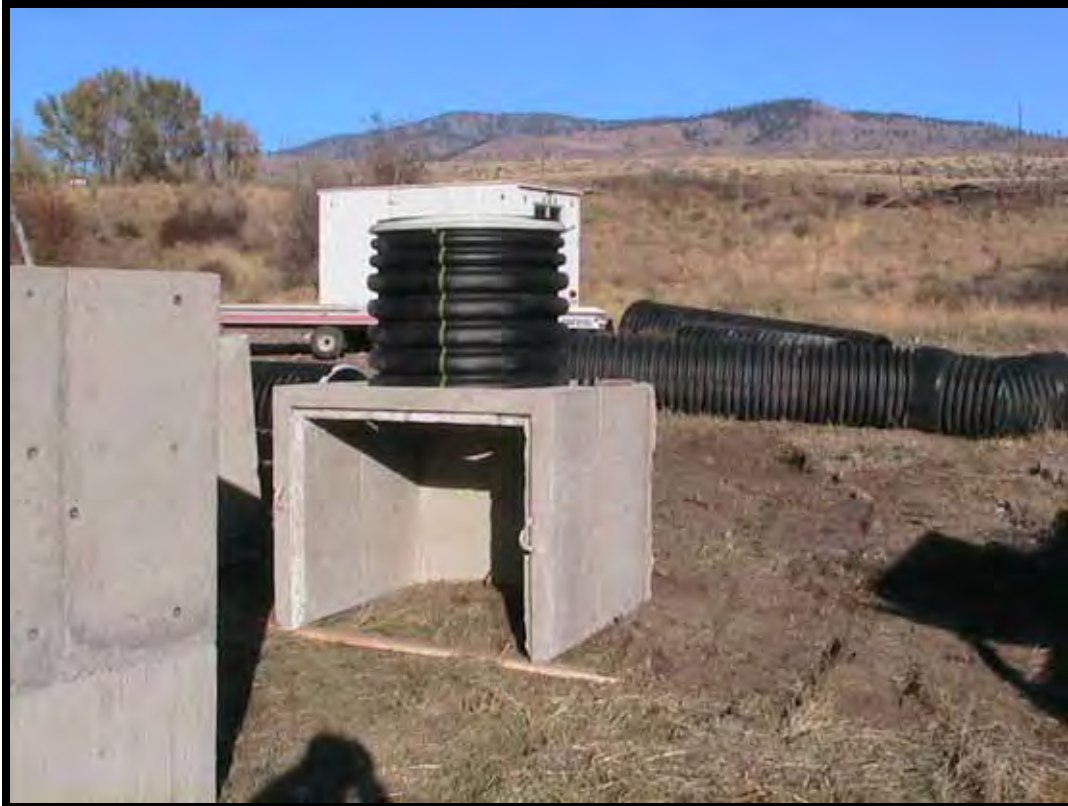
Photo A-16. Viewing back section of new diversion control box; the new turnout structure is at the left side of photo.

8. Installation of diversion box and backfill (1day); Photos A-16, A-17, and A-18.
9. Removal of temporary 12-inch pipe and installation of 36-inch-diameter conveyance pipe (1 day).

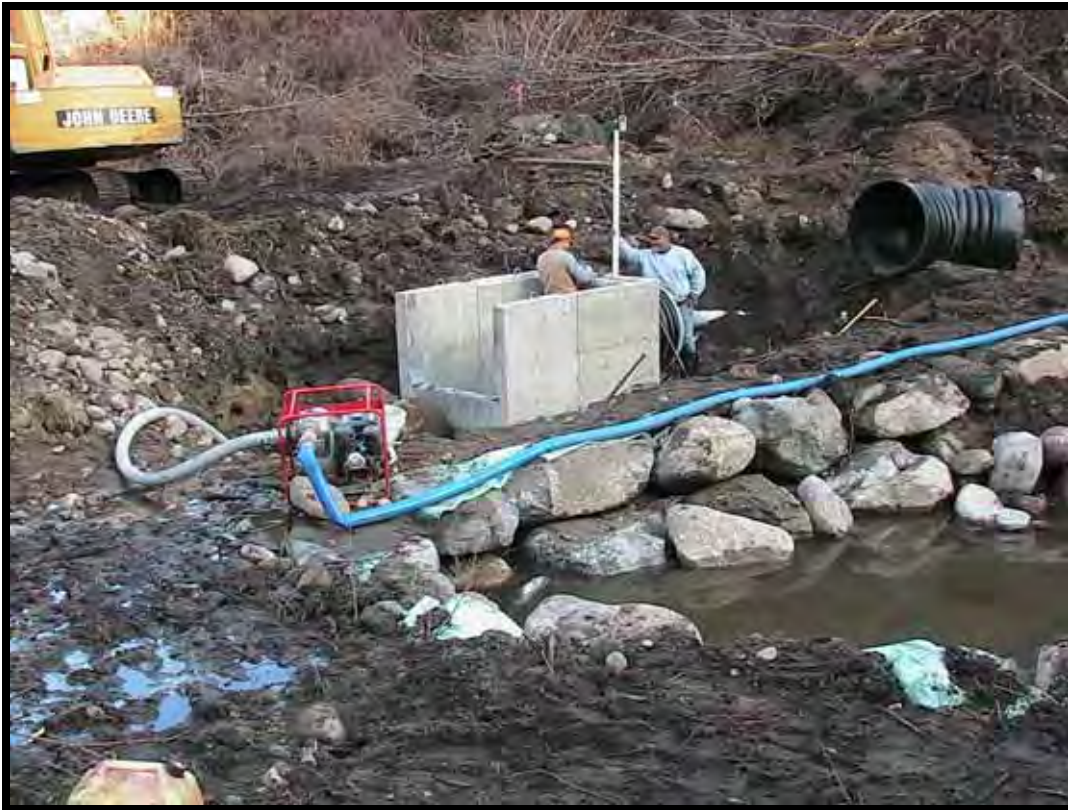
Photo A-17. Setting concrete control structure on right side of V-type Weir No. 1. Pump with blue pipeline is removing seepage water.

Due to the weight of the structure, the box was cast in two sections so there was a front half and a back half (photos A-17 and A-17) . The pipe stub was 36-inch-diameter, double-walled HDPE (high density polyethylene) pipe. The two halves of the structure were fastened together using six metal plates, 3/8th-inch thick (two on each side and two on the bottom). These were attached onto the two concrete sections with 3/8th-inch impact-type anchor bolts. The gap between the sections was filled with a mastic (tar-like) pipe-joint material (such as used to seal CMP, corrugated metal pipe); then, non-shrink grout was applied all around the joint to seal it against the elements. To prevent uneven settling brought on by the weight of the structure, a 6-inch-thick layer of compacted gravel was laid over a section of geotextile as a foundation

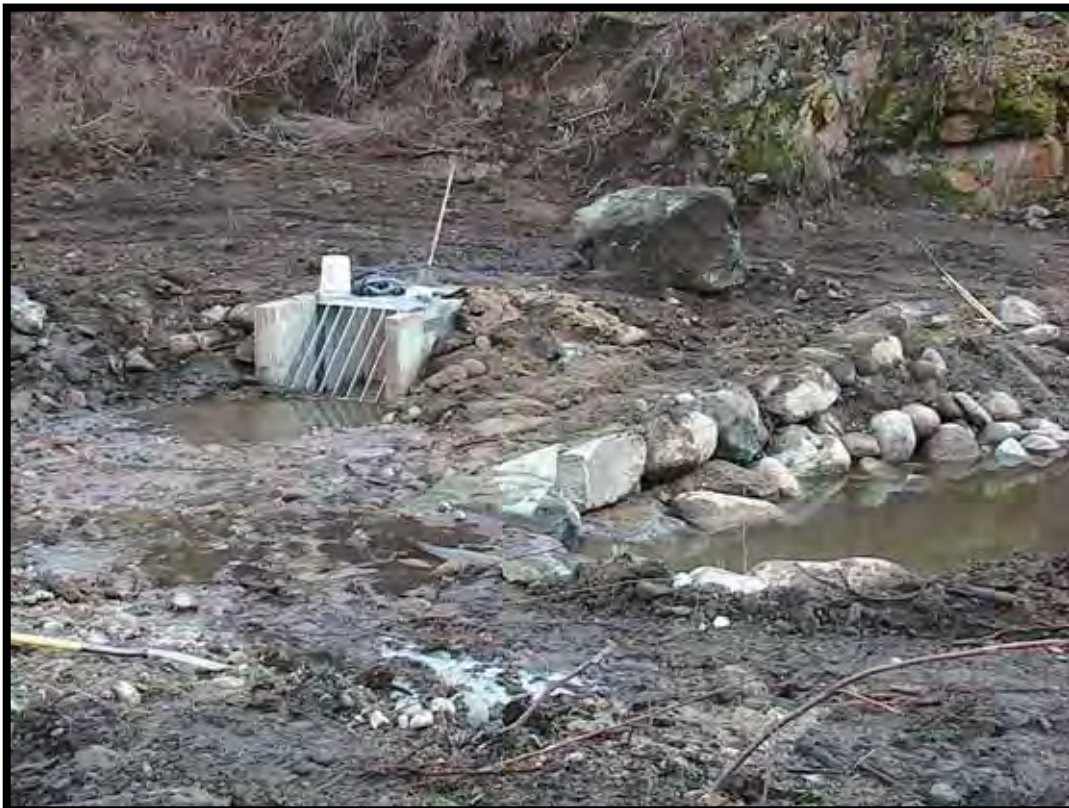
Photo A-18. On left side upstream from A-type Weir No. 2, concrete diversion structure with trashrack in place. The permanent diversion pipe is in place and backfilled. Note the metal strap holding the two sidepieces of the trashrack. In all, six straps were used.

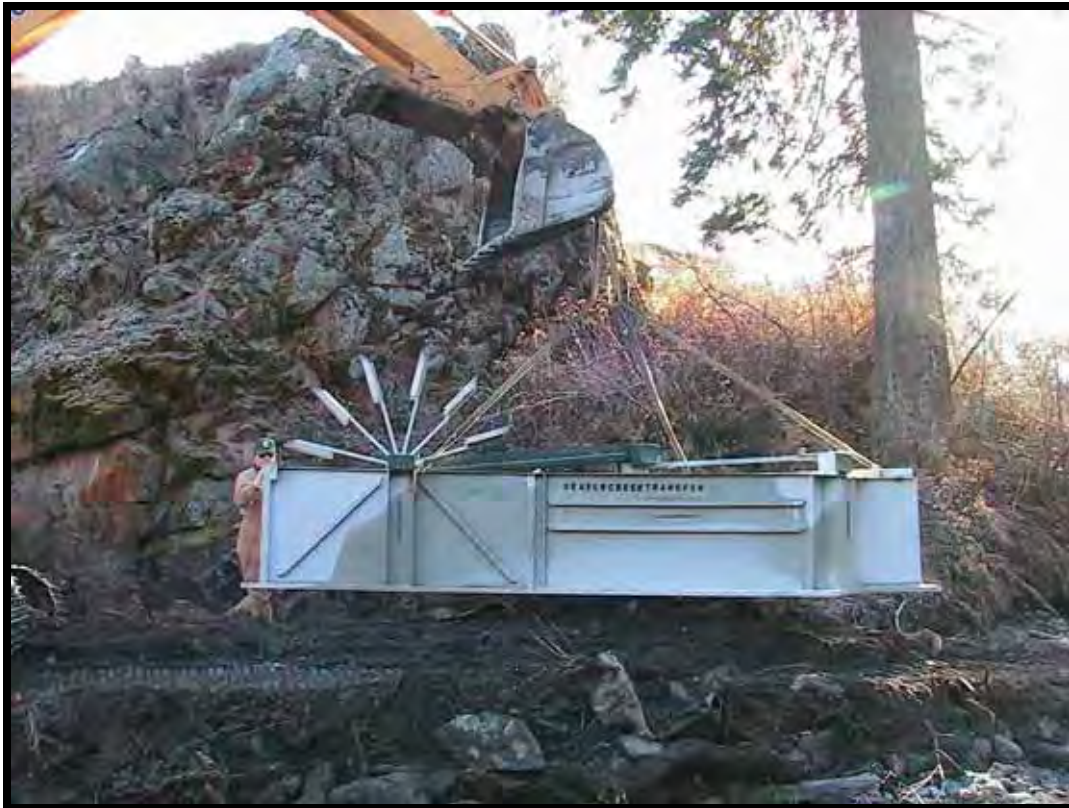
Photo A-19. Track hoe moving new fishscreen structure for placement in diversion ditch.

Fish screen — The drum-type fish screen is powered by a paddlewheel and its single drum is sized for 3.5 cfs. The bypass is an 8-inch-diameter, Schedule 40 PVC pipe. The fishscreen was supplied by the WDFW Yakima Screen Shop; it was delivered to the site by two WDFW employees who helped with its installation. (See photos A-19 and A-20.)

10. Installation of fish screen and fish-screen bypass pipe (1 day); Photos A-19 and A-20.
11. Installation of wasteway/control structure. (1/2 day); Photo A-20.

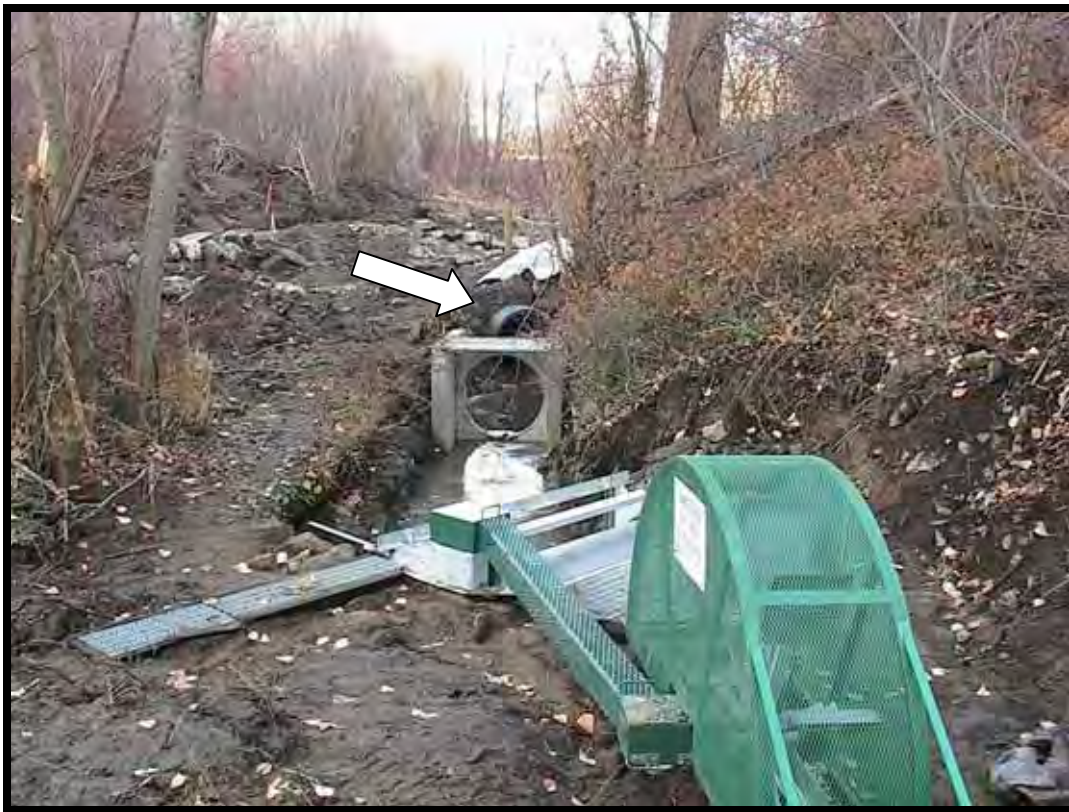
Photo A-20. View looking up diversion ditch; the new fishscreen is in place. Behind the turnout structure (arrow) is the end of the 30-inch-diameter permanent diversion pipe.

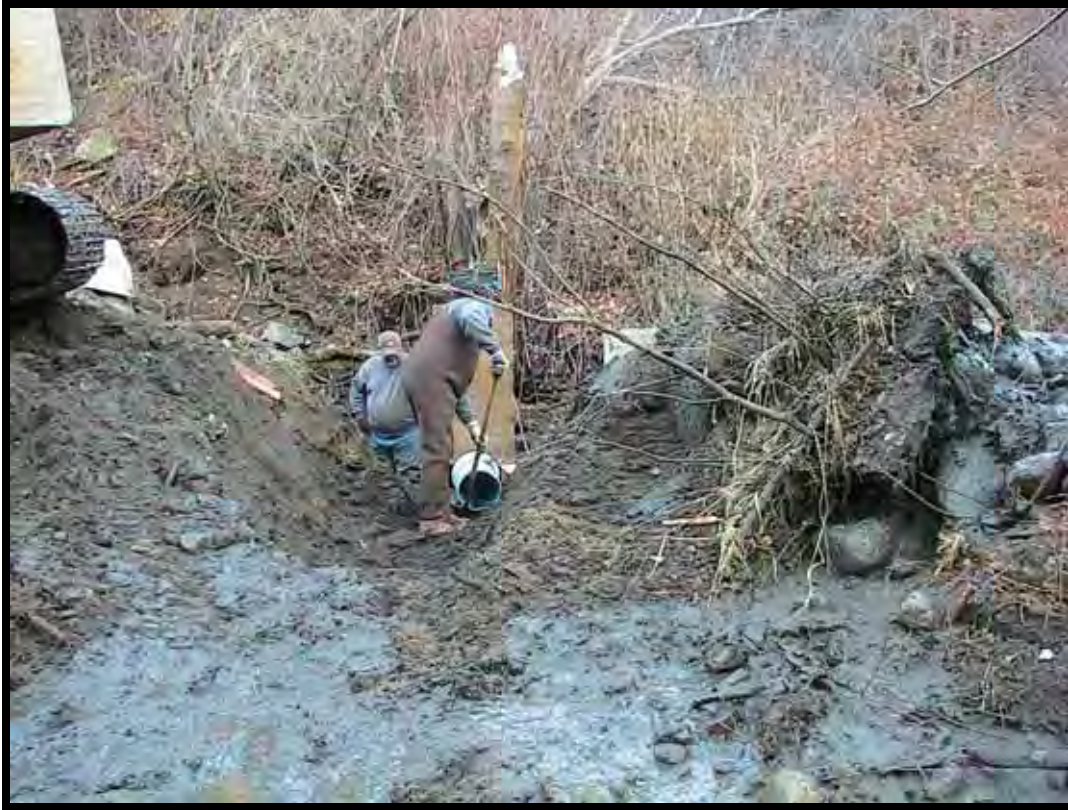
Photo A-21. Contractor installing sluice gate in diversion ditch just upstream of turnout structure.

12. Installation of sluice gate and sluice pipe (1/2 day); Photo A-21.

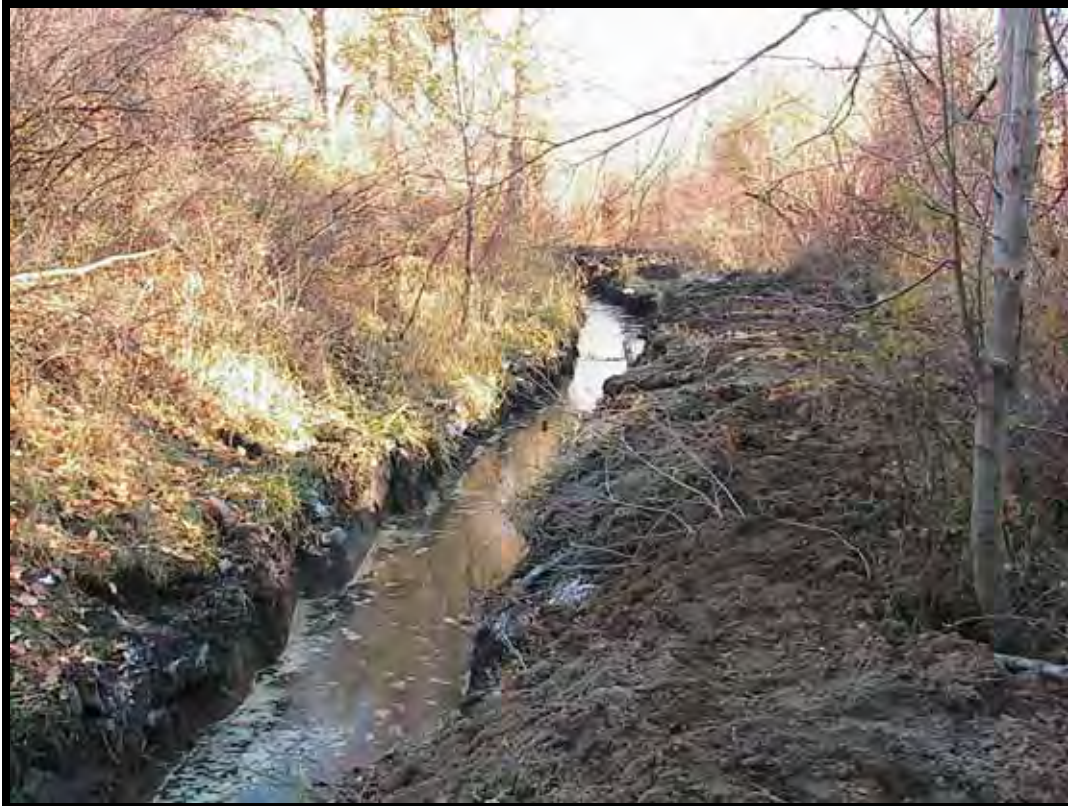
Photo A-22. View from fishscreen looking down diversion ditch.
