COMPLETION REPORT
THURLOW TRANSFER DITCH
FISH PASSAGE IMPROVEMENT PROJECT
BEAVER CREEK,
METHOW SUBBASIN, WASHINGTON
MAY 2004

Thurlow Diversion Fish Passage Improvement Project

Appendix A. Construction Photographs (color)

Appendix B. As-Built Drawings

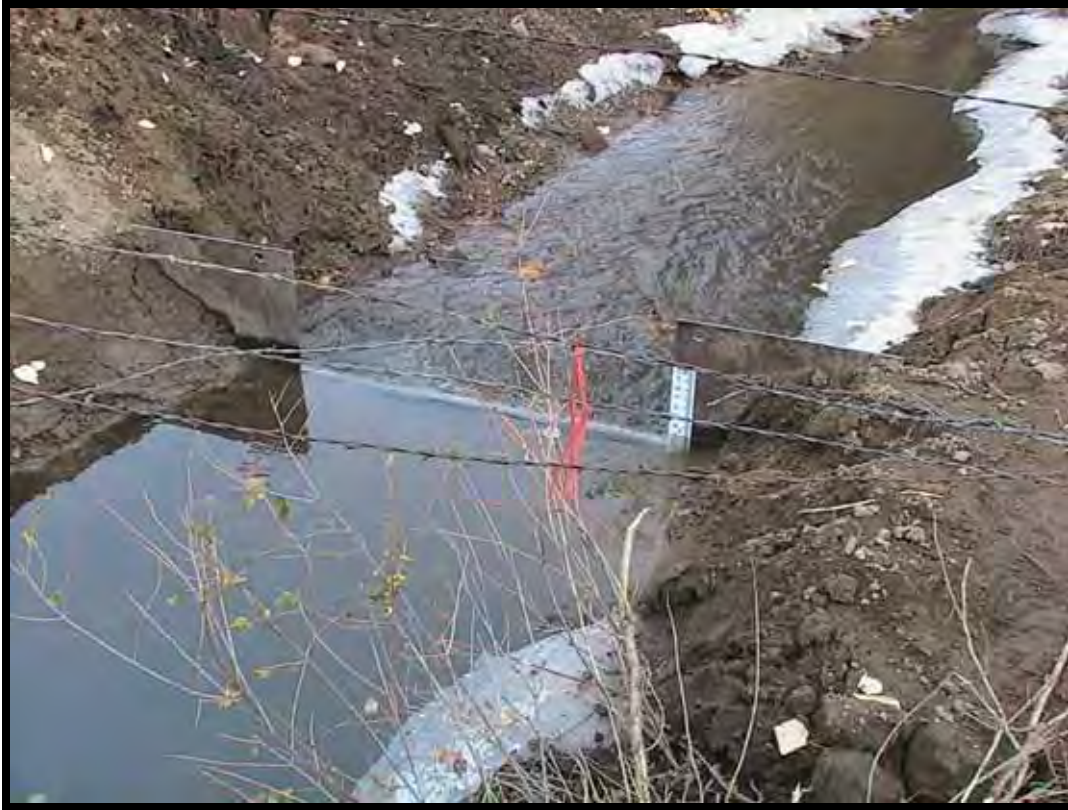
Photo A-23. Installed by Okanogan Conservation District, this new, sharp-crested rectangular measuring weir is located on the irrigation ditch about 400 feet downstream of the diversion point.

6. Deepen ditch and install new measuring weir. (1 day); Photo A-23.
7. Construction of most of Weir No. 1 and backfill (1 day); Photos A-15 and A-17. A small section is left uncompleted to allow equipment access downstream.

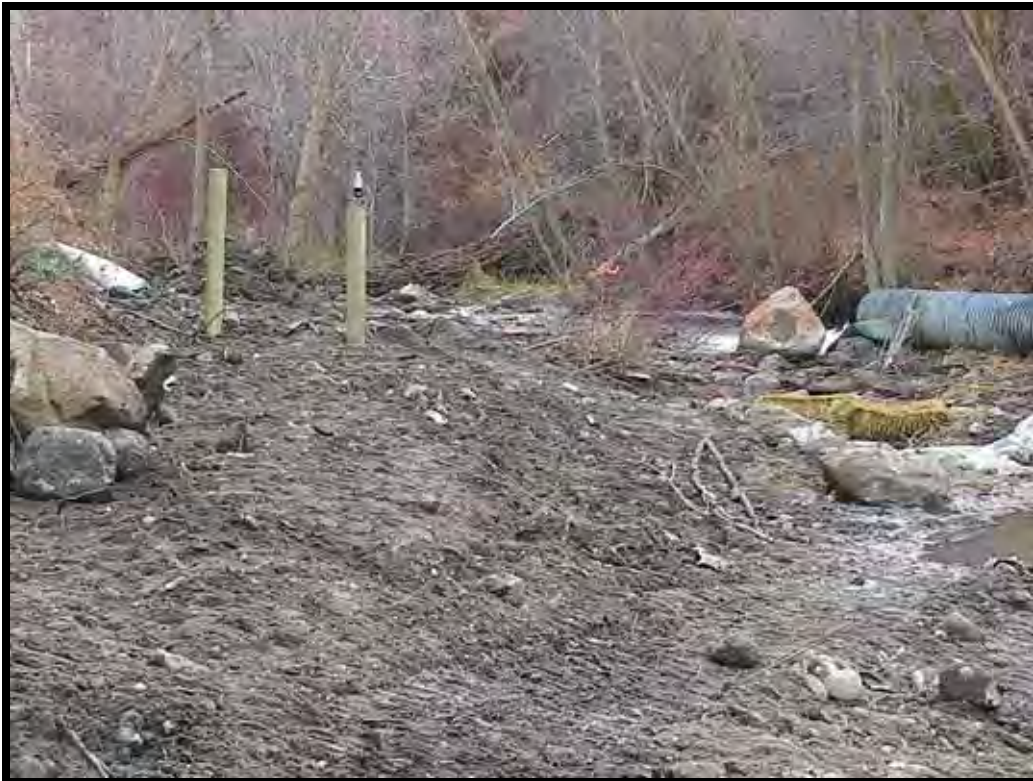
Photo A-24. Looking downstream from left side, the majority of construction is complete, and the temporary dewatering pipe is still in place. Site rehabilitation is underway; the diversion pipe ends just beyond the new fence posts.

13. Completion of cleanup, regrading, removal of materials and dewatering pipe, etc.; initial revegetation (1 day); Photo A-24 and A-26.

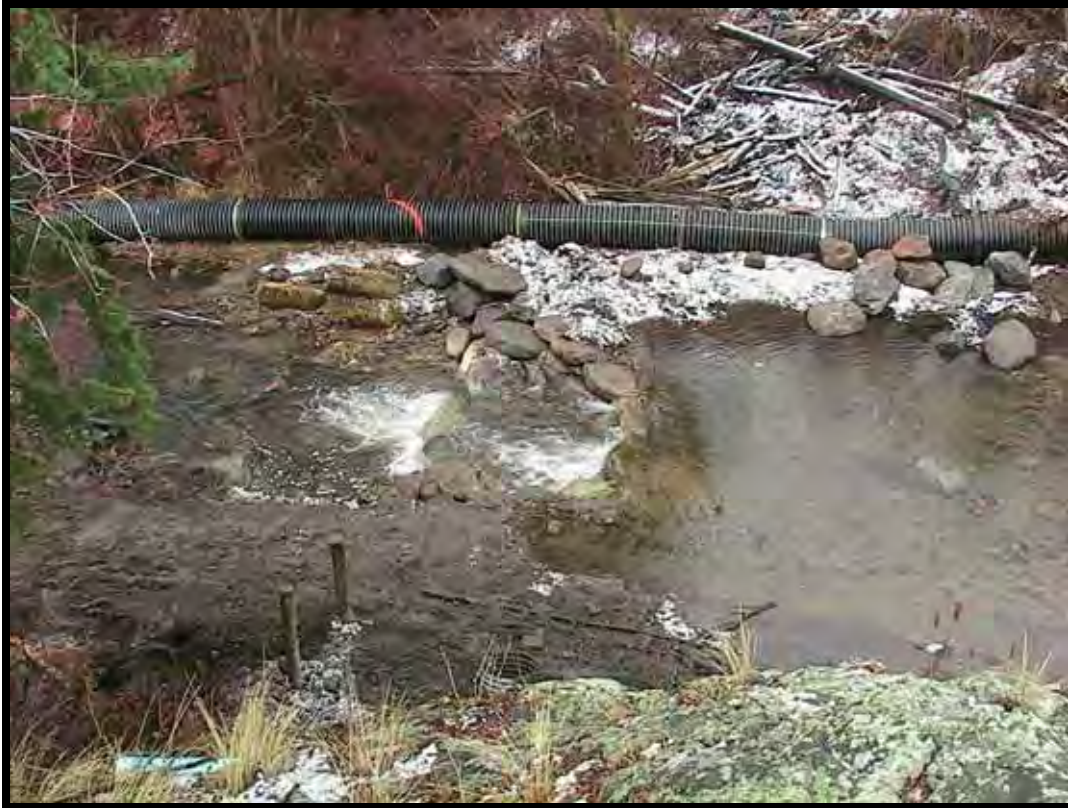
Photo A-25. Looking downward at completed A-type Weir No. 2. The cofferdam has been removed and normal seasonal flows are in the stream channel.

1. Installation of 125 feet of dewatering pipe around site of both proposed weirs and the existing dam; Photos A-7, A-10, A-13, and A-25.
2. Temporary installation of 12-inch PVC pipe from upstream of cofferdam to the existing ditch to provide irrigation water during construction; Photo A-10.

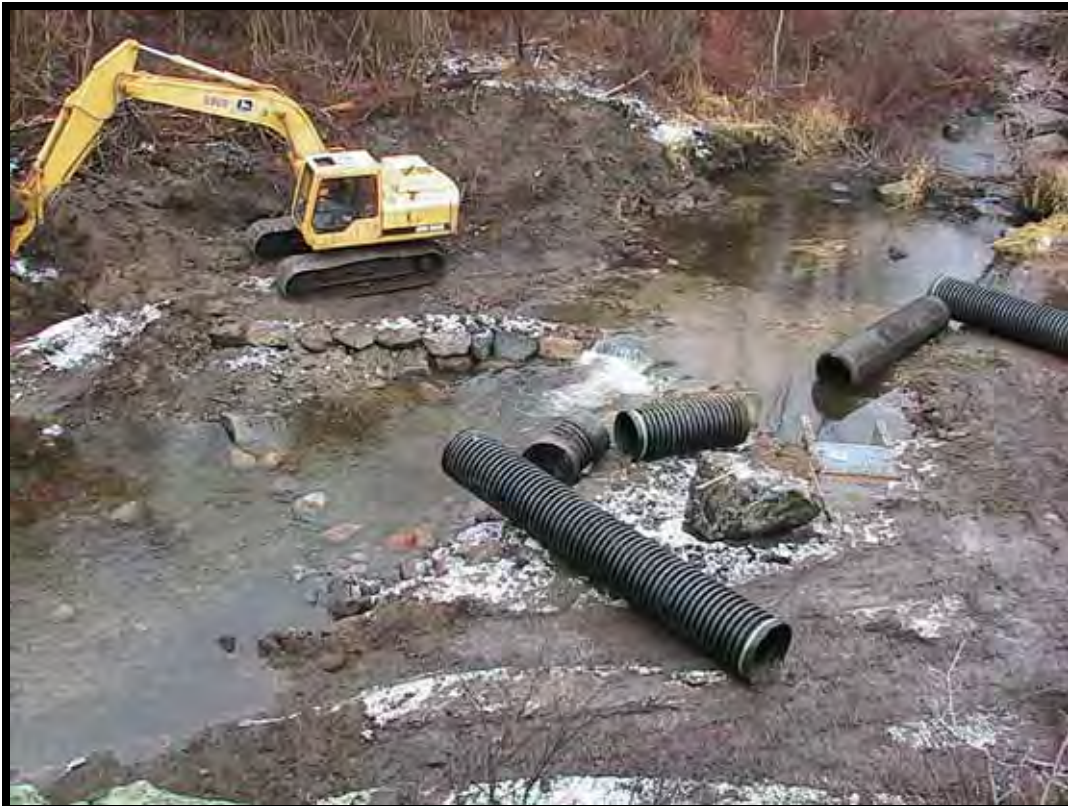
Photo A-26. Looking downward at Weir No. 2; the dewatering pipe has been removed and has been temporarily set along the stream. The excavator is finishing the rock weir.

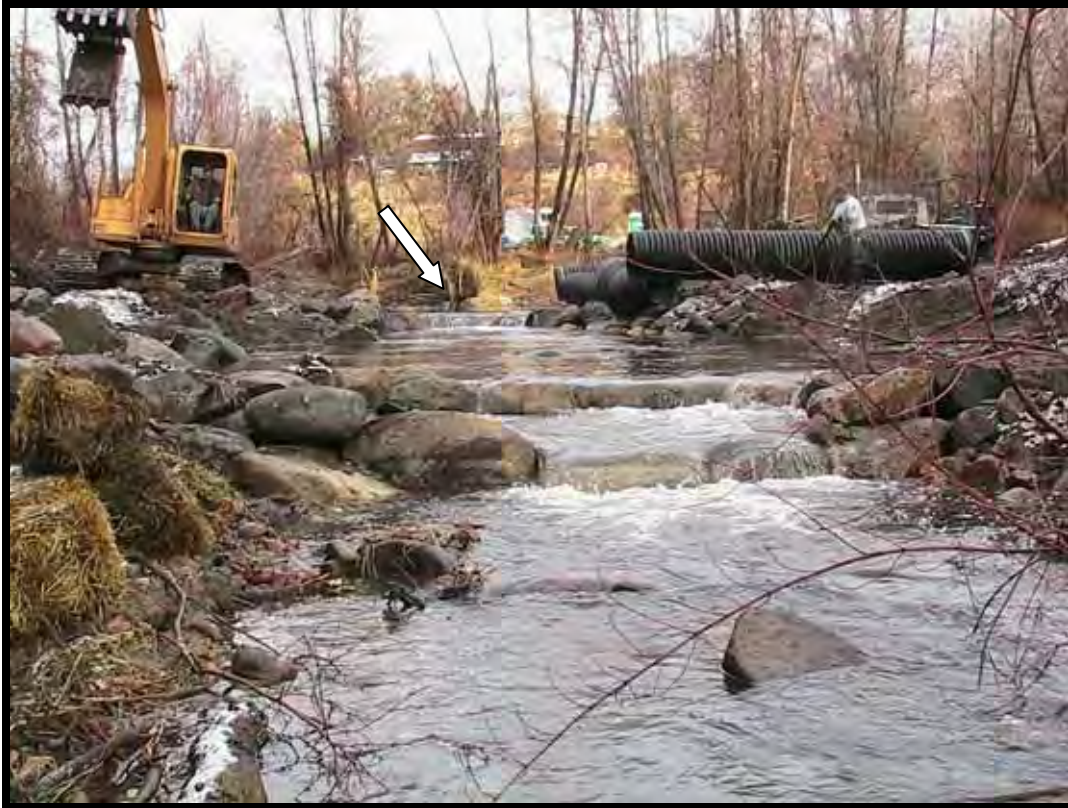
Photo A-27. Looking upstream at completed weirs. The A-type Weir No. 2 and the V-type Weir No. 1 is indicated by arrow. The dewatering pipe is soon to be moved offsite.

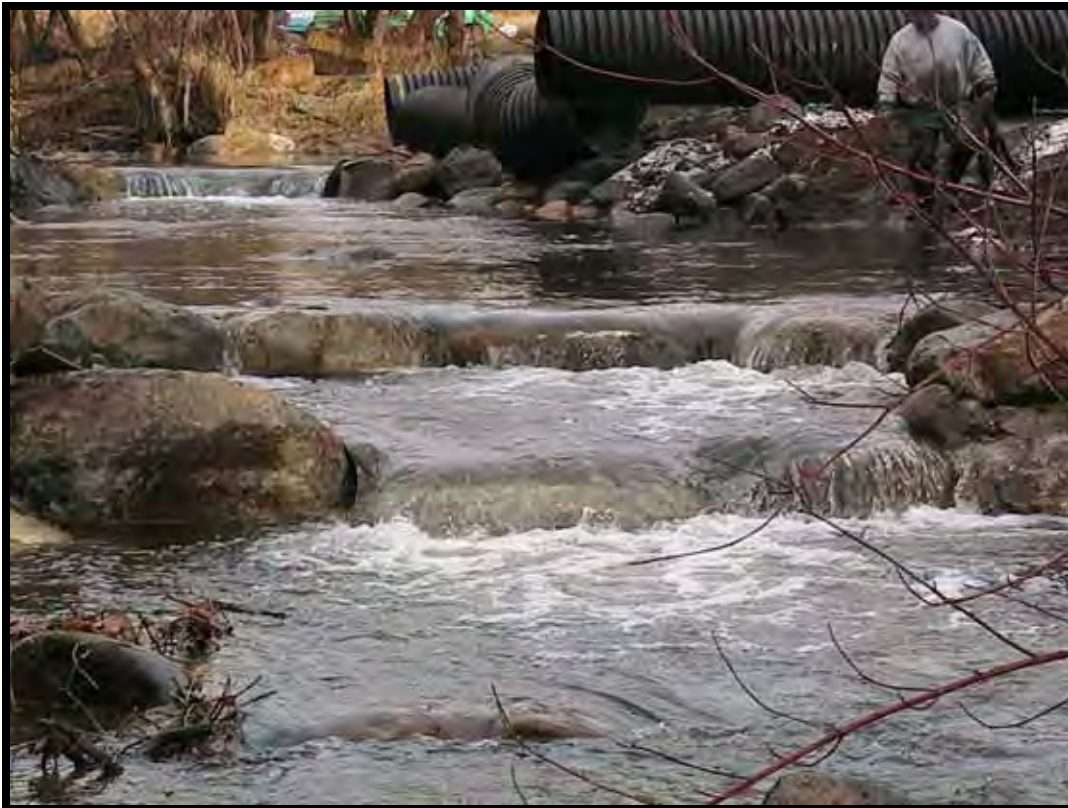
Photo A-28. Closer upstream view of project. Weir No. 2 is in the foreground and Weir No. 1 in the background. Flows are normal for the time of the season, about 6 cfs.

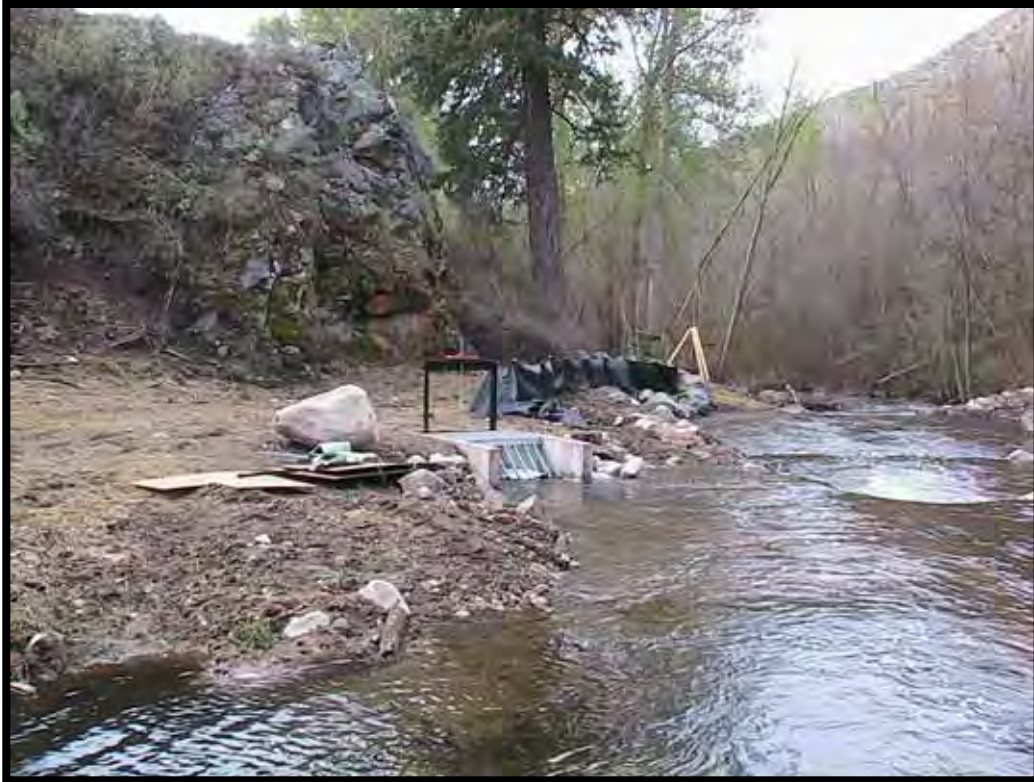
Photo A-29. Looking downstream at the new diversion box; Weir No. 1 is creating the vortex in the middle-left of the photo. *(April 2004)*

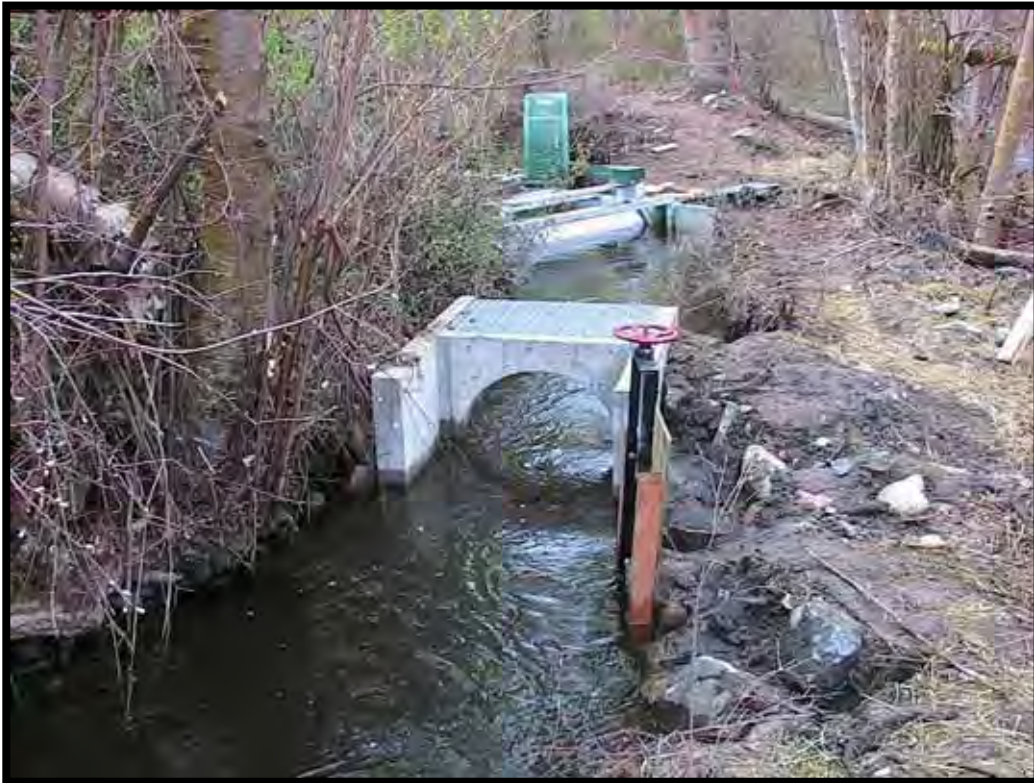
Photo A-30. Looking up the Thurlow Transfer Ditch. The headgate to the new 12-inch sluiceway is in front and the fish screen in the background. *(April 2004)*

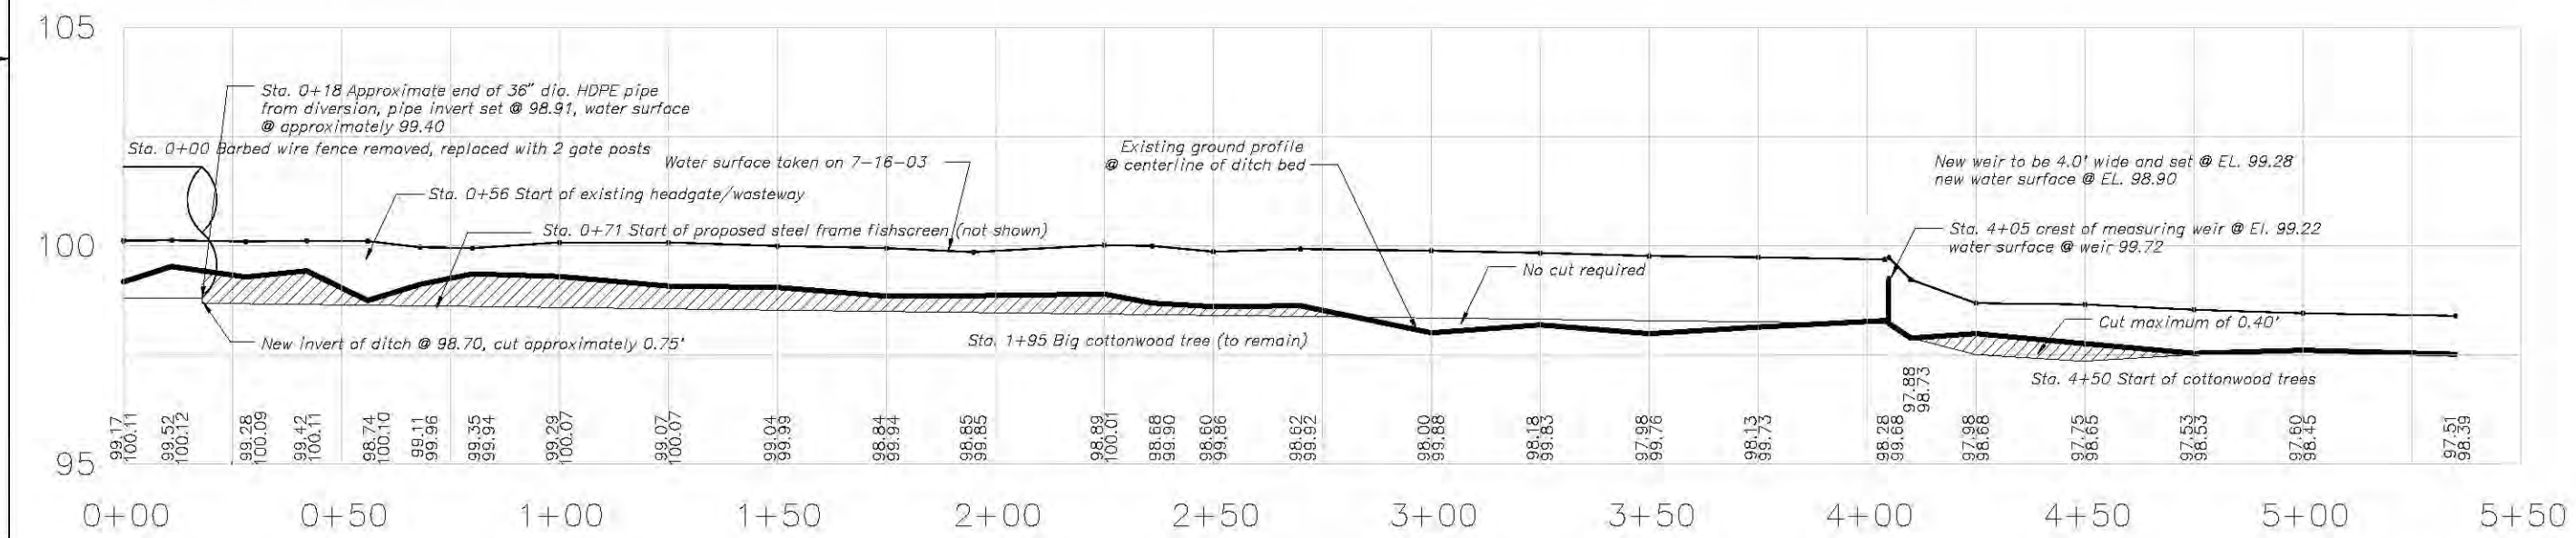
DITCH PROFILE

PROPOSED V-WEIR LOCATIONS

STATION	ELEVATION	DESCRIPTION
0+95	100.26	Proposed V- weir #2
1+35	99.20	Proposed double drop V- weir #1
1+45	98.40

Elevations and Stations are @ low point on weirs

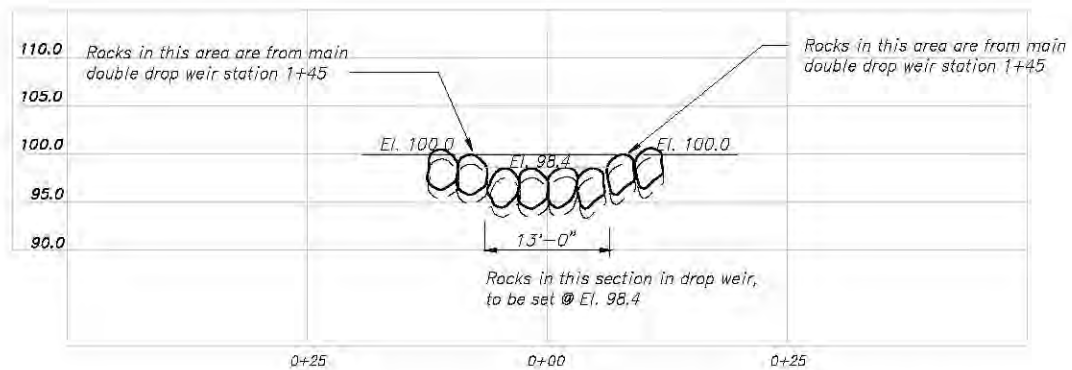
DOUBLE DROP V - WEIR #2 SECTION C-C
STATION 1+45
SCALE OF FEET

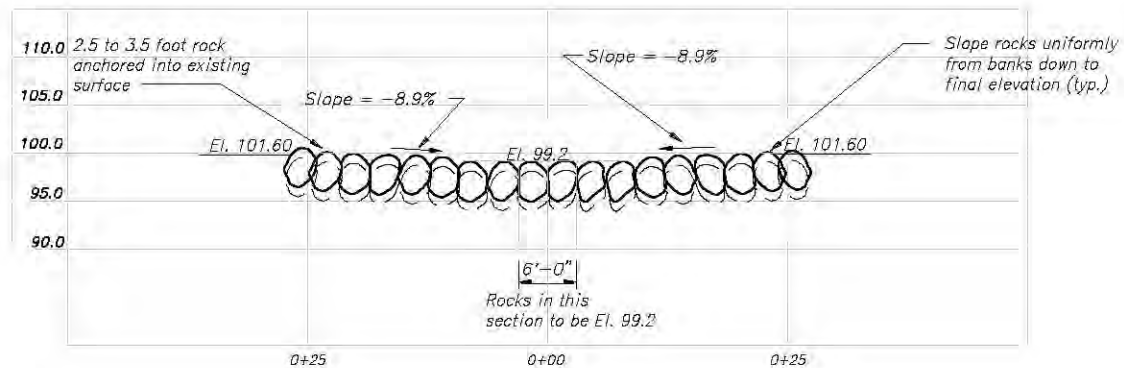
DOUBLE DROP V - WEIR #2 SECTION B-B
STATION 1+35
SCALE OF FEET

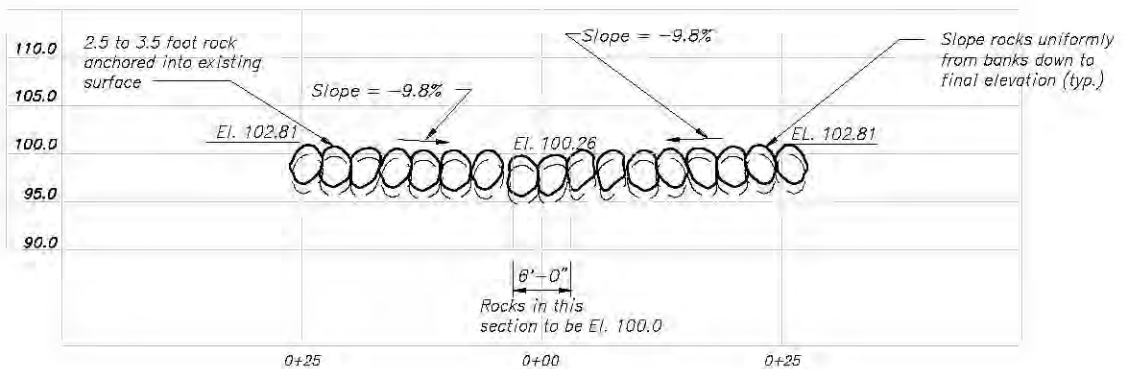
V - WEIR #1 SECTION A-A
STATION 0+95
SCALE OF FEET

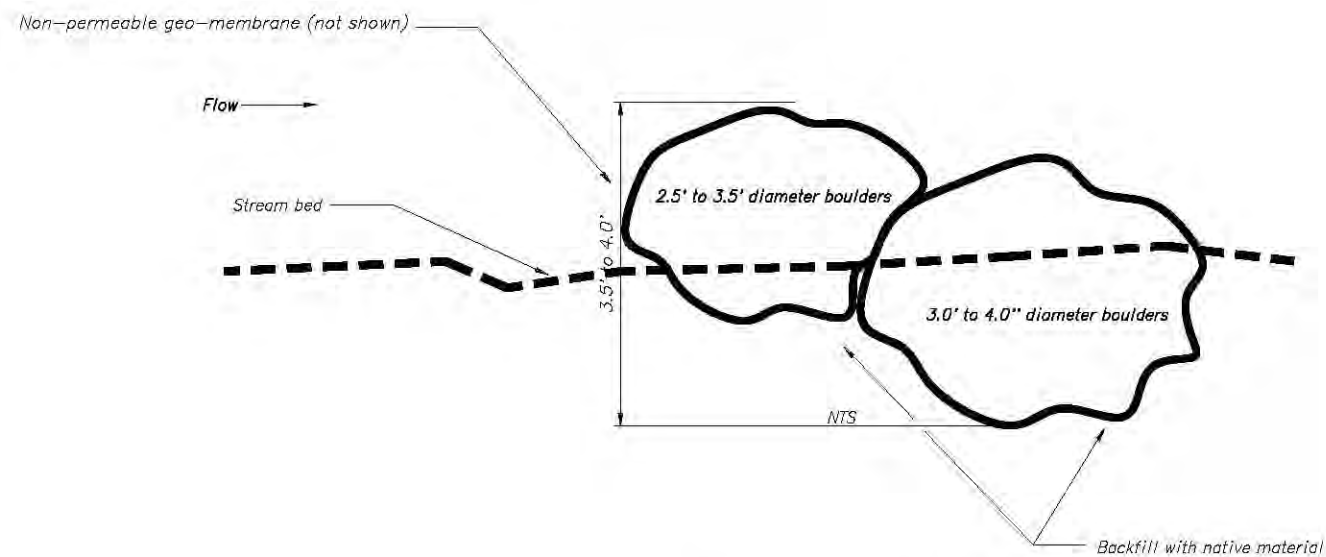
SECTION OF TYPICAL ROCK WEIR

Seepage reduction — After the rocks for each weir were in place, an impervious “geocomposite” fabric was spread on the upstream side of each one. The purpose of the fabric was to reduce or prevent water from traveling underneath the large rocks and to encourage deposition of fine materials if small leaks through the backfill did occur. The fabric was placed in various configurations and was held in place by the weight of the large rocks and by fill material.

The fabric consists of two layers of “16-ounce” geotextile (weight per square yard) bonded to each side of a 50-mil-thick (about 1/20th of an inch), impermeable polyvinylacetate membrane. The fabric was manufactured by Huesker Inc. (product number HGC-165016) and purchased directly from the company. About 500 square feet of material was installed at the Thurlow Transfer Ditch

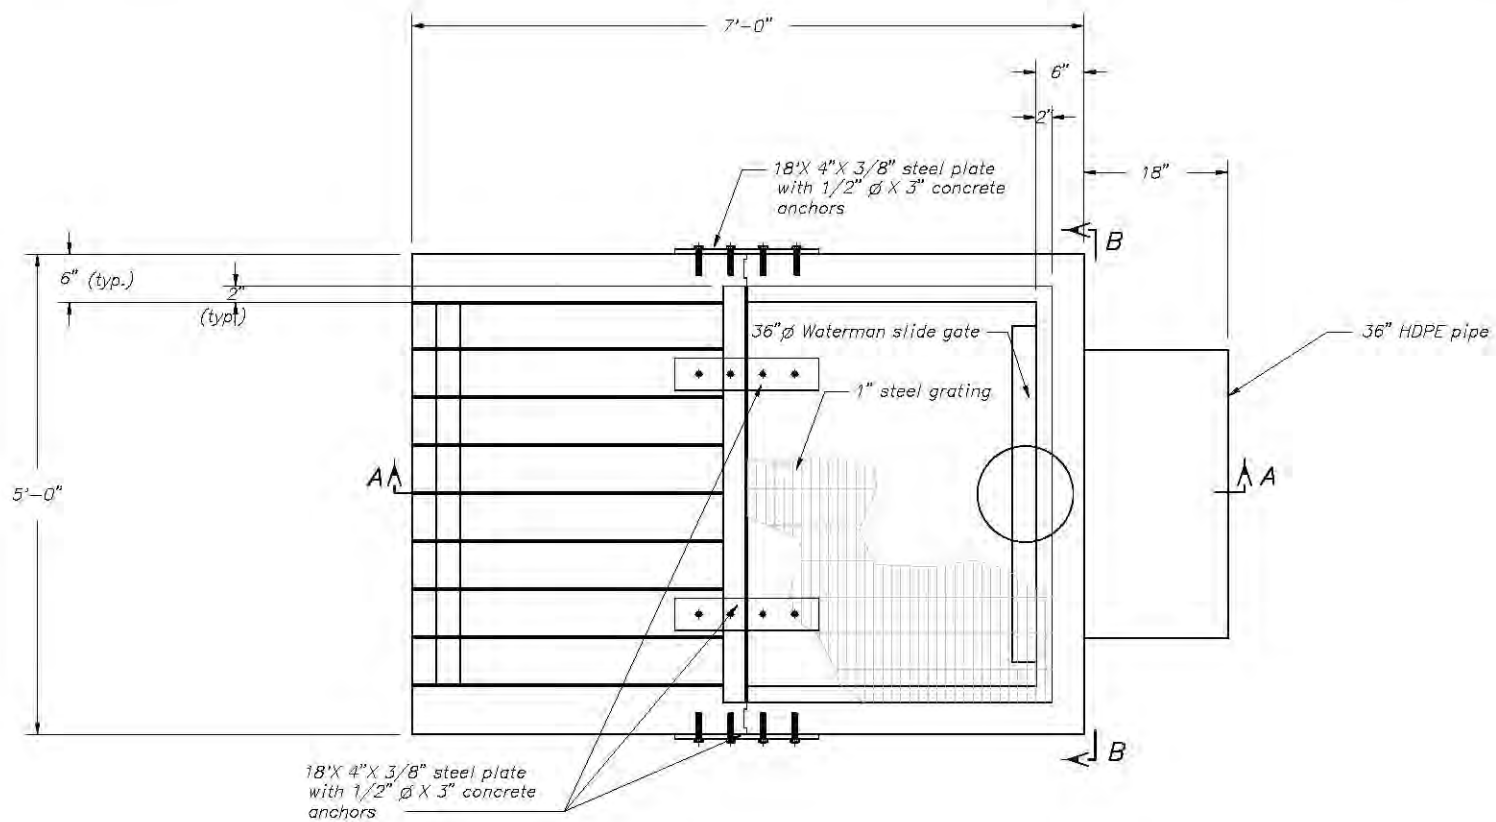
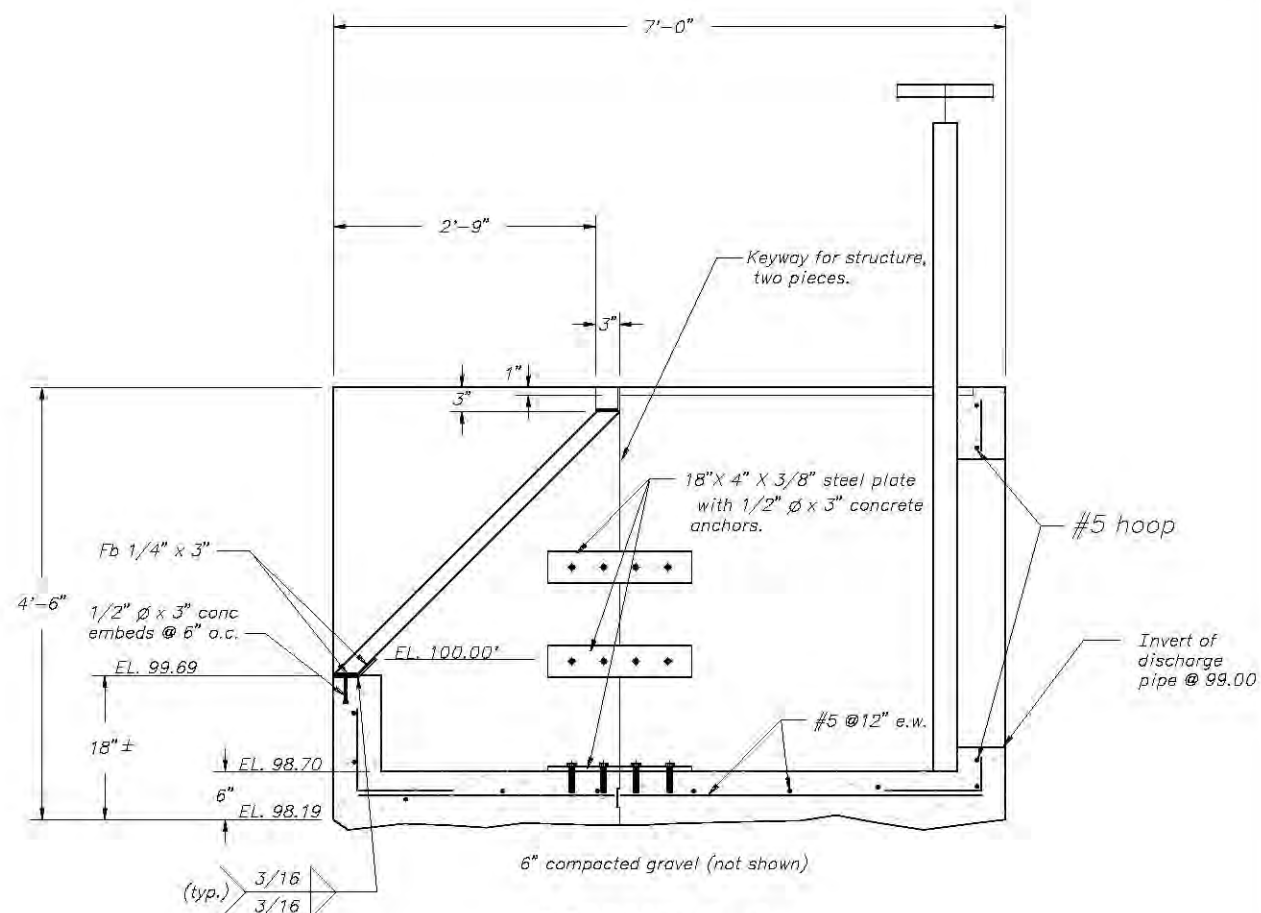
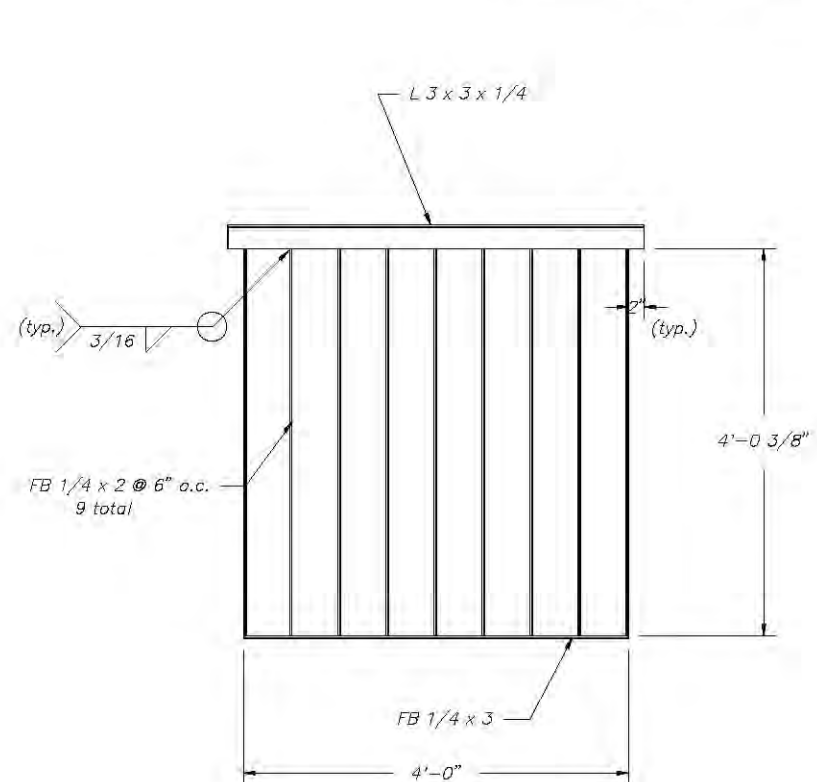
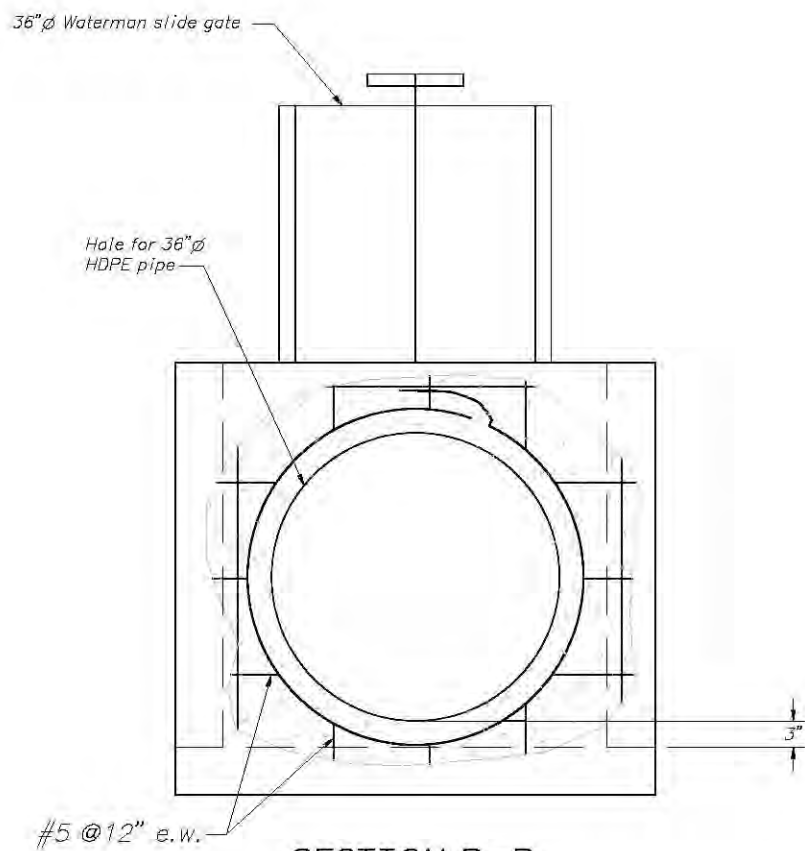
Figure B-5. Thurlow Transfer Ditch, Control Structure, Plan, Section and Detail (1678-100-303)

PLAN

SECTION A-A

TRASHRACK DETAIL

SECTION B-B

Diversion structure — The concrete diversion box — including the headgate, trashrack, grating, and pipe stub — was pre-cast locally and delivered to the site by Arm and Hammer Construction Company of Twisp. The diversion box was built to the dimensions shown on the drawings with minor changes (the method of attaching the trashrack to the concrete box). The trashrack was fabricated as a single piece and also galvanized. The diversion box grating (on top) is standard 1 inch grate and was galvanized as a unit (photo A-18). A 36-inch diameter, Waterman C-10 slide gate was used as a headgate. Due to difficulties at the factory, the gate was unavailable during the fall construction period and wasn't installed by district employees until March 2004.

Due to the weight of the structure, the box was cast in two sections so there was a front half and a back half (photos A-17 and A-17) . The pipe stub was 36-inch-diameter, double-walled HDPE (high density polyethylene) pipe. The two halves of the structure were fastened together using six metal plates, 3/8th-inch thick (two on each side and two on the bottom). These were attached onto the two concrete sections with 3/8th-inch impact-type anchor bolts. The gap between the sections was filled with a mastic (tar-like) pipe-joint material (such as used to seal CMP, corrugated metal pipe); then, non-shrink grout was applied all around the joint to seal it against the elements. To prevent uneven settling brought on by the weight of the structure, a 6-inch-thick layer of compacted gravel was laid over a section of geotextile as a foundation

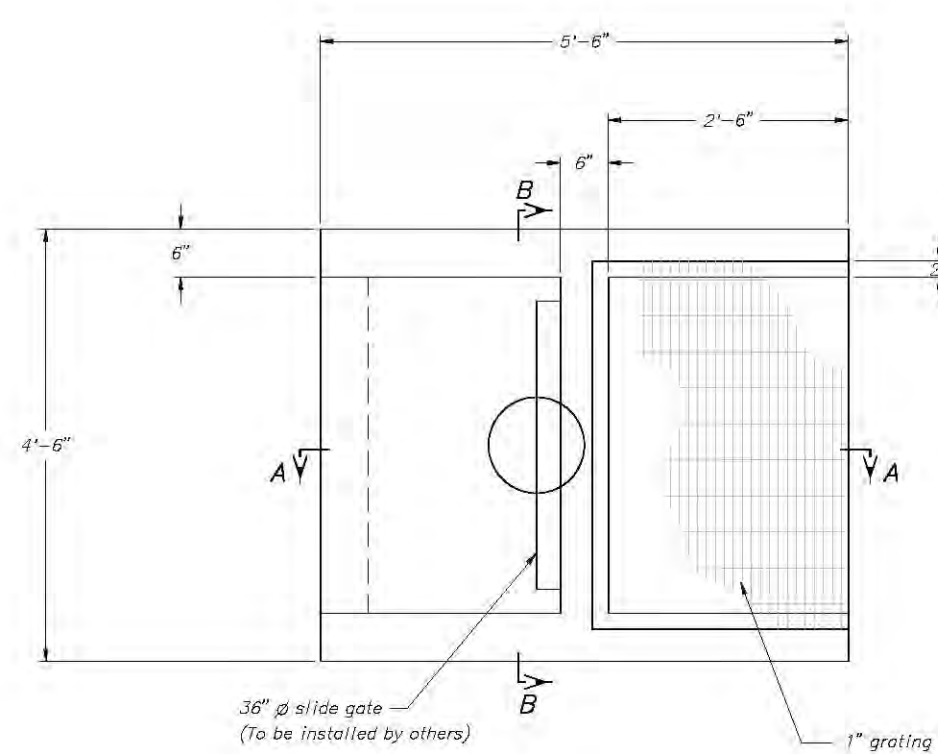
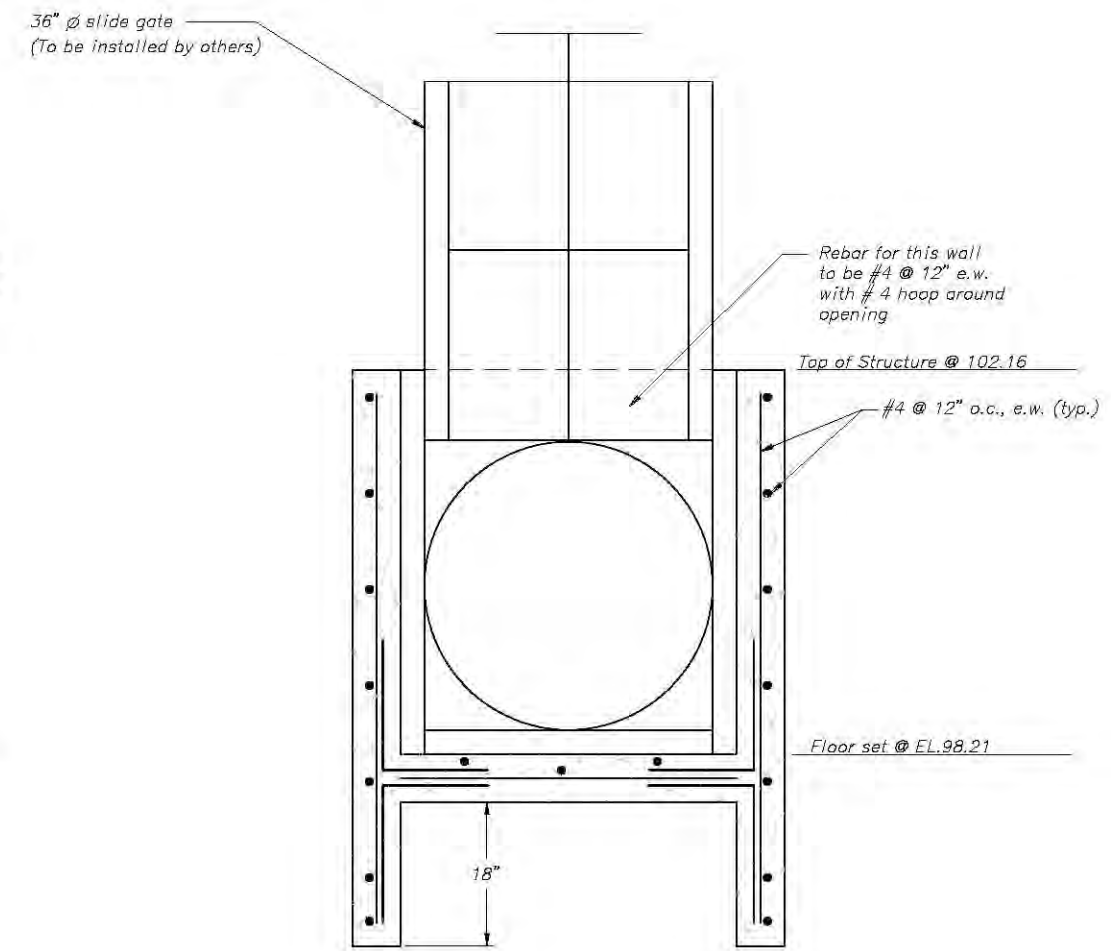
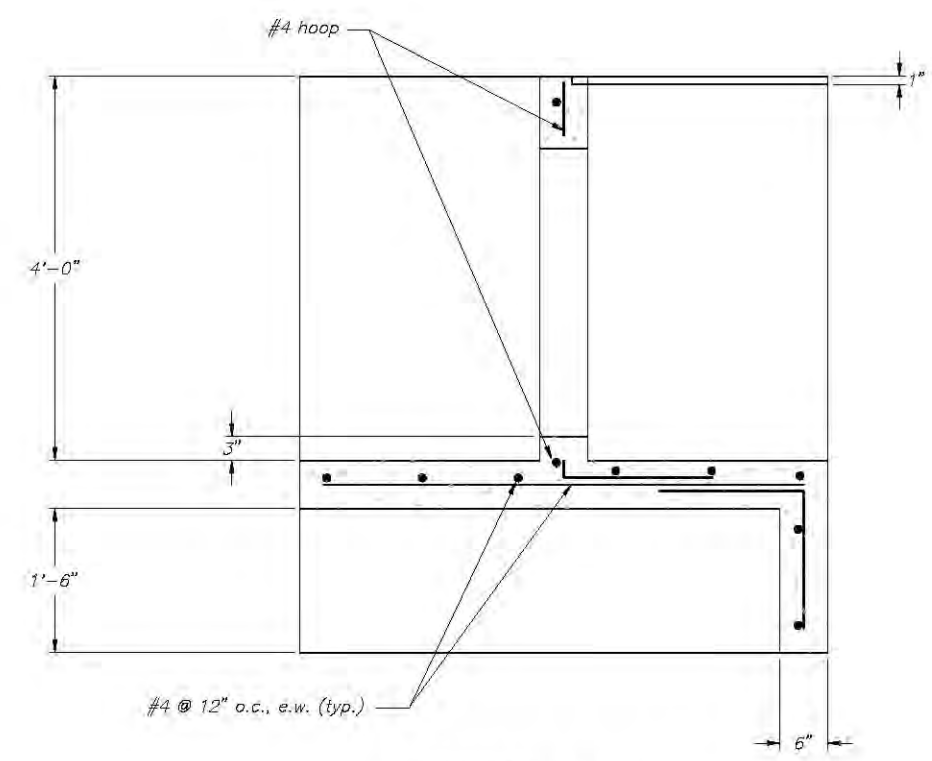
Figure B-6. Thurlow Transfer Ditch, Wasteway Structure, Plan and Sections (1678-100-304)

PLAN

SECTION B-B

SECTION A-A

Wasteway — The concrete wasteway/control structure was installed between the delivery pipe from the headworks and the fish screen. Its purpose is to provide additional control over water flow down

the ditch; it will also provide a backup control gate should the headworks be flooded or otherwise unreachable during very large flow events in the creek. This concrete structure will support a 36-inch-diameter, Waterman C-10 slide gate, which is expected to arrive by April 2004 and be installed by district personnel after high flows have receded.
