NASON CREEK TRIBUTARY ASSESSMENT Chelan County, Washington

**BUREAU OF RECLAMATION
TECHNICAL SERVICE CENTER, DENVER, CO,
AND
PACIFIC NORTHWEST REGIONAL OFFICE, BOISE, ID.**

JULY 2008

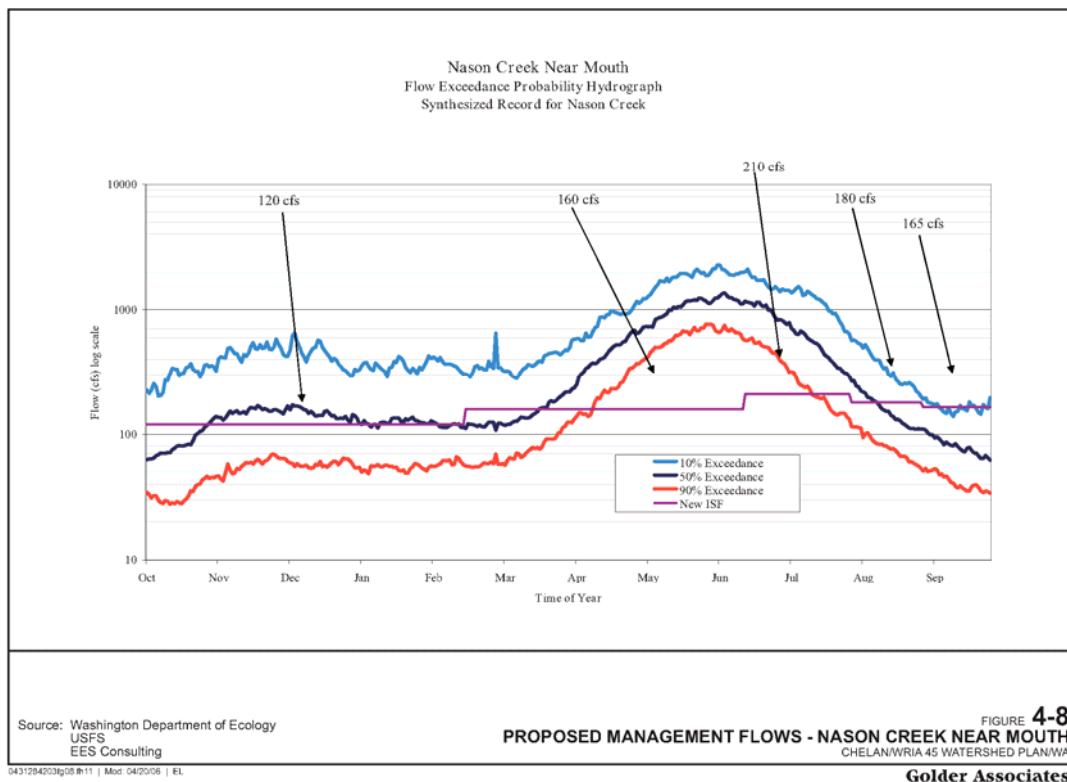
Figure 4. Summary of instream flow recommendations for Nason Creek near the mouth (WRIA Planning Unit 2006).

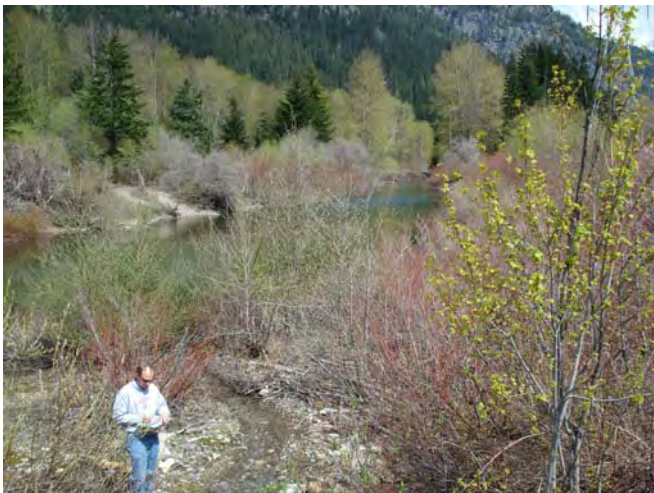
Figure 6. View to the north of ponding in the historical channel near RM 13.5. (Reclamation photograph by R. McAfee, May 2, 2007).

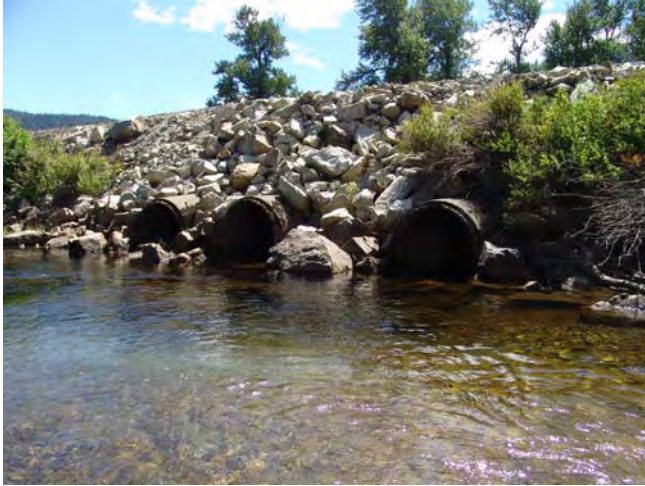
Figure 7. View to the south near RM 9.7 looking at the right river bank with concrete culvert invert at water surface level. (Reclamation photograph by D. Bennett, August 8, 2007).

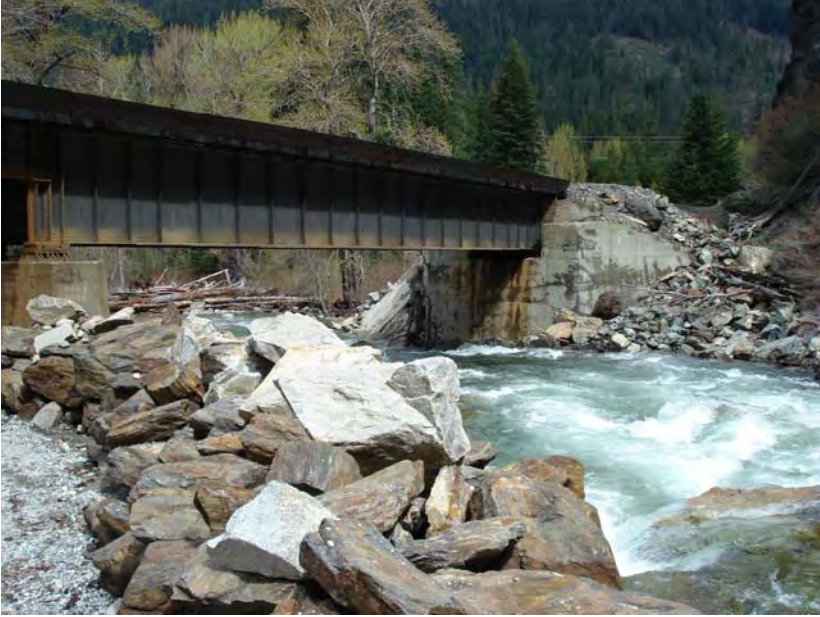
Figure 9. Downstream view to the north at riprap placed along USFS road and White Pine Railroad Bridge abutment near assessment area boundary (RM 14). (Reclamation photograph by R. McAfee, May 2, 2007).

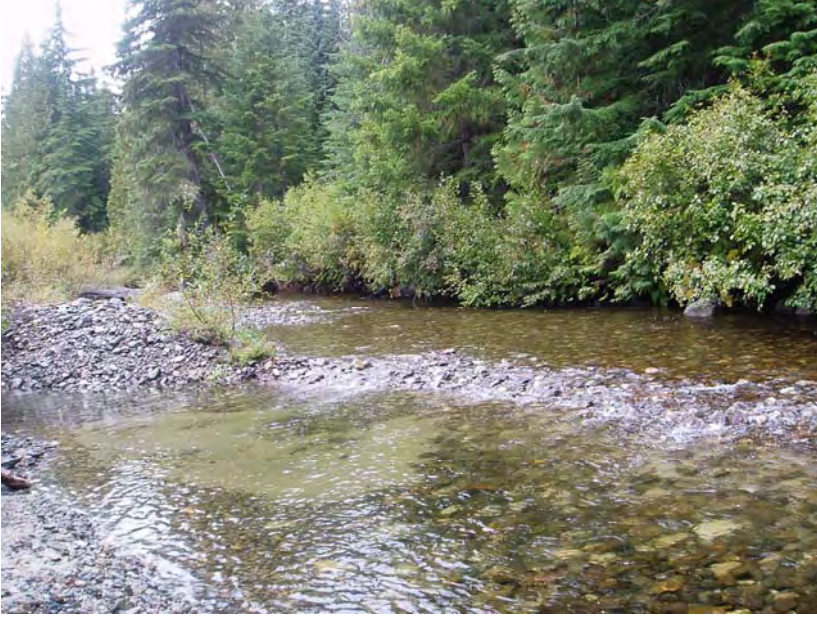
Figure 10. Upstream view of confluence of side and main channel in upper subwatershed near split in highway (vicinity of RM 20 to 22). (Reclamation photograph by J. Bountry, October 2007)

Sediment sizes in the channel above RM 15 were observed in a few locations where accessible by the road, and a helicopter video of the channel from spring of 2006 was also obtained for this effort. In the locations viewed, gravel bars were common and the dominant sediment sizes on the surface of the channel bed and bars ranged from gravel to cobble (2 to 256 mm) (Figure 10 and Figure 11).

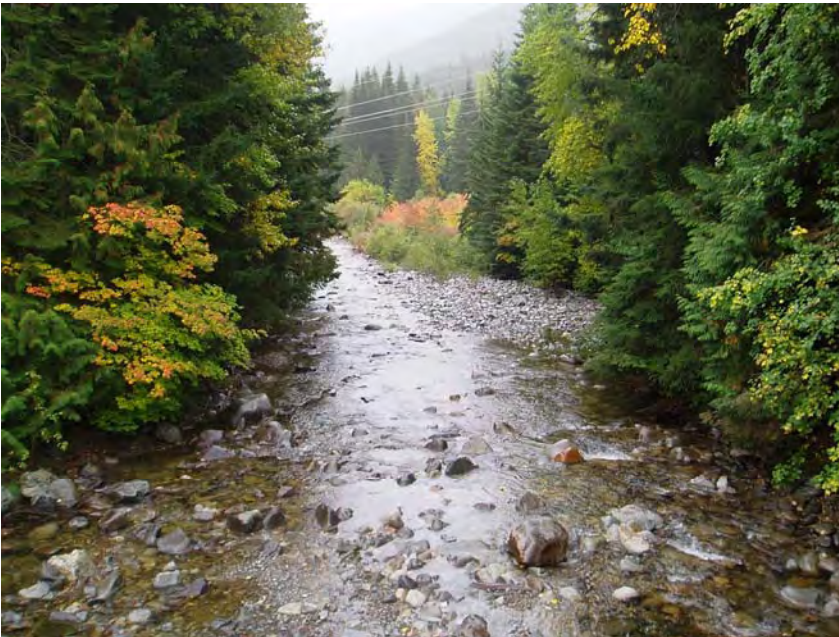
Figure 11. Example of gravel and cobble size sediment near U.S. Highway 2 bridge crossing in upper subwatershed. (Reclamation photograph by P. Makar, October 2007).

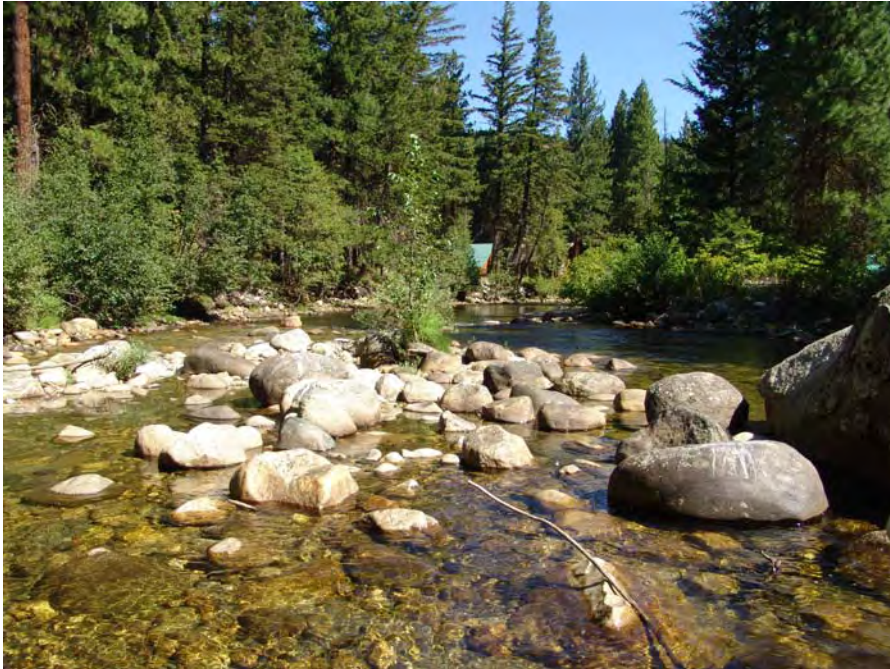
Figure 15. View is to the north looking downstream showing boulder field at downstream end of Reach 2 near RM 9. (Reclamation photograph by D. Bennett, August 9, 2007).

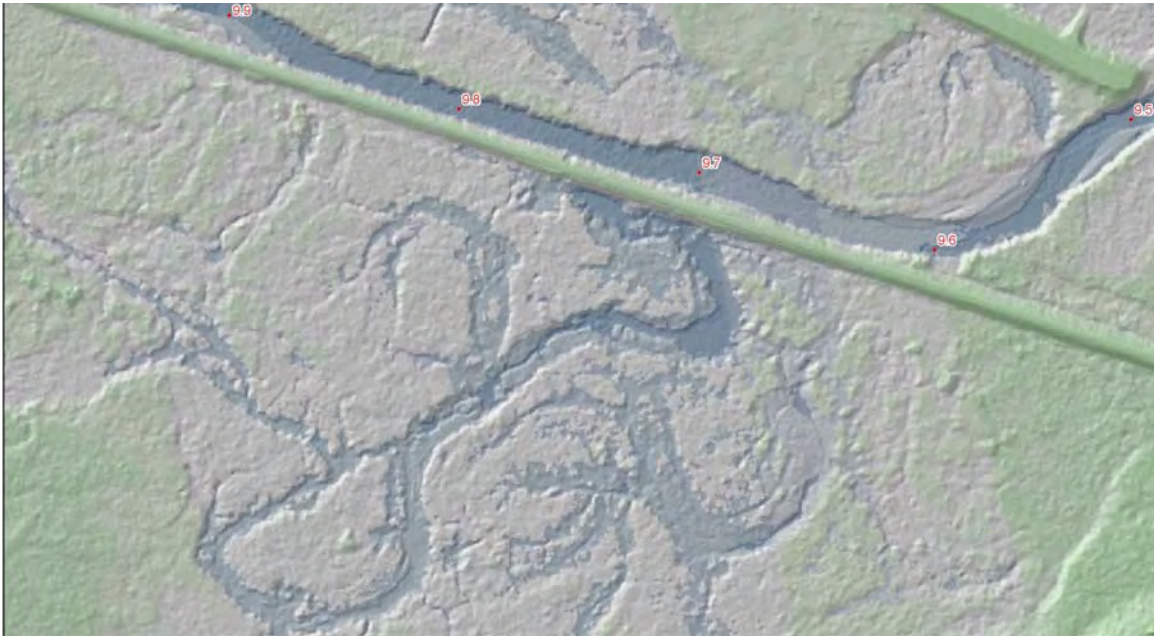
Figure 23. Example of disconnected historical channels and floodplain between RM 9.6 to RM 9.9. Colors represent elevations relative to present main channel elevations, dark blue being the closest and green being the farthest (highest elevations). The railroad embankment can be seen in green running along the present channel identified by red river mile markers, flowing from upper left to right in the image.

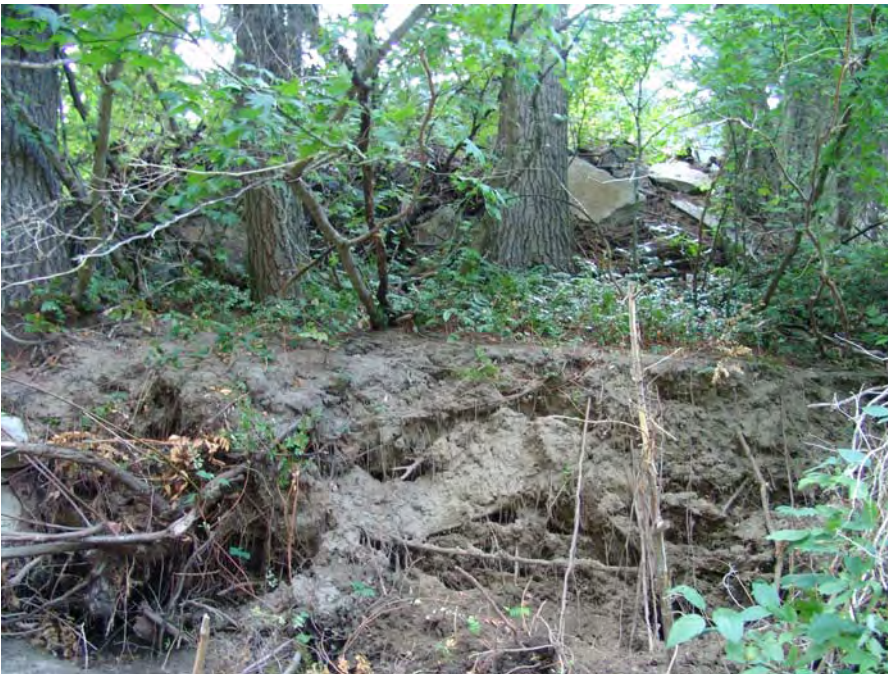
Figure 24. View is to the south looking at the right bank showing original ground level with fill material on top at river bank adjacent to Merritt. (Reclamation photograph by D. Bennett, August 8, 2007).

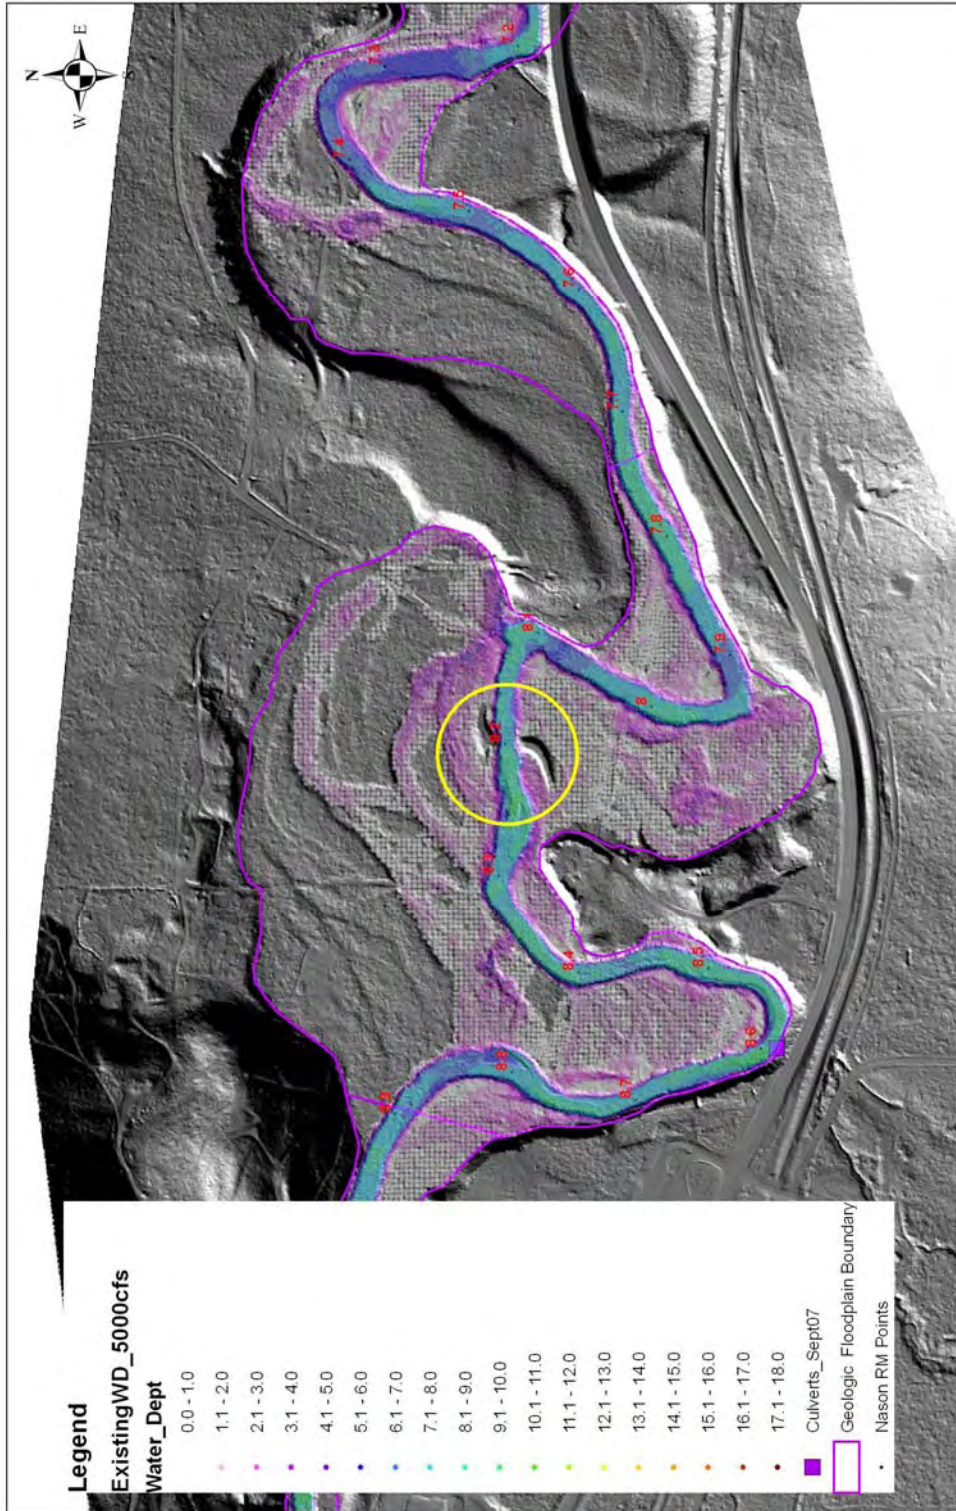
Figure 26. Impact to floodplain processes at RM 8 where flow can still go around embankment. Water depth (ft) results from the 2D model at a discharge of 5,000 cfs are shown, and are fairly shallow beyond the banks of the active channel.

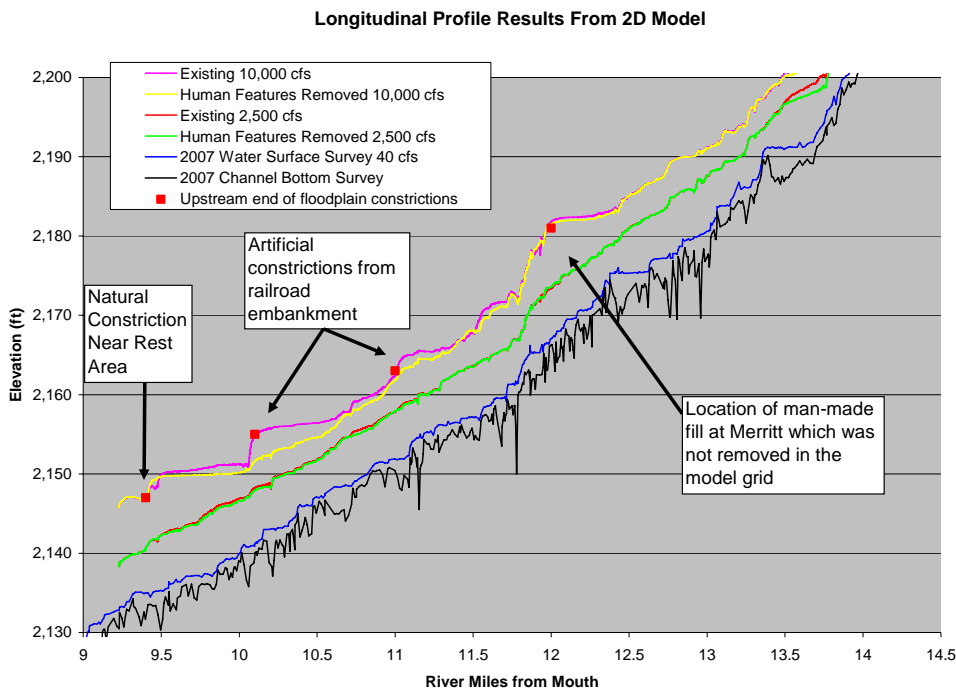
Figure 28. Backwater impacts from confined floodplain areas in Reach 3.

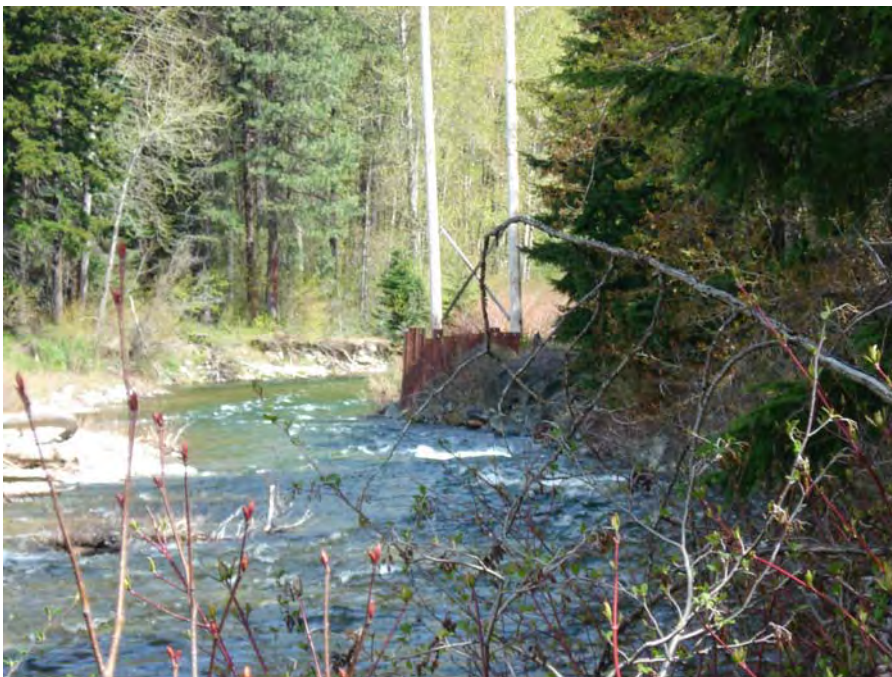
Figure 30. Downstream view to the east of sheet pilings that protect the power pole near RM 13.5

About 50 percent of the main channel in Reach 3 has riprap on at least one side of the main channel (Table 13). Less riprap is present in Reaches 1 and 2. The majority of riprap is associated with protecting the railroad and highway embankments from erosion, but an additional 9 percent is located along bridges, private property, and power and transmission line poles that reduce channel migration in additional areas beyond those confined by the railroad and highway (Figure 29 and Figure 30; also, see maps 23 and 24 for locations of riprap and human-made features that limit migration).

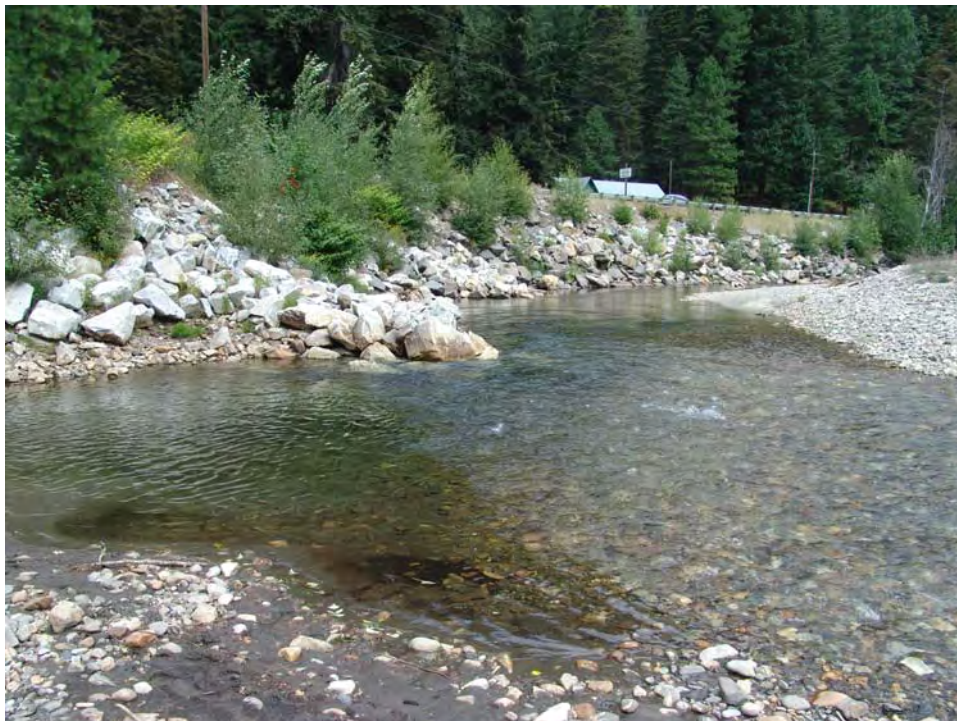
Figure 32. View is to the northeast looking downstream, showing riprap with two rock spurs into channel at RM 13.3. (Reclamation photograph by D. Bennett, August 7, 2007).

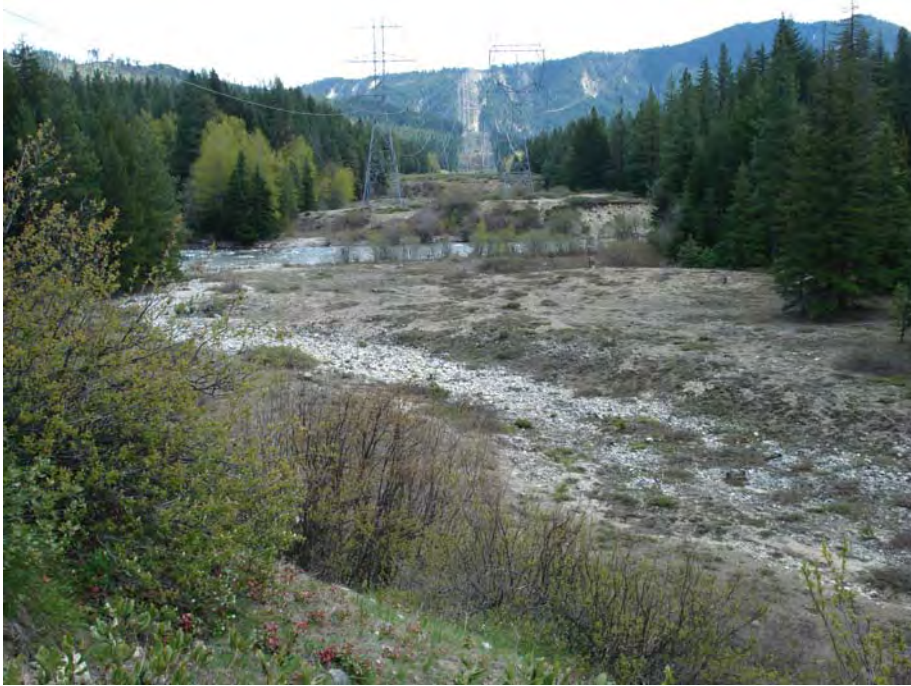
Figure 35. Photograph of split flow at RM 6.

This section has a side channel that has developed through channel migration and reworking since 1962 near the confluence with Kahler Creek (Figure 35). The power line crossing presently runs through this side channel and vegetation has been cleared along its path. There is no bank protection currently, but the power line poles are at risk if further migration occurs. Because the banks have been cleared of vegetation, lateral bank erosion on the left side may be accelerated and altering the rate of migration.

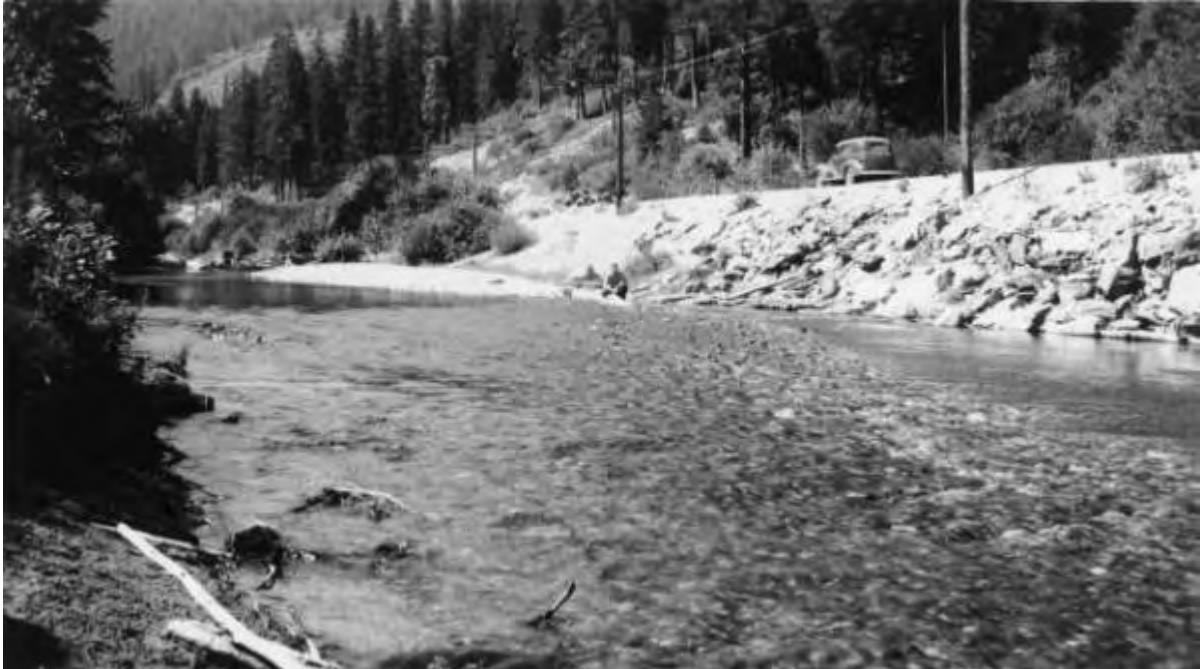
Figure 36. Historical image labeled as “a spawning riffle on Nason Creek” that also shows the road embankment at an unknown location. Photograph by Alfred S. Witter from 1930s to 1940s timeframe reprinted with permission from Oregon State University Historical Photograph Collection.

Channel geometry has been impacted in the majority of channel areas along this section of Nason Creek. Some changes are obvious, such as in areas that have been artificially confined, and other impacts are more difficult to discern, such as areas that have been ripped for many decades along road and railroad embankments (Figure 36).

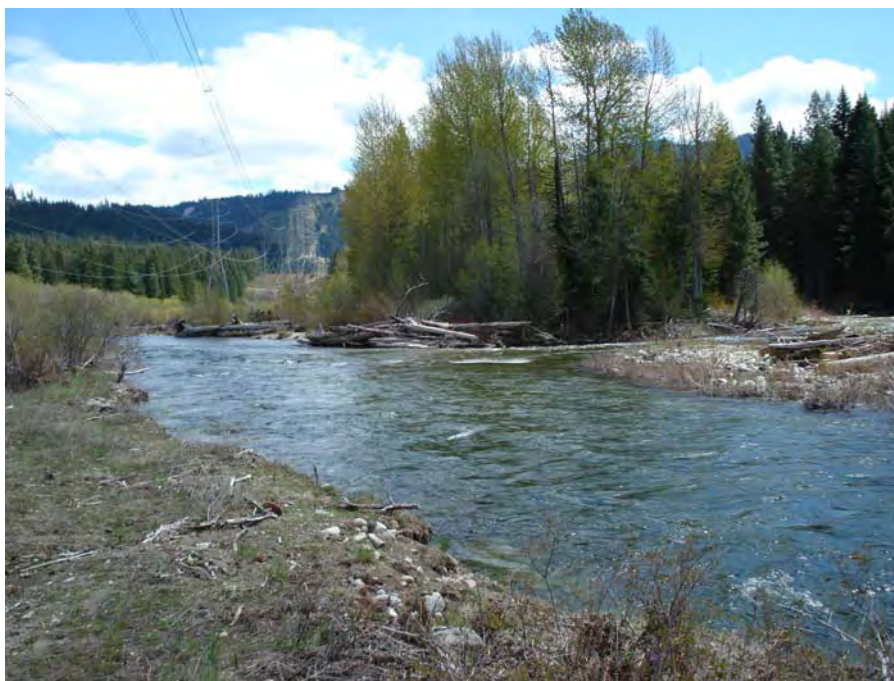
Figure 44. View to the east (downstream) showing large woody debris and split flow located near RM 6.2. (Reclamation photograph by R. McAfee, May 4, 2007).

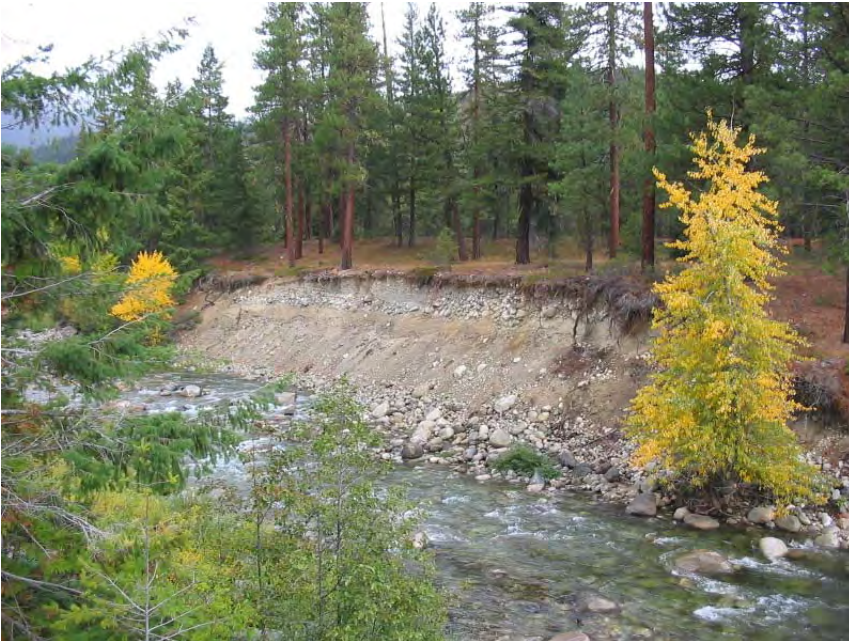
Figure 45. Looking at eroding glacial bank on left side of river in section where highway has cut off the historical meander bend near RM 6.6. (Reclamation photograph by D. Callahan, October 9, 2007).

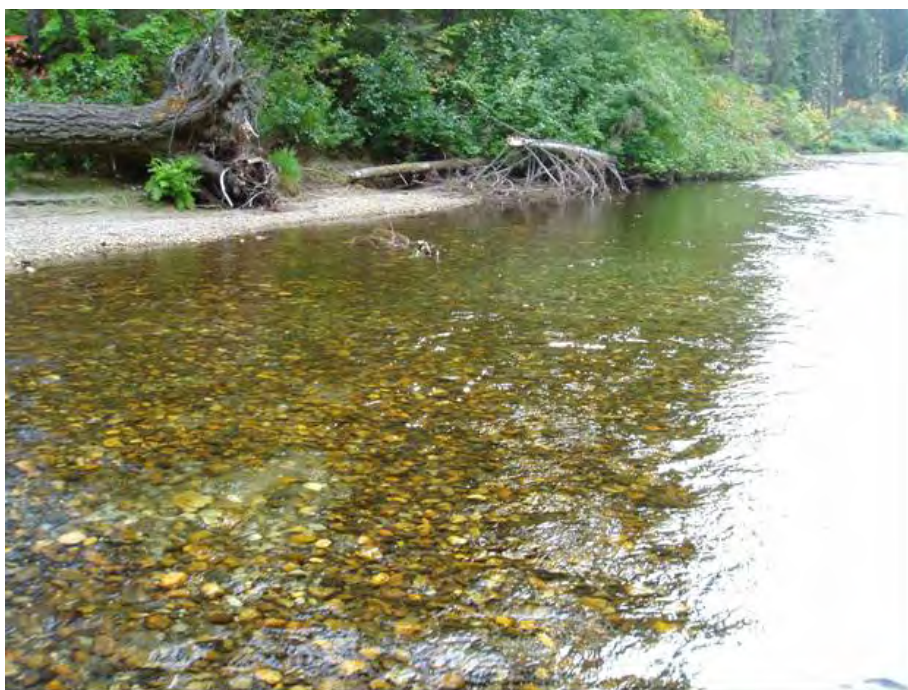
Figure 46. Photograph of spawning habitat present between RM 9.2 to 9.3.

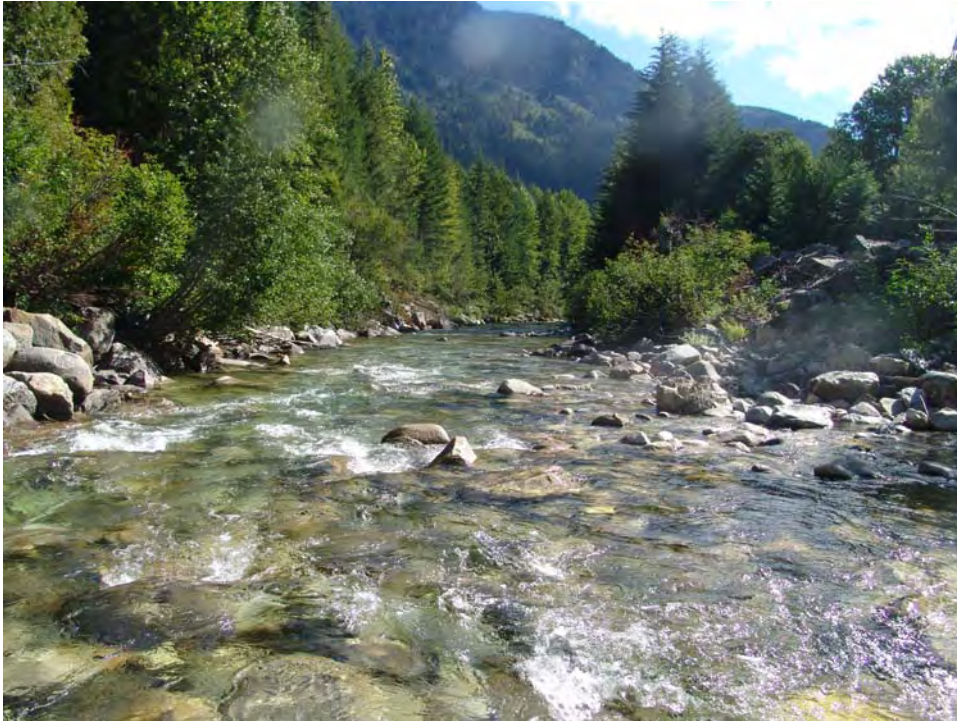
Figure 47. Looking downstream at confined, high energy channel section along railroad embankment near RM 13.9 that provides little to no habitat value. (Reclamation photograph by D. Bennett, August 7, 2007).

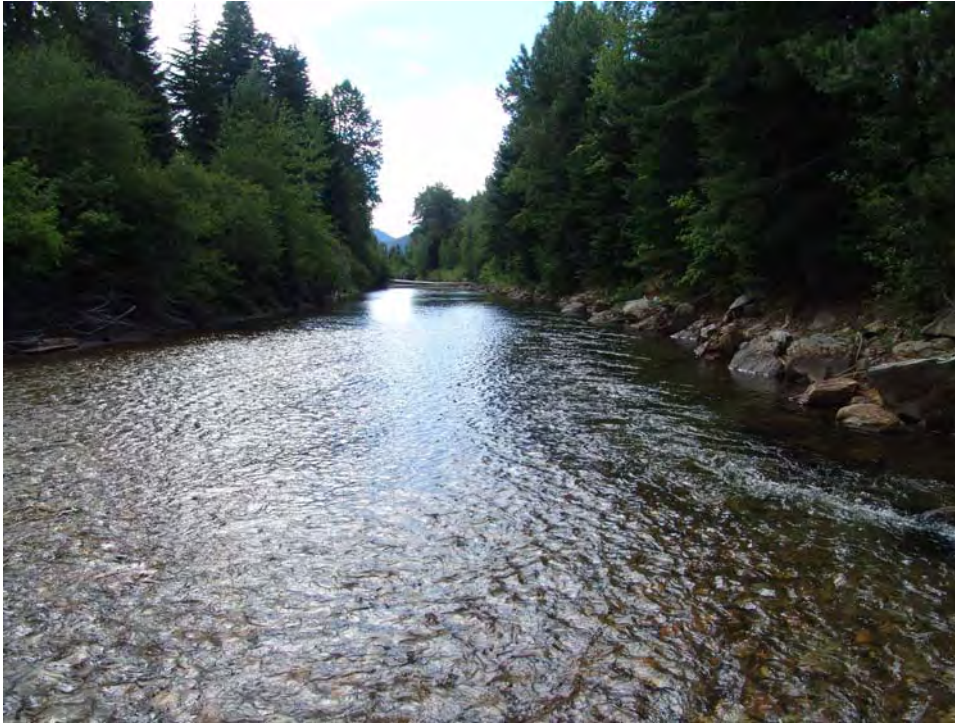
Figure 48. Looking downstream at straightened channel near RM 11.6. (Reclamation photograph by D. Bennett, August 8, 2007).

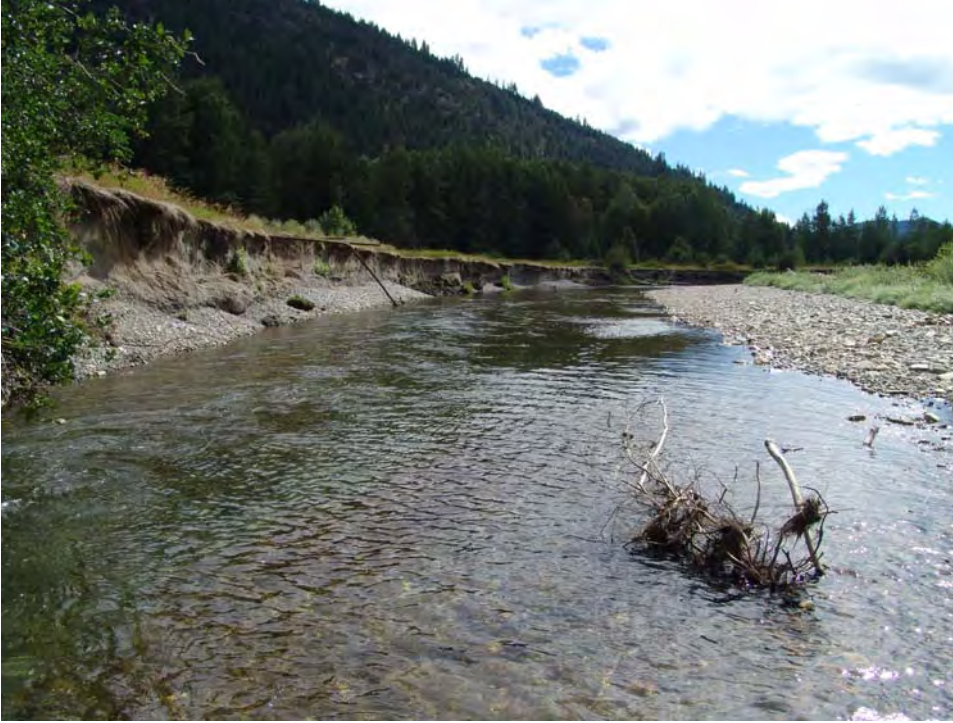
Figure 49. Looking downstream along meandering section near RM 11.2 that is eroding into an unvegetated bank about 8 to 10 feet high. (Reclamation photograph by D. Bennett, August 8, 2007).

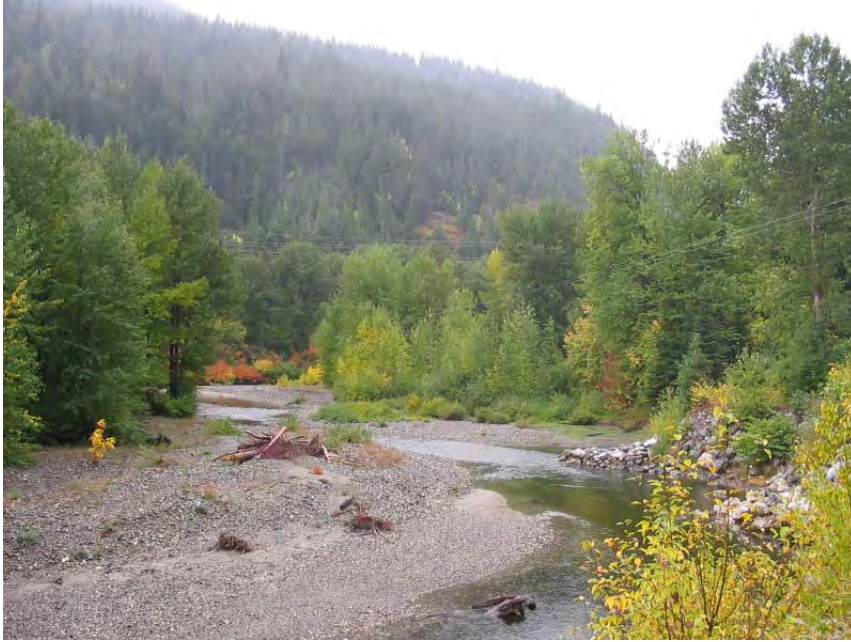
Figure 50. Area near RM 13 that is presently meandering and contains some LWD-formed pools. (Reclamation photograph by D. Callahan, October 9, 2007).

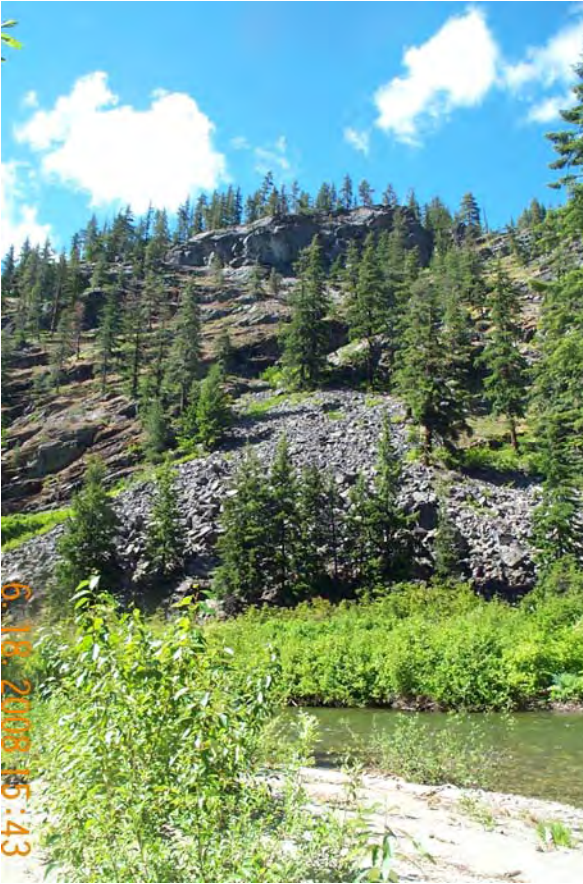
Photograph 1. Typical view of the upper Nason Creek drainage where the alpine glaciers over-ride or surmounted bedrock outcrops rounding their profile and talus accumulation at the base of the outcrop. (Reclamation photograph by E. Lyon, June 18, 2008).

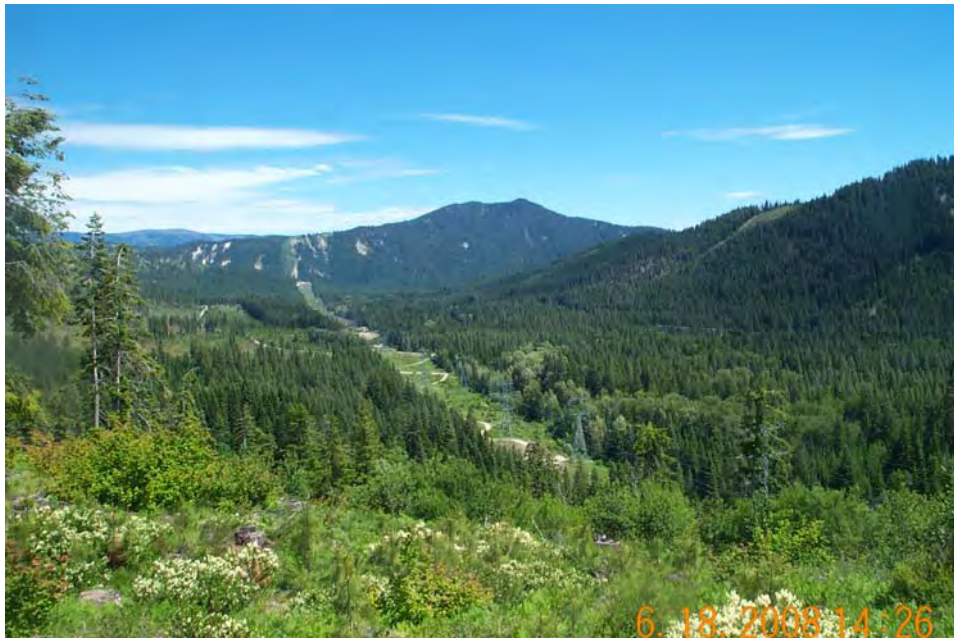
Photograph 2. View is from the left abutment of a terminal moraine over 200 feet above the valley floor believed to be of Evans Creek age looking downstream at the lower Nason Creek drainage area. The moraine is just downstream of the Leavenworth fault and contains clasts from both the Nason terrane and Chumstick Formation. (Reclamation photograph by E. Lyon, June 18, 2008).

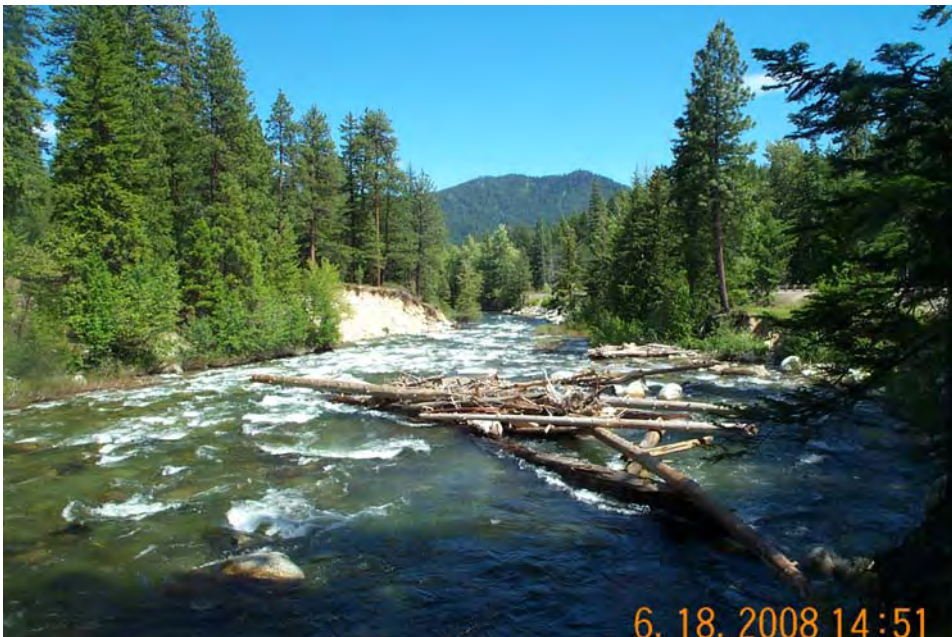
Photograph 3. View is looking downstream at boulders up to 10 feet in dimension deposited during the failure of the terminal moraine. At the base of the cutbank near center of photograph the boulder deposit and subsequent glacial outwash deposit can be observed in-place. (Reclamation photograph by E. Lyon, June 18, 2008).

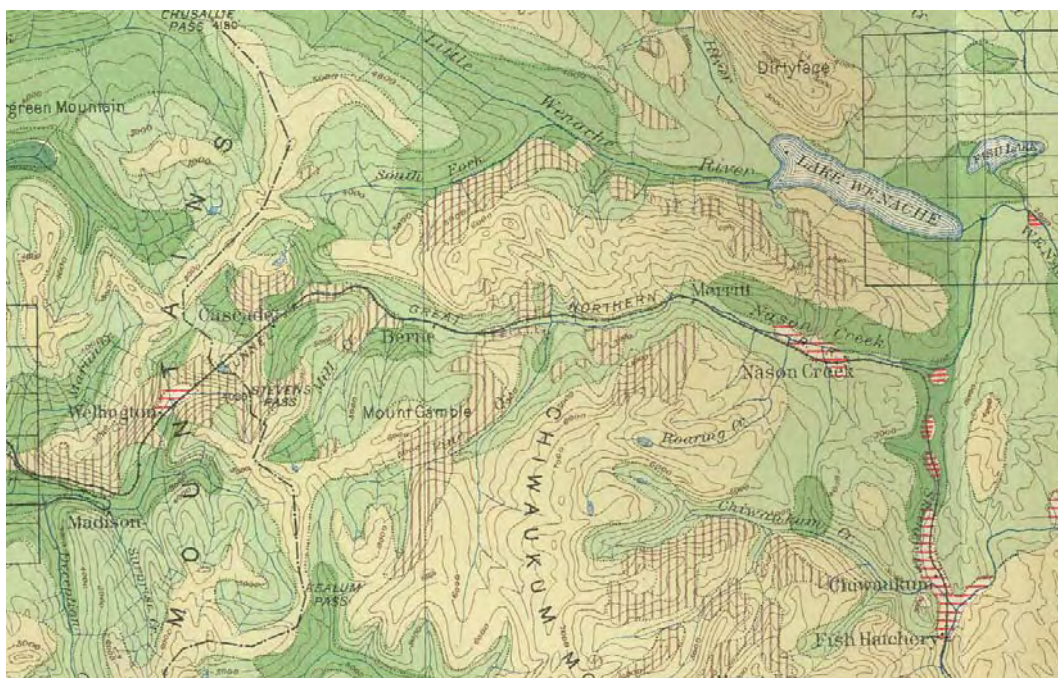
Figure 1. The USGS land classification map of 1902 shows fires identified as vertical black-striped areas and logged areas as horizontal red-striped areas (Plummer 1902).

Nason Creek, before the advent of the Great Northern Railway in 1891, would have had a relatively undisturbed forest and riparian corridor. Around the turn of the century, the best timber was found in the vicinity of the Cascade tunnel in the upper subwatershed, and consisted of fir, Patton hemlock, and Engelmann spruce, with some red cedar (Plummer 1902). Fires set to clear the right of way during railroad construction spread over considerable areas of the valley and adjacent hills, and these, together with the cutting for railroad uses, greatly reduced the amount of standing timber (Plummer 1902). The U.S. Geological Survey (USGS) land classification map of 1902 (Figure 1) shows active logging at this time (Plummer 1902). Plummer states that “*Near Nason Creek station a mill having a daily capacity of 10,000 feet is in operation, and ships lumber to Wenatchee*” (Plummer 1902).

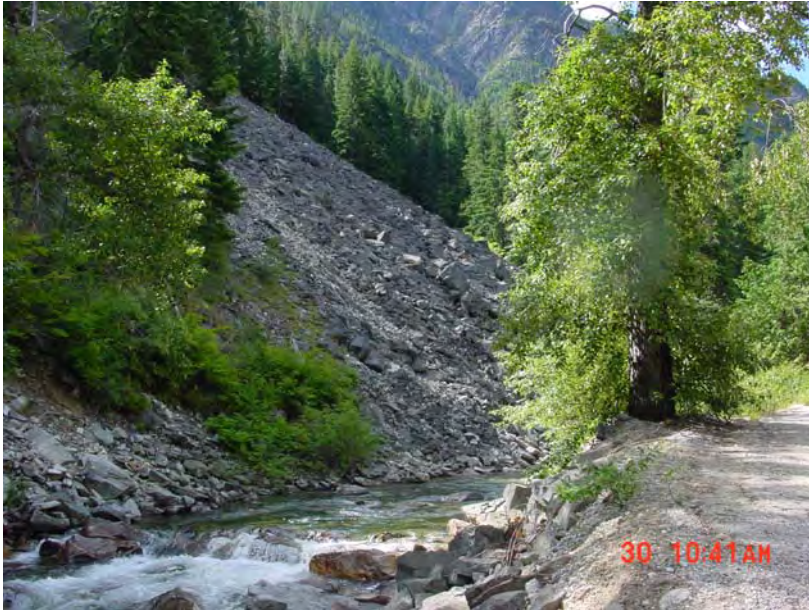
Figure 6. Example of slope failure on right side of river just upstream of White Pine Railroad Bridge. (Reclamation photograph taken by J. Bountry, June 2005).

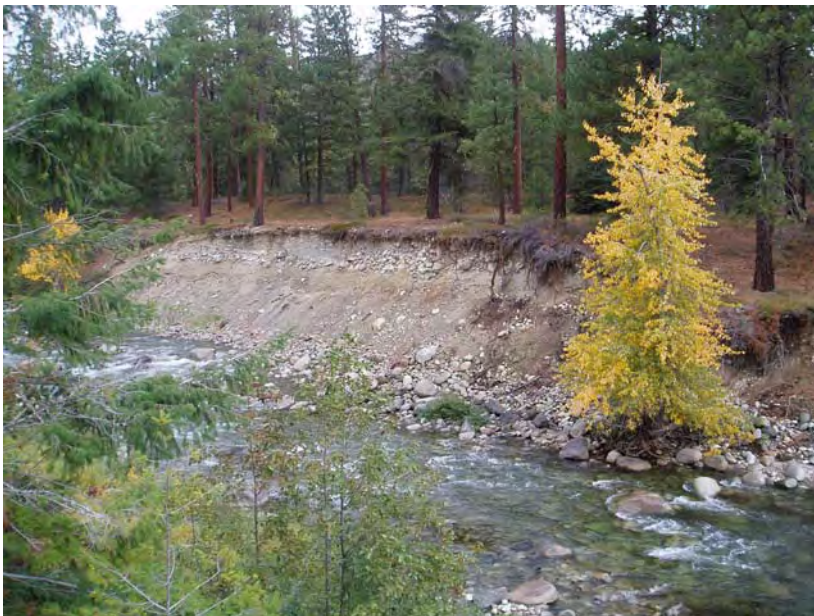
Figure 7. Example of terrace bank erosion along left side of channel between RM 4 and RM 9 on Nason Creek. (Reclamation photograph taken October 2007).

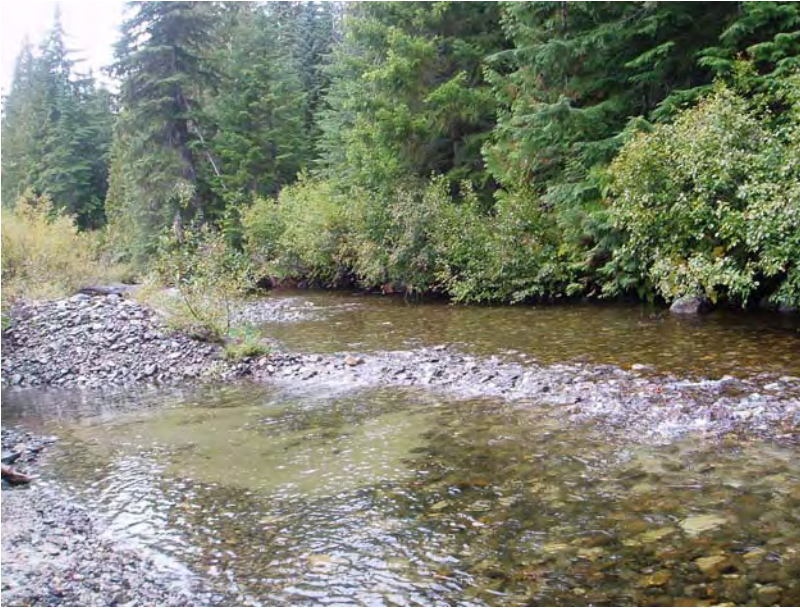
Figure 8. Example of sediment present in Nason Creek channel bed in upper portion of subwatershed. (Reclamation photograph taken by P. Makar, October 2007)

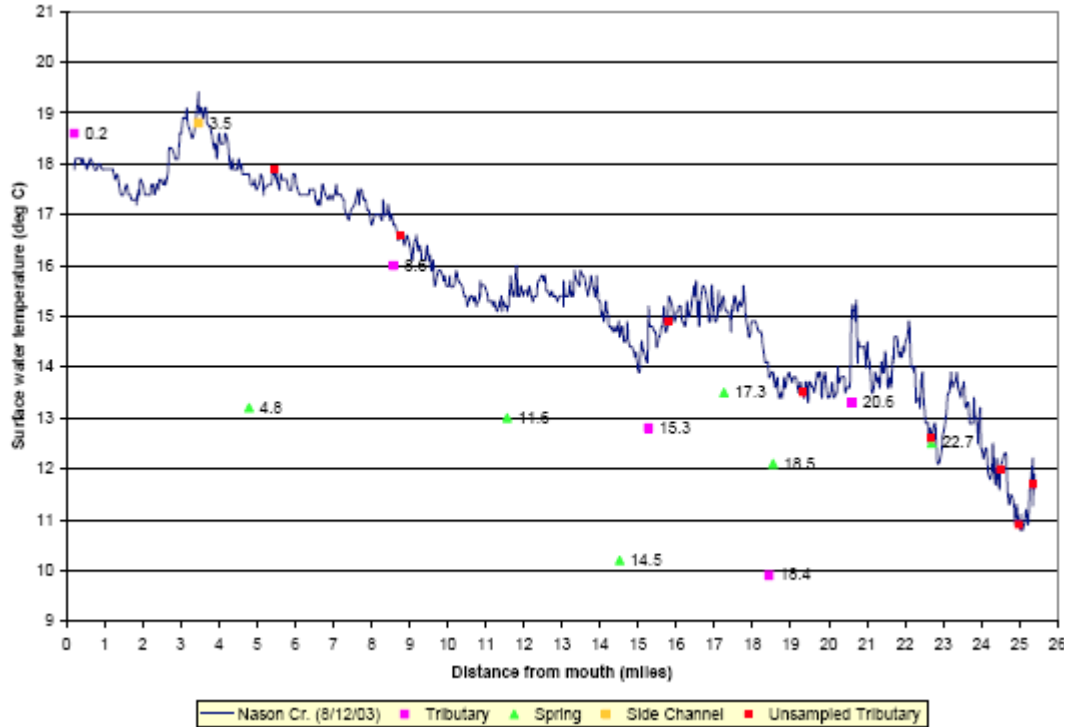
Figure 5. Median channel temperatures versus river mile for Nason Creek (August 12, 2003) (Watershed Sciences, LLC. 2003)

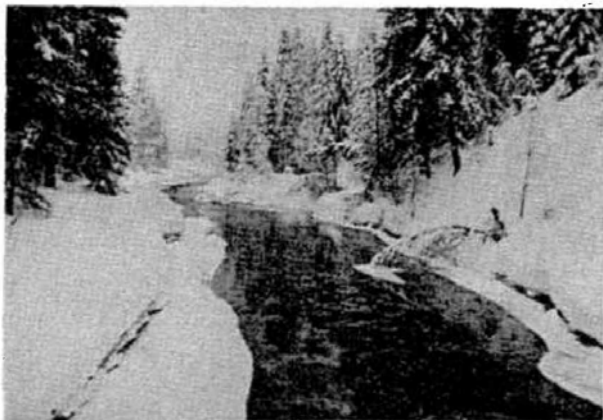
STATION 1 NASON CREEK JAN 1956

Figure 7. Photograph of 1956 water temperature sampling location (Seabloom 1958).

Collection of water samples for chemical and physical analyses was done at Nason Creek near the mouth at the State Park Bridge (estimated at RM 0.8) in 1955 and 56 (Figure 7; Seabloom 1958). Methods used an average of two samples at the site collected in 1 to 2 week intervals between June through September of 1955, and monthly samples during winter and spring of 1955-56 (when weather permitted). Data presented in the report are reproduced in Table 3, Table 4, Figure 8, Figure 9, Table 5, and Table 6. The 1958 report summarized the data as follows:

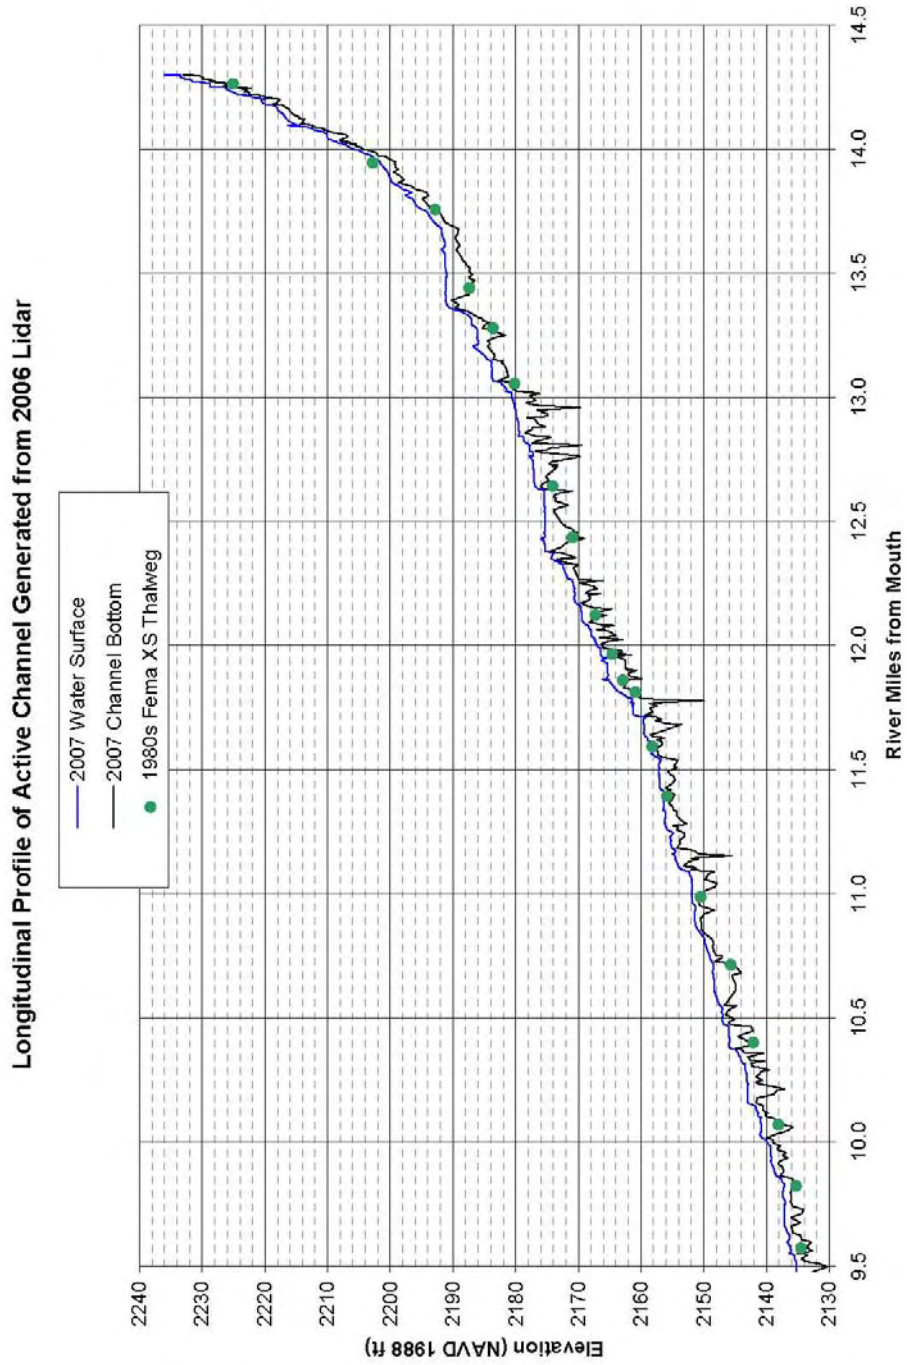
Figure 10. Longitudinal profile comparison of 2007 and 1980s channel bottom from RM 9.5 to RM 14.5.
