NASON CREEK TRIBUTARY ASSESSMENT Chelan County, Washington

**BUREAU OF RECLAMATION
TECHNICAL SERVICE CENTER, DENVER, CO,
AND
PACIFIC NORTHWEST REGIONAL OFFICE, BOISE, ID.**

JULY 2008

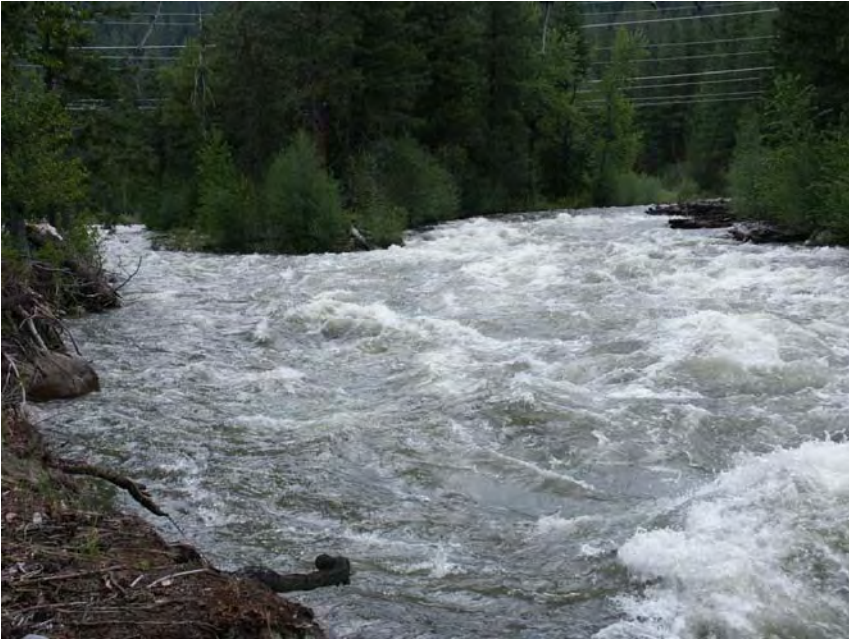
Figure 18. Looking upstream at May 2006 flood from locations shown in previous figure (near RM 6.6).

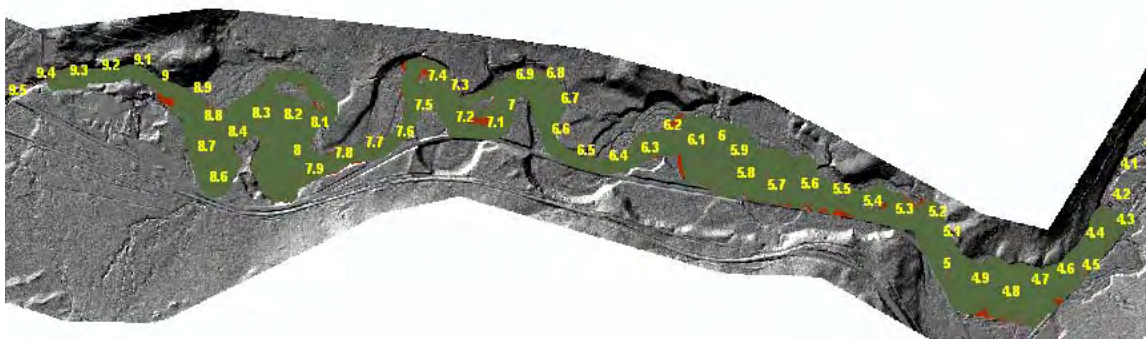
Figure 22. Inundation comparison of roughness of 0.04 (green) versus 0.05 (red) in geomorphic reach 1 for existing conditions. Areas in red represent the additional inundation caused by the higher roughness value in the active channel.

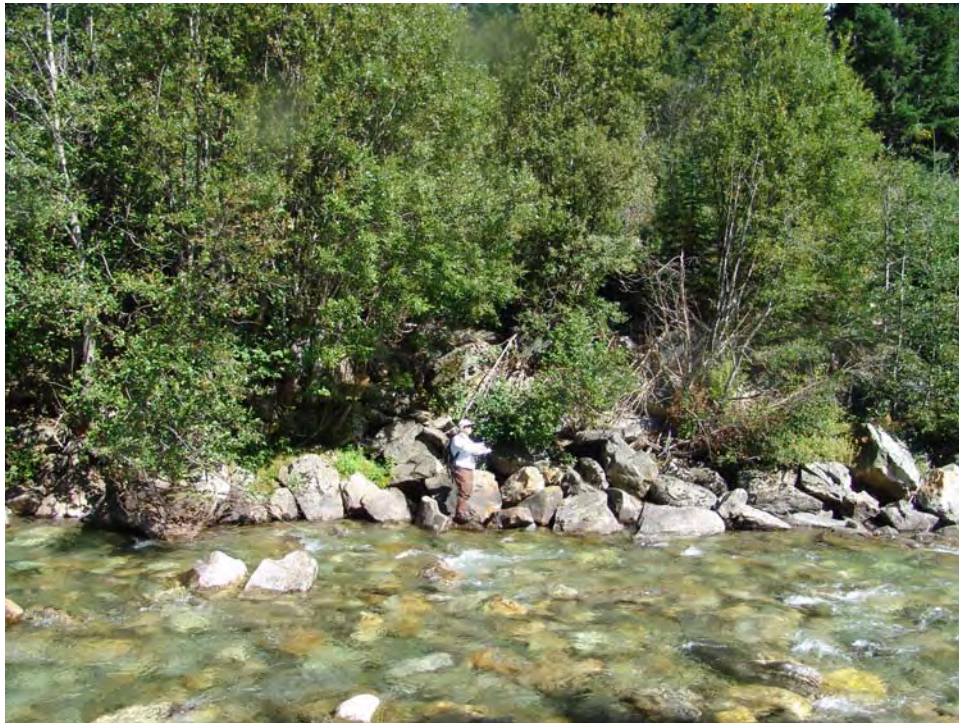
Photograph No.7. View is to the north at bank profile site of left bank. Nason Creek - Wenatchee Subbasin, Washington. (Reclamation photograph by D. Bennett, August 7, 2007)

Date described: August 7, 2007		Reach:3 Location: RM 12.875 on outside of active meander bend within floodplain	Reach:3 Location: RM 12.06 along constructed fill at Merritt	Reach:3 Location: RM 11.96 along constructed fill at Merritt
Characteristic				
Evidence of active landslide	Headscarps Slumps Disturbed vegetation Water out of bank	Headscarps Slumps Disturbed vegetation Water out of bank	Headscarps Slumps Disturbed vegetation Water out of bank	Headscarps Slumps Disturbed vegetation Water out of bank
Evidence of active erosion	Undercut Exposed roots	Undercut Exposed roots	Undercut Exposed roots	Undercut Exposed roots
Photographs taken	8-7-07, #7	8-7-07, #29	8-7-07, #45	8-7-07, #48

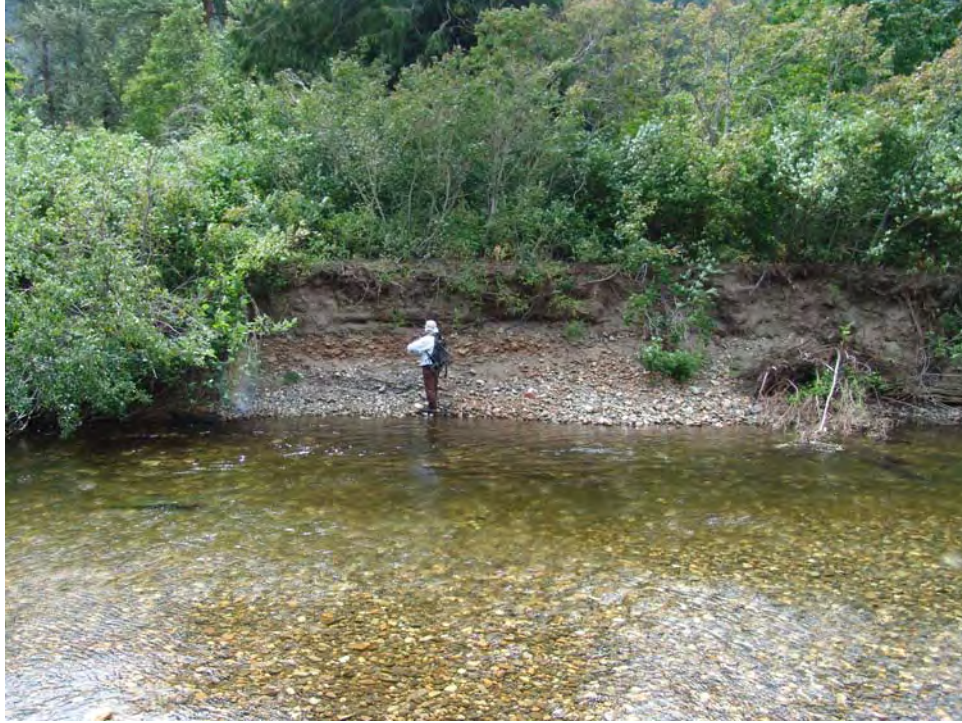
Photograph No.29. View is to the south at bank profile site of right bank. Nason Creek - Wenatchee Subbasin, Washington. (Reclamation photograph by D. Bennett, August 7, 2007)

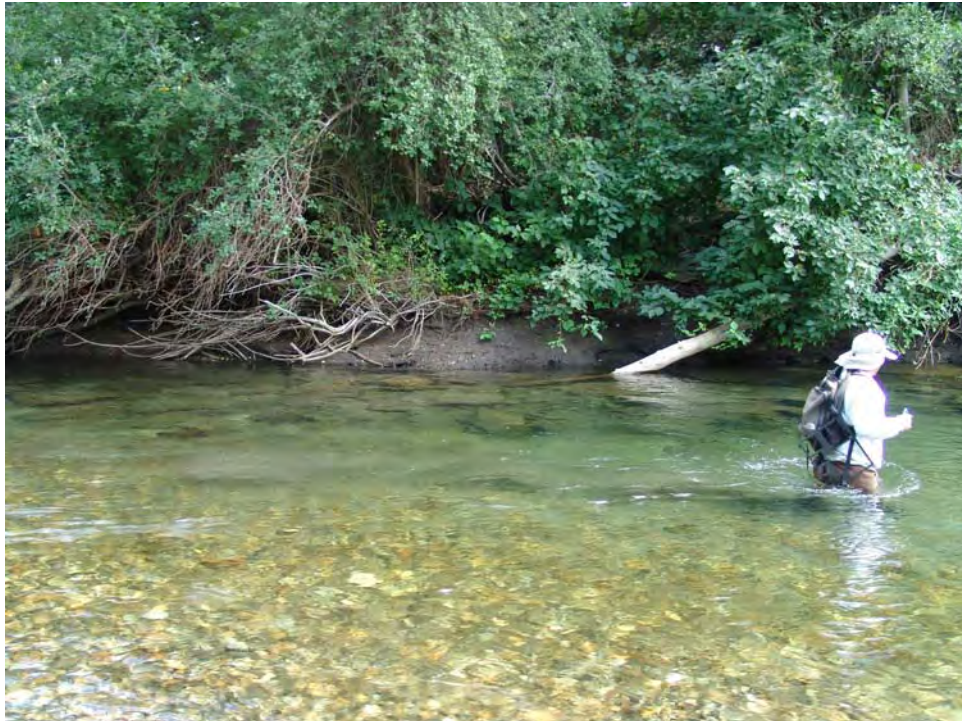
Photograph No.45. View is to the east looking at bank profile site on right bank. Nason Creek - Wenatchee Subbasin, Washington. (Reclamation photograph by D. Bennett, August 8, 2007)

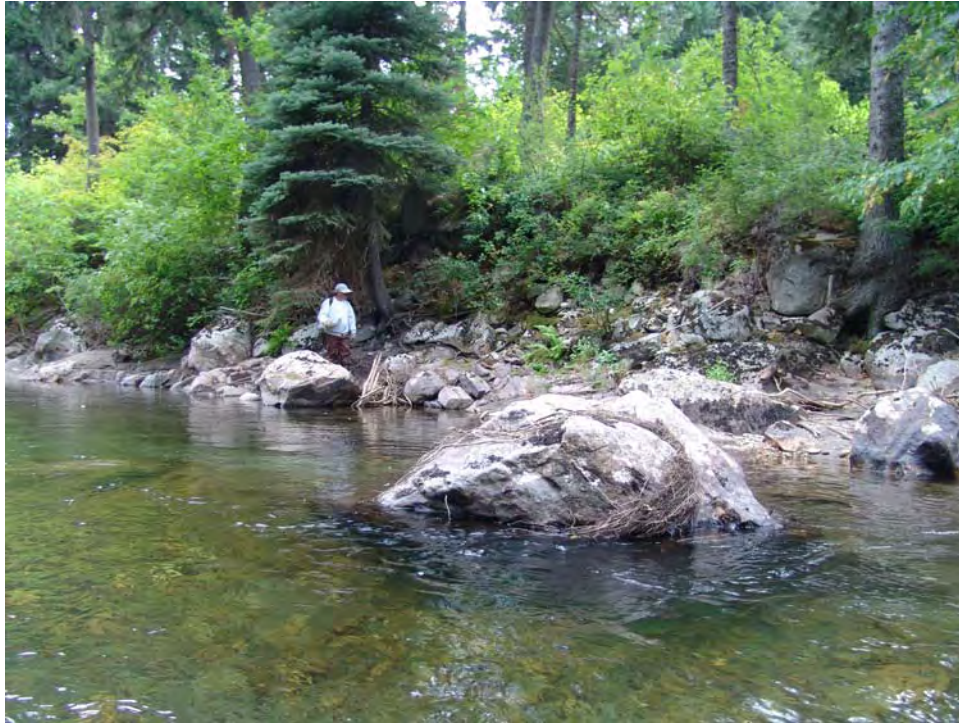
Photograph No.48. View is to the south looking at bank profile site on right bank. **Nason Creek - Wenatchee Subbasin, Washington. (Reclamation photograph by D. Bennett, August 8, 2007)**

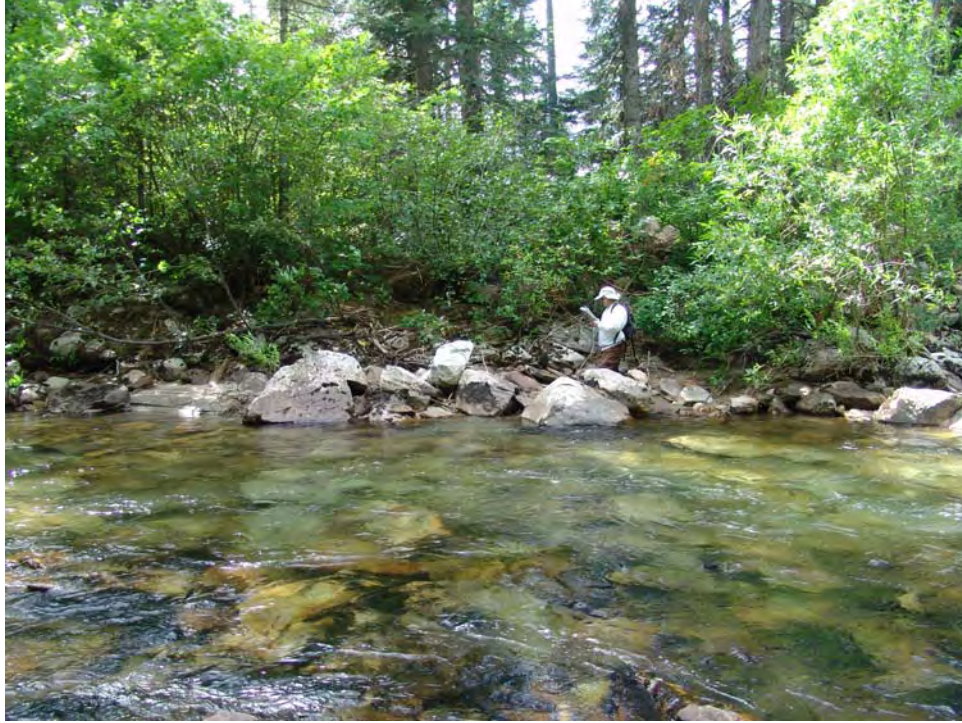
Photograph No.50. View is to the west looking at bank profile site on right bank. Nason Creek - Wenatchee Subbasin, Washington. (Reclamation photograph by D. Bennett, August 7, 2007)

Date described: August 7, 2007	Reach:3 Location: RM 11.86 along constructed fill at Merritt	Reach:3 Location: RM 11.22 along outside of meander bend	Reach:3 Location: RM 10.95 along engineered channel bank	Reach:3 Location: RM 9.95 along engineered channel within floodplain
Characteristic				
Evidence of active erosion	Undercut Exposed roots	Undercut Exposed roots	Undercut Exposed roots	Undercut Exposed roots
Photographs taken	8-7-07, #50	8-8-07, #13, 14 and 15	8-8-07, #23	8-8-07, #44

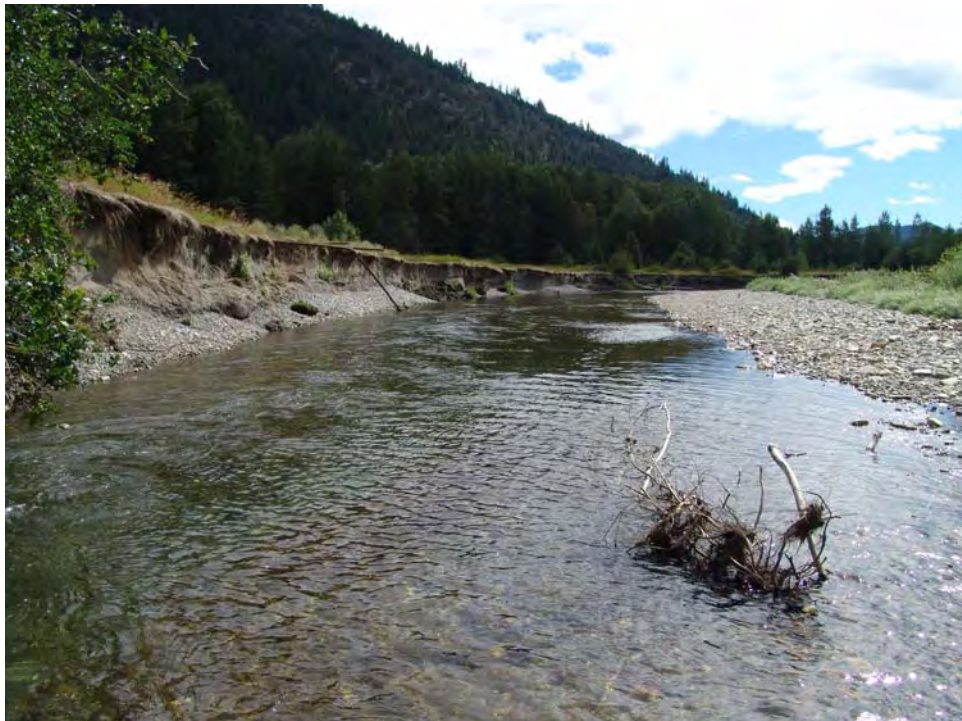
Photograph No.13. View is to the east looking downstream showing both banks. Nason Creek - Wenatchee Subbasin, Washington. Downstream view. (Reclamation photograph by D. Bennett, August 8, 2007).

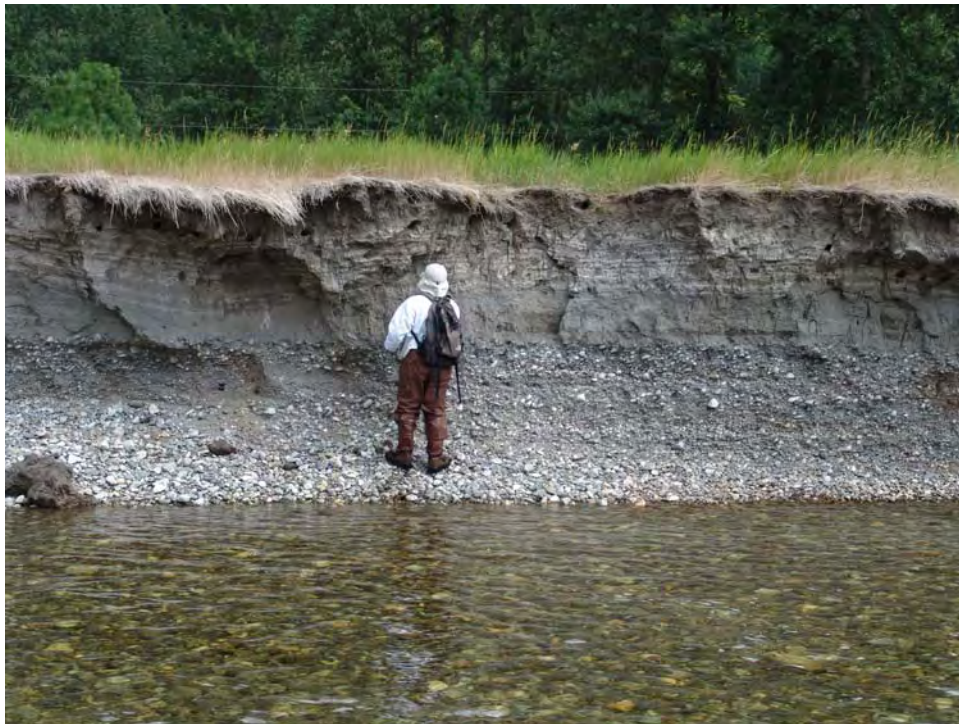
Photograph No.14. View is to the north at bank profile site of left bank. Nason Creek - Wenatchee Subbasin, Washington. (Reclamation photograph by D. Bennett, August 8, 2007).

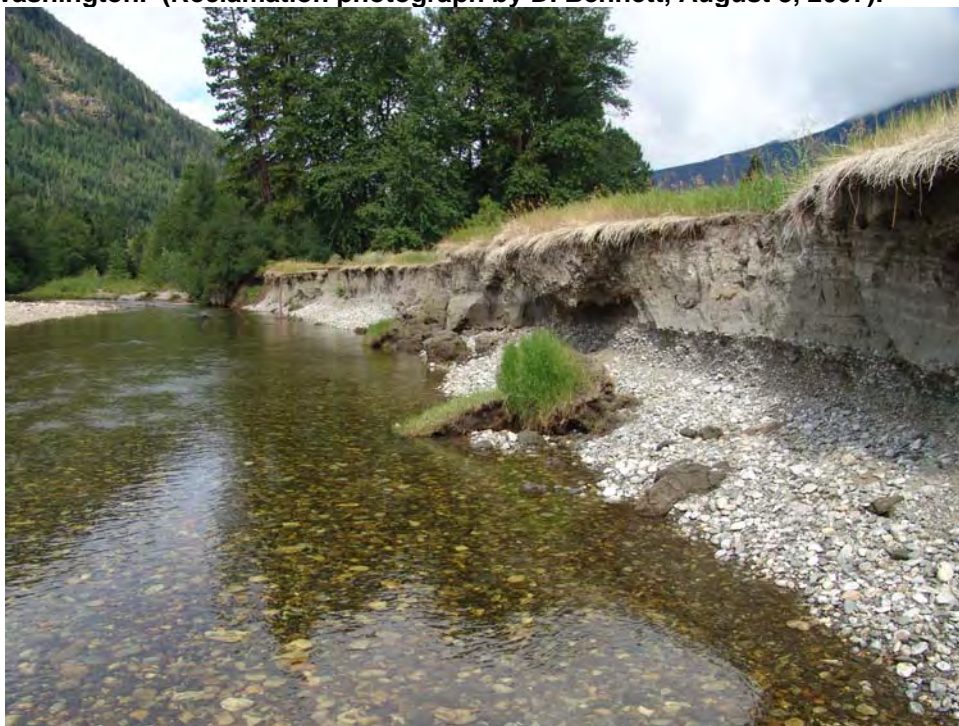
Photograph No.15. View is to the west looking upstream, showing close-up of left bank near bank profile site. Nason Creek - Wenatchee Subbasin, Washington. (Reclamation photograph by D. Bennett, August 8, 2007).

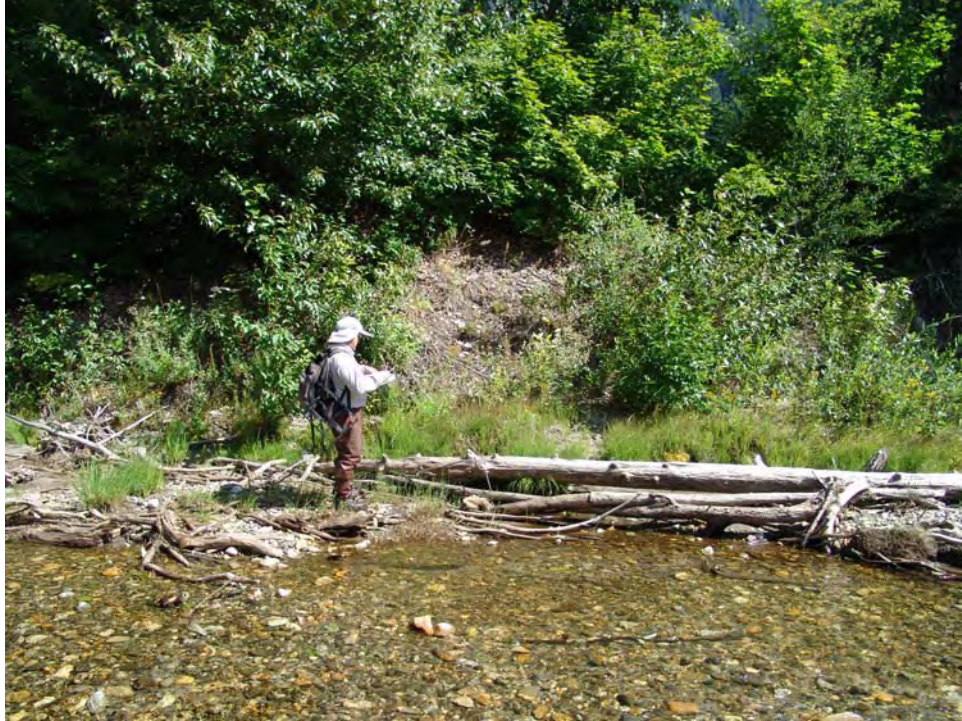
Photograph No.23. View is to the north at bank profile site of left bank. Nason Creek - Wenatchee Subbasin, Washington. (Reclamation photograph by D. Bennett, August 8, 2007).

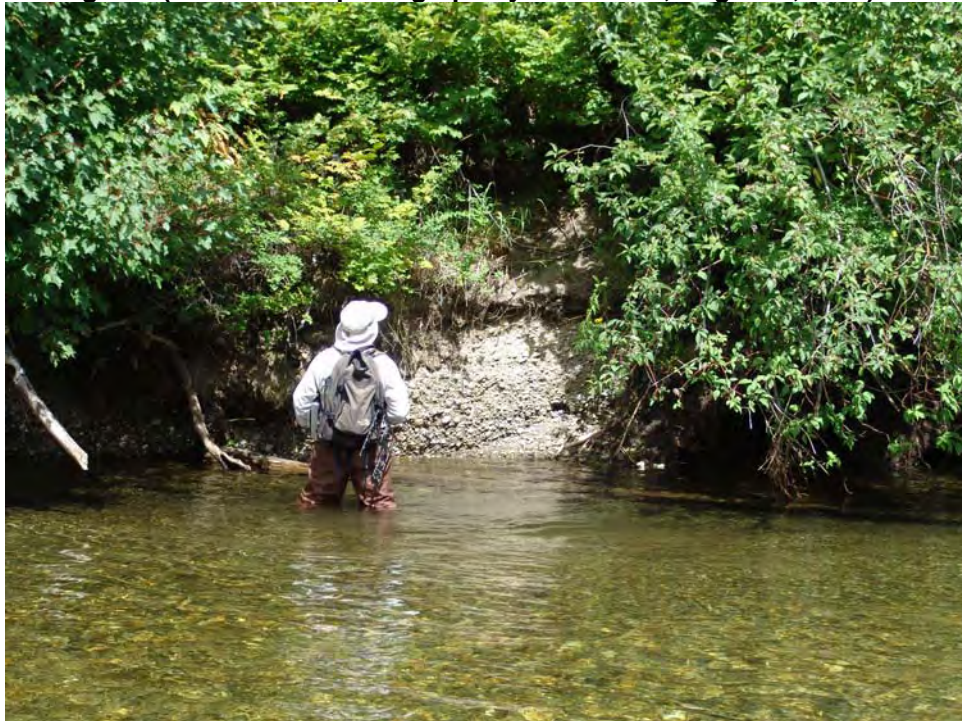
Photograph No.44. View is to the north at bank profile site of left bank. Nason Creek - Wenatchee Subbasin, Washington. (Reclamation photograph by D. Bennett, August 8, 2007).

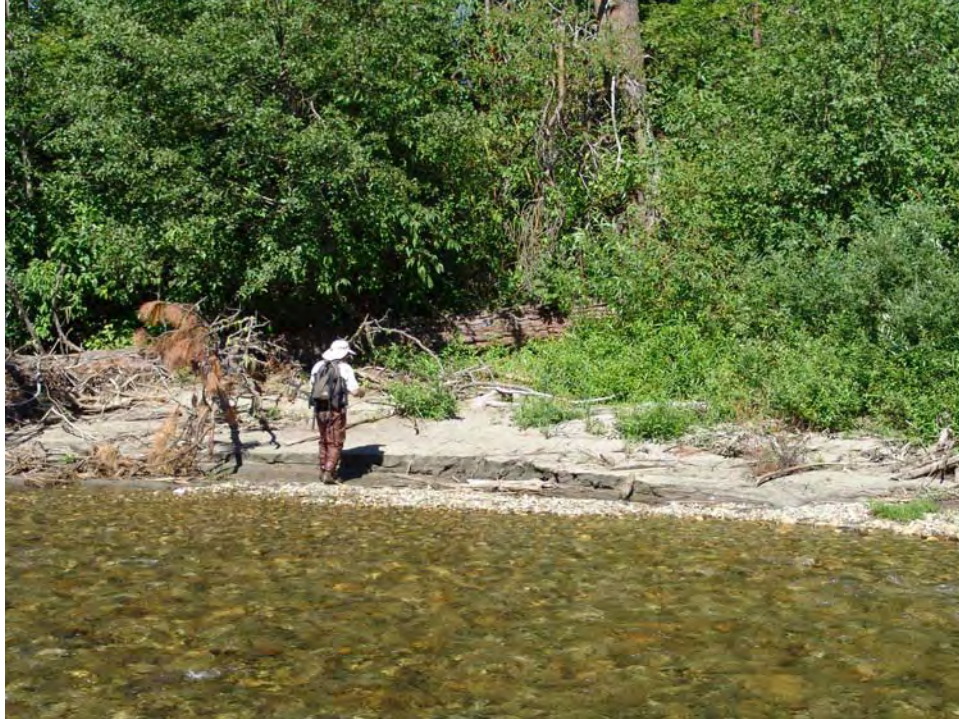
Photograph No.12. View to the west looking at bank profile site on the right bank. Nason Creek - Wenatchee Subbasin, Washington. (Reclamation photograph by D. Bennett, August, 9, 2007).

Date described: August 9, 2007 Characteristic	Reach:1 Location: RM 8.8 on right bank within floodplain	Reach:1 Location: RM 8.68 on terrace forming floodplain boundary	Reach:1 Location: RM 8.35 on left bank of terrace within floodplain	Reach:1 Location: RM 7.56 on right bank of terrace forming floodplain boundary
Evidence of active landslide	Headscarps Slumps Disturbed vegetation Water out of bank	Headscarps Slumps Disturbed vegetation Water out of bank	Headscarps Slumps Disturbed vegetation Water out of bank	Headscarps Slumps Disturbed vegetation Water out of bank
Evidence of active erosion	Undercut Exposed roots	Undercut Exposed roots	Undercut Exposed roots	Undercut Exposed roots
Photographs taken	8-9-07, #12	8-9-07, #15	8-9-07, #21	8-9-07, 34

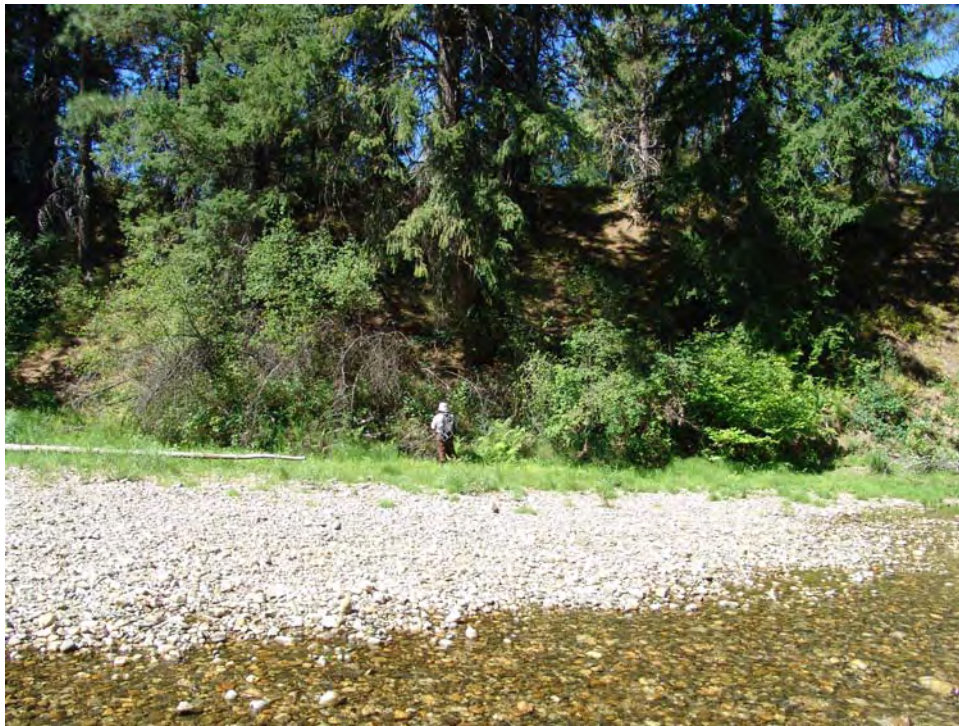
Photograph No.15. View to the west looking at bank profile site on the right bank. Nason Creek - Wenatchee Subbasin, Washington. (Reclamation photograph by D. Bennett, August 9, 2007).

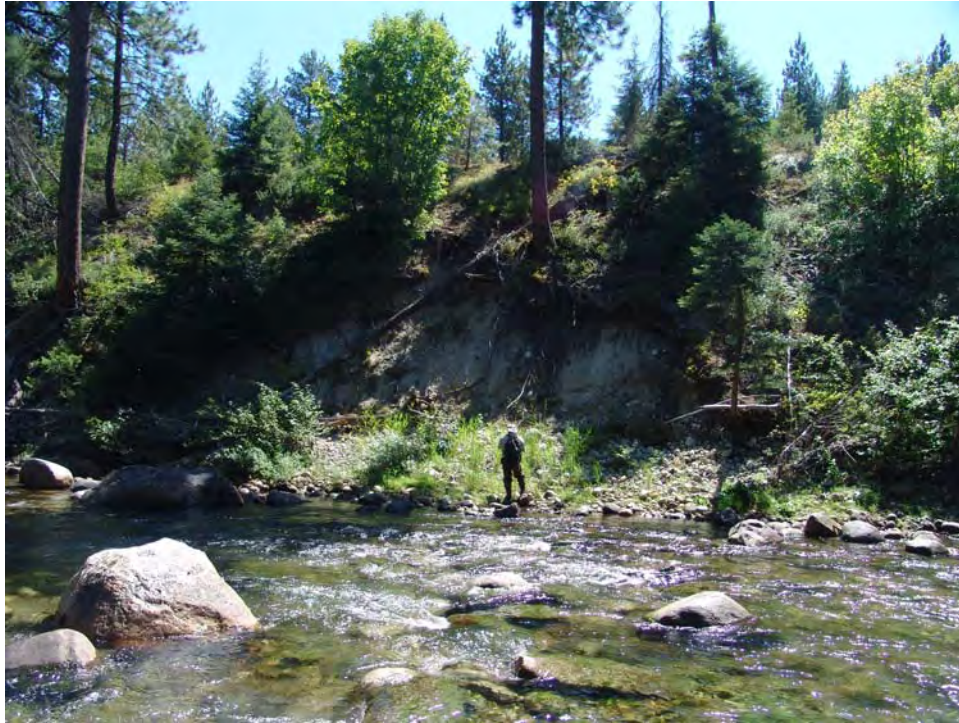
Photograph No.34. View is to the east showing bank profile site on right bank. Nason Creek - Wenatchee Subbasin, Washington. (Reclamation photograph by D. Bennett, August 9, 2007).

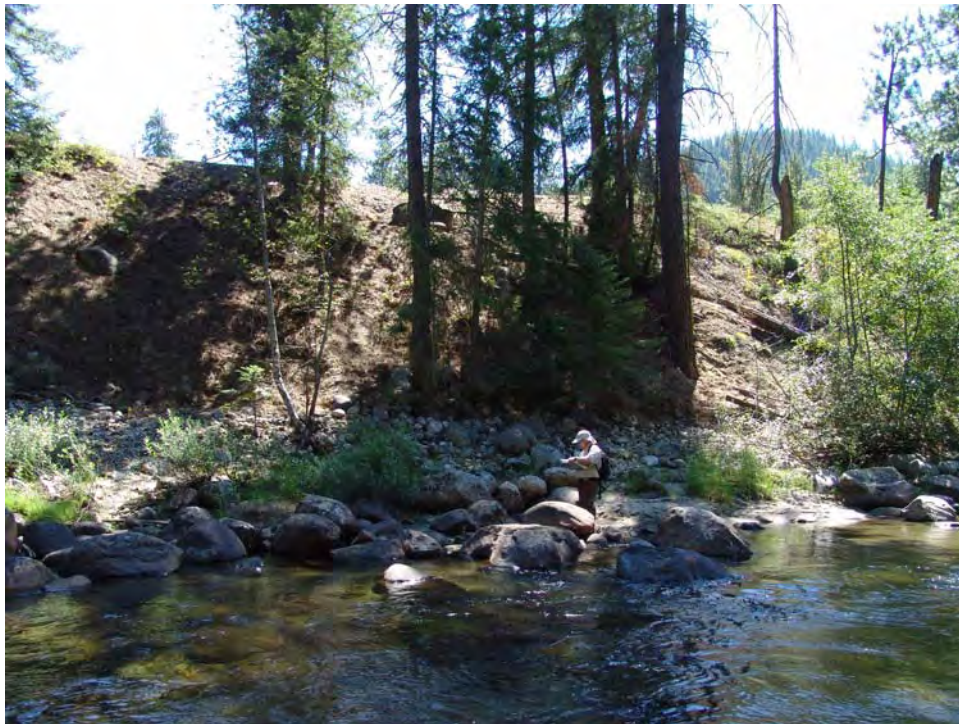
Photograph No.36. View is to the east showing bank profile site on right bank. Nason Creek - Wenatchee Subbasin, Washington. (Reclamation photograph by D. Bennett, August 9, 2007).

Date described: August 9-10, 2007	Reach:1 Location: RM 7.51 on right terrace bank forming floodplain boundary	Reach:1 Location: RM 7.45 on right bank within floodplain	Reach:1 Location: RM 6.735 on left terrace bank forming floodplain boundary	Reach:1 Location: RM 6.54 on left terrace bank forming floodplain boundary
Characteristic	Headscarps? Slumps Disturbed vegetation Water out of bank	Headscarps Slumps Disturbed vegetation Water out of bank	Headscarps Slumps Disturbed vegetation Water out of bank	Headscarps Slumps Disturbed vegetation Water out of bank
Evidence of active landslide	Headscarps? Slumps Disturbed vegetation Water out of bank	Headscarps Slumps Disturbed vegetation Water out of bank	Headscarps Slumps Disturbed vegetation Water out of bank	Headscarps Slumps Disturbed vegetation Water out of bank
Evidence of active erosion	Undercut Exposed roots	Undercut Exposed roots	Undercut Exposed roots	Undercut Exposed roots

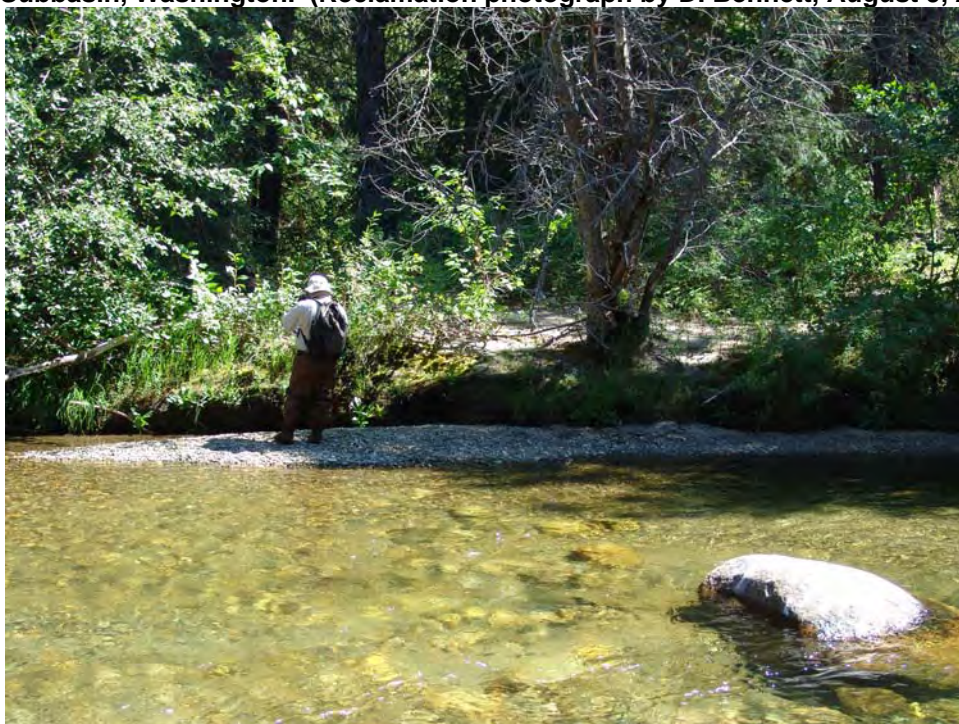
Photograph No.41. View is to the east showing bank profile site on right bank. Nason Creek - Wenatchee Subbasin, Washington. (Reclamation photograph by D. Bennett, August 9, 2007).

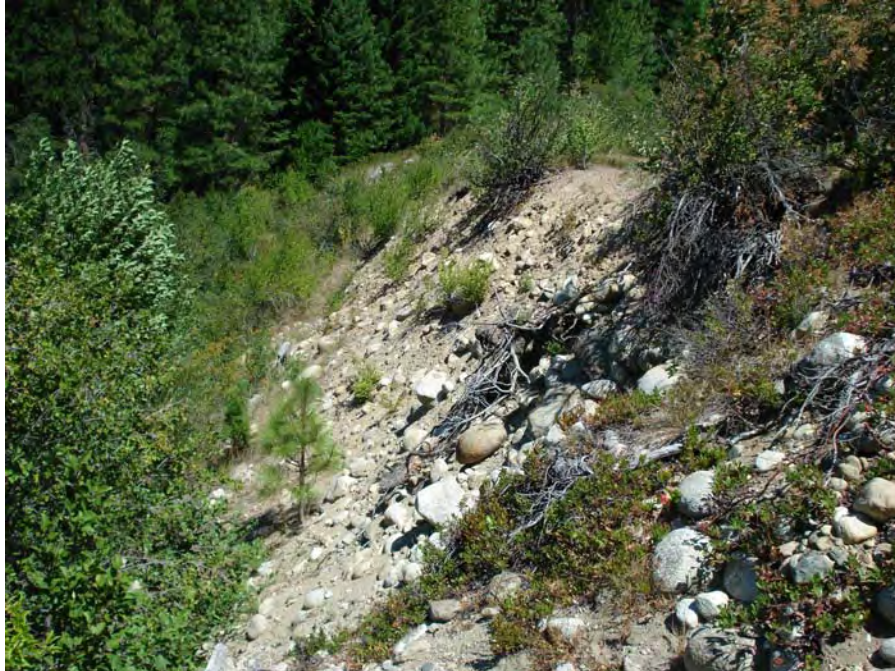
Photograph No. 1. A view to the north, looking upstream along the left bank at location of bank profile measurement. Nason Creek – Wenatchee subbasin, Washington –(Reclamation photograph by R. M^cAffee, August 10, 2007).

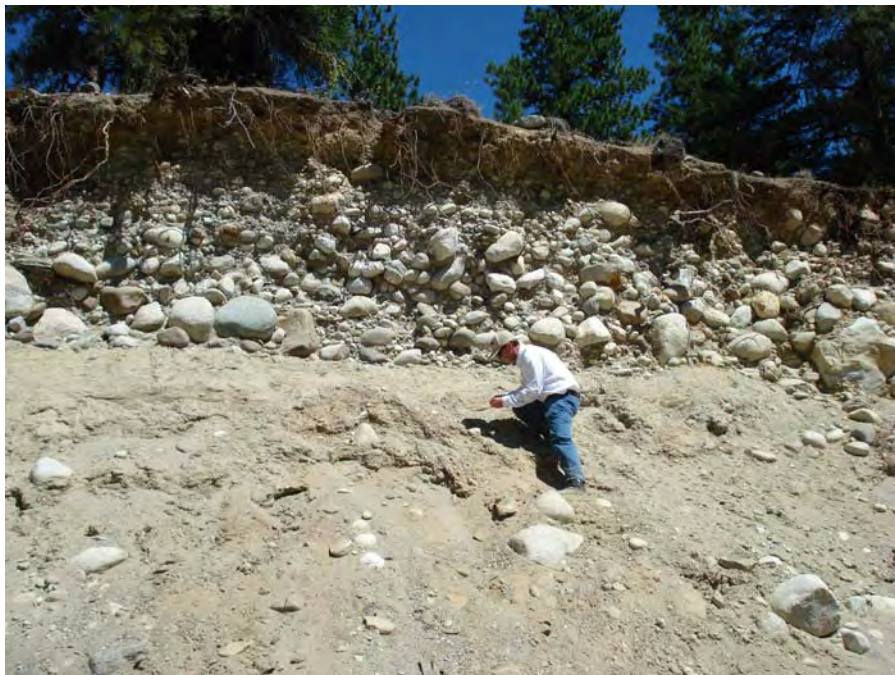
Photograph No. 2. A view to the north looking at the different deposits that is visible in the left bank at a location of a bank profile. Nason Creek – Wenatchee subbasin, Washington – (Reclamation photograph by R. M^cAffee, August 10, 2007).

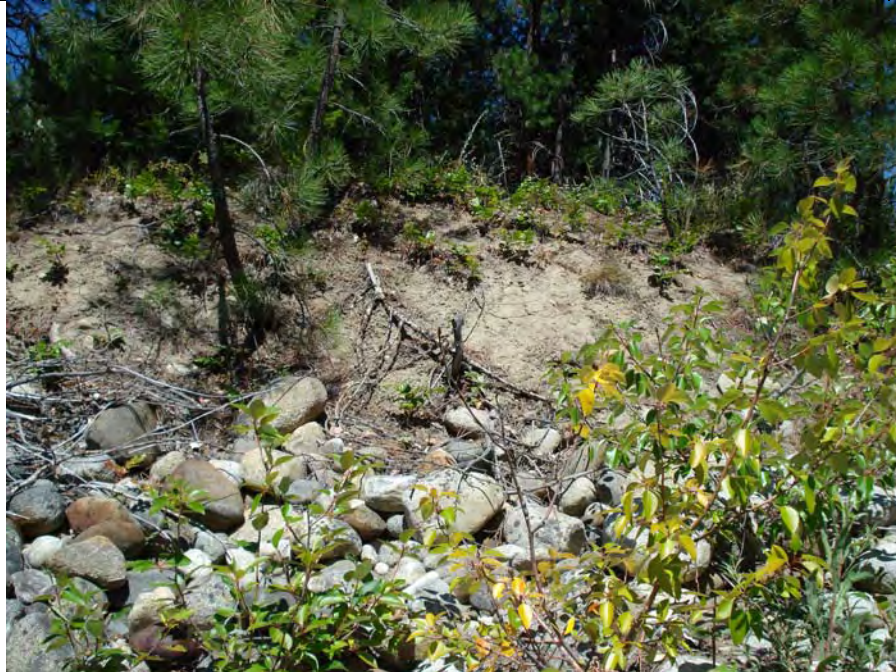
Photograph No. 3. A view to the north showing the middle surface in a succession along the left bank of the river. Nason Creek – Wenatchee subbasin, Washington (Reclamation photograph by R. M^cAfee, August 10, 2007).

Date described: August 10, 2007 Characteristic	Reach:1 Location: RM 6.48 on left terrace forming floodplain boundary	Reach:1 Location: RM 6.44 on right bank within floodplain	Reach:1 Location: RM 6.33 on right bank of terrace within floodplain	
Evidence of active landslide	Headscarps Slumps Disturbed vegetation Water out of bank	Headscarps Slumps Disturbed vegetation Water out of bank	Headscarps Slumps Disturbed vegetation Water out of bank	
Evidence of active erosion	Undercut Exposed roots	Undercut Exposed roots	Undercut Exposed roots	
Photographs taken	8-10-07, #3	8-10-07, #4	8-10-07, #5

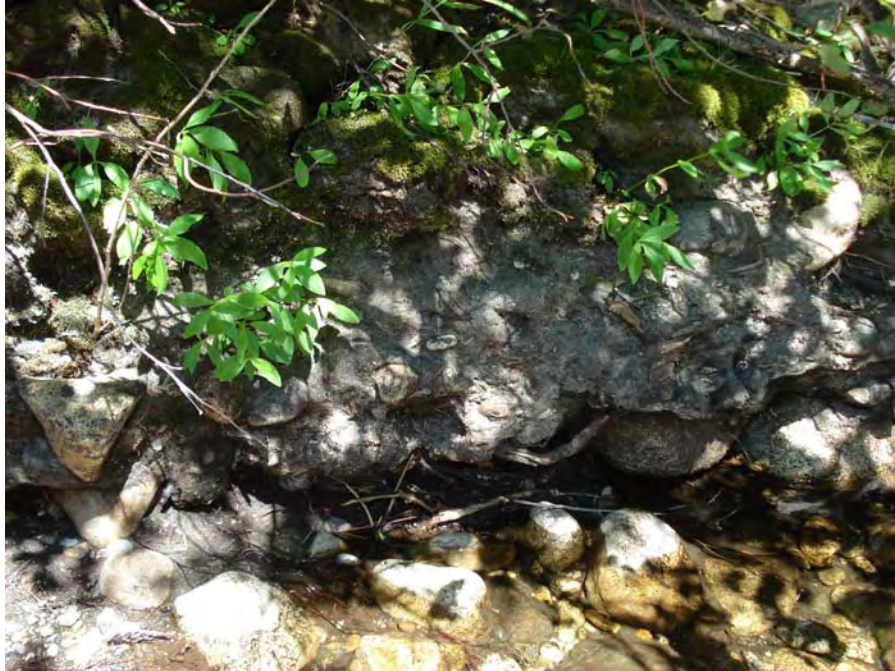
Photograph No. 4. A view to the north showing the lowest surface in a succession of terraces along the left bank of the river. Nason Creek – Wenatchee subbasin, Washington. (Reclamation photograph by R. McAffee, August 10, 2007).

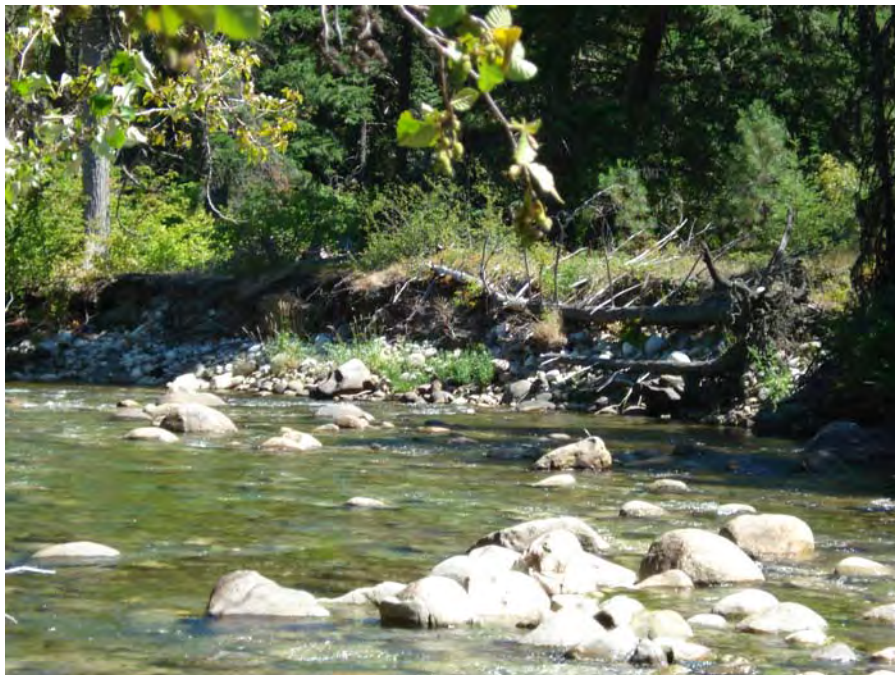
Photograph No. 5. A view to the east showing the right bank which is comprised of finer material over cobbles and boulders. Nason Creek – Wenatchee subbasin, Washington. (Reclamation photograph by R. McAffee, August 10, 2007).
