FINAL REPORT

SMITH-YORLUM #7H PRODUCTION FACILITY  
4554 JIM CRISTAL ROAD  
DENTON, DENTON COUNTY, TEXAS

**Re: Final Report**

**Site: Smith-Yorum #7H Production Facility – 4554 Jim Christal Road, Denton,  
Denton County, Texas 76207**

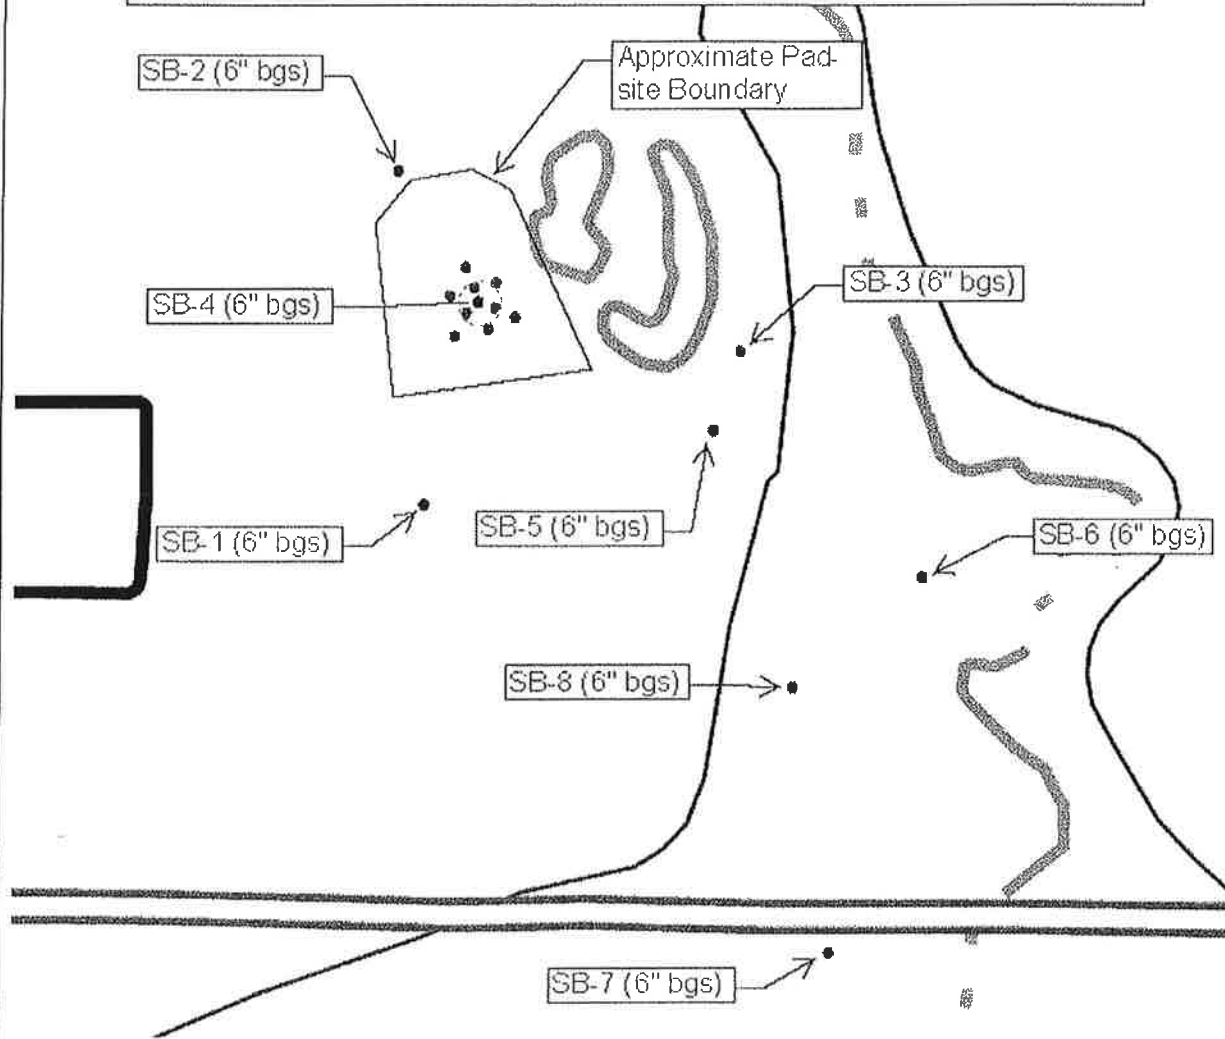
Site Topographic Map with Sample  
Locations  
Smith-Yorlum #7H Production Facility  
4554 Jim Christal Road, Denton, Denton  
County, Texas 76207

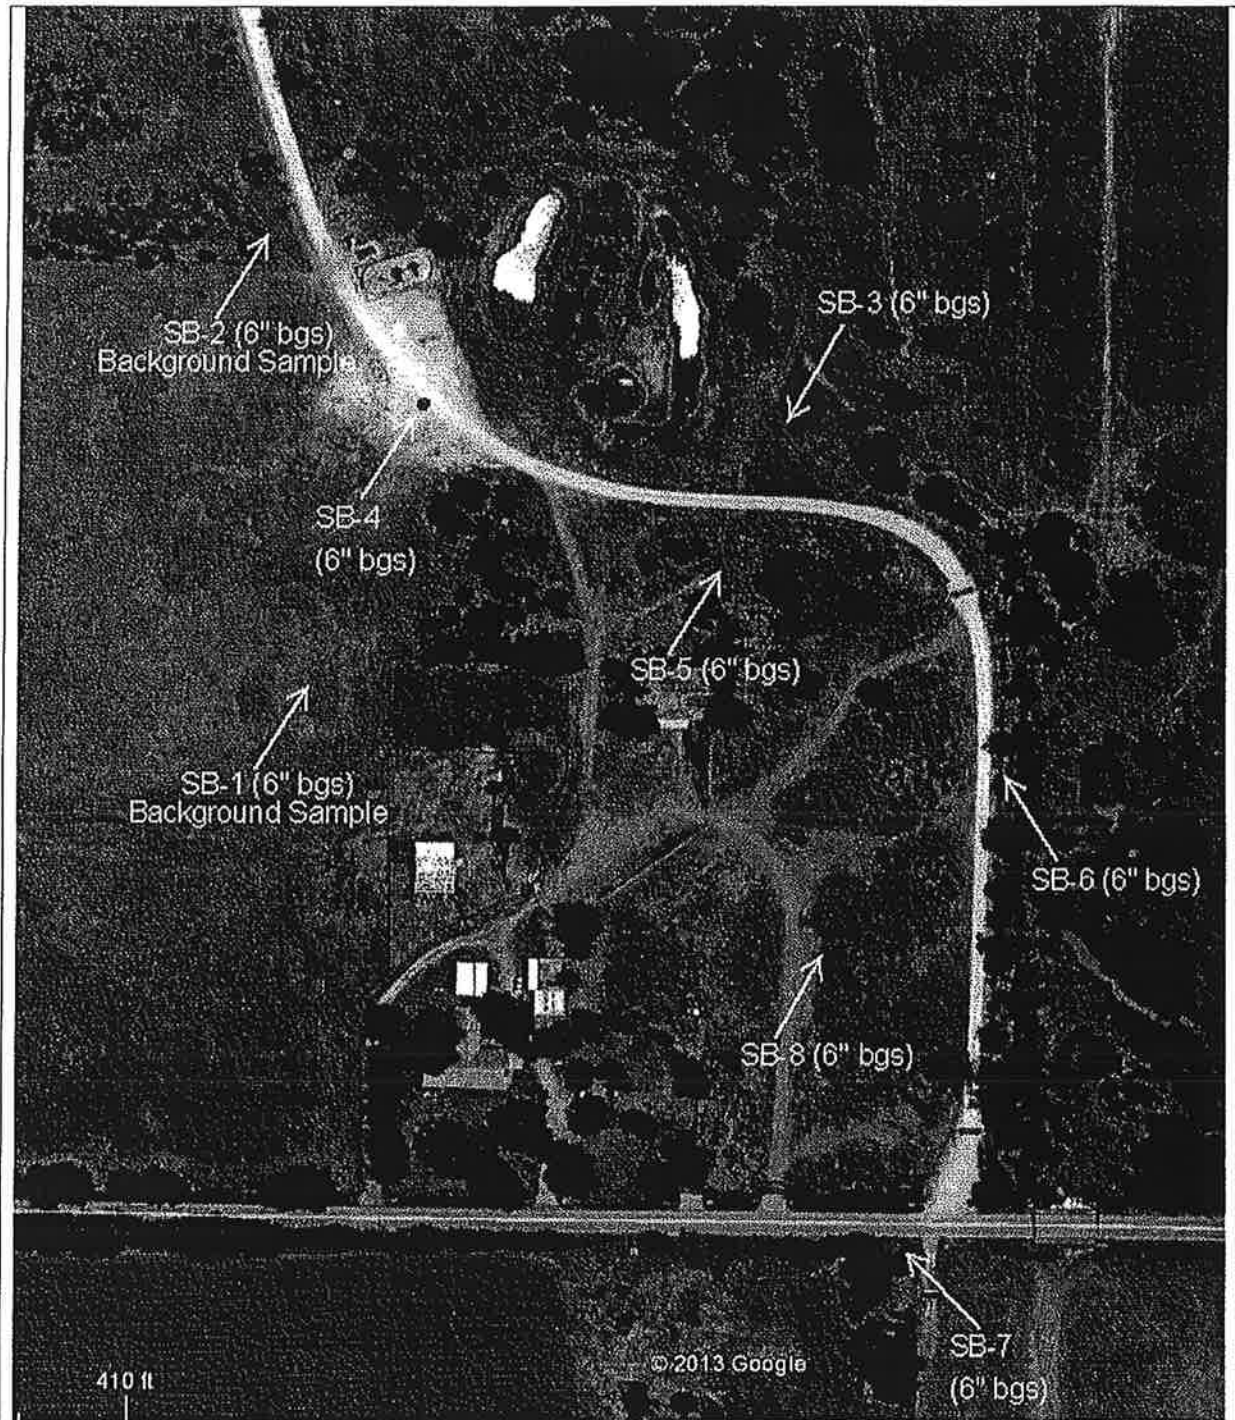
Release Investigation Sample Locations  
Locations of samples collected on  
April 29, 2013  
Smith-Yorum #7H Production Facility  
4554 Jim Christal Road, Denton, Denton  
County, Texas 76207

For the soil samples collected on April 29, 2013, the laboratory analytical results of the background soil samples (SB-1 and SB-2), showed levels of Chloride at 1,390 and 596 mg/kg, respectively. Laboratory analytical results of the soil samples from the release-affected areas indicated that one (1) soil sample (SB-4) exceeded the RRC's action limit for Chloride in soil of 3,000 mg/kg, with a concentration of 3,780 mg/kg. This sample was collected from the pad site.

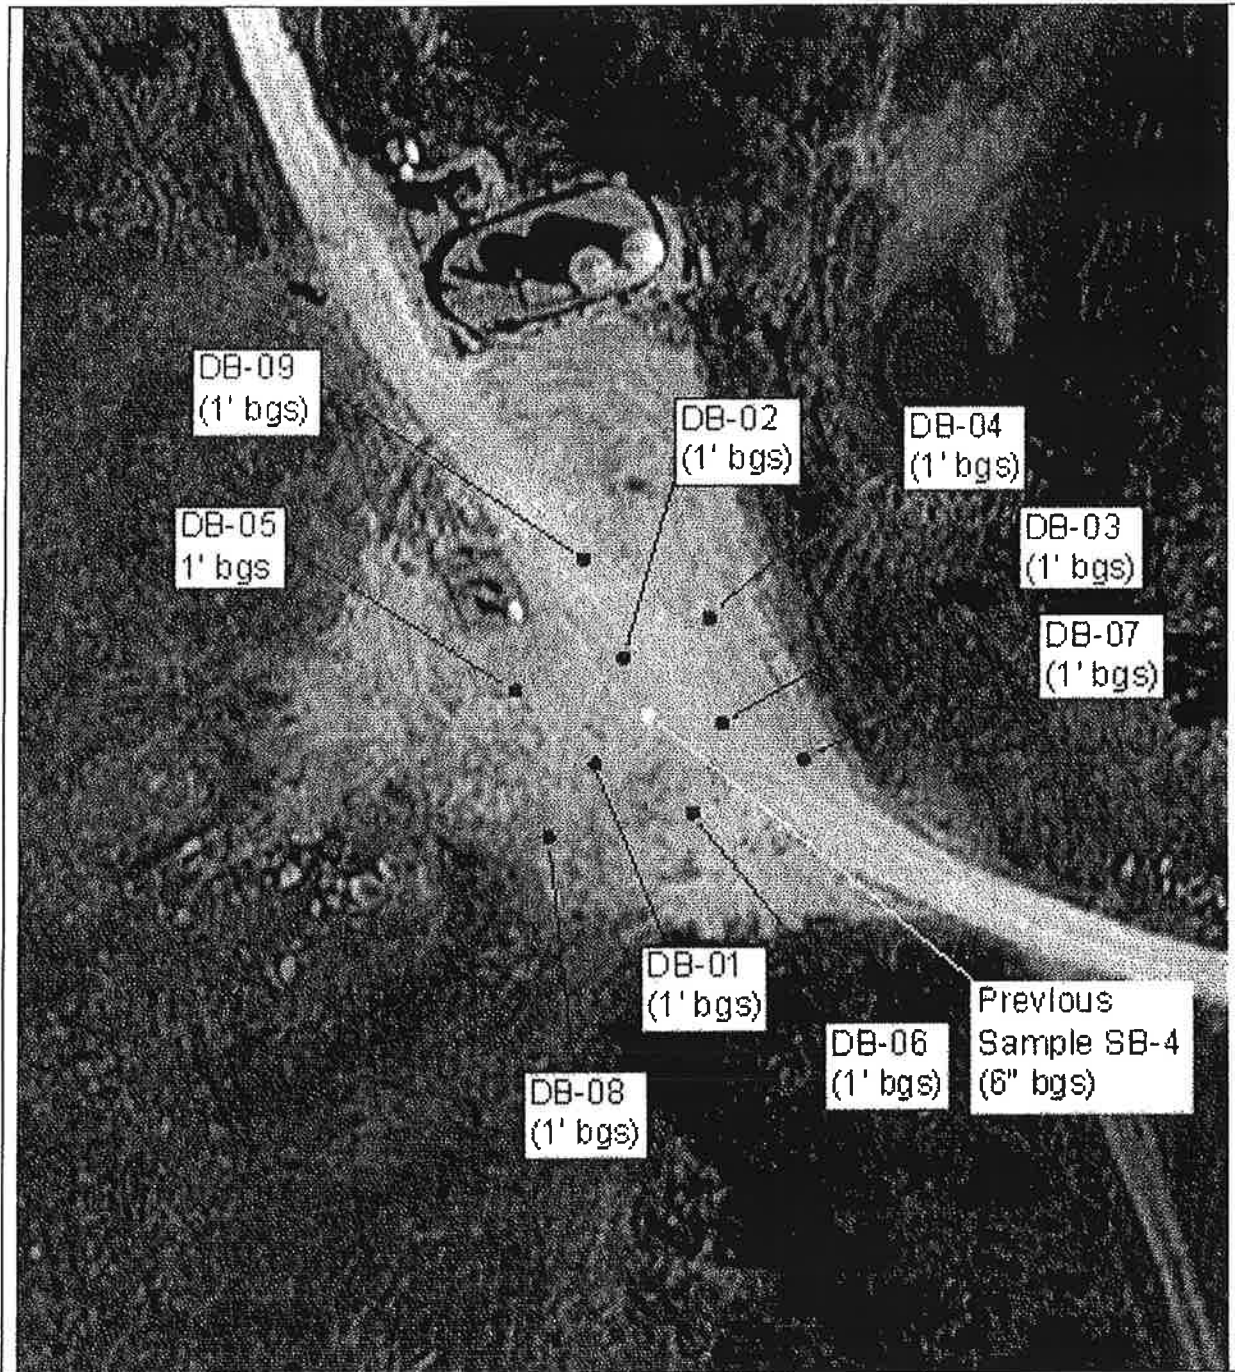
Release Delineation Sample Locations  
 Locations of samples collected on  
 May 20, 2013  
 Smith-Yorum #7H Production Facility  
 4554 Jim Christal Road, Denton, Denton  
 County, Texas 76207

For the soil samples collected on May 20, 2013, the laboratory analytical results of the soil samples from the release-affected area indicated that no samples exceeded the RRC's action limit for Chloride in soil.

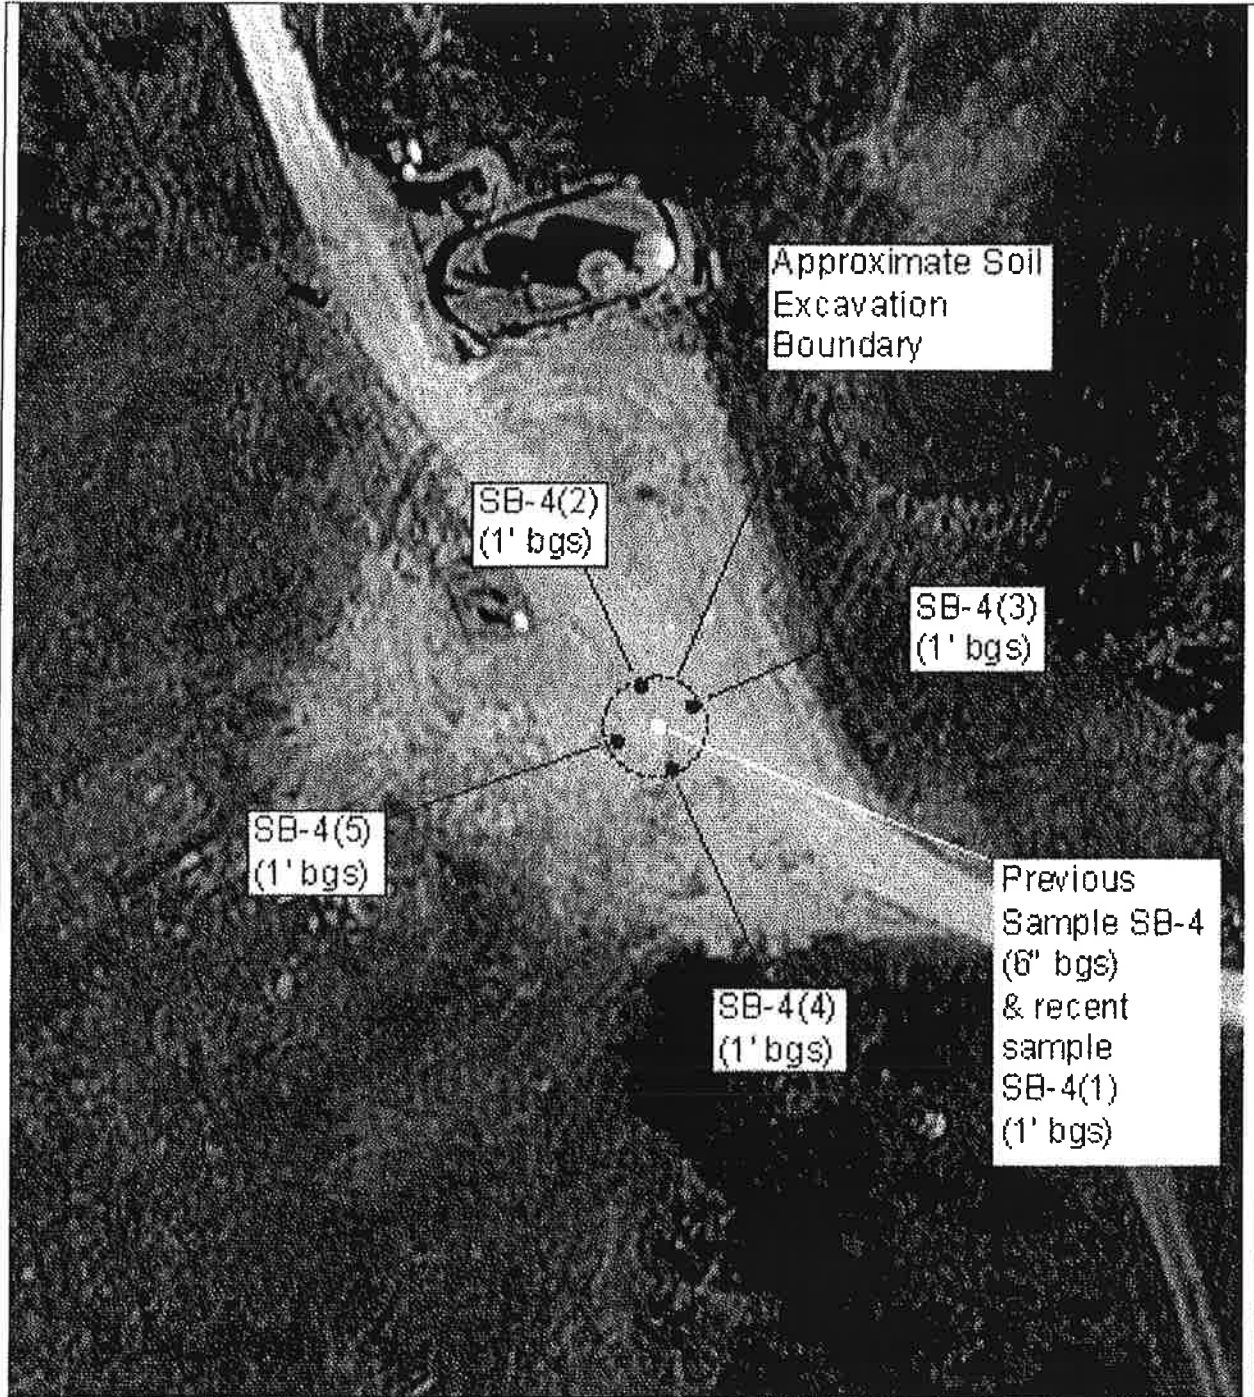
Remediation & Clearance Sample Locations  
Locations of samples collected on June 19, 2013  
Smith-Yorum #7H Production Facility  
4554 Jim Christal Road, Denton, Denton  
County, Texas 76207

For the soil samples collected on June 19, 2013, the laboratory analytical results of soil samples SB-4(1), SB-4(2), SB-4(3), SB-4(4), and SB-4(5), collected from below and surrounding the location of soil sample SB-4, indicated that no samples exceeded the RRC's action limit for Chloride in soil.

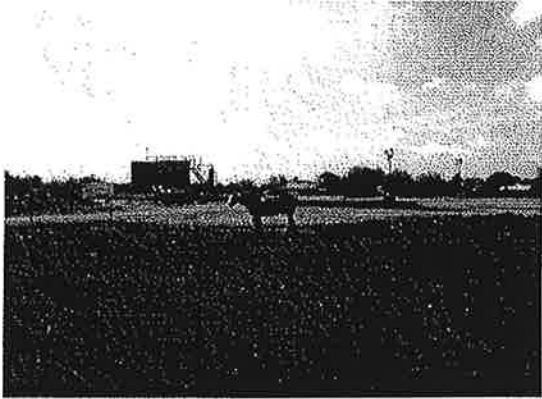
**Photo #1** View of the on-site gas production facility.

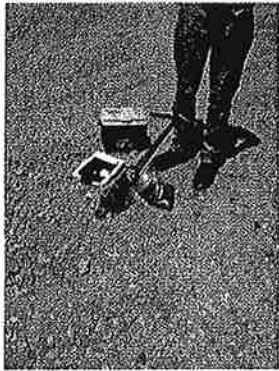
**Photo #3** Location of SB-4.

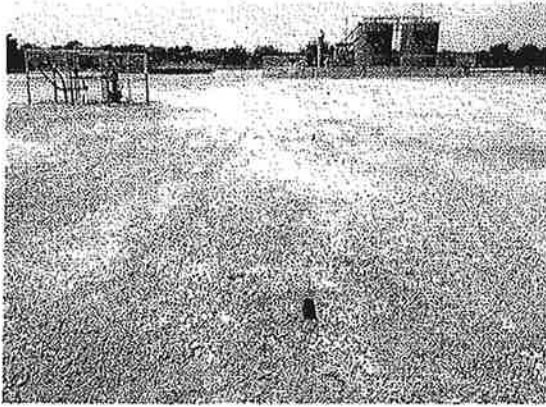
**Photo #1** View of SB-4, DB-02, and DB-09 from bottom to top, respectively.

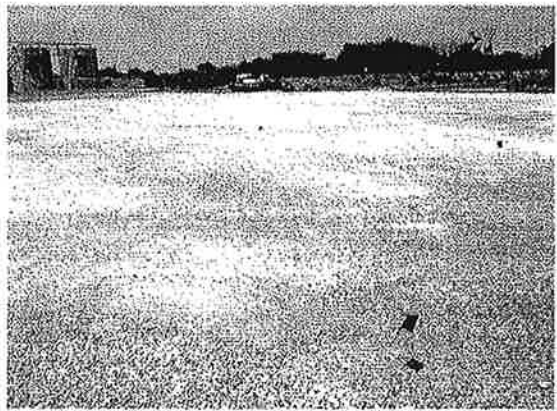
**Photo #4** View of DB-01 (bottom right), SB-4 (top right), DB-02 (top center) and DB-09 (Top left).

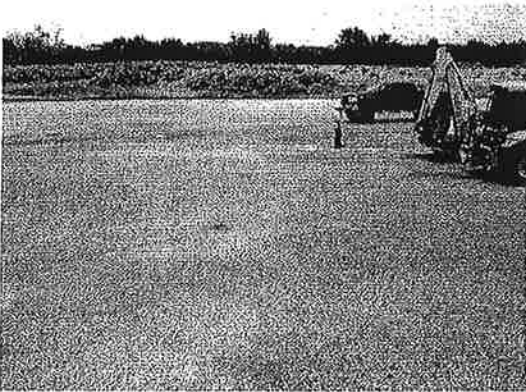
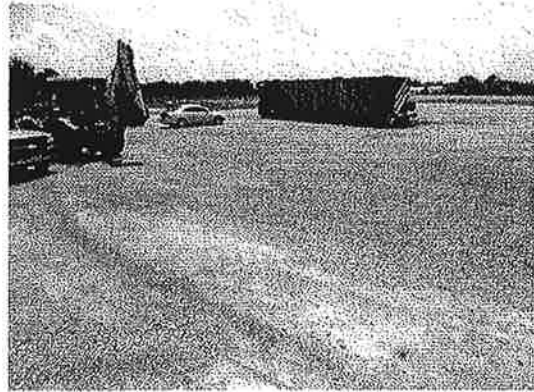
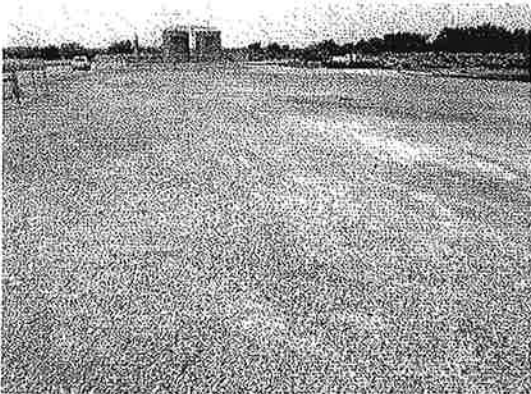
**Photo #1** View of the marked 20-foot diameter area surrounding SB-4, facing east.

**Photo #2** View of the marked 20-foot diameter area surrounding SB-4, facing southwest.

**Photo #3** View of the marked 20-foot diameter area surrounding SB-4, facing north.

On June 19, 2013, KJE provided oversight for the excavation of soil surrounding the location where the previously-mentioned soil sample SB-4 was collected. As agreed upon with the RRC, soil within a 20-foot diameter circle around the location of soil sample SB-4 was excavated by ERO's contractor to a depth of one (1) foot below ground surface (bgs). Following the excavation of soil surrounding soil sample SB-4, KJE collected five (5) clearance soil samples [SB-4(1), SB-4(2), SB-4(3), SB-4(4), and SB-4(5)]. Clearance soil sample SB-4(1) was collected from the floor of the excavated pit. Clearance soil samples SB-4(2), SB-4(3), SB-4(4), and SB-4(5) were collected from the north, east, south, and west walls of the excavated pit, respectively. Following the sample collection activities, MasterVac removed the excavated soil stockpiles from the site via vacuum truck. A total of 81 barrels of excavated soil was transported off-site by Chico Autopark & Services and disposed of at the Polk Operating, LLC Polk R<sup>3</sup> Facility, located at P.O. Box 1271 in Bowie, Texas (See Appendix E for copy of disposal ticket).

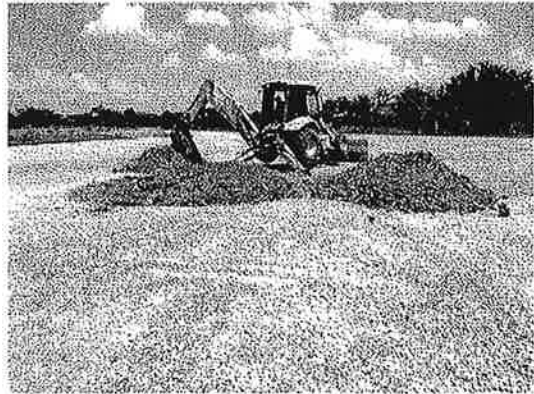
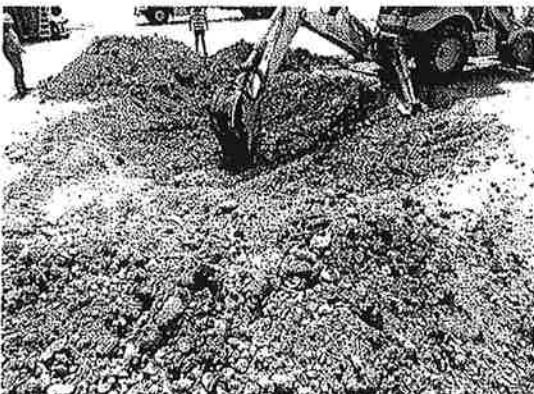
**Photo #4** View of the pit excavation.

**Photo #5** View of the pit excavation.

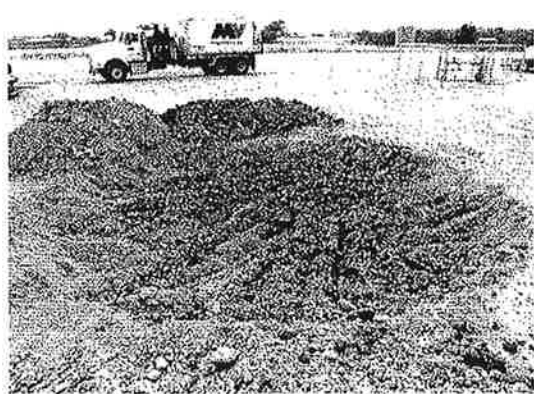
**Photo #6** View of the soil sample locations inside the pit (marked with blue flags).

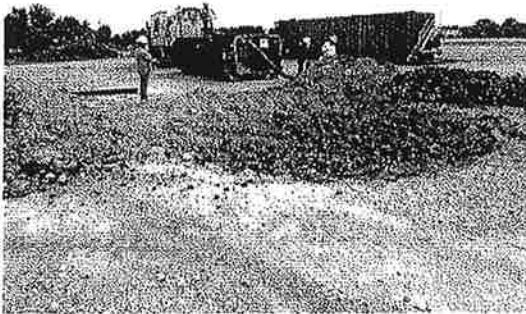
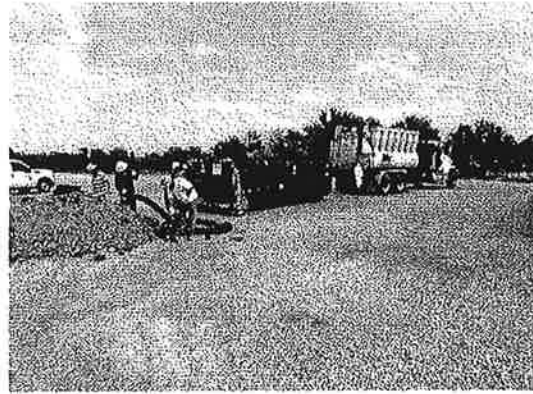
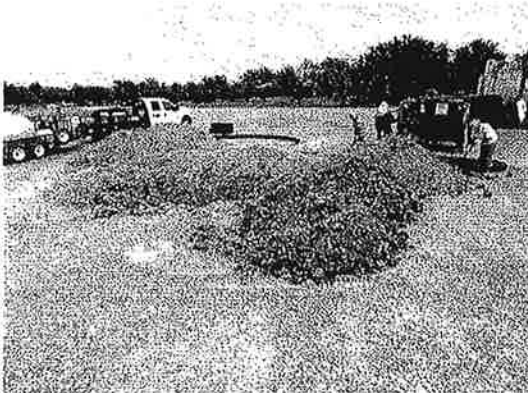
**Photo #7** View of the vacuum truck and associated storage container.

**Photo #8** View of the vacuum truck and associated storage container.

**Photo #9** View of the excavated soil being loaded into the vacuum truck and associated storage container.
