BRIDGING THE IMJIN

CONSTRUCTION OF LIBBY AND TEAL BRIDGES DURING
THE KOREAN WAR (OCTOBER 1952 - JULY 1953)

Studies in Military Engineering
Number 5

OFFICE OF HISTORY
UNITED STATES ARMY CORPS OF ENGINEERS
FORT BELVOIR, VIRGINIA
1989

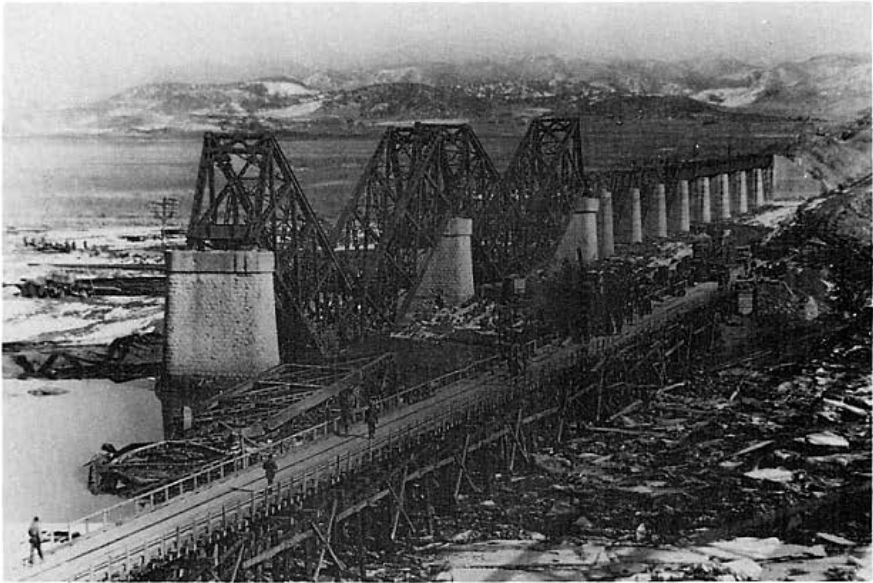
Figure 7. The low-level pile bridge at the Freedom Gate site that the 84th Engineer Construction Battalion erected in January–February 1952 between two destroyed railway spans. The shadow cast by the more southerly of the railway bridges, which the 84th would reopen in July 1952, is visible at the right of this 10 March 1952 photo.

Assigning two companies and devoting over 140,000 man-hours to this project, the battalion made rapid progress and was able to open the bridge on 15 February. (Figure 7) Six days later friendly aircraft mistakenly bombed the bridge and damaged seven bents. The 84th replaced all of the damaged bents except one which stood dangerously close to an unexploded 1,000-pound bomb that could not be removed. That area was spanned by a 36-inch I-beam supported on specially braced bents.²⁰

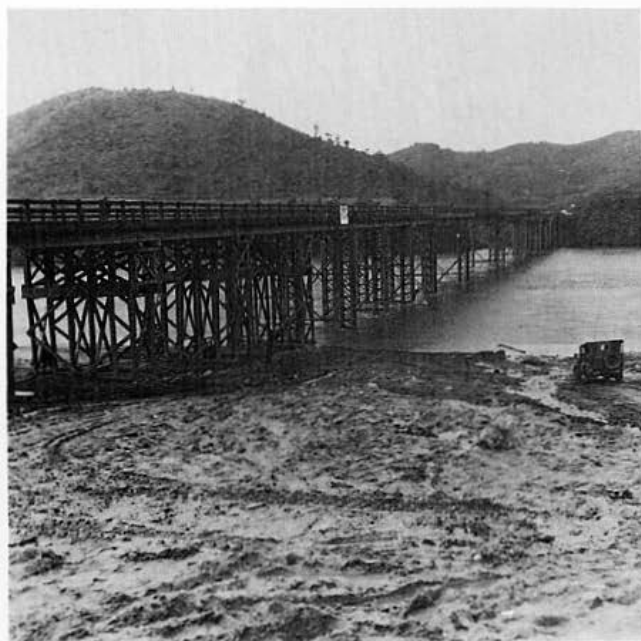
Figure 10. The high-level White-front bridge on 27 July 1952.

As the 62d began work on the new X-Ray and Pintail bridges, the 84th Engineer Construction Battalion began a high-level bridge of similar capacity at the Whitefront site. The bridge was 1,184 feet long and stood 44 feet above low water on 13 timber trestle bents supported by steel piles. (Figure 10) Timber piling was tried, but it would not penetrate adequately even when a pile shoe was used. Company B of the 84th completed the bridge by the end of May, investing 111,000 man-hours in its construction.²⁶

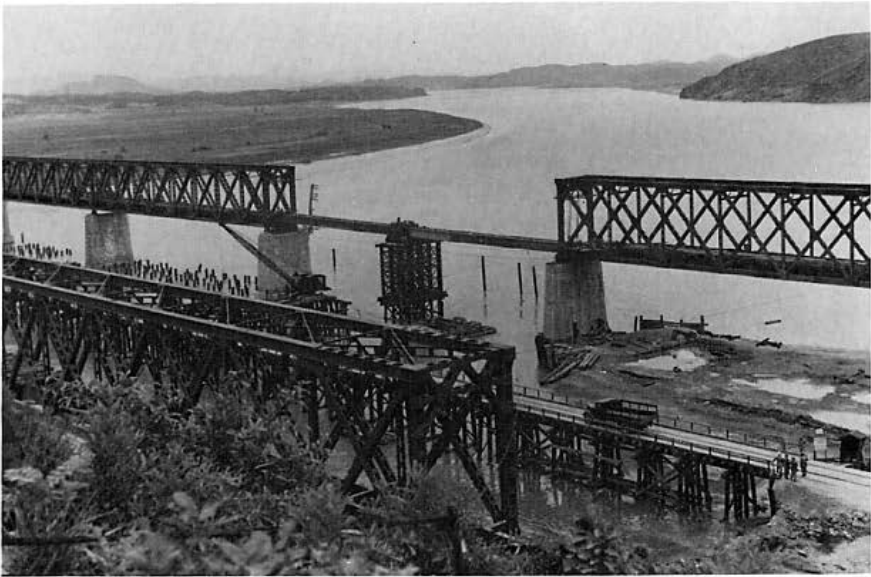
Figure 11. Construction under way to reopen the more southerly railroad bridge at the Freedom Gate site. The low-level pile bridge is visible at the right of this 9 July 1952 photo.

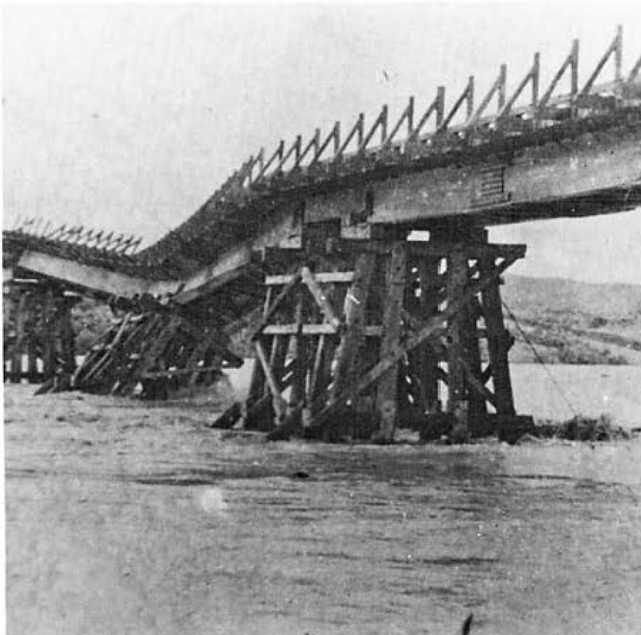
Figure 12. The high-level Teal bridge collapsing under the pressure of floodwater on 30 July 1952.

After a rise of 27 feet at Teal ... two spans failed and were washed out at 1200 hours on 30 July. Failure of the bridge occurred when little debris was present in the channel, none hung on the piers, and when no previous observable displacement of the structure had occurred from the striking of debris. Debris was not a primary or secondary cause of failure within the observation of spectators. Previous pile penetration of ten feet had been reduced to as little as two feet on some piers by scour action. Nine piers were scoured at the base but otherwise still in good condition. Three piers were completely destroyed by the flood. Maximum velocities observed upstream were as great as 15-20 feet per second in the deepest part of the river?

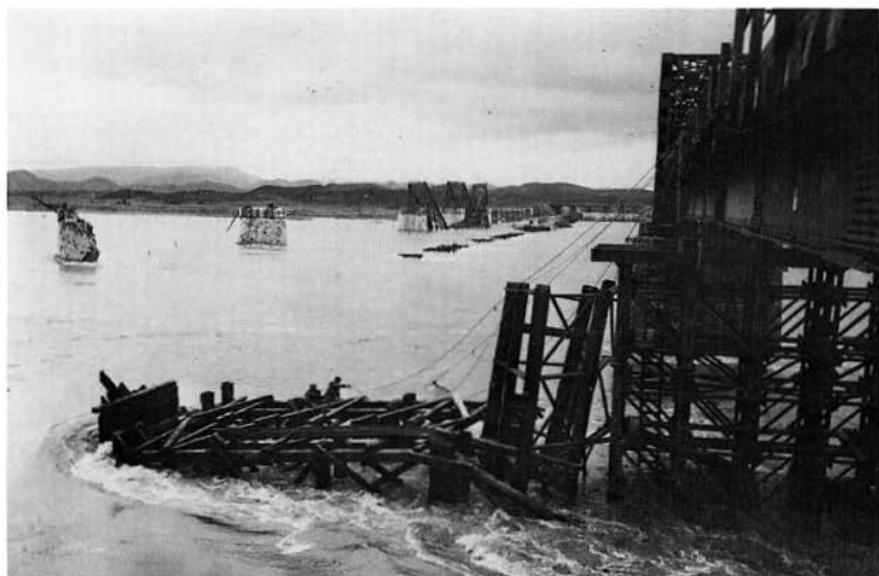
Figure 13. Pier from the collapsed high-level Teal bridge lodged against protective fender piles at the reopened span of the Freedom Gate bridge on 30 July 1952.

Heavy rains at the end of July raised the level of the Imjin by 13 feet on 27 July, causing the new Mallard bridge to collapse and forcing the removal of the Honker floating treadway. The rains continued for the next three days, and by 30 July the Imjin at Pintail had risen 38 feet. At noon that day, after river currents as fast as 15 to 20 feet per second had exposed the base of some of the piles supporting the Teal bridge, two of the bridge's spans washed out. Debris from Teal washed downstream to X-Ray, where it struck a bridge that had already been moved about four feet downstream by the floodwaters. Two piers of the X-Ray bridge failed at 1:30 PM. (*Figure 12*) Debris also lodged against the high-level Freedom Gate bridge near the river's mouth, leading the engineers to close it for four hours on 31 July while they removed the debris with a crane.²⁹ (*Figure 13*)

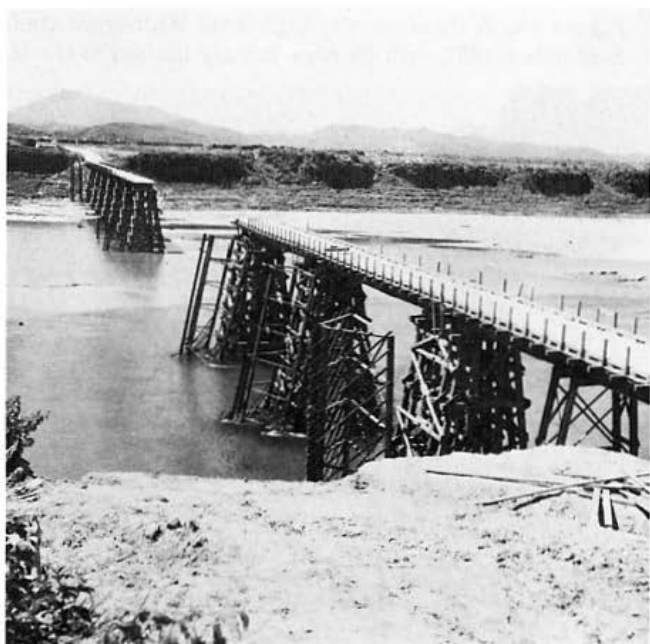
Figure 15. The high-level Teal bridge after the flood of 24-25 August 1952.

An even greater flood roared down the Imjin on 24 and 25 August, fed largely by rains that fell in North Korea. Raising the Imjin 40.5 feet in ten hours at Pintail, these waters destroyed the Widgeon bridge and swept away additional piers of the Teal and X-Ray bridges. (*Figure 15*) This was the year’s last significant flood on the Imjin. At the end of the 1952 flood season, the I Corps engineer observed with some satisfaction that three high-level bridges—at Whitefront, Pintail, and Freedom Gate—had survived the summer unscathed, and each supported a different division across the river. (*Figure 16*) But more than 16 miles separated the Freedom Gate and Pintail bridges, and this stretch of open river could have threatened the U.N. forces if the enemy had launched a serious offensive in August 1952.³¹

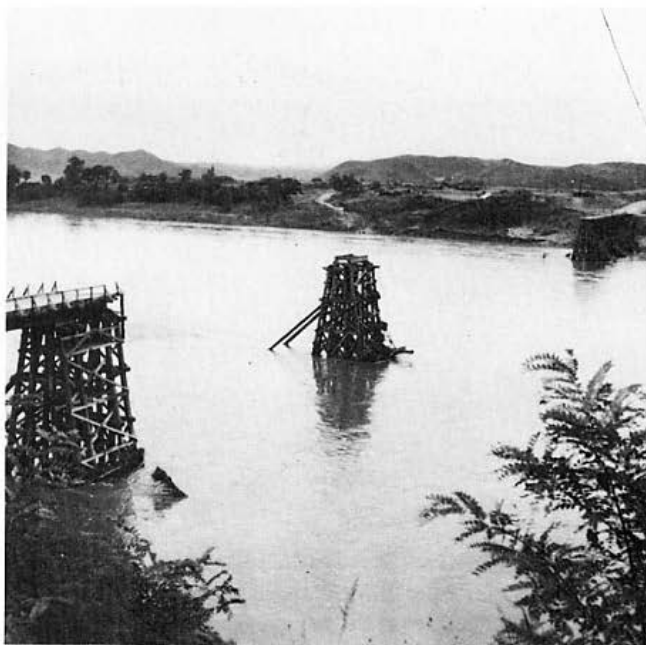
Figure 16. A survivor: the high-level Whitefront timber-pile bridge in September 1952 with damage largely limited to the fender piles.

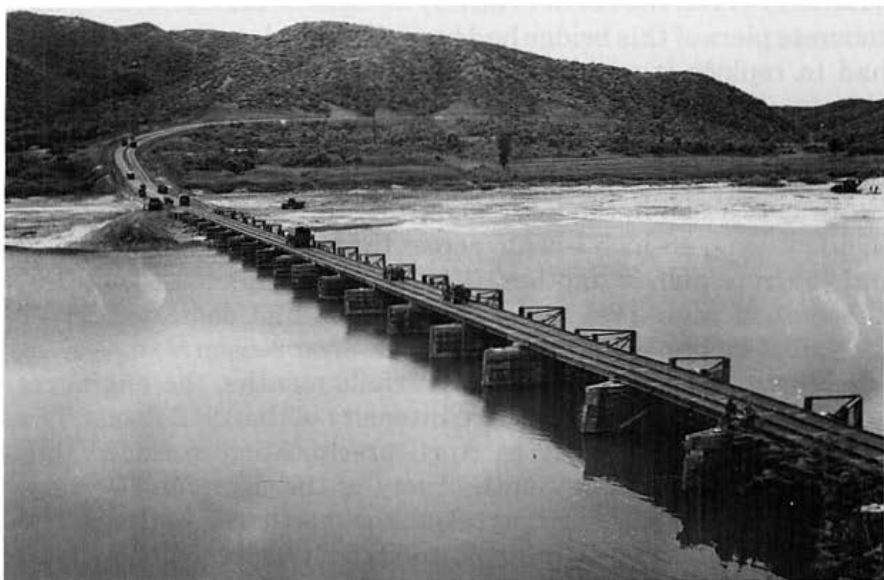
Figure 17. Spoonbill bridge on 20 June 1953.

The need for bridges in that reach of the Imjin led I Corps to install new floating treadway bridges at the X-Ray and Teal sites in September and to build a rock-crib pier bridge at the naturally defiladed Spoonbill site three miles south of the X-Ray crossing. (*Figure 17*) With its piers strengthened by piles made from railway rails, the Spoonbill bridge opened to traffic on 30 October.³² But these bridges too would be temporary, and the need to construct permanent bridges to replace the two high-level crossings that had been destroyed by the summer floods of 1952 remained. Eighth Army’s 84th Engineer Construction Battalion undertook the job, constructing a submersible, low-level bridge at the Teal site and the high-level, steel and concrete Libby bridge at the X-Ray site. Standing 49 feet above mean low water, the Libby bridge remains in use today. (*Figure 18*) The Teal bridge provided eight years of useful service before it was removed in late 1961. It was replaced the following spring by a new low-level bridge made of reinforced concrete. These superb wartime bridges were responses to a river-crossing problem that had faced the American

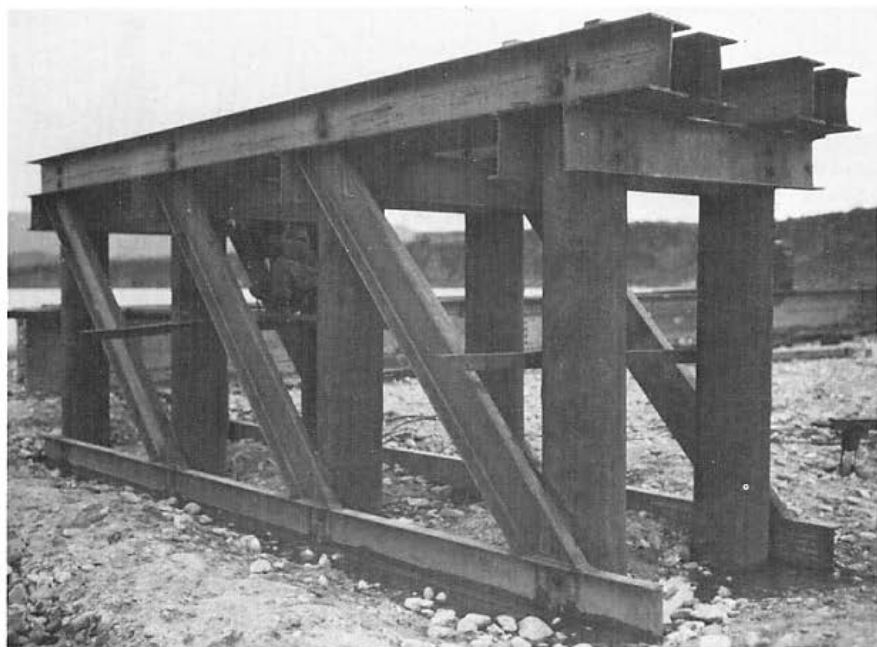
Figure 22. A nearly completed pier featuring diagonal channel-iron bracing.

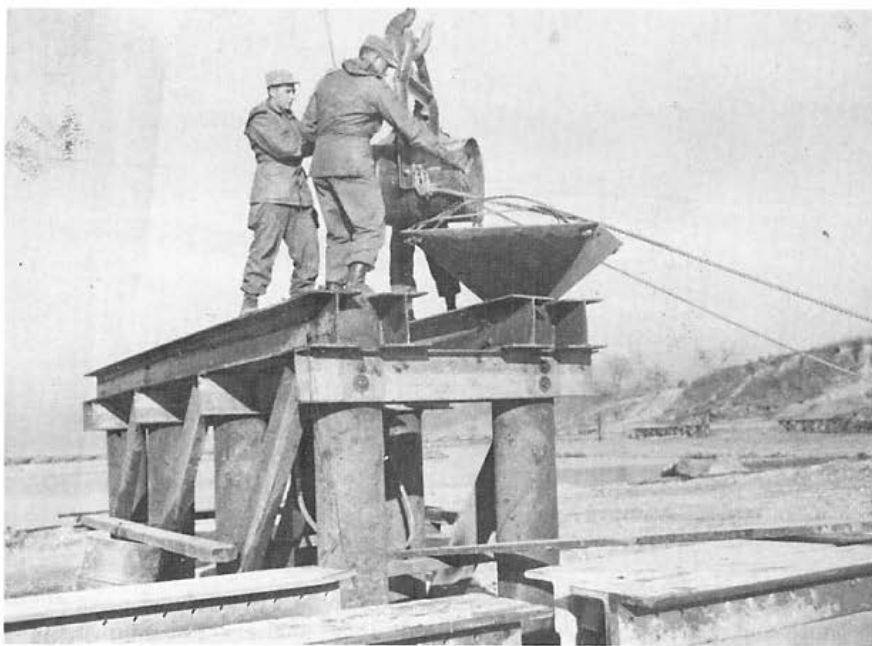
Figure 24. Troops filling the hollow Armco piles with concrete, with 36-inch I-beam girders in the foreground.

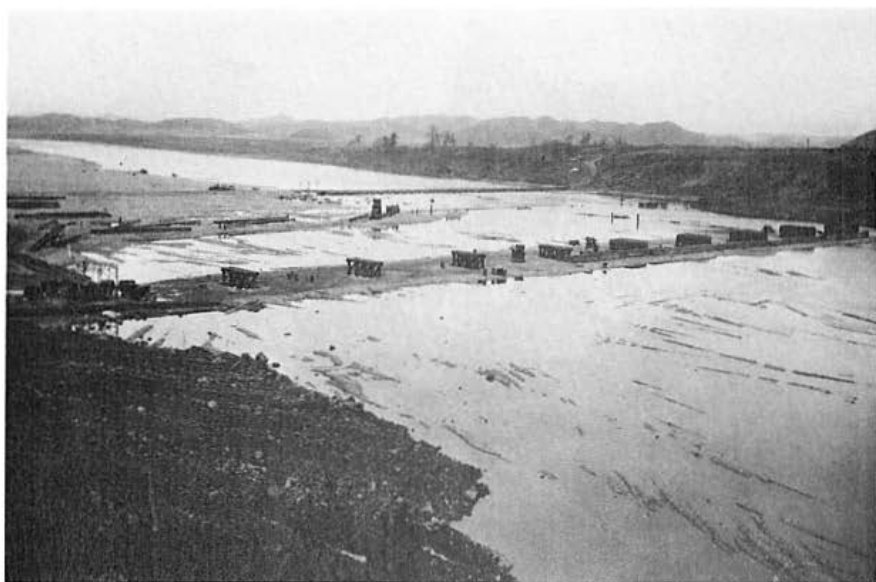
Figure 26. Teal site on 26 November 1952 showing completed piers at south end of bridge, left, and others still under shelters. I-beam girders and the Imjin River flowing north of the causeway are visible at right.

On 20 November the welding on pier 11 was completed, and concrete was poured into the piles. (*Figures 24 and 25*) The canvas shelters were put to a new use at this time, as it was necessary to provide heat to keep the concrete in the piles from freezing before it cured. (*Figure 26*) A shelter was set up around the pier, and a hot-air blower maintained a suitable temperature, about 60°, until the concrete was cured.⁸

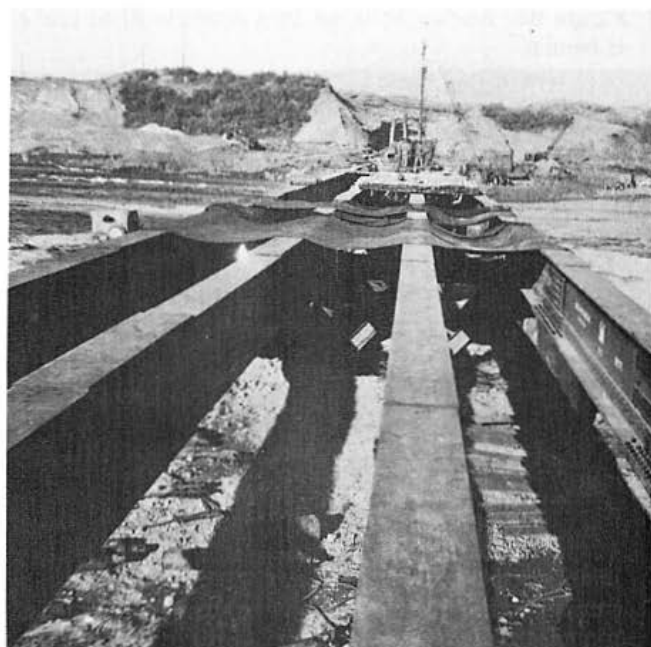
Figure 27. Thirty-six-inch I-beams in place on bridge with a pile driver, in background, working on one of the northernmost piers.

On 29 November, when the tops of the piles were sealed with asphalt and the bearing plates set in place, the first girders were lifted into place in span 11 with cranes. The I-beams used as girders were of three different types: ten spans were made up of four 36-inch, rolled-steel I-beams; six spans were of four 36-inch, built-up (bolted splices) steel I-beams; and the remaining span, from pier 16 to the north abutment, was made up of six 24-inch, rolled-steel beams. (*Figures 27, 28, and 29*) The first two types were salvaged from the old Teal bridge.

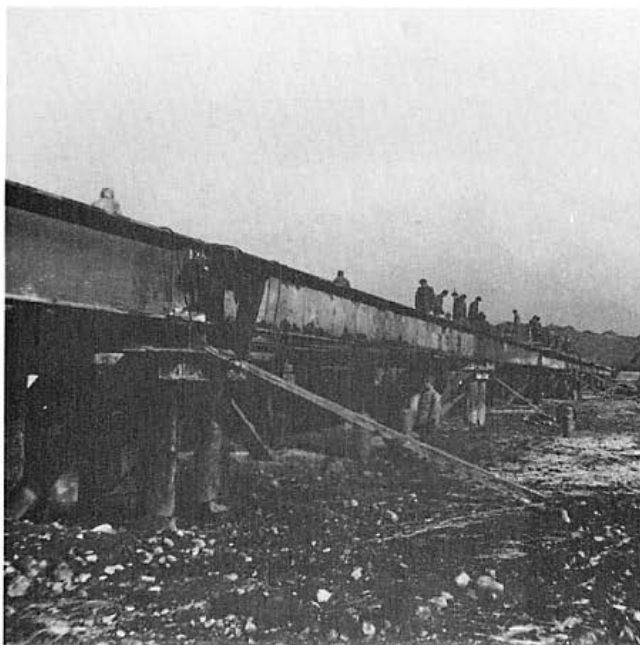
Figure 29. Troops placing decking from pier 16 to the north abutment. This was the only span which used six 24-inch girders. Note angle-iron diaphragming between girders. Visible at center is two-inch by six-inch laminated sub-decking and beyond that is three-inch by twelve-inch diagonal decking.

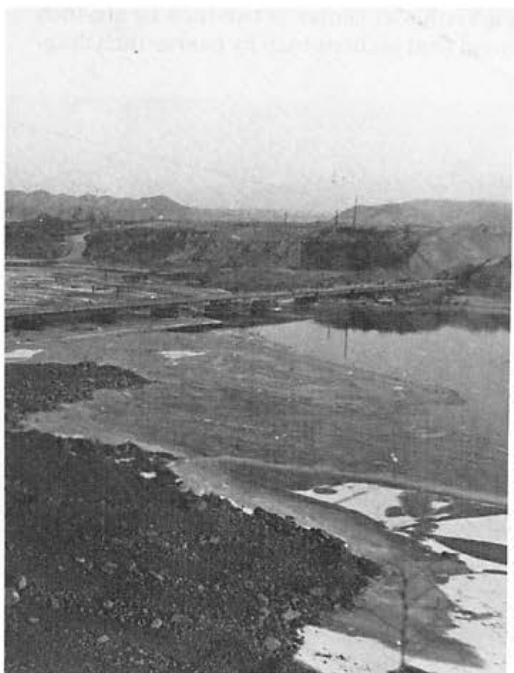
Figure 31. Teal bridge from the south shore on 7 January 1953 as troops place decking on the north end.

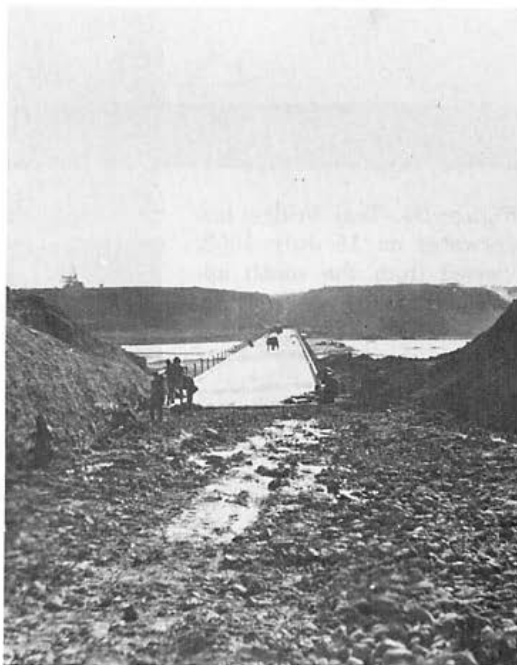
Figure 33. Army vehicles crossing the completed Teal low-level bridge at the end of January 1953.

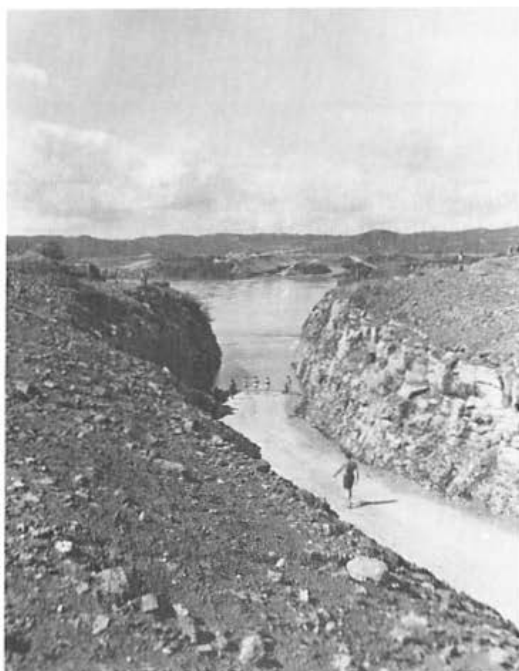
Figure 35. The Imjin River flowing 12 feet over the Teal bridge on 15 July 1953.

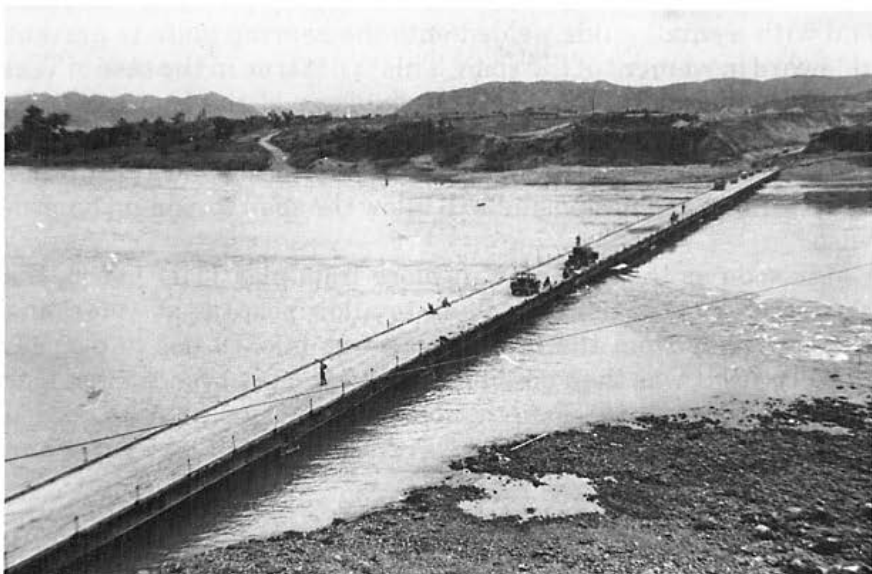
Figure 37. Teal bridge after the flood of 15 July 1953 showing the damage to the removable guardrail, which was not removed due to the rapid rise of the river.

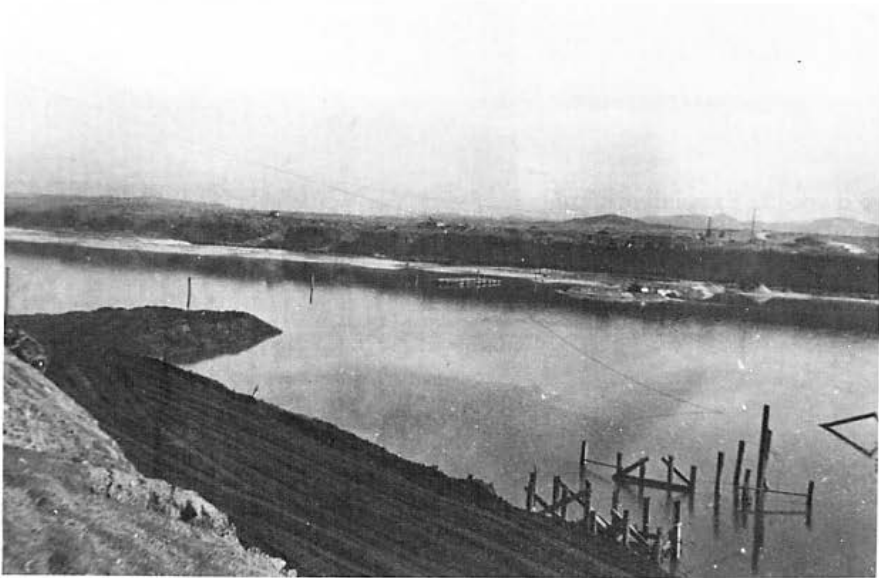
Figure 38. The Imjin River at the X-Ray site, showing early progress on the construction causeway and test piles driven in November 1952 to determine the depth of bedrock.

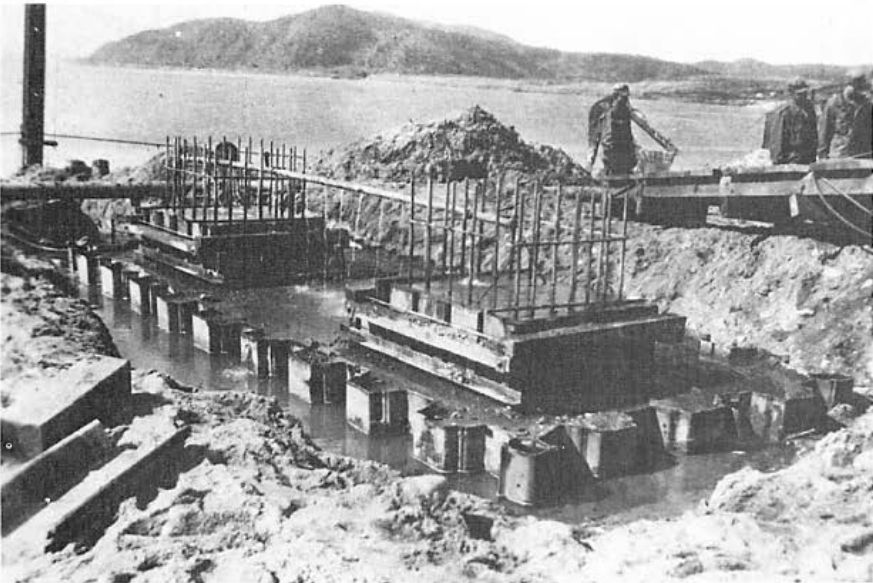
Figure 42. Interior view of a cofferdam showing 12-inch H-beams, or whalers, which enabled it to withstand outside pressure. Buckling of the H-beam is visible at the upper left.

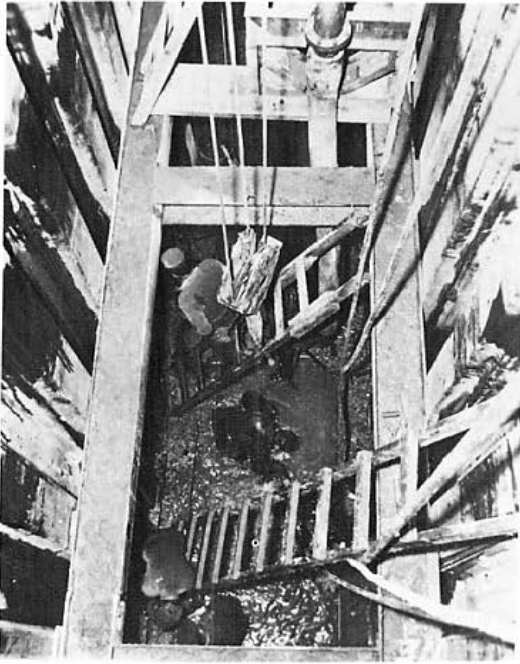
Figure 43. The central concrete batch plant, which furnished hot aggregates or warm concrete from its location on the Imjin's west bank. The plant's two 60-ton bins fed coarse and fine aggregate to the 80- to 150-ton-per-hour dryer that discharged into bins inside the plant.

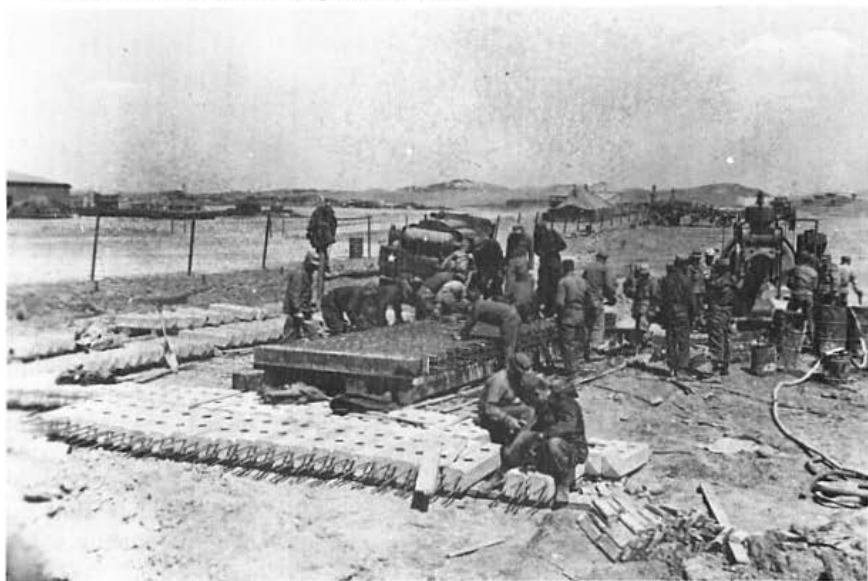
Figure 50. Full-scale model of a section of decking that was built in the work yard for practice and testing purposes.

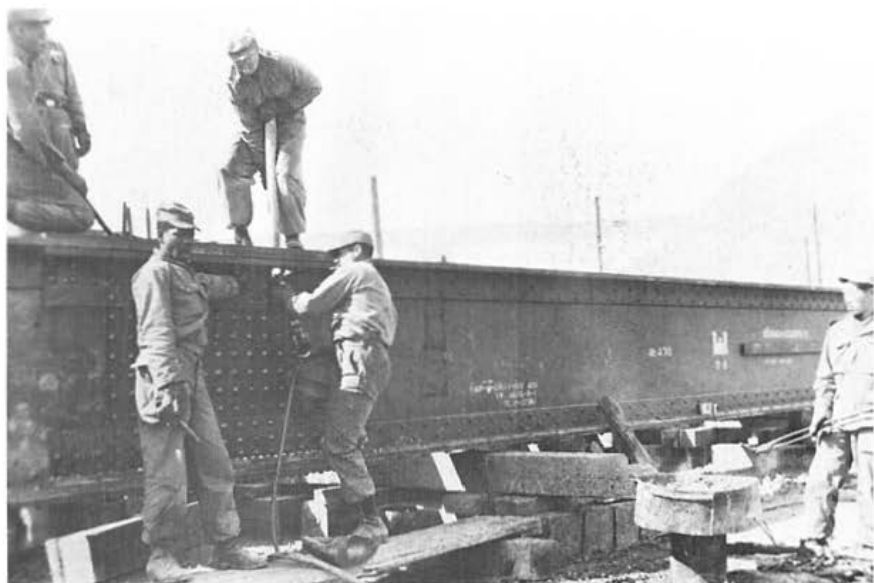
Figure 51. Riveters at work on steel beams. Newly trained American and Korean riveters developed their skills so quickly that a 121-foot span was launched with a deflection of only 17 inches.

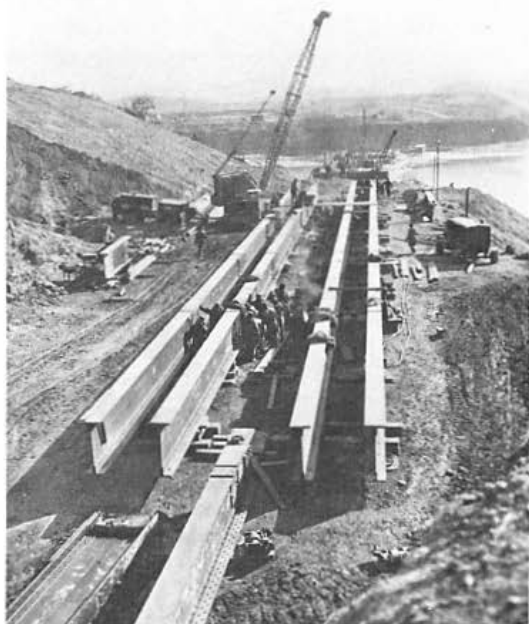
Figure 53. Steel beams in place from the west abutment across pier 8 to pier 7. The 30-foot launching nose may be seen beyond pier 7.

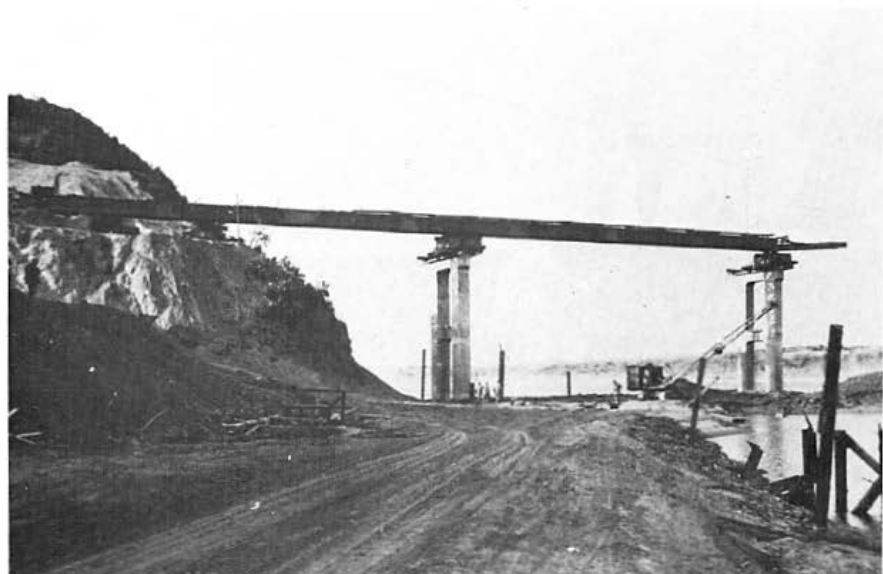
Figure 54. Launching the span across piers 7, 6, and 5. Launching noses extend both east and west into the gap between piers 5 and 6.

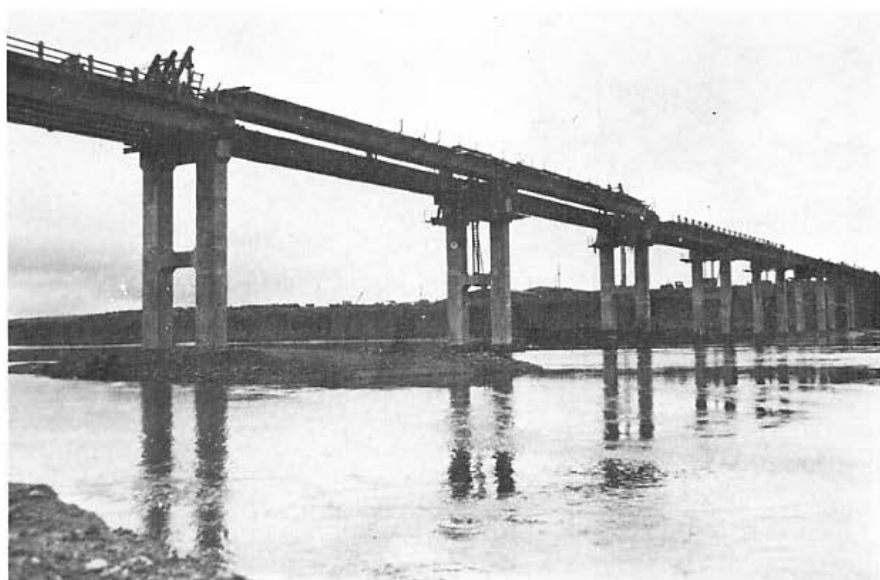
Figure 56. Close-up view of chain hoist lowering downstream girder across piers 7, 6, and 5. This girder was lowered in 22 hours, a much shorter period than the eight days required to lower the corresponding girder from the west abutment to pier 7 with jacks.

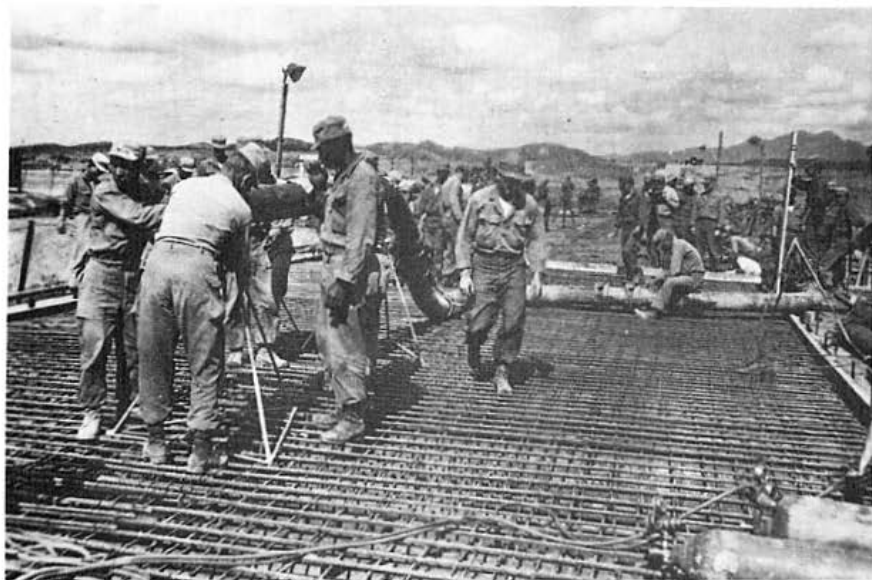
Figure 58. A burlap drag being used to give the deck surface the desired rough texture perpendicular to traffic. Reinforcing steel for curbing is visible.

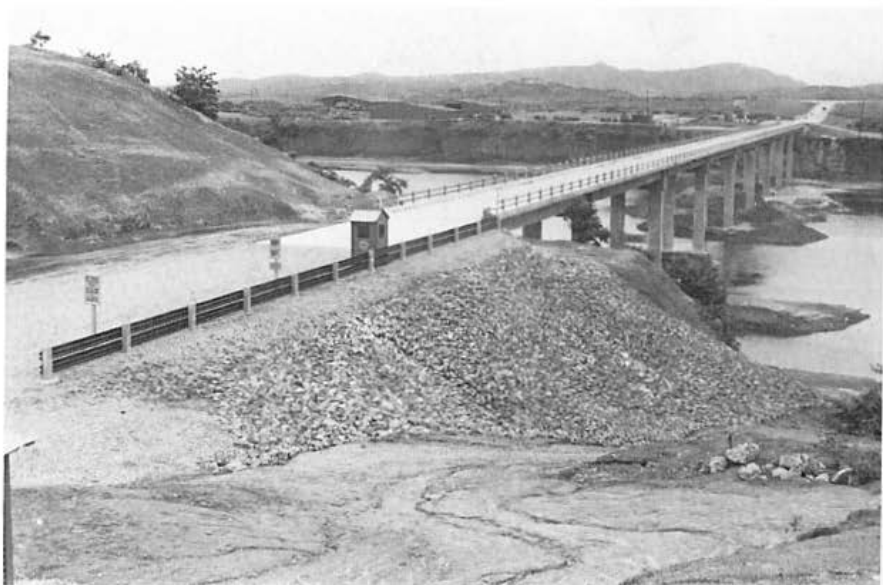
Figure 60. Completed Libby bridge from the west bank on 4 July 1953.

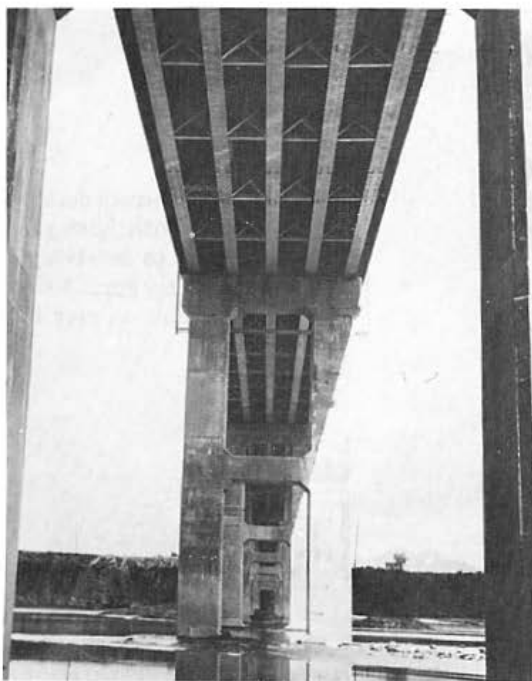
Figure 62. Libby bridge withstanding the flood of 15 July 1953 with more than 20 feet of clearance.

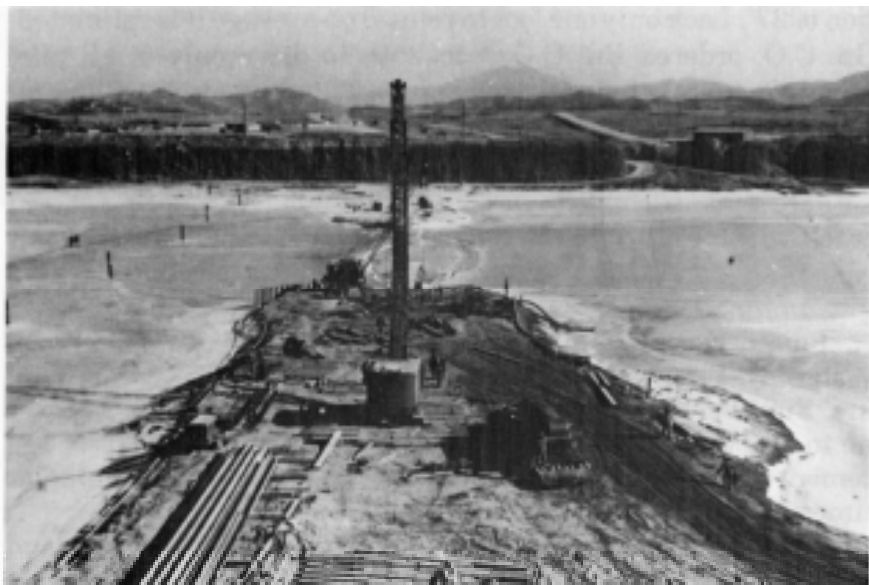
Figure 65. Excavation of cofferdam 6, begun by a $3\frac{1}{4}$ -yard clam bucket on 16 January 1953. Shower unit at lower left provided hot water for cement. Twelve inches of ice on the Imjin provided access to the far shore on foot.

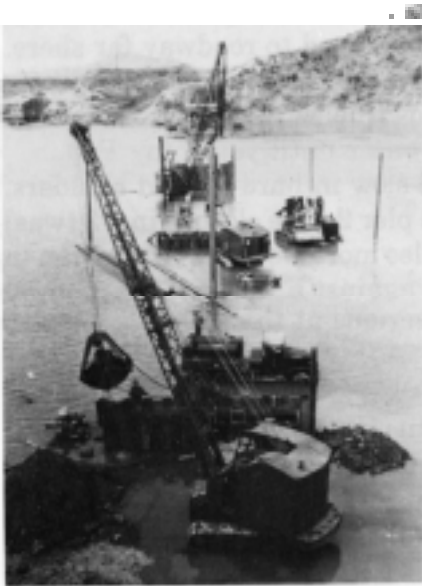
Figure 66. Work continuing on piers 1, 2, and 3 from submerged east causeway during high tide on 17 March 1953.

Fair weather for a change with temperature above freezing all day. High tide at 1030 hrs. rose to elev. 15.2 MSL. (Figure 66) Highest tide of spring expected tomorrow morning. Tide flooded both causeways and badly eroded near shore. Timing of tide hinders hauling in sand for concrete and repairs as tide covers sand bar.

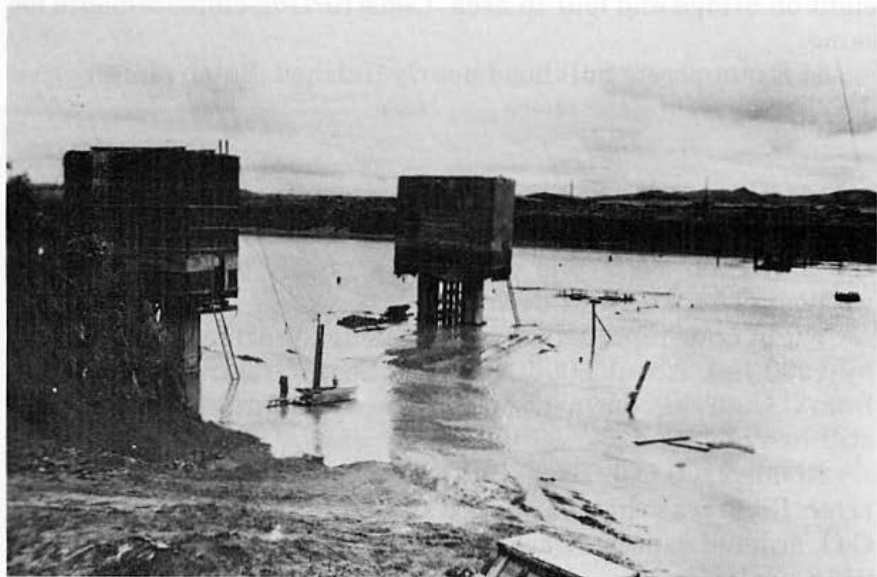
Figure 67. Storm water and a spring high tide combined to force an evacuation of the causeway on 20 March 1953. Piers 7 and 8 are in the foreground.

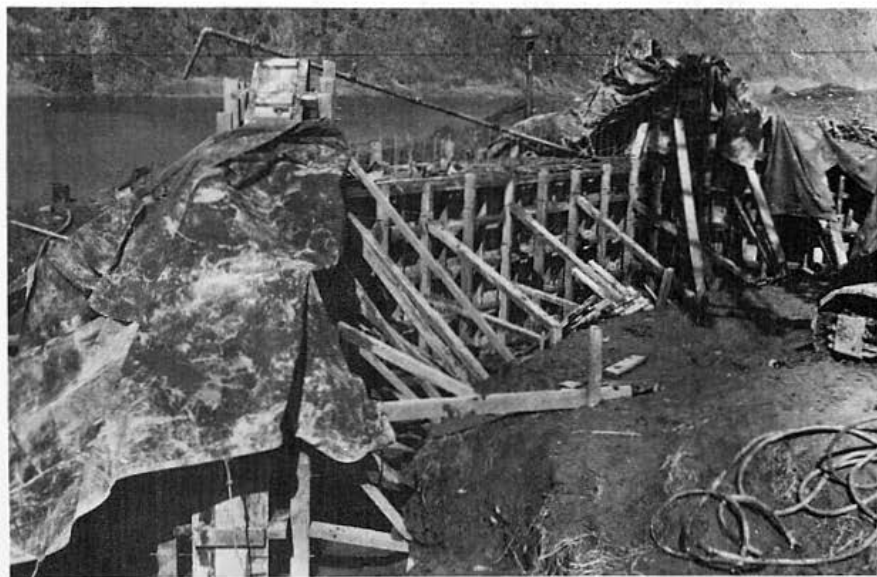
Figure 68. East abutment, completed on 25 March 1953, prior to stripping of forms.

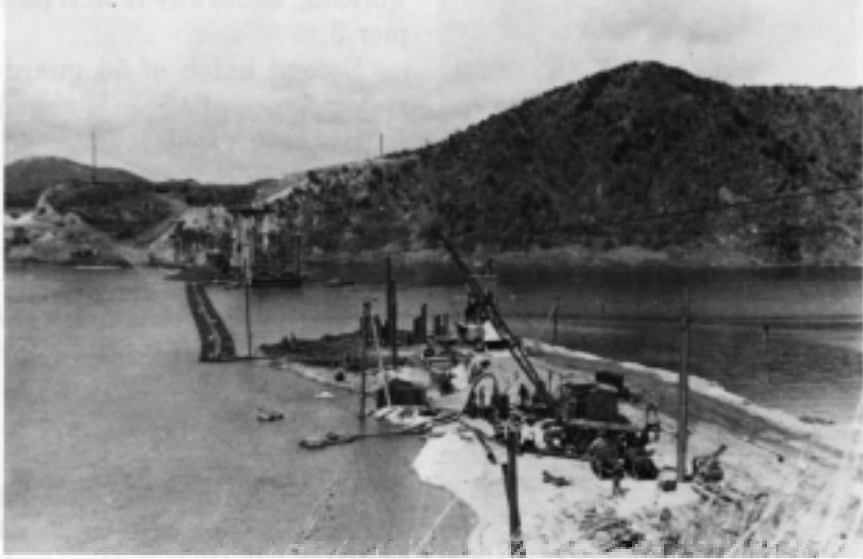
Figure 70. View of the footbridge that enabled the pumpcrete machine to pump concrete from its location near pier 3, at center, to pier 6 across the river channel.

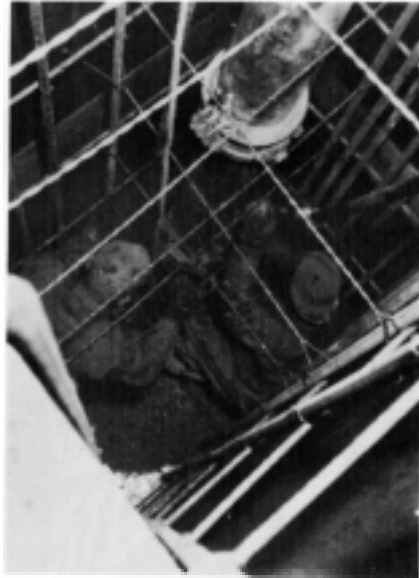
Figure 72. Inside pier 2 during D pour showing the pumpcrete pipe at top and the base for the pneumatic vibrator, used to assure proper placement of cement, at right.

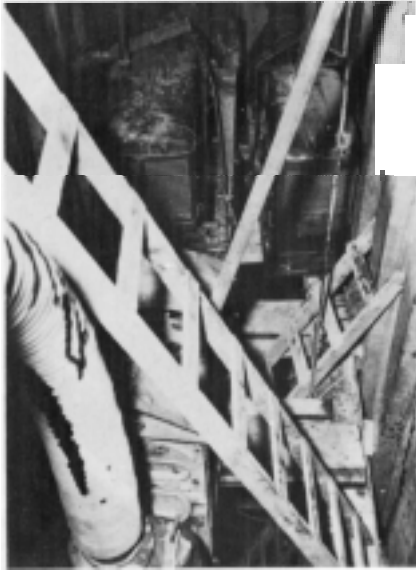
Figure 73. The 4,100-gallon-per-minute pump used to dewater cofferdam 4 so that the lower whaler could be installed.

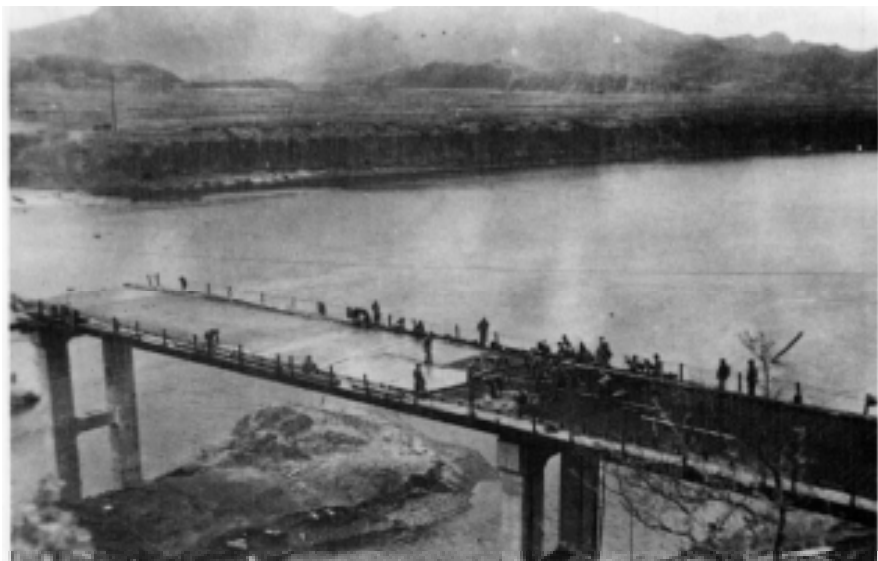
Figure 75. Troops laying the concrete deck. Two steel mats reinforced the concrete to provide an "antiartillery" safety factor beyond the necessary load-carrying strength. The concrete placing was monolithic and continuous.

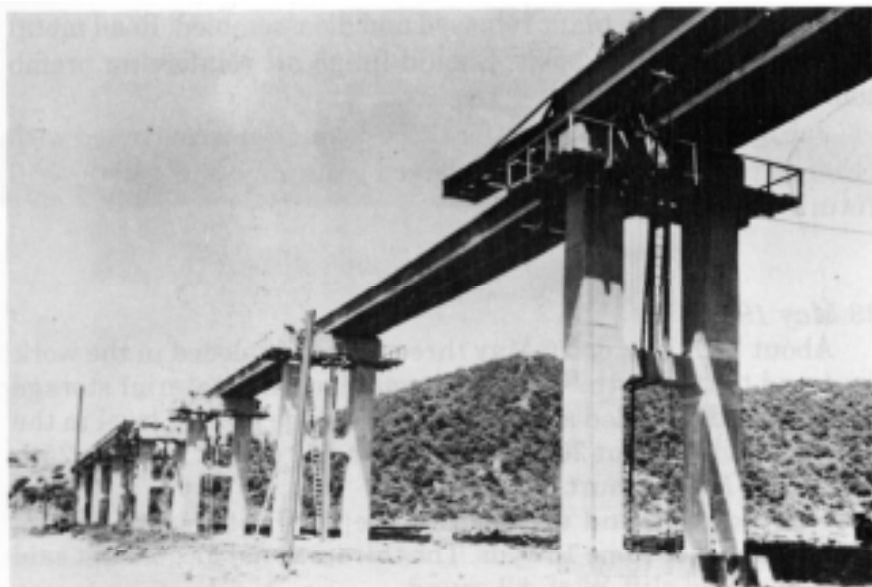
Figure 77. View showing portions of the 606-foot girders that were launched from the east abutment to pier 5. These were the longest girders used on the bridge.
