# Cobbs Creek Fish Passage

## Project - Appendices

PNDI Project Review  
Cobbs Creek/Woodland Dam  
Fish Passage Restoration Project  
City and County of Philadelphia, PA

PHILADELPHIA COUNTY, PENNSYLVANIA  
CORBS CREEK FISH  
PASSAGE - WOODLAND DAM REMOVAL  
GENERAL INFORMATION SHEET

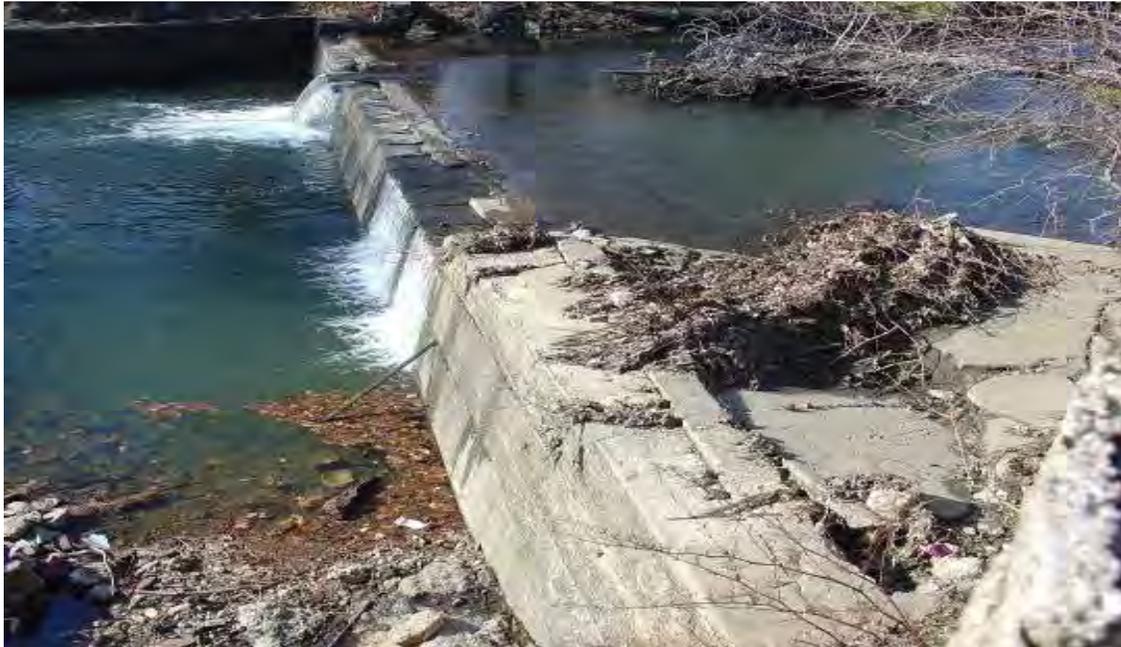
Figure 1-2. Woodland Dam shown from the north bank adjacent to the Blue Bell Inn. Photo taken by Mark Eberle, April 22, 2009.

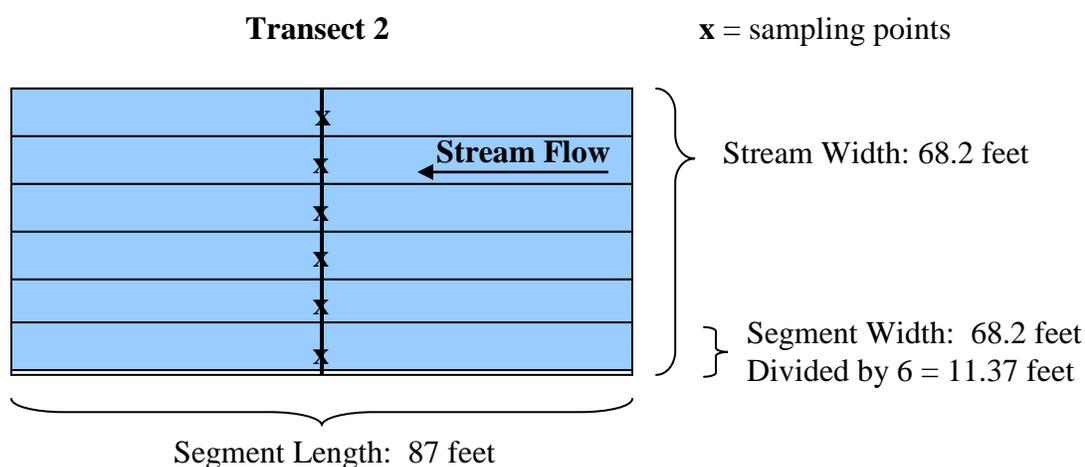
Figure 2-1. Example transect of Cobbs Creek divided into 6 polygons for extrapolating sediment depth measurements. At this location, the stream was 68.2 feet wide. Thus, each polygon at this segment was 11.37 feet wide and 87 feet long.

Among the six points across six transects upstream of the dam, a total of 36 sediment depth measurements were recorded. These 36 depth measurements were assumed to be representative of depths of sediment in 36 polygons upstream of the dam. For Transects 2 through 6, the polygons were rectangular in shape, each 87 feet long, with polygon width varying based on the width of the stream at that transect (Figure 2-1).

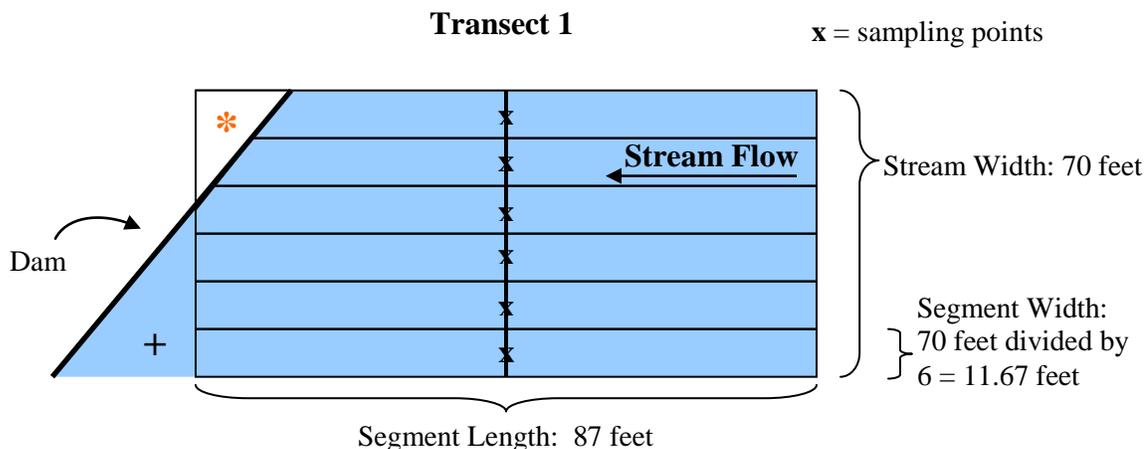
Figure 2-2. Transect 1 polygon configuration at Cobbs Creek. At this location, the stream was 70 feet wide. Area indicated by the red asterisk (\*) was subtracted from the polygon area estimates, while area indicated by the black plus sign (+) was added to the polygon area estimates.

Due to its proximity to the dam (which was set at an angle across the stream), polygon area and sediment volume estimates for Transect 1 required additional computation. Area indicated by the red asterisk (\*) (which was downstream of the dam and therefore not in the sampling area) was subtracted from the polygon area estimates (Figure 2-2). Area indicated by the black plus sign (+) (which was upstream of the dam and could be contributing sediment) was added to the polygon area estimates. Table 2-2 presents the calculated areas for the polygons in Transect 1.

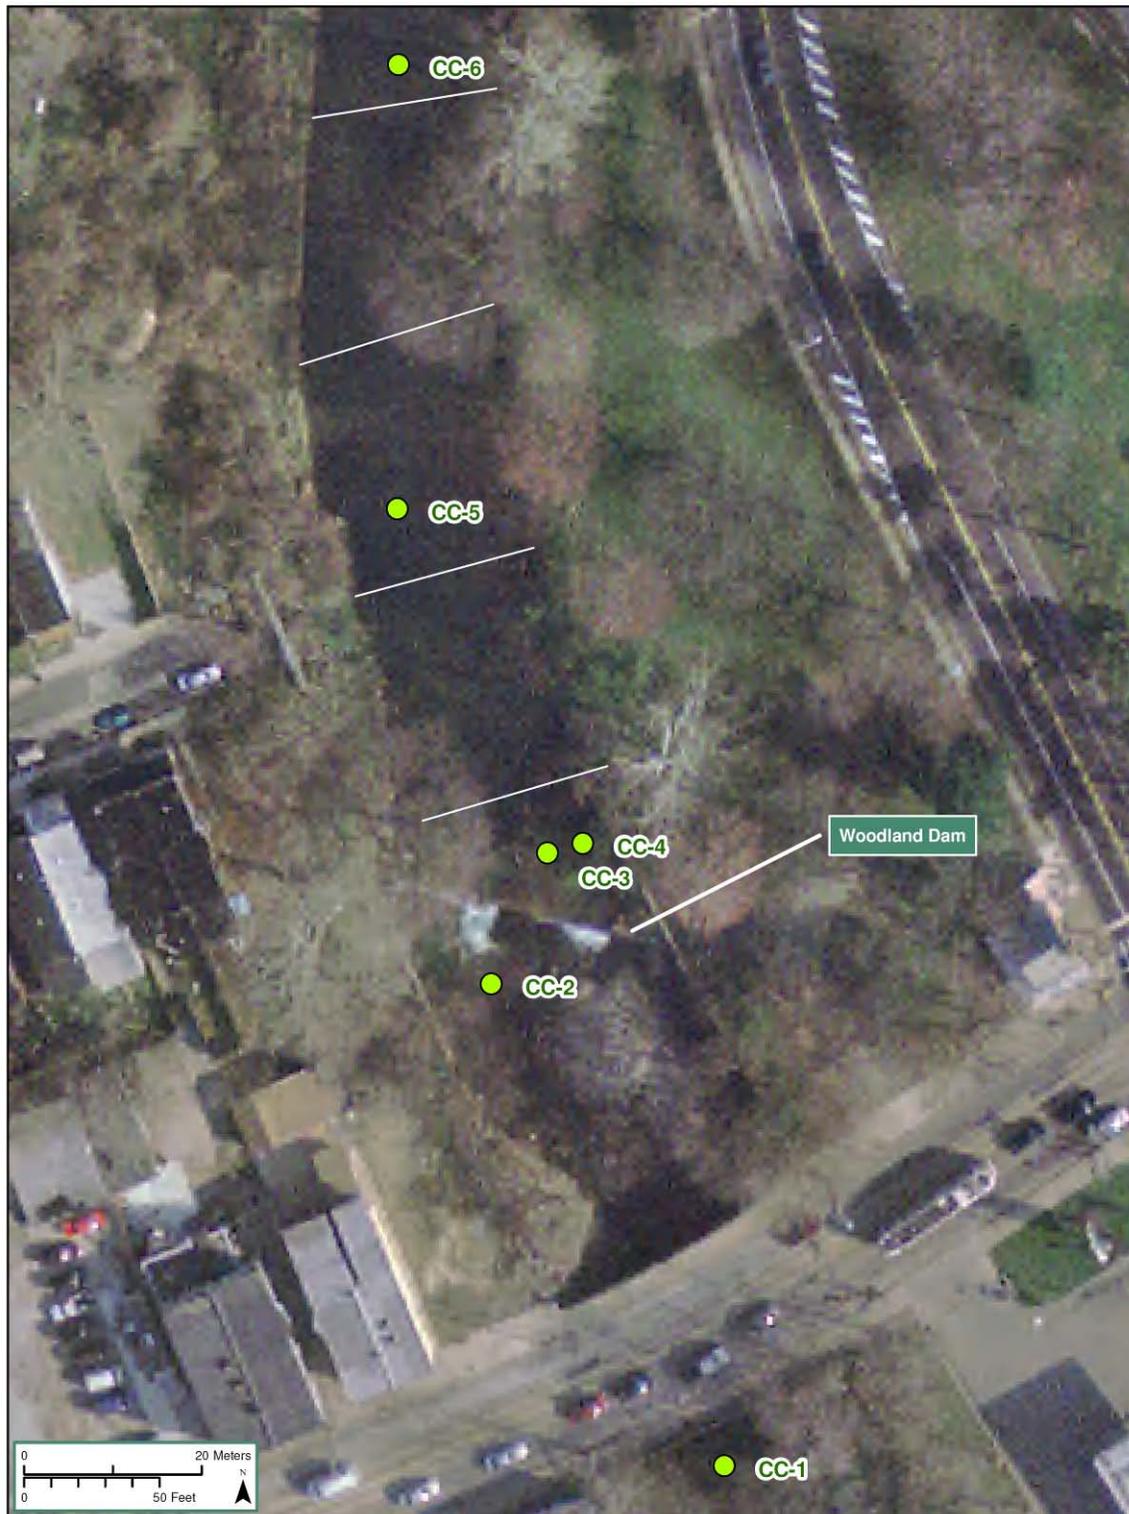
Figure 2-3. Sediment sampling locations for contaminant analysis at Woodland Dam. Transect lines indicate the locations of the sediment depth measurements.

Sediment samples were collected from six stations; four upstream and two downstream of Woodland Dam (Figure 2-3). Target collection points had to be repositioned slightly to obtain samples of silt due to the presence of bedrock and rock cobble substrate. Sediment samples for bulk chemical analysis were collected with a decontaminated stainless steel ponar grab. Each of the six samples was analyzed for TCL Volatiles, TCL Semi Volatiles, TCL Pesticides and aroclor PCBs, and TCL Inorganics (see Scope of Work in Appendix A). One composite from the two downstream stations and another from the four upstream stations was prepared and analyzed for high resolution congener specific PCBs (using method 1668a) and Dioxin/Furans using method SW-8468290. All sediment samples were analyzed for grain size using ASTM Method D422-63. Sieve sizes ranged from 4.75 mm (U.S. Standard Sieve No. 4) to 63 µm (U.S. Standard Sieve No. 230). Sediments were categorized by Wentworth’s classifications (Table 2-3).

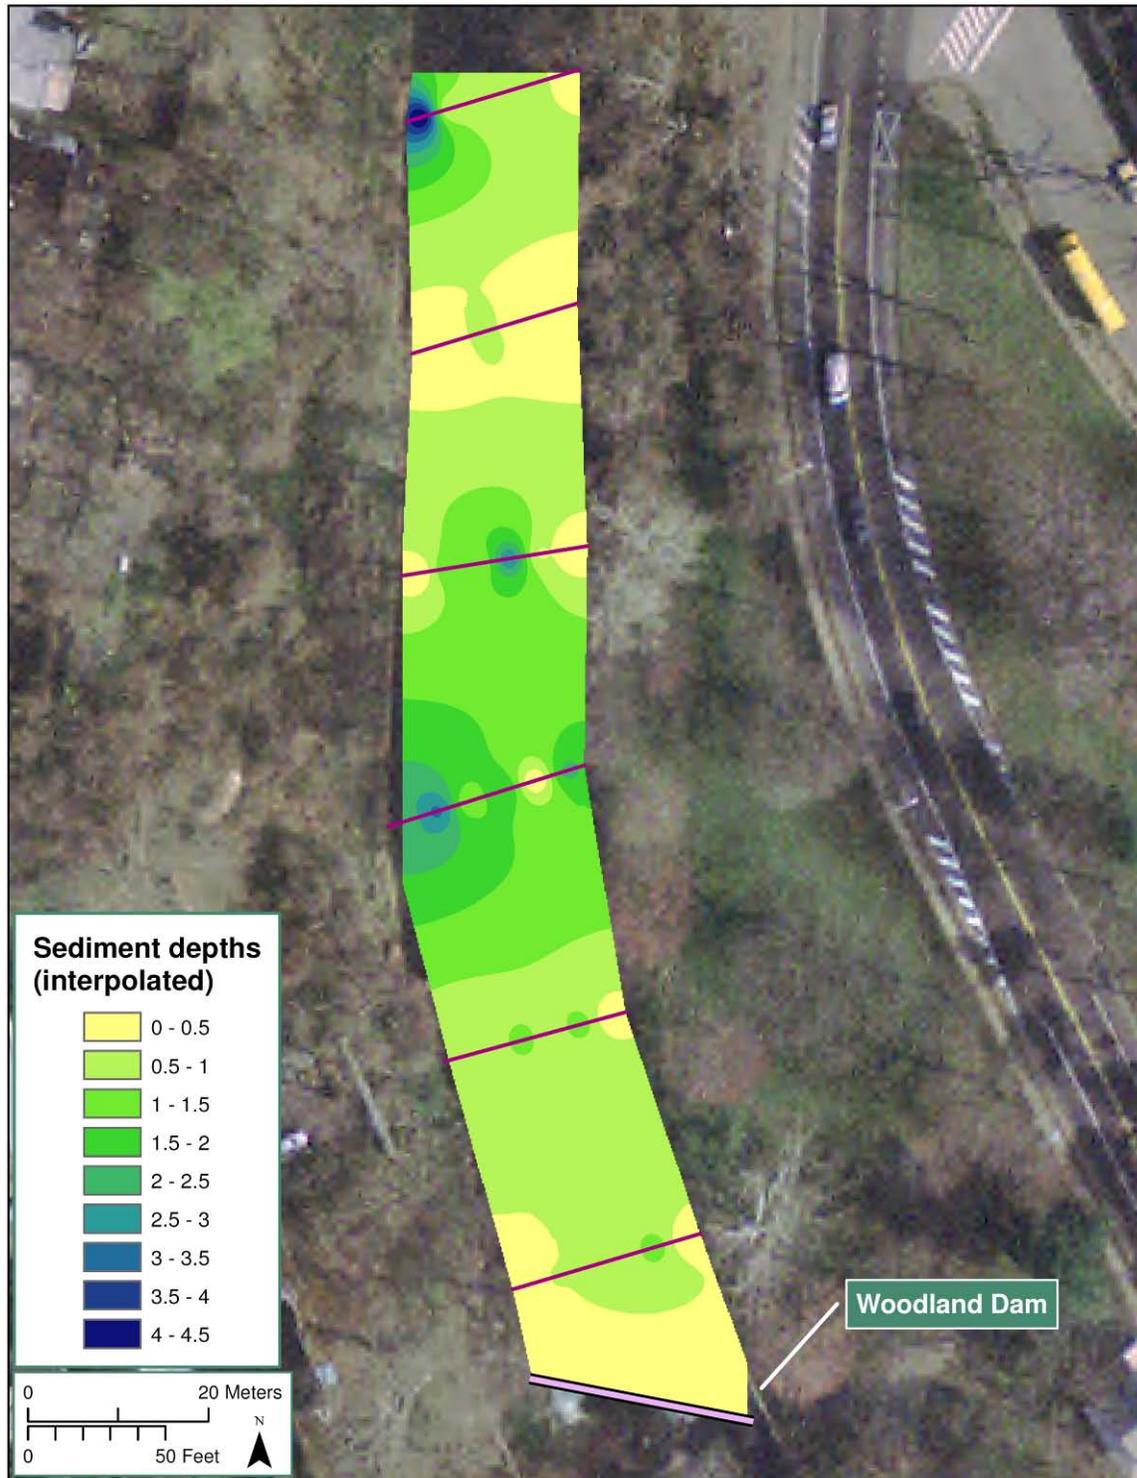
Figure 3-1. Distribution of sediment directly behind Woodland Dam to 500 feet upstream. Sediment measurement transect lines indicate approximate sediment sampling points.

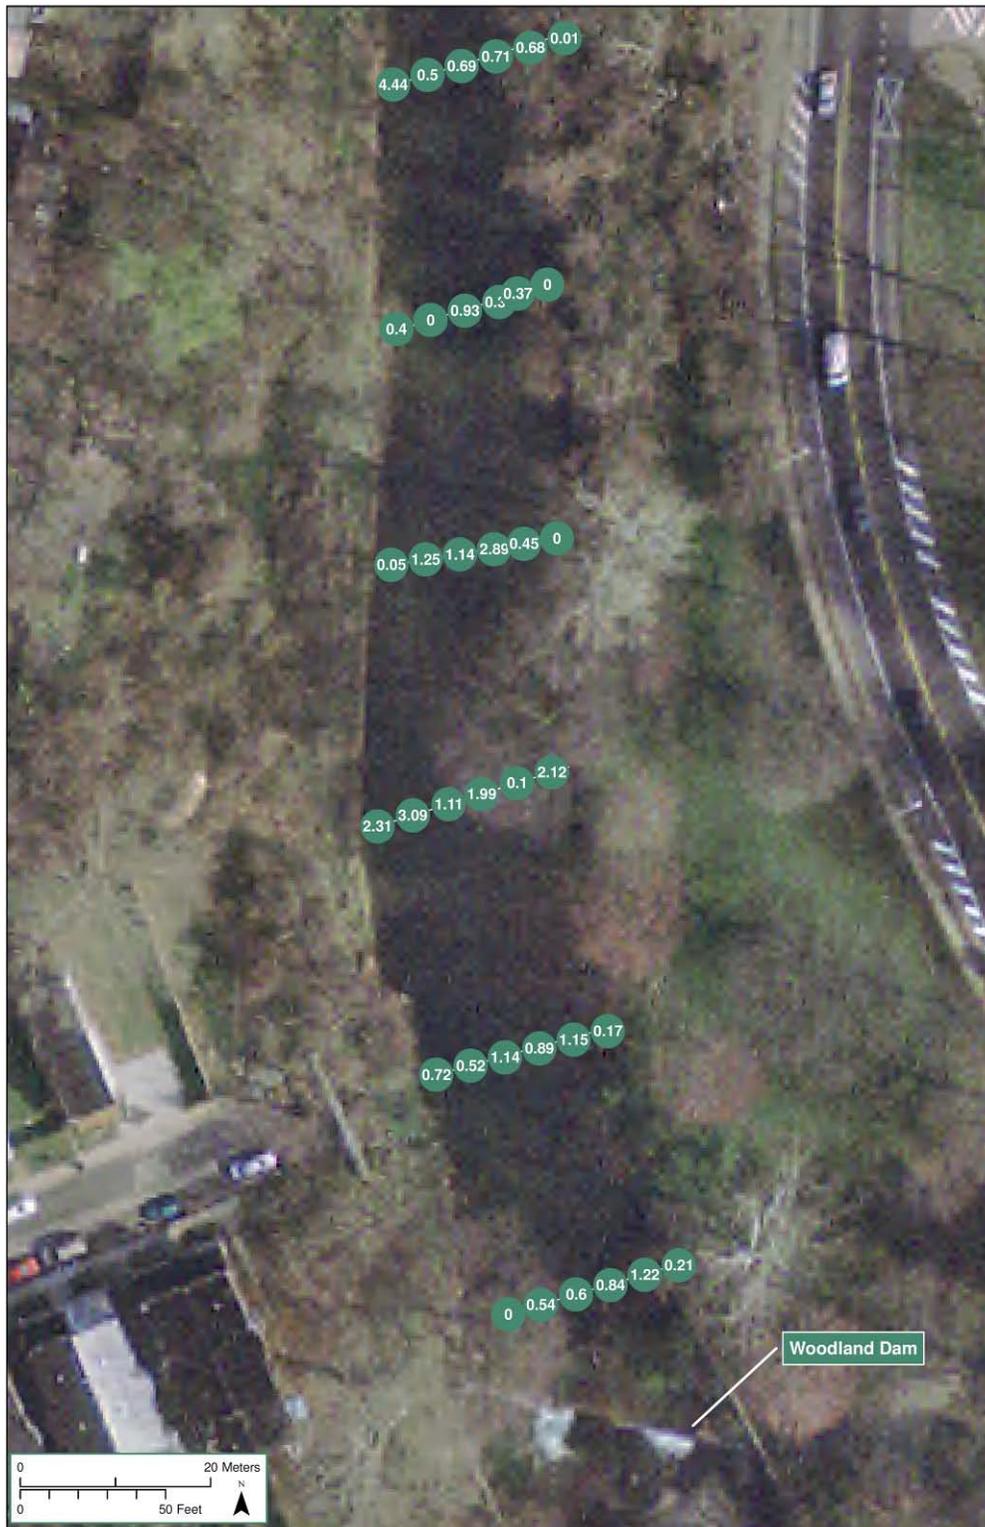
Figure 3-2. Measured sediment depth at each sampling point behind Woodland Dam

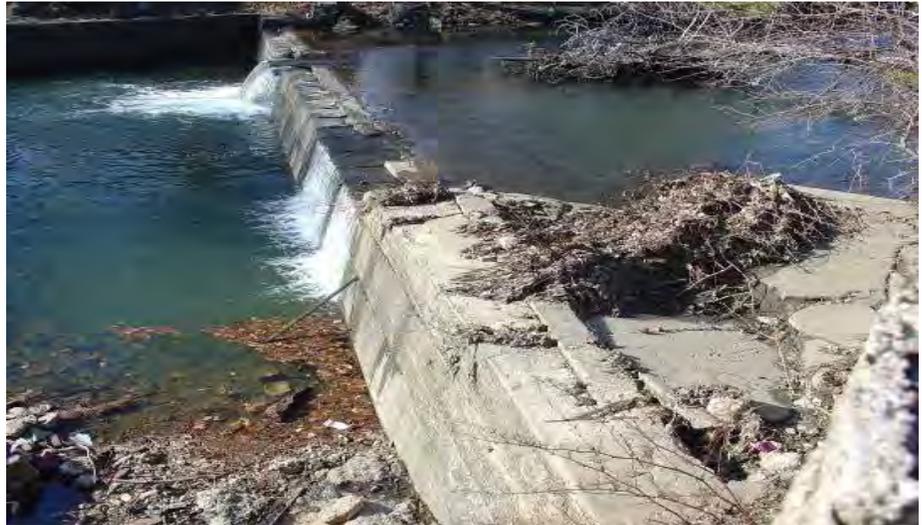
Figure 3: Woodland Dam shown from the Woodland Avenue Bridge approximately 200 feet downstream of the dam. Photo taken January 26, 2006.

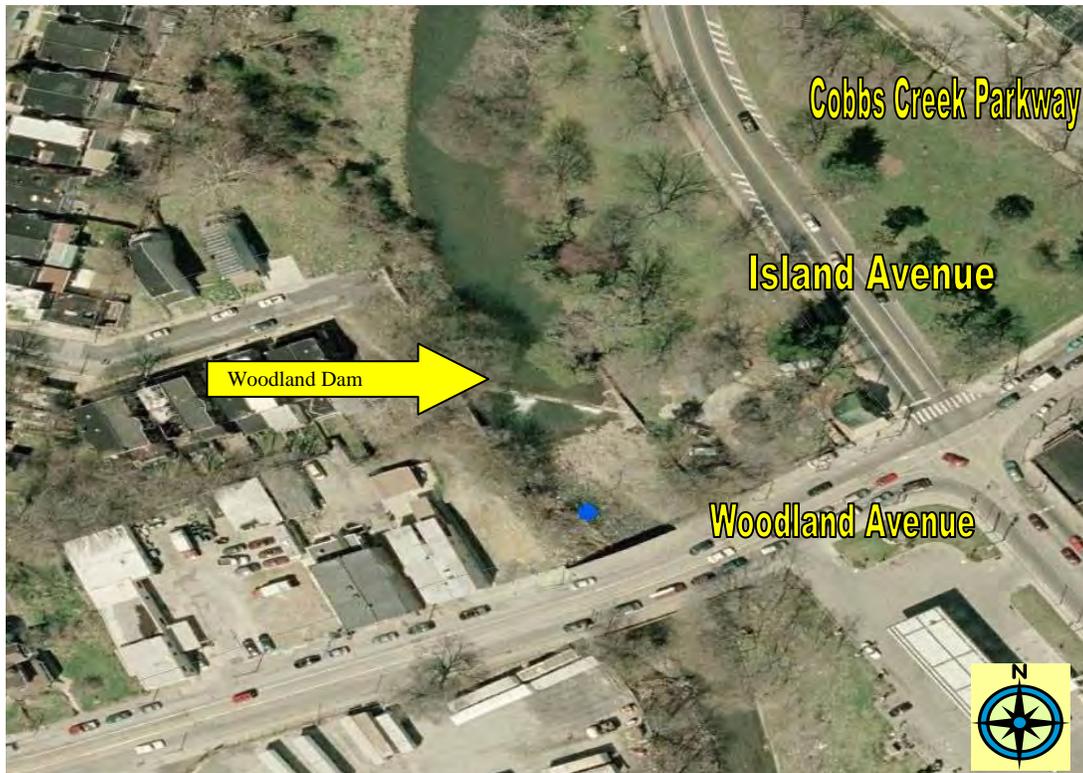
Figure 7: Aerial photograph of project site showing location of the Woodland Dam in respect to Woodland and Island Avenues. Aerial photograph taken in 2006.

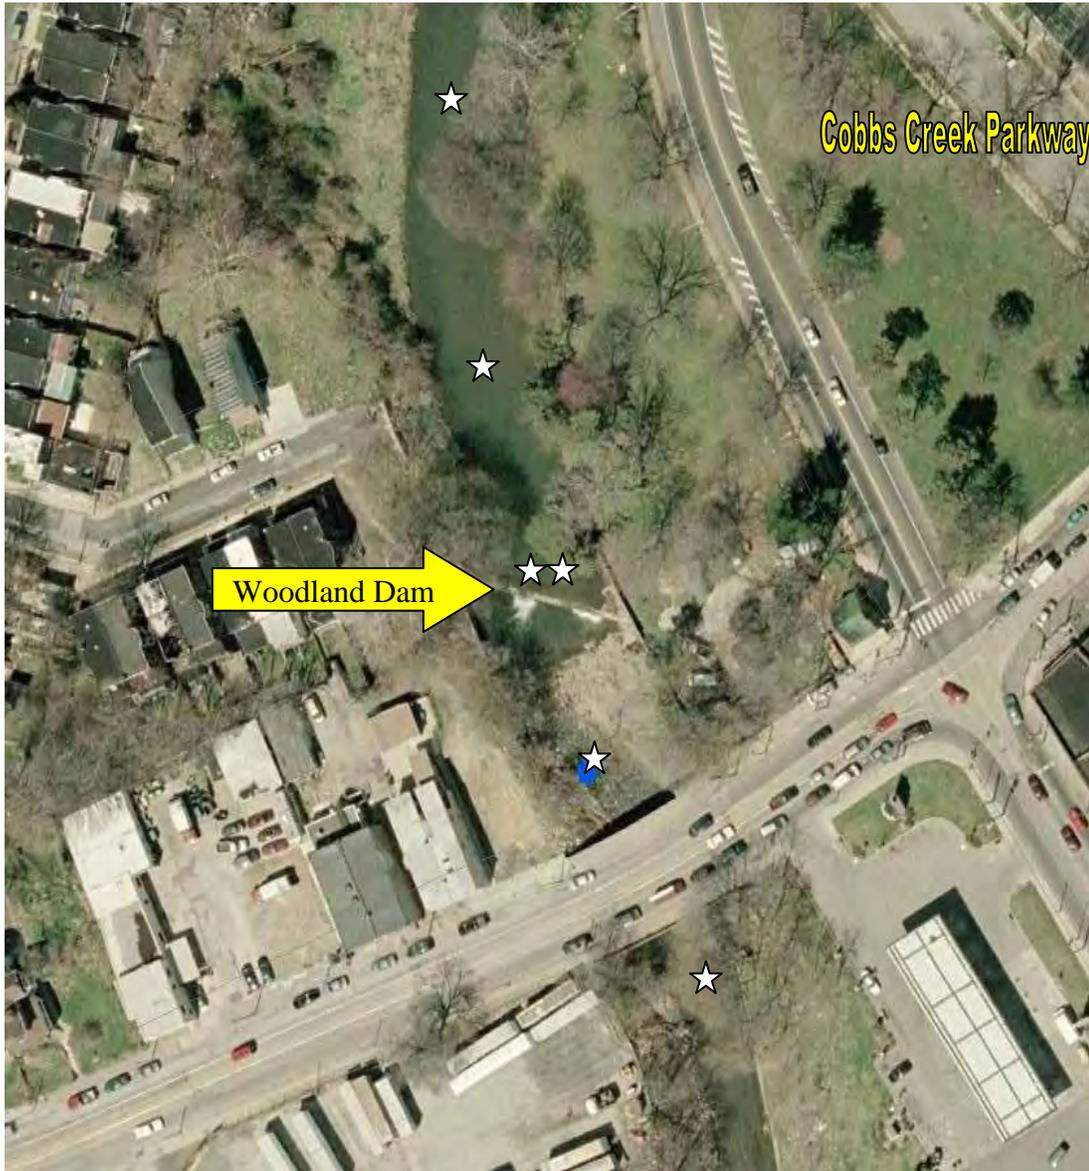
Figure 5. Sample locations on Cobbs Creek.

Sediment samples will be collected from six stations; four upstream and two downstream of Woodland dam (Figure 5). Target collections points may need to be repositioned slightly to obtain samples of silt due to the presence of bedrock and rock coble substrate. Sediment samples for bulk chemical analysis will be collected from either a decontaminated stainless steel ponar

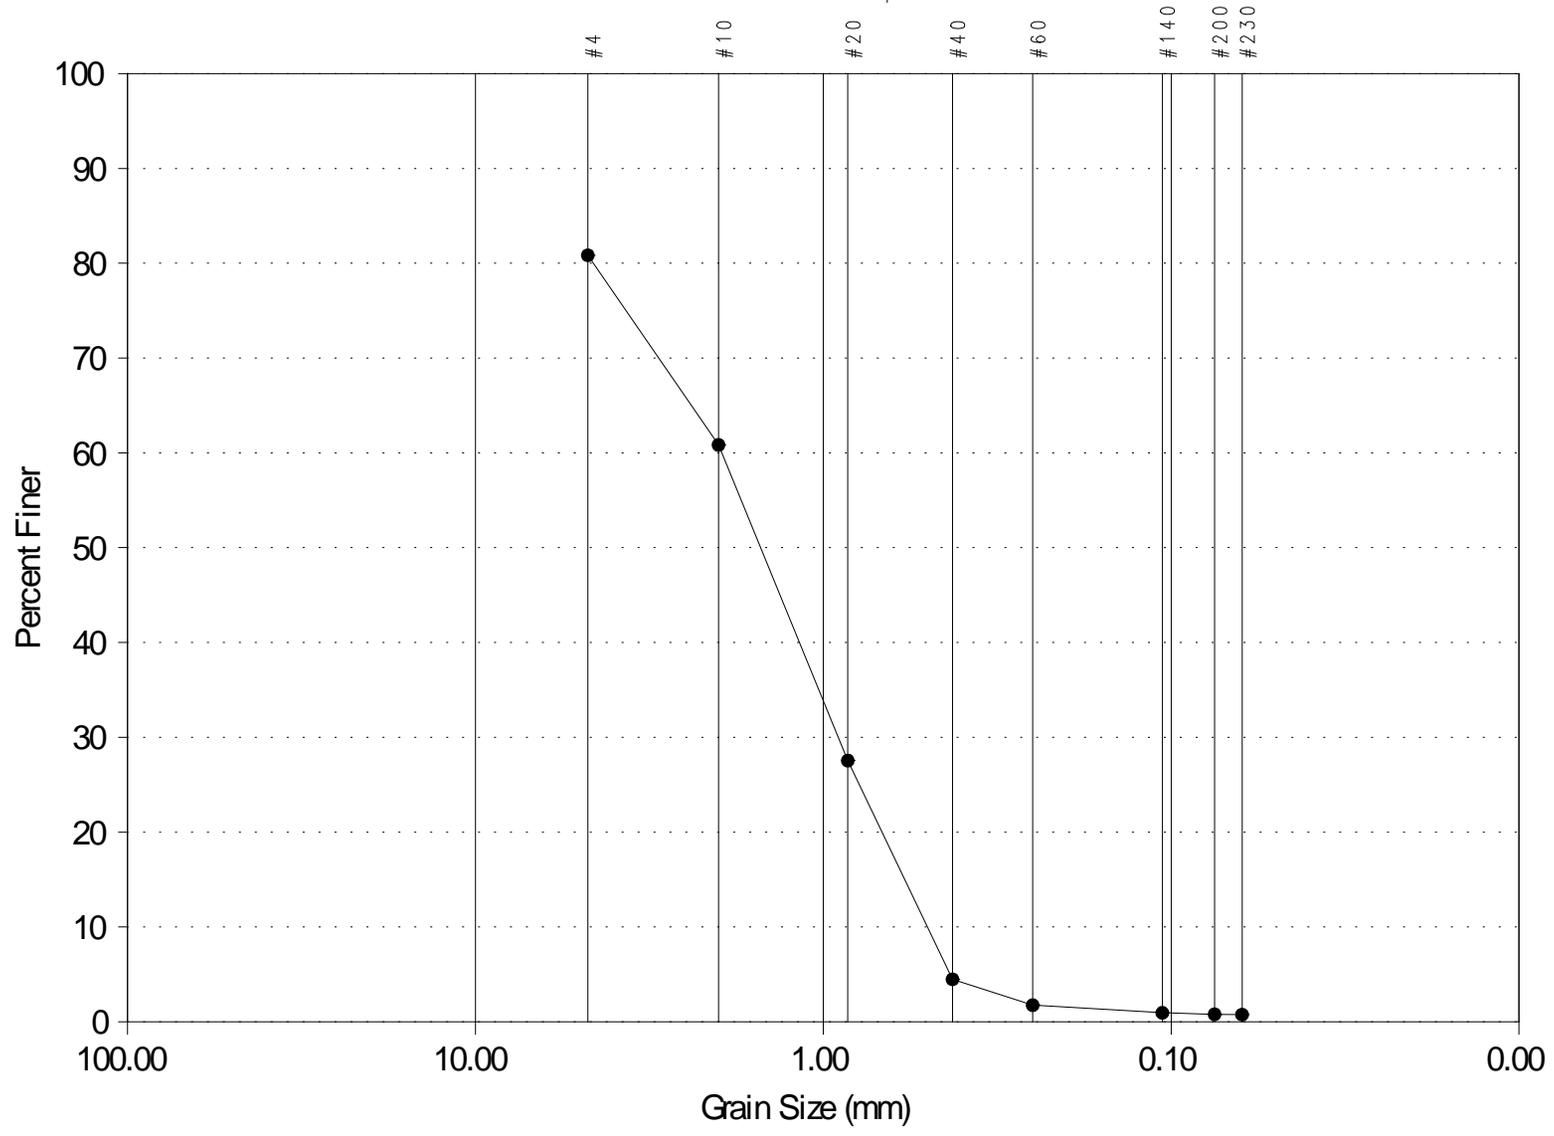
B-3

Sediment Grain Size Curve  
Cobbs Creek 2009 Sample: CC-1

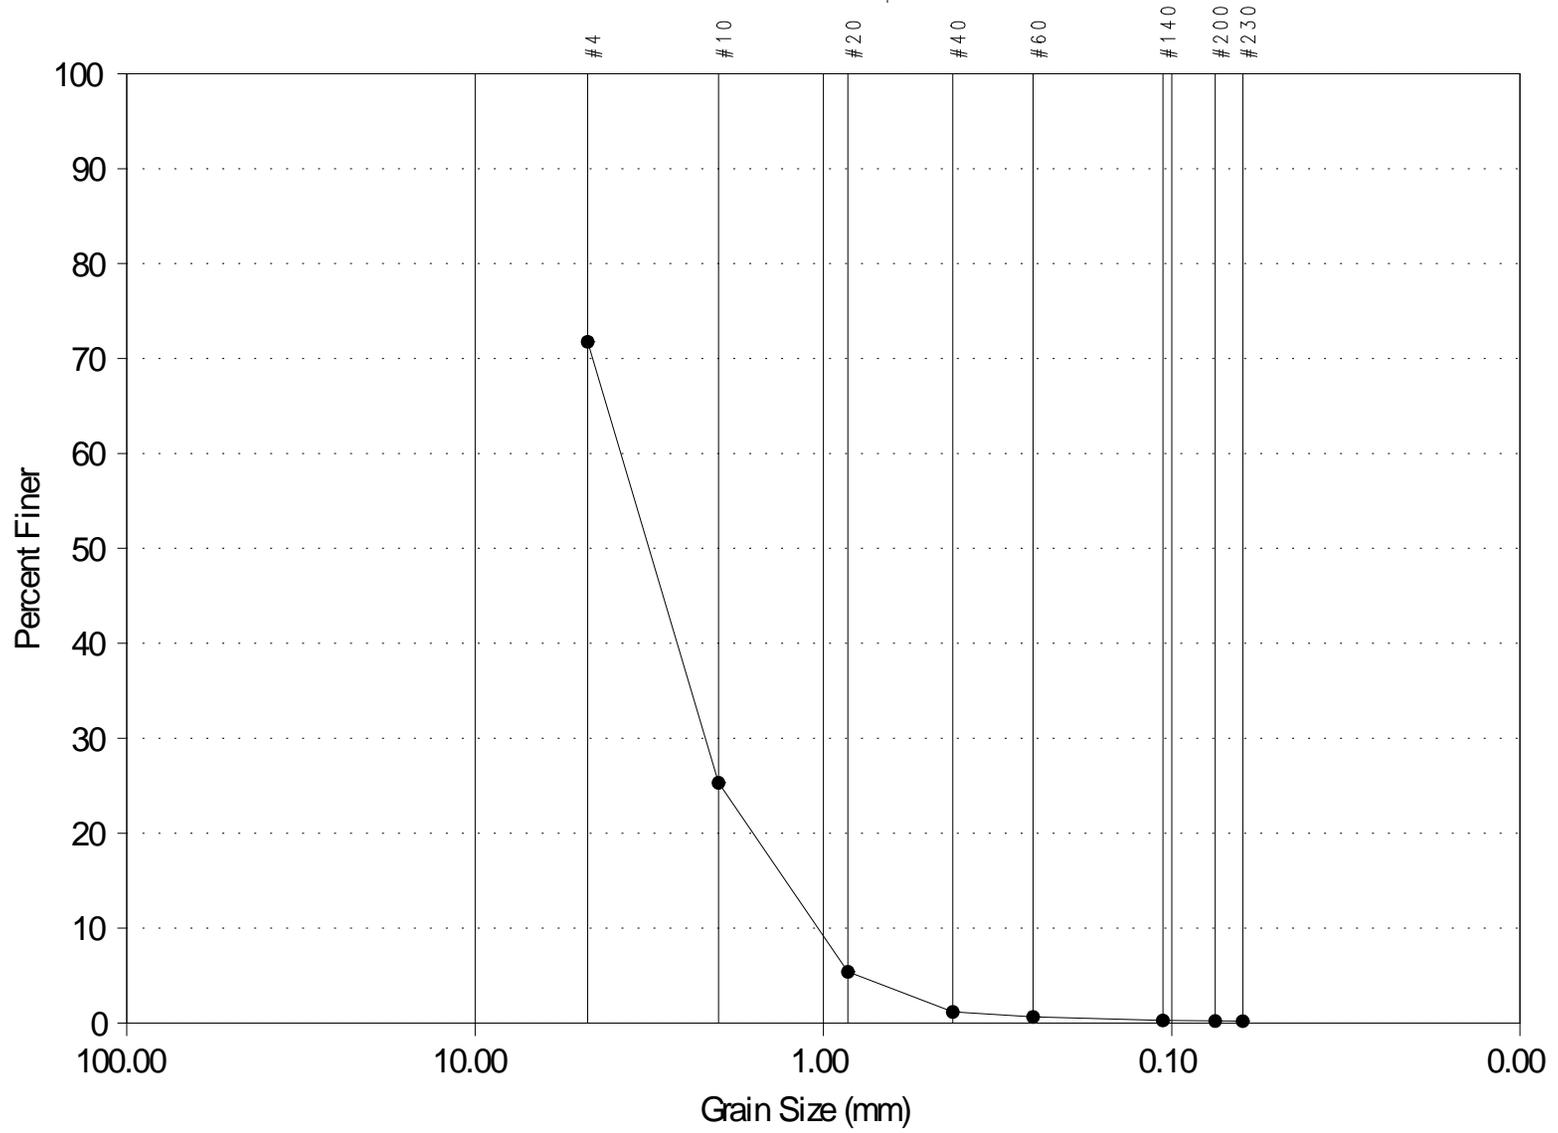
B-4

Sediment Grain Size Curve  
Cobbs Creek 2009 Sample: CC-2

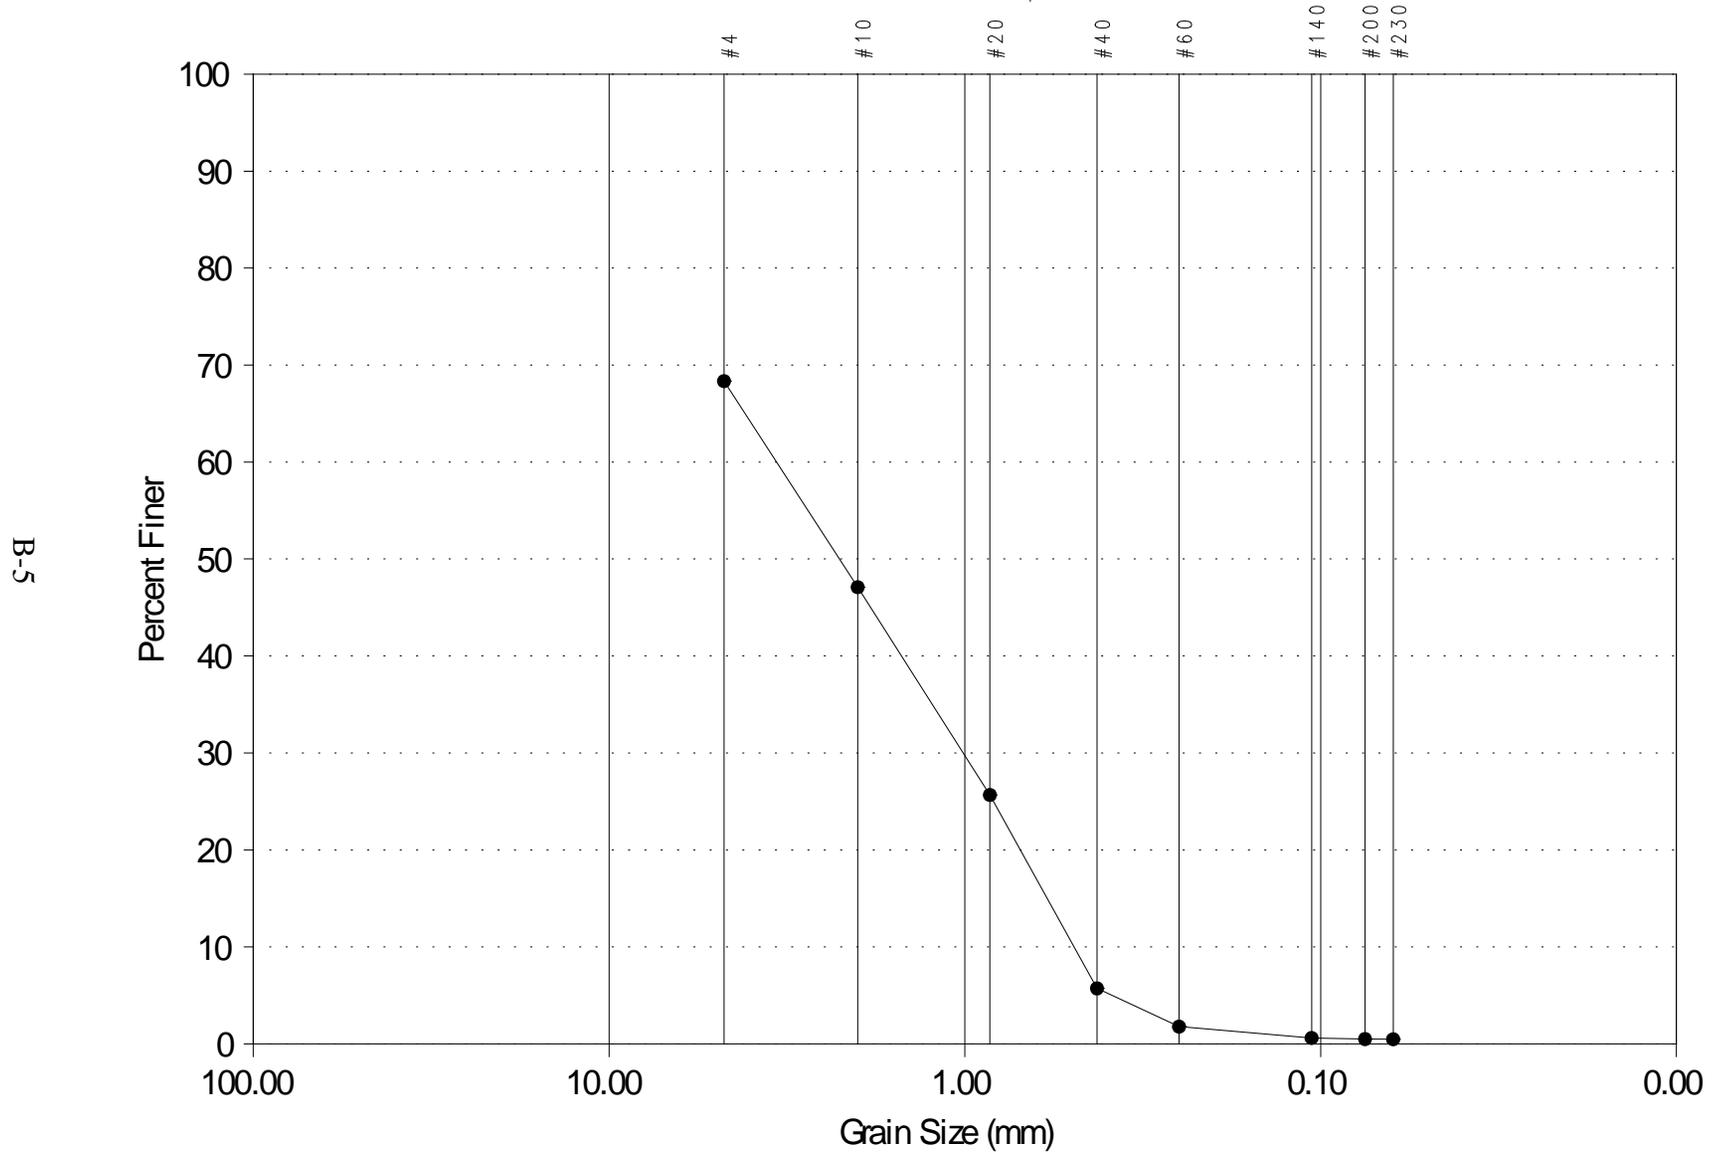
# Sediment Grain Size Curve

Cobbs Creek 2009 Sample: CC-3

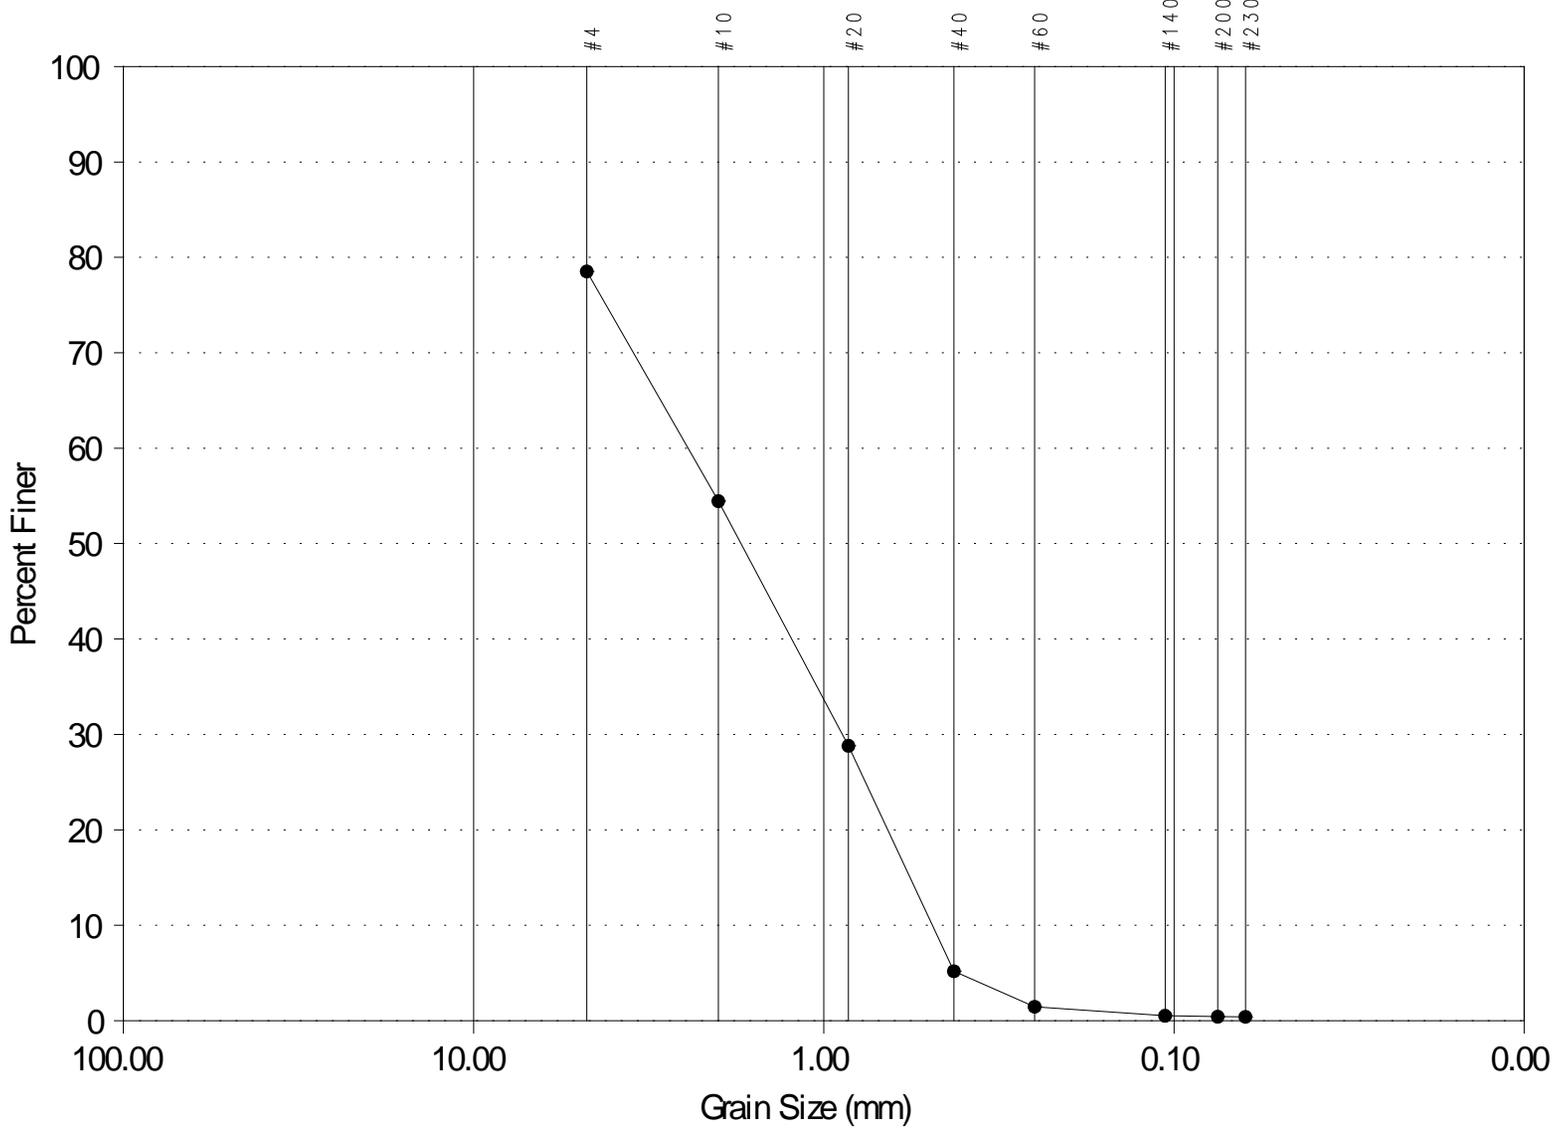
B-6

Sediment Grain Size Curve  
Cobbs Creek 2009 Sample: CC-4

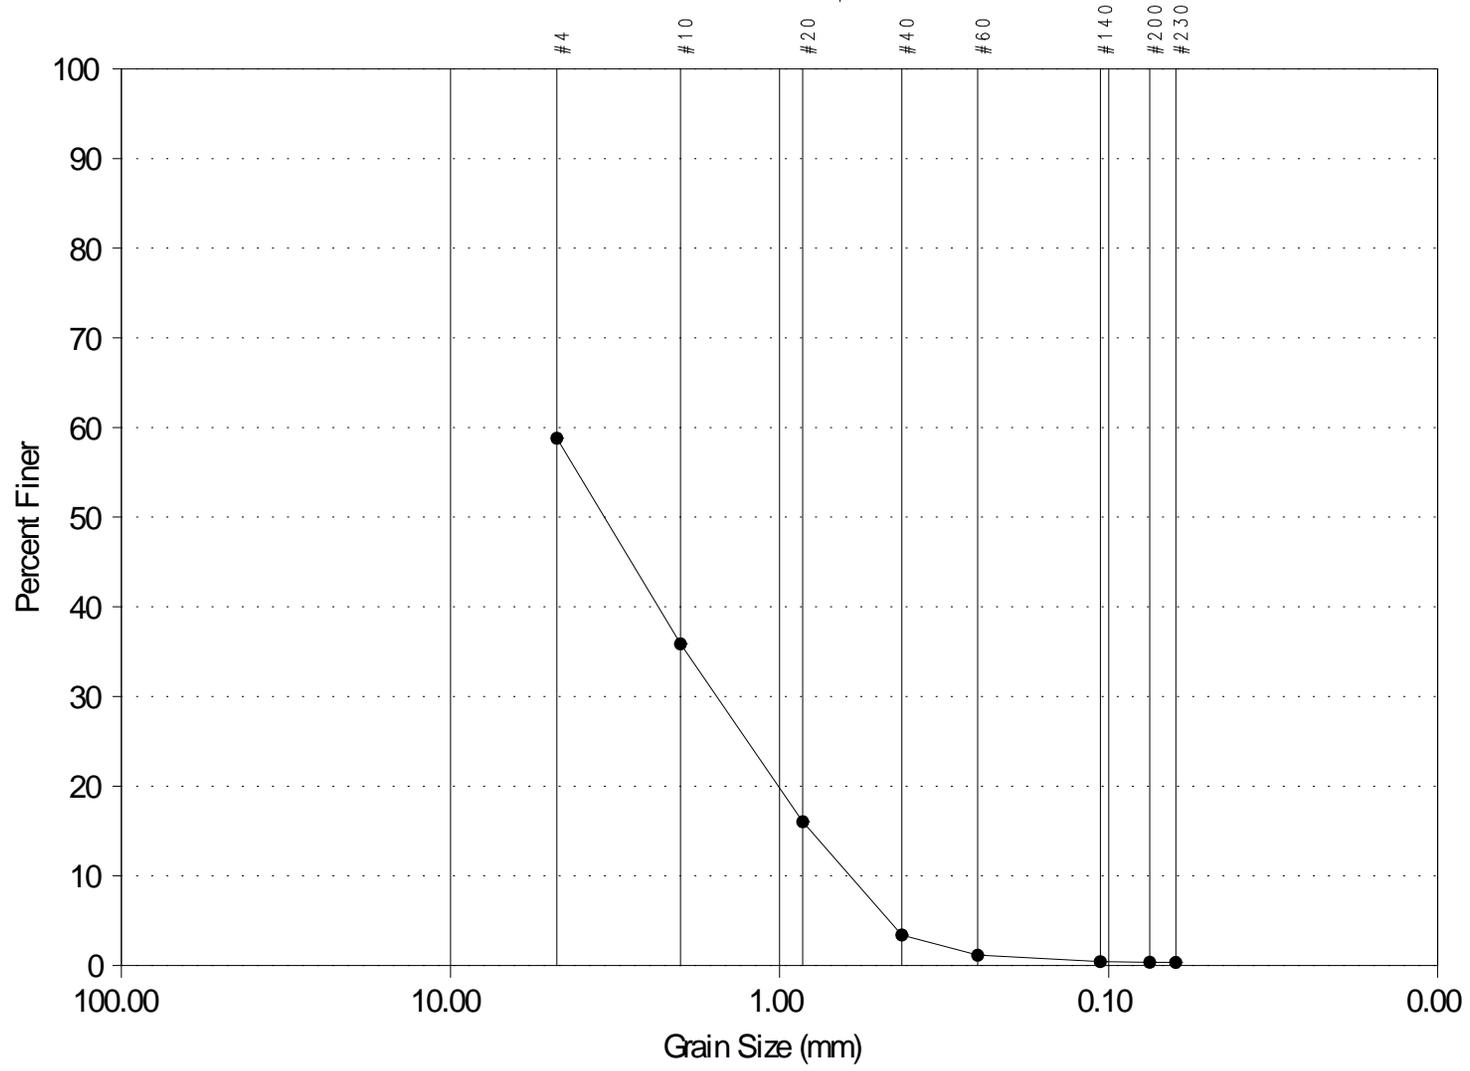
B-7

Sediment Grain Size Curve  
Cobbs Creek 2009 Sample: CC-5

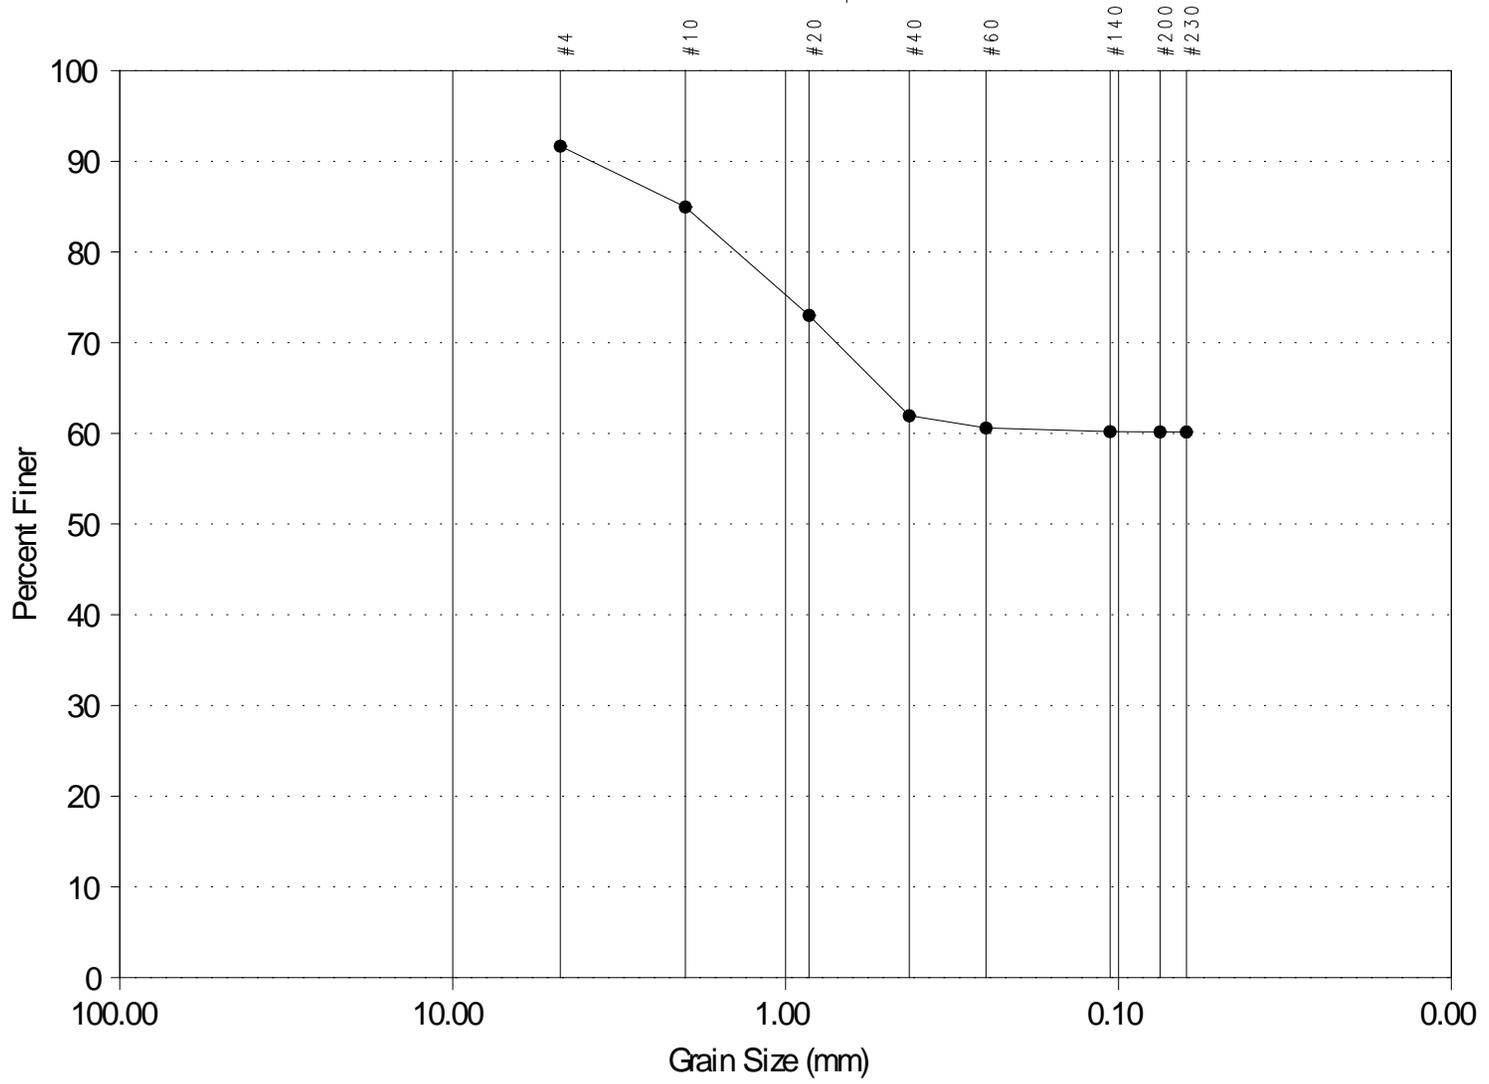
B-8

Sediment Grain Size Curve  
Cobbs Creek 2009 Sample: CC-6

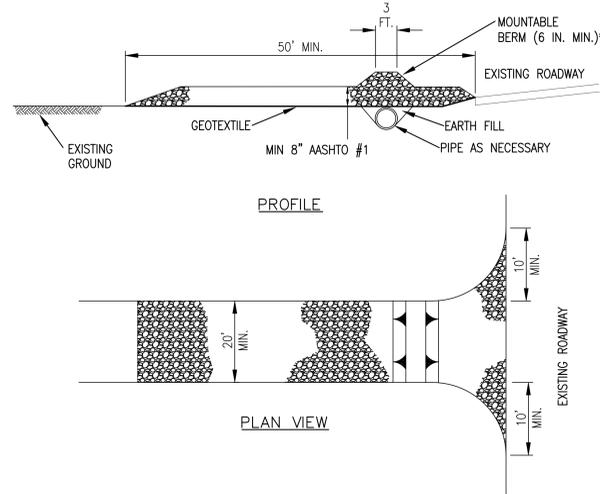
1 DETAIL - ROCK CONSTRUCTION ENTRANCE  
SCALE: NOT TO SCALE

- \* MOUNTABLE BERM USED TO PROVIDE PROPER COVER FOR PIPE
- NOTES:
1. REMOVE TOPSOIL PRIOR TO INSTALLATION OF ROCK CONSTRUCTION ENTRANCE. EXTEND ROCK OVER FULL WIDTH OF ENTRANCE.

2. RUNOFF SHALL BE DIVERTED FROM ROADWAY TO A SUITABLE SEDIMENT REMOVAL BMP PRIOR TO ENTERING ROCK CONSTRUCTION ENTRANCE.
  3. MOUNTABLE BERM SHALL BE INSTALLED WHEREVER OPTIONAL CULVERT PIPE IS USED AND PROPER PIPE COVER AS SPECIFIED BY MANUFACTURER IS NOT OTHERWISE PROVIDED. PIPE SHALL BE SIZED APPROPRIATELY FOR SIZE OF DITCH BEING CROSSED.

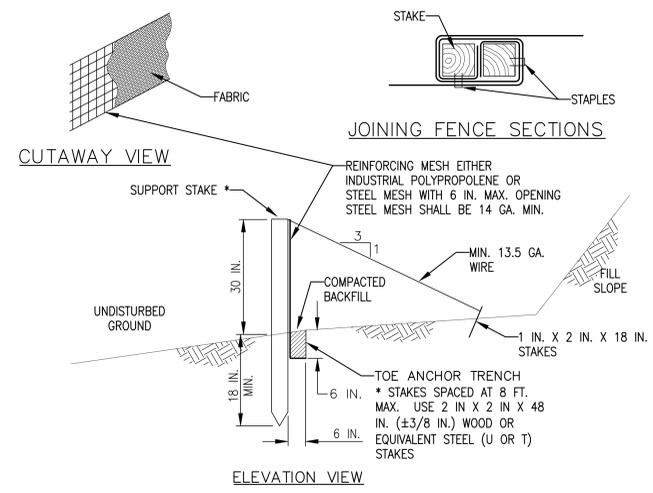
4 DETAIL - REINFORCED SILT FENCE  
SCALE: NOT TO SCALE

- NOTES:
1. FABRIC SHALL HAVE THE MINIMUM PROPERTIES AS SHOWN IN TABLE 4.3 OF THE PA DEP EROSION CONTROL MANUAL.
  2. FABRIC WIDTH SHALL BE 42 IN. MINIMUM. STAKES SHALL BE HARDWOOD OR EQUIVALENT STEEL (U OR T) STAKES. AN 18 IN. SUPPORT STAKE SHALL BE DRIVEN 12 IN. MINIMUM INTO UNDISTURBED GROUND.
  3. SILT FENCE SHALL BE PLACED AT LEVEL EXISTING GRADE. BOTH ENDS OF THE FENCE SHALL BE EXTENDED AT LEAST 8 FEET UP SLOPE AT 45 DEGREES TO THE MAIN FENCE ALIGNMENT.
  4. SEDIMENT SHALL BE REMOVED WHEN ACCUMULATIONS REACH HALF THE ABOVE GROUND HEIGHT OF THE FENCE.
  5. ANY SECTION OF SILT FENCE WHICH HAS BEEN UNDERMINED OR TOPPED SHALL BE IMMEDIATELY REPLACED WITH A ROCK FILTER OUTLET (STANDARD CONSTRUCTION DETAIL # 4-6).
  6. FENCE SHALL BE REMOVED AND PROPERLY DISPOSED OF WHEN TRIBUTARY AREA IS PERMANENTLY STABILIZED.

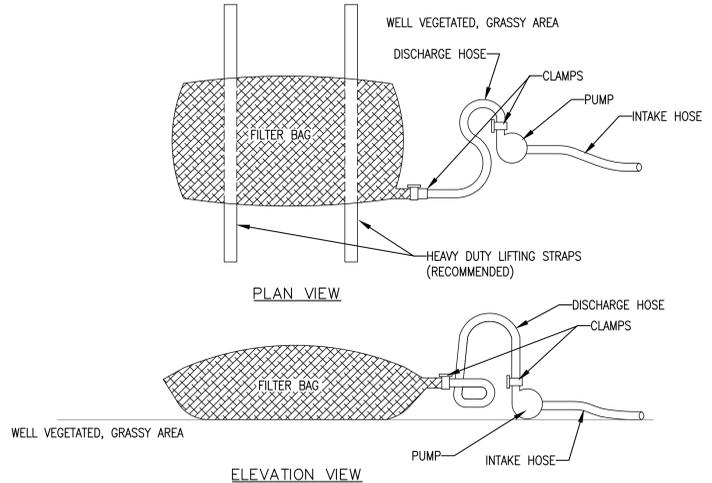
2 DETAIL - PUMPED WATER FILTER BAG  
SCALE: NOT TO SCALE

- NOTES:
1. LOW VOLUME FILTER BAGS SHALL BE MADE FROM NON-WOVEN GEOTEXTILE MATERIAL SEWN WITH HIGH STRENGTH, DOUBLE STITCHED "J" TYPE SEAMS. THEY SHALL BE CAPABLE OF TRAPPING PARTICLES LARGER THAN 150 MICRONS. HIGH VOLUME FILTER BAGS SHALL BE MADE FROM WOVEN GEOTEXTILES THAT MEET THE FOLLOWING STANDARDS:

7. FILTER BAGS SHALL BE INSPECTED DAILY. IF ANY PROBLEM IS DETECTED, PUMPING SHALL CEASE IMMEDIATELY AND NOT RESUME UNTIL THE PROBLEM IS CORRECTED.

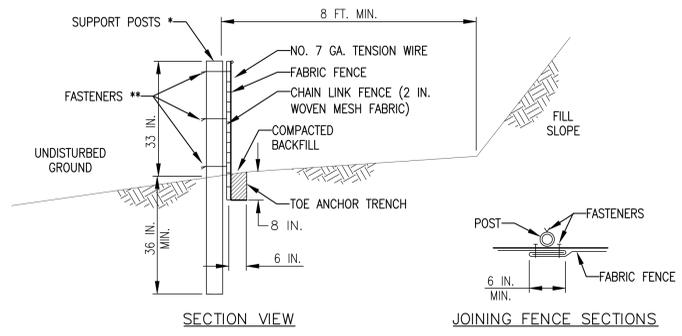
5 DETAIL - SUPER SILT FENCE  
SCALE: NOT TO SCALE

- \* POSTS SPACED AT 10 FT. MAX. USE 2-1/2 IN. DIA HEAVY DUTY GALVANIZED OR ALUMINUM POSTS.
- \*\* CHAIN LINK TO POST FASTENERS SPACED AT 14 IN. MAX. USE NO. 9 GA. ALUMINUM WIRE OR NO. 9 GALVANIZED STEEL WIRE. FABRIC TO SHAIN FASTENERS SPACED AT 24 IN. MAX. ON CENTER.

- NOTES:
1. FABRIC SHALL HAVE THE MINIMUM PROPERTIES AS SHOWN IN TABLE 4.3 OF THE PA DEP EROSION CONTROL MANUAL.
  2. FABRIC WIDTH SHALL BE 42 IN. MINIMUM.

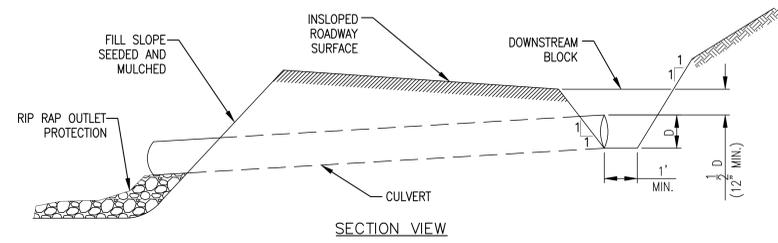
1 DETAIL - INSLOPED ROADWAY  
SCALE: NOT TO SCALE

- NOTES:**
- CUT AND FILL SLOPES SHALL BE STABILIZED IMMEDIATELY UPON COMPLETION OF ROADWAY GRADING. THESE AREAS SHALL BE BLANKETED WHEREVER THEY ARE LOCATED WITHIN 50 FEET OF A SURFACE WATER OR WITHIN 100 FEET OF AN HQ OR EV SURFACE WATER OR WHERE A SUITABLE VEGETATIVE FILTER STRIP DOES NOT EXIST.
