# Cobbs Creek Fish Passage

## Project - Appendices

PNDI Project Review  
Cobbs Creek/Woodland Dam  
Fish Passage Restoration Project  
City and County of Philadelphia, PA

PHILADELPHIA COUNTY, PENNSYLVANIA  
CORBS CREEK FISH  
PASSAGE - WOODLAND DAM REMOVAL  
GENERAL INFORMATION SHEET

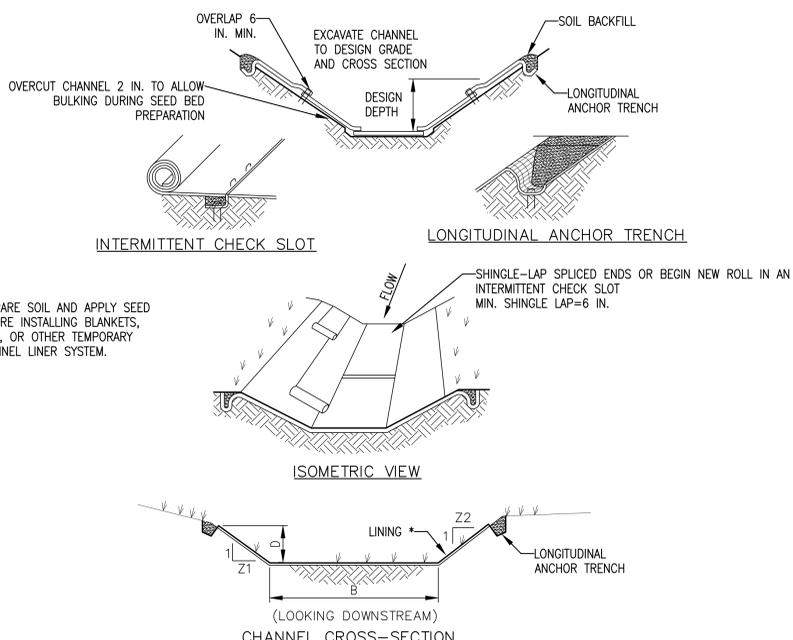
4 DETAIL - VEGETATED CHANNEL  
SCALE: NOT TO SCALE

\* SEE MANUFACTURER'S LINING INSTALLATION DETAIL FOR STAPLE PATTERNS, VEGETATIVE STABILIZATION FOR SOIL AMENDMENTS, SEED MIXTURES AND MULCHING INFORMATION

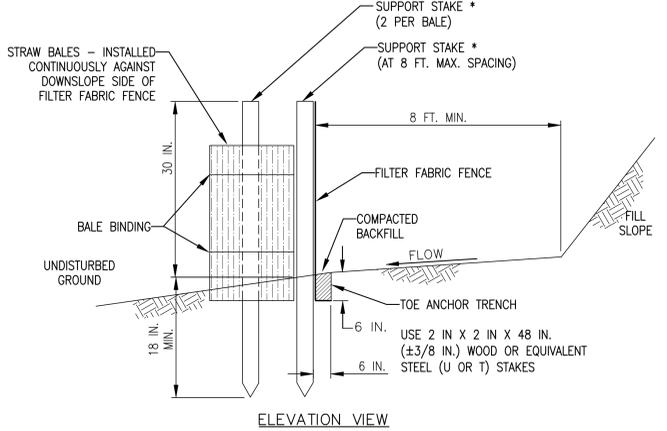
2 DETAIL - SILT FENCE REINFORCED BY STAKED STRAW BALES  
SCALE: NOT TO SCALE

- NOTES:**
- FABRIC SHALL HAVE THE MINIMUM PROPERTIES AS SHOWN IN TABLE 4.3 OF THE PA DEP EROSION CONTROL MANUAL.
  - THIS BMP IS NOT SUITABLE FOR PROJECTS LASTING LONGER THAN 3 MONTHS UNLESS BALES ARE REPLACED QUARTERLY.
  - FABRIC WIDTH SHALL BE 42 IN. MINIMUM. STAKES SHALL BE HARDWOOD OR EQUIVALENT STEEL (U OR T) STAKES.
  - SILT FENCE SHALL BE PLACED AT LEVEL EXISTING GRADE. BOTH ENDS OF THE FENCE SHALL BE EXTENDED AT LEAST 8 FEET UP SLOPE AT 45 DEGREES TO THE MAIN FENCE ALIGNMENT.
  - SEDIMENT SHALL BE REMOVED WHEN ACCUMULATIONS REACH HALF THE ABOVE GROUND HEIGHT OF THE FENCE.
  - ANY SECTION OF SILT FENCE WHICH HAS BEEN UNDERMINED OR TOPPED SHALL BE IMMEDIATELY REPLACED WITH A ROCK FILTER OUTLET (STANDARD CONSTRUCTION DETAIL # 4-6).
  - FENCE SHALL BE REMOVED AND PROPERLY DISPOSED OF WHEN TRIBUTARY AREA IS PERMANENTLY STABILIZED.

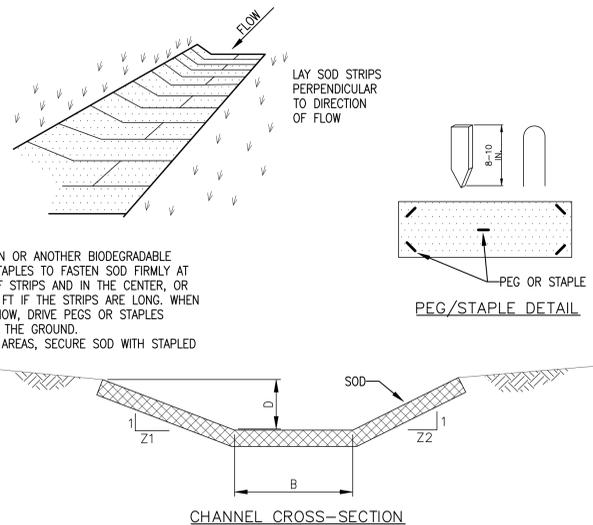
5 DETAIL - SODDED CHANNEL  
SCALE: NOT TO SCALE

- SOD NOTES:**
- USE WOODEN OR ANOTHER BIODEGRADABLE PEGS OR STAPLES TO FASTEN SOD FIRMLY AT THE END OF STRIPS AND IN THE CENTER, OR EVERY 3-4 FT IF THE STRIPS ARE LONG. WHEN READY TO MOW, DRIVE PEGS OR STAPLES FLUSH WITH THE GROUND.
  - IN CRITICAL AREAS, SECURE SOD WITH STAPLED NETTING.

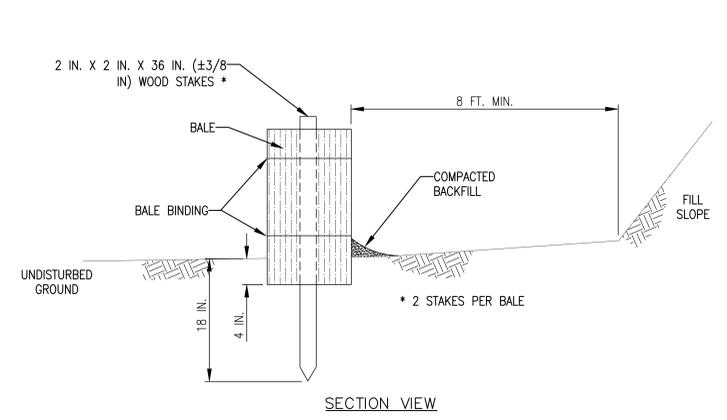
3 DETAIL - STRAW BALE BARRIER  
SCALE: NOT TO SCALE

- NOTES:**
- STRAW BALE BARRIERS SHALL NOT BE USED FOR PROJECTS EXTENDING MORE THAN 3 MONTHS.
  - STRAW BALE BARRIERS SHALL BE PLACED AT EXISTING LEVEL GRADE WITH ENDS TIGHTLY ABUTTING THE ADJACENT BALES. FIRST STAKE OF EACH BALE SHALL BE ANGLED TOWARD ADJACENT BALE TO DRAW BALES TOGETHER. STAKES SHALL BE DRIVEN FLUSH WITH THE TOP OF THE BALE. BOTH ENDS OF THE BARRIER SHALL BE EXTENDED AT LEAST 8 FEET UP SLOPE AT 45 DEGREES TO THE MAIN BARRIER ALIGNMENT.

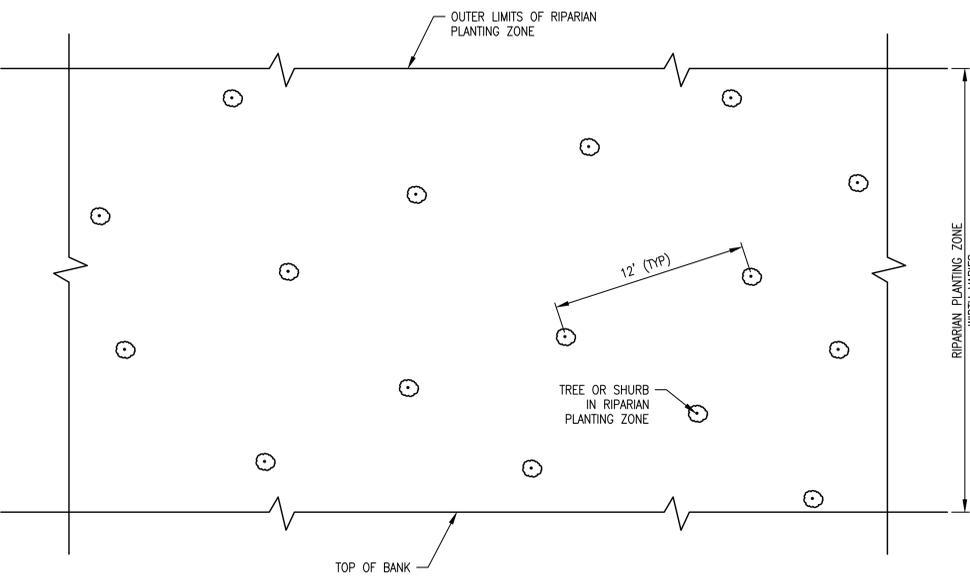
1 PLAN - TREE AND SHRUB PLANTINGS  
SCALE: NO TO SCALE

NOTE:  
1. TREE/SHRUB PLANTINGS TO BE RANDOMLY PLACED AT 12' O.C. AVERAGE SPACING FROM PROPOSED AND EXISTING RIPARIAN PLANTS.
