# Snow Guards for Metal Roofs

By Wayne Tobiasson, M.ASCE, James Buska, M.ASCE, and Alan Greatorex

*This study was first published by the American Society of Civil Engineers for its 8th International Conference on Cold Regions Engineering in August 1996 and is reprinted by permission.*

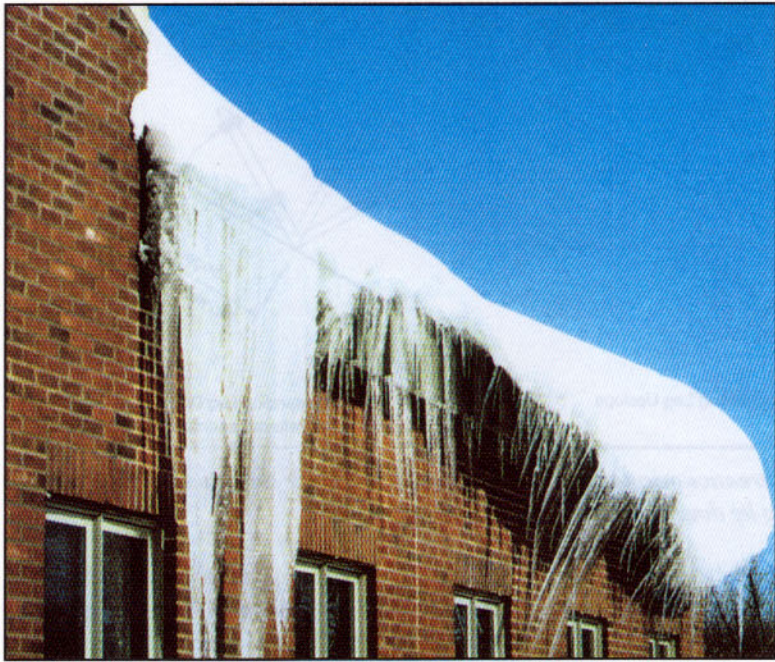
**Figure 7:** *Icicles will form on an overhanging, creeping mass of ice and snow.*

Meltwater tends to follow the underside of such ice and snow cantilevers instead of flowing off the roof along the heat traced path. This results in the formation of dangerously large icicles at the end of the ice and snow cantilever as shown in Figure 7.

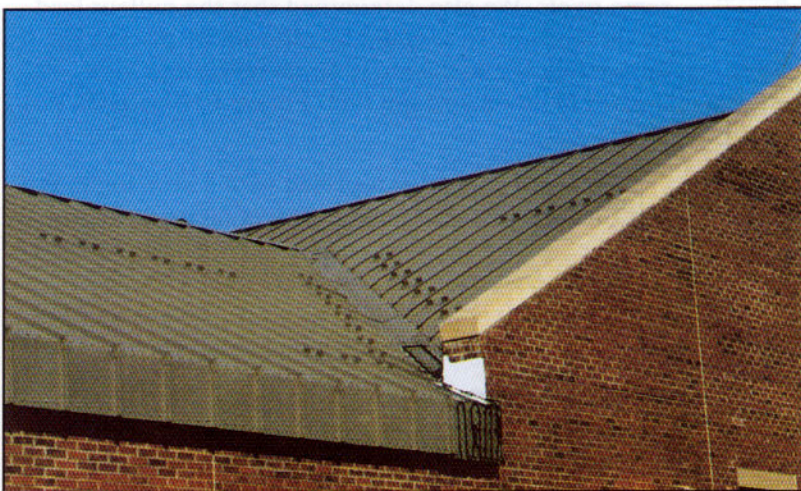
**Figure 9:** *Individual aluminum angle snow guards attached with butyl-based peel-and-stick adhesive.*

We also wished to evaluate snow guards attached with adhesive, but because we would be installing them in the late fall, our adhesive choices were limited to those that did not require many weeks of warm-weather curing before their first winter of use. We selected a snow guard made from 89-mm- (3 1/2-in.-) long pieces of 3-mm (1/8-in.-) thick, aluminum angle with unequal legs 64 mm (2 1/2-in.) and 102 mm (4 in.) long. A butyl-based peel-and-stick tape had been attached to the longer leg in the factory. We cleaned the painted metal roof with alcohol and applied a primer to the contact area before peeling and sticking the snow guard to the metal. These guards were attached to the base of the metal pans, not to the standing seams. Some are shown in Figure 9.
