Attic Ventilation Guidelines to Minimize Icings at Eaves

BY WAYNE TOBIASSON, JAMES BUSKA AND ALAN GREATOREX

ABSTRACT

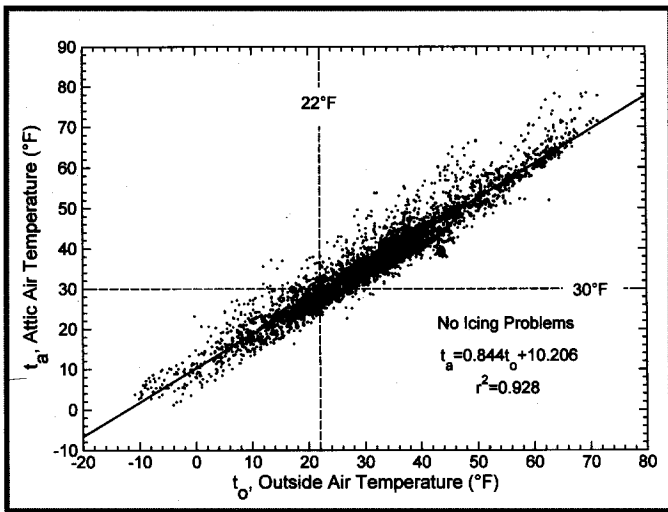
Figure 5: Attic temperature vs. outside air temperature for a roof experiencing no icing problems.

Plots of attic air temperature vs. outside air temperature are presented in Figures 5, 6, and 7 for buildings experiencing no icing problems, "some" icing problems and severe icing problems, respectively. Figure 6 is representative of two other buildings that also experienced "some" icing problems. The least-squares equation of best fit and its correlation coefficient (r^2) are presented on each figure. Horizontal and vertical lines, representing, respectively, an attic air temperature of 30°F and an outside air temperature of 22°F are also presented on each figure. The portion of each graph to the right of the vertical 22°F line is warmer than conditions observed to create icings. The portion of each graph below the 30°F horizontal line is also not within the "icing envelope" because the attic is then so cold that snow on the roof is not melted by building heat.

Of the four quadrants created in Figures 5-7 by the 22°F vertical line and the 30°F horizontal line, the upper left quadrant defines the problem area (i.e., the "icing envelope").

For the roof with no icing problems (Figure 5), very few data points fall within the icing envelope, as expected. For the roof with "some" icing problems (Figure 6), about 6% of the observations fall within the "icing envelope." For the roof with

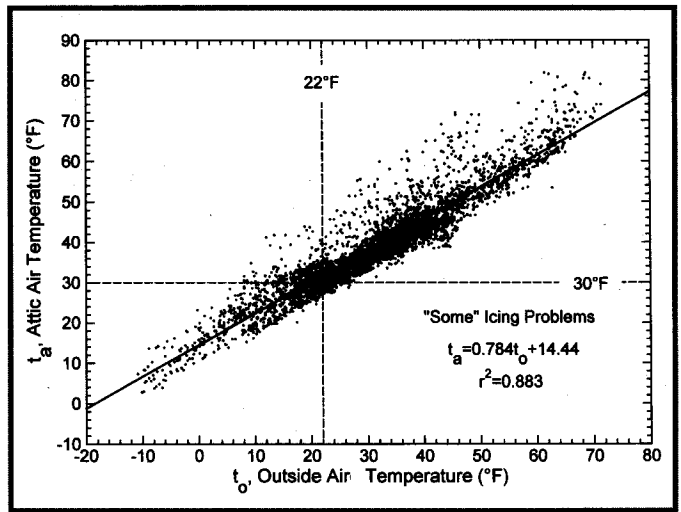
Figure 6: Attic temperature vs. outside air temperature for a roof experiencing "some" icing problems.

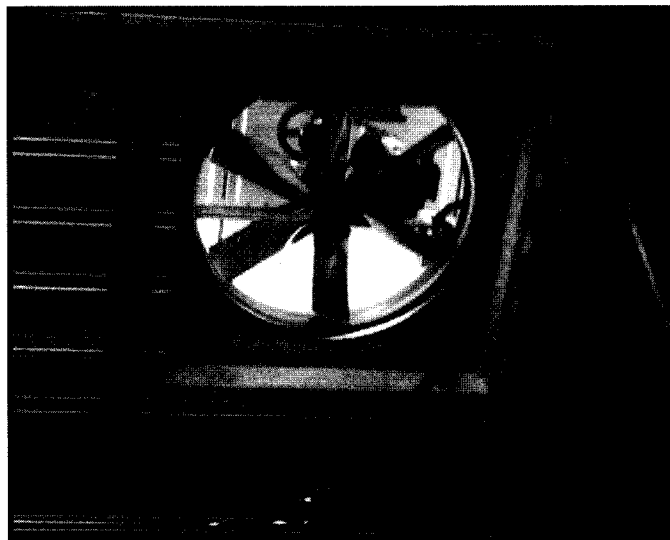
Figure 9: Attic ventilation fan installed near ridge of modified building.

The fans are thermostatically controlled, since they are needed infrequently. They operate only when the attic temperature is above 30 $^{\circ}\text{F}$ and the outside temperature is below 22 $^{\circ}\text{F}$. We installed instrumentation to monitor when the fans

Seven large fans were installed to mechanically ventilate this attic. Each one consumes about one kilowatt of power. Using the calculations discussed in this paper, four such fans would be enough to do the job but the designers used seven fans. To determine if only four fans would suffice, on Feb. 23, 1994, we had three of the fans turned off and blocked with sheet metal to preclude both mechanical and natural ventilation through them.

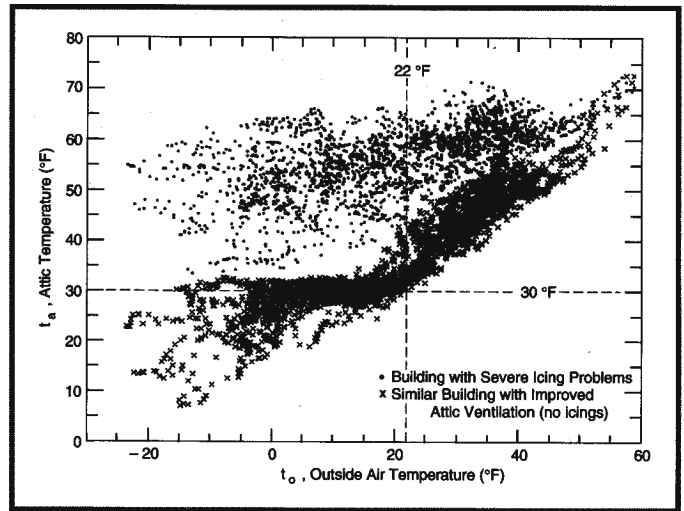
Figure 10: Attic temperature vs. outside air temperature for a building with severe icing problems and a similar building with improved attic ventilation experiencing no icing problems.

Figure 10 compares the modified building to a similar unmodified building for the period Nov. 15, 1993 to Feb. 23, 1994. Both buildings were having similar severe icing problems before one was modified. The portion of each data set to the right of the 22 $^{\circ}\text{F}$ outside air temperature line in *Figure 10* relates to natural ventilation since the fans cannot operate when it is warmer than 22 $^{\circ}\text{F}$ outside. The dramatic difference in that portion of the two data sets indicates that natural ventilation has been improved significantly. We expect that much of this improvement would not have been achieved if the fans contained louvers that were opened only when the fans were on.

The "hunk" taken out of the data set for the building with improved attic ventilation reflects the contribution of the mechanical ventilation system. The mechanical system has been able to keep that attic out of the "icing envelope" most of the time. Without mechanical ventilation, it appears that the attic would have operated within the icing envelope for a significant amount of time with problematic icings expected. This verified our feeling that natural ventilation alone would not solve the icing problems being experienced by some of these buildings.

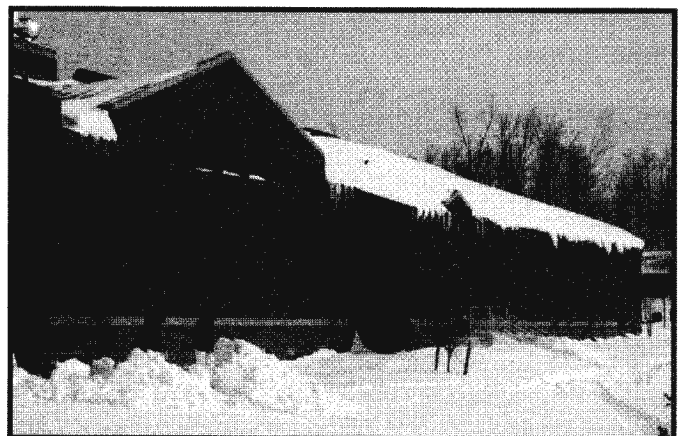
Figure 11: Both buildings from Figure 10 photographed at the same time. The unmodified building shown at the left was experiencing severe icings. The other building with improved attic ventilation had no icing problems.

Figure 11 shows the two buildings just discussed on the same date (Jan. 12, 1994). The unmodified building is subjected to severe icings all along its eaves. There are only a few small icicles at the base of the valleys of the building with improved attic ventilation. All other irregularities along the eaves of that roof are snow cornices, not icicles.
