EROSION PROTECTION ANALYSIS

American River Watershed

**AMERICAN RIVER, CALIFORNIA
COMMON FEATURES PROJECT
GENERAL REEVALUATION REPORT**

**Attachment E
Draft Erosion Protection Report**

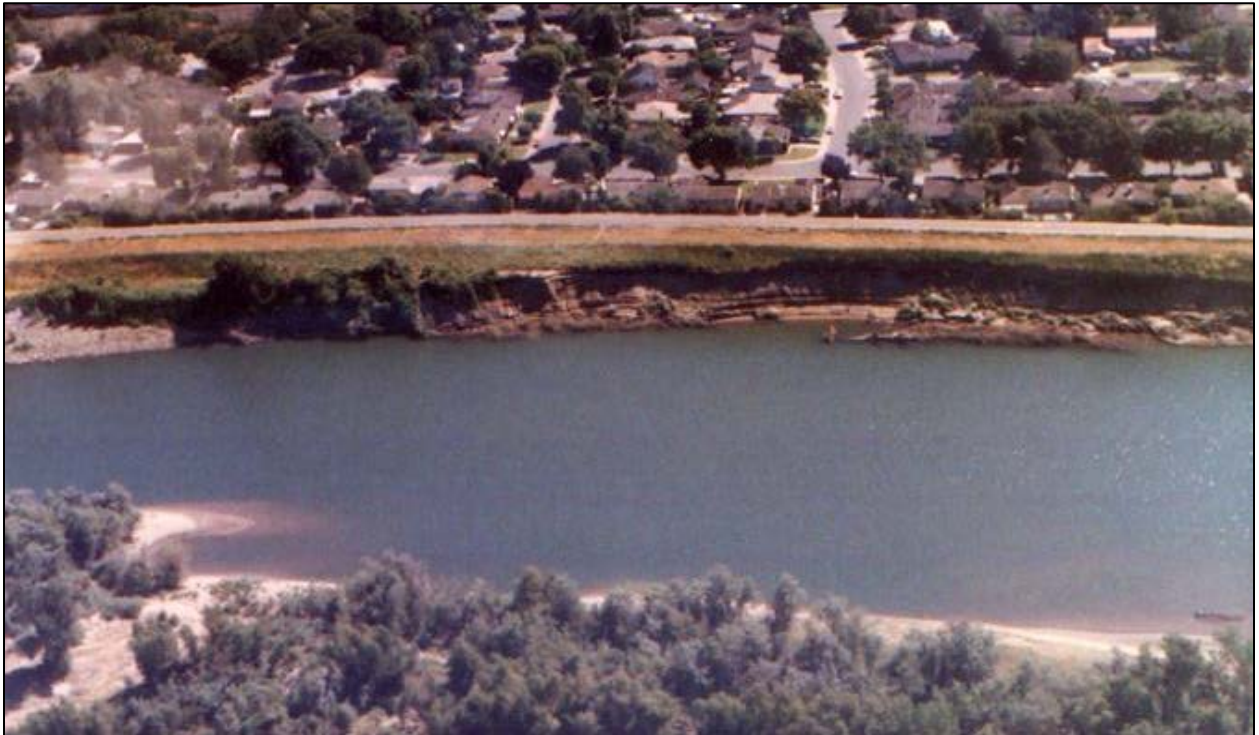
*Erosion of the left bank and levee of the Lower American River between
river miles 4 and 5 resulting from the February 1986 flood.*

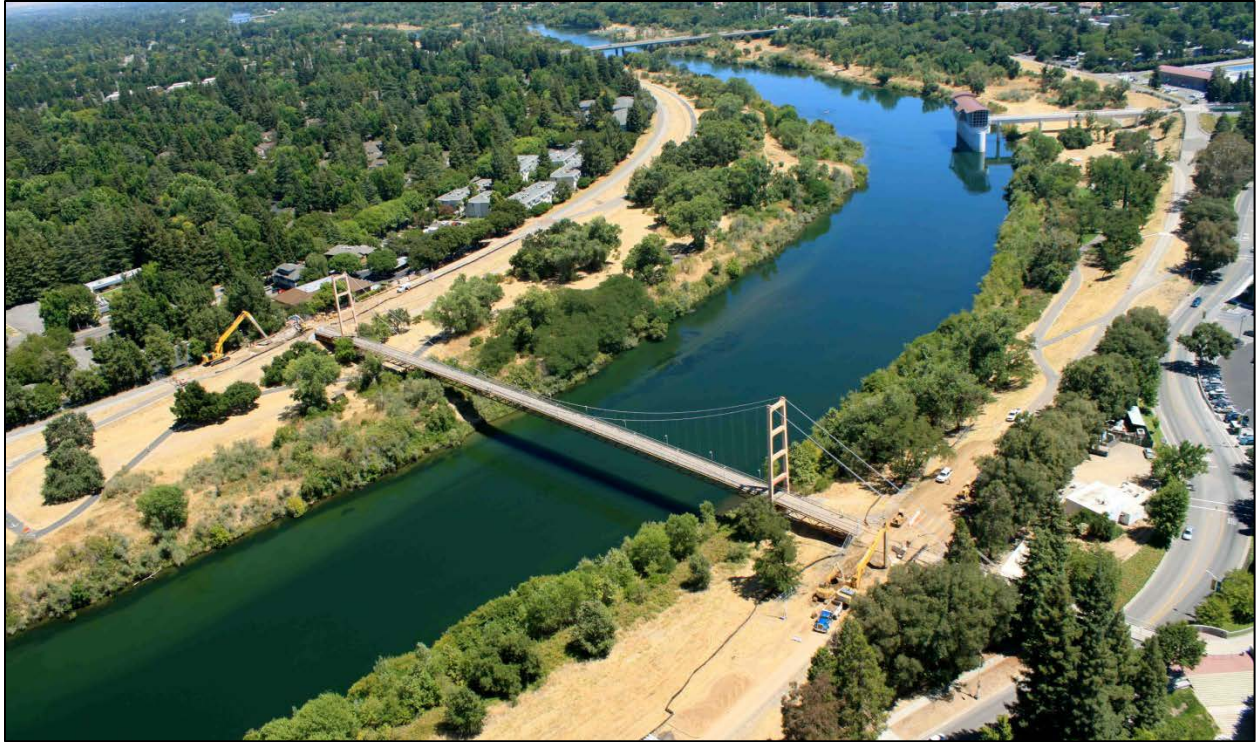
Figure 1-2. View of Lower American River (looking upstream) at Guy West pedestrian bridge

Figure 1-2 is a typical view of the leveed reach of the Lower American River. This photo is looking upstream in the vicinity of the Guy West pedestrian bridge (RM 7). Figure 1-3 shows a view of an erosion site on the left bank near the lower end of the American River at RM 0.3 in 2008. This site is located just upstream from the Interstate 5 crossing (bridge seen in the background) and is affected by backwater from the Sacramento River.

- The river bottom at Guy West Bridge is scoured clean of alluvium. The exposed material in the riverbed consists of clay and has been found to be erodible.

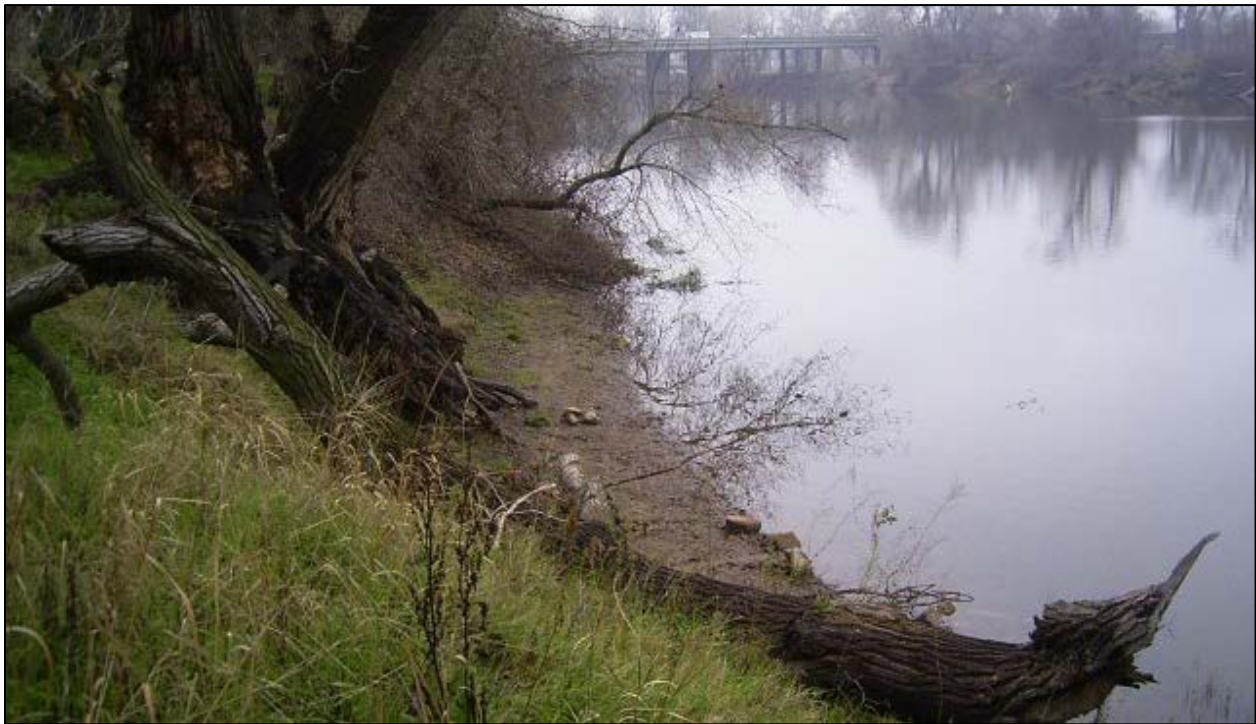
Figure 1-3. Erosion site on left bank near LAR RM 0.3 (2008)

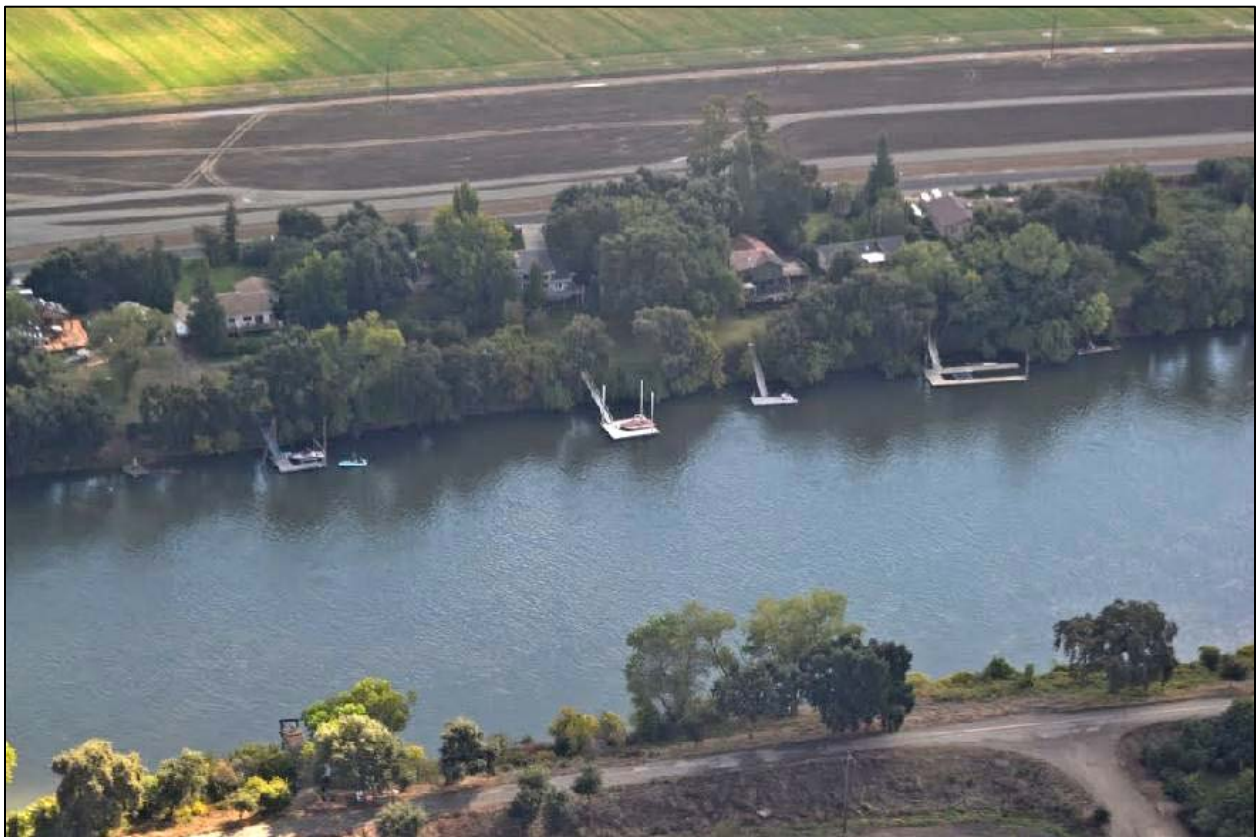
Figure 1-4. Typical View of the Sacramento River - Verona to American River Confluence (RM 79 to RM 61)

Sacramento River – Verona to American River Confluence (RM 79 to RM 61). This reach of the Sacramento River has the levees close to the river and contains the Sacramento Weir which diverts flow into the bypass system. This reach was intentionally designed with the levees close to the banks to help move some of the bed load and debris that remained from the days of hydraulic mining. In addition, USACE was responsible for keeping the river navigable up to the city of Colusa. As a result of this design, much of the reach is protected with rock, especially the outsides of bends. The majority of the rock in this reach consists of cobbles placed prior to the 1960s and some areas with more recent quarry stone. The cobble sites are reaching the end of their design life. Many of the levees are constructed of dredged soils from the bottom of the channel. This reach is also notable because it contains numerous private residences and commercial structures including boat docks on the waterside of the levee. Figure 1-4 shows a section of this reach of the Sacramento River.

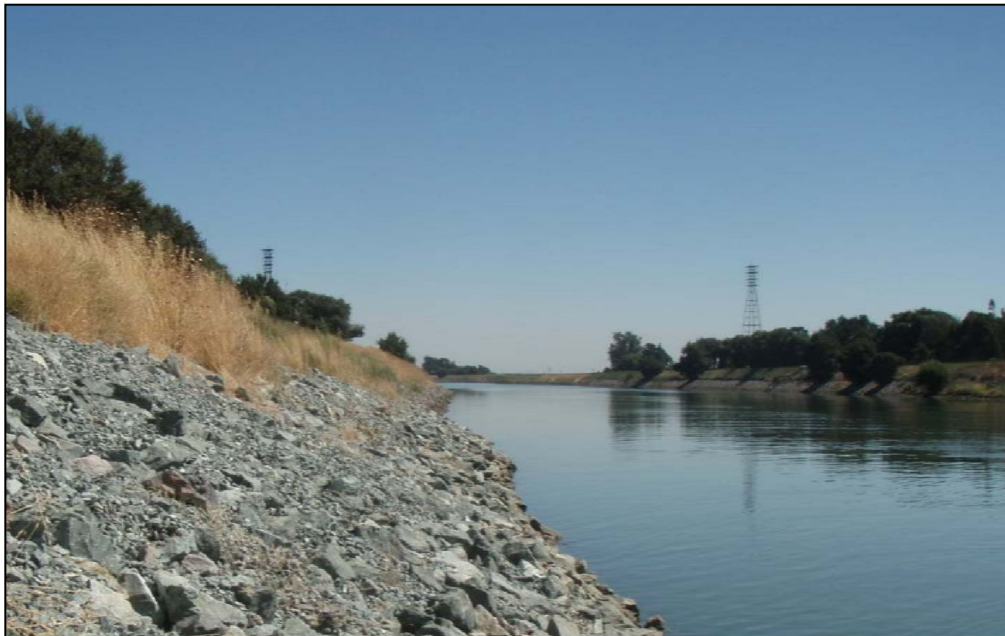
Figure 1-5. Typical View of the Sacramento River Sacramento River South, American River Confluence to Freeport (RM 61 to RM 45)

Sacramento River – Sacramento River South, American River Confluence to Freeport (RM 61 to RM 45). This section of the Sacramento River has tight levees and is tidally influenced. The location of the channel has been relatively stable for the past 150 years (although local scour and erosion can still be an issue). A large percentage of this reach has already been armored with riprap. This area has heavy wave action from recreational boats and wind, and the banks are heavily used by the general public in contrast to the reach discussed above where the banks are heavily occupied by private residences and commercial structures that limits public access along the levees. The general public use in this reach often creates local erosion by walking directly on the levee and banks. Many of the levees are constructed of dredged soils from the bottom of the channel. This reach does not have significant waterside structures such as private and commercial buildings, but has some sections of heavy vegetation and boat docks. Figure 1-5 shows a section of the Sacramento River South study area. The causes of erosion in this reach are boat wake, wind-wave, mass failure, fluvial processes, and public use.

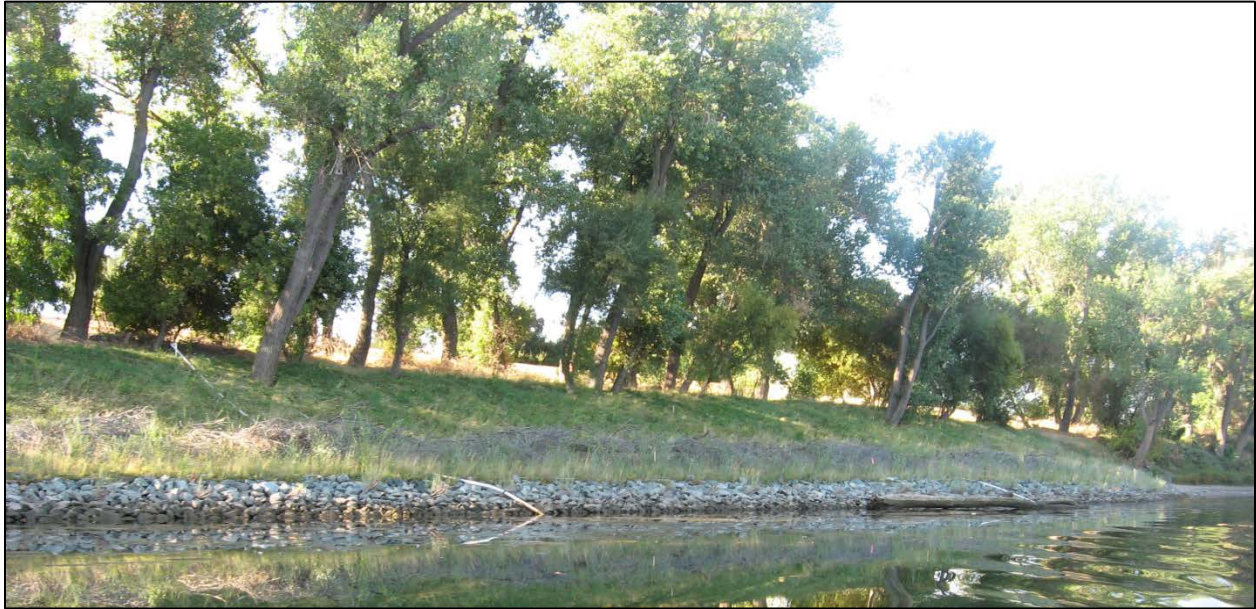
Figure 2-2. View of repair site on the left bankline near LAR RM 0.3 (2009)

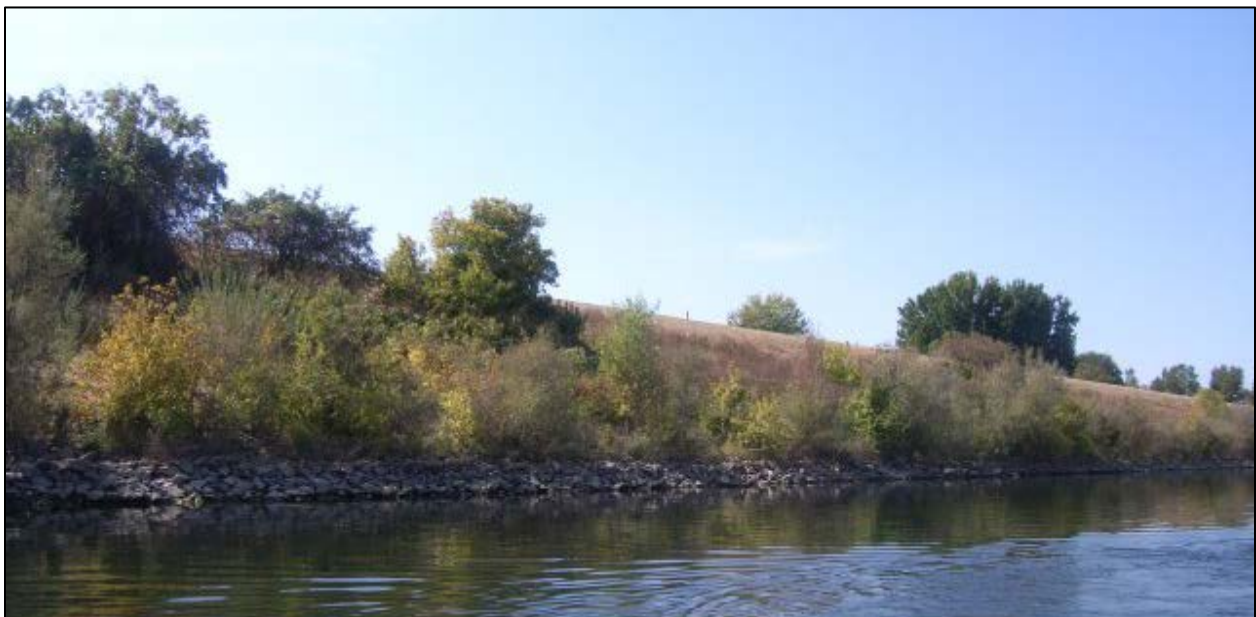
Figure 2-3. View of repair site on left bankline near LAR RM 4.3 (2010)

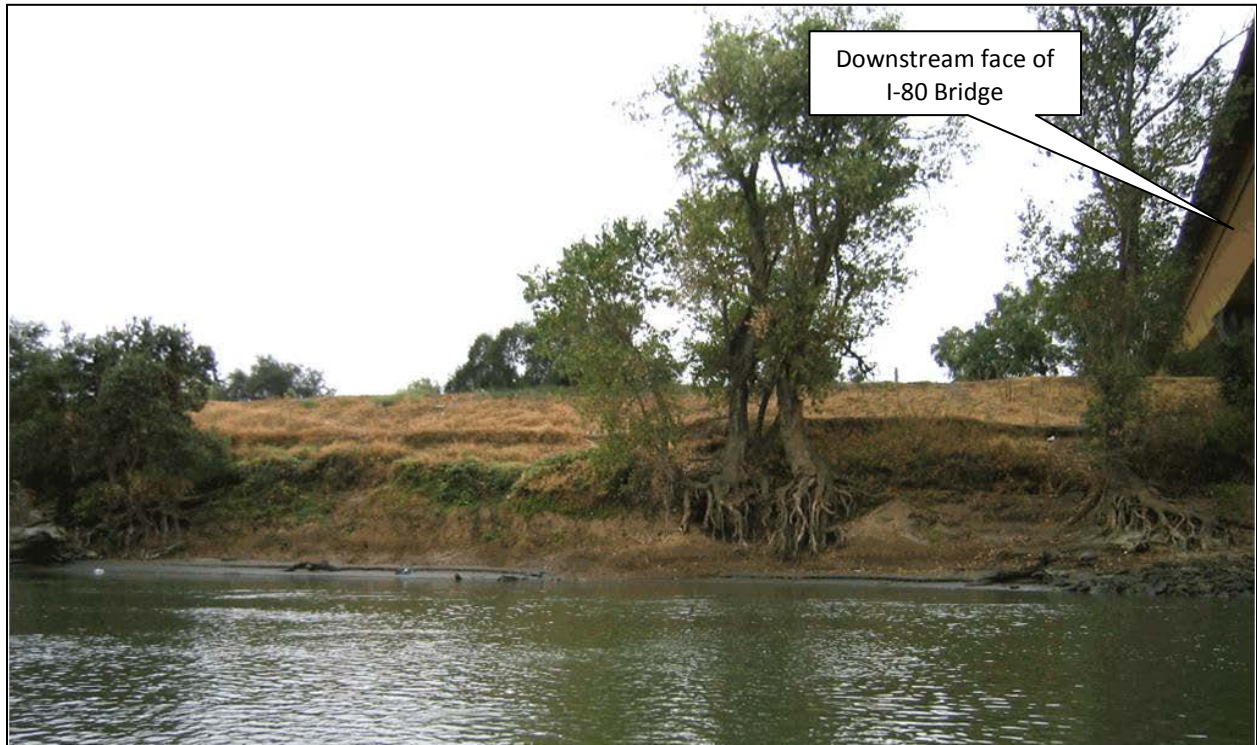
Figure 2-4. Erosion site of the right bank of the Sacramento River at RM 62.5 (2005)

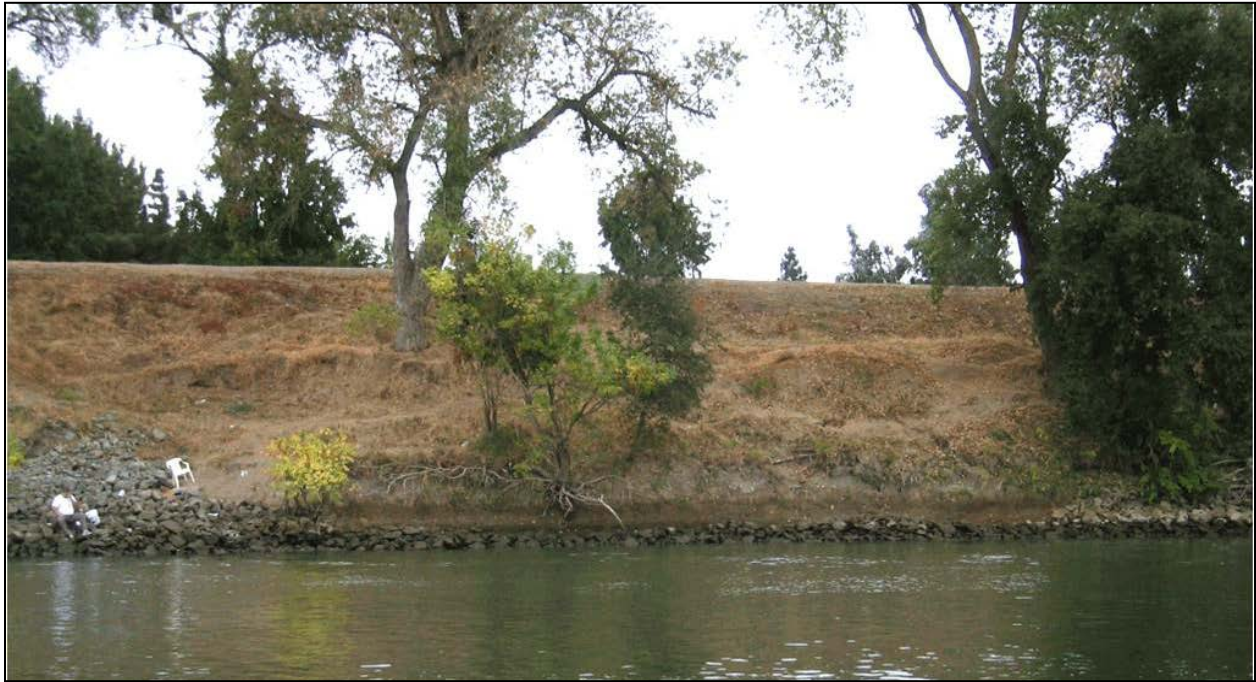
Figure 2-6. Erosion site of the left bank of the Sacramento River at RM 53.2 (2005)

Another Sacramento River erosion site is illustrated in Figure 2-6. Specifically, this photo shows the erosion and slope stability problems along the left bank at RM 53.2 in 2005. The repair for this site is shown in Figure 2-7 which was completed under the SRBPP.

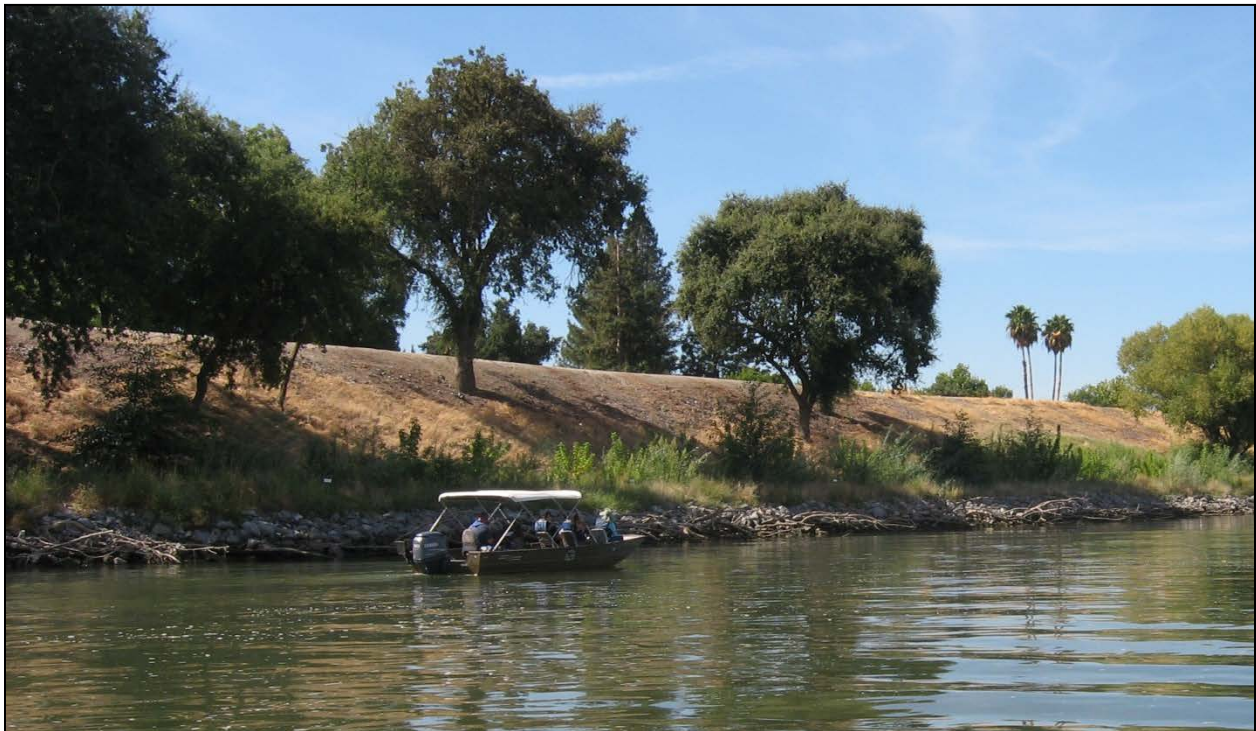
Figure 2-7. Repaired site at Sacramento River left bank RM 53.2 (2009)

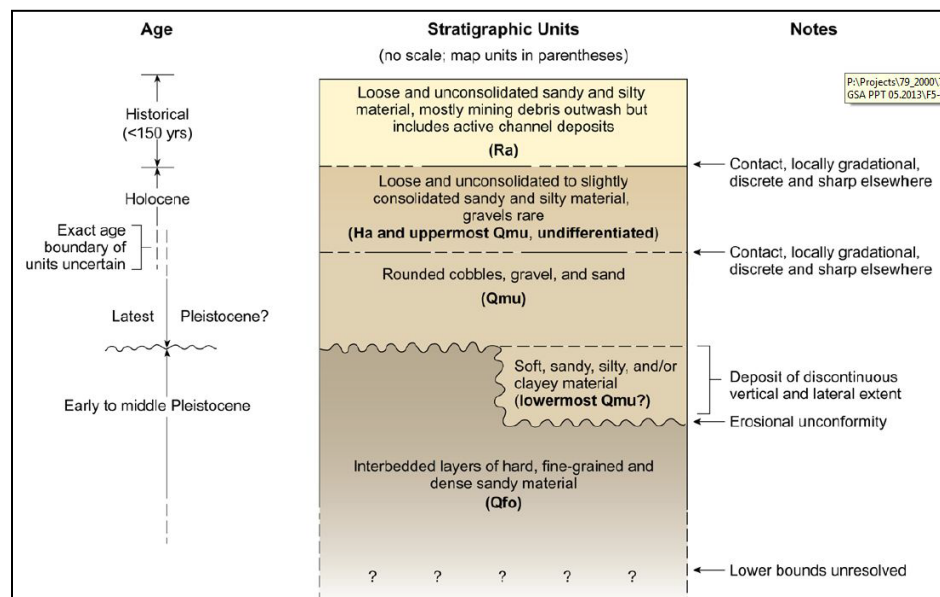
Figure 3-1. Generalized, composite stratigraphic section of the Lower American River

Detailed geologic mapping, as well as petrographic and pedogenic analyses, completed during this study demonstrated the presence of two potentially erosion-resistant units within the stratigraphy of the LAR. These were: (1) a moderately cohesive silty and sandy interbed of relatively limited lateral and longitudinal extent within a thicker package of loose Holocene sediments (the "upper" unit); and (2) much thicker, more widespread relatively erosion-resistant deposits associated with the Pleistocene-aged Fair Oaks formation of Shlemon (1967) (the "lower unit"). Figure 3-3 presents a generalized stratigraphic section.

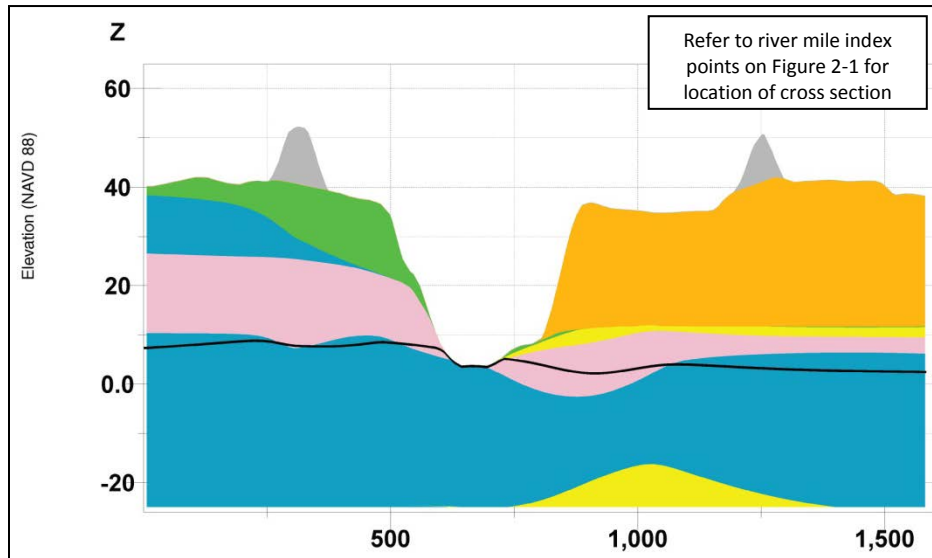
Figure 3-2. 3D Stratigraphic Model Section 11 Near RM 7.2

Figures 3-4 and 3-5 are examples of cross sections generated from the 3D stratigraphic model depicting the layer discussed above. Figure 3-6 provides a graphical legend for stratigraphic units displayed in the cross sections. Figures 3-4 and 3-5 are looking downstream.

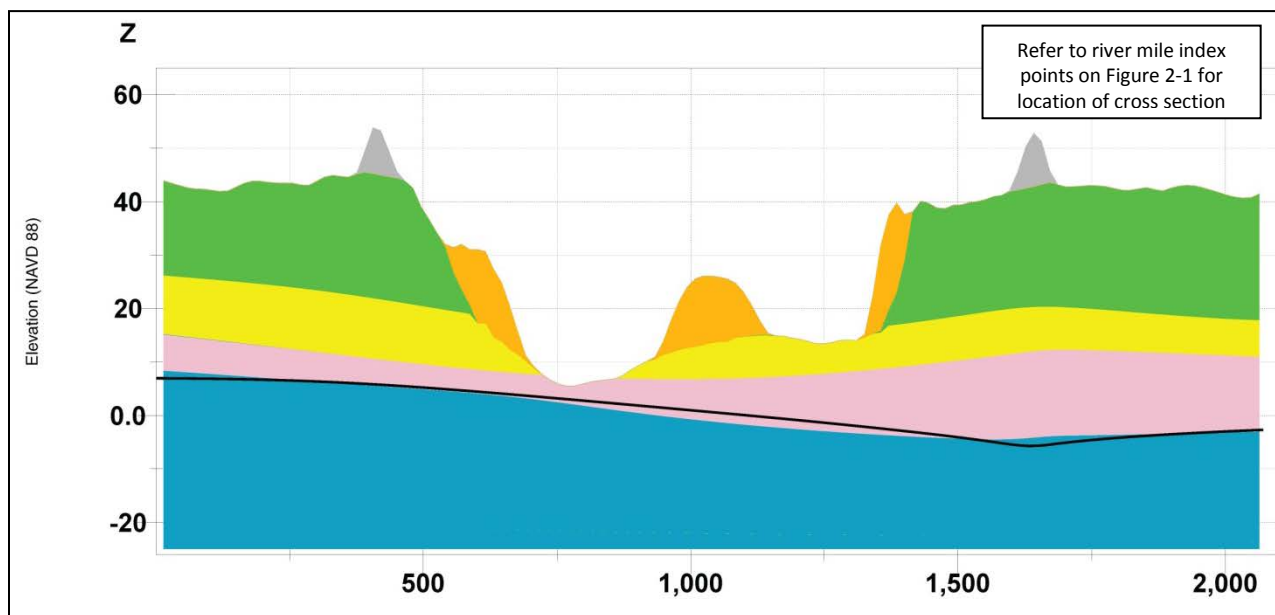
Figure 3-3. 3D Stratigraphic Model Section 15 Near RM 7.9

EXPLANATION	
Fill	= Fill; levees, road embankments, other
1850	= 1850s mining deposits
SS	= silty sand, sandy silt, silt, sand
S	= sand; locally silty sand, gravelly sand, clayey sand
BCG	= boulders, cobbles, gravel, with sand; locally with silt and clay
CS	= silty clay, sandy clay, clay; locally clayey sand, silty sand, silt
C	= clay
—	= Erosionally resistant surface

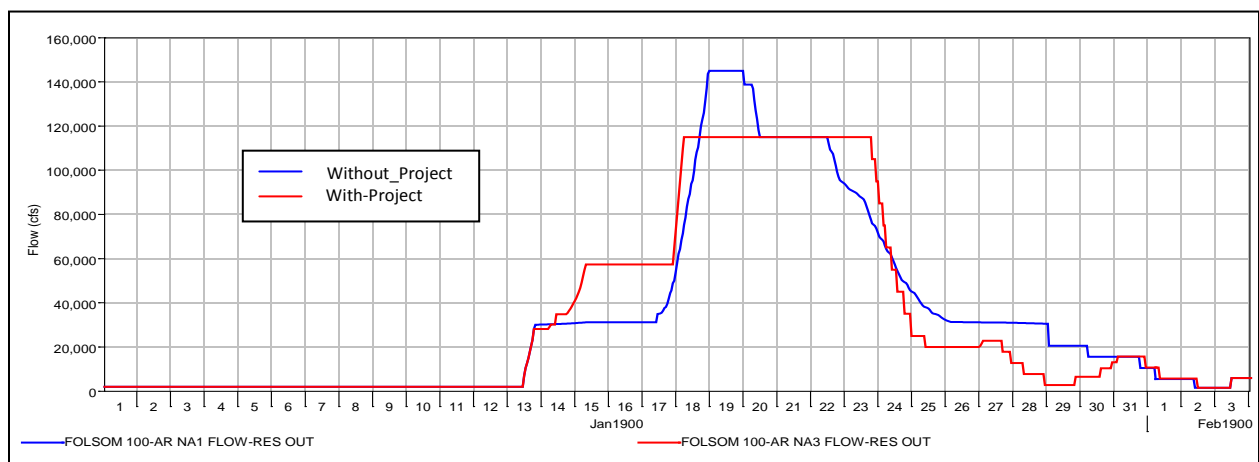
Figure 4-3. With- and without-project hydrographs for the 1% (1/100) ACE event on the LAR

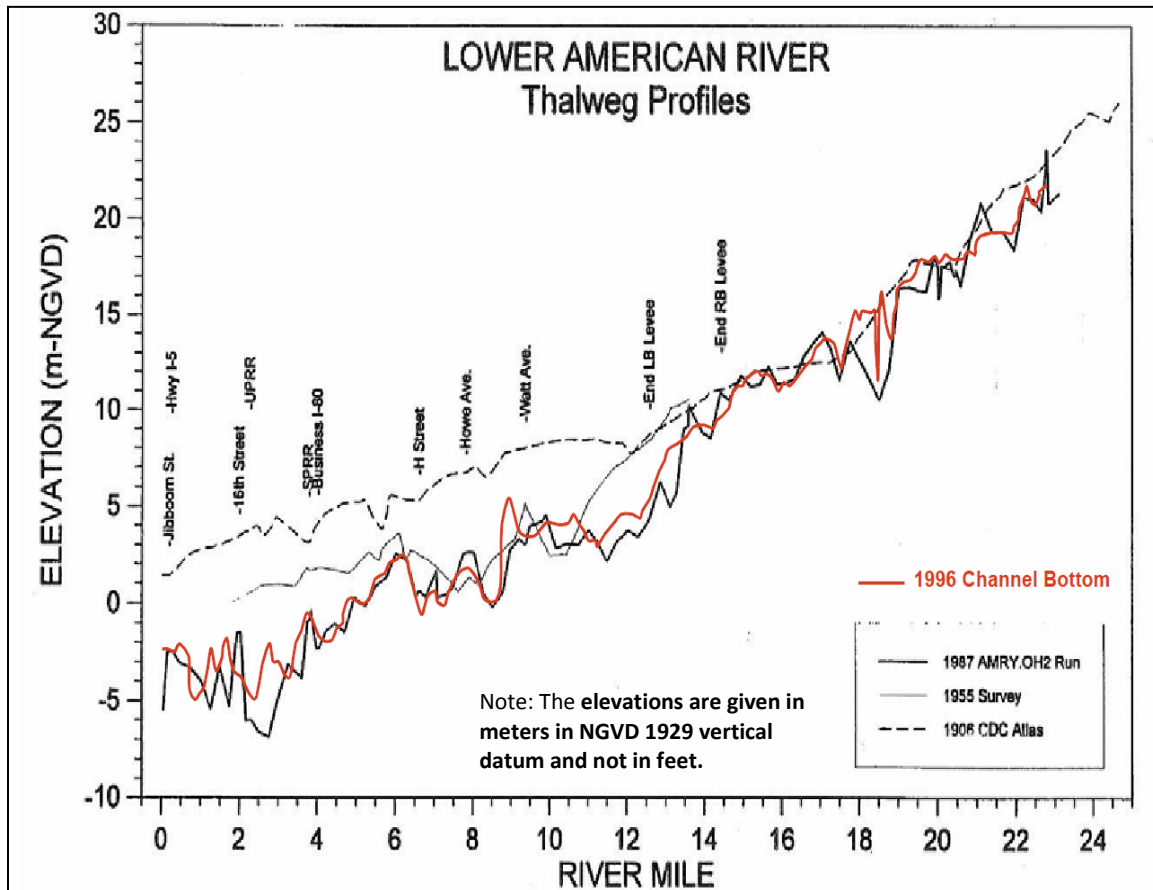
Figure 5-1. Historical profile of the Lower American River showing general degrading trend since 1906 (NHC 2009)

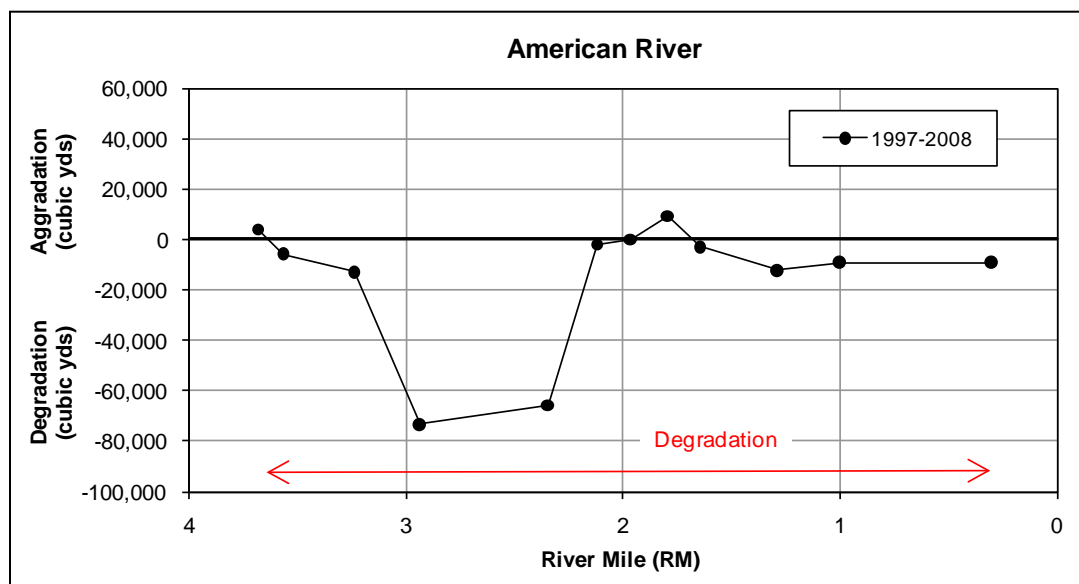
Figure 5-3. Aggradation/degradation trends for lower portion of the American River showing degradation between 1997 and 2008, supporting the trend noted in long-term HEC-6T simulations

an average of 0.67 feet over the lower 3.7 miles. This degrading trend is shown in Figure 5-3 below (NHC 2012) (Note elevations are in meters). A similar degrading trend is also observed further upstream using a different approach. A plot of the changes in rating curve for the Fair Oaks gage on the American river indicates a general trend of erosion from 1986 to 2008 as shown in Figure 5-4 (NHC 2009). This general erosional trend is expected to occur in the future as indicated in Figure 5-5.

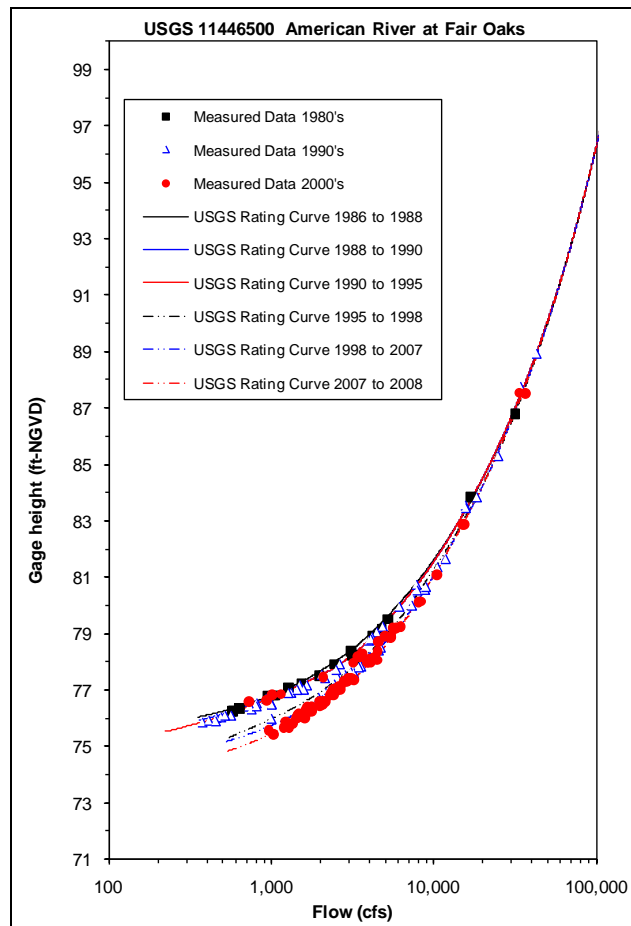
Figure 5-4. Stage versus flow plot of Fair Oaks gage on the American river indicating vertical erosion (reduction of water surface for the same discharge) from 1986 to 2008 (from NHC 2012)

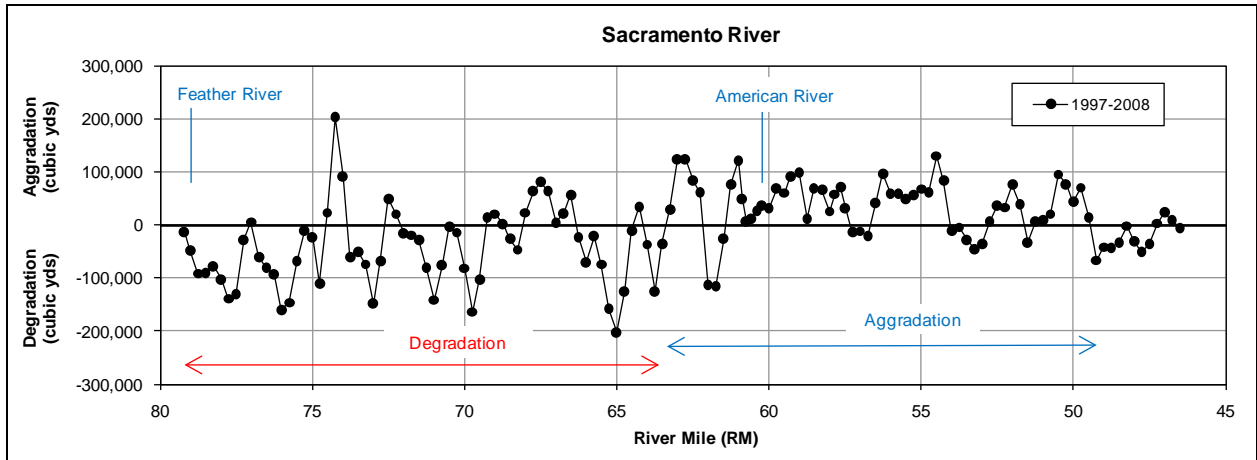
Figure 5-6. Aggradation/degradation trends of a portion of the Sacramento River showing aggradation between the Sacramento Weir and Freeport between 1997 and 2008, supporting the trend noted in long-term HEC-6T simulations

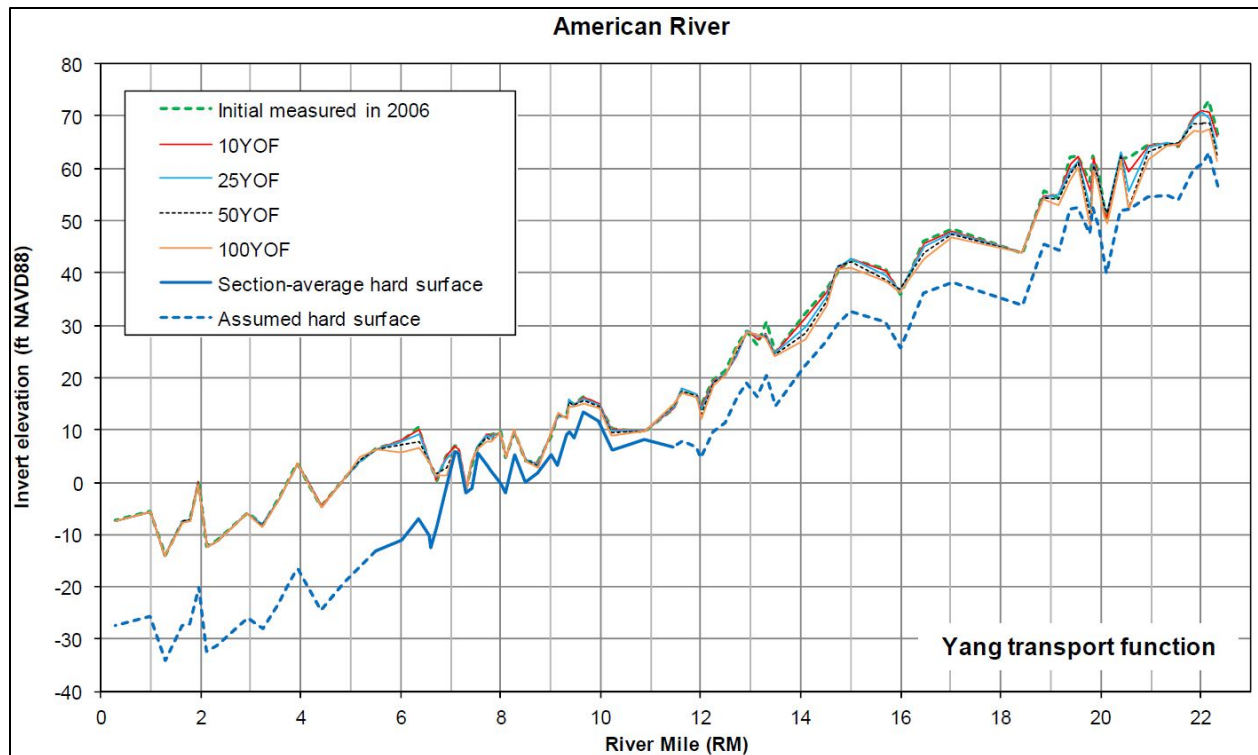
Figure 5-9. Draft results from simulation of a series of high flow flood events showing estimated erosion resistant material (e.g. Section-average hard surface).

Therefore the results depicted in Figure 5-9 cannot be compared directly with those shown in Figure 5-5. The amount of scour seems to be much less than previously predicted, which may be partially explained by model differences noted above. Despite these model differences, the average expected channel erosion for the Lower American River for 50 to 100 years of simulation is about 5 to 7 feet (see in Table 5-1). The results show it is possible the channel will degrade to the erosion resistant material between RM 6.5 and 10 (as shown in Figure 5-9). It is also possible that the bed will erode to the erosion resistant surface for portions of the reach above RM 15 (above where the current federal levees end); especially since the depth of active erosion likely exceeds that observed or predicted by the models. This makes protecting the levee toe critical for flood risk reduction and future degradation upstream of the levees may have detrimental impacts on environmental and recreational interests in that reach.

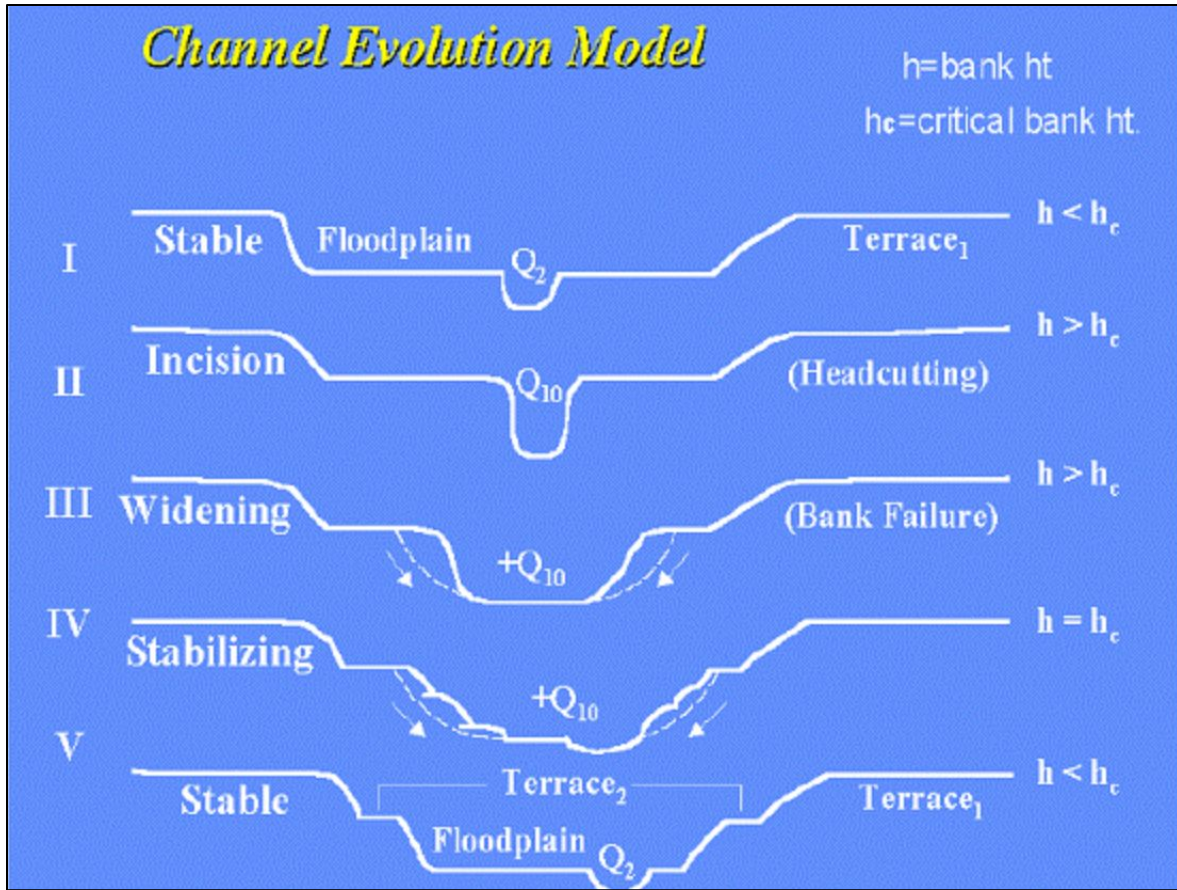
Figure 5-10. Channel Evolution Model describing how a stable channel responds to a disturbance that causes channel incision before reaching a new stable dynamic equilibrium

Similar to the Lower American River, the Channel Evolution Model indicates channel widening potential between Verona and the Sacramento Weir due to degradation. The reach between the Sacramento Weir and Freeport is already relatively confined by levees and it is possible the long-term aggrading trend shown in Figure 5-7 becomes degradational during individual flood events. This is supported by HEC-6T model results that show long-term aggradation for this reach (Figure 5-7) but degradation during an individual flood event (Figure 5-8). The Channel Evolution Model is applicable to long-term trends and not individual flood events. However, it is reasonable to conclude the degradation expected in this reach during a single flood event could destabilize channel banks that exceed a critical height threshold, leading to bank failure and channel widening at least in localized areas. Further, Therefore channel widening could be a possible long-term result for this reach as well due to destabilization of channel banks from degradation during flood events. This observation indicates lateral erosion and channel widening can reasonably be expected for both the Lower American River and Sacramento River within the Common Features GRR project.

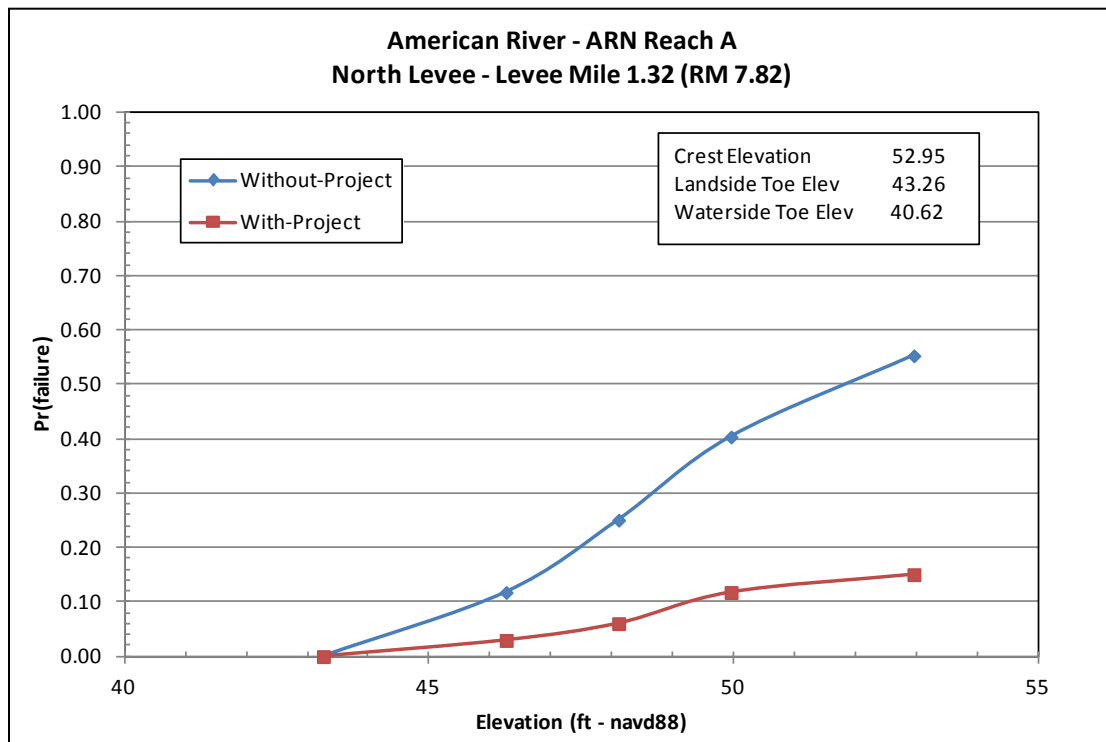
Figure 5-12. “Judgment” component of the levee fragility curves for the American River north levee at RM 7.82

fragility curves in these figures indicates the change, or reduction, in probability of failure due to with-project improvement measures. Both the with- and without-project fragility curves account for the reduction in probability of poor performance due to the cutoff walls constructed as part of the ARCF WRDA 1996-1999 project. Therefore, the combined fragility curve at these two locations represents the judgment curve, of which erosion is the primary contributor to the without-project curve. The with-project curve accounts for residual risk due to vegetation, animal burrows, encroachments, and utilities that may not be addressed by the project alternatives or structural improvements. In both sample figures, the cumulative probability of poor performance, or levee failure, is less than 20 percent for the condition where the water surface elevation is at the top of the levee crest once the project is constructed. Without the project, the cumulative probability of poor performance is greater than 50% and indicates the erosion protection provided by this project is needed to reduce flood damage risk.
