# PA 62 - SURVEY AREA 'A'

# PA 62 - SURVEY AREA 'B'

# PA 63 - SURVEY AREA 'C'

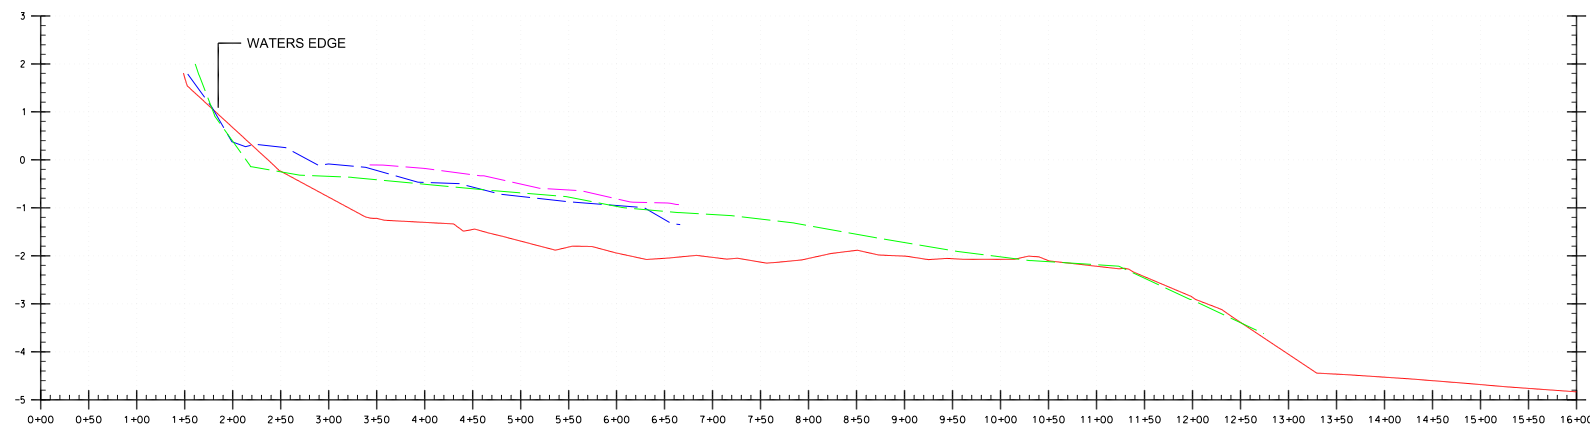
CROSS-SECTION

Note: January Survey was performed before the contractor was finished pumping in this area.

All surveys shown are referenced to NAVD88 Elevation.

- January Survey
- April Survey
- July Survey
- Existing Ground Surface

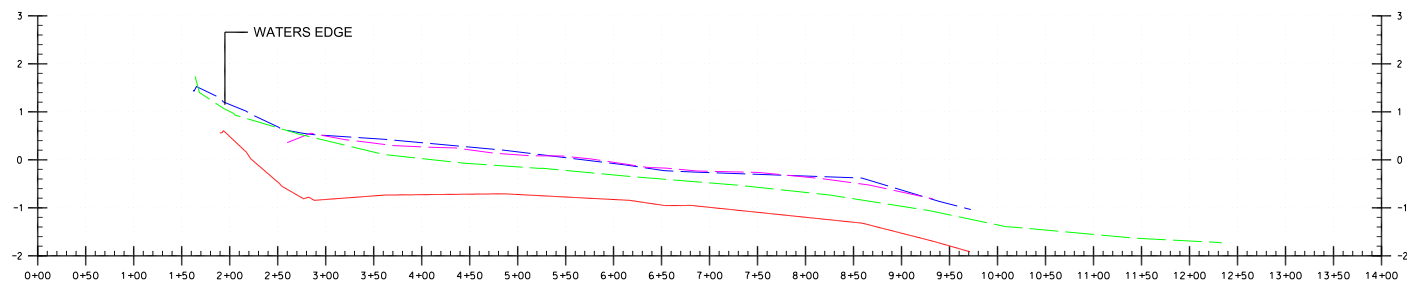
CROSS-SECTION

- January Survey
- April Survey
- July Survey
- Existing Ground Surface

Note: All surveys shown are referenced to NAVD88 Elevation.

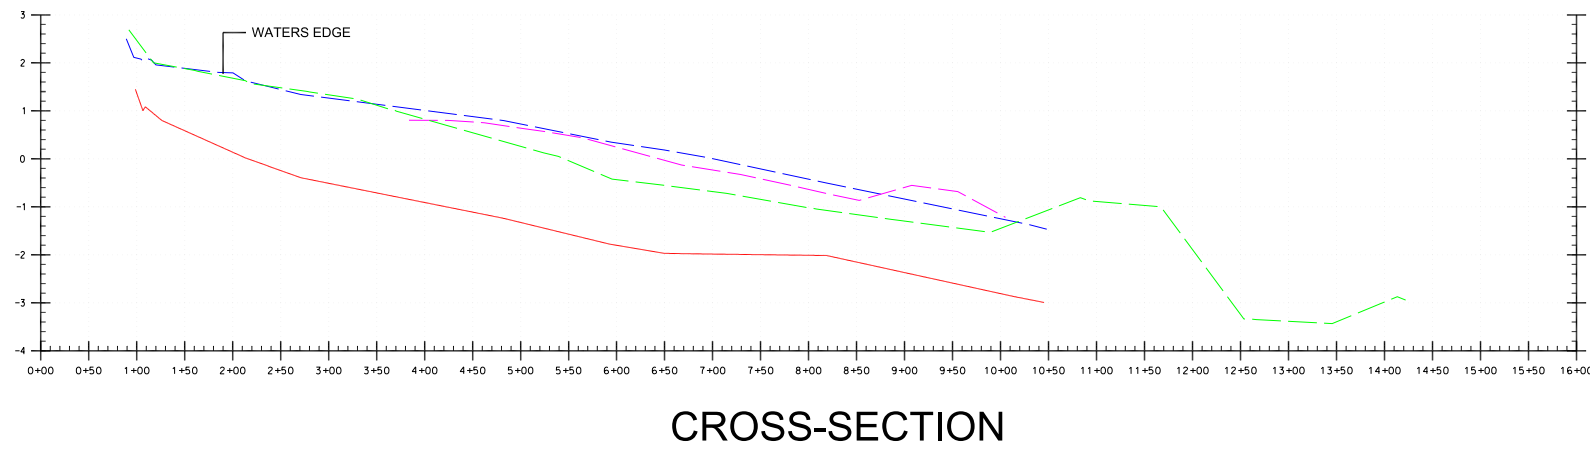
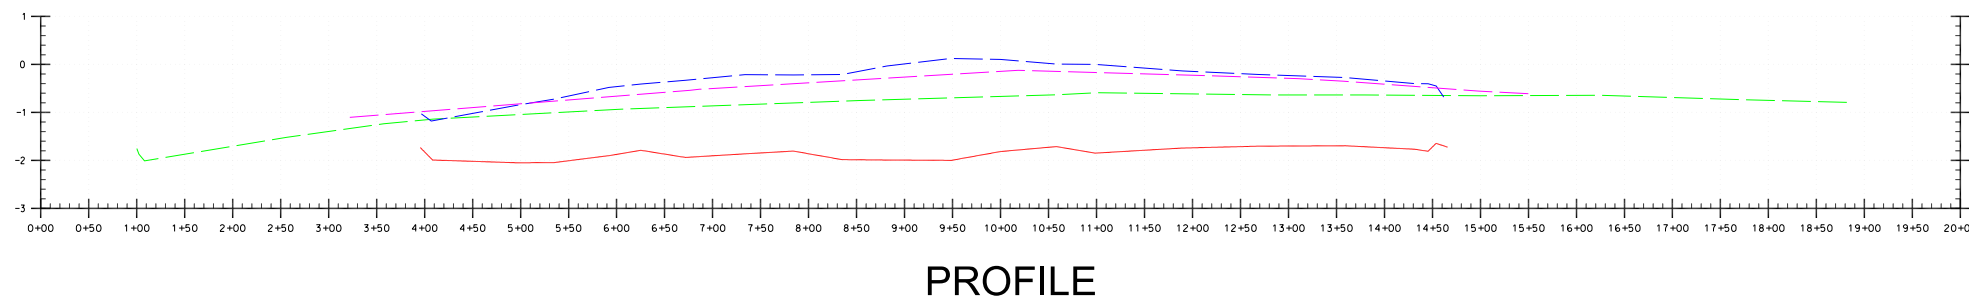
- January Survey
- April Survey
- July Survey
- Existing Ground Surface

Note: All surveys shown are referenced to NAVD88 Elevation.

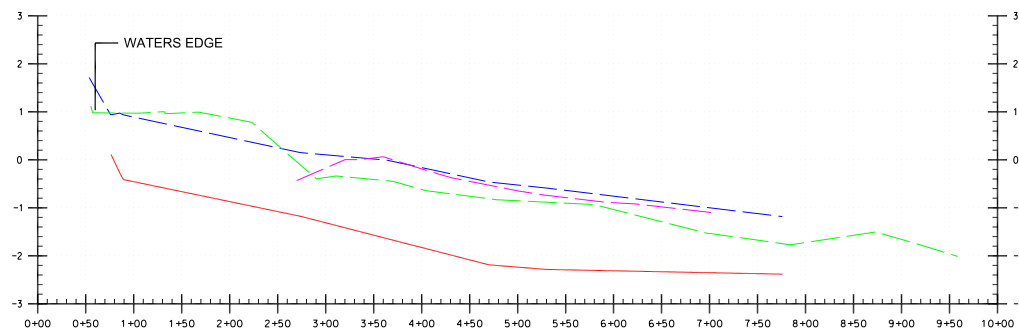
CROSS-SECTION

- January Survey
- April Survey
- July Survey
- Existing Ground Surface

Note: All surveys shown are referenced to NAVD88 Elevation.

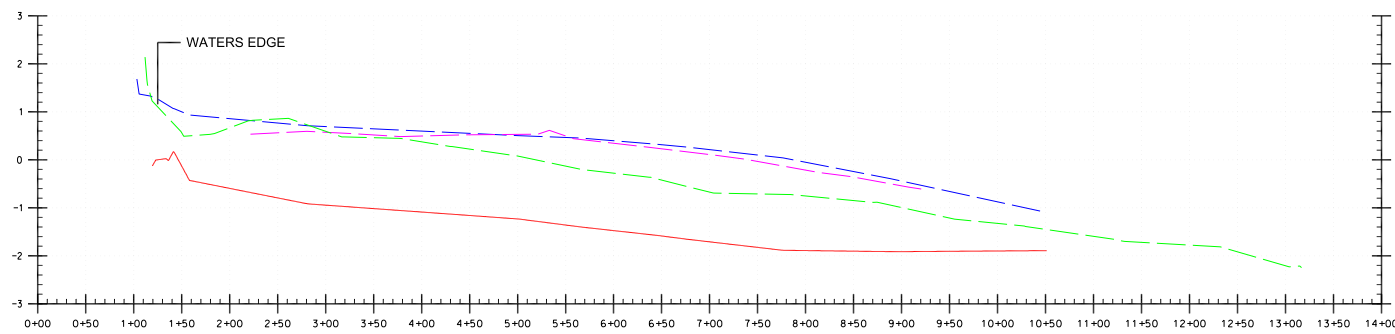
CROSS-SECTION

- January Survey
- April Survey
- July Survey
- Existing Ground Surface

Note: All surveys shown are referenced to NAVD88 Elevation.
