SURVEY OF SEAGRASS BEDS AT PLACEMENT

AREAS 62 & 63, WEST BAY

CONTRACT NO. W912HY-10-C-0036

BELAIRE ENVIRONMENTAL, INC.

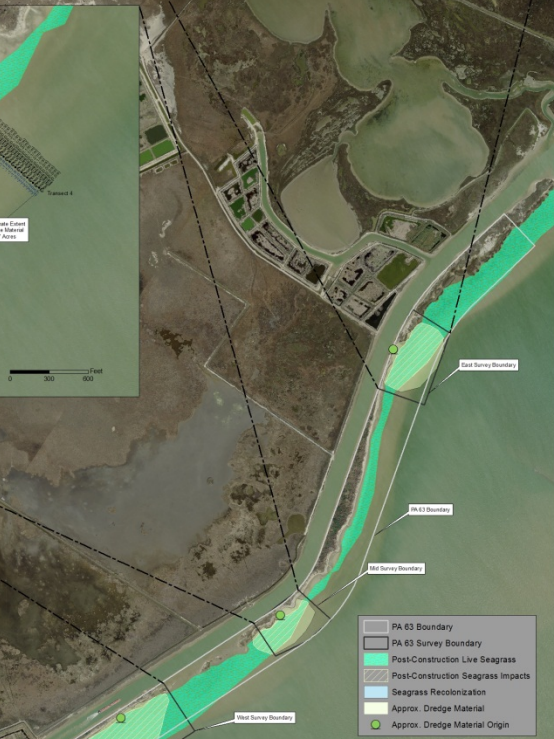
**Figure 4a: Data Overview Map
Seagrass Survey Area
Corps of Engineers GIWW PA63,
Galveston County, Texas**

- Overall Elevations: -3.612 Ft to +3.369 Ft (NAVD88)
- Shoalgrass: -2.348 Ft to +0.545 Ft
- Clovergrass: -1.514 Ft to -0.584 Ft

- Surveyed Nov. 2012
- 1,218 post hole samples
- Along 9 transects
- Average depth of 0.85 ft of previously placed dredge material
- Average buried seagrass root depth of 0.99 ft

Placement Area (PA) 63:	
Seagrass Impacts:	Acres
East Survey Area	27.33
Mid-Survey Area	16.57
West Survey Area	48.04
Total Impacts:	91.94
Dredge Material Areas:	
East Survey Area	40.69
Mid-Survey Area	27.27
West Survey Area	47.59
Total DMA:	115.55
Seagrass Recolonization in DM:	1.89
Post-Construction Total Area of Live Seagrass (acreage outside of DM impact areas):	150.35

- APPROXIMATELY 91.9 ACRES OF SEAGRASS BEDS WERE BURIED AS A RESULT OF THE PLACEMENT OF APPROXIMATELY 115.6 ACRES OF DREDGE MATERIAL IN PA62
- A 1.86ACRE AREA OF SHOALGRASS BED IN PA 62 HAS BEGUN RECOLONIZING ATOP DREDGE MATERIAL SINCE THE PLACEMENT OF MATERIAL IN 2011-2012
