# Contractor Serious Mishap

## Crane Boom Collapse

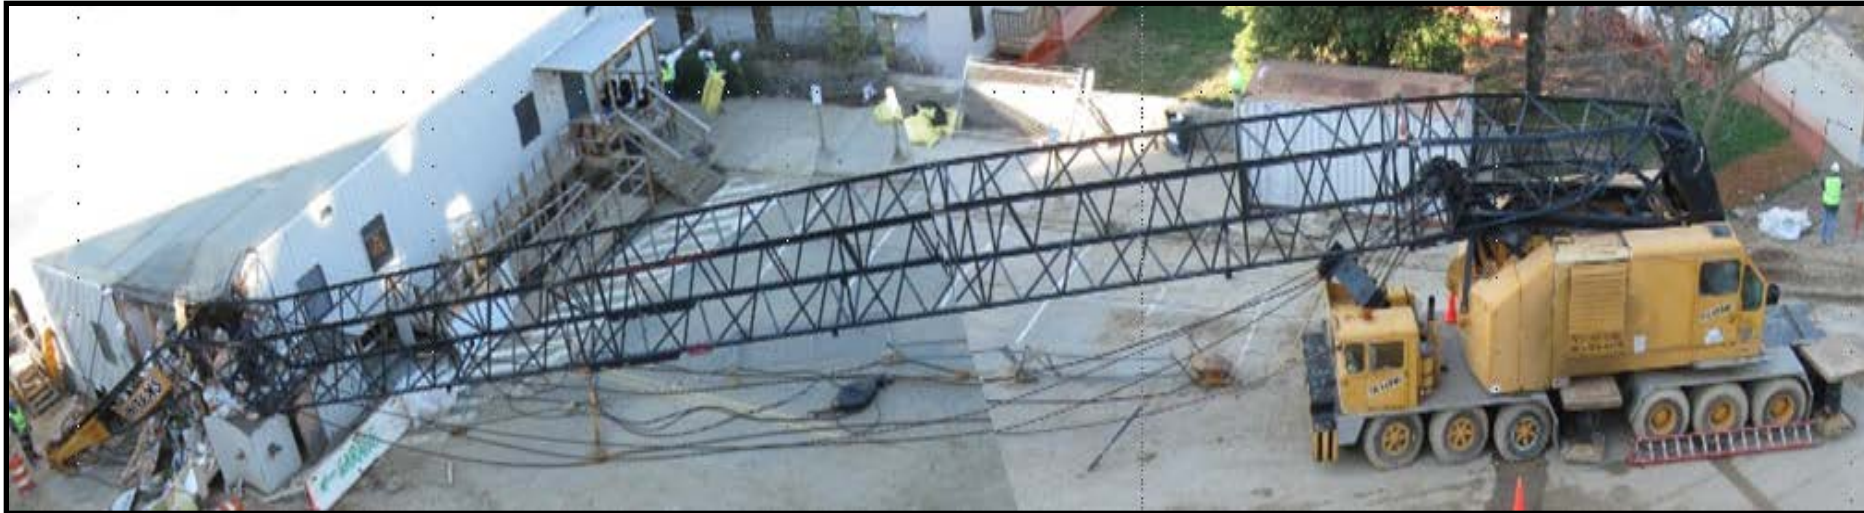
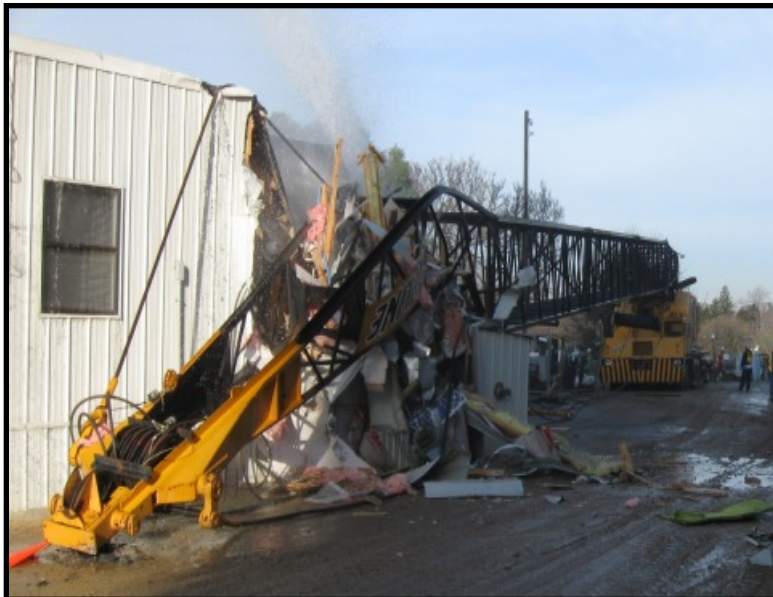
- **140 ton model 3900 Manitowoc crane**
- **Activity:** Crane operator left crane cab unattended with running engines during pre-cast concrete installation. Boom rose, breaking two load line anchor points off the frame, & collapsing boom backward.
- **Damage:** Crushed corner of temporary on-site office trailer.
- **Root causes:**
  - Crane unattended with running engine
  - Torque converter rigged to full power; bypassing controls
- **Lessons learned:**
  - **NEVER** leave running crane unattended
  - Controls must be well maintained and never bypassed

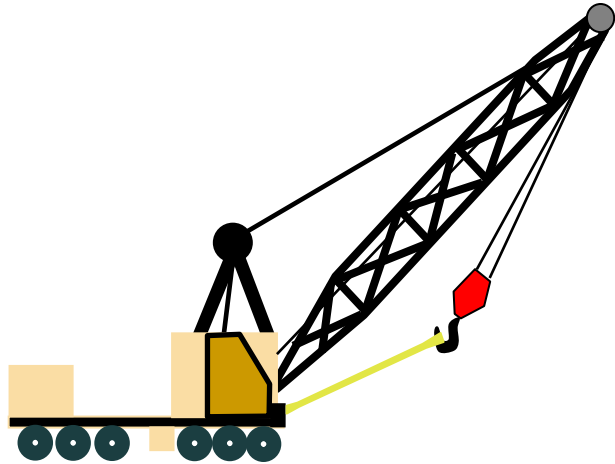
Original position – crane idling (there were two hooks – only one shown)

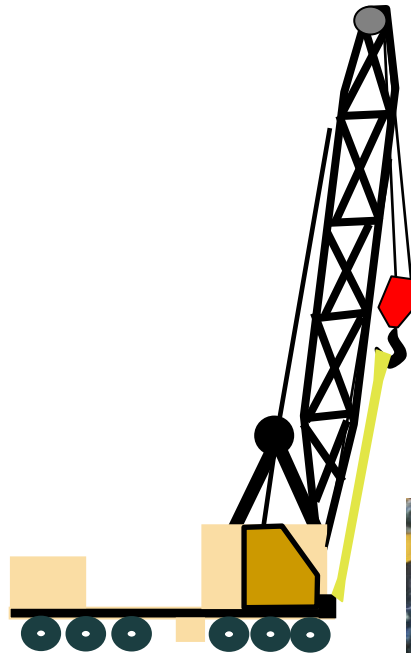
Approximate position when two loud pops were heard (cast iron rings breaking off)

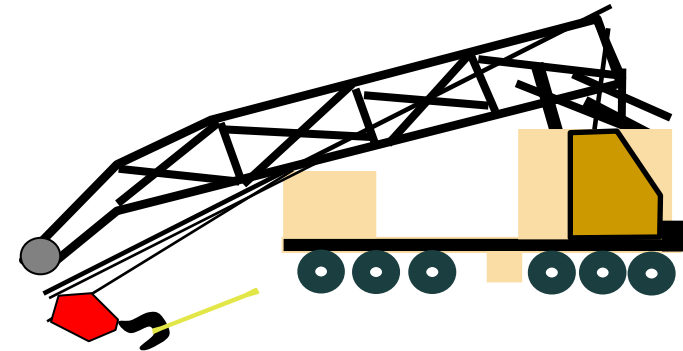
Final position
