Contractor Serious Mishap

Crushed by Piling

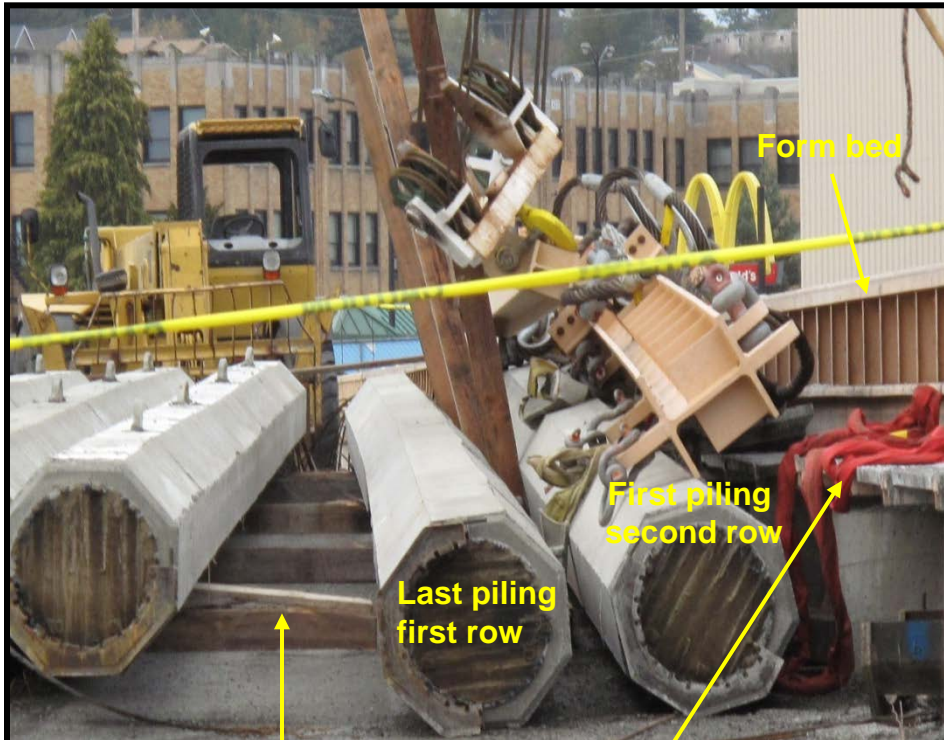
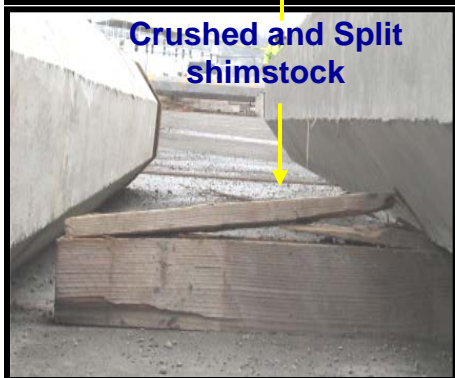
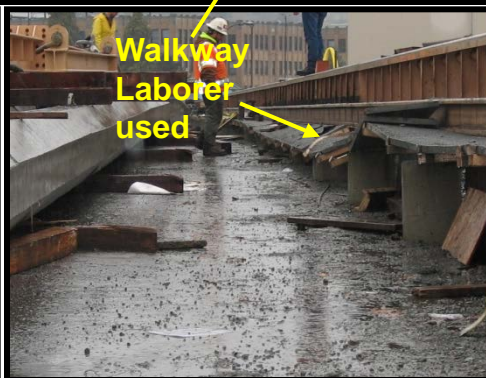
• **Activity:** Stowing newly casted pilings. First row of pilings were placed on dunnage and shimstock. Second tier begun with outside piling located on last piling set. Rigging was removed by rigger and laborer and both moved away from site on form bed walkway. After stowage of second tier piling, it rolled on the legs of the laborer standing in form bed walkway.

• **Injury:** Partial leg amputation; fractured leg and hip

- workers knowingly worked in a crushing hazard area
- failure of shimstock and dunnage
- no inspection criteria used
- storage area surface slopes
- training of personnel assisting in handling pilings

- Activity Hazard Analyses must be updated when additional site hazards are discovered
- Inspection criteria must be developed and followed when using wood dunnage for storing heavy materials
- Personnel must be properly trained and supervised when engaging in unfamiliar workplace activities
