Contractor Serious Mishap

Fall From Heights

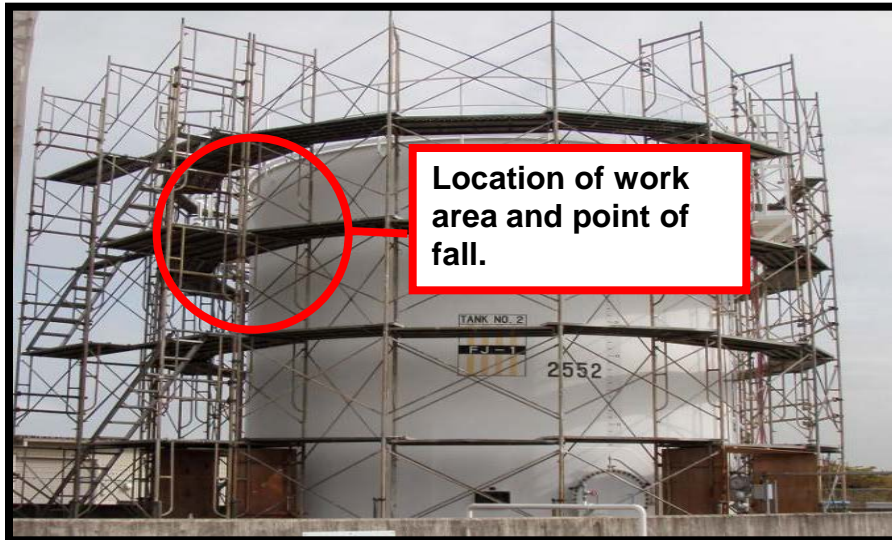
Location of work area and point of fall.

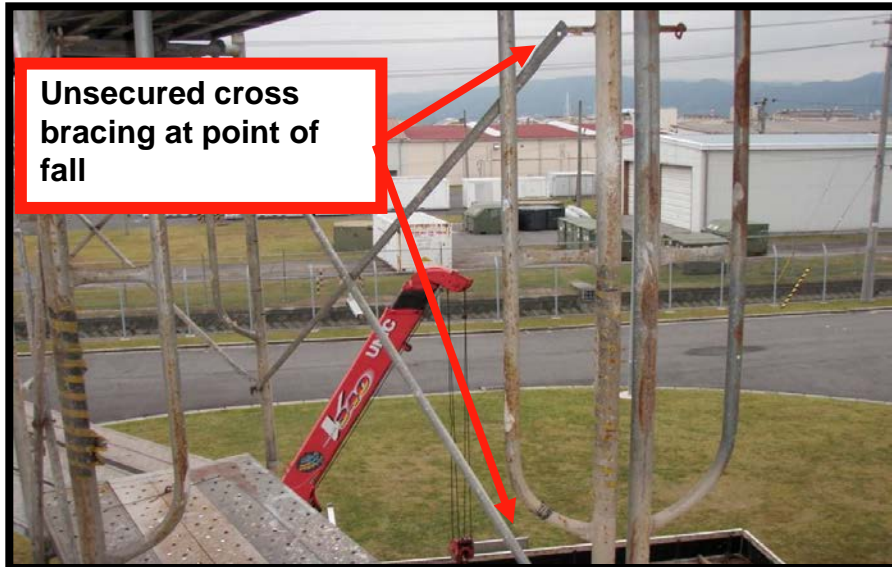
Unsecured cross bracing at point of fall

- **Injury:** Male Contractor Employee in Coma over 60 days
- **Activity:** Workers were assembling a scaffold work platform around fuel tank. While allowing access for co-worker, victim stepped on outboard side and fell through an unsecured cross brace approximately 18 ft. (5.4 m) to ground.
- **Direct Cause:**
 - Failure to attach, and maintain attached at all times, personal fall arrest system while working at heights
- **Root Cause:**
 - Safety culture and workforce mindset in an overseas environment.
- **Lessons Learned:**
 - Erection, moving, dismantling, or altering of work platforms shall be under the supervision of a Competent Person in accordance with EM 385-1-1, Safety and Health Requirements Manual, Paragraph 22.A.05
 - Educating and mentoring contractors on EM 385-1-1 requirements shall remain a priority until demonstrated proficiency across entire contractor workforce.

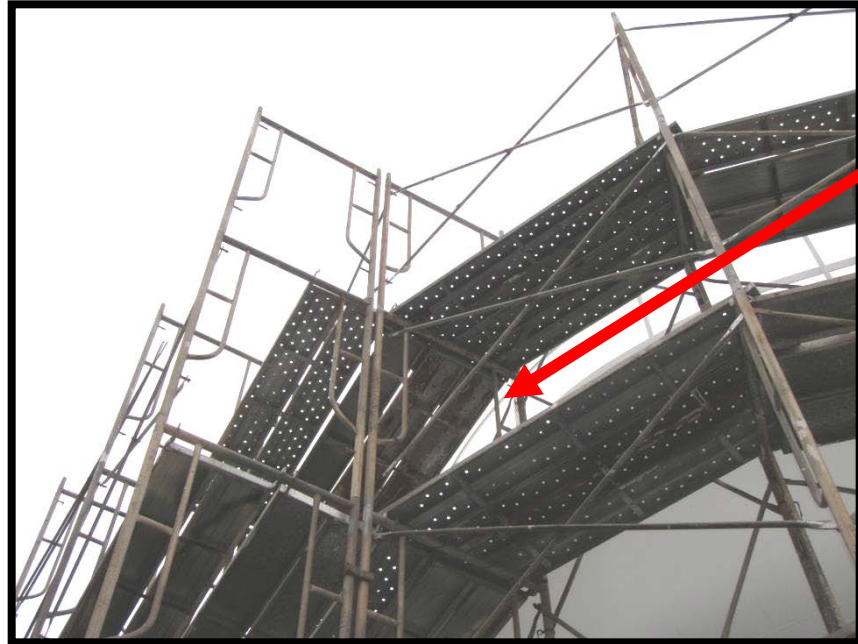
Approx. location of fall point looking up from the bottom of scaffolding.

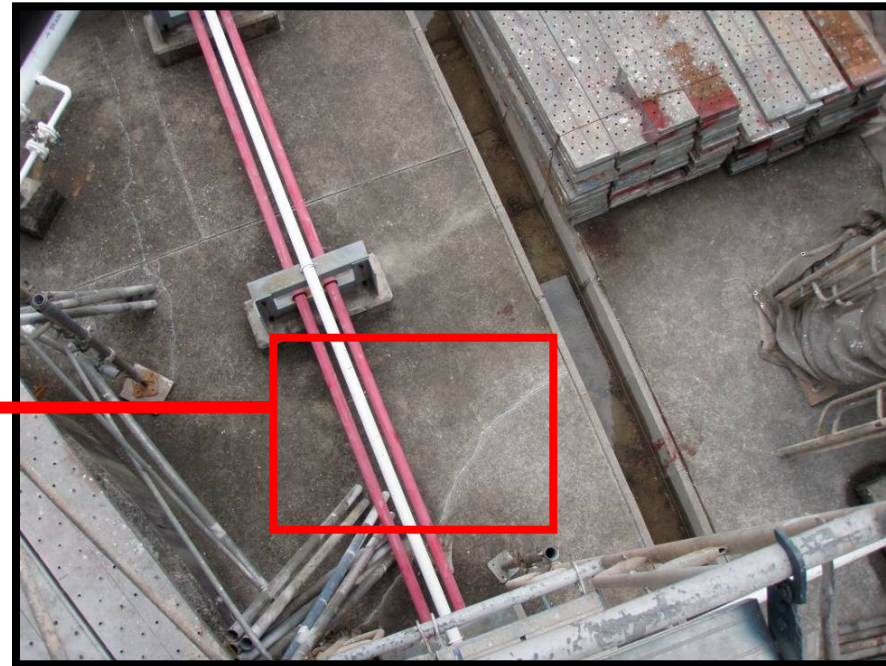
Approx. location of fall landing area from fall point looking down 18 ft (5.4 m).

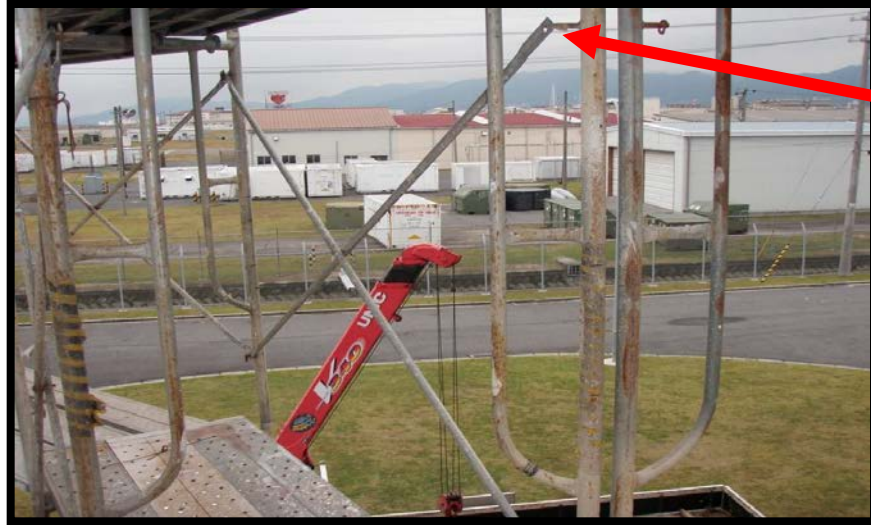
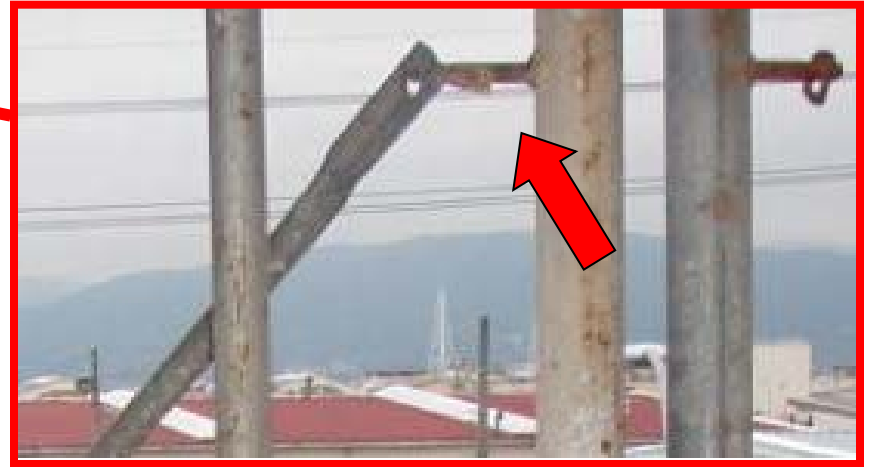
**Unsecured "X" bracing
at the point of the fall.**
