Property Damage Falling Brick Tower

Activity: Building Demolition

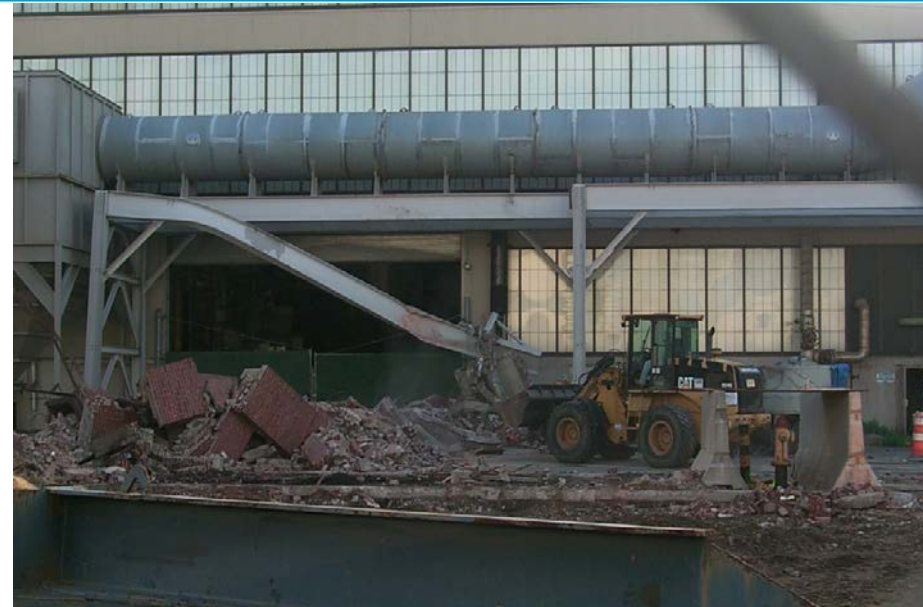
A contractor was removing a 62ft. high brick tower of an old fire house. With the fire house portion of the demo complete, the contractor intended to demo the brick tower by removing several top sections by hand, then using a grappler to complete the demo. This changed when the contractor found the top section (Roof) was made of concrete. The contractor attempted to pull the top concrete section down with wire rope attached to an excavator when the base of the tower collapsed. The brick tower fell east striking and damaging a beam of another facility.

Failure to use proper equipment and approach for demolition.

- AHA did not detail the hazards.
- No FEAD notification before starting critical activity
- No EM-385-1-1 required Engineering and Demolition Plan signed by a Registered Professional Engineer
- No ORM adjustment made when conditions changed

- Ensure an Engineering and Demolition Plan is provided by a Registered Professional Engineer.
- AHA must be site specific for each definable feature of work, and all control measures must be followed.
- Ensure diligence in all three phases of QA / QC
