# Contractor Near Miss Toppled Excavator

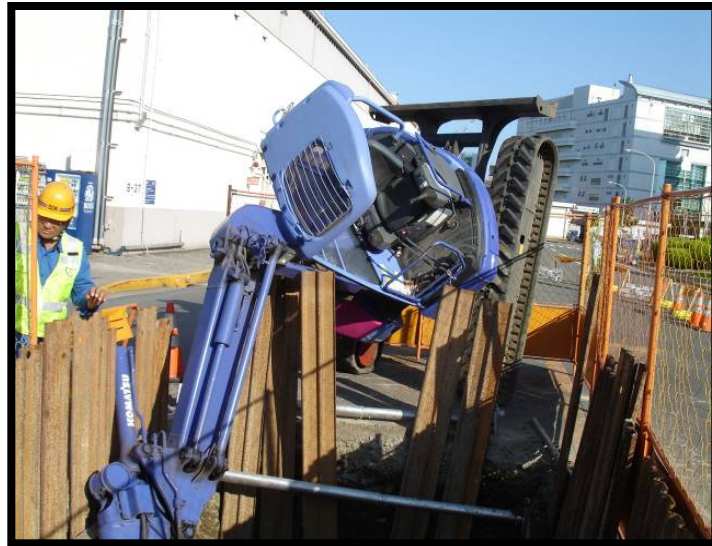
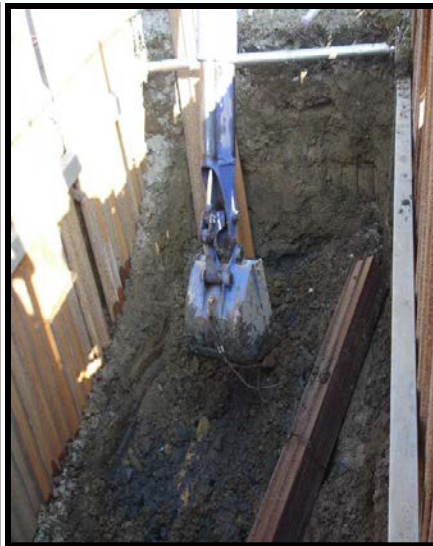
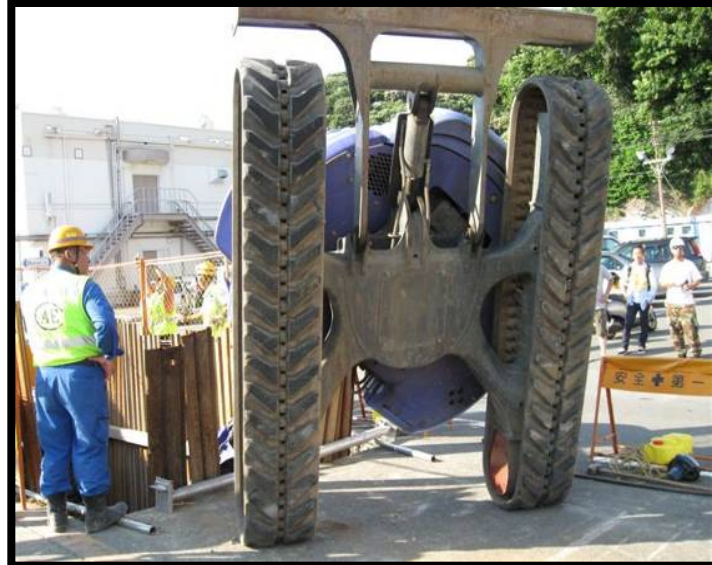
A contractor was using an excavator to lift sheet piles into an excavation. As the boom for the excavator was extended to place a beam in the excavation, the lifting load capacity for the excavator was overloaded causing the excavator to topple forward until the bucket landed in the bottom of the excavation.

Improper use of equipment. Excavator was not designed to be used as weight handling equipment.

Operator was not licensed to operate excavator as a crane.

- Document, review, and post P1 “Certificate of Compliance” crane documentation IAW contract specifications.
- Use the right equipment for the job or activity.
- Proactive safety oversight by Contractor and Government personnel IAW contract specifications and BMS processes
